# NATIONAL TRANSPORTATION SAFETY BOARD

## MATERIALS LABORATORY FACTUAL REPORT

Report No. 18-027

Place : Westphalia, Kansas  
Date : September 29, 2017  
Vehicle : Piper PA-25-235, N7336Z  
NTSB No. : CEN17LA372  
Investigator : Aaron Sauer, AS-CEN

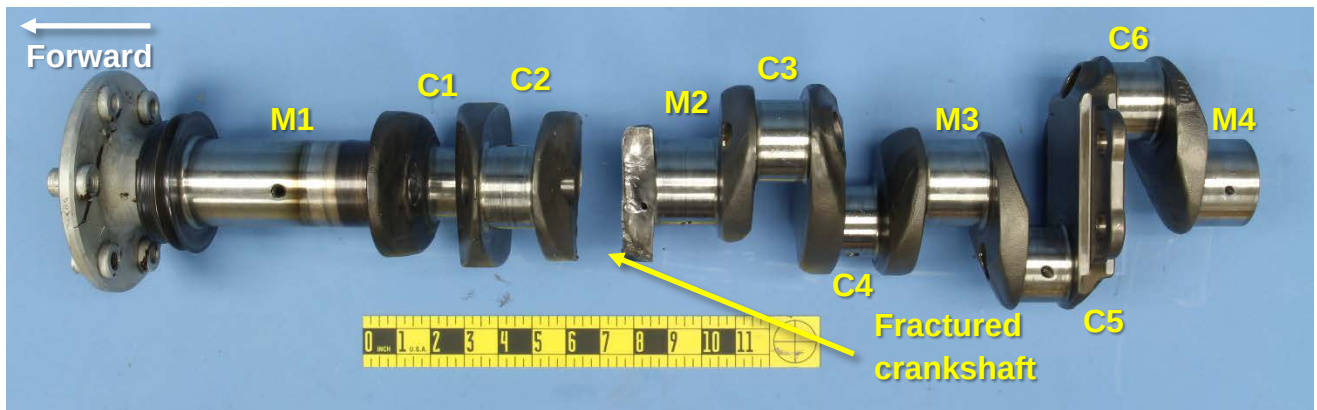
Figure 1 shows the fractured engine crankshaft, as received. The crankshaft had fractured across a web located between the second cylinder (C2) journal and the second main (M2) journal. A closer view of this fracture is depicted in Figure 2. The mating faces of this fracture surface are illustrated from the aft and forward sides in Figure 3 and Figure 4, respectively. The diameters of these journals were measured using digital Vernier calipers. The data are compiled in Table 1.

Figure 1 – The fractured crankshaft, as received. The part fractured at the web between the C2 and M2 journals, as labeled in the figure.

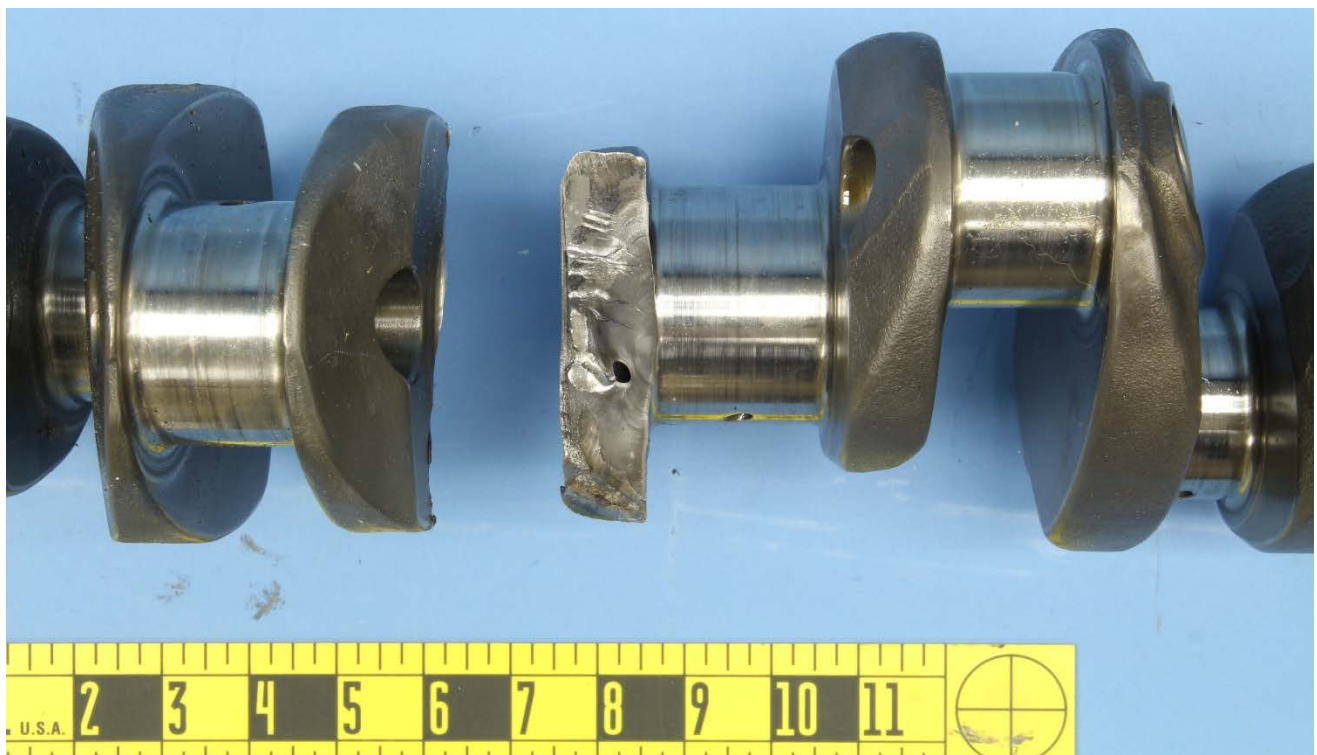
Figure 2 – Closer view of the mating fracture surfaces of the crankshaft, located at the web between the C2 and M2 journals.

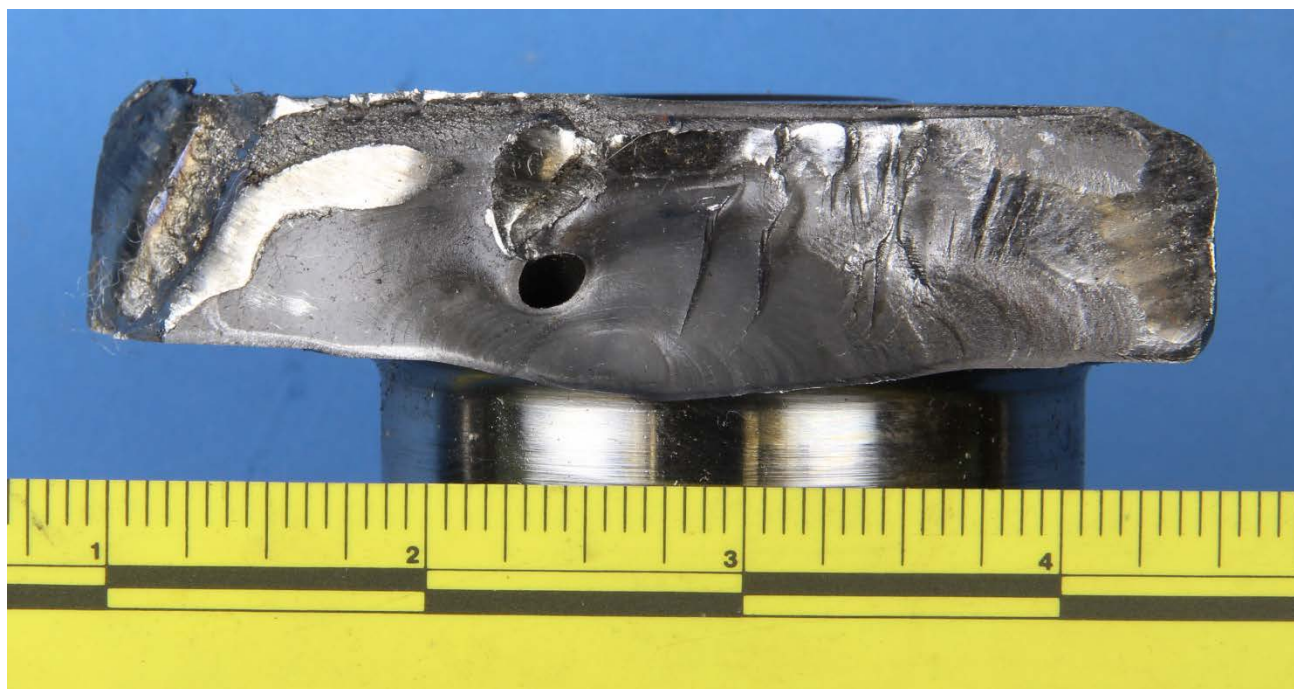
The fracture surface exhibited some smearing and rubbing damage, consistent with post-fracture contact, as exemplified in the upper left and right portions of Figure 3 and Figure 4. Approximately 60% of the fracture surface exhibited a generally flat portion with

crack arrest marks. These crack arrest marks appeared to emanate out from near the corner of the web near the M2 journal, as shown in Figure 3.

Figure 3 – View of the aft mating fracture surface of the crankshaft, as received.

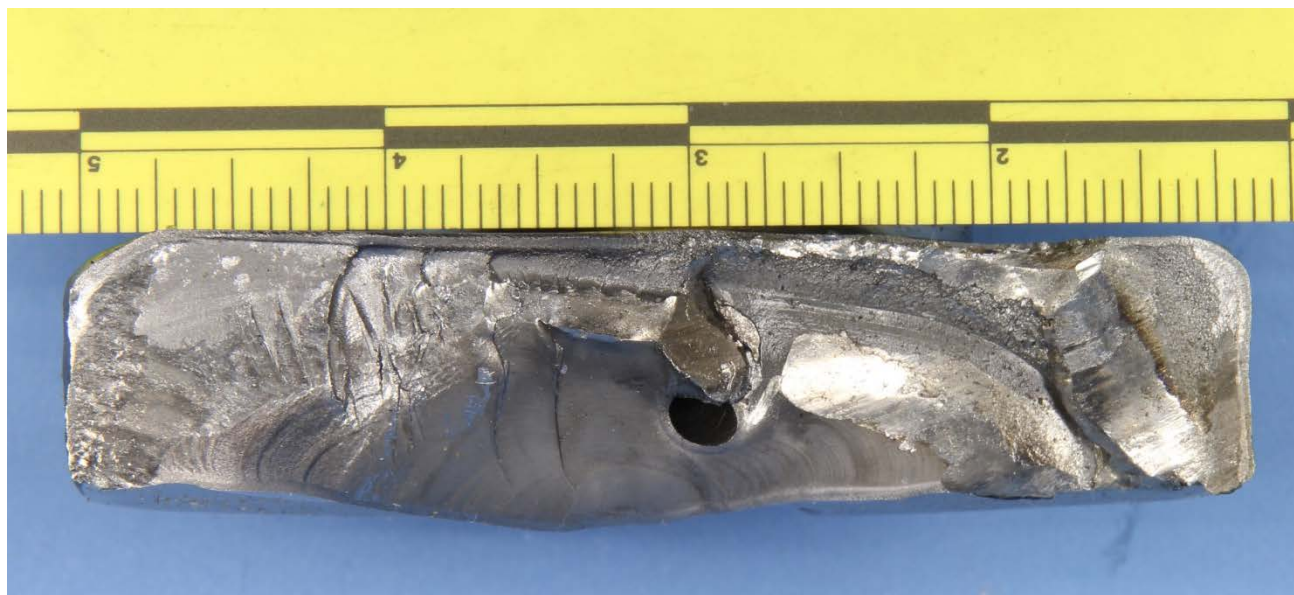
The forward face of the crankshaft web fracture surface was sectioned and cleaned using acetone (displayed in Figure 4). A closer view of the crack initiation site, from where the crack arrest marks progressed, is shown in Figure 5 and Figure 6. The crack arrest features were not consistent with having progressed from a surface or from an internal feature, such as a lubrication hole or a sludge plug. Rather, as shown in Figure 6, the fracture features were consistent with a subsurface crack initiation.

Figure 4 – View of the forward mating fracture surface of the crankshaft, after sectioning and cleaning with acetone.

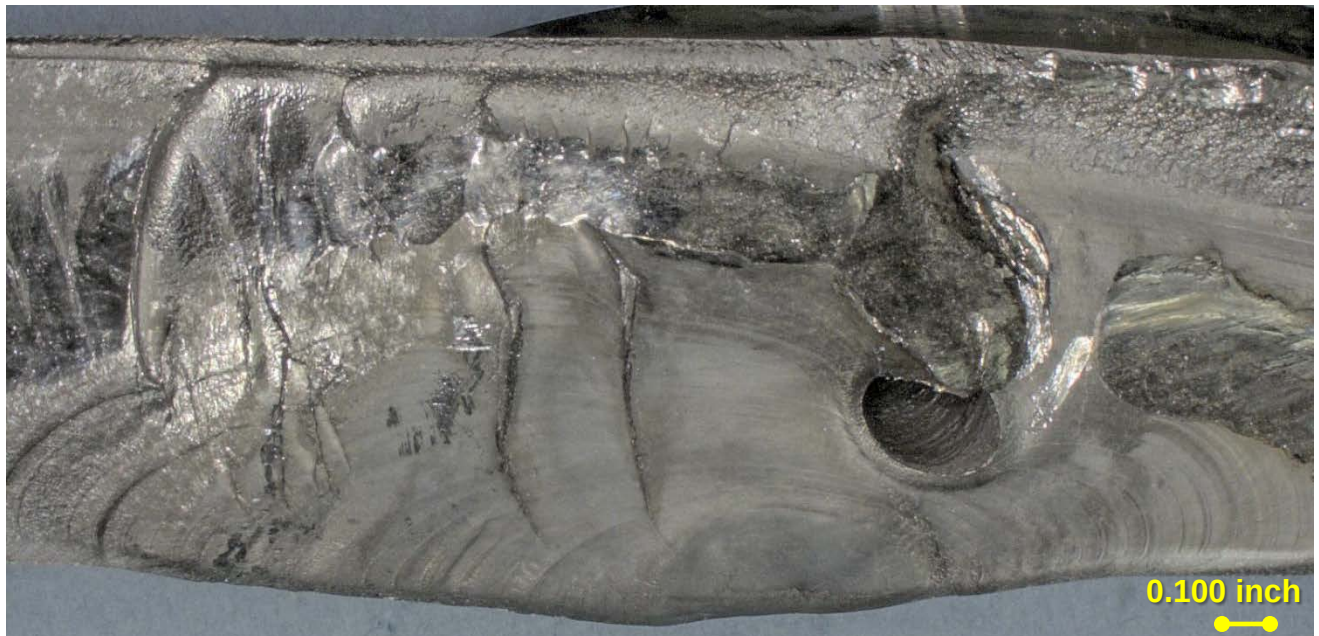
Figure 5 – Closer view of the crack initiation site of the forward fracture surface in Figure 4.

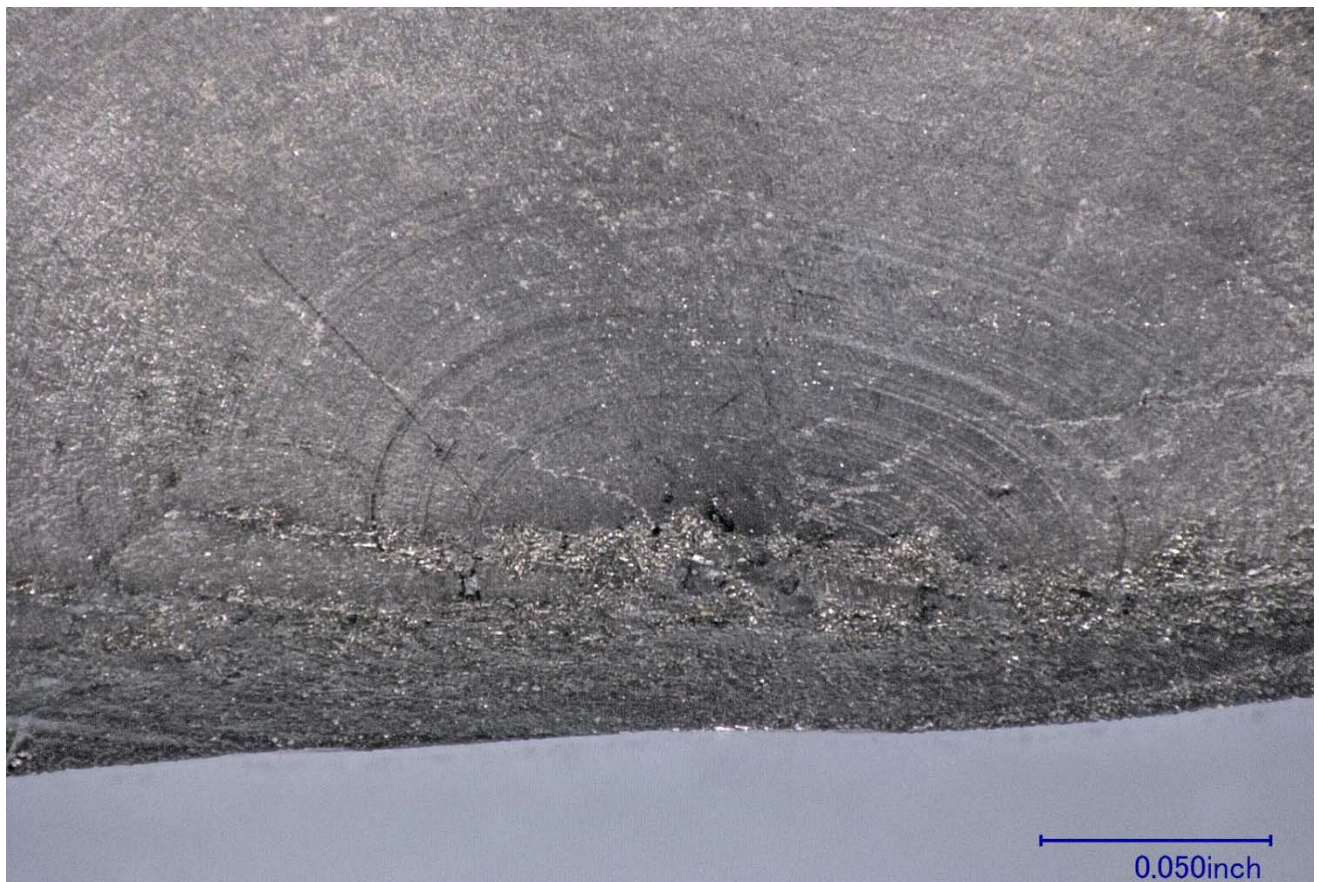
Figure 6 – Closer view of the crack initiation site from Figure 5.

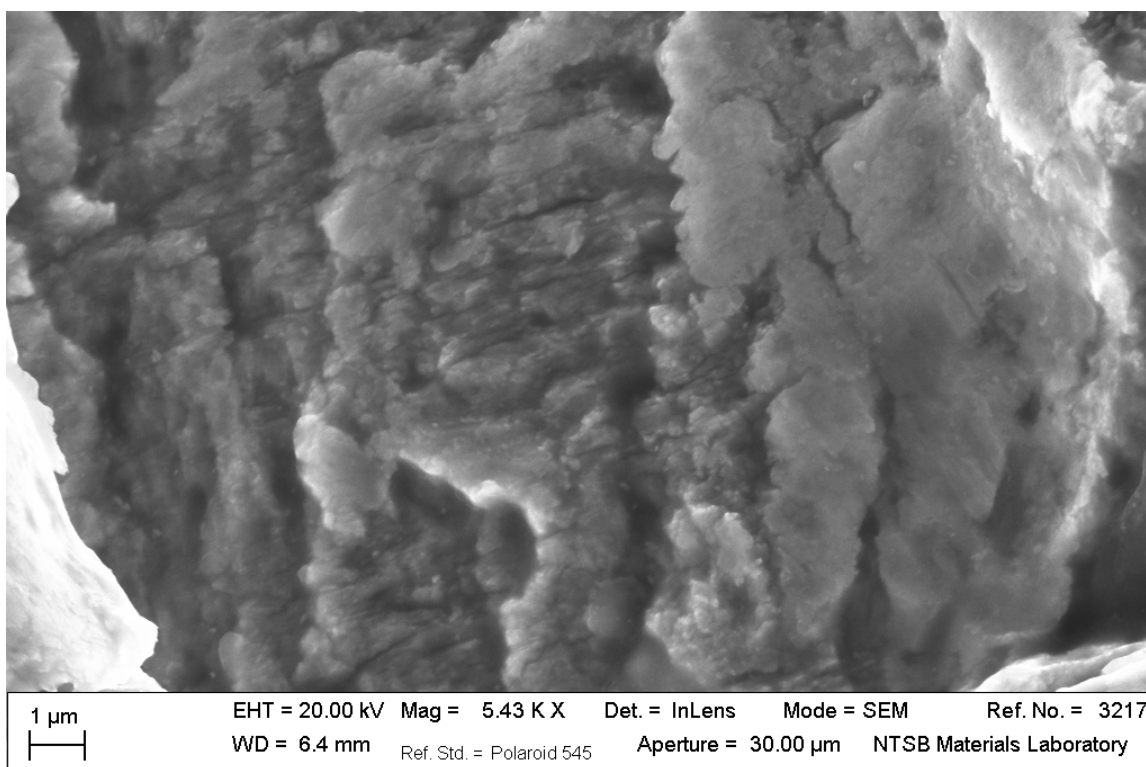
The forward fracture surface of the crankshaft was examined using a scanning electron microscope (SEM). Figure 7 and Figure 8 show typical features from areas near the crack initiation site and near the end of the crack, respectively. These figures show fatigue striations, consistent with fatigue crack propagation. The fatigue striations increased in spacing during propagation (compare Figure 7 at 5430X magnification and Figure 8 at 2150X magnification). The spacing and morphology of the striations, particularly near the initiation site, were consistent with high-cycle fatigue in this alloy.

Figure 7 – Secondary electron (SE) micrograph of striations near the beginning of the fatigue crack.

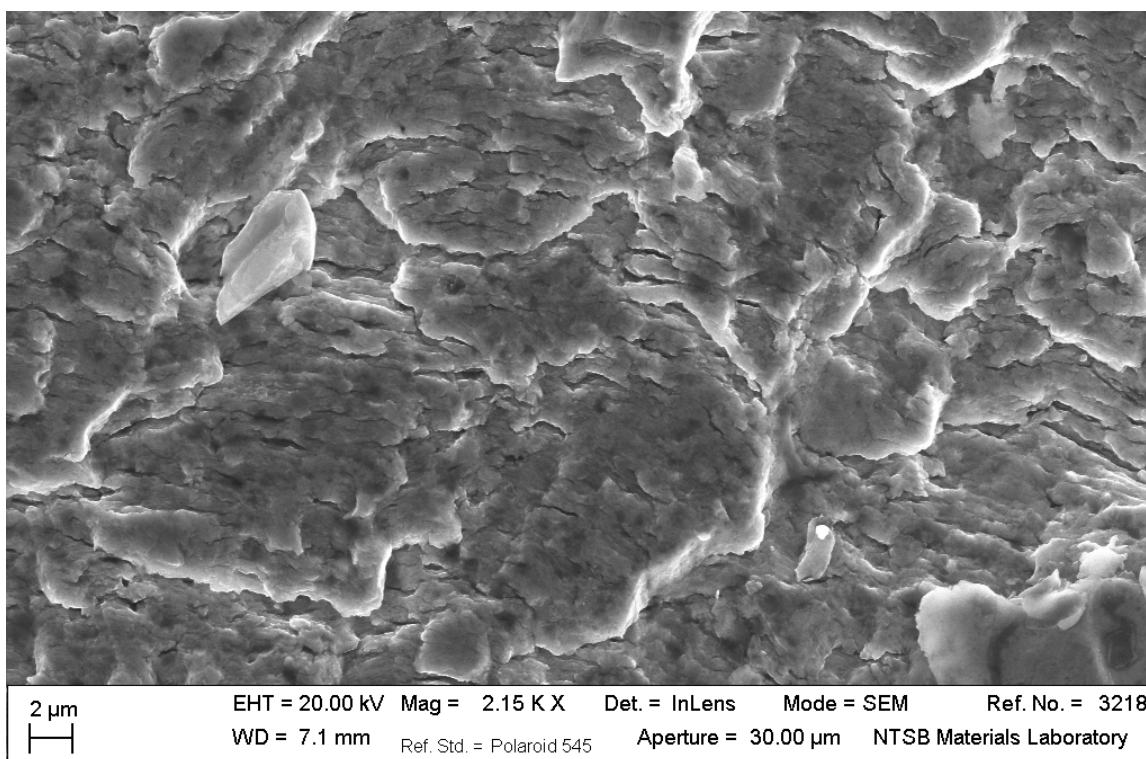
Figure 8 – SE micrograph of fatigue striations at the end of the fatigue crack.

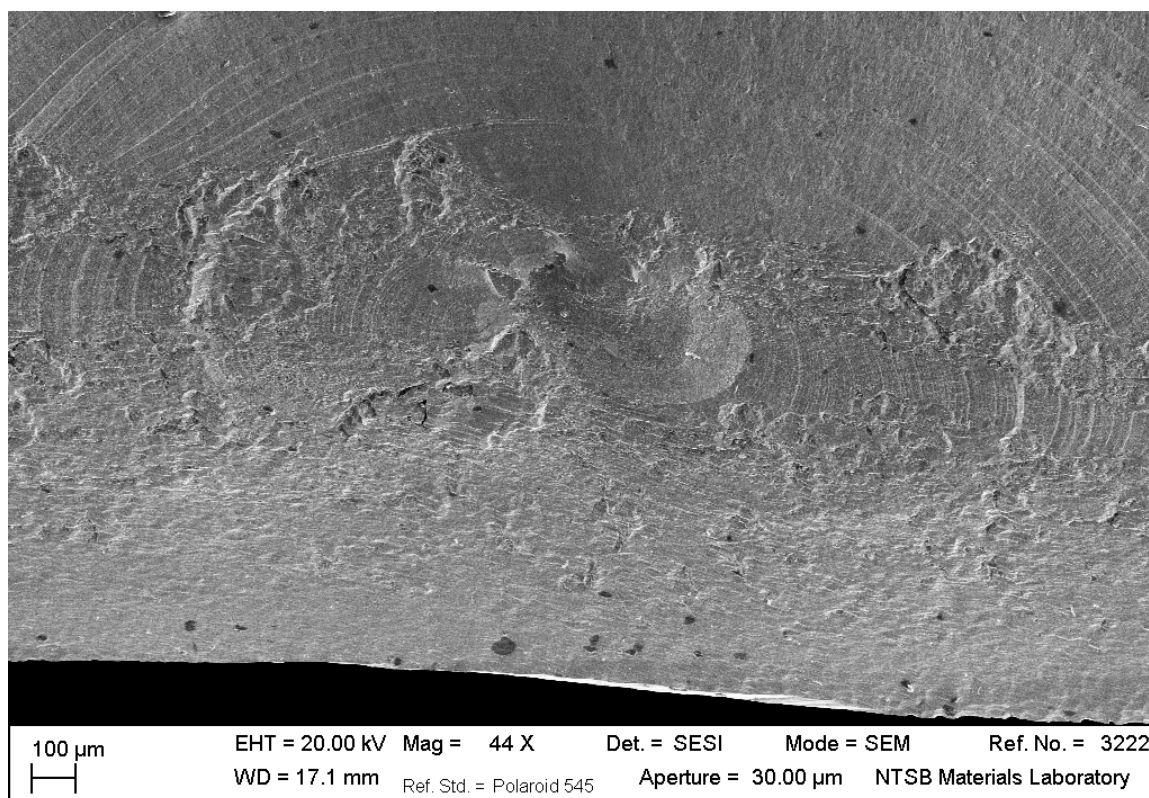
The fatigue crack initiation site is shown in Figure 9. Closer views of the initiation site are shown in Figure 10 through Figure 12. As shown in Figure 11 and Figure 12, the fatigue striations and crack arrest marks progressed out of a small ridge-like portion of the fracture surface (Figure 11). Much of this area was smeared consistent with post-fracture damage. Examination of this initiation site did not reveal any material defects such as inclusions or voids. As measured using the SEM, the fatigue crack initiation site was located 0.32 inches (0.822 mm) below the surface.

Figure 9 – SE micrograph of the fatigue crack initiation site, located 0.82 mm from the surface.

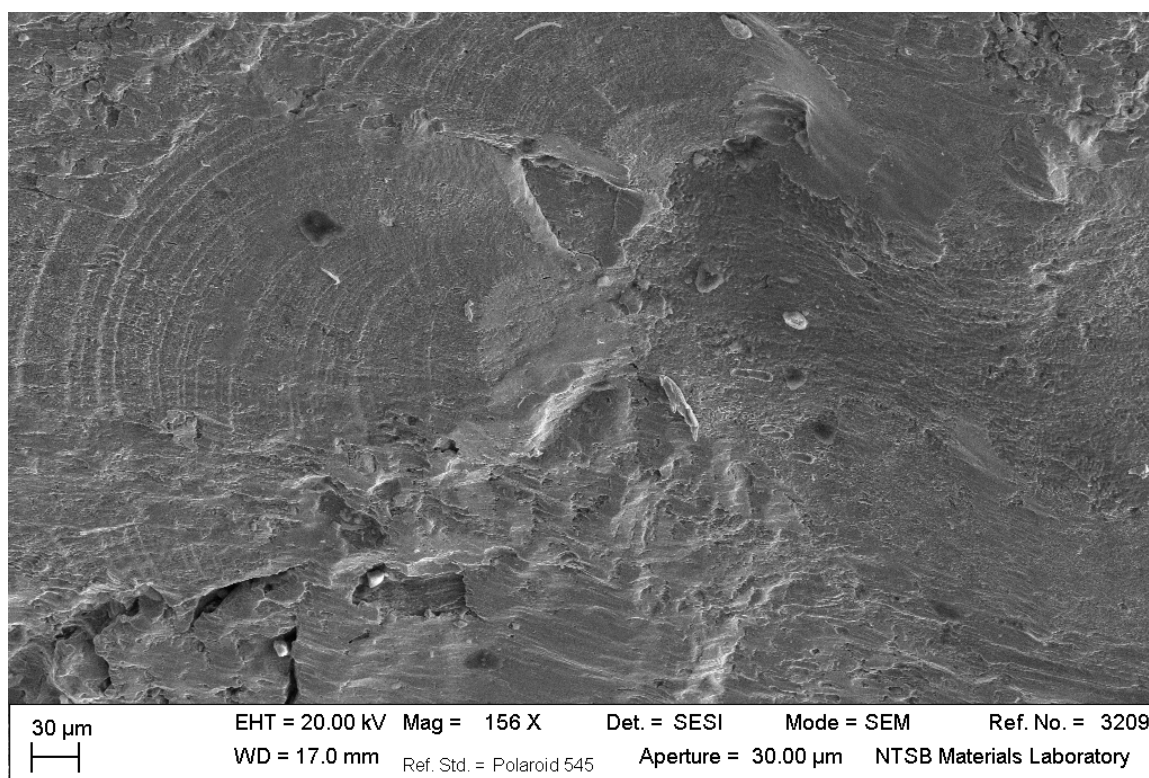
Figure 10 – SE micrograph of a closer view of the crack initiation site from Figure 9.

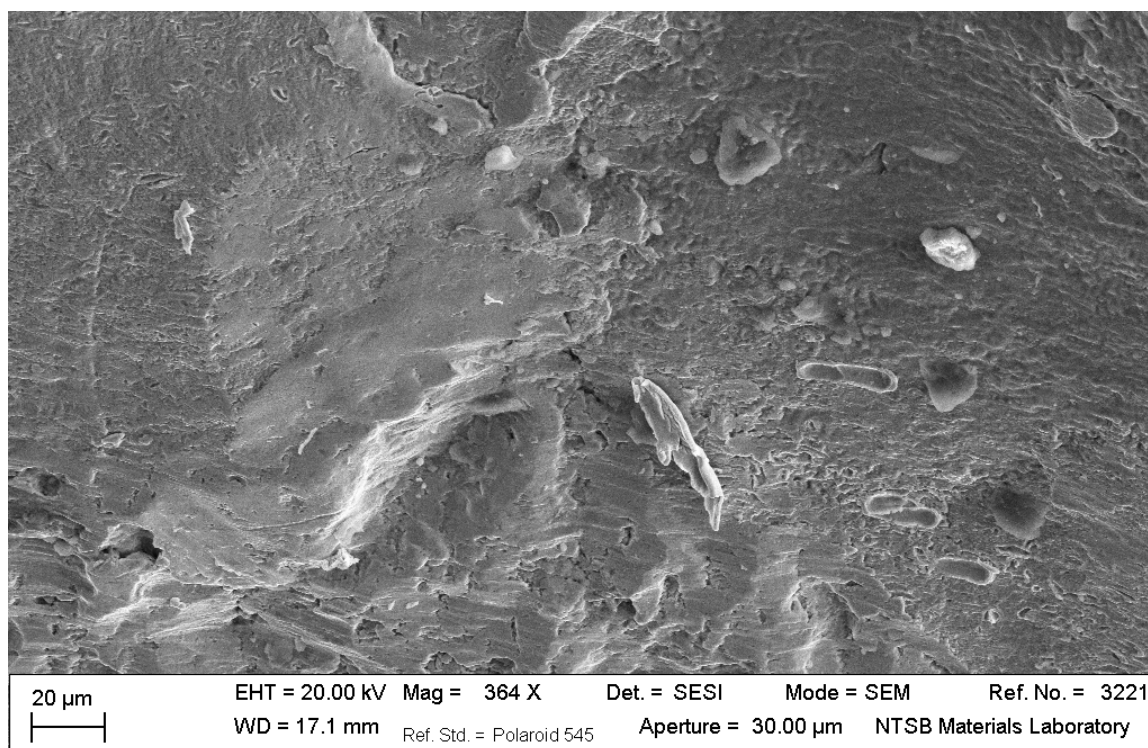
Figure 11 – SE micrograph of a closer view of the crack initiation site from Figure 10.

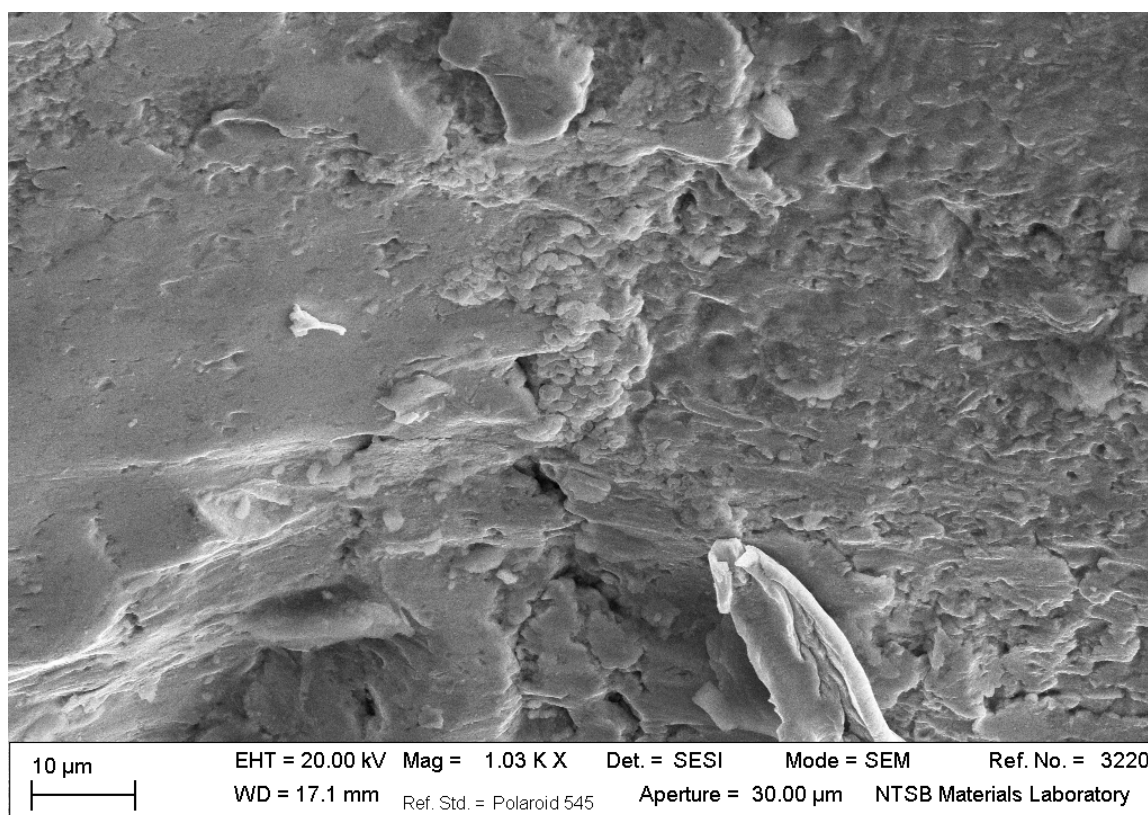
Figure 12 – SE micrograph of a closer view of the crack initiation site from Figure 11.

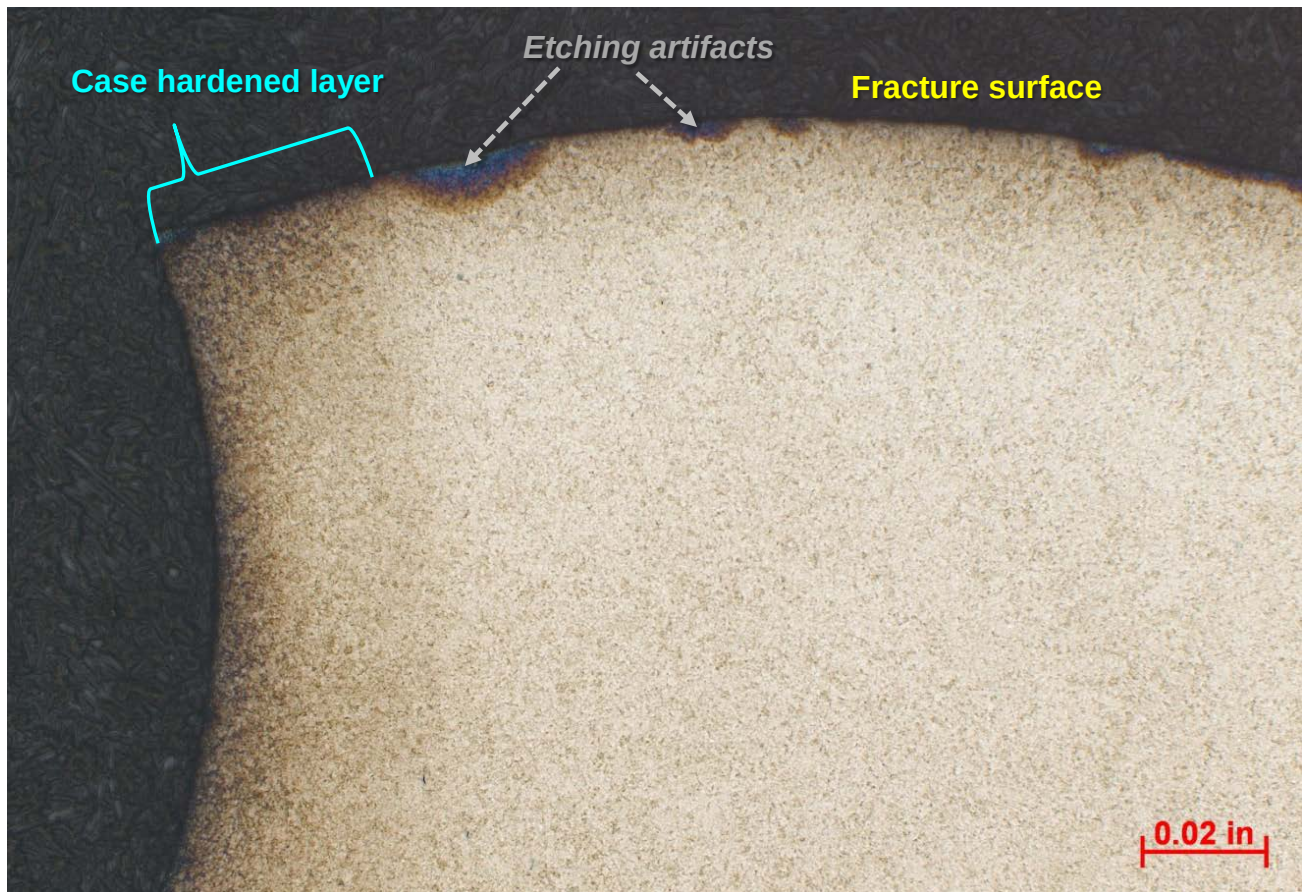
A portion of the forward fracture surface was cross-sectioned, mounted and polished. Figure 13 shows some of the cross-sectioned fracture surface, after etching with 2% Nital solution. There were no noted features adjacent to the fatigue crack initiation site. Note that the dark bluish colored regions near the fatigue crack initiation site cross section in Figure 13 were artifacts from overetching.

However, there was a noted darker region towards the external surface of the web piece (the left side of Figure 13). This darker region was consistent with a layer that had been case hardened (such as through a carburizing or nitriding surface treatment). The approximate depth of this layer was 0.03 inches.

Figure 13 – Bright-field (BF) optical micrograph of a cross section of the fracture surface (~200X, etched 2% Nital).

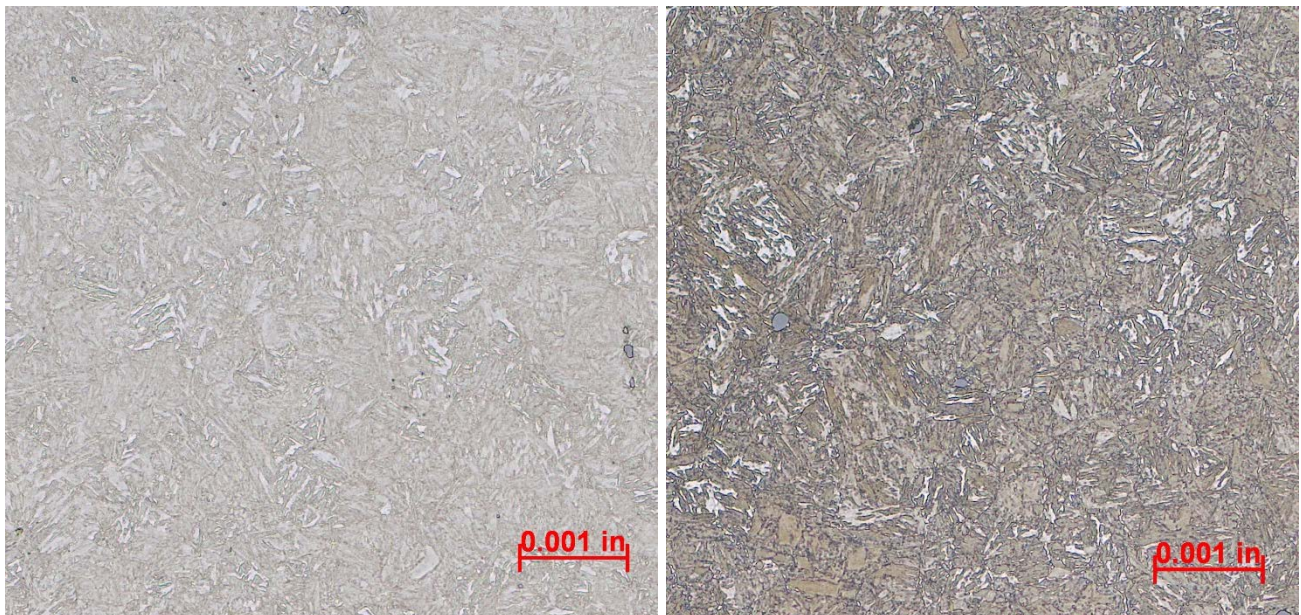
This depth was consistent with the depth of the fatigue crack initiation site. Figure 14 shows a closer view of the microstructures from both those regions. In comparing Figure 14a and Figure 14b, the case-hardened region exhibited a darker contrast, consistent with higher carbon or other interstitial-strengthening element content. The tempered martensite microstructure was typical for those observed in examining alloy steels.

Figure 14 – BF optical micrograph of (a) a cross section of the bulk microstructure and (b) the microstructure near the surface, in the case hardened region (~500X, etched 2% Nital).

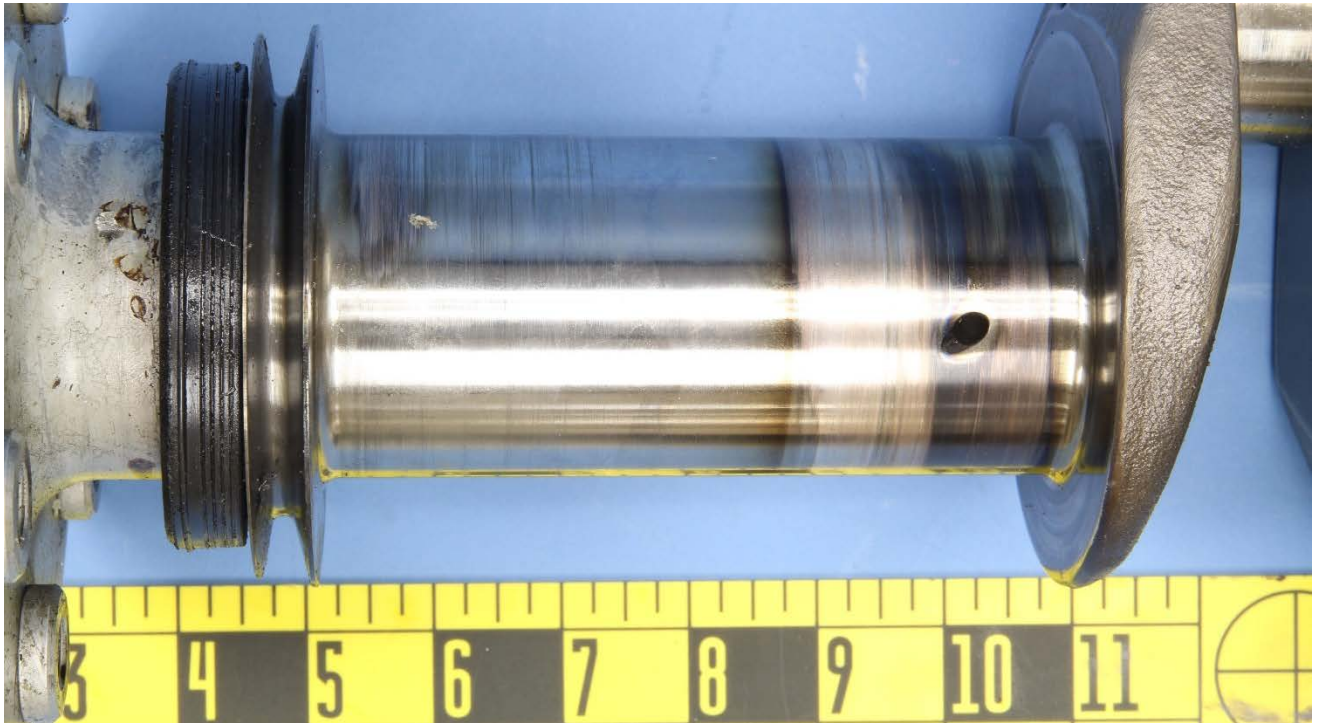
The forwardmost main bearing journal (M1) is shown from opposite sides in Figure 15 and Figure 16, as received. Of most note was the discoloration and dark circumferential wear marks on the aft most two inches. Figure 17 shows the inner bearing surfaces of the forward thrust bearings placed near the M1 journal, in their positions during service. The upper and lower bearing in Figure 17 were labeled bearing A and bearing B for the purposes of this report. The markings on the outside of both Bearing A and Bearing B stated, "AEL13884M006, REV K H0, FAA-PMA".

Figure 15 – The M1 crankshaft journal, as received, showing heat tinting and circumferential wear of the aft portion.

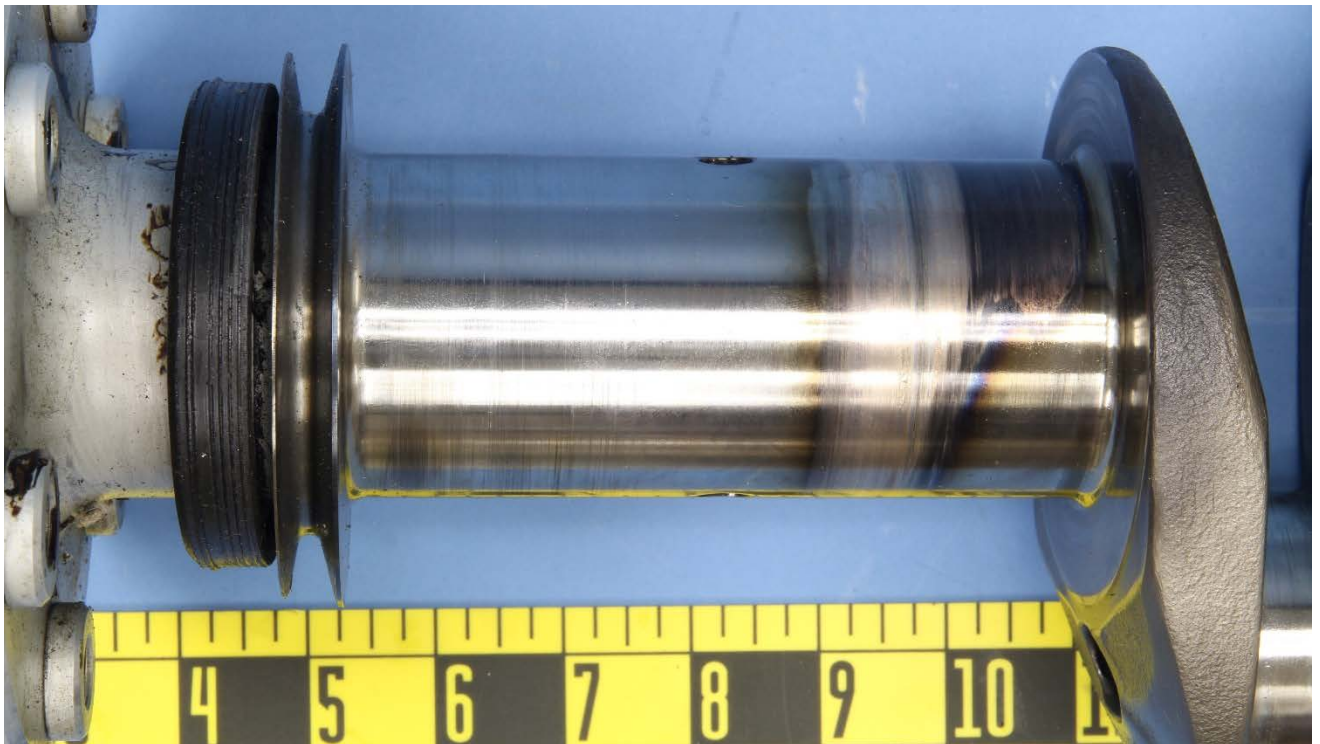
Figure 16 – The crankshaft M1 journal, rotated 180° from Figure 15.

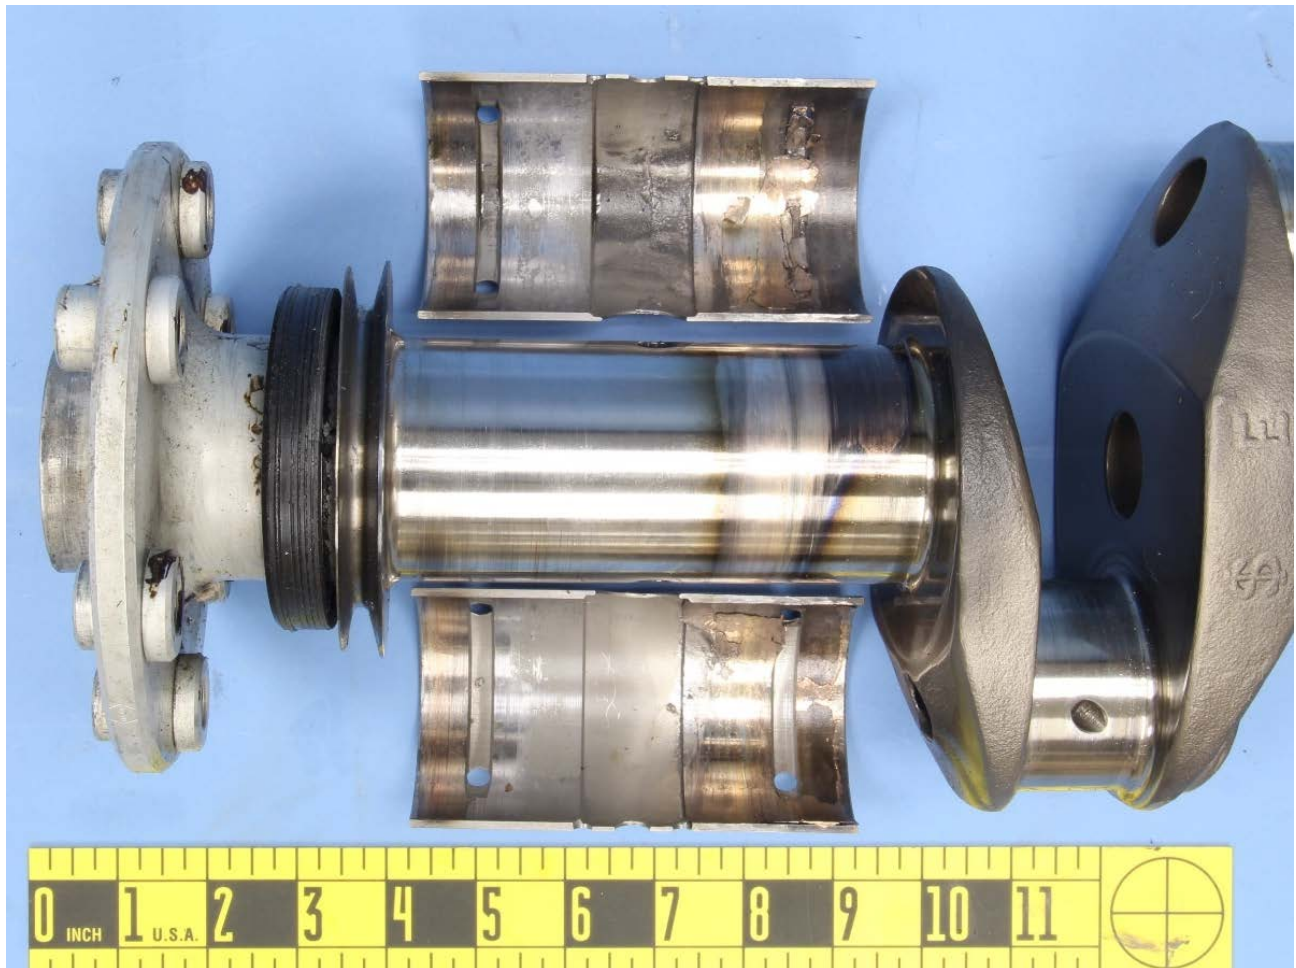
Figure 17 – The crankshaft M1 bearing journal, with the bearings placed next to the journal in the locations they were located during service. The damage on the aft side of the bearings was co-located with the damage to the crankshaft journal.

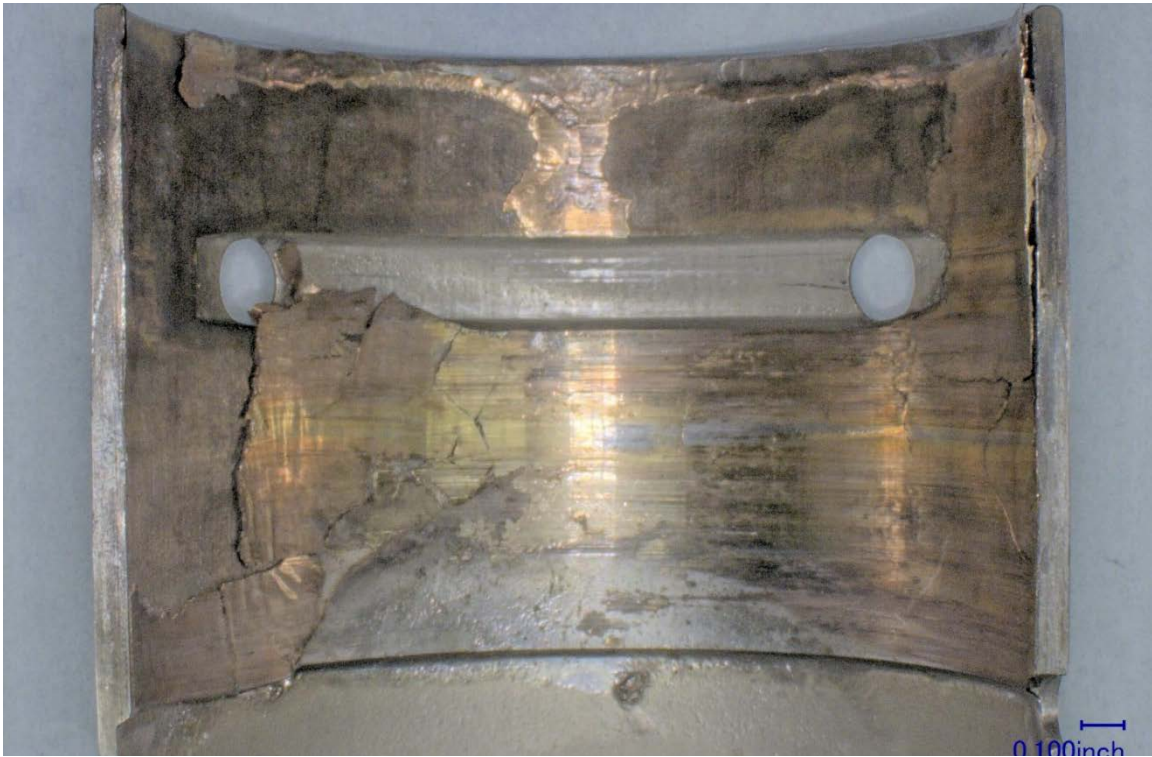
Figure 18 shows the internal surface of the aft side of bearing A. When compared to the inner bearing surface on the forward side (Figure 19), the aft side had been significantly more damaged. While both sides exhibited circumferential wear marks, consistent with rotational contact with the crankshaft, the aft side exhibited severe metal deformation of the underlying material. This material was smeared outside of the inner surface, as shown in Figure 20. Closer examination of the aft bearing surface revealed spalling, displacement, and cracking consistent with bearing wear fatigue (Figure 21).

Figure 18 – The aft side of the internal surface of Bearing A, showing circumferential wear and material smearing and spalling.

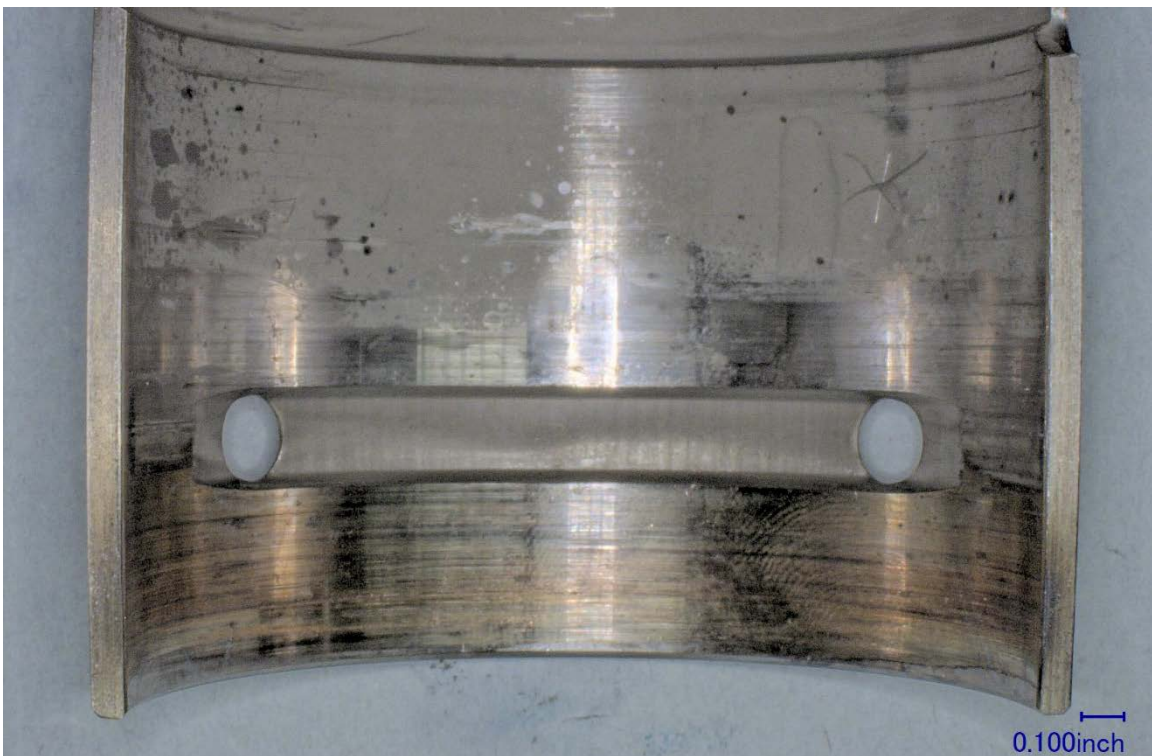
Figure 19 – The forward side of the internal surface of Bearing A.

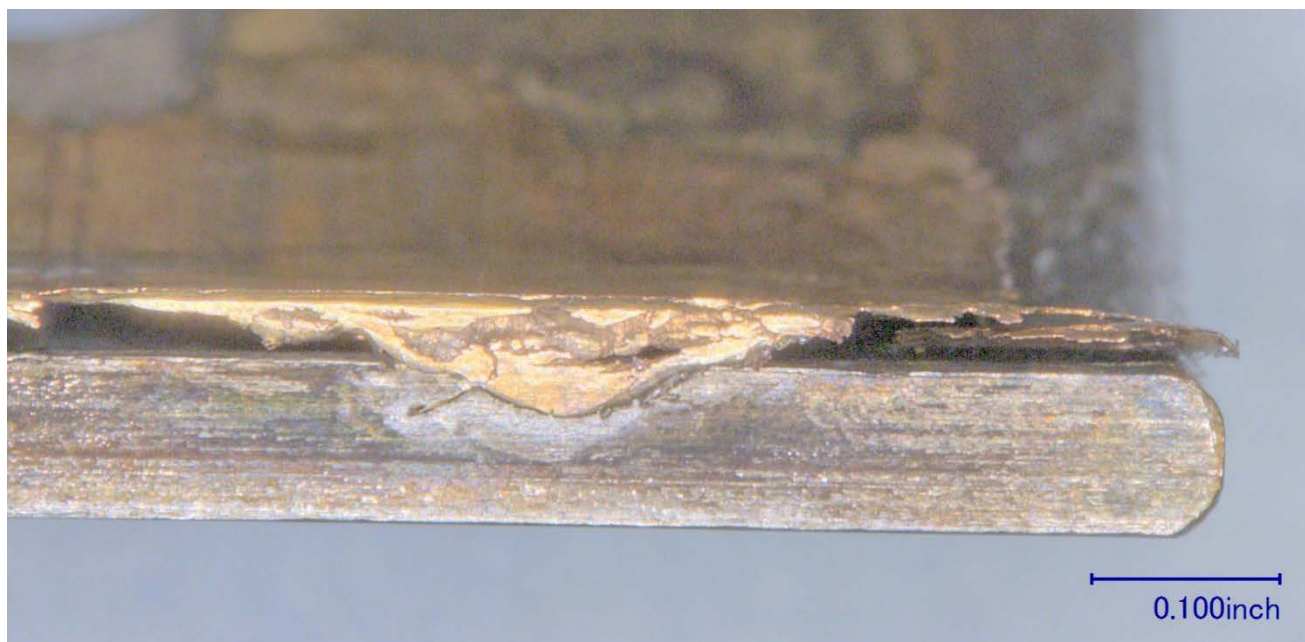
Figure 20 – The side of aft portion of Bearing A, showing material smeared over the bearing edge.

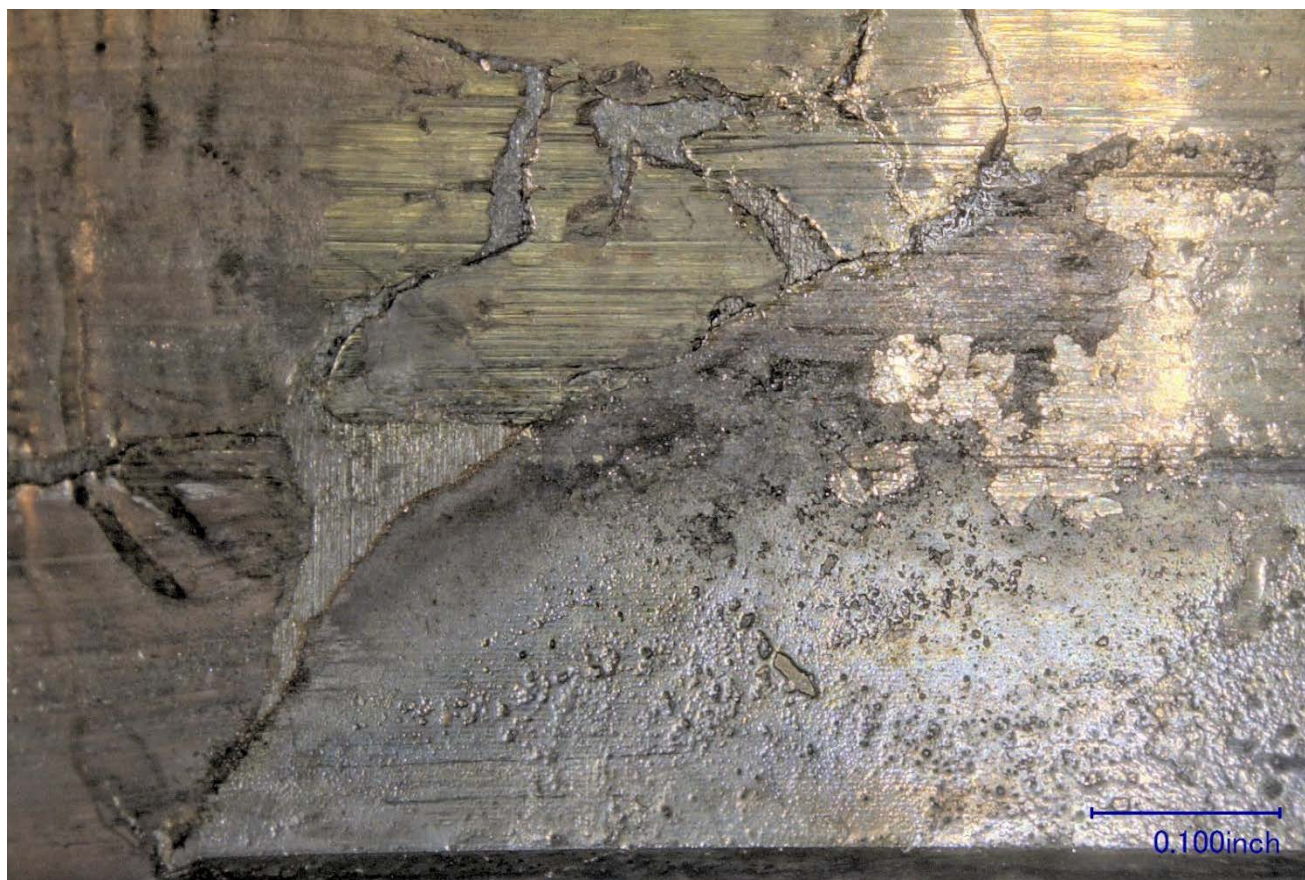
Figure 21 – Closer view of the smearing damage, spalling, and fatigue cracking on the aft side of the Bearing A internal surface.

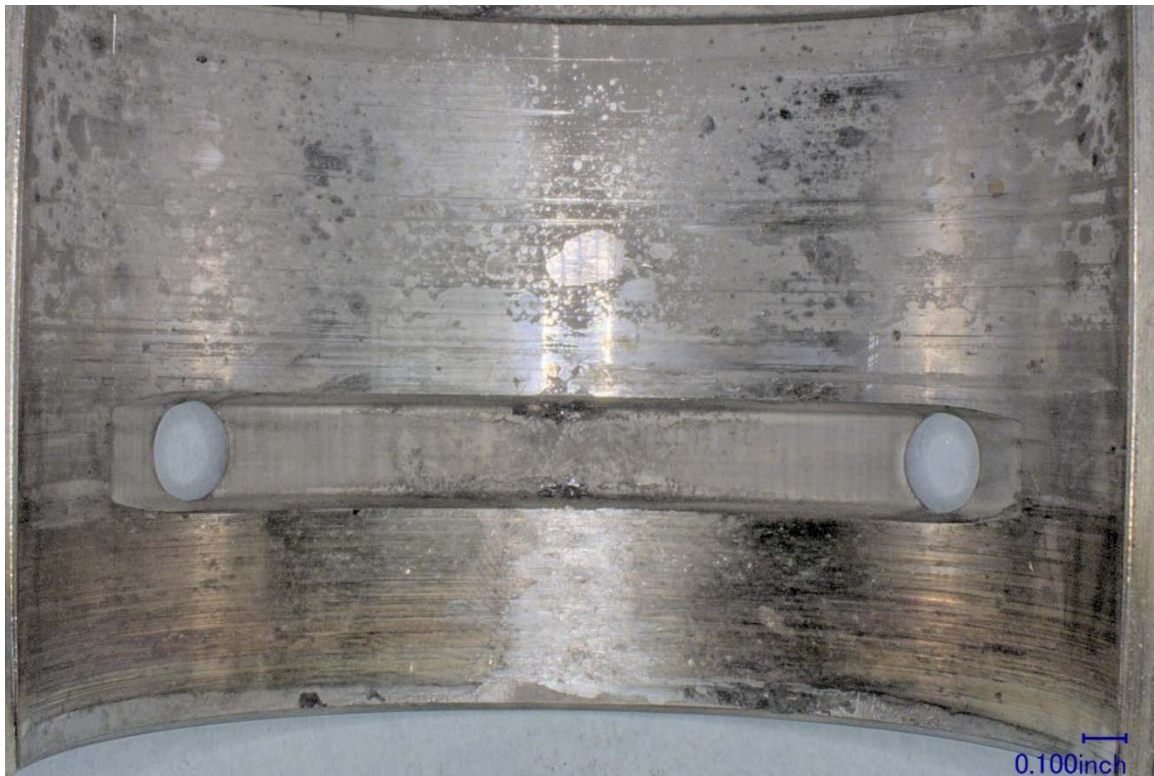
These features were amplified on the inner surfaces of Bearing B (Figure 22 and Figure 23). While the forward surface exhibited some minor rotational wear, the aft bearing surface exhibited spalling, material displacement, and smearing. Much of this spalled and smeared material was found accumulated in the lubrication groove, as shown in Figure 23. The material had cracked and deformed, as shown in Figure 24. All this bearing damage was typical of similar bearing that operated at elevated temperatures using inadequate lubrication.

Figure 22 – The forward side of the internal surface of Bearing B.
