# NATIONAL TRANSPORTATION SAFETY BOARD

## MATERIALS LABORATORY FACTUAL REPORT

Report No. 18-027

Place : Westphalia, Kansas  
Date : September 29, 2017  
Vehicle : Piper PA-25-235, N7336Z  
NTSB No. : CEN17LA372  
Investigator : Aaron Sauer, AS-CEN

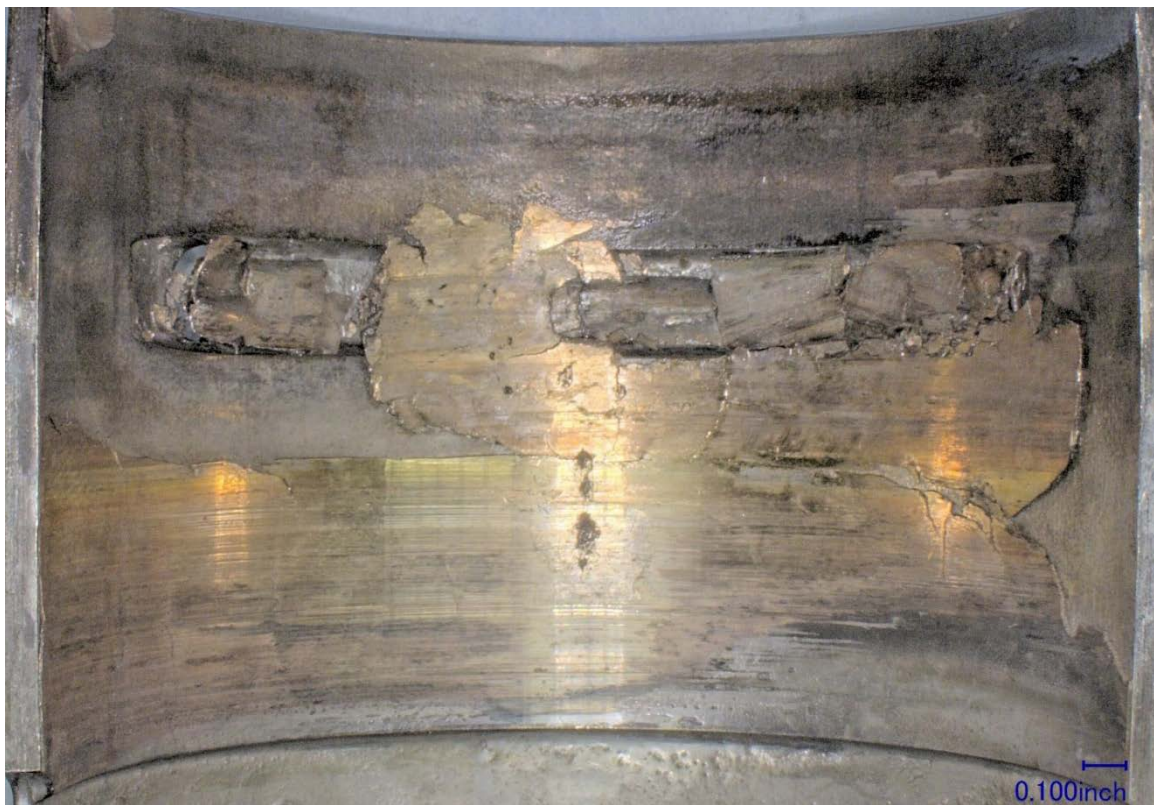
These features were amplified on the inner surfaces of Bearing B (Figure 22 and Figure 23). While the forward surface exhibited some minor rotational wear, the aft bearing surface exhibited spalling, material displacement, and smearing. Much of this spalled and smeared material was found accumulated in the lubrication groove, as shown in Figure 23. The material had cracked and deformed, as shown in Figure 24. All this bearing damage was typical of similar bearing that operated at elevated temperatures using inadequate lubrication.

Figure 23 – The aft side of the internal surface of Bearing B, showing circumferential wear and material smearing and spalling.

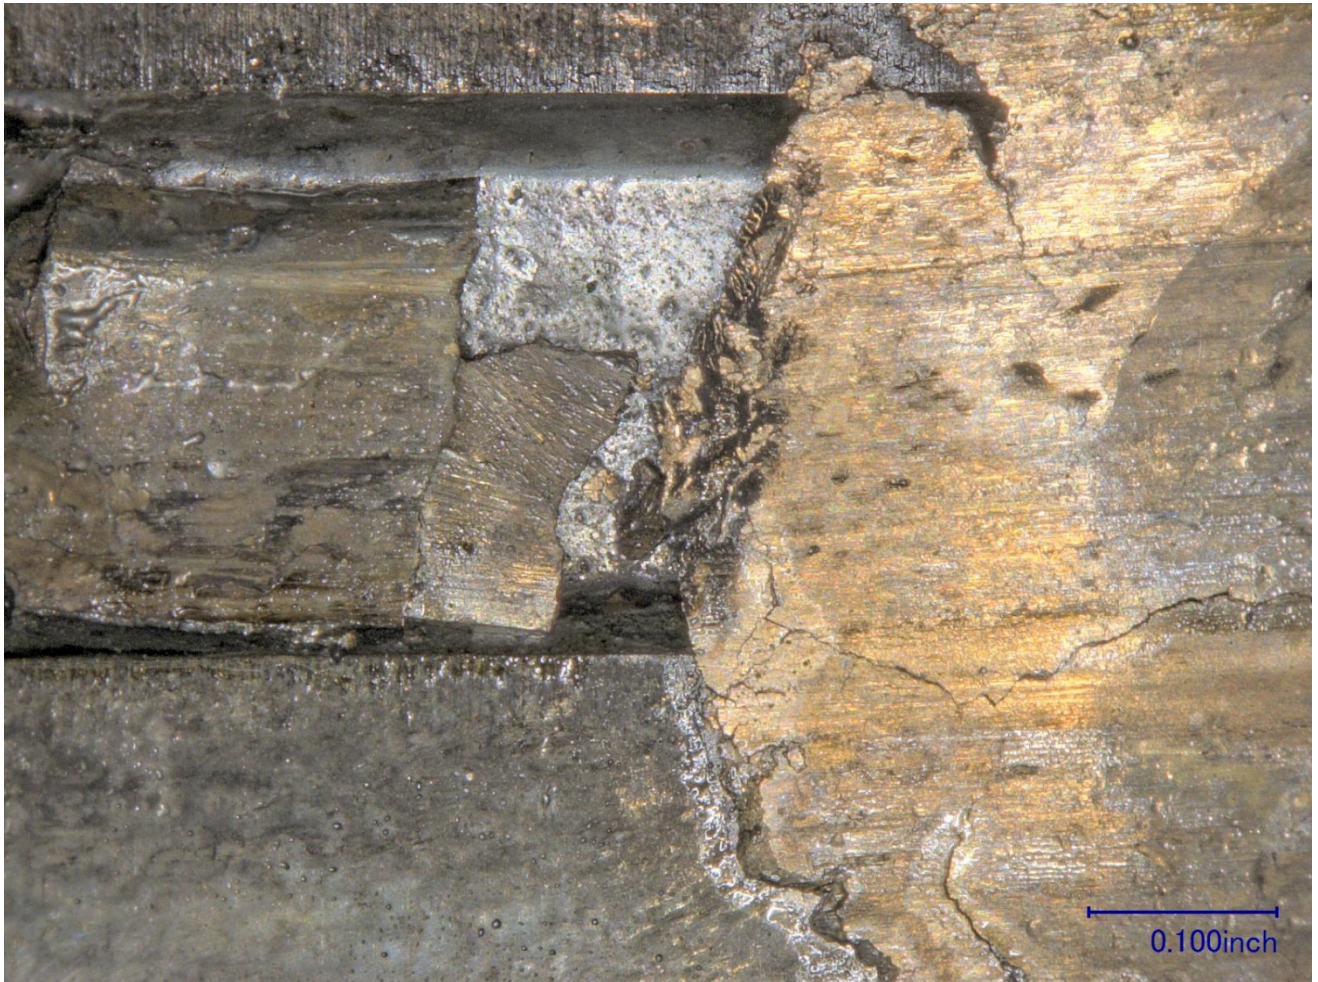
Figure 24 – Closer view of the smearing damage and spalling on the aft side of the Bearing B internal surface.
