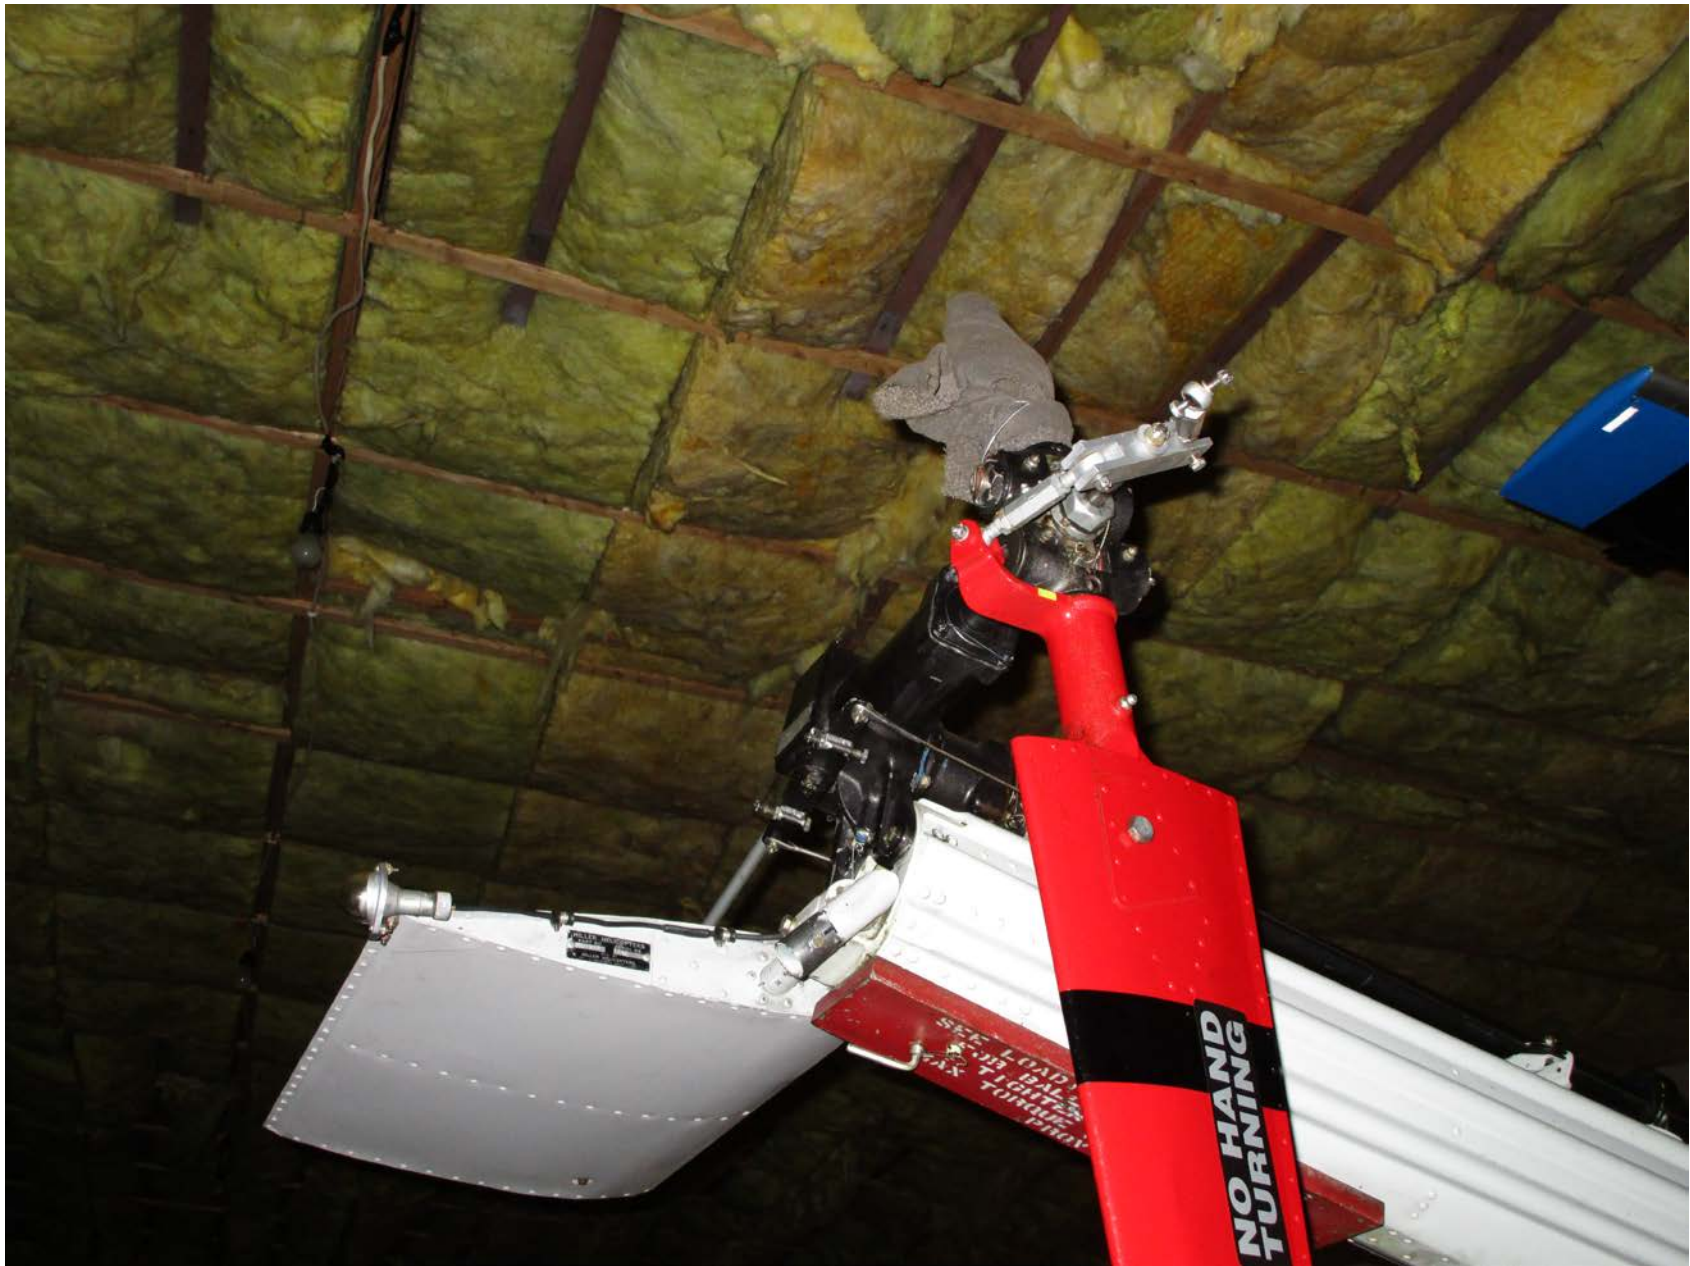
**Photo 1 – Damaged Tail Rotor Assembly**
