**NATIONAL TRANSPORTATION SAFETY BOARD**  
Office of Research and Engineering  
Washington, D.C. 20594

## **Video Study**

**NTSB Case Number:**  
**CEN18FA023**

Location: Alva, Oklahoma  
Date: November 4, 2017  
Time: 1728 CDT  
Airplane: Beech V35B

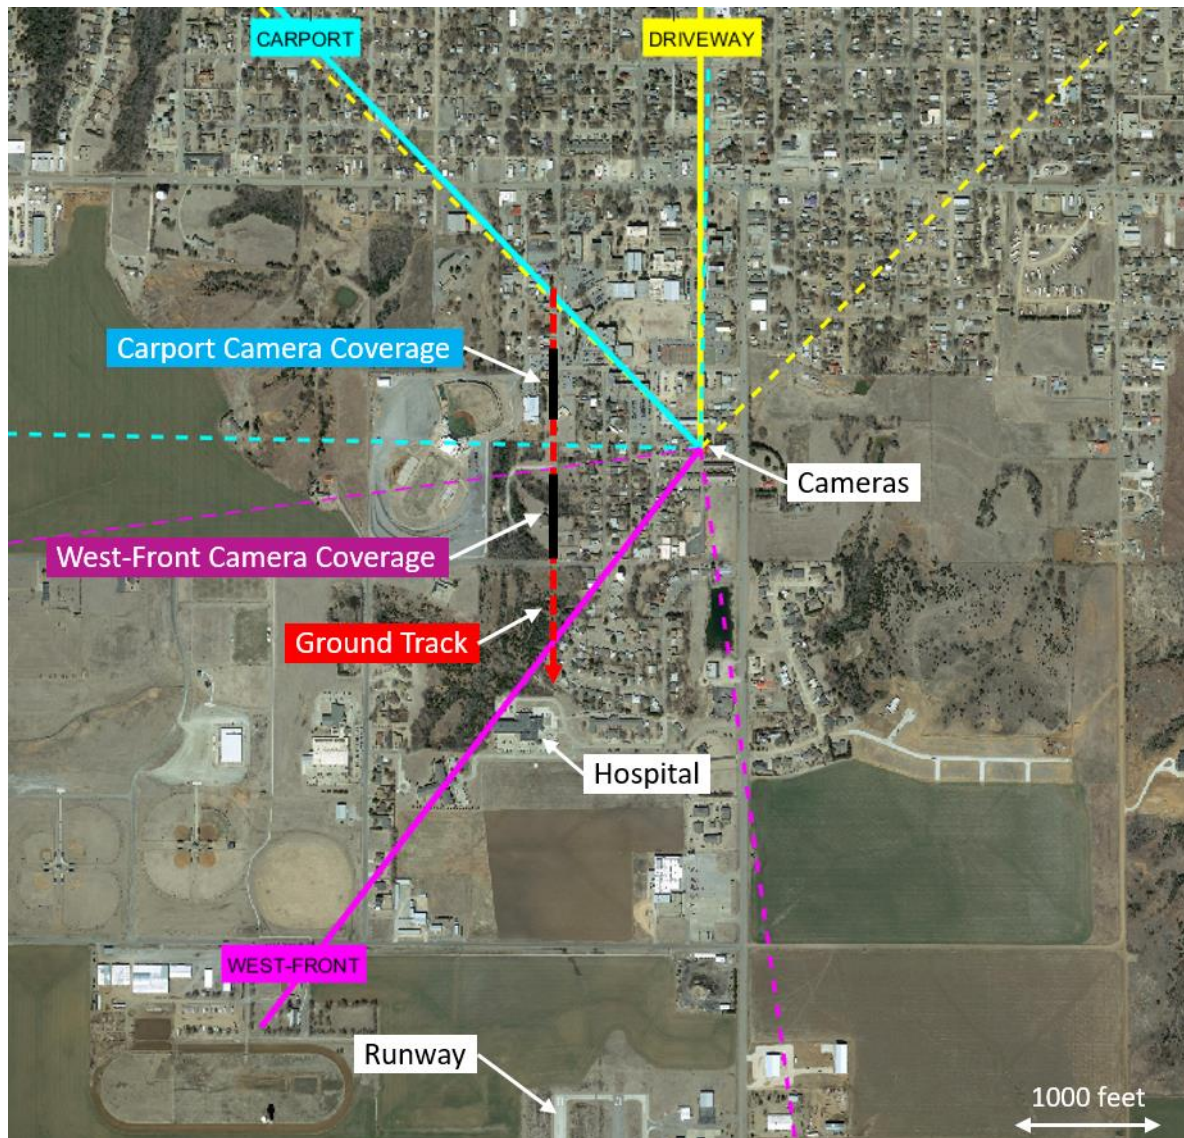
**Figure 1. Aerial View of Alva, Oklahoma**

The location of the cameras is marked in the figure. The fields of view of the three cameras are color coded. The solid lines originating at the location of the cameras are their azimuth orientations. The broken lines indicate the fields of view of the cameras. The Driveway camera, color coded yellow, was pointed north. Its main use was calibrating the horizontal field of view (HFOV) of the cameras. The Carport camera was color coded cyan and was pointed in the northwest direction. It recorded the airplane as it was approaching the airport. The West-Front camera was color coded magenta and

was pointed in the southwest direction. It recorded the airplane as it was approaching the airport and after it exited the field of view of the Carport camera.

The airplane crashed north of the hospital, at the location of the arrowhead of the ground track marked in red in Figure 1. This assumed ground track passes about 1000 feet west of the cameras. Because of the long distance from the cameras to the airplane, image analysis of the video frames from the Carport and West-Front videos could not determine whether the ground track was a straight line leading south to the crash location or if there were small deviations from a straight line. Therefore, a straight ground track was assumed and is shown in Figure 1.

The black segments on the ground track mark the portion of the ground track where airplane trajectory and speed were estimated based on the Carport and West-Front camera videos. The West-Front camera segment represents the entire period when the airplane was visible in that video. The Carport segment corresponds to the time before the airplane exited the camera field of view. The airplane was visible in the video before that time, but its image was too small to allow accurate analysis. Note that there is a gap in coverage of about 390 feet between the segments that corresponds to about 3.2 seconds of flight. Figure 2 shows the upper left quarter of a frame from the Carport camera video with the image of the airplane marked and Figure 3 shows the upper right quarter of a frame from the West-Front camera video with the image of the airplane marked.

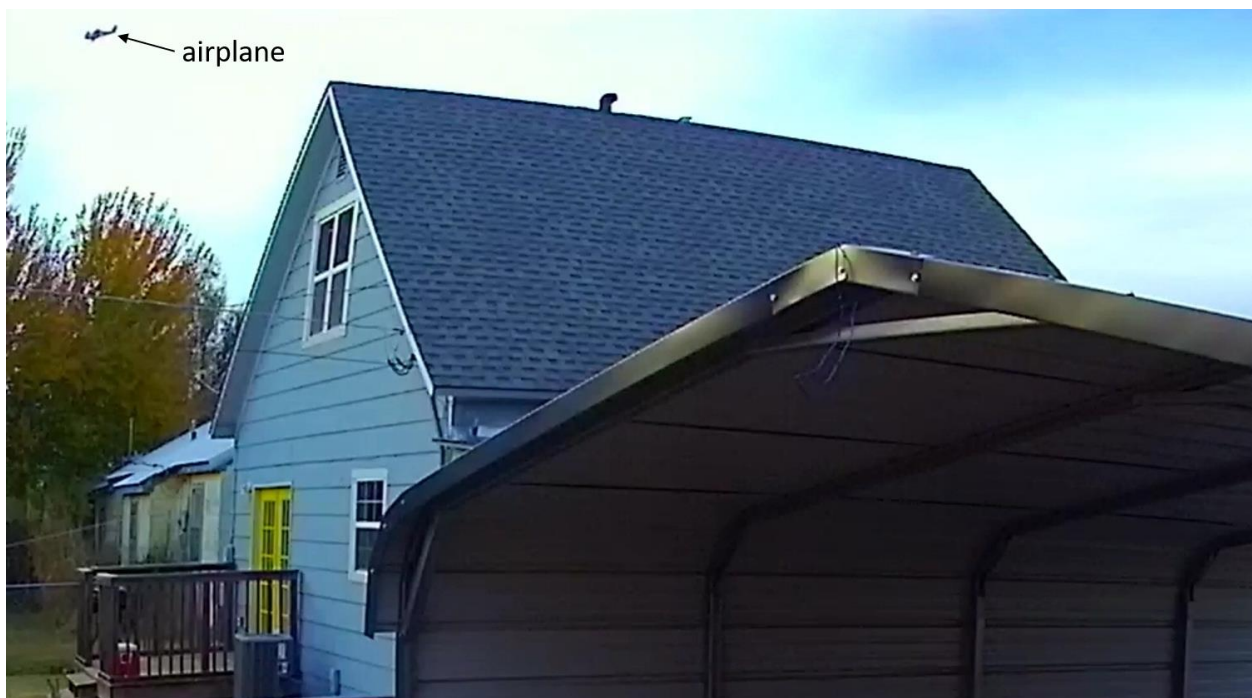
**Figure 2. Upper Left Quarter of a Frame from the Carport Camera Video**

Several trajectory points were estimated during a 4.2 seconds-long time period when the airplane was recorded by the Carport camera. The ground speed during this period was estimated as 76 kts. As mentioned above, because of the large distance from the cameras to the airplane, it was not possible to account for small deviations of the actual ground track from the assumed ground track shown in Figure 1. Therefore, the estimated speed was assigned a tolerance of  $\pm 5\%$ , resulting in  $76 \pm 4$  kts.

There is no information in the videos on the speed of the airplane during the approximately 850 feet from the last location observed in the West-Front video to the crash location. According to witness statements, during the approach to the airport, the left engine cowling opened. The open cowling can be seen in Figure 2. It was open during the entire 12 seconds analyzed in this report and at least 2 seconds before the analyzed time. The time when the cowling opened could not be determined because at earlier times, the airplane was too far from the Carport camera and its image was too small to show details such as an open engine cowling. The position of the flaps during the analyzed time period could not be determined either because of the distance of the airplane from the cameras.

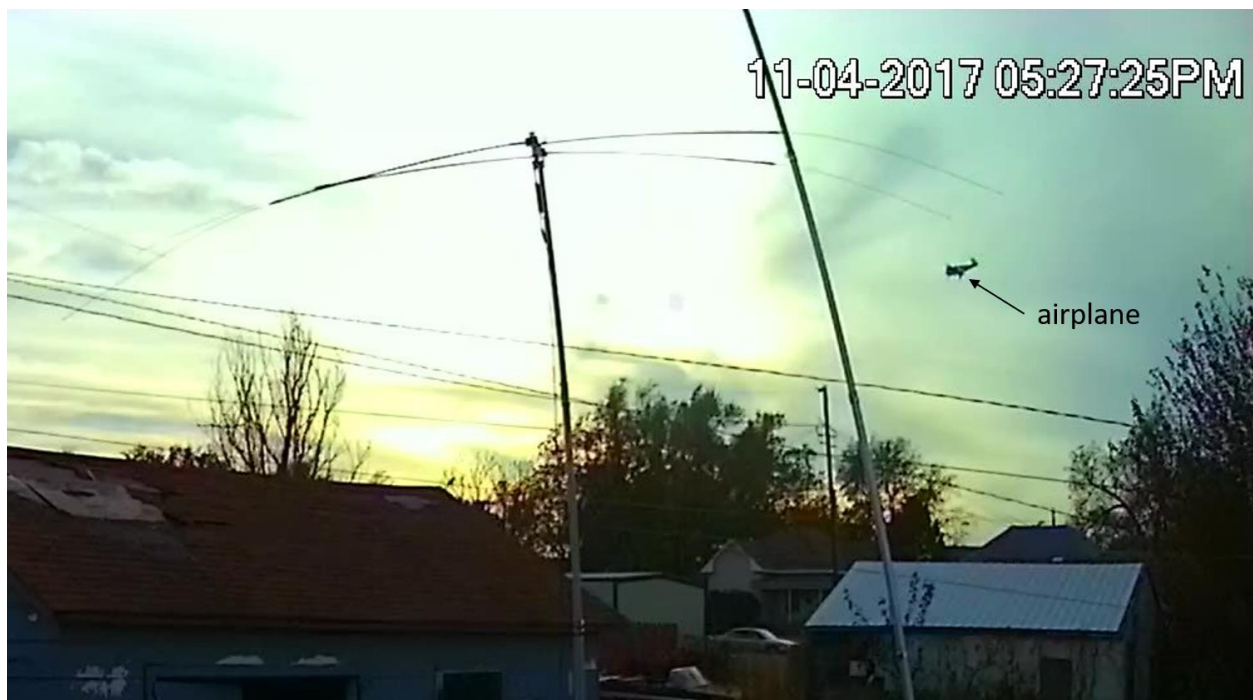
**Figure 3. Upper Right Quarter of a Frame from the West-Front Camera Video**

After a 3.2 seconds-long gap in coverage, speed was estimated during a 4.6 seconds-long period based on the West-Front camera video. The estimated speed was  $71 \pm 4$  kts. Note that the two speed estimates overlap in the 72 kts to 75 kts interval when their tolerances are taken into account. The time elapsed from the beginning of the Carport camera coverage shown in Figure 1 to the end of the West-Front camera coverage was approximately 12 seconds and the ground distance between these

During the analyzed 12 seconds, the altitude of the airplane above the crash location decreased from approximately 250 feet to approximately 100 feet, resulting in an average descent rate of 750 ft/minute. Toward the end of the time segment when the airplane was recorded by the Carport camera, the rate of descent was decreasing and then coverage was lost for 3.2 seconds. Toward the end of the time segment when the airplane was recorded by the West-Front camera, the descent rate increased to approximately 1000 ft/minute and then coverage ended.
