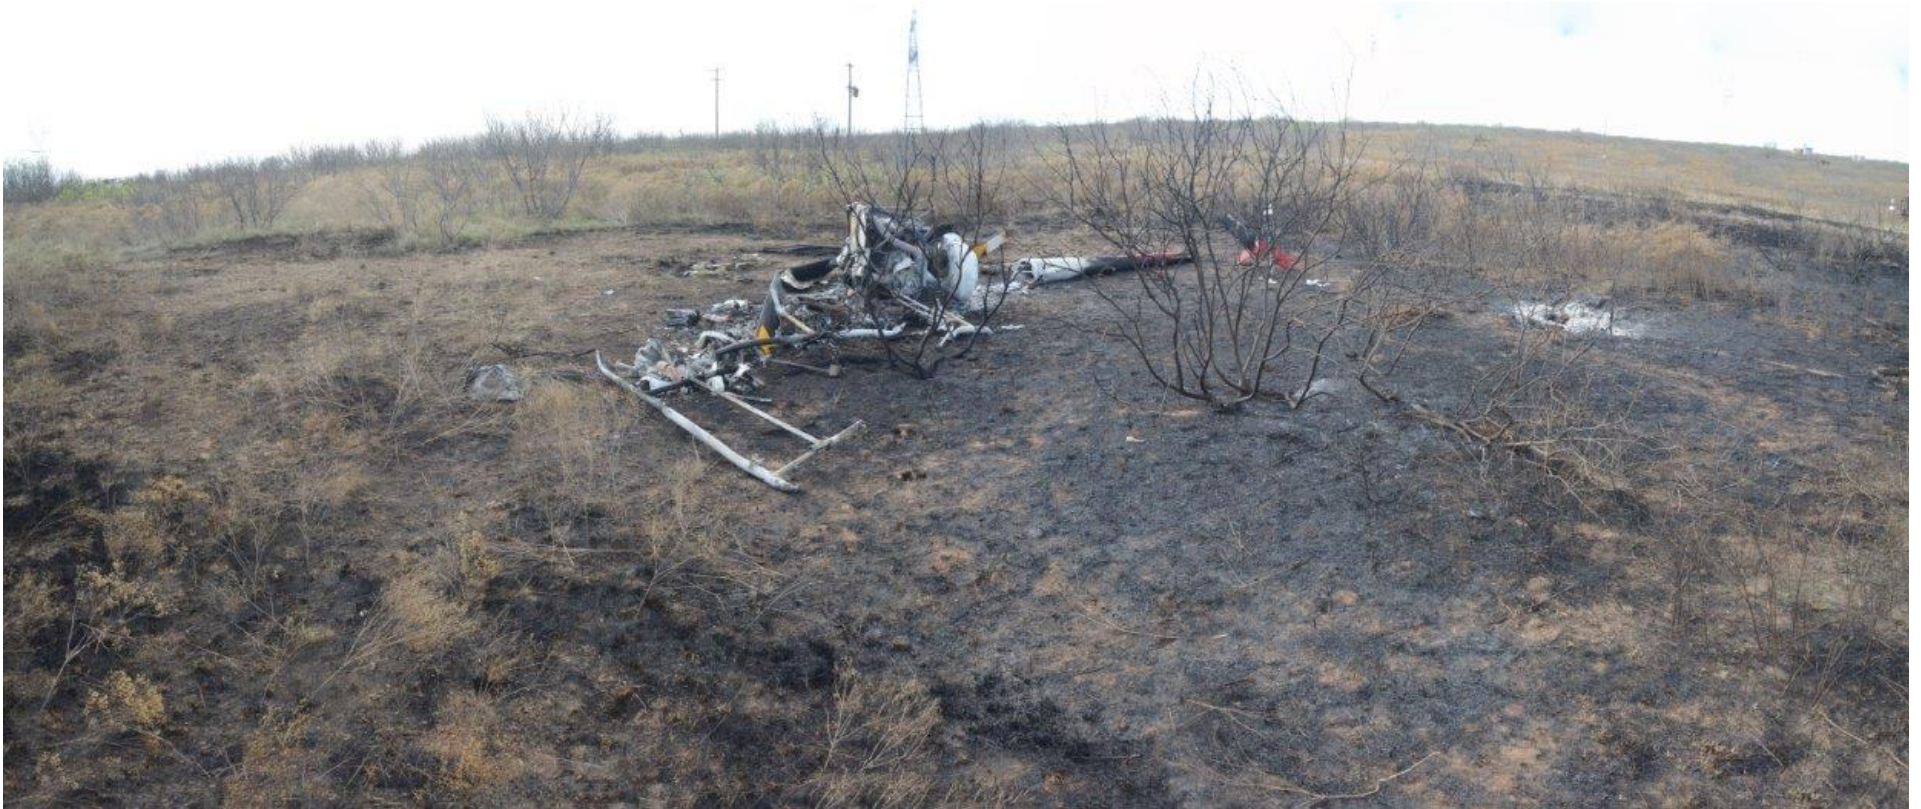
**Photo 1 – View of the helicopter wreckage at the accident site.**

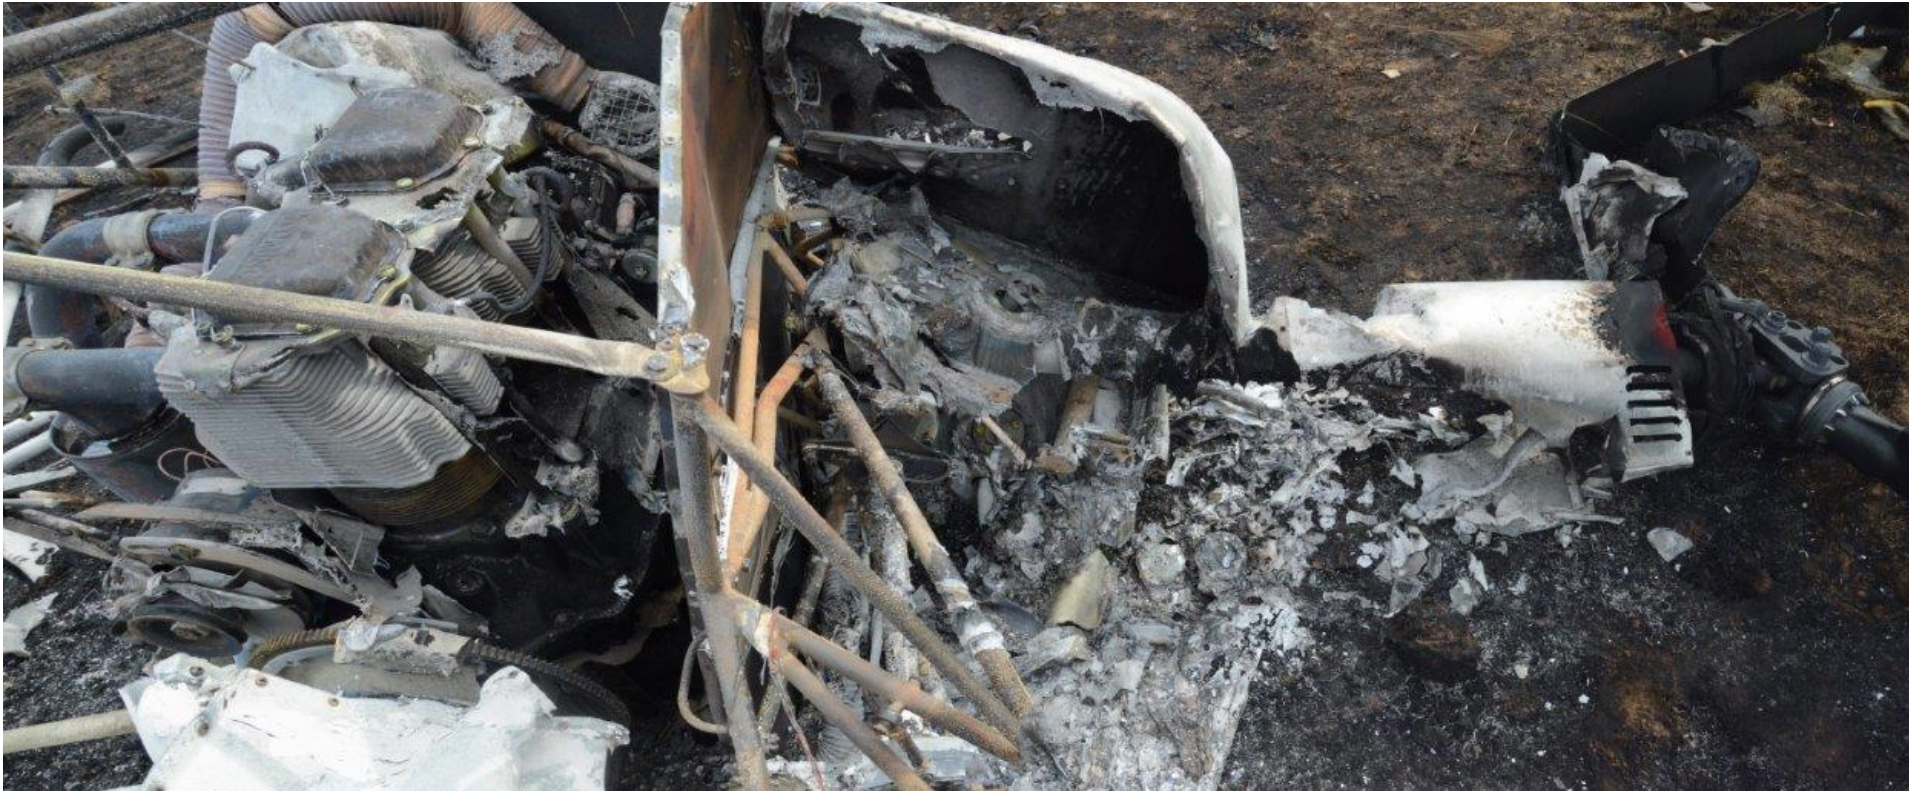
**Photo 2 - View of the helicopter engine, transmission, and mast.**

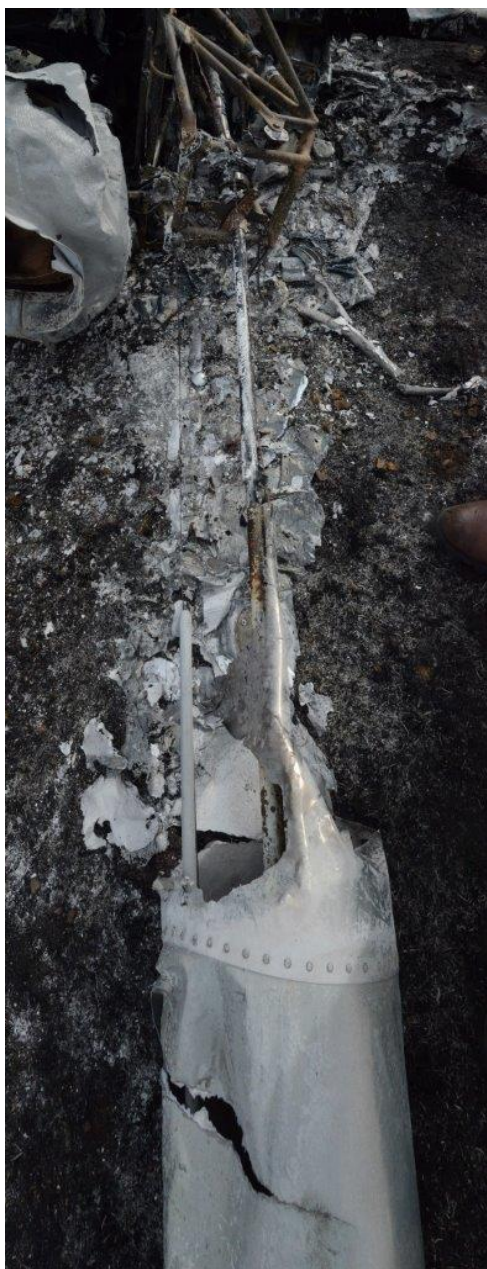
**Photo 3 - View of a section of tailboom that was consumed by fire.**

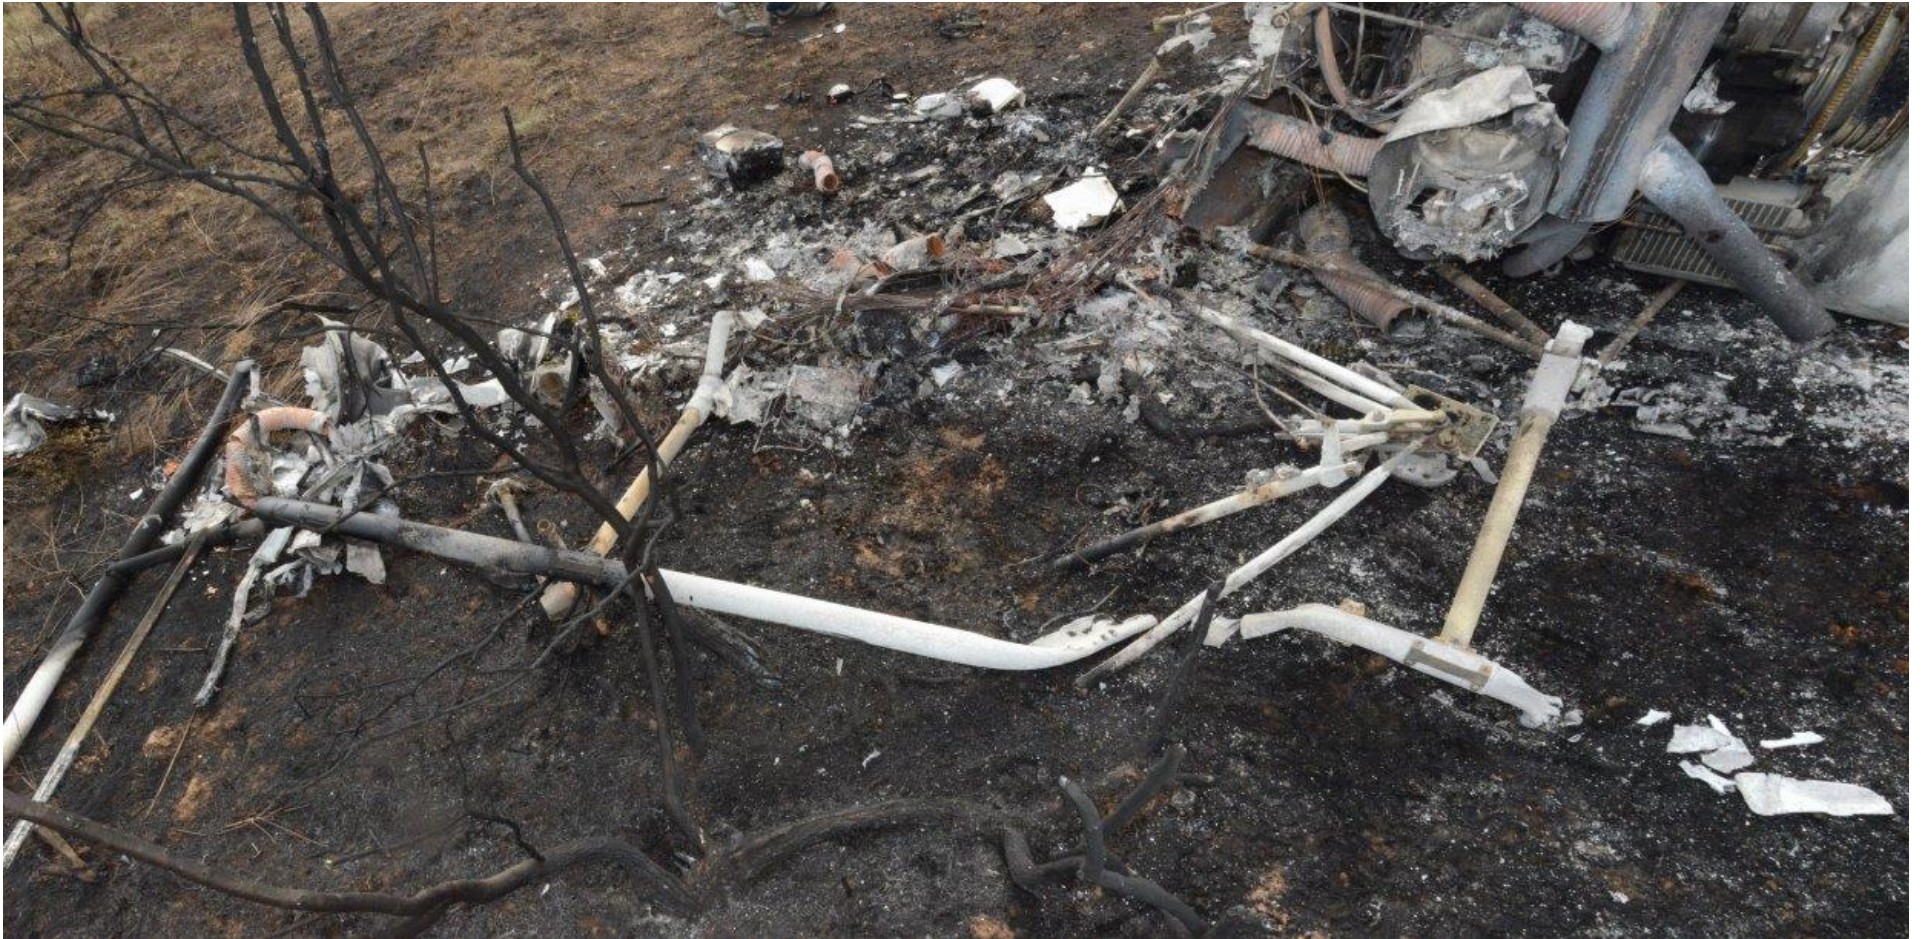
**Photo 4 - View of skid and crosstube components.**

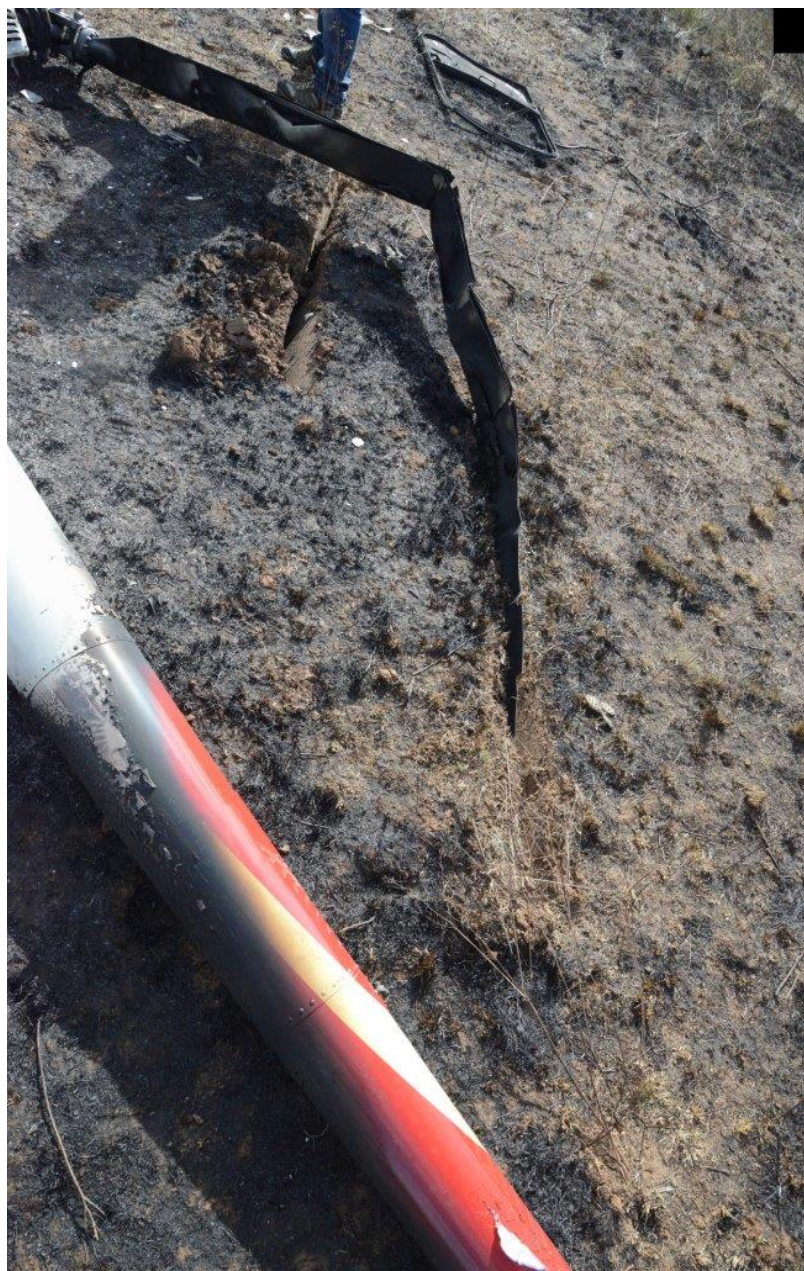
**Photo 5 - View of the tailboom, main rotor blade, and ground scars.**

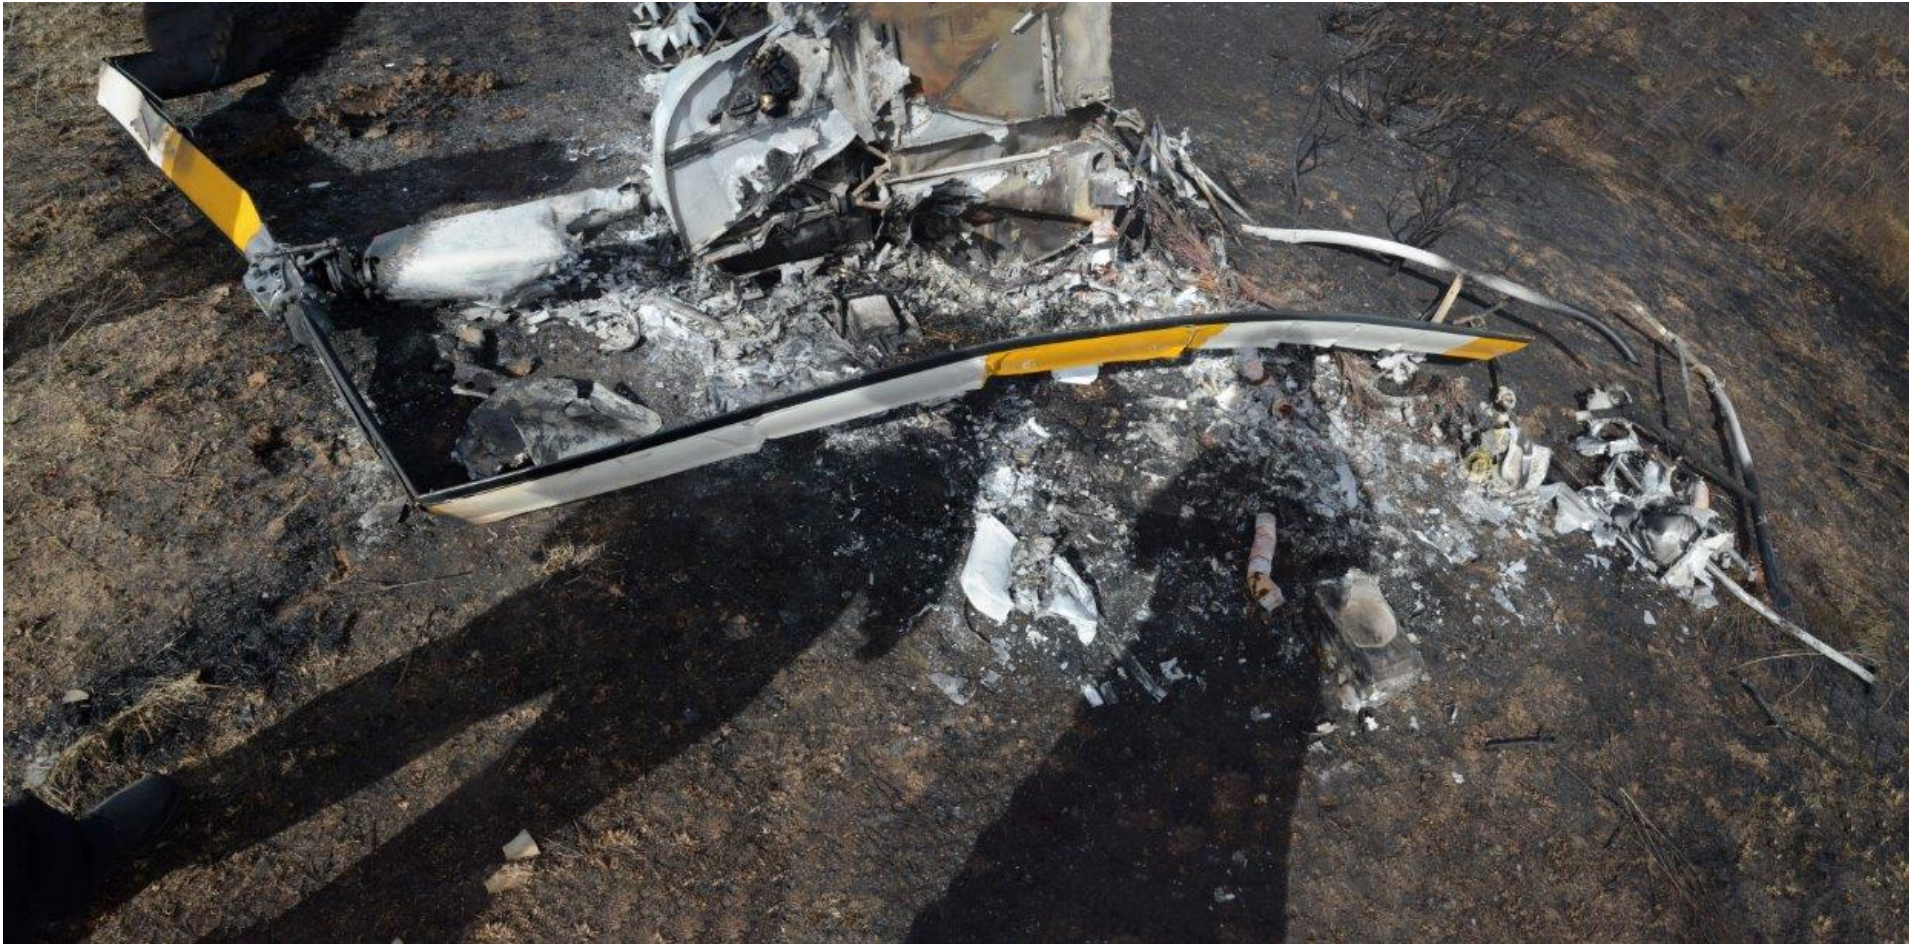
**Photo 6 - View of the main rotor blades and mast.**

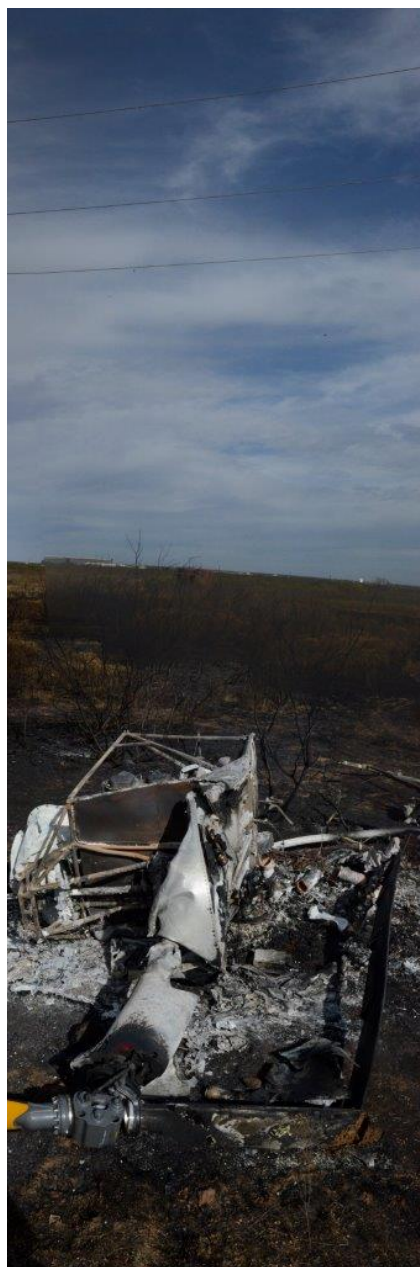
**Photo 8 - View of the wreckage below the powerlines.**

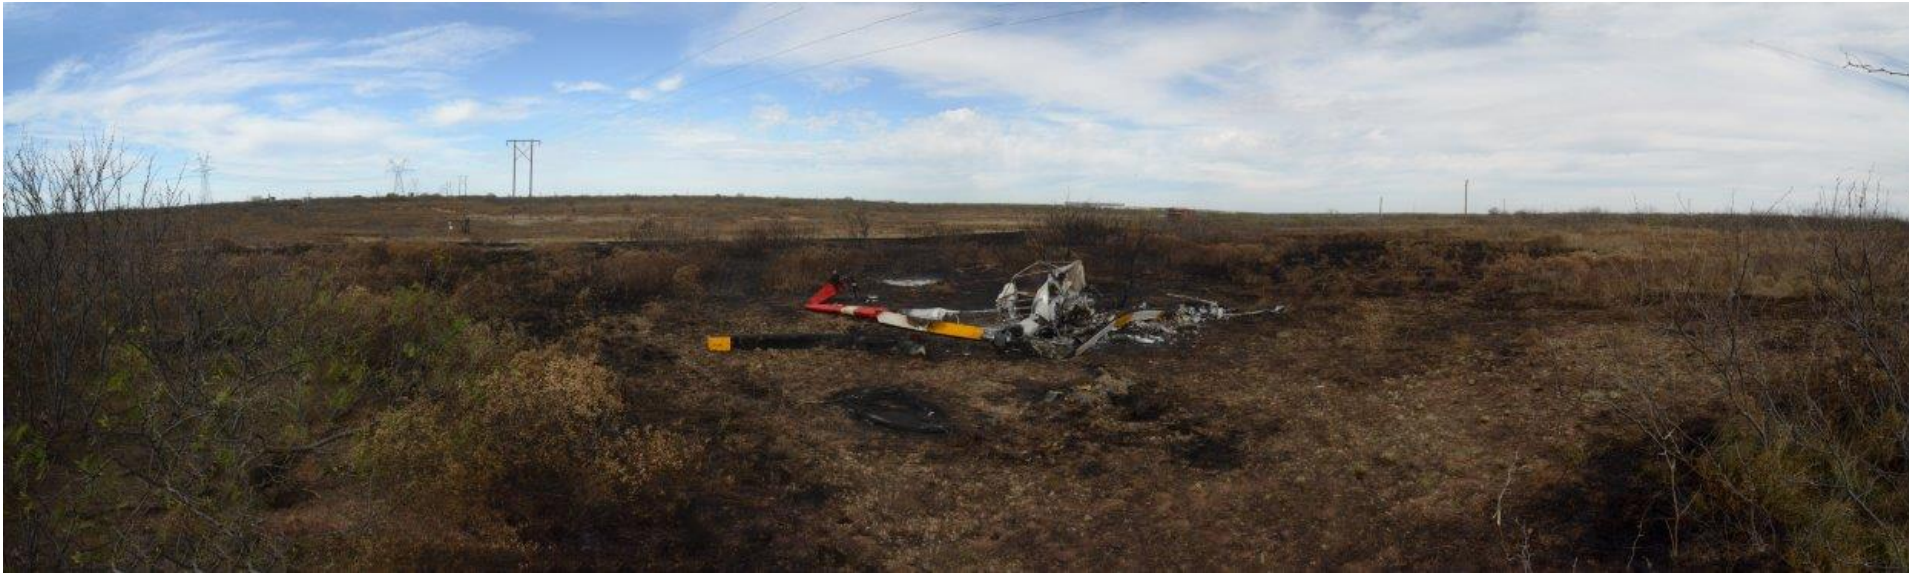
**Photo 9 - View of the helicopter wreckage at the accident site.**

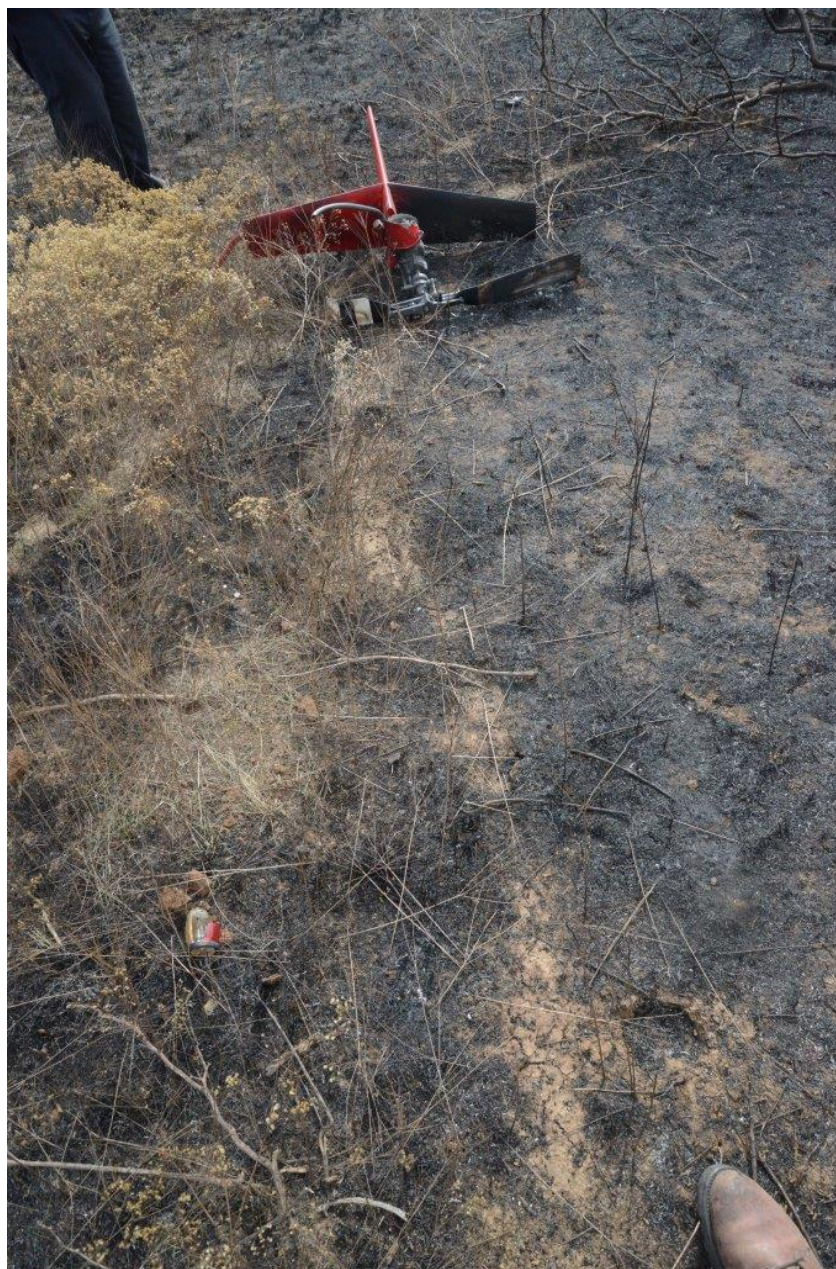
**Photo 10 - View of the aft section of tailboom and tail rotors.**

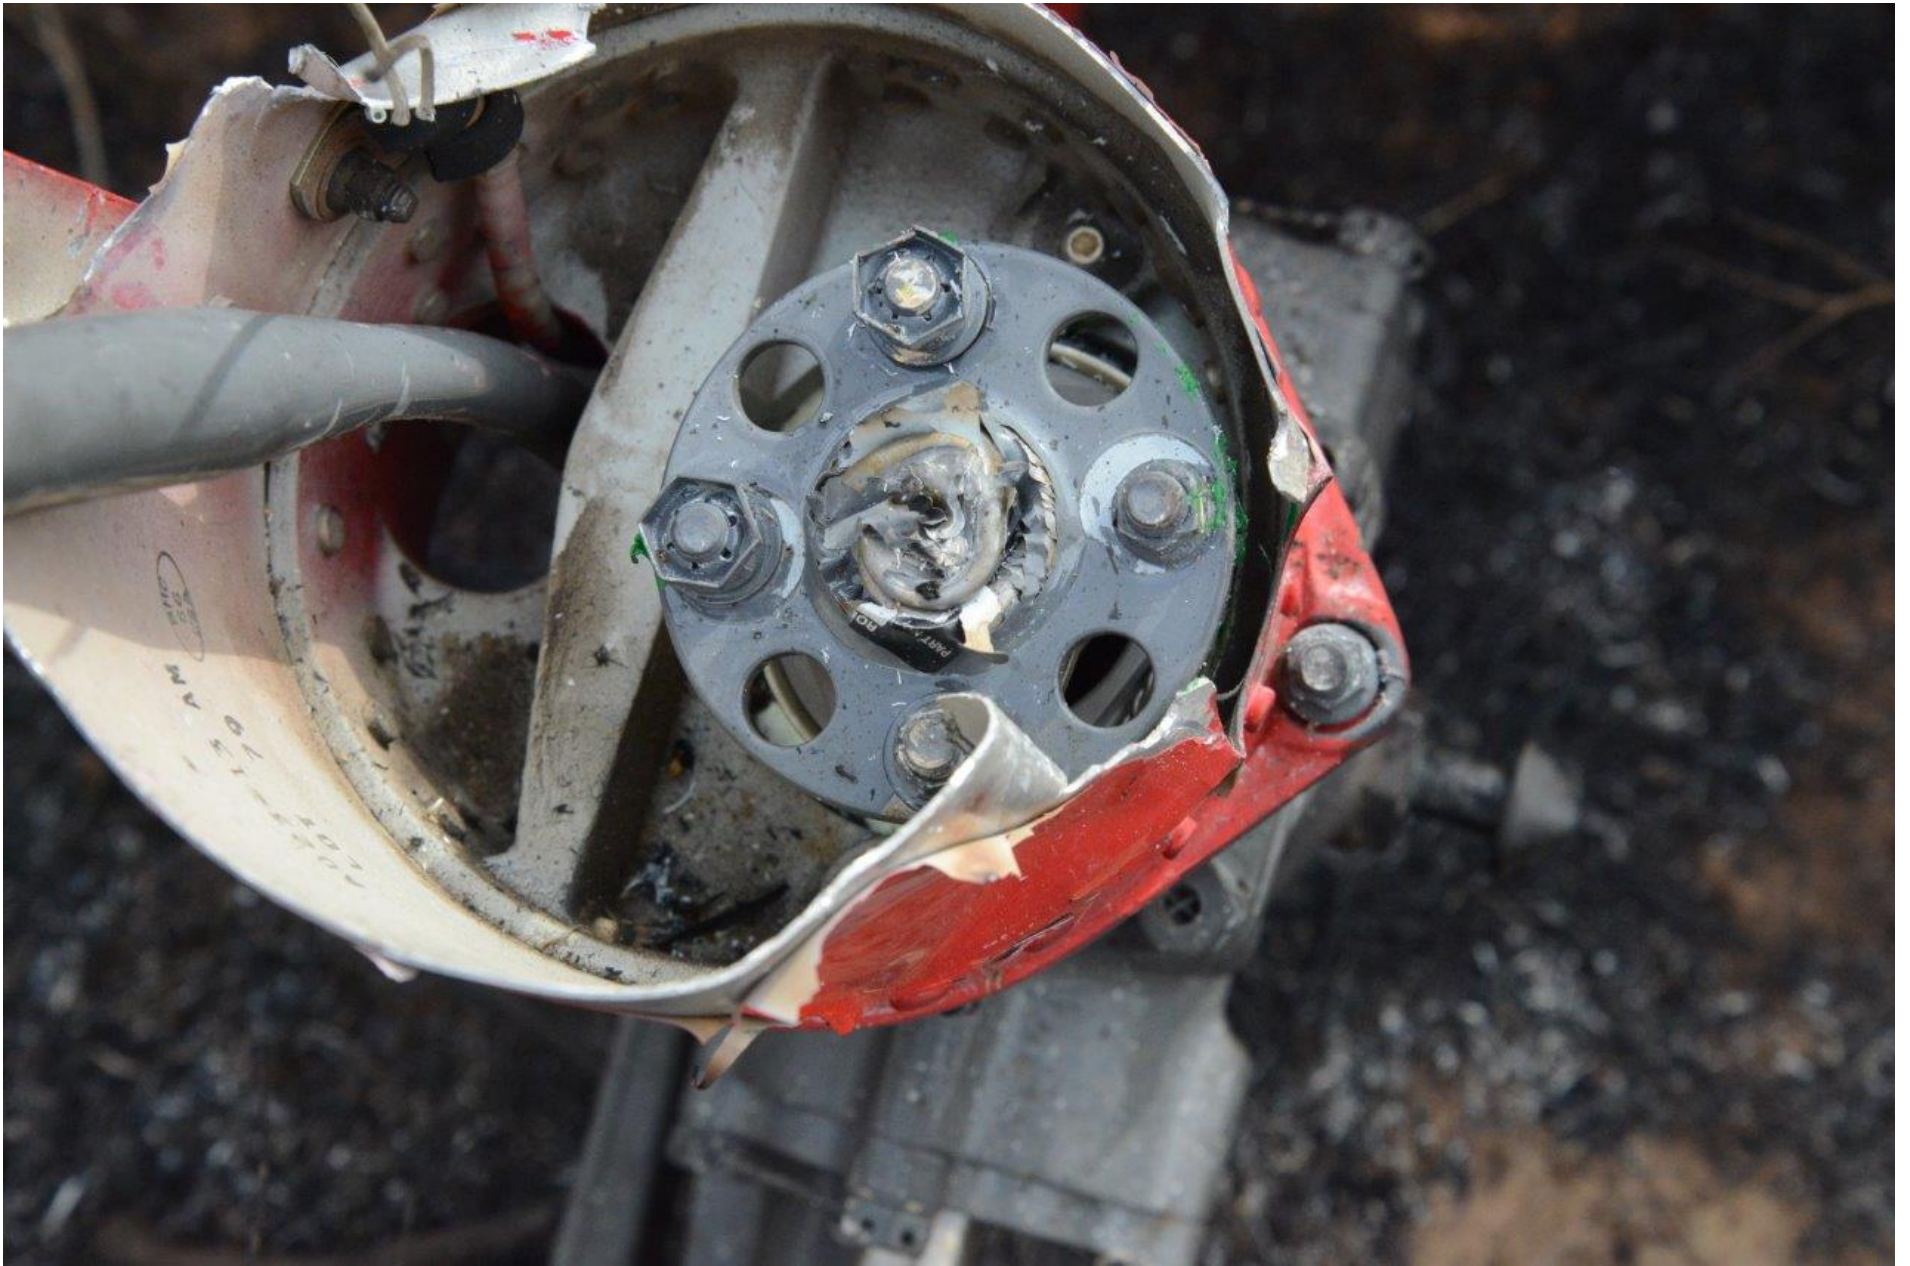
**Photo 11 - Close up view of the tail rotor drive shaft.**

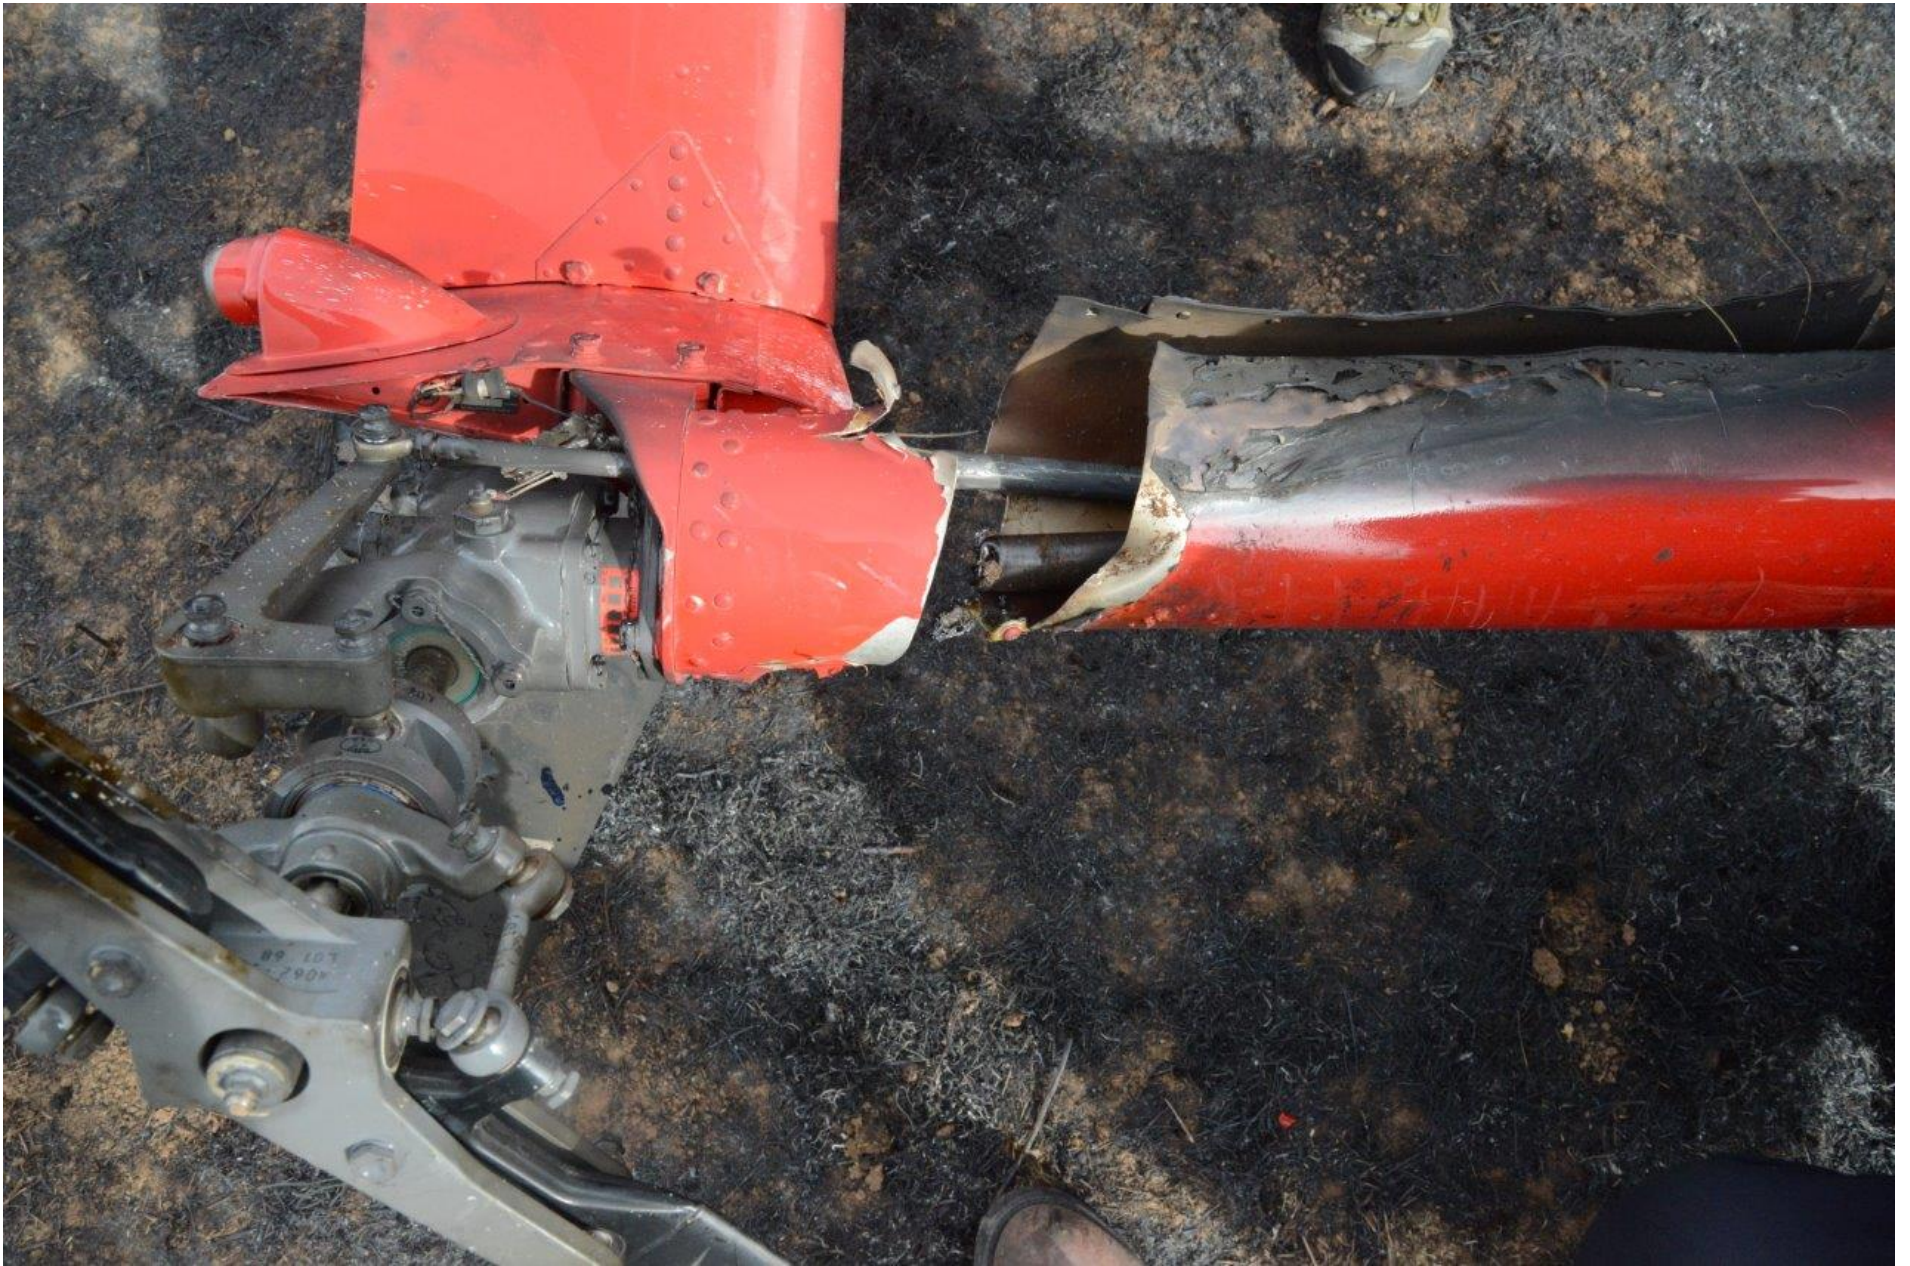
**Photo 12 - View of the separation of the aft section of tailboom.**

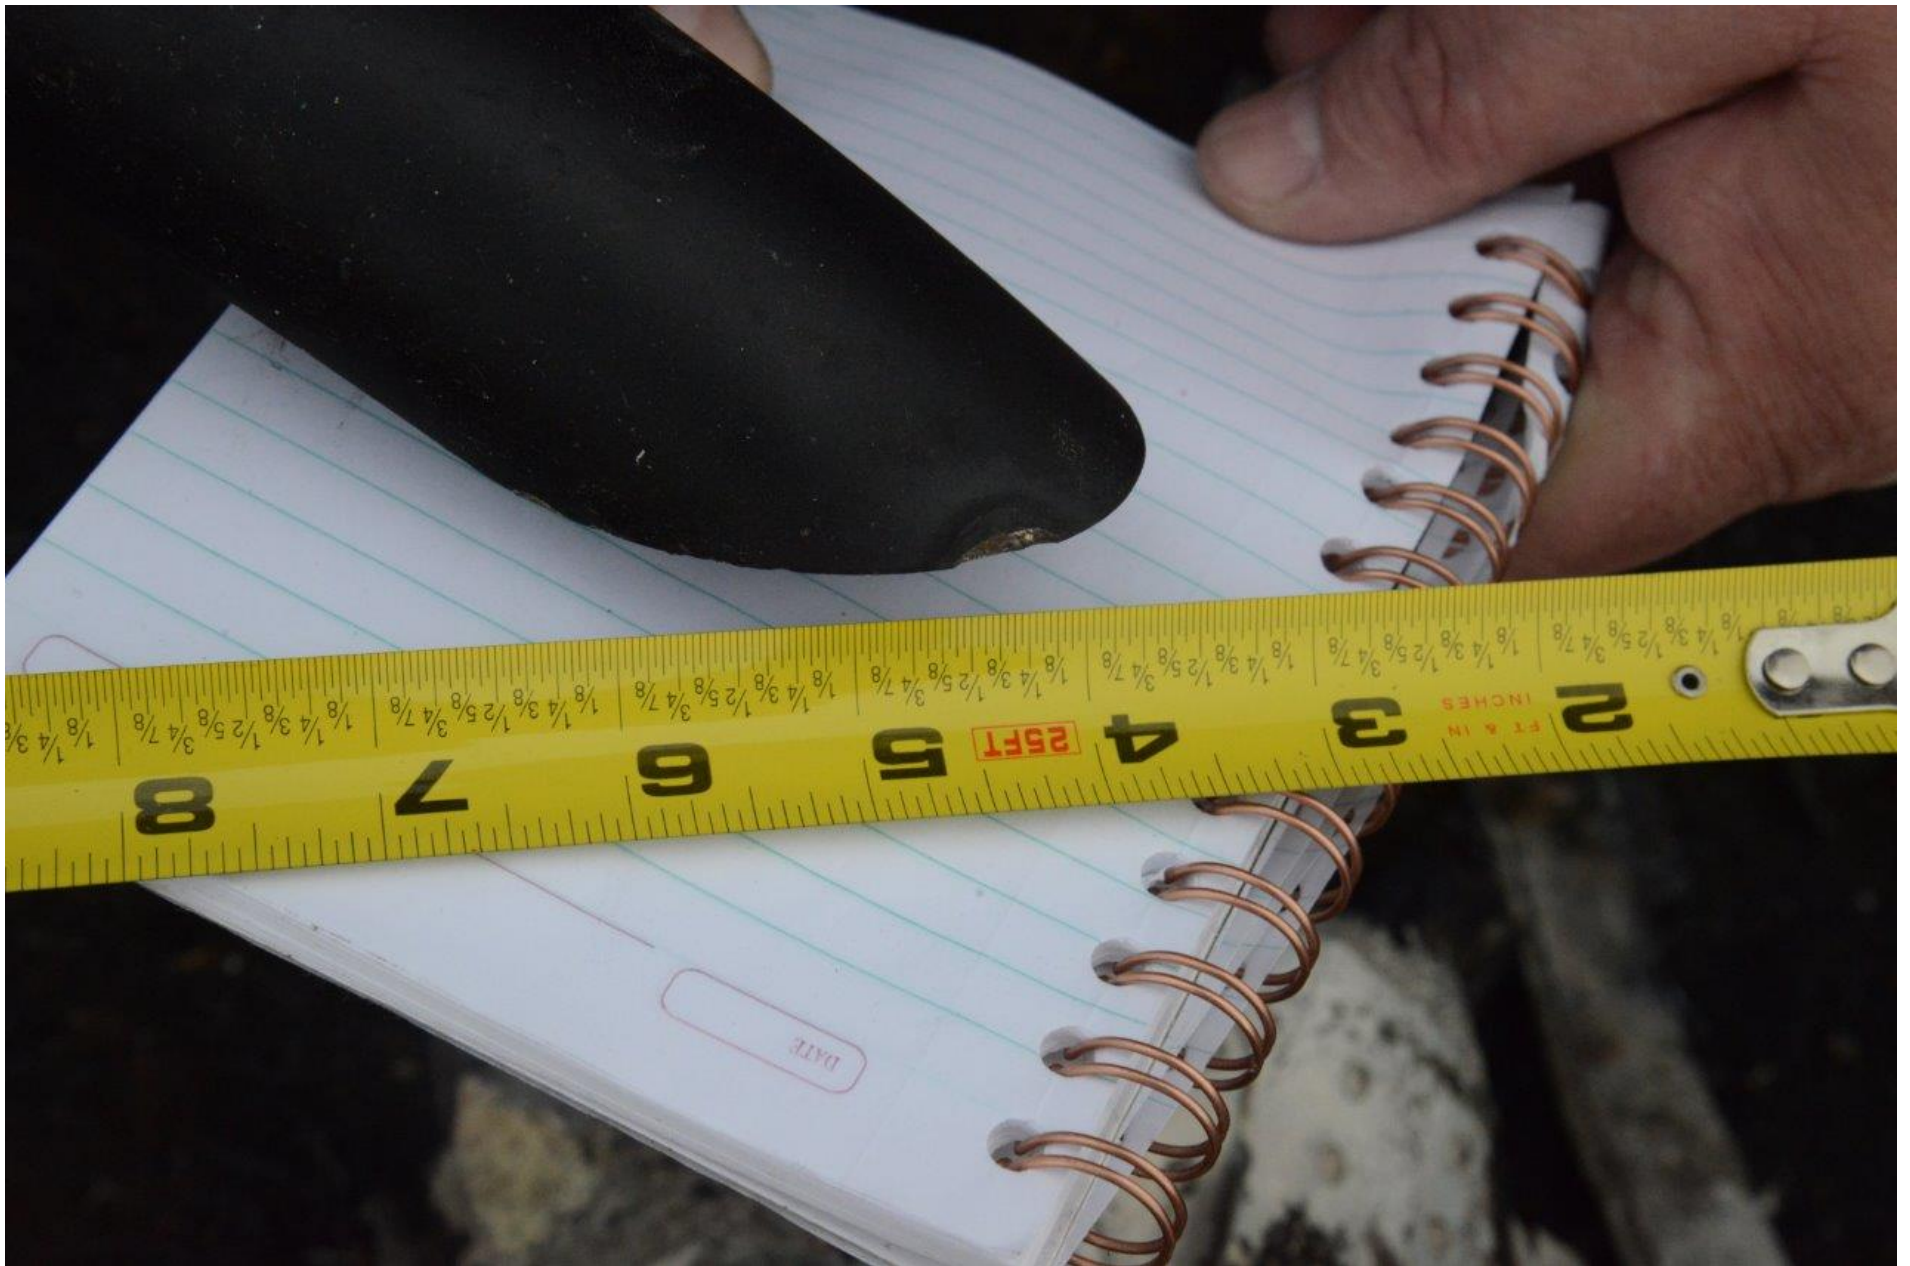
**Photo 13 - View of a skid tip with a semicircular witness mark.**

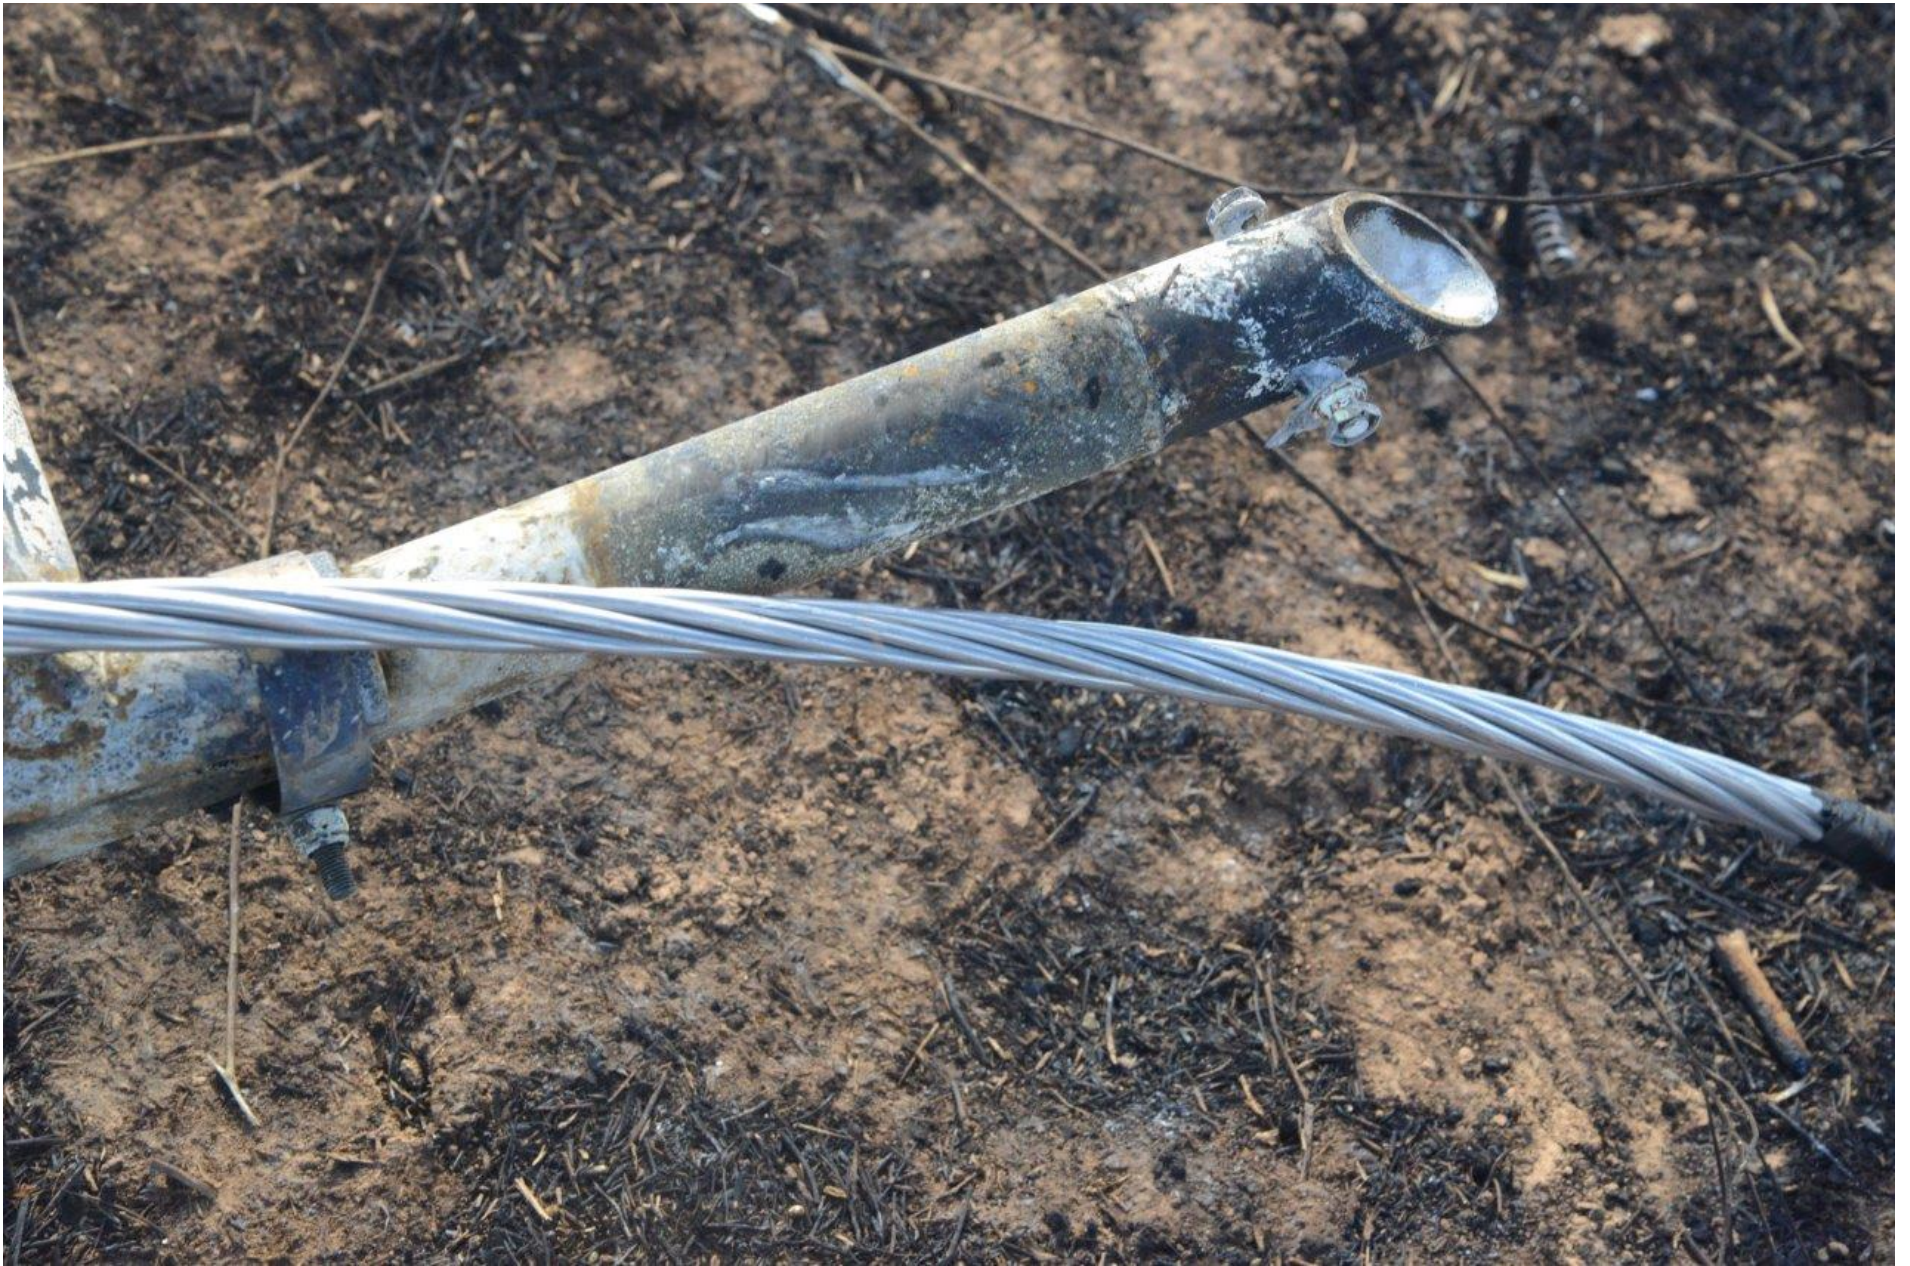
**Photo 14 - View of a crosstube with a witness mark and an exemplar section of powerline.**

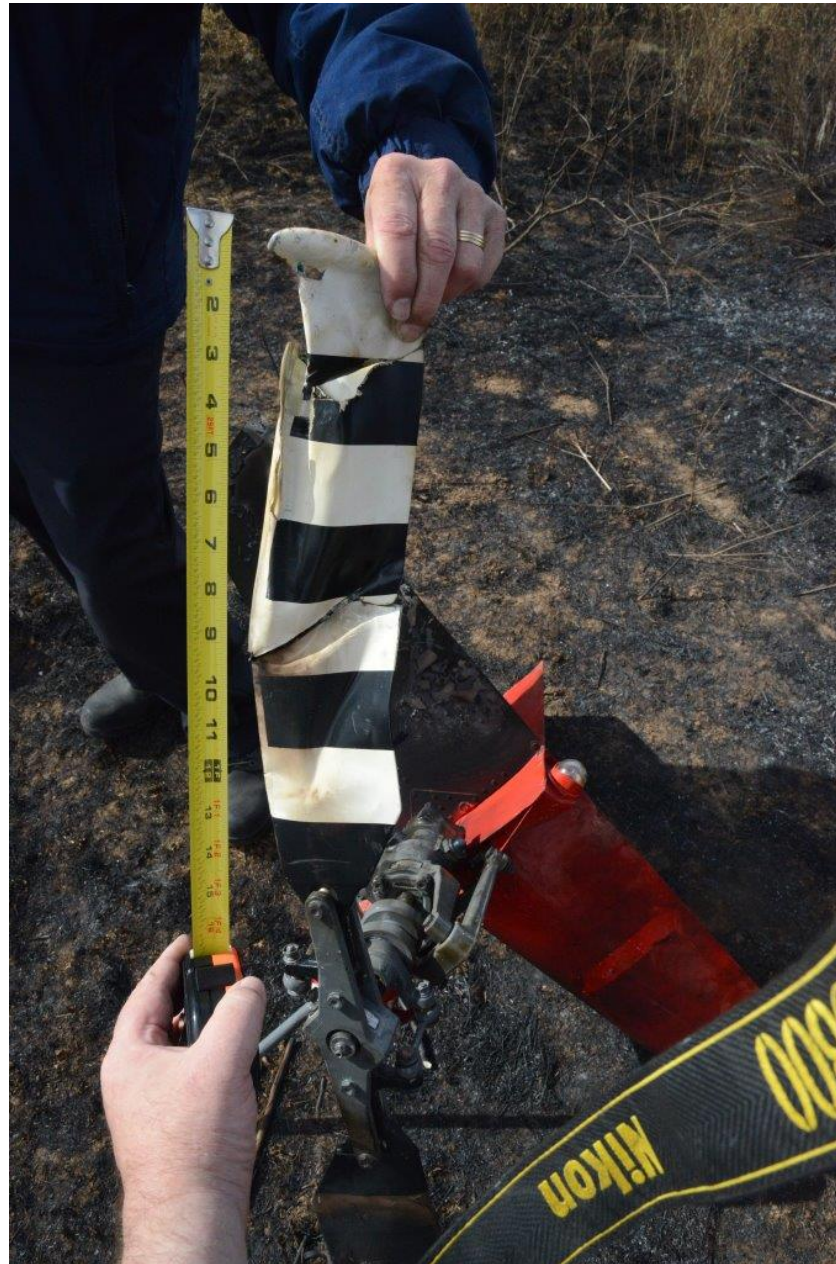
**Photo 15 - View of a tail rotor blade with its liberated blade tip.**

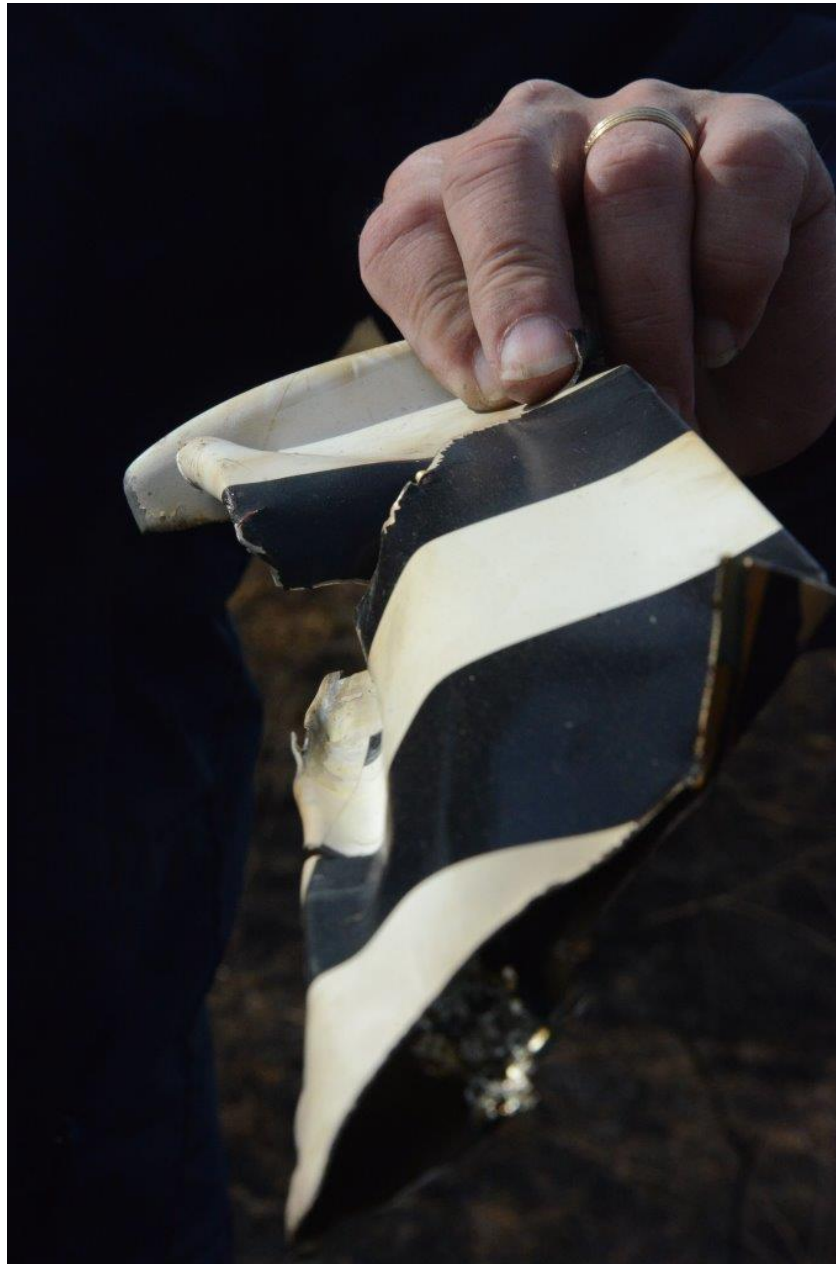
**Photo 16 - Side view of a tail rotor blade with its liberated blade tip.**
