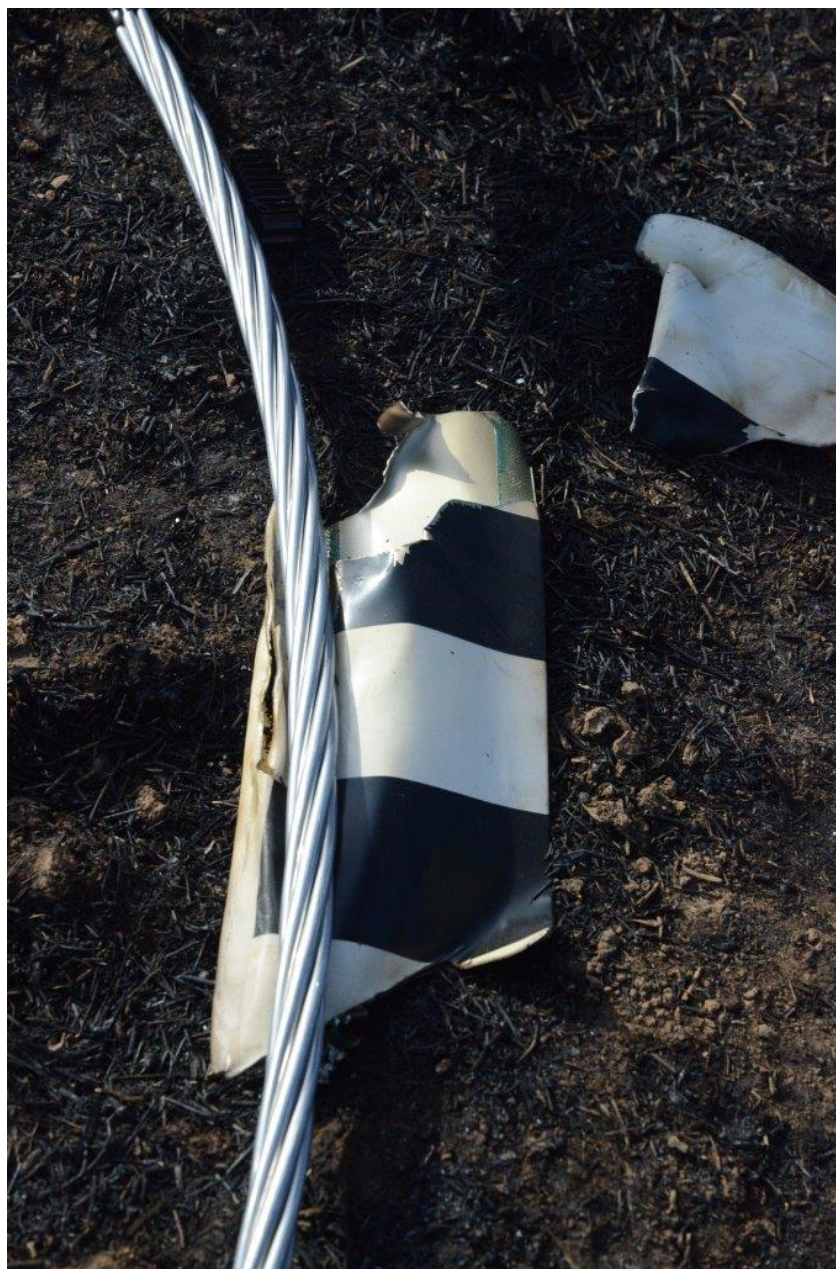
**Photo 17 - View of a tail rotor blade with an exemplar section of powerline.**

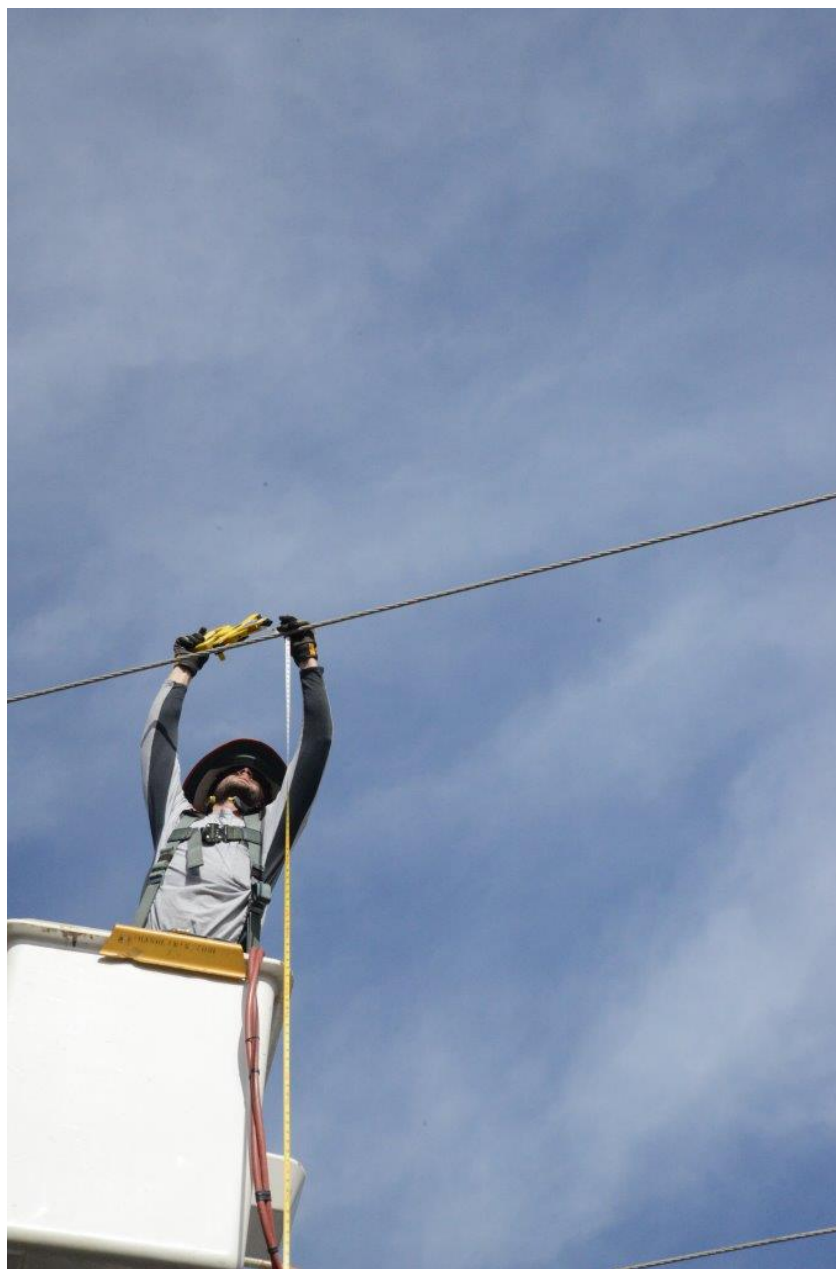
**Photo 18 - Powerline personnel measuring the height of the powerline at the accident site.**

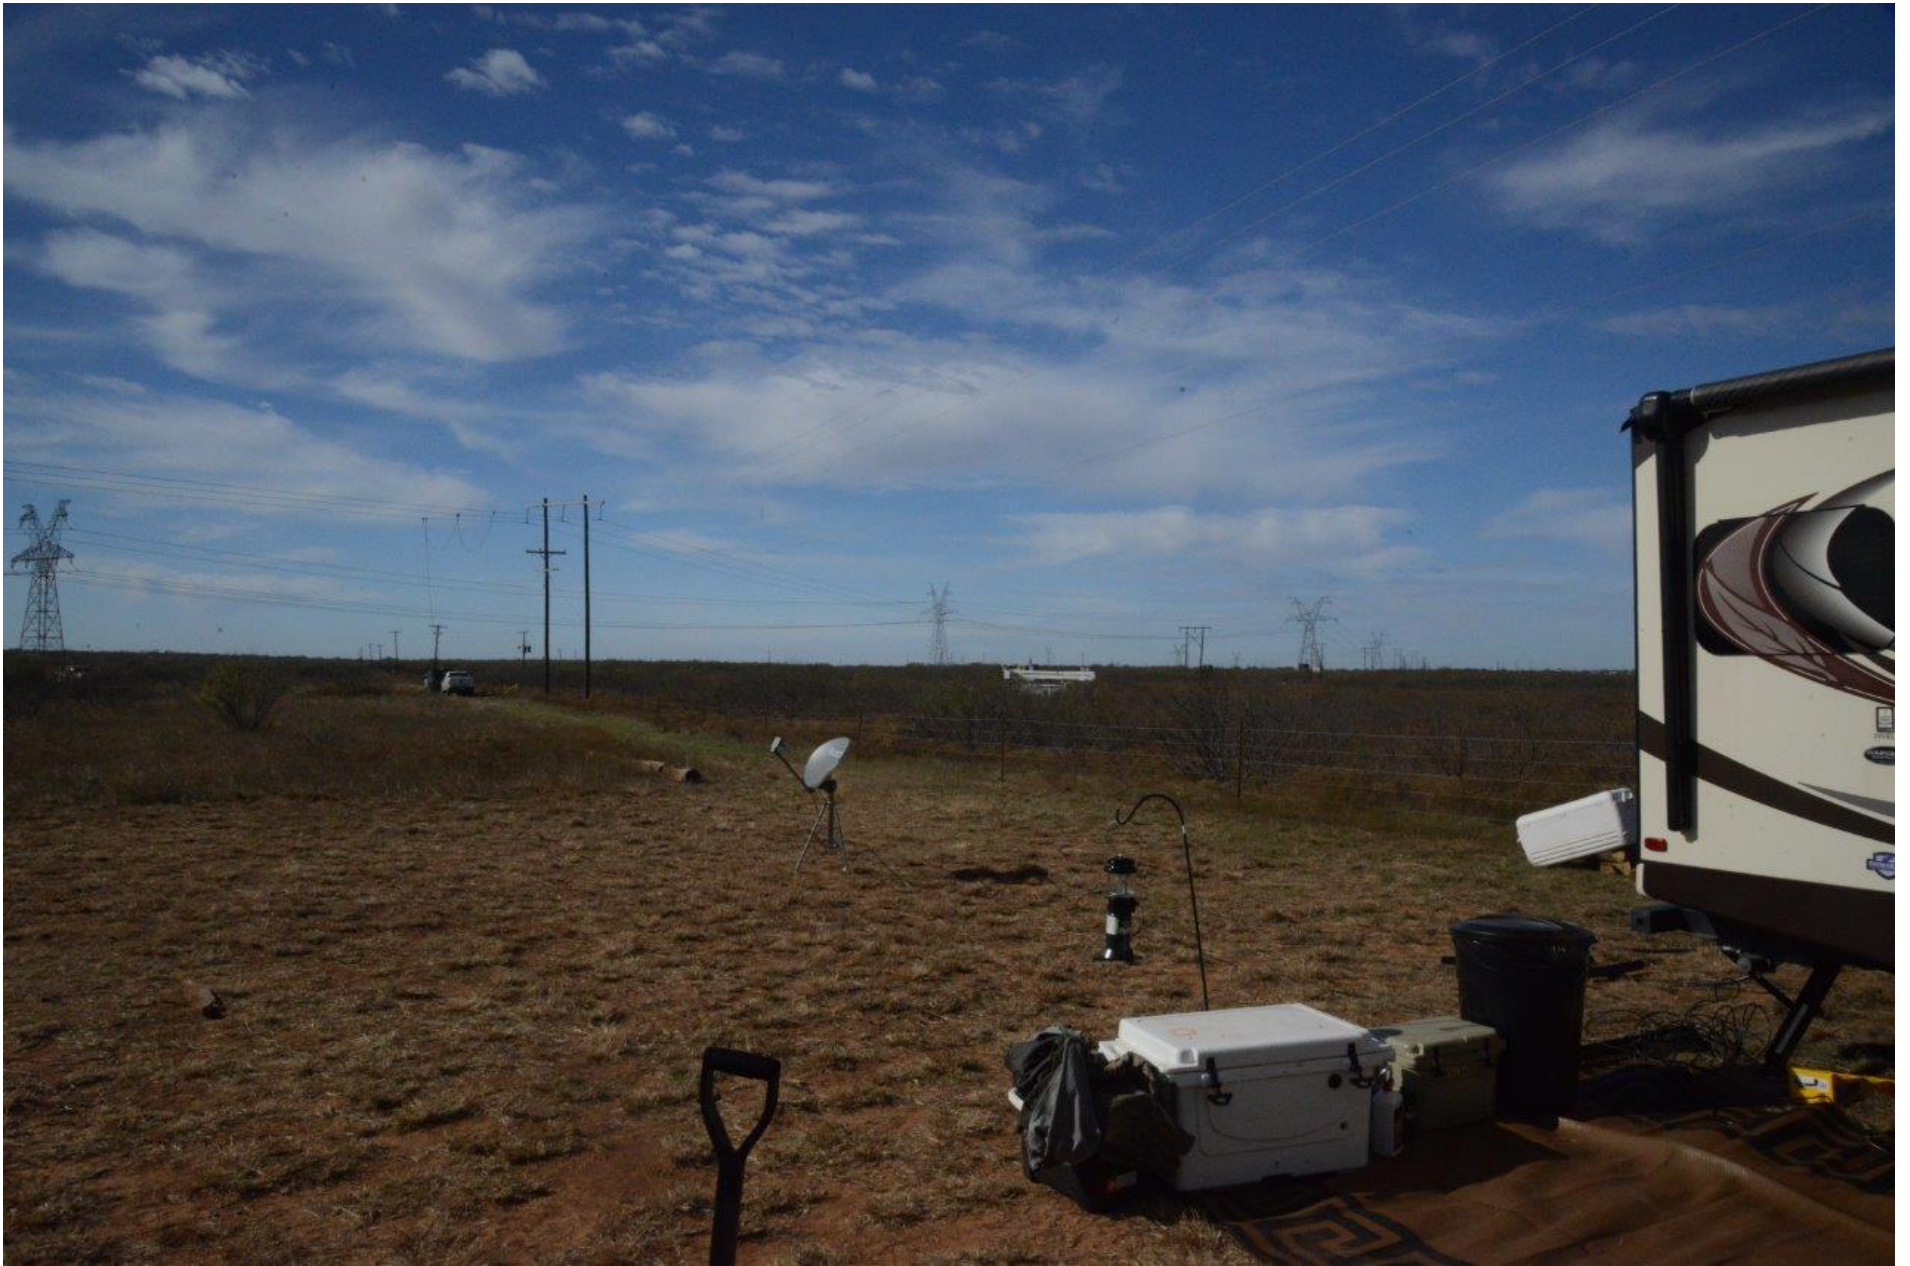
**Photo 19 - View from the witness location to the powerlines.**

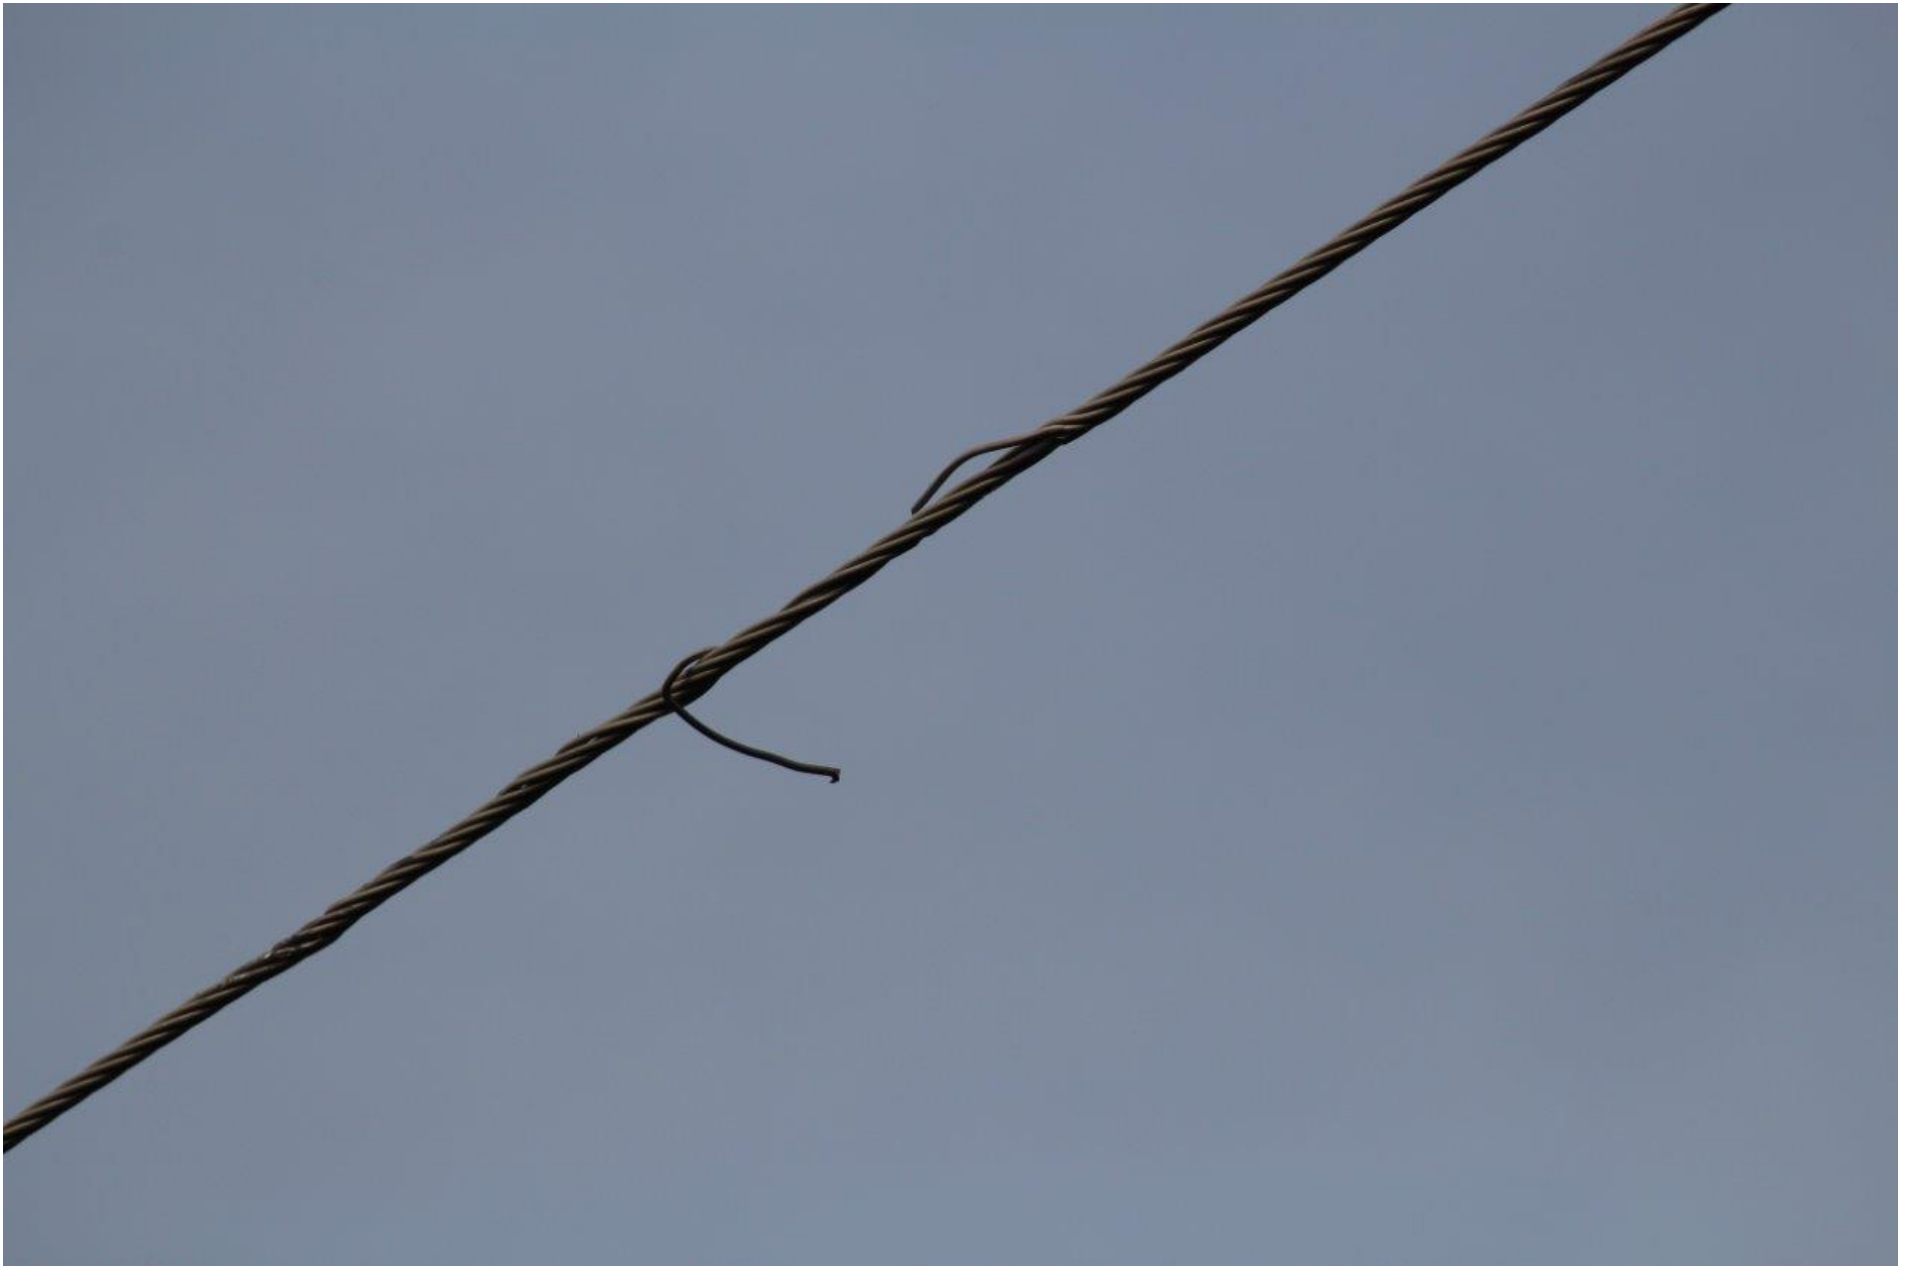
**Photo 20 - Close-up view of a powerline with a separated strand.**
