**NATIONAL TRANSPORTATION SAFETY BOARD**

**FIELD NOTES**

**CEN18FA037**

On November 22, 2017, about 1700 eastern standard time, a Cessna 172G, N4676L, was destroyed when it impacted trees and terrain near Pittsford, Vermont. The pilot was fatally injured. The aircraft was registered to Anne Kristine II, Inc., and operated by the pilot under the provisions of 14 *Code of Federal Regulations* Part 91 as a personal flight. Weather conditions at the site are to be determined. The flight was not on a flight plan. The flight originated from the Pittsfield Municipal Airport (PSF), Pittsfield, Massachusetts at an unconfirmed time and the Middlebury State Airport (6B0), Middlebury, Vermont, was the intended destination.

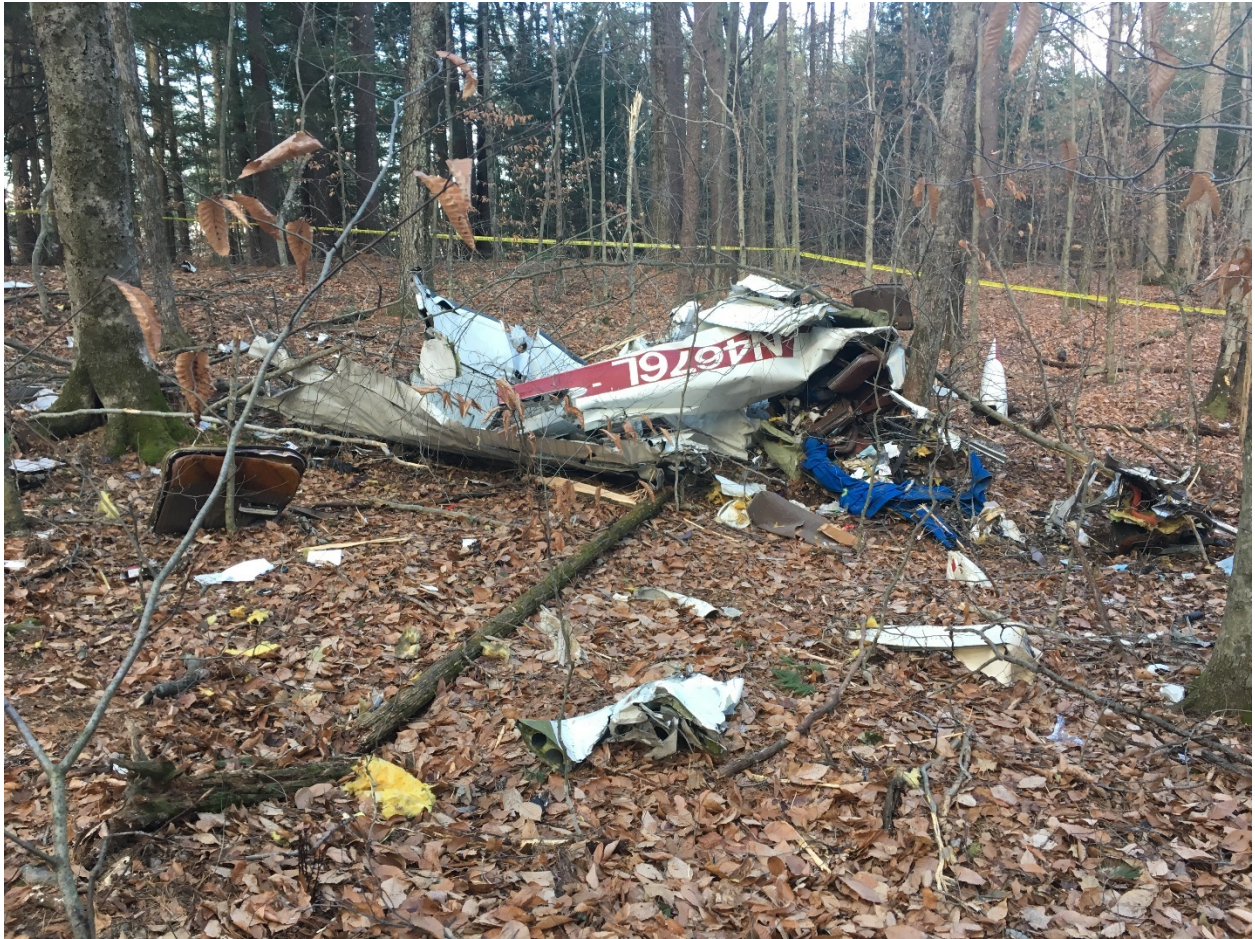
The airplane impacted trees and terrain and came to rest at coordinates 43-45.341N, 73-2.402W. The initial impact point was a tree at location 43-45.33N, 73-2.424W. The engine was found at location 43-45.354N, 73-2.394W and it and the battery were the farthest pieces from the main wreckage. The airframe was severely fragmented and came to rest at the base of a large tree. A tree limb about 4 inches in diameter was found that had a clean propeller slash completely through the limb.

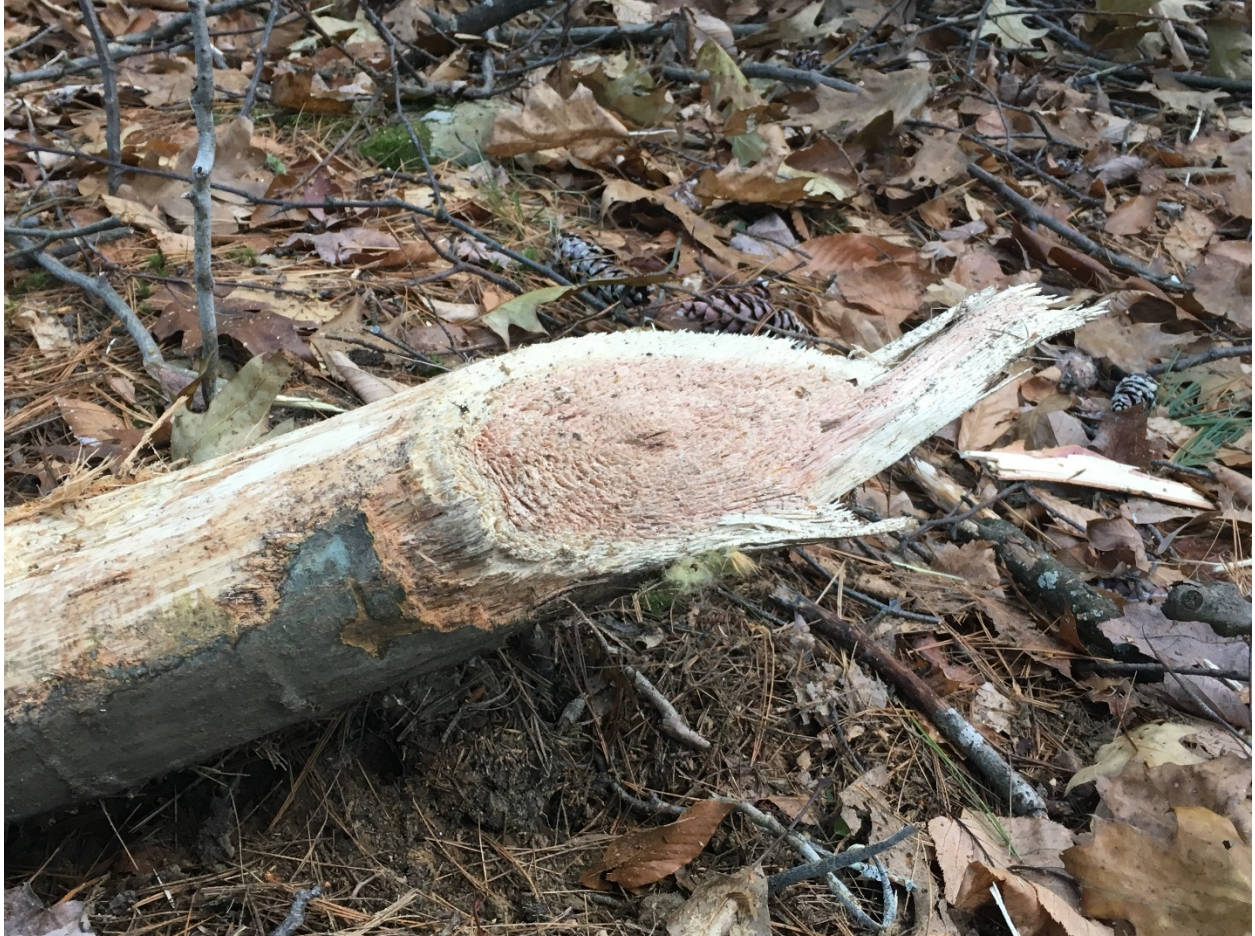
The fuselage was crushed rearward to the cabin area. The aft fuselage was intact but bent to the left. The tail surfaces were separated from the fuselage. Portions of the top, middle and bottom of the vertical stabilizer were found near the main wreckage. The bottom rib of the rudder, including the control bellcrank remained attached to the rudder cables. The cables were continuous to the cabin area. The left cable was broken and the break was consistent with overload failure. The right rudder cable was cut near the firewall to facilitate transportation. The main landing gear was still attached to the fuselage. The engine, and nose landing gear had separated from the fuselage. The forward fuselage including the firewall was cut from the aft fuselage to facilitate transportation.

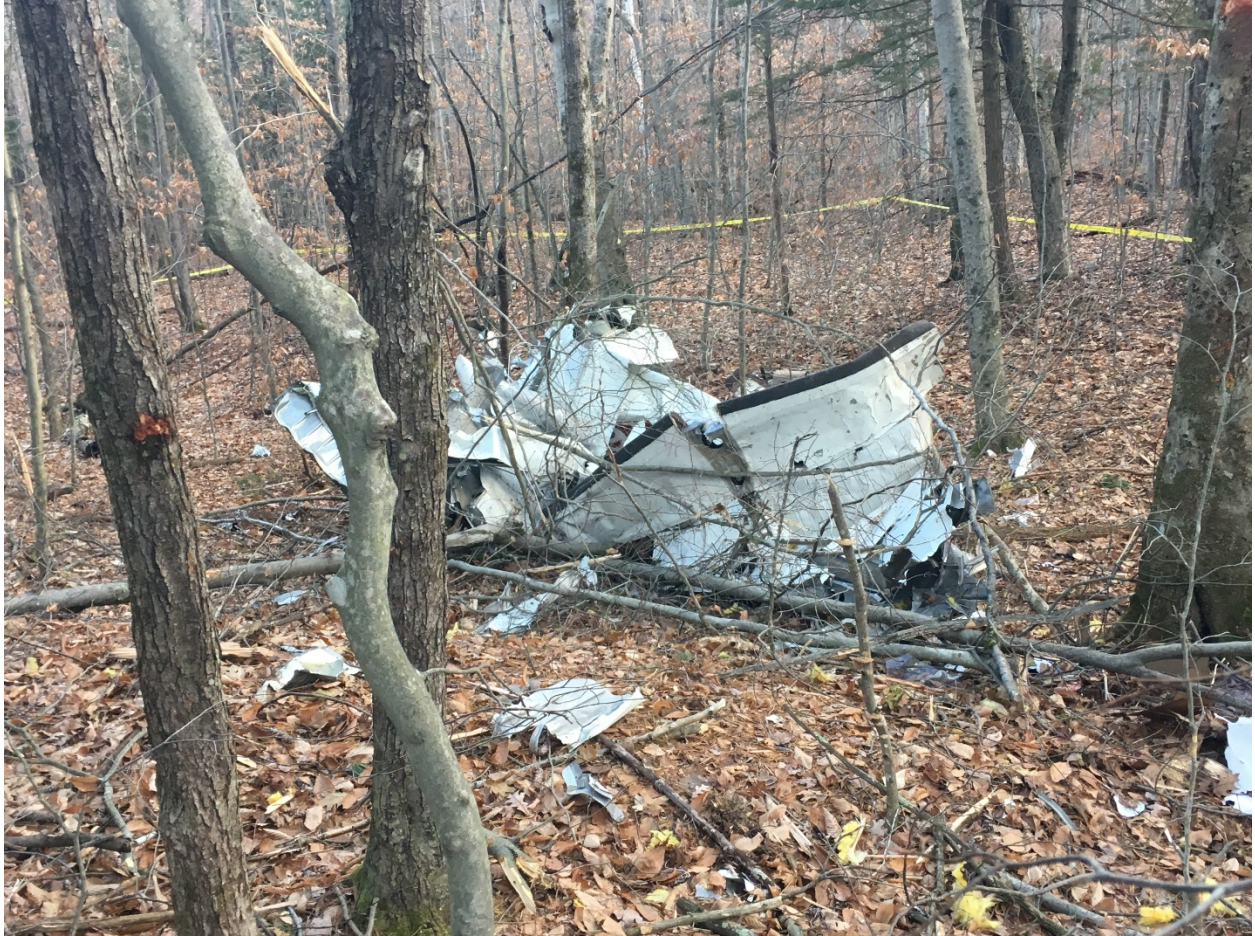
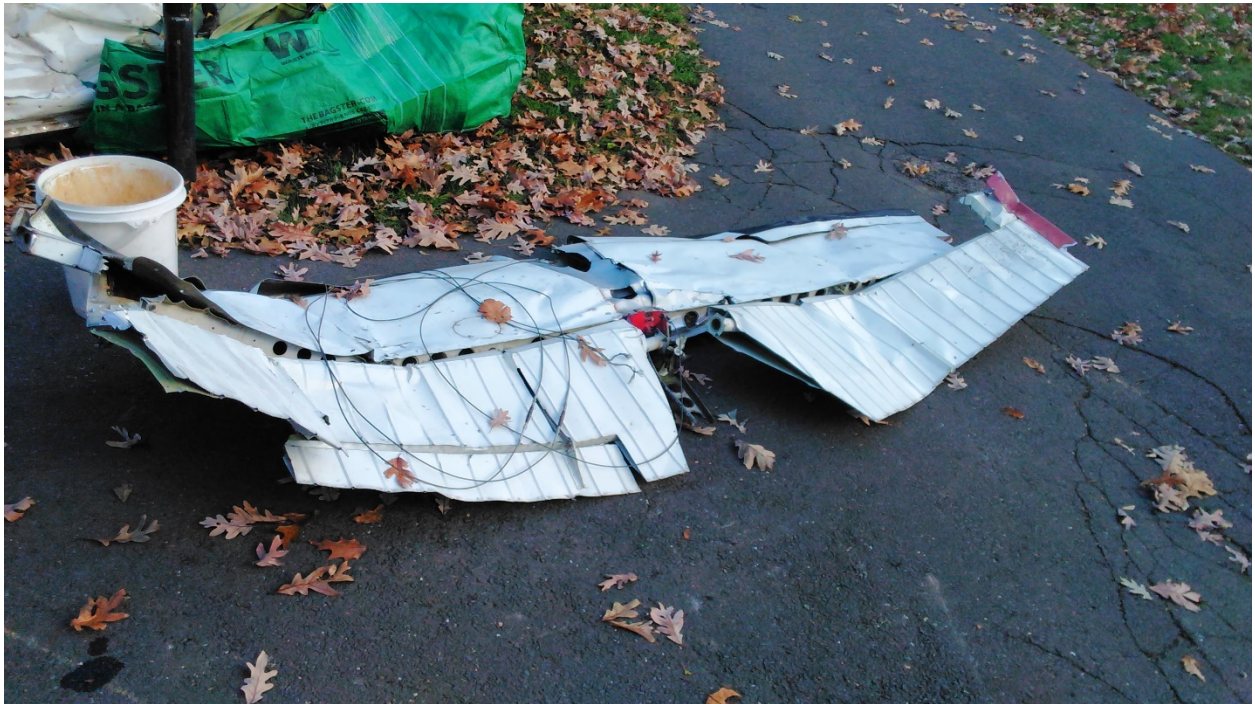
The horizontal stabilizer was found adjacent to the aft fuselage with both elevators still attached. The right tip of the horizontal stabilizer and the right elevator balance weight were separated. The elevator control cables remained attached to the elevator bellcrank, but had breaks that would have been located within the fuselage structure. The breaks were consistent with overload failure.

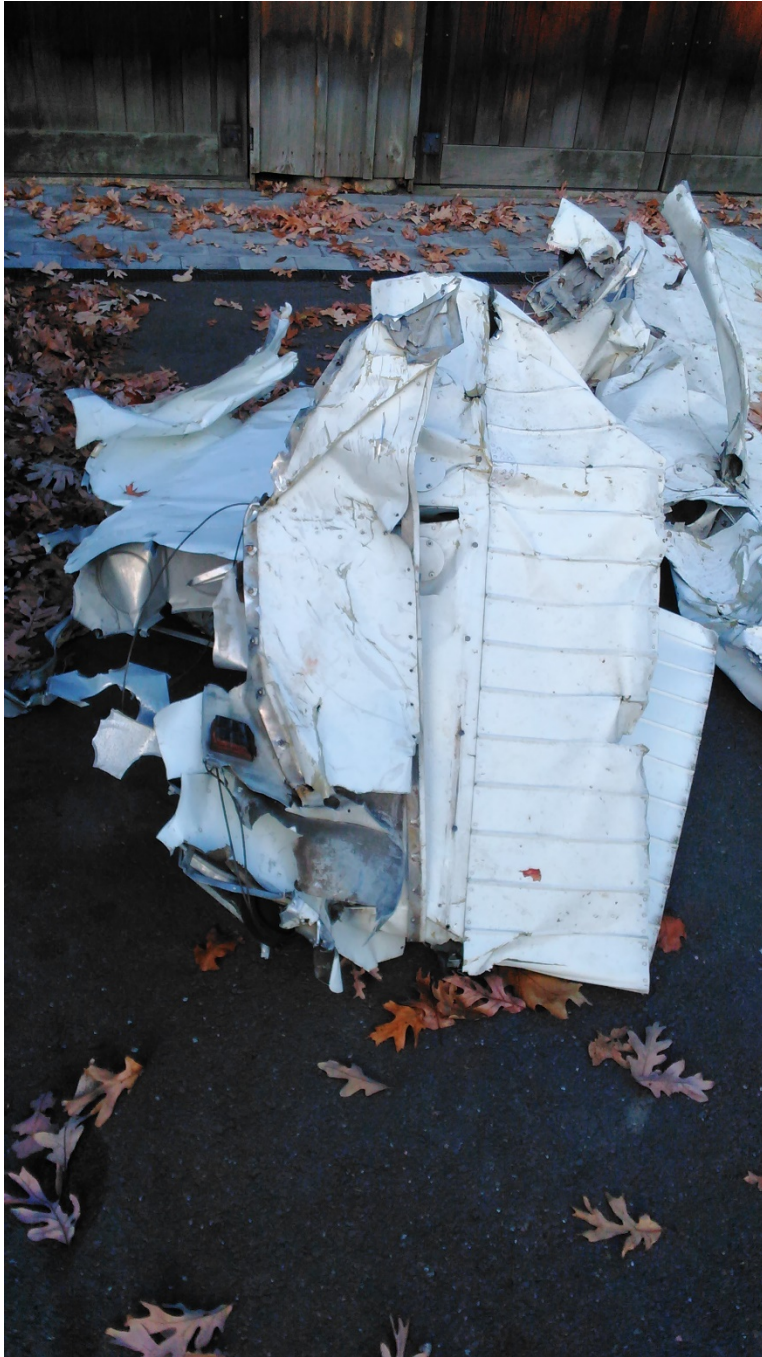
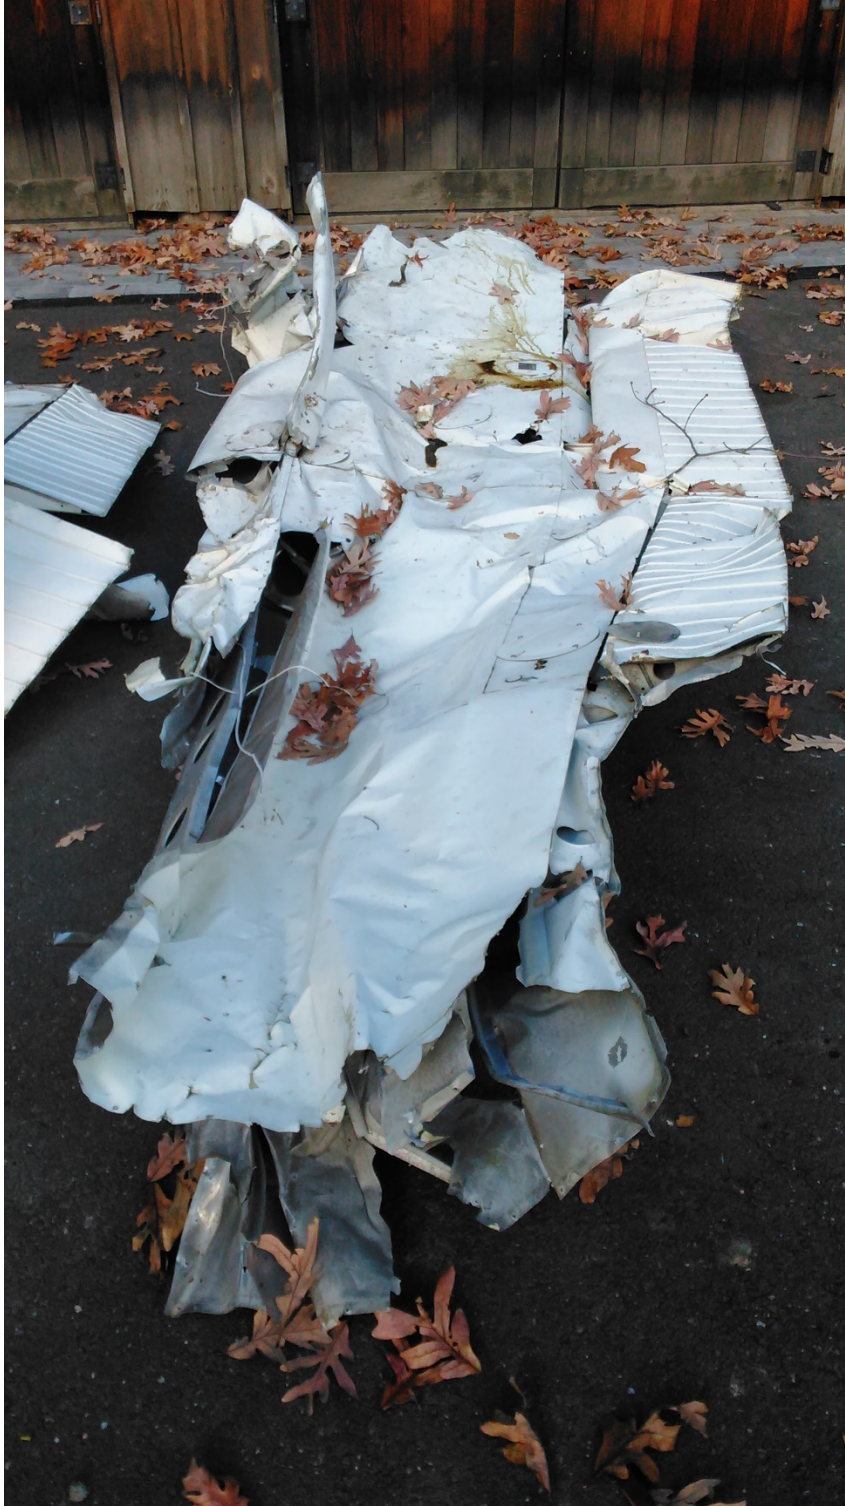
The wings were separated from the fuselage. About 5 feet of the outboard left wing was separated from the remainder of the left wing. The right wing tip fairing was separated from the right wing. Both fuel tanks were breached and both wings had impact damage and crushing. The

right aileron was still attached and left aileron was separated. The left and right aileron control cables were continuous from the bellcrank near the surfaces to the wing root.

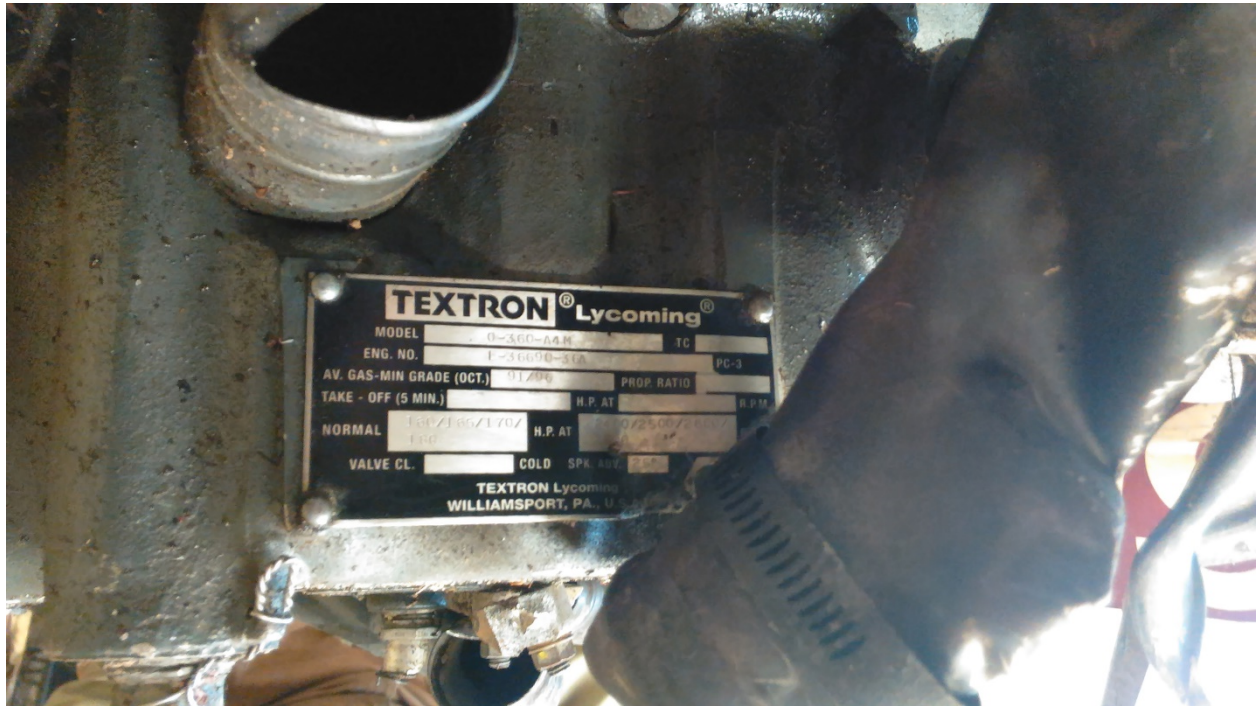
The airplane's engine had separated from the fuselage. The carburetor was separated from the engine. It was found that although the airplane was originally equipped with a Continental O-300D engine, the engine installed at the time of the accident was a Lycoming O-360-A4M, serial number L-36690-36A. The propeller had separated from the engine. The lower spark plugs were removed from the engine and indicated normal-worn appearance when compared to a Champion Aviation Check-a-plug chart. The crankshaft could be rotated and thumb compression was verified on all cylinders. Valve action was verified on all cylinders when the crankshaft was rotated. The left magneto remained attached to the engine and produced spark on 3 leads during engine rotation. The 4<sup>th</sup> spark plug wire was impact damaged near the distributor cap. The cap was removed and one of the other leads was used to verify spark from the remaining distributor tower. The impulse coupling of the left magneto could be heard to click during rotation of the engine. The right magneto was separated from the engine and did not have an impulse coupling. All 4 ignition wires were pulled from the distributor cap. The left cap and leads were used as a surrogate to verify spark from all 4 distributor lead locations. The magneto shaft was rotated using an electric drill and spark was produced on all lead locations.

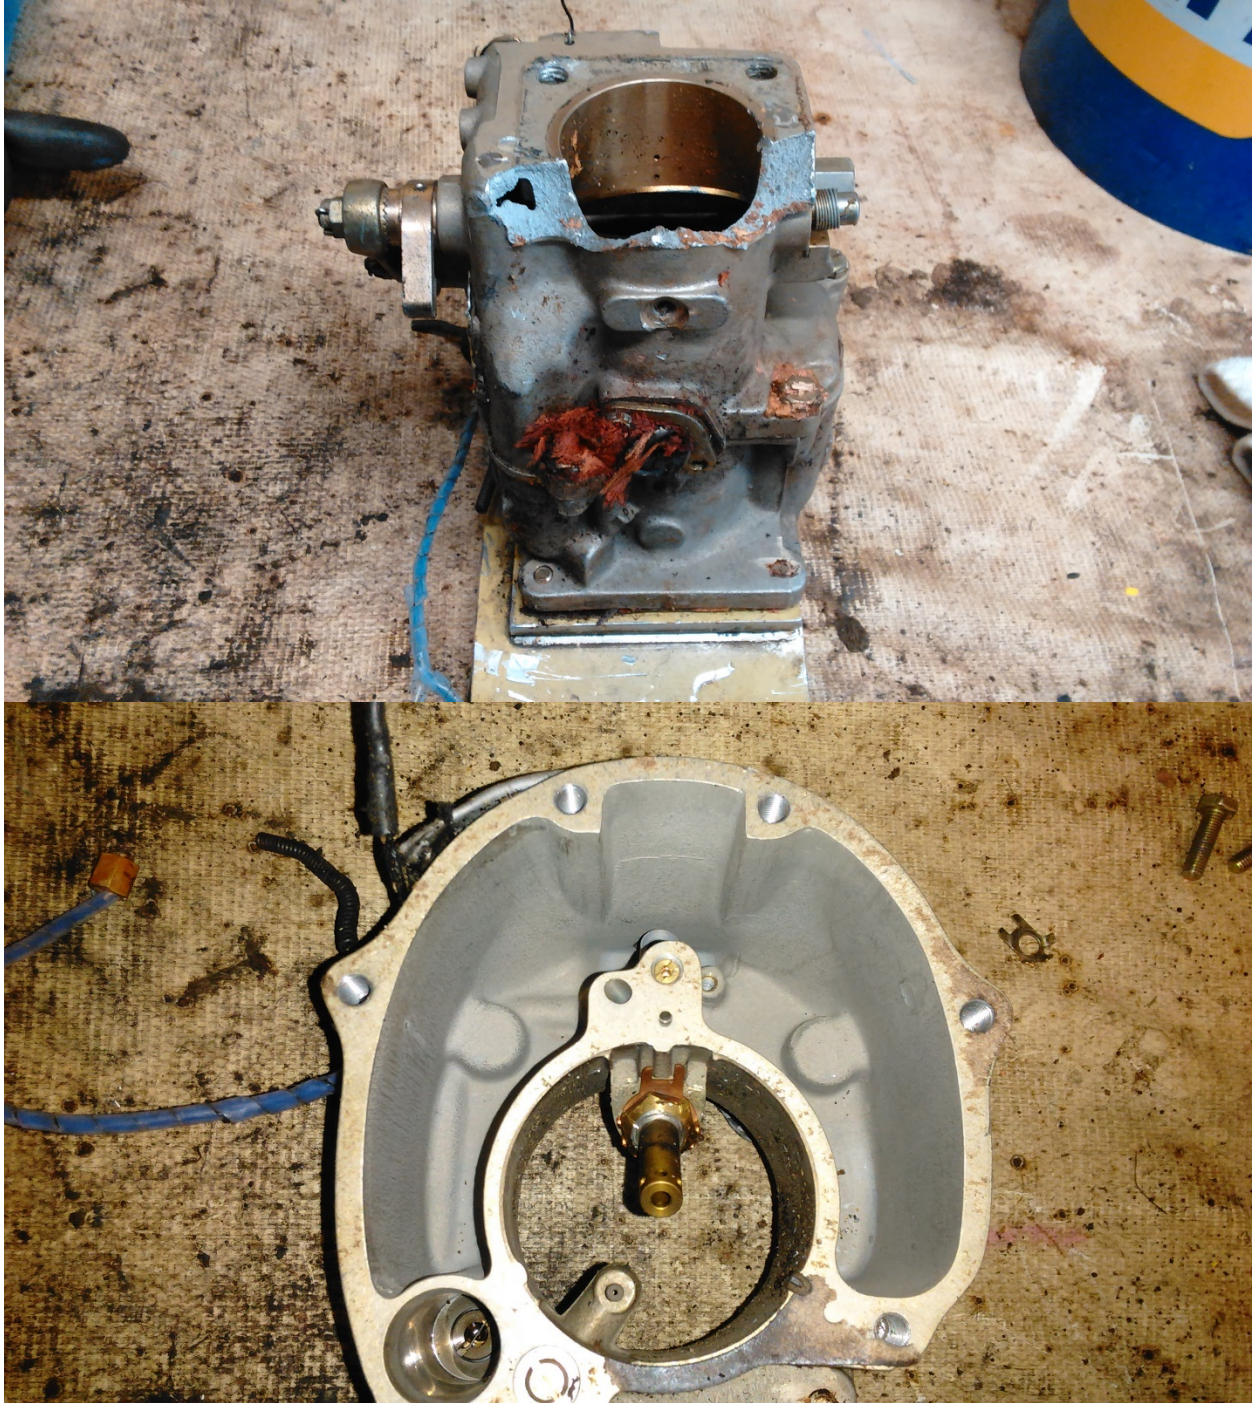
The engine carburetor was separated from the engine and the mounting flange broken. The throttle arm could be rotated freely and the throttle plate was intact. The mixture control arm was separated from the shaft and the shaft was bent. The carburetor bowl was removed and the float operated freely. The floats were of a blue plastic material. The float needle operated normally when the float was moved. The interior of the float bowl was clean and free of any debris. The carburetor fuel inlet screen was removed and the screen was clean.

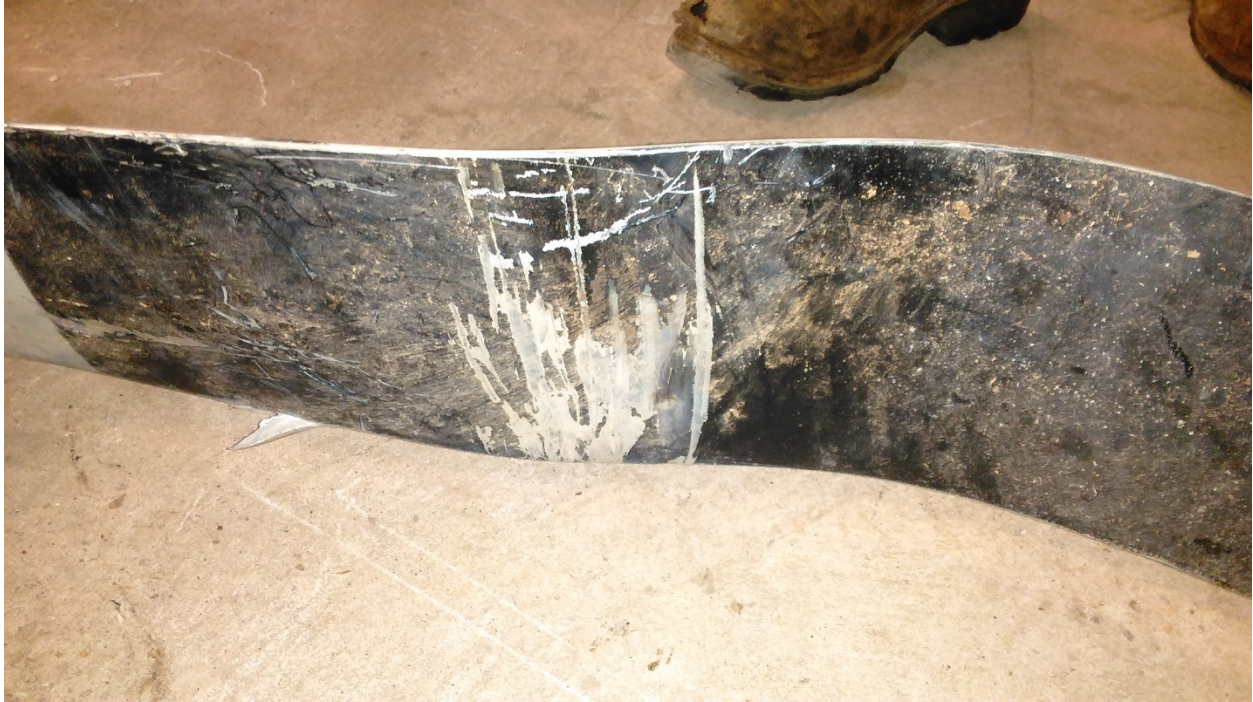
The propeller had separated from the engine. The propeller was intact from tip to tip with bending to both blades. There was a chordwise scratch on the rear face of one blade.

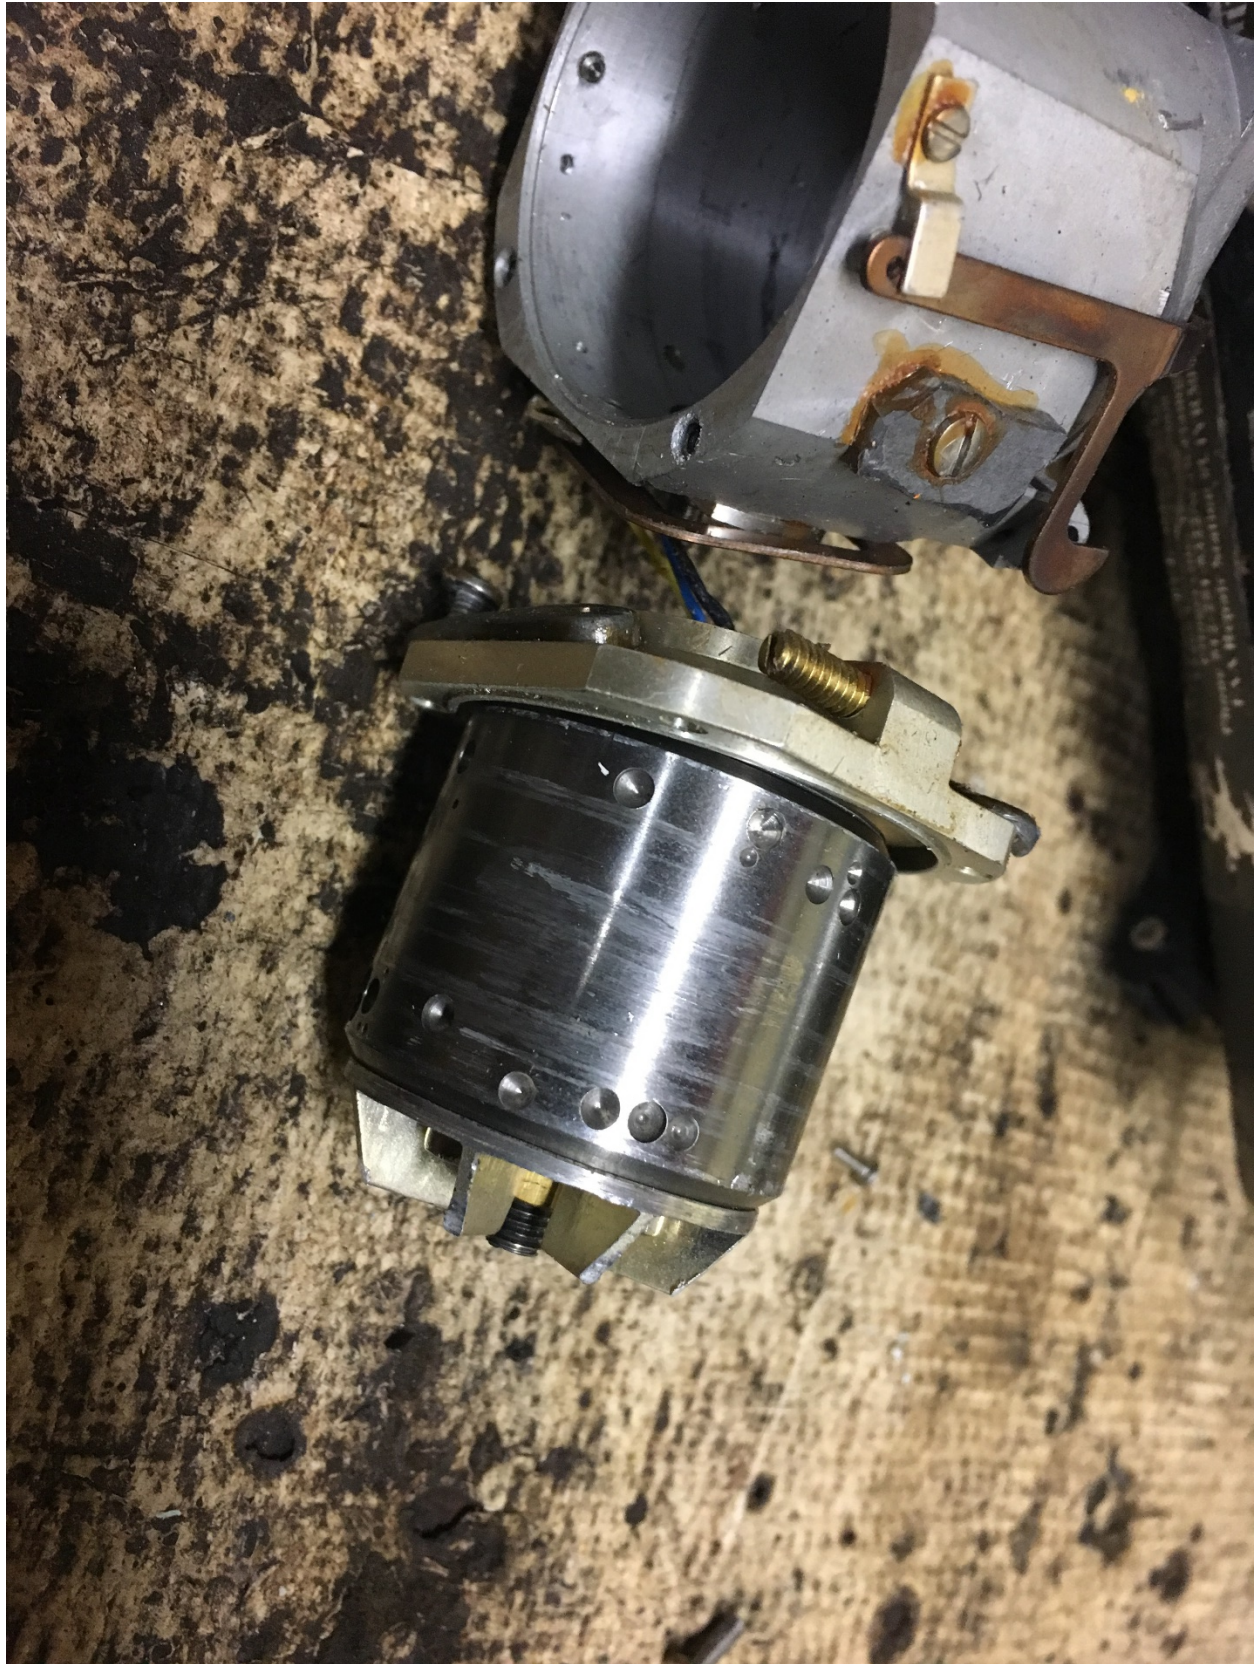
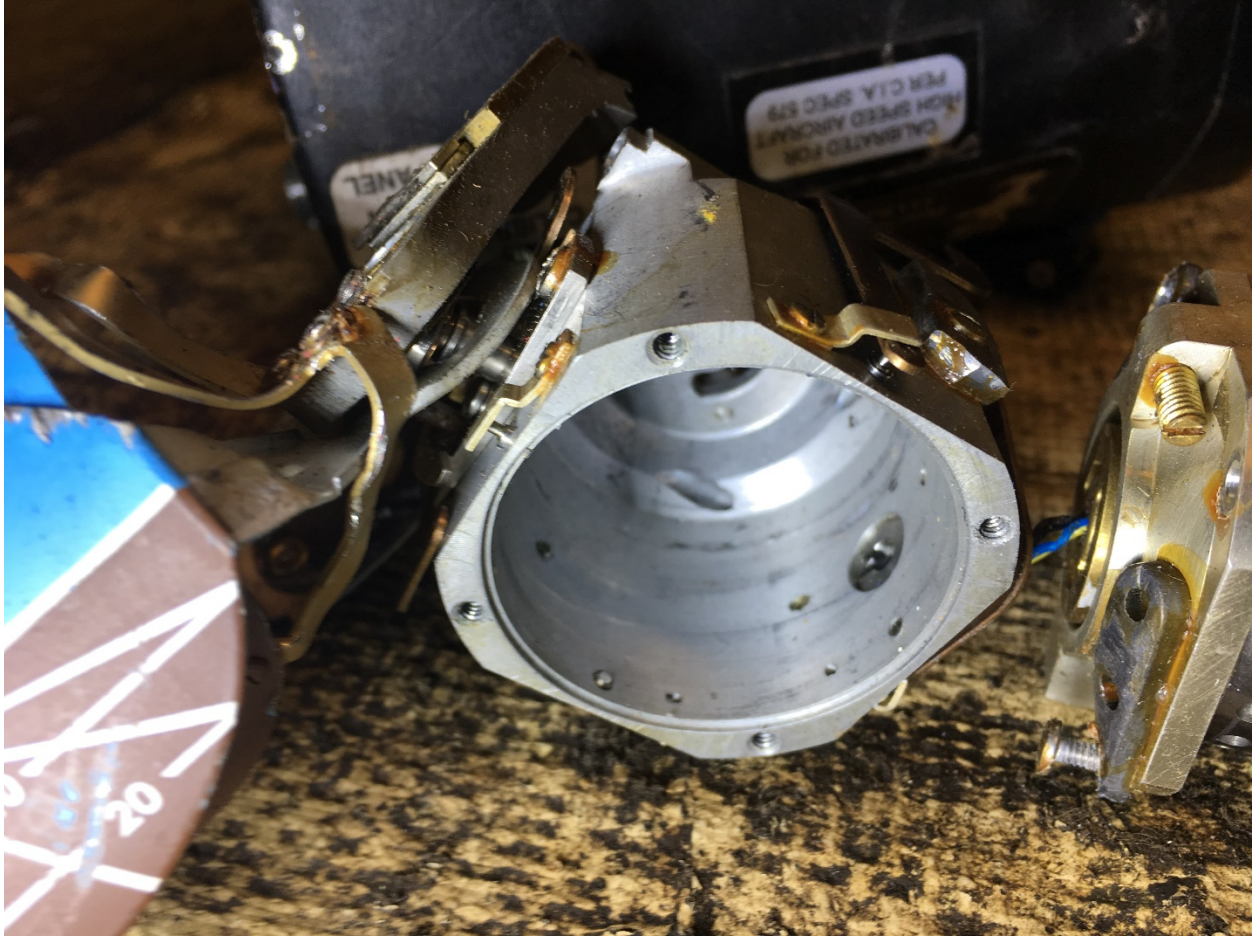
The airplane's mechanical vacuum pump was separated from the mounting pad on the rear of the engine. An electric powered artificial horizon was found as well as the face and external case of another artificial horizon. The internal components of the second artificial horizon were not located. The first artificial horizon was disassembled. The gyroscope housing had one of the bearing mounting areas fractured. Examination of the rotating core of the gyroscope and its cage showed evidence of circumferential scoring on both components.

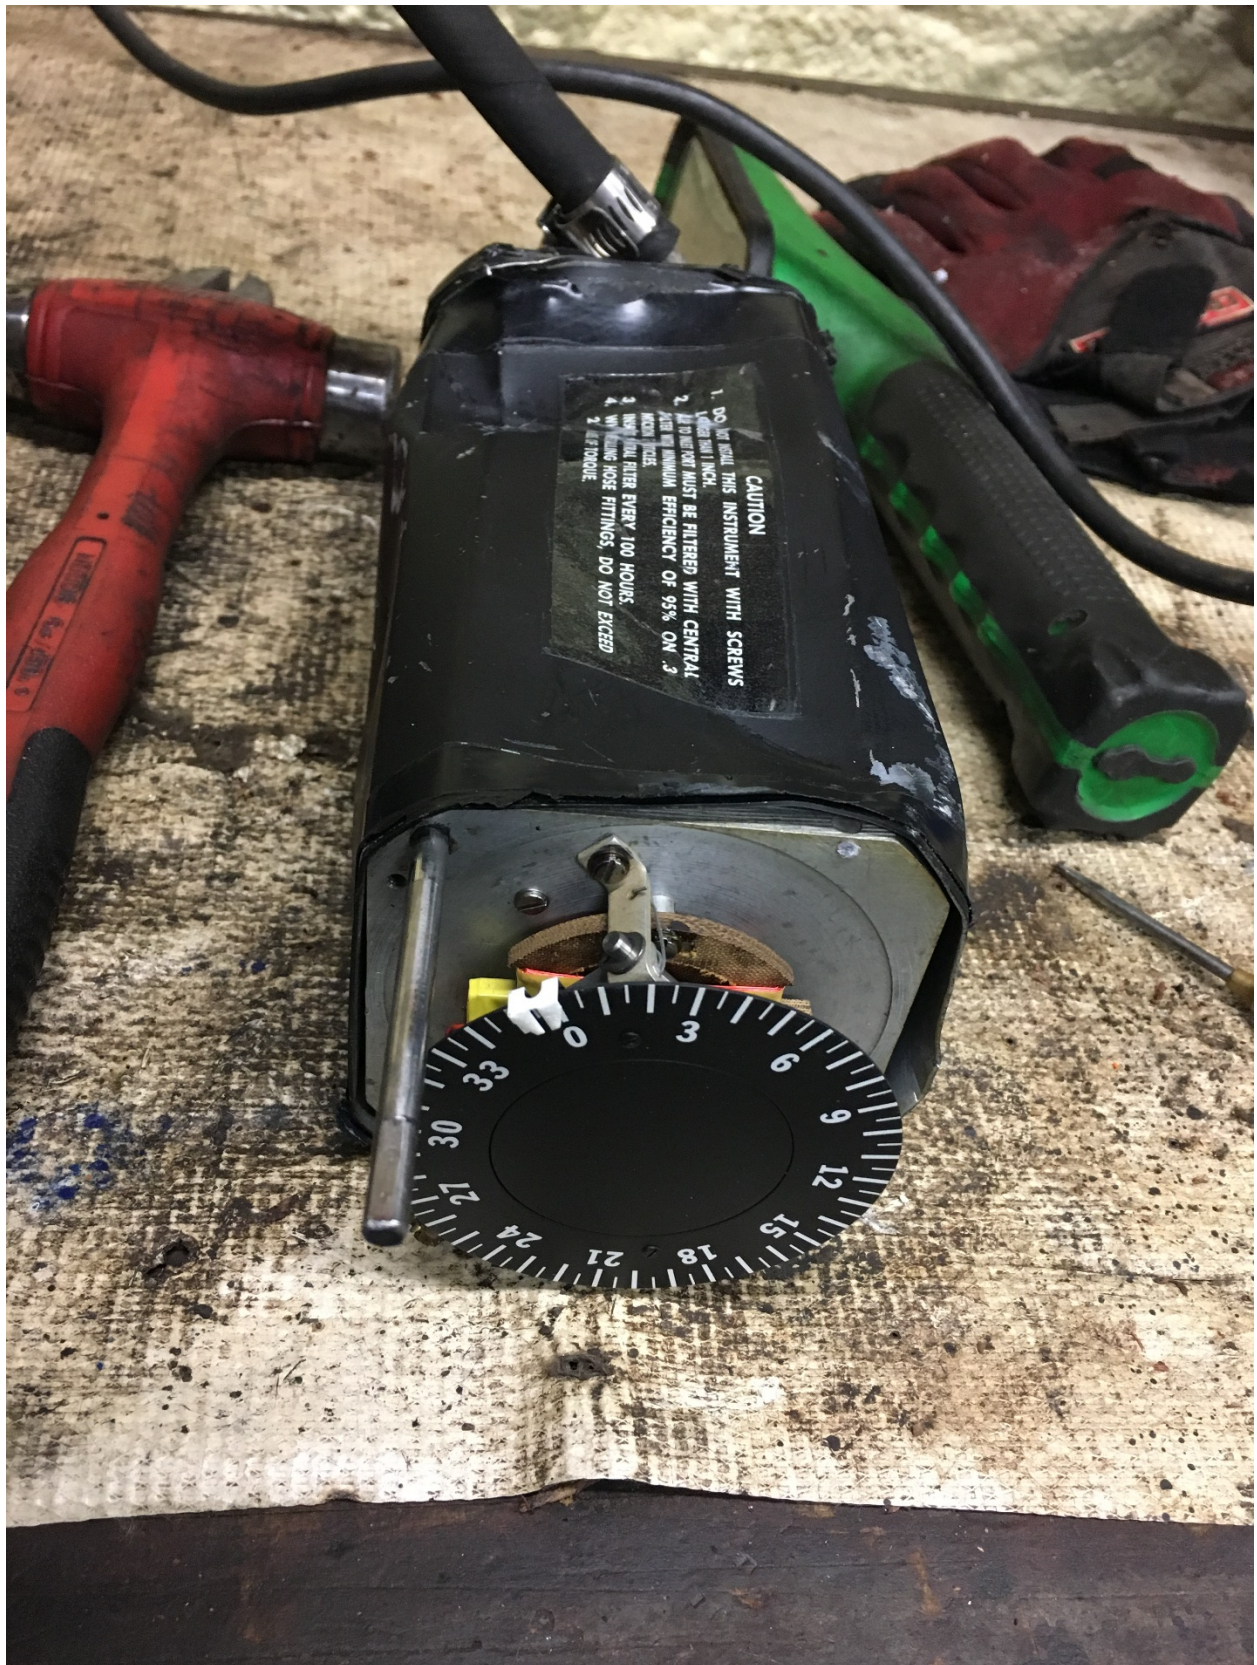
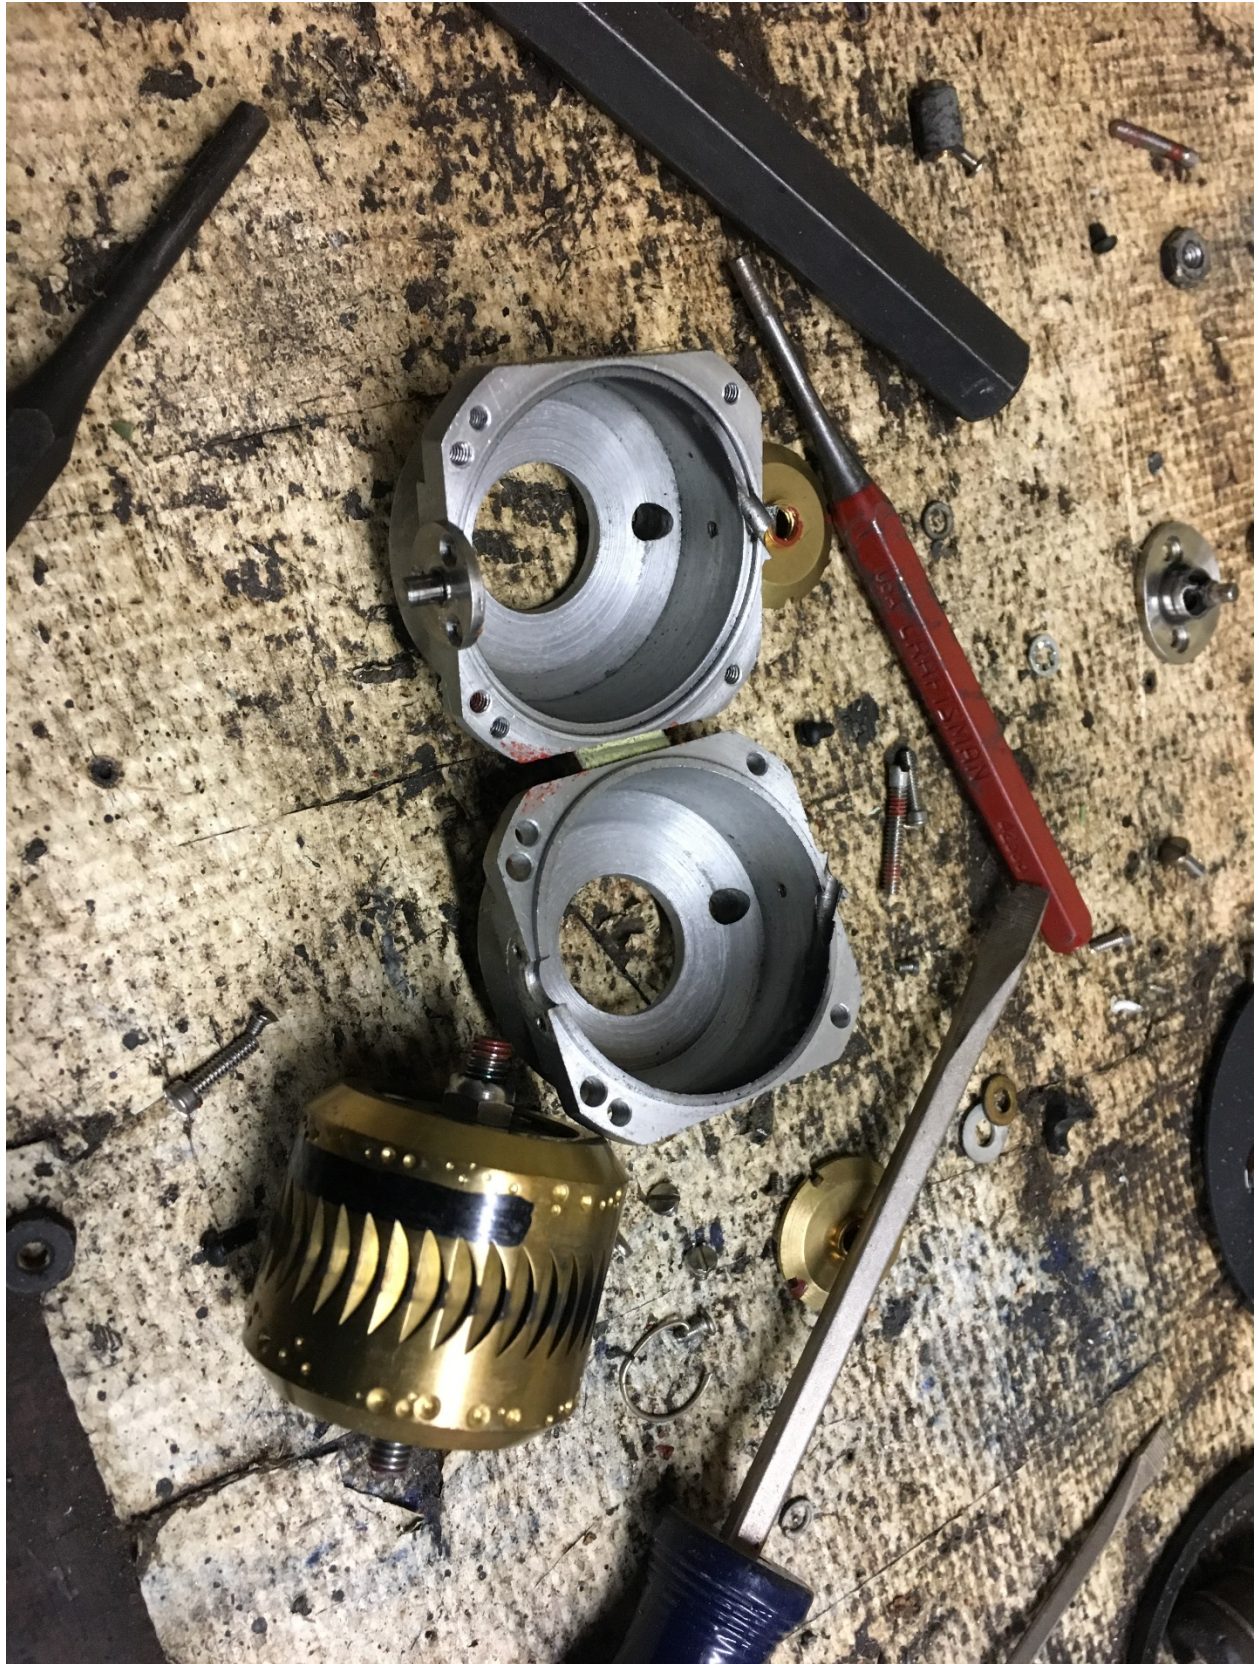
A vacuum operated directional gyroscope was found and disassembled. The bearing mounts and the rotating core of the gyroscope were intact and did not show any evidence of the core having contacted the housing during the mishap.

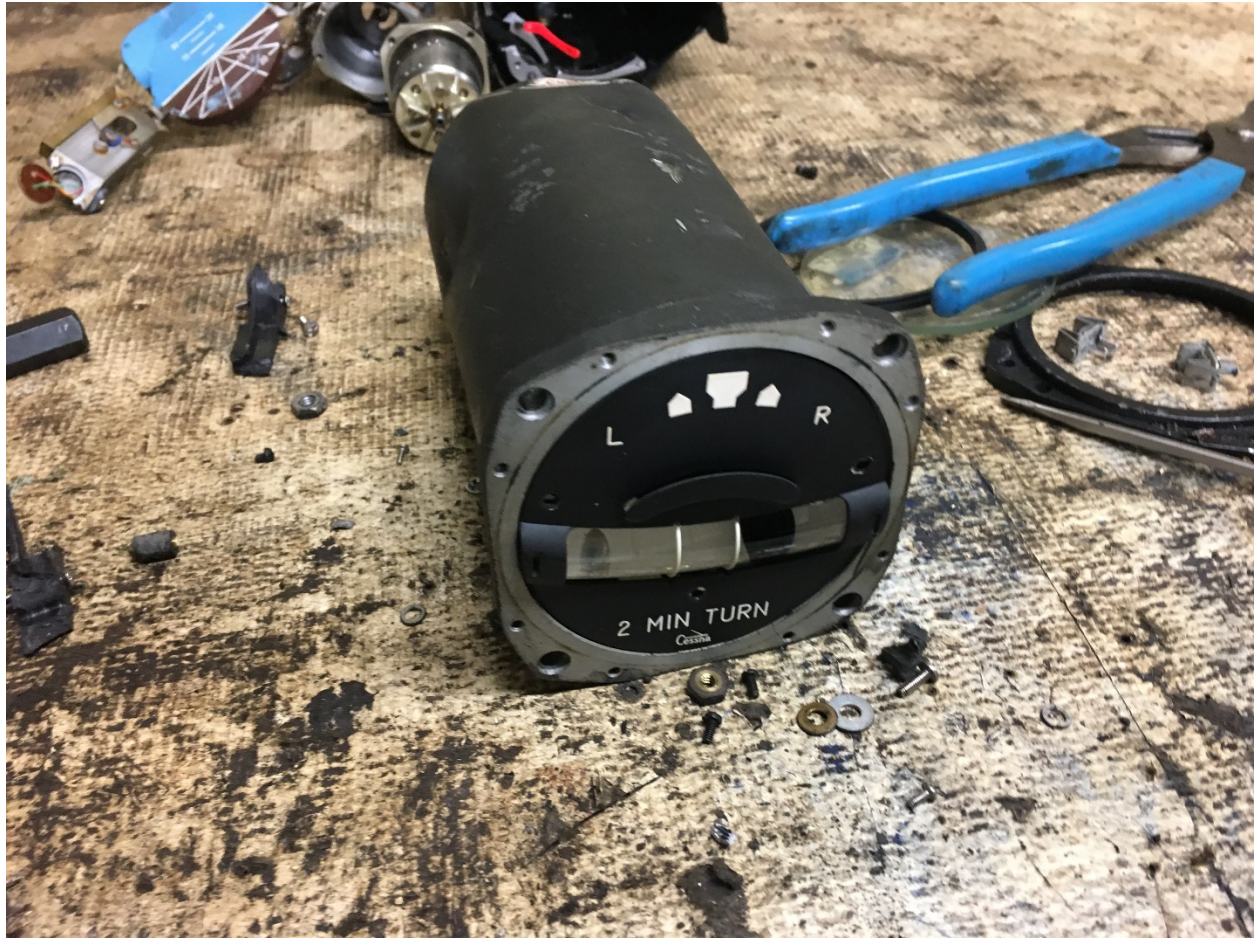
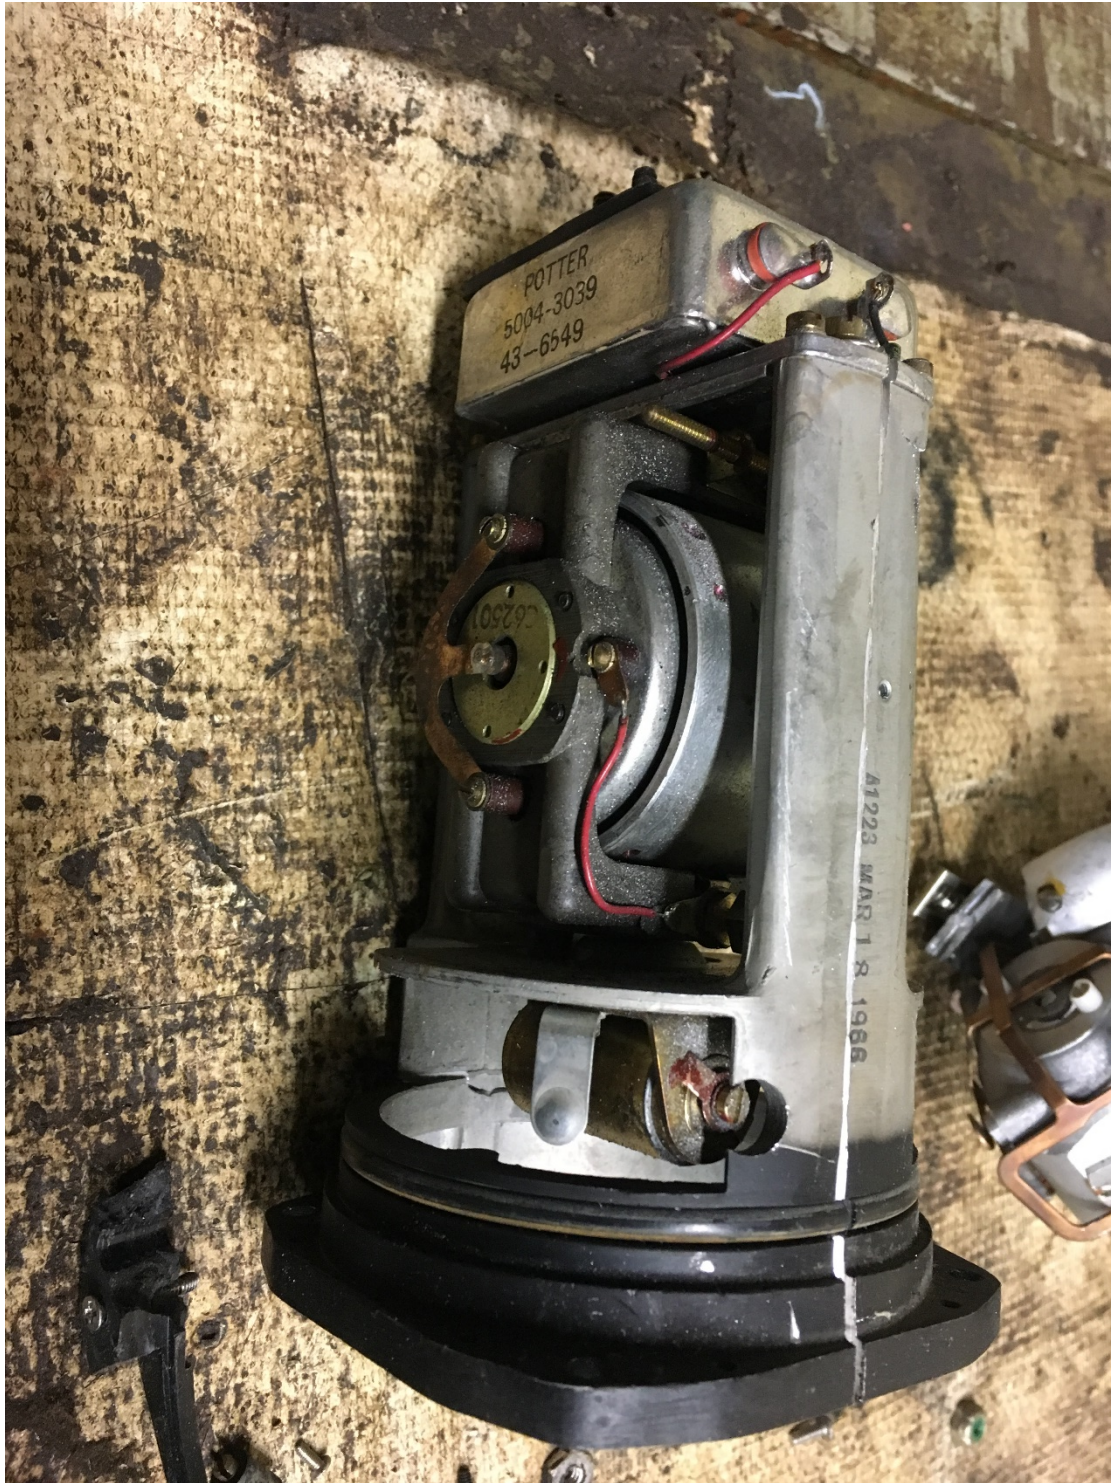
A gyroscopic turn and bank indicator was found and was partially disassembled. Upon removal of the outer case it was evident that the rotating gyroscope was intact and still turned freely on its bearings. No further disassembly was performed.
