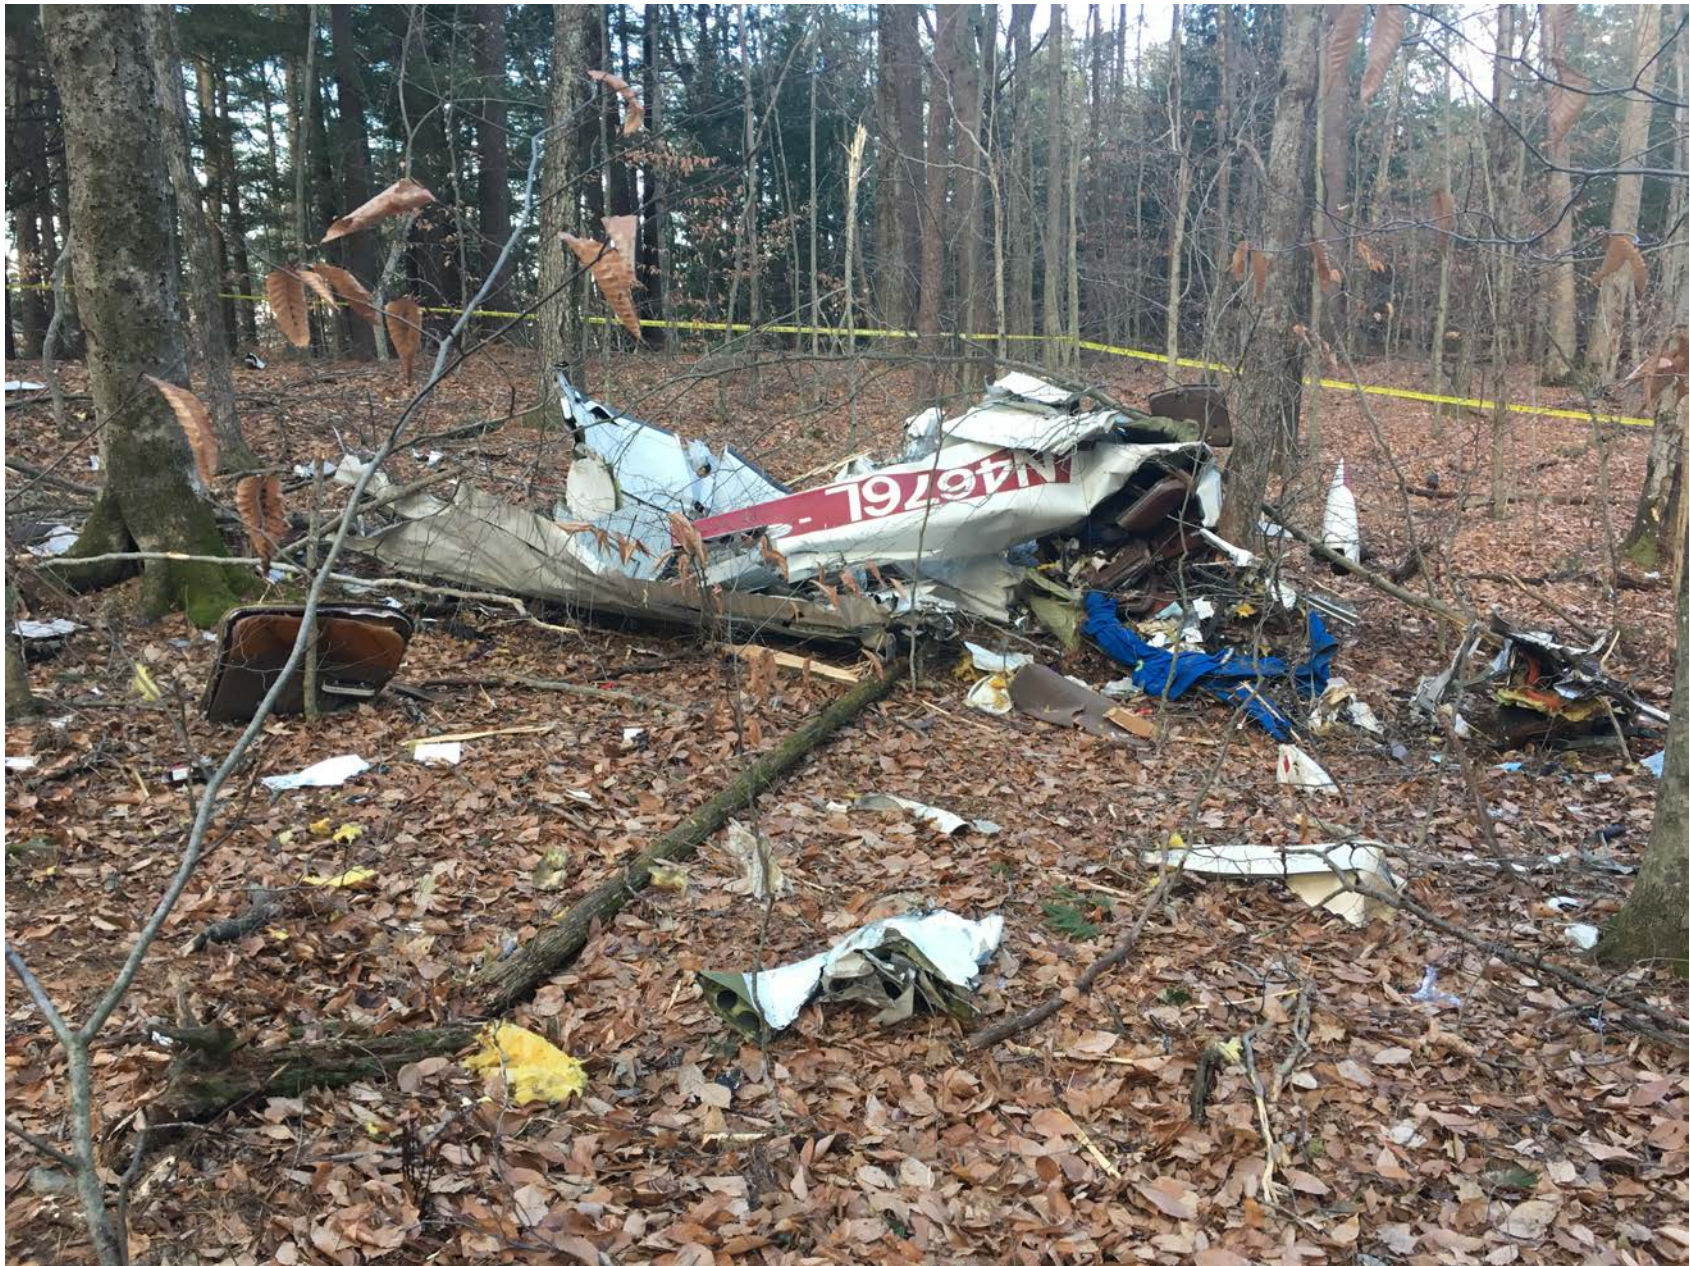
**Photo 1 – Main wreckage**

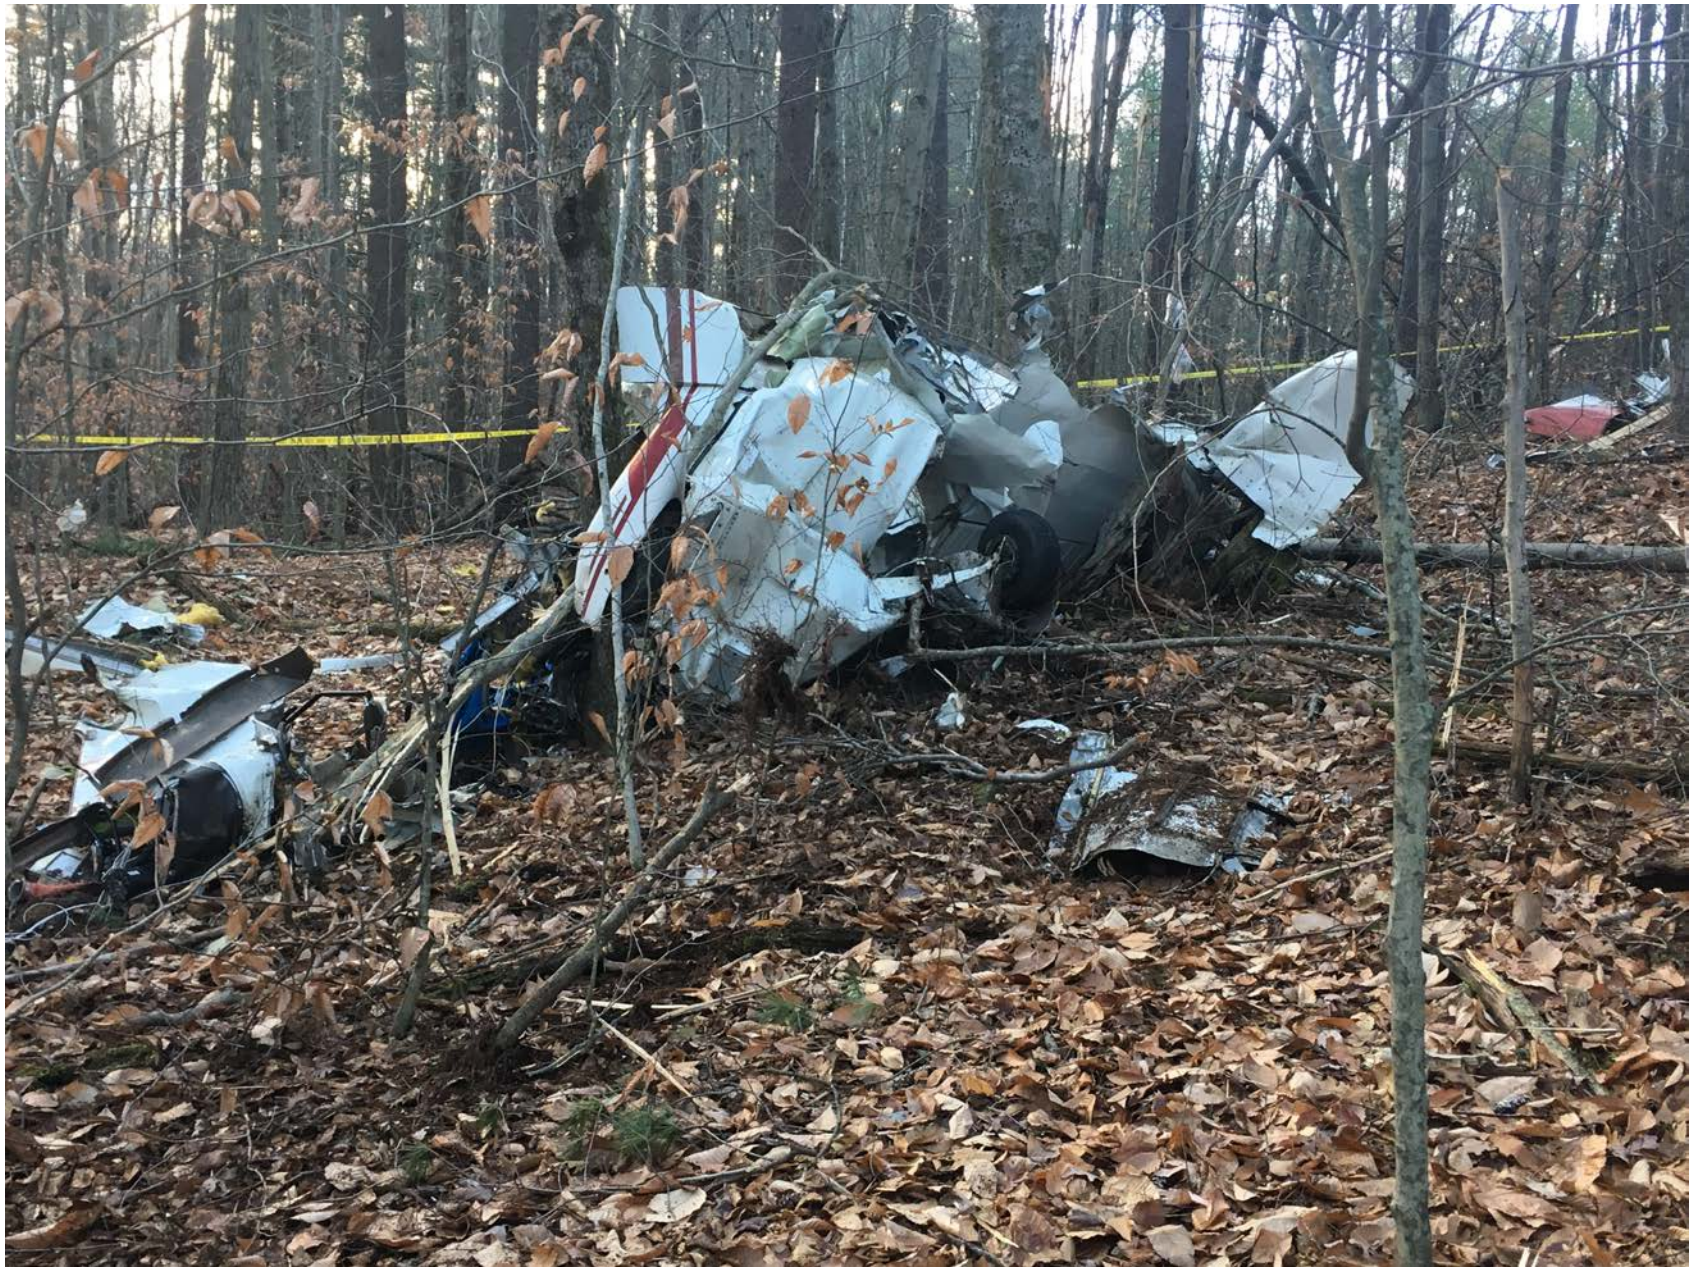
**Photo 2 – Main wreckage**

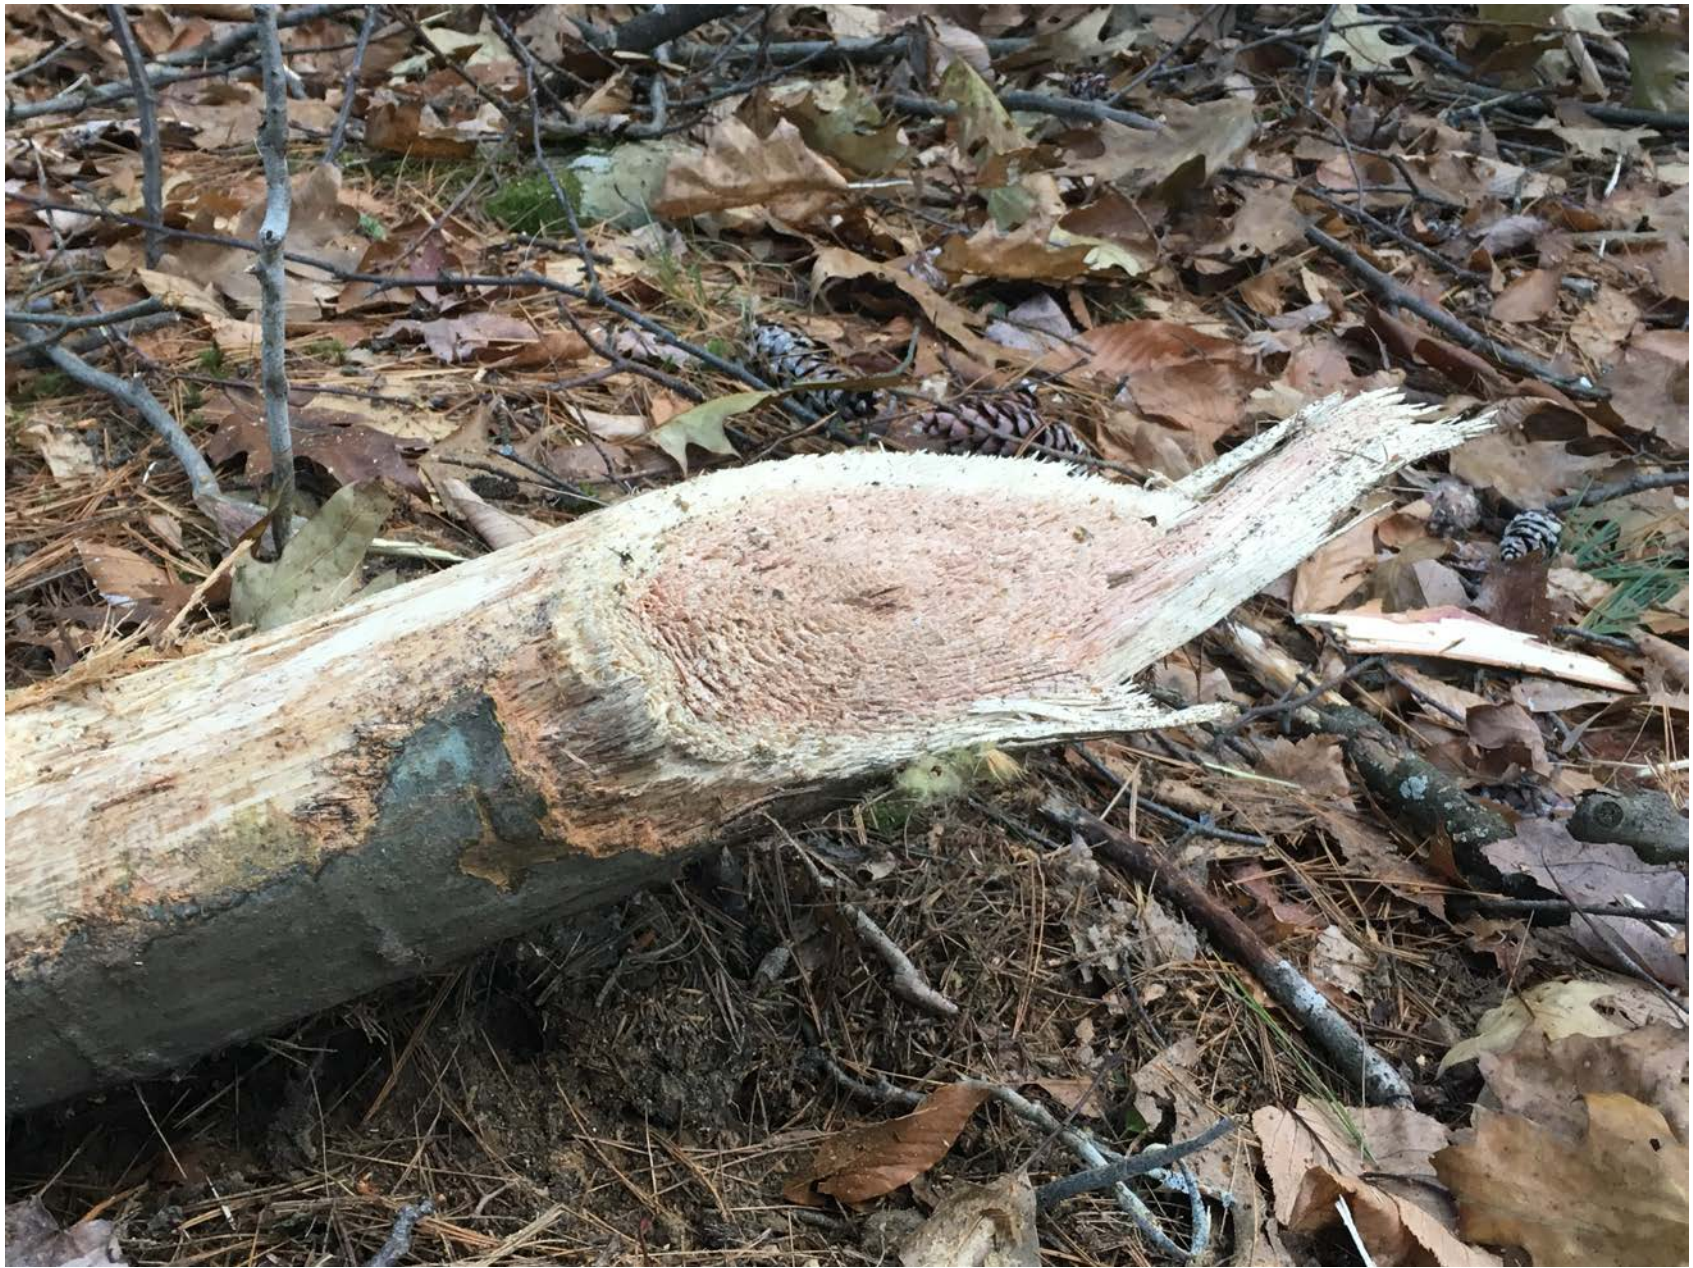
**Photo 3 – Tree limb showing prop slash**

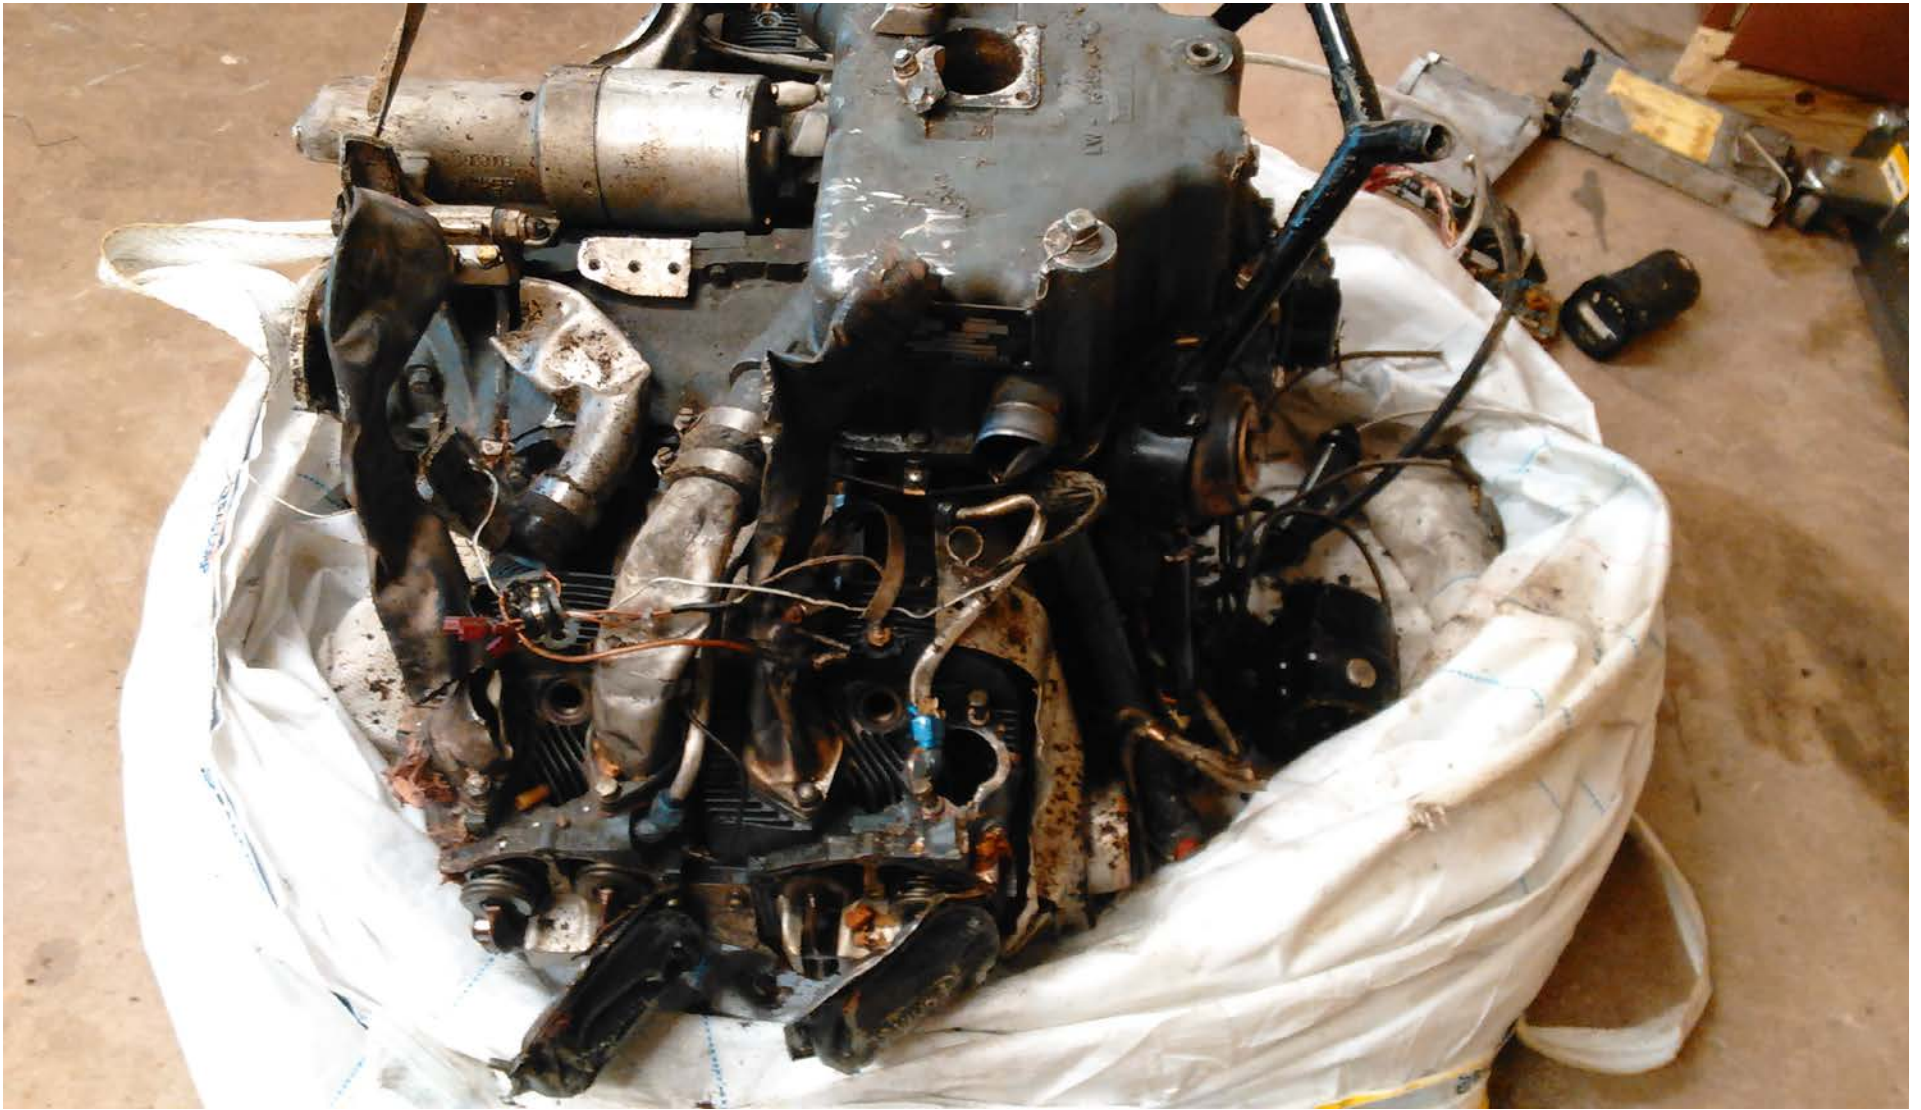
**Photo 4 – Engine during examination**

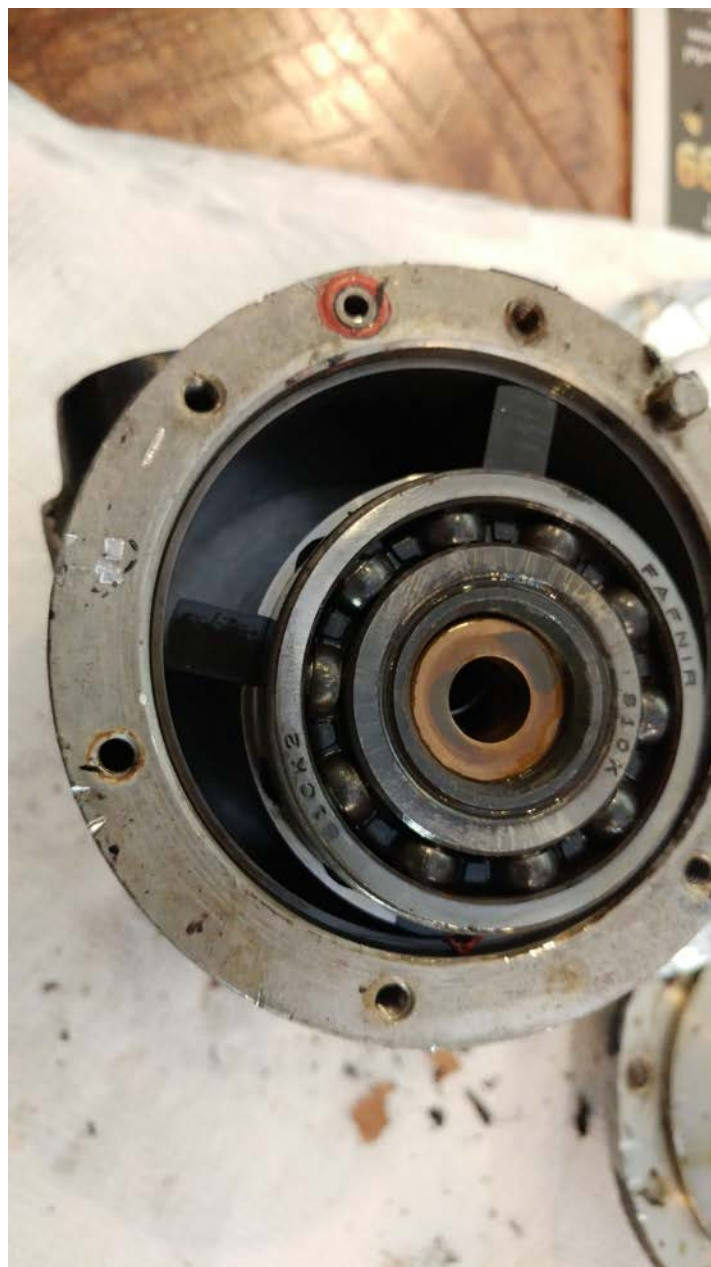
**Photo 5 – Vacuum pump during examination**
