# Continental Motors

## ENGINE RUN REPORT

| ENGINE MODEL | TSIO-520-UB17B |
| FILE NUMBER | 17-333 |

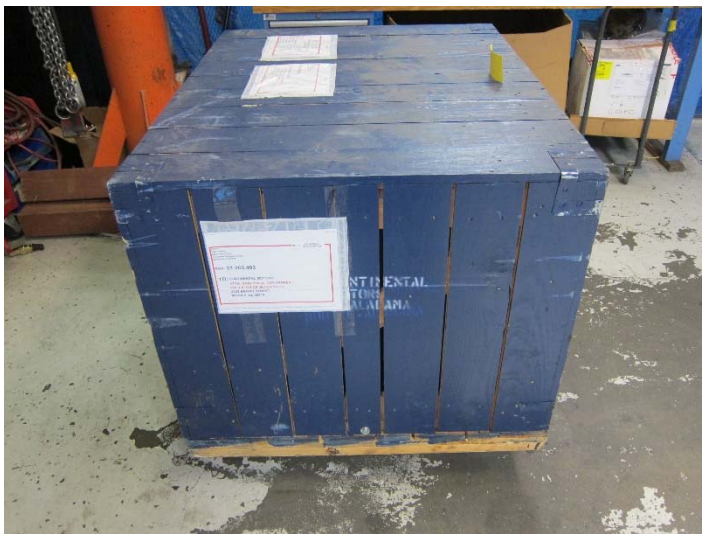
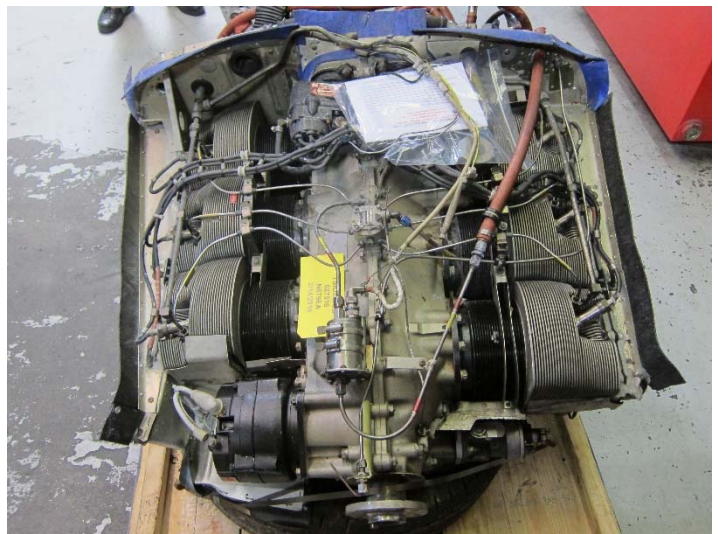
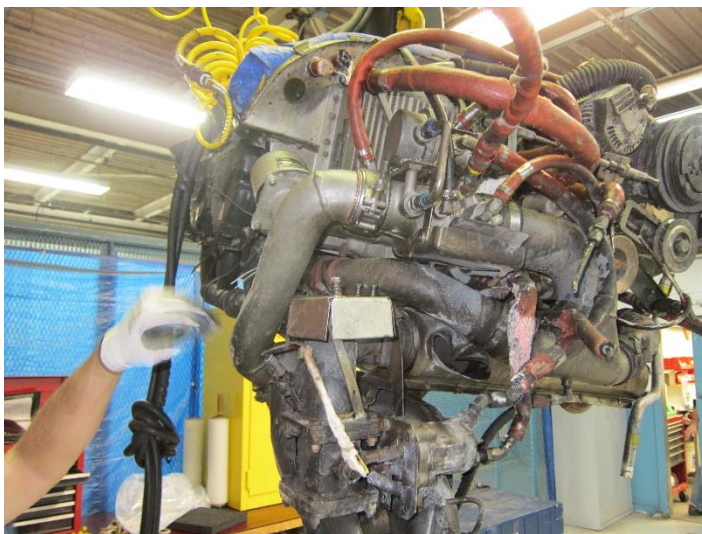
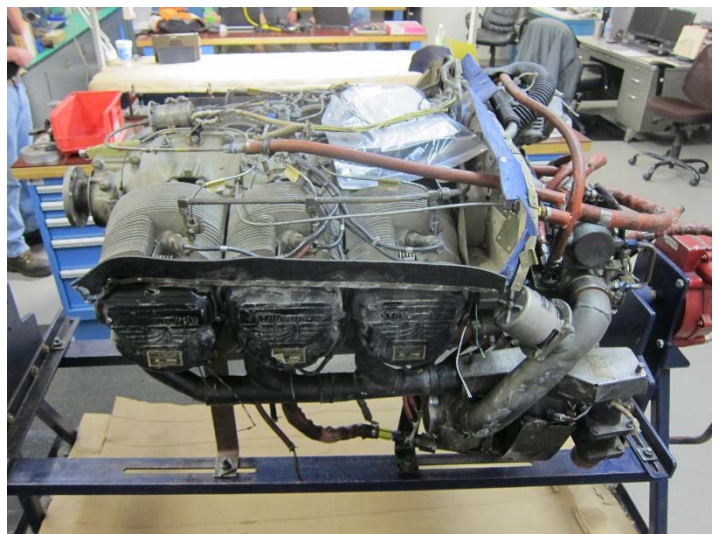
The engine exhibited light thermal damage to the accessory section and residue from fire extinguishing efforts. Three of the engine mount legs were broken. The induction and exhaust systems exhibited slight impact damage. The turbocharger remained attached to the engine and exhibited impact damage to the mount bracket and the turbine housing. The turbocharger did not rotate freely by hand.

The turbocharger was removed and replaced with a slave turbocharger for the test run. The accident engine turbocharger was subsequently disassembled and the turbine housing appeared to have impact damage that prevented the turbine wheel from rotating. The other components of the turbocharger exhibited no anomalies.

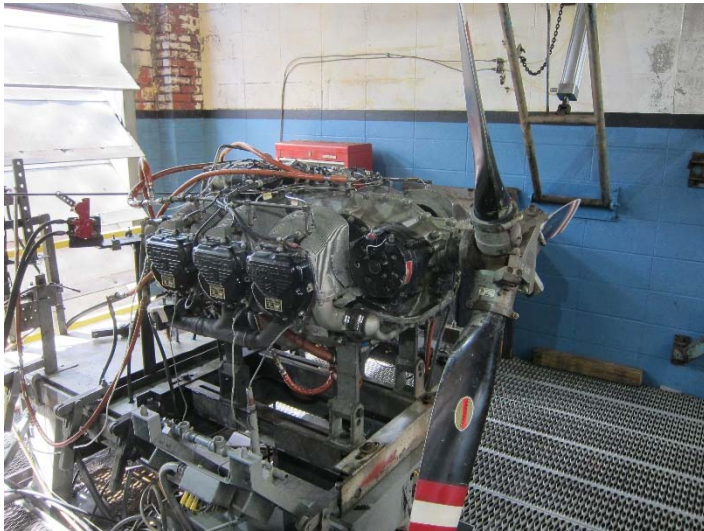
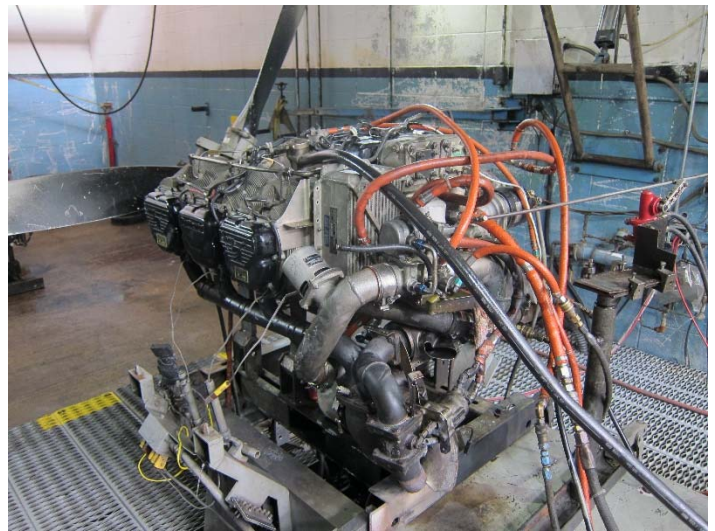
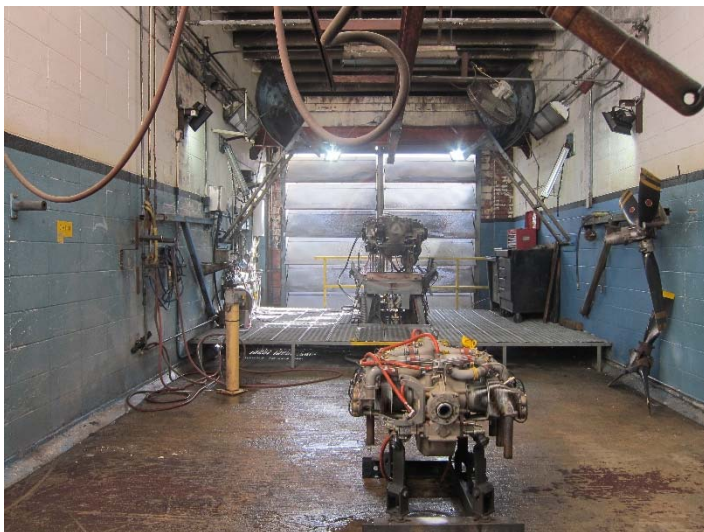
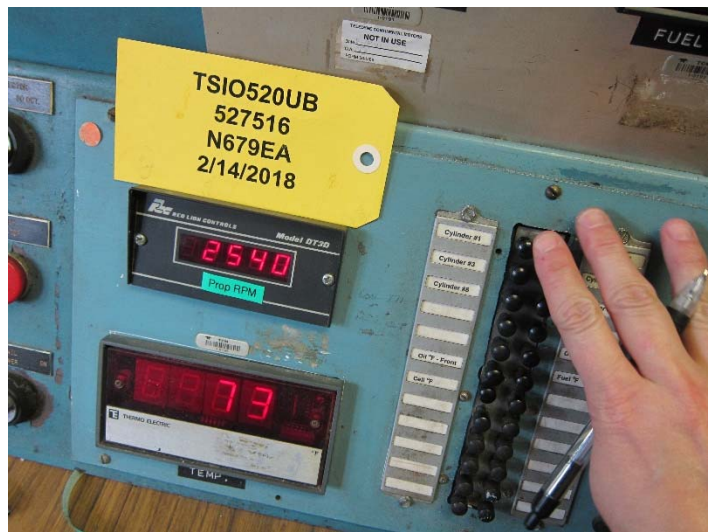
The first attempt to start the engine was unsuccessful. During trouble shooting, one of the test cell slave fuel lines was found to be obstructed. The obstructed fuel line was replaced and the engine started on the next attempt without hesitation or stumbling in observed RPM.

The engine RPM was advanced in steps for warm-up in preparation for full power operation. The engine throttle was advanced to 1200 RPM and held for five (5) minutes to stabilize. The engine throttle was advanced to 1600 RPM and held for five (5) minutes to stabilize. The engine throttle was advanced to 2450 RPM and held for five (5) minutes to stabilize. The engine throttle was advanced to full open position and held for five (5) minutes to stabilize. The engine throttle was rapidly advanced from idle to full throttle four times where it performed normally without any hesitation, stumbling or interruption in power. Throughout the test phase, the engine accelerated normally without any hesitation, stumbling or interruption in power and demonstrated the ability to produce rated horsepower.
