# Continental Motors

## ENGINE EXAMINATION REPORT

| ENGINE MODEL | TSIO-520-NcNB via RAM STC |
| FILE NUMBER | 17-361 |

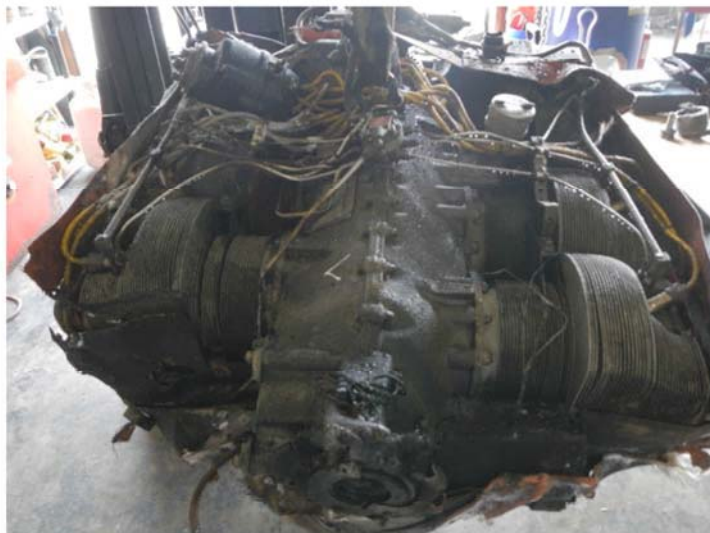
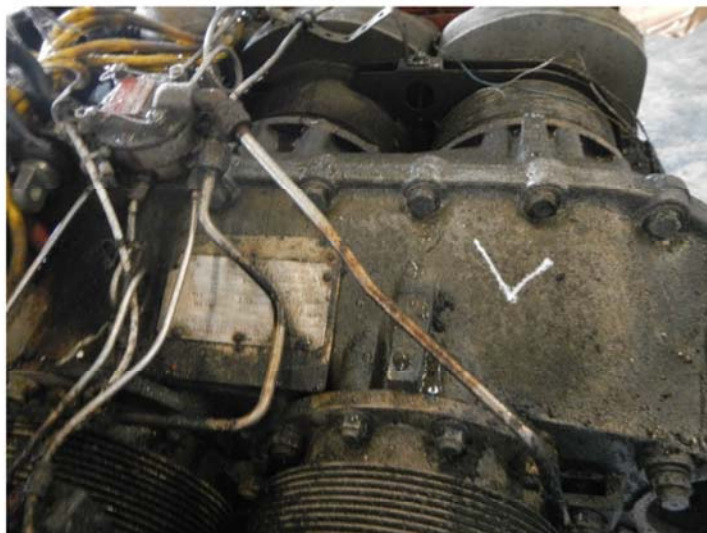
The engine was separated from the airframe and was labeled as the left engine based on the data plate and the aircraft maintenance records. The crankshaft was fractured at the nose oil seal and the propeller flange remained attached to the propeller hub. The crankshaft fracture surface displayed tearing, shear lips, and discoloration features consistent with overload. The alternator was separated from the engine and the alternator face gear, bevel gear, and propeller governor drive gear were visible through the alternator mounting pad. No pre-accident anomalies were noted with the gears. The engine sustained impact and thermal damage.

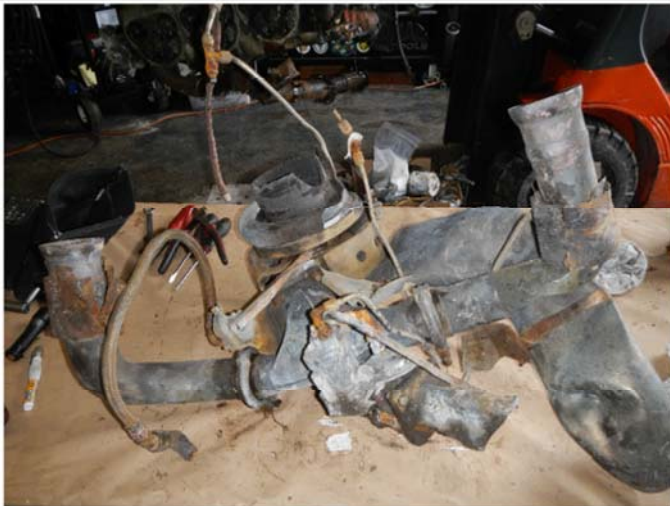
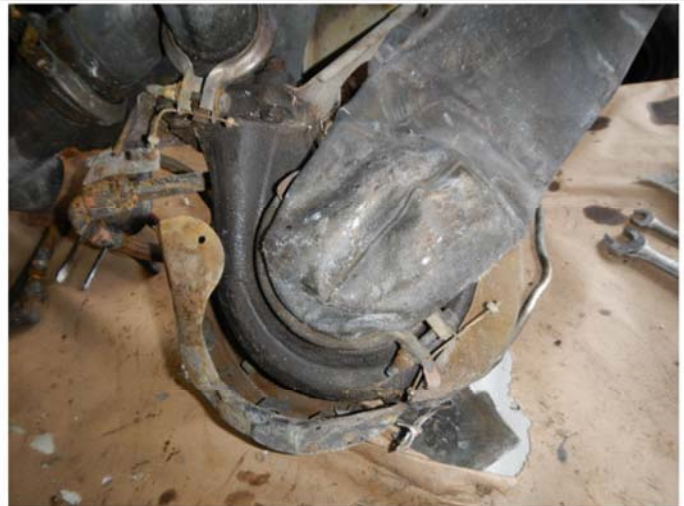
#### EXHAUST SYSTEM

Condition: The exhaust system sustained impact-related deformation and separation damage. There were no pre-accident anomalies noted with the v-band clamps, bolted couplings, or slip joints. The waste gate actuator linkage did not display and pre-accident anomalies. Sand and dirt was impacted in the right side exhaust slip joint and the aft exhaust risers were displaced forward.

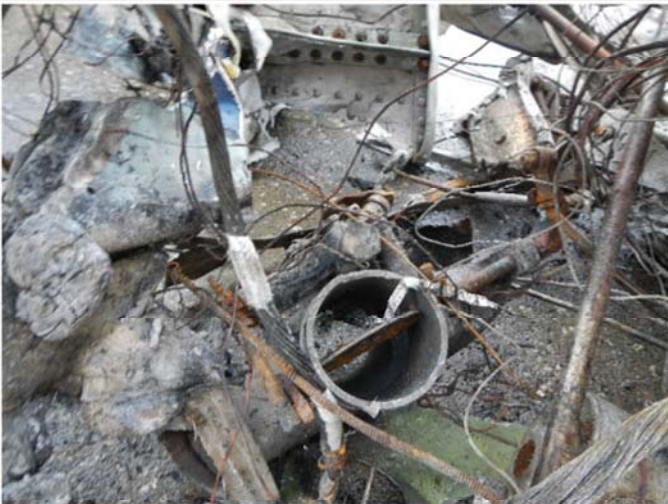
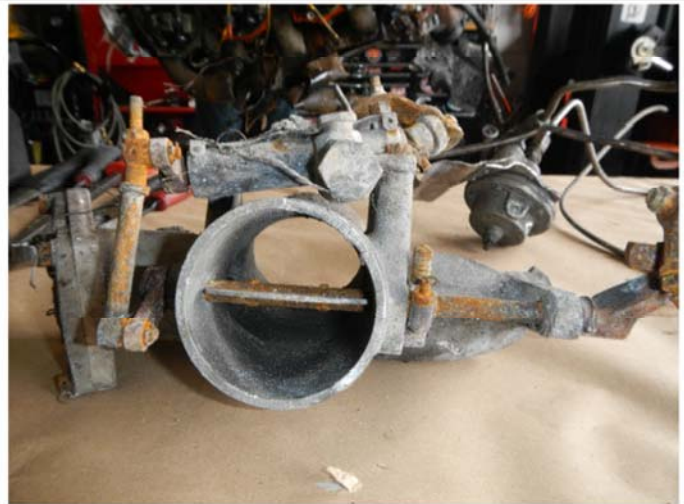
### INDUCTION SYSTEM

The induction system was impact and thermally damaged. The turbocharger intake was unobstructed. The intercooler was separated from the engine nacelle (it should be noted that the intercooler for both the left and right engines were separated and it was not clear as to which one belonged to which engine. Regardless, they displayed similar impact-related damage with no pre-accident anomalies noted). No pre-accident anomalies were noted with the system.

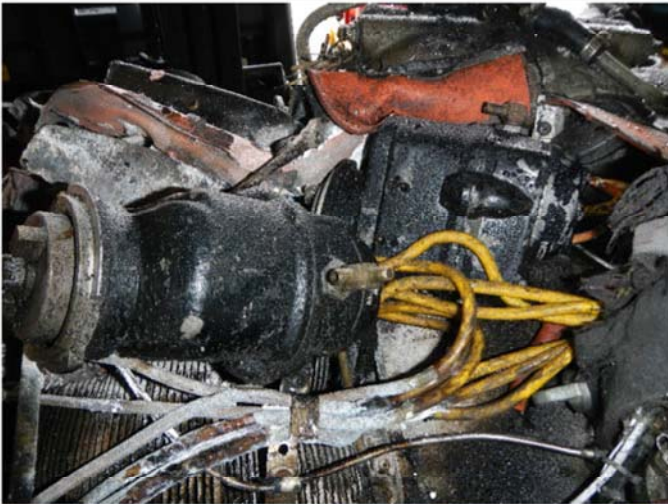
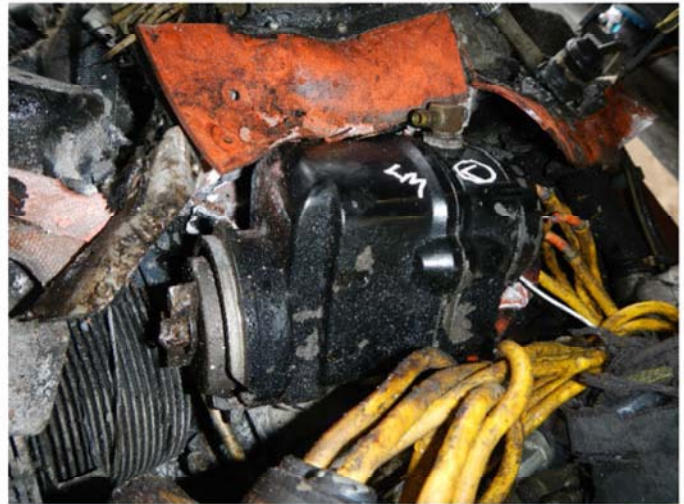
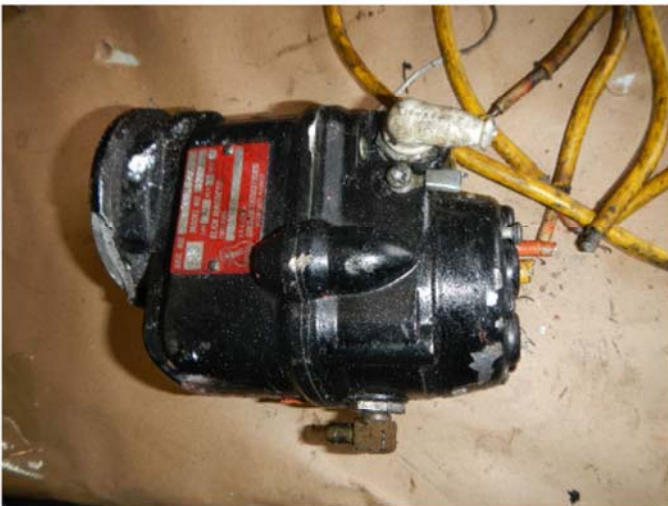
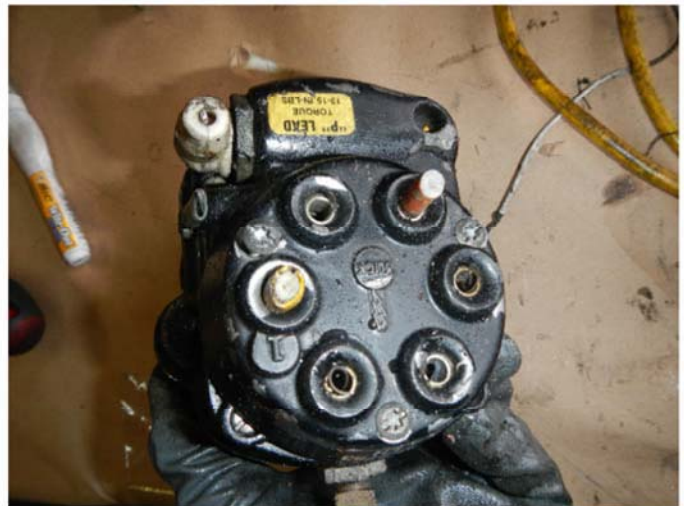
#### LEFT MAGNETO

**Condition:** The magneto was separated from the mounting pad but remained attached to the engine via the ignition harness. The magneto drive shaft was manually rotated and it produced a spark from each lead in firing order when an audible snap of the impulse coupling was heard (the left ignition harness cap was removed for the testing due to damage sustained in the accident sequence, and the right magneto's ignition harness cap was utilized for testing).

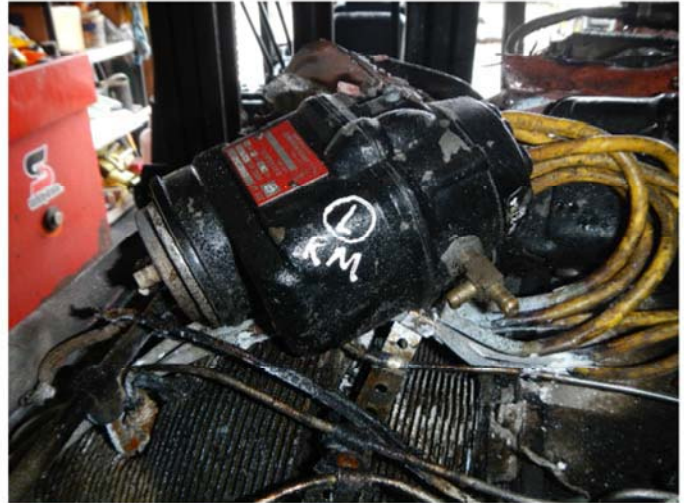
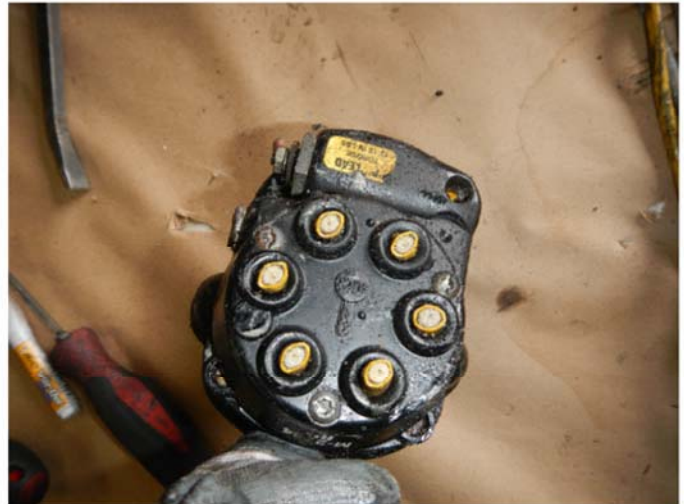
## RIGHT MAGNETO

The magneto was separated from the mounting pad but remained attached to the engine via the ignition harness. The magneto drive shaft was manually rotated and it produced a spark from each lead in firing order when an audible snap of the impulse coupling was heard.

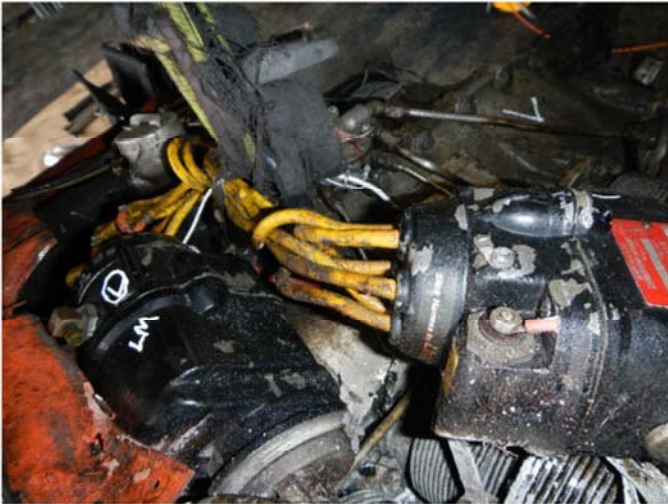
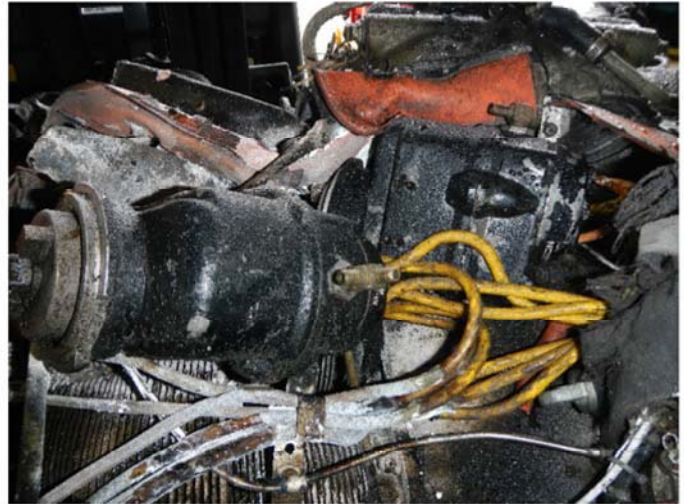
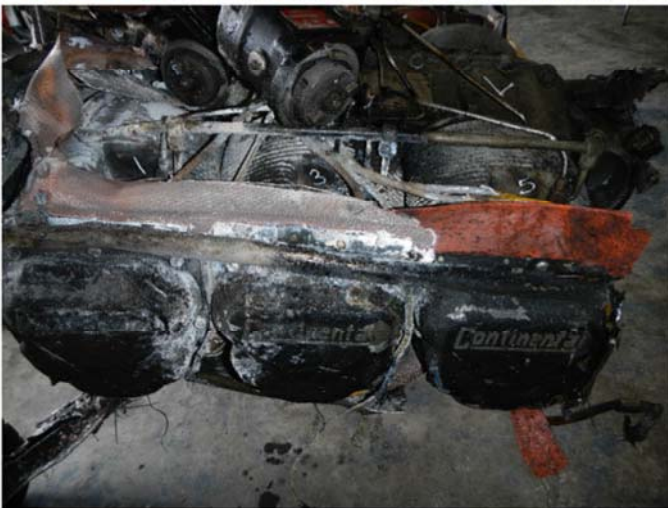
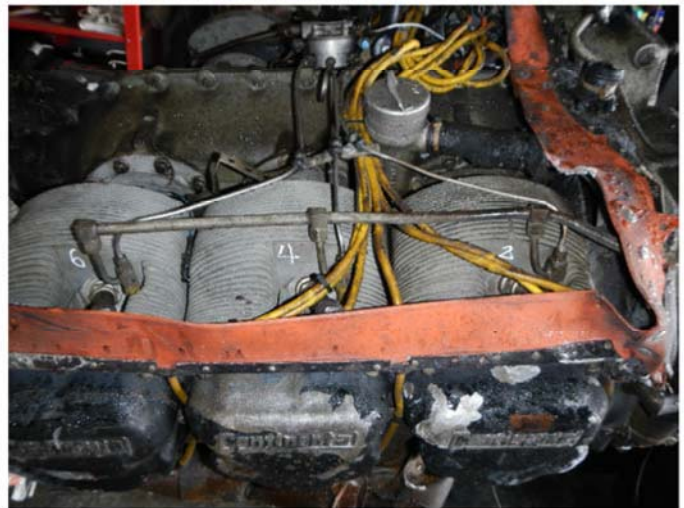
### IGNITION HARNESS

The ignition harnesses remained attached to the magnetos and all terminals remained attached to their respective sparkplugs, but many of the leads sustained pulling and thermal damage. The leads were cut from the right magneto harness cap, which was used during the functional testing of both magnetos. No pre-accident anomalies were noted with either harness/cap.

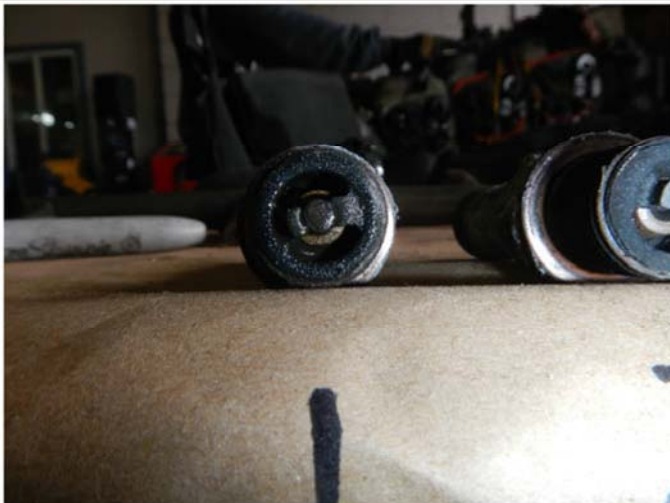
## SPARK PLUGS

All of the sparkplugs remained secured to their respective cylinders with no pre-accident anomalies noted. The top sparkplugs were removed from the cylinders. All displayed a normal worn appearance with no signs of lead or carbon fouling. The bottom sparkplugs were examined via a lighted borescope with no pre-accident anomalies noted with the electrodes.

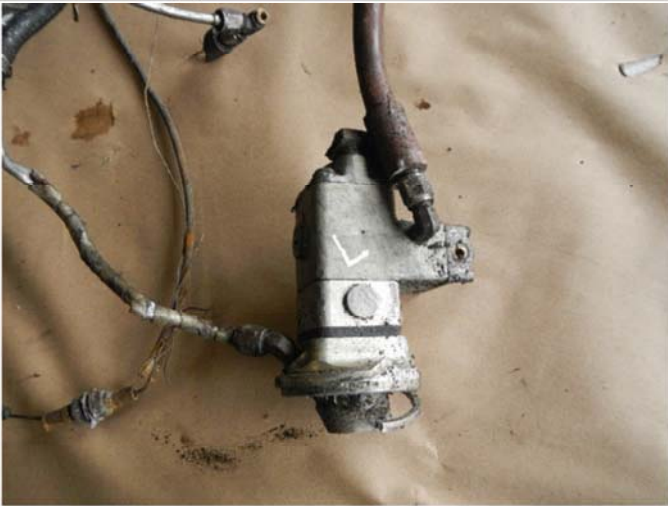
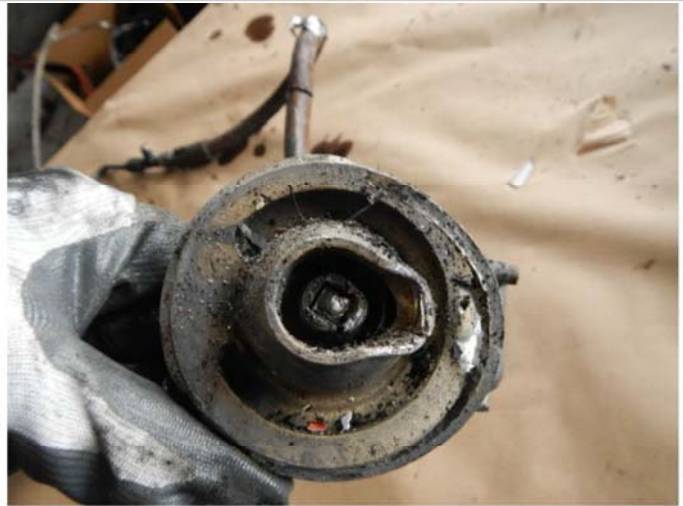
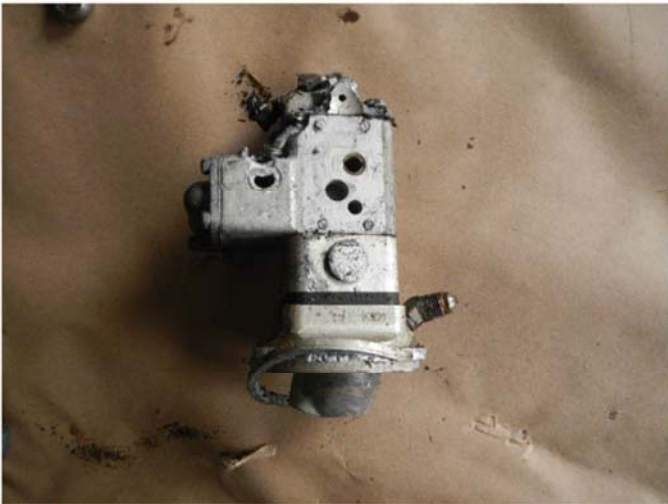
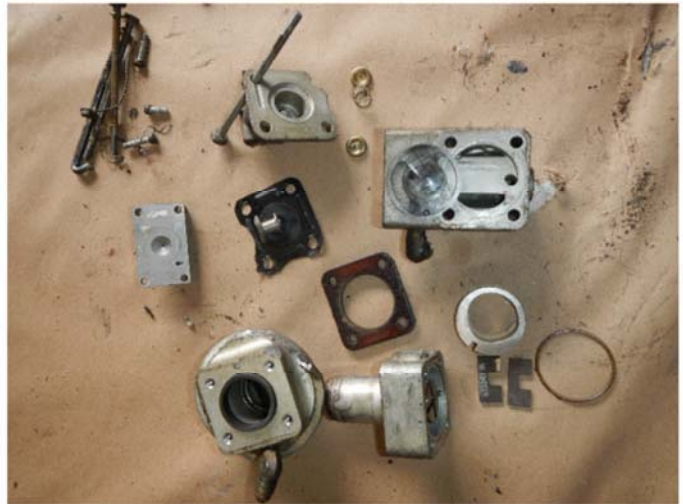
#### FUEL PUMP

The engine-driven fuel pump was separated from the backside of the engine and the mounting flange and drive coupling were fractured and displaced to one side with the metal was smeared in the same direction. The aneroid bellows and upper deck reference line, vapor return fitting, and fuel inlet line were separated from the pump. The return line from the fuel pressure regulator to the fuel pump remained in place. Removal of the line resulted in residual fuel pouring from the pressure regulator. The pump was disassembled and the pump vanes were intact with no pre-accident anomalies noted with the observed internal components.

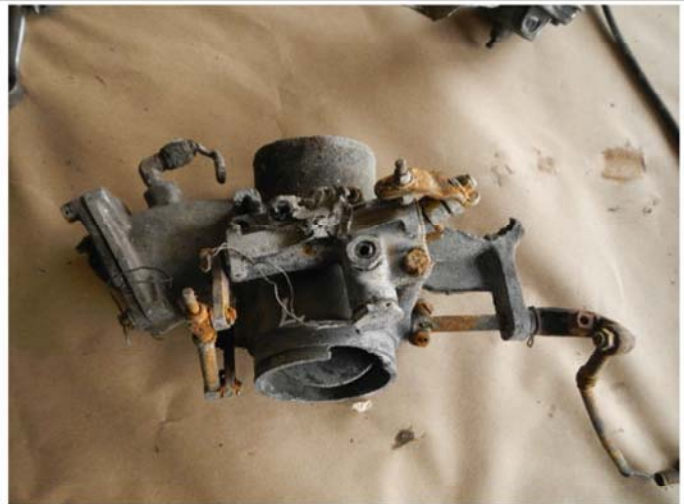
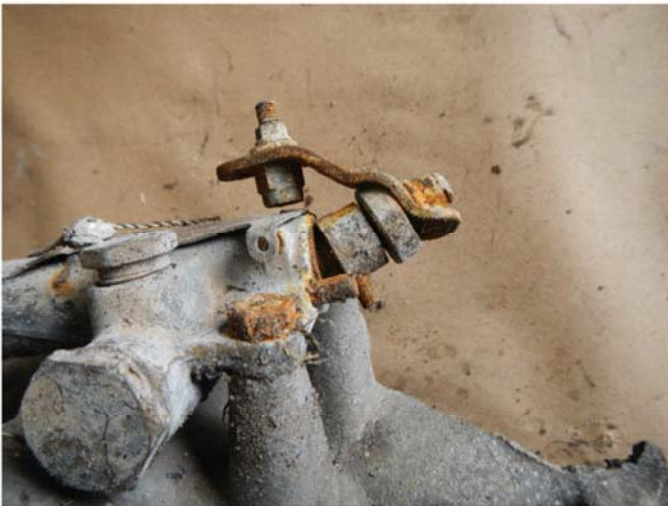
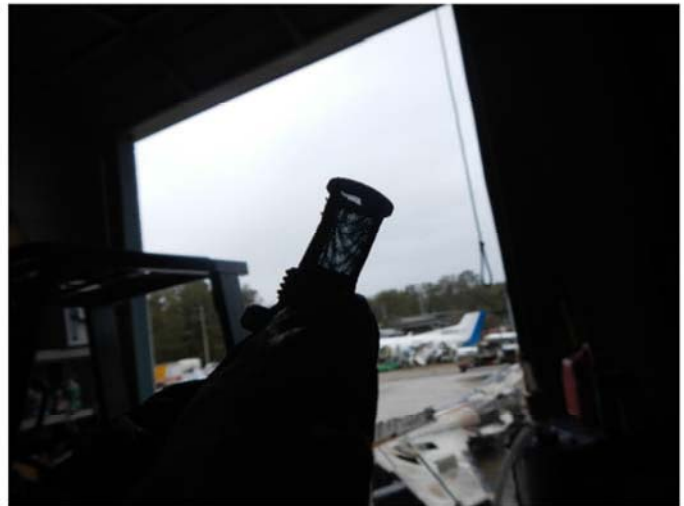
## THROTTLE BODY METERING UNIT

The throttle body/fuel metering unit remained attached to the left engine nacelle and was thermally damaged and fractured. The mixture and throttle control cables remained attached to their respective control levers, both of which sustained deformation damage. The throttle valve was found in the full open position. The interconnect link between the throttle and the turbo wastegate pressure controller was separated. The mixture control shaft was bent. All of the fittings were fractured on the fuel metering unit. The inlet fuel screen was removed and no obstructions were noted.

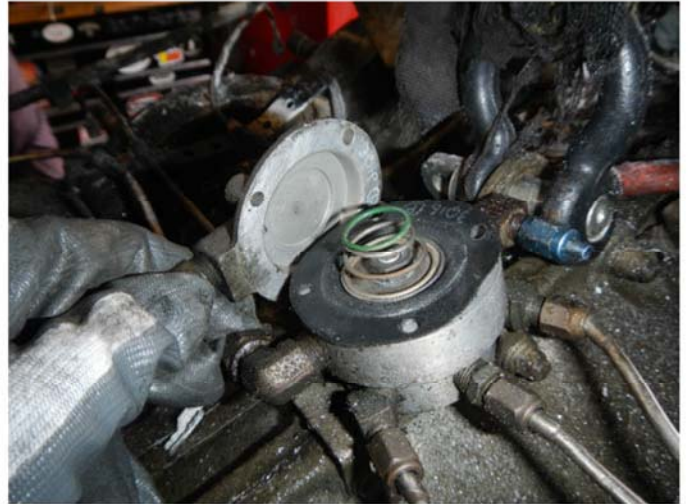
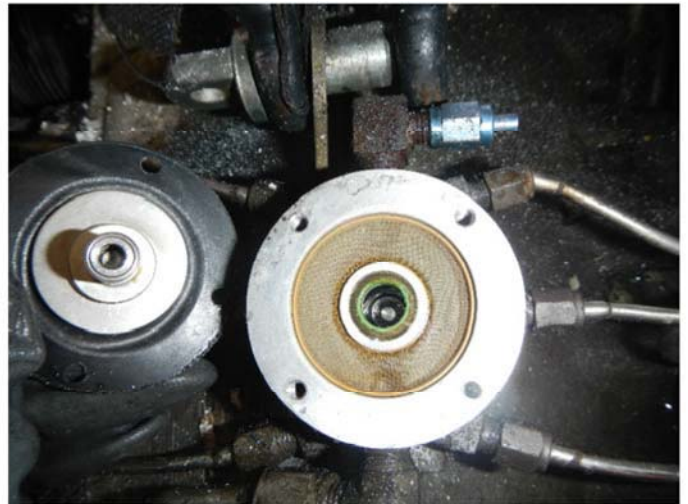
## FUEL MANIFOLD VALVE

The fuel manifold valve remained secured to the topside of the engine and the fuel lines remained attached to the housing. The fuel manifold valve cap was removed and the screen was free from obstructions. Residual fuel was observed in the housing.

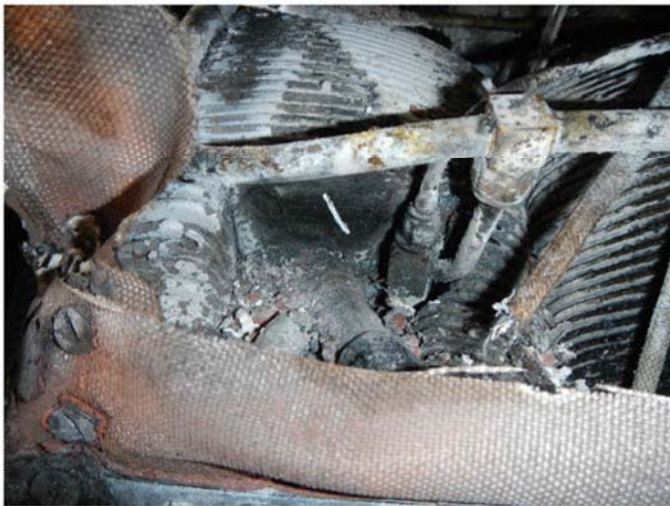
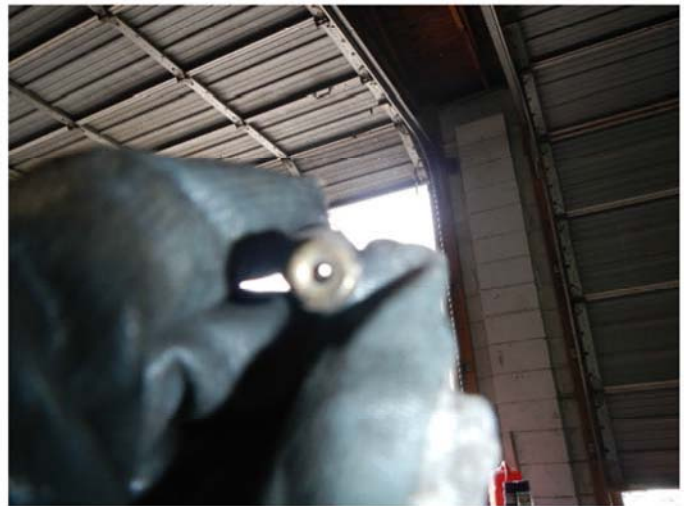
### FUEL NOZZLES AND LINES

The fuel lines remained secured to their nozzles and the upper deck reference line remained secured to the nozzles. Removal of the nozzles revealed they were clear and unobstructed.

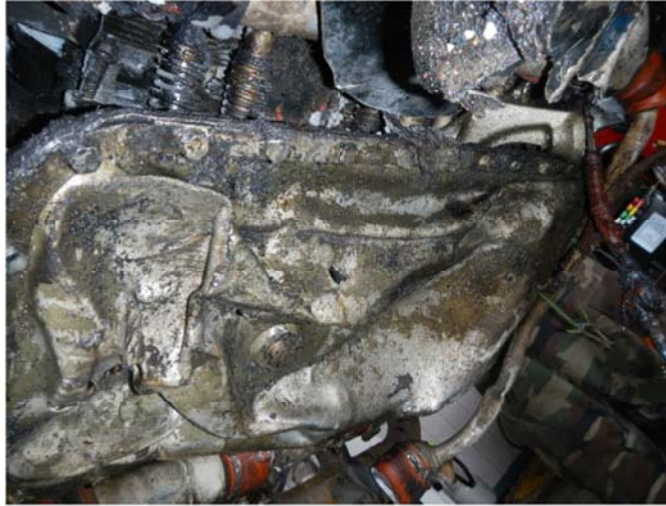
#### OIL SUMP

Condition: The oil sump remained attached to the bottom side of the engine, but it was displaced upward and camshaft gear teeth were protruding from punctures.

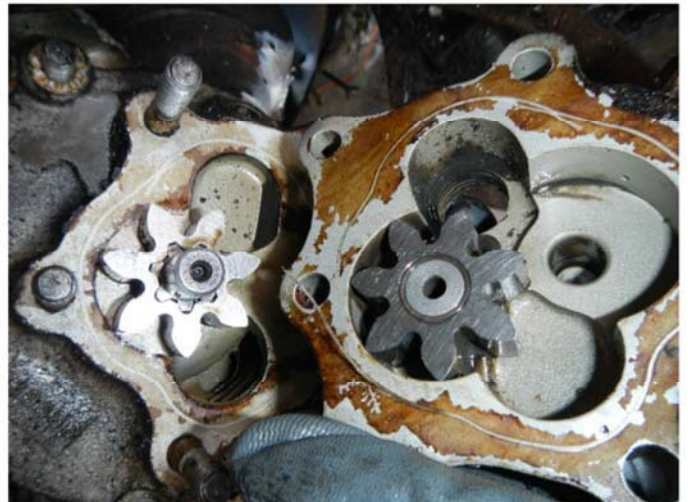
#### OIL PUMP

Condition: The oil pump and scavenge pumps remained intact, but the cap for both were impact damaged. The oil pump and scavenge pump caps were removed. Residual oil was observed on the gears and in the gear housing. Short shavings of metal were observed on the oil pump's gear teeth and coinciding gouges were noted on the housing walls, consistent with rotation at impact. No pre-accident anomalies were noted.

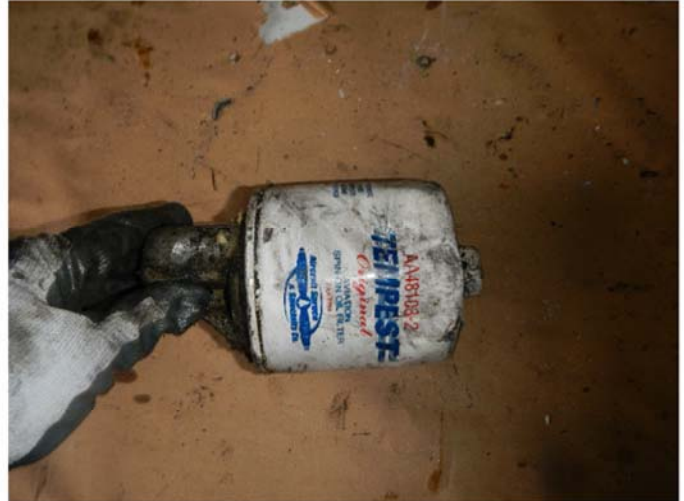
## OIL FILTER

Condition: The oil filter remained attached to the adapter, but the adapter was fractured and separated from the engine. The oil filter was deformed and punctured. The following information was hand-written on the side associated with the date and tach time, respectively: 11/6/14 1543.

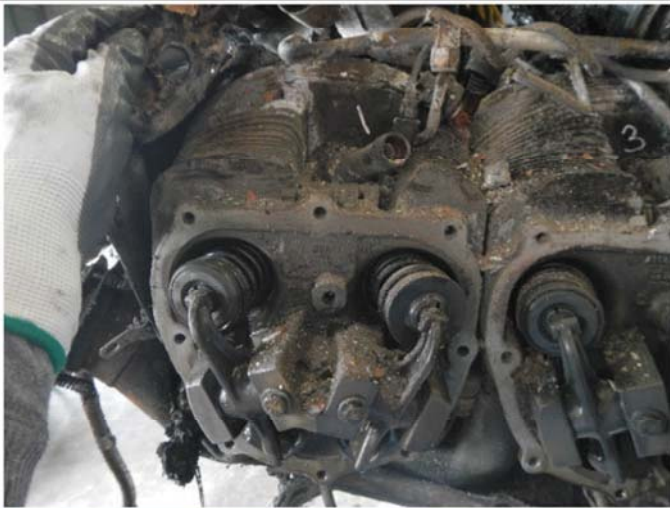
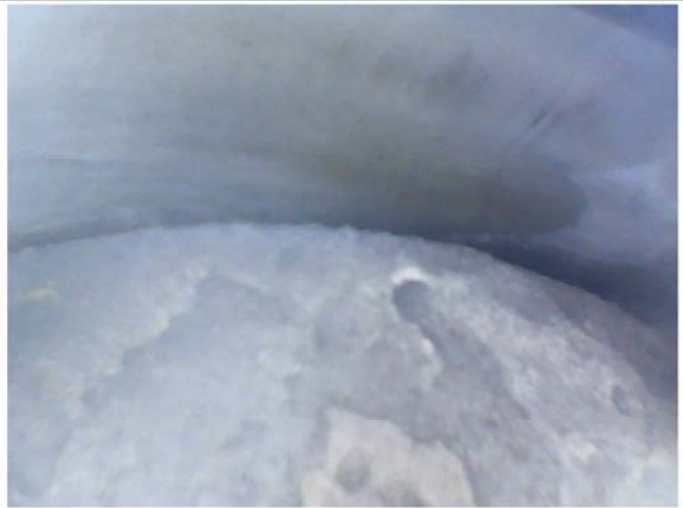
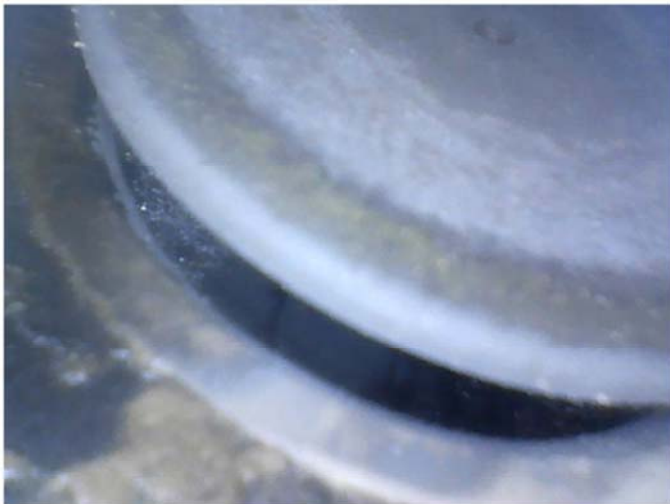
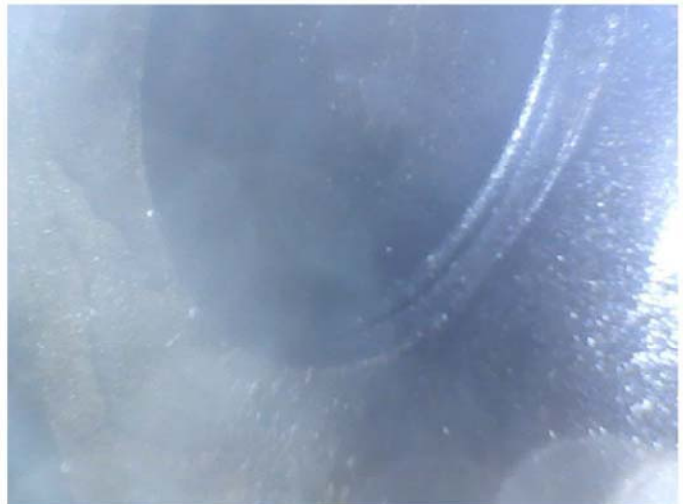
#### CYLINDER #1

The cylinder remained attached to the crankcase with no external signs of operational distress. The rocker cover was removed and the valve springs displayed signs of corrosion. Residual oil was observed in the rocker cover. The cylinder was inspected and documented utilizing a lighted borescope. The piston, valves, and valve seats were unremarkable.

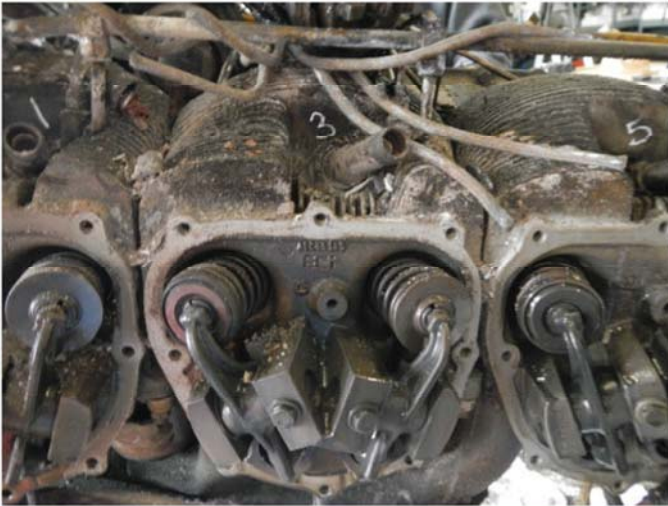
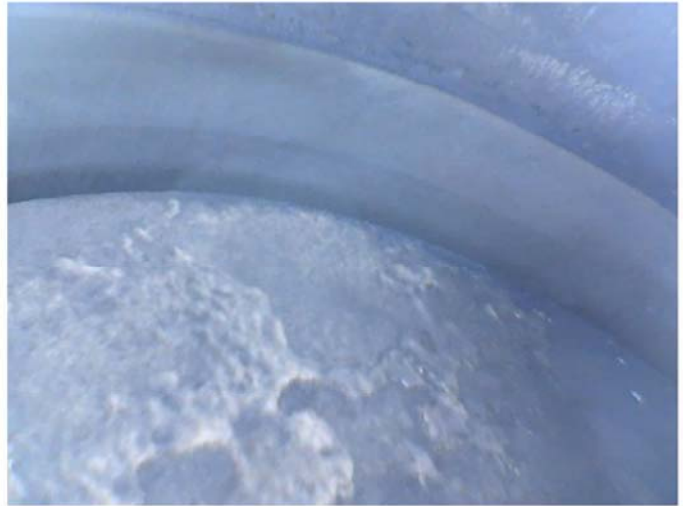
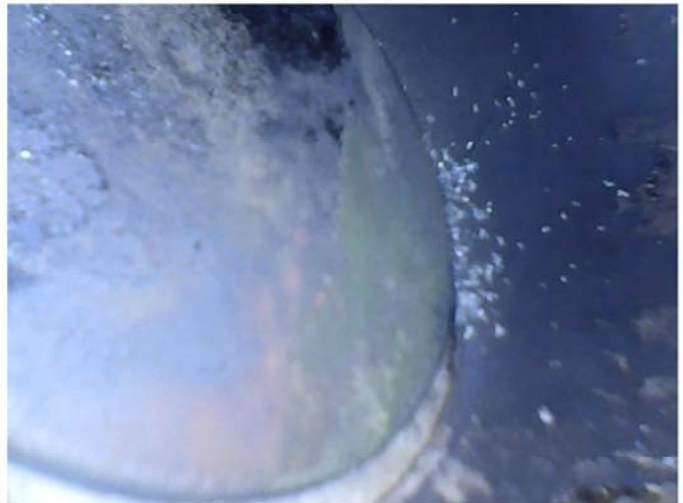
### CYLINDER #3

Condition: The cylinder remained attached to the crankcase with no external signs of operational distress. The rocker cover was removed and the valve springs displayed signs of corrosion. Residual oil was observed in the rocker cover. The cylinder was inspected and documented utilizing a lighted borescope. The #3 exhaust valve displayed two areas of green discoloration consistent with a pre-existing exhaust gas leak (the last three photos in this section consist of different views of the exhaust valve). Otherwise, the piston, valves, and valve seats were unremarkable.

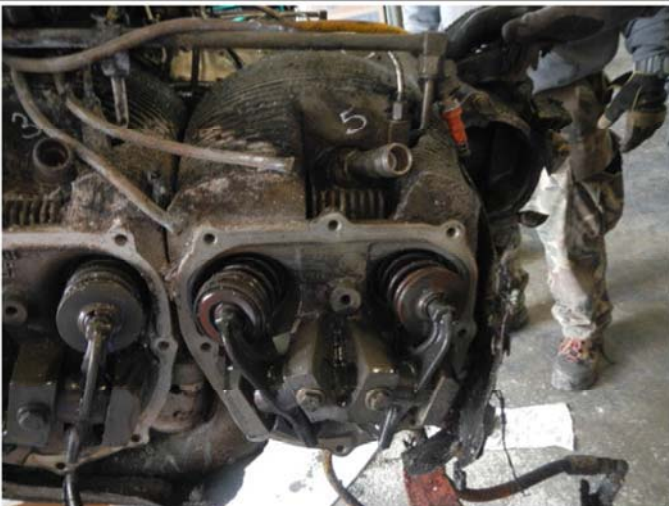
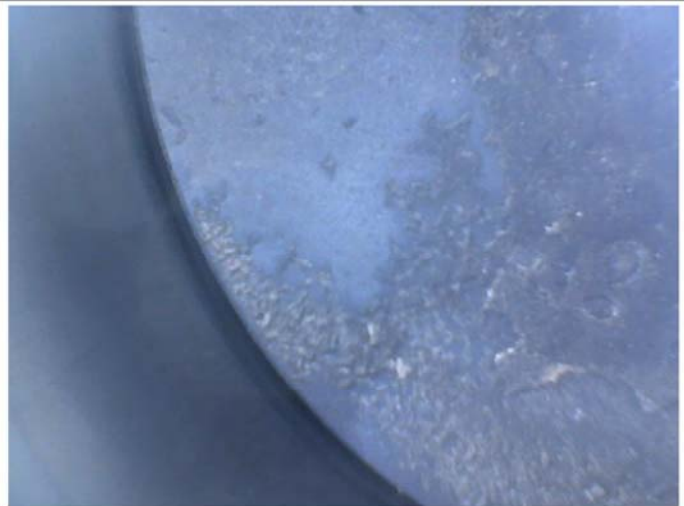
### CYLINDER #5

The cylinder remained attached to the crankcase with no external signs of operational distress. The rocker cover was removed and the valve springs displayed signs of corrosion. Residual oil was observed in the rocker cover. The cylinder was inspected and documented utilizing a lighted borescope. The piston, valves, and valve seats were unremarkable.

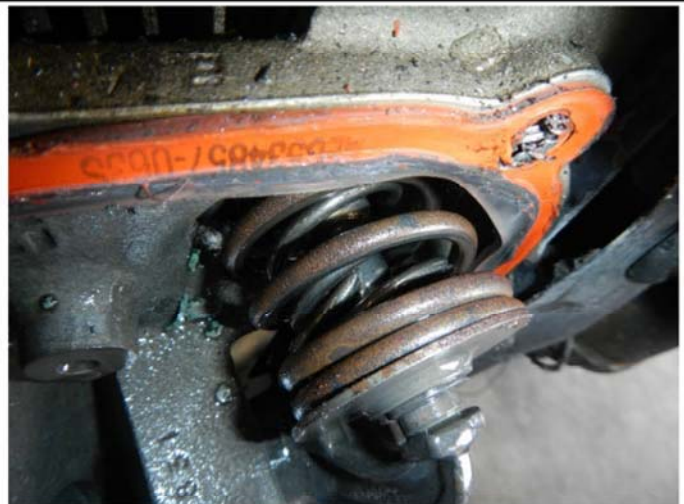
### CYLINDER #2

The cylinder remained attached to the crankcase with no external signs of operational distress. The rocker cover was removed and the valve springs displayed signs of corrosion. The #2 intake inner valve spring was fractured. Residual oil was observed in the rocker cover. The cylinder was inspected and documented utilizing a lighted borescope. The piston, valves, and valve seats were unremarkable. The 2<sup>nd</sup>, 3<sup>rd</sup> and 4<sup>th</sup> photographs below are closer views of the intake valve springs.

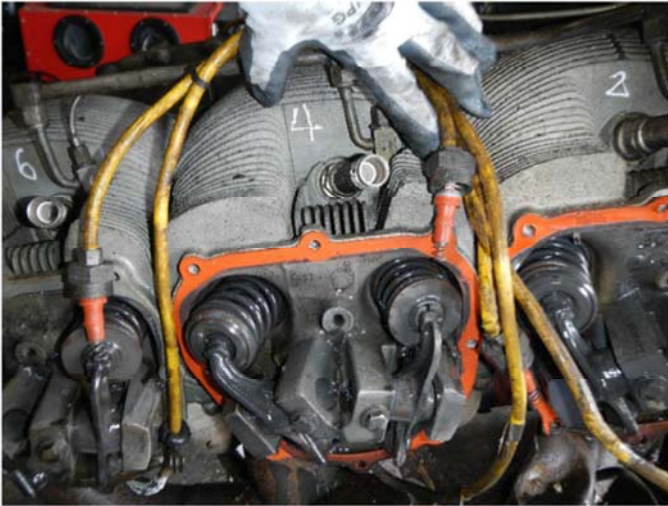
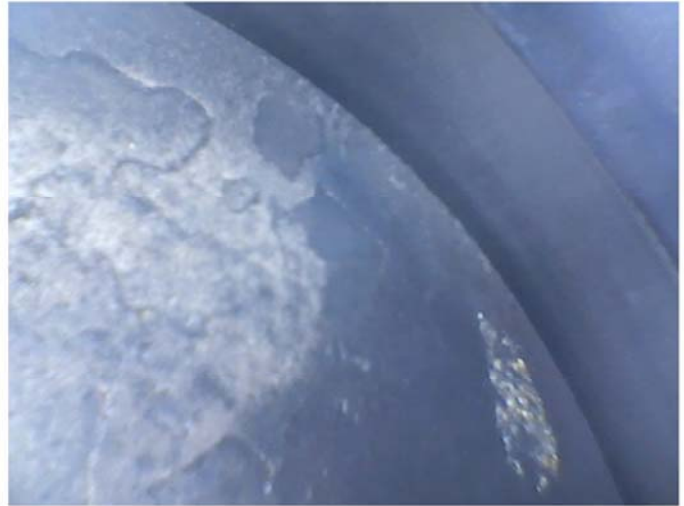
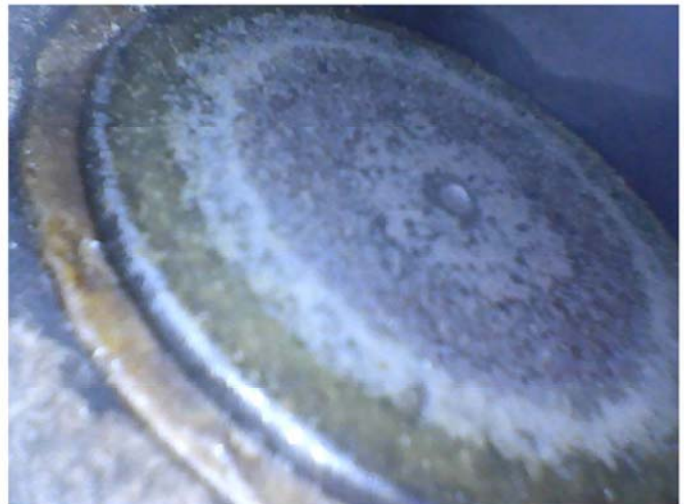
### CYLINDER #4

Condition: The cylinder remained attached to the crankcase with no external signs of operational distress. The rocker cover was removed and the valve springs displayed signs of corrosion. Residual oil was observed in the rocker cover. The cylinder was inspected and documented utilizing a lighted borescope. The piston, valves, and valve seats were unremarkable.

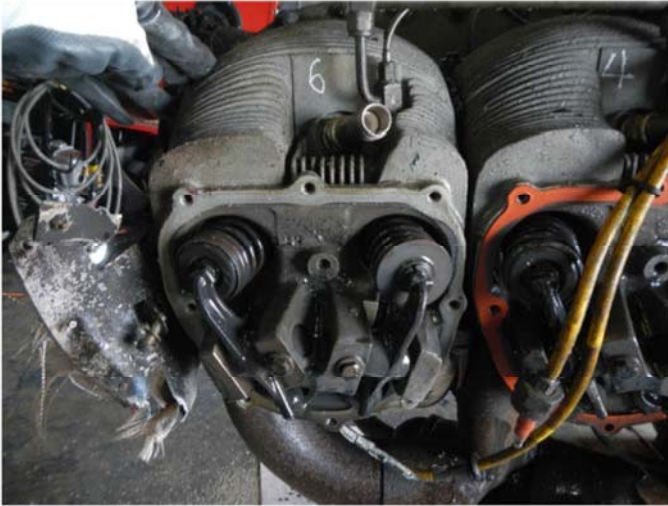
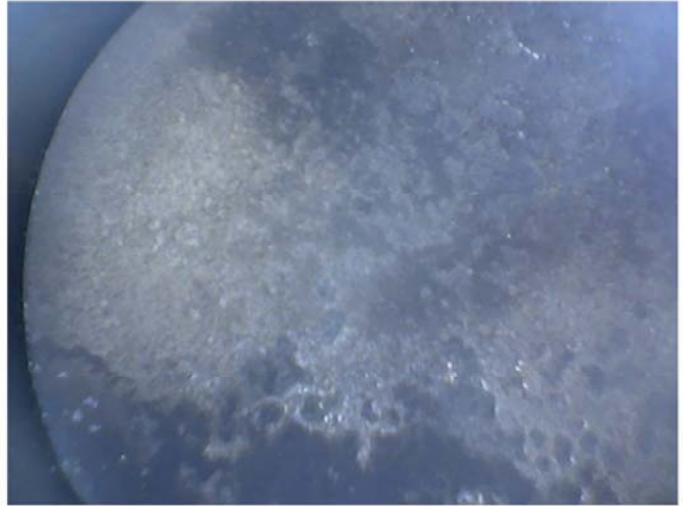
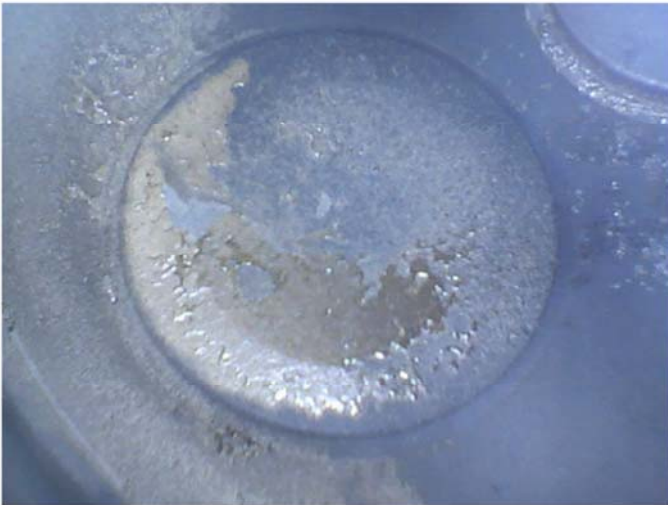
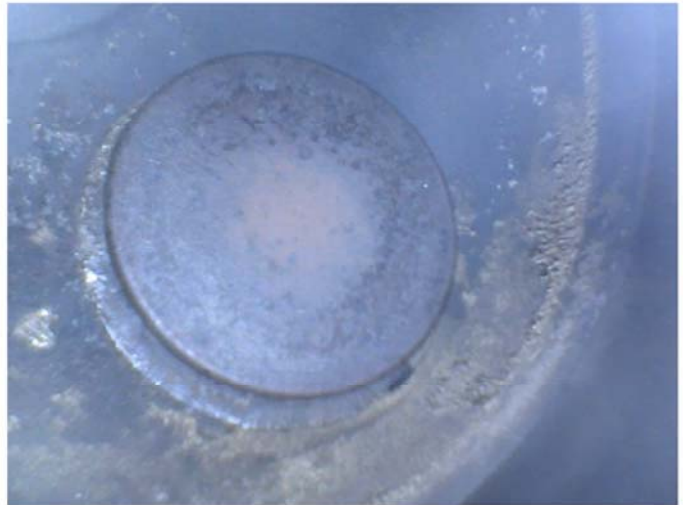
### CYLINDER #6

Condition: The cylinder remained attached to the crankcase with no external signs of operational distress. The rocker cover was removed and the valve springs displayed signs of corrosion. Residual oil was observed in the rocker cover. The cylinder was inspected and documented utilizing a lighted borescope. The piston, valves, and valve seats were unremarkable.

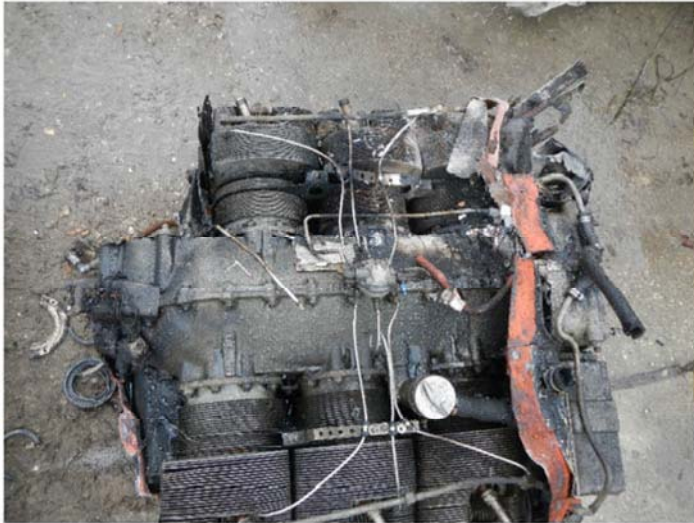
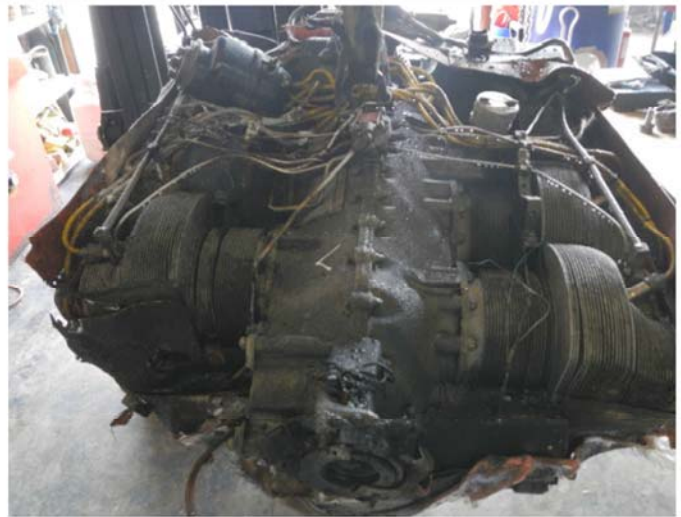
### CRANKCASE ASSEMBLY

| Condition: | The crankcase remained intact with no external signs of operational distress noted. | | | |

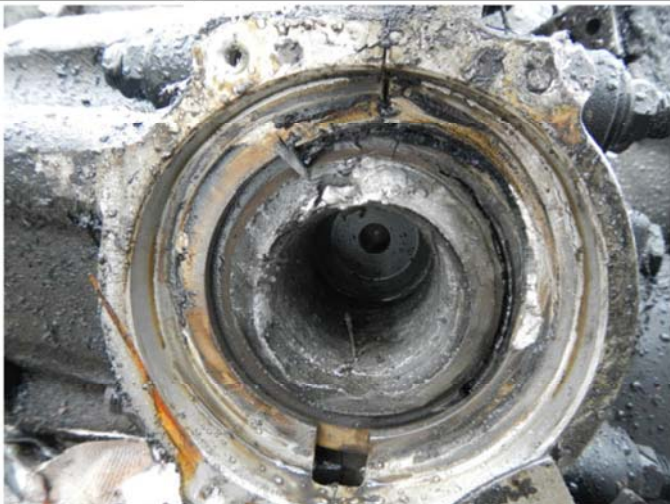
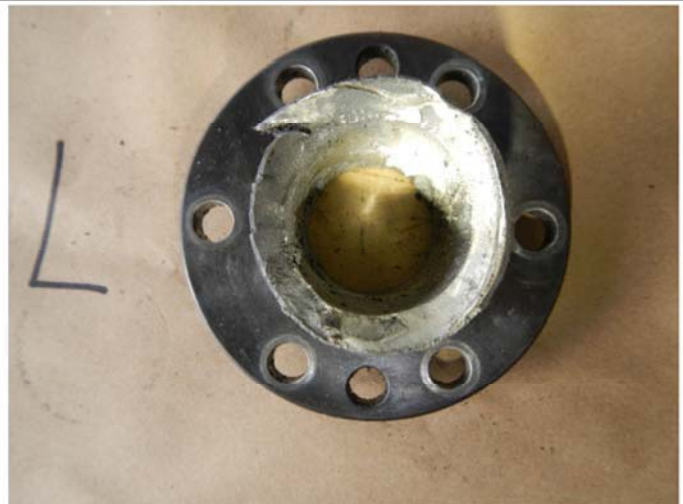
### CRANKSHAFT ASSEMBLY

| Condition: | The propeller flange was separated from the crankshaft and the fracture surface displayed tearing, shear lips, and discoloration features consistent with overload. A tool was fitted to the backside of the crankshaft and rotation of the crankshaft was not possible. Impingements on the crankshaft and camshaft were noted at the front of the crankcase and the oil sump respectively. Examination of the crankshaft through the alternator mounting bad showed no pre-accident anomalies with the alternator face gear and oil transfer collar. The crankshaft gear was secured in place. | | |

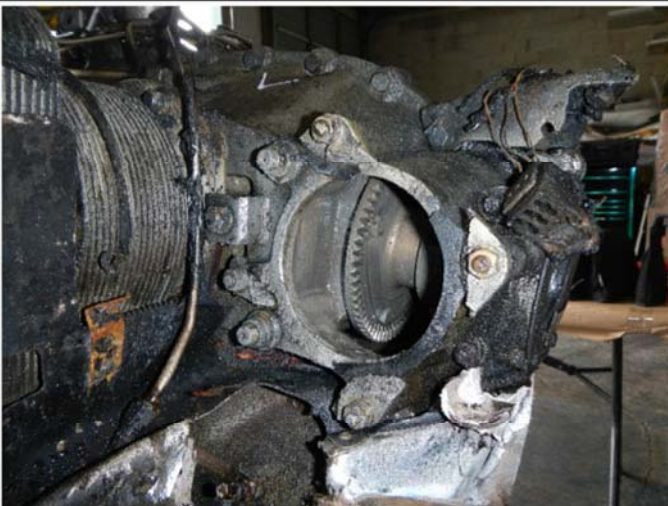
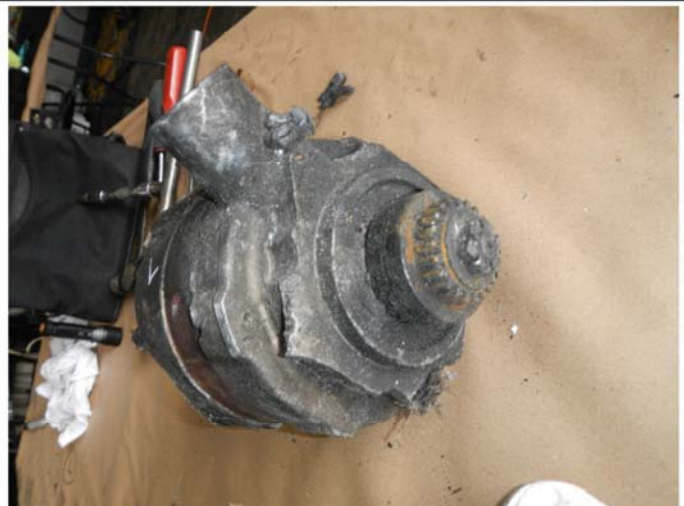
**ALTERNATOR**

The alternator was separated from the engine and the mounting flange was fractured. The alternator drive coupling remained in place and no pre-accident anomalies were noted. The alternator face gear remained intact with no pre-accident anomalies noted.

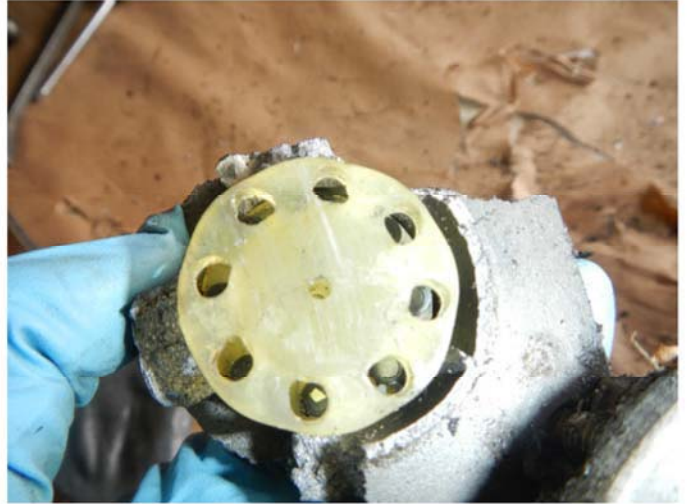
## VACUUM PUMP

The vacuum pump was separated from the backside of the engine and fragments were noted in the wreckage. The vacuum pump drive coupling was identified and it was intact. The pump housing, rotors, and vanes were fractured (the bottom photo represents the two housings identified in the wreckage).

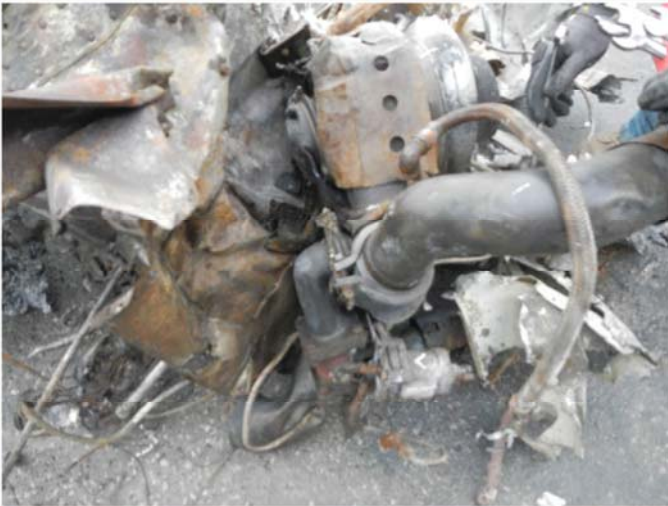
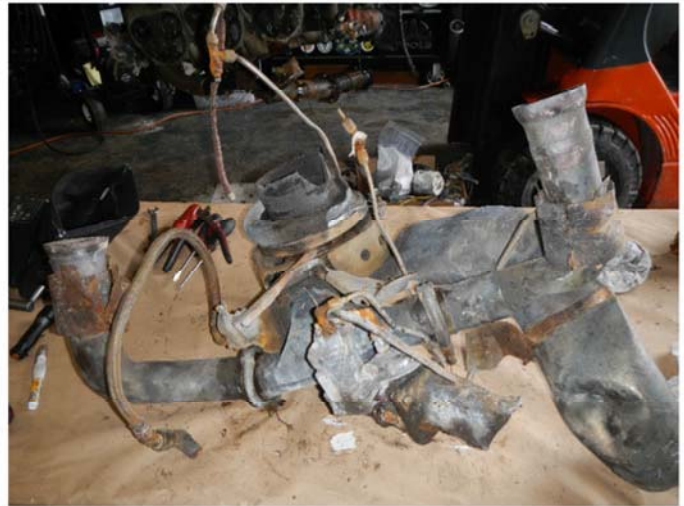
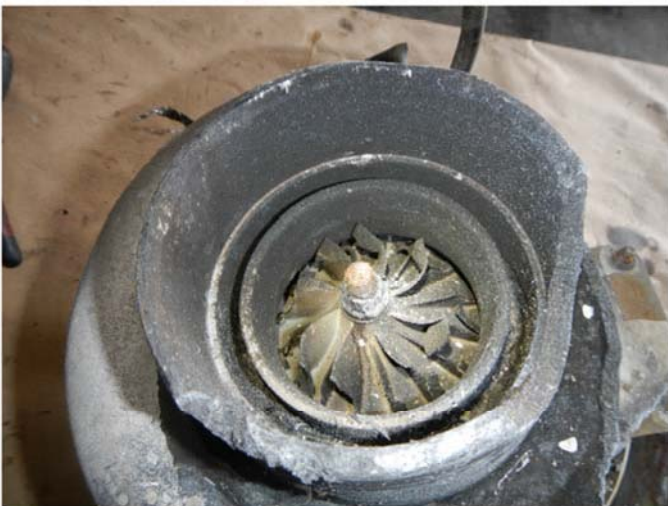
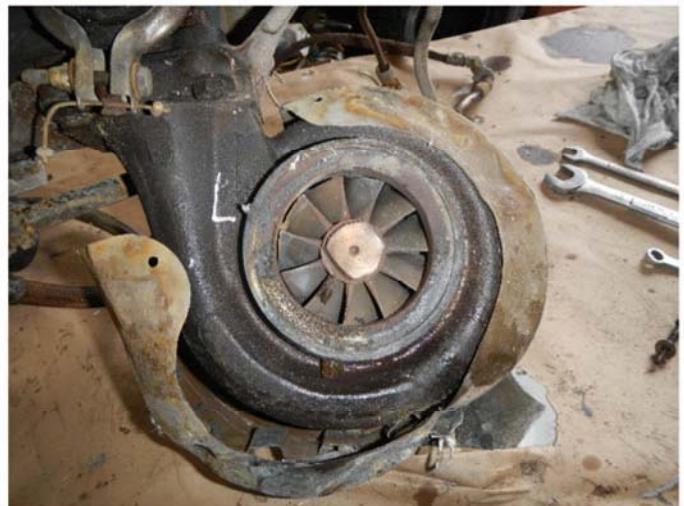
## TURBO

The turbocharger remained with the left nacelle area. The compressor housing was fractured. The intake impeller blades displayed deformation damage and curling opposite the direction of normal rotation. The turbocharger turbine wheel/blades remained intact.
