# Continental Motors

## ENGINE EXAMINATION REPORT

| ENGINE MODEL | TSIO-520-NcNB via RAM STC |
| FILE NUMBER | 17-361 |

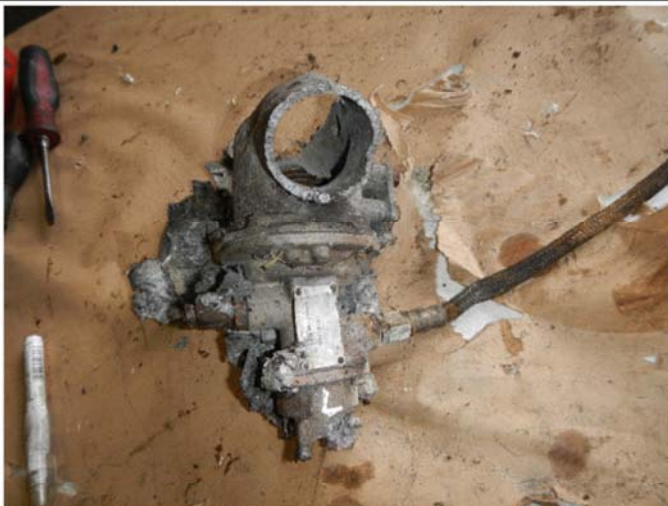
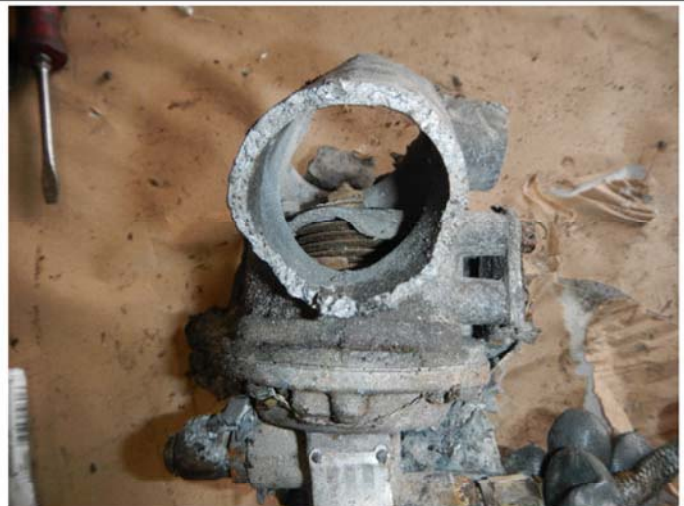
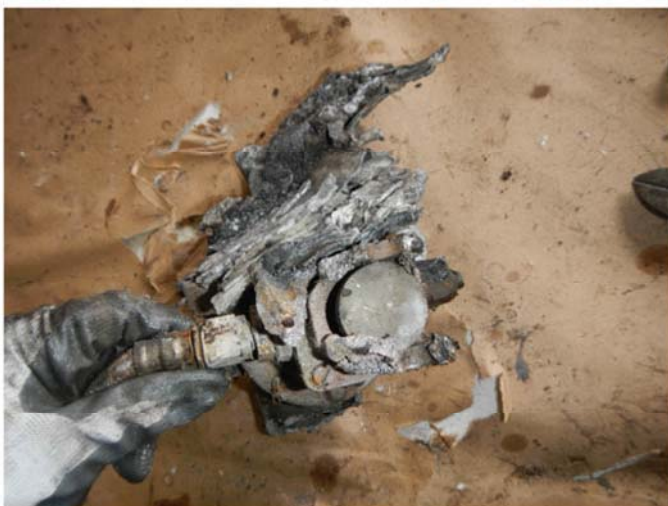
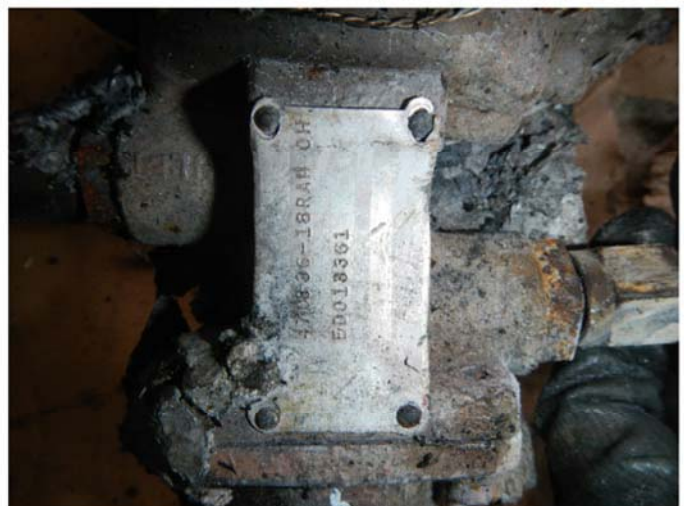
## TURBO CONTROLLER

The turbo wastegate controller was thermally damaged and separated from the engine.

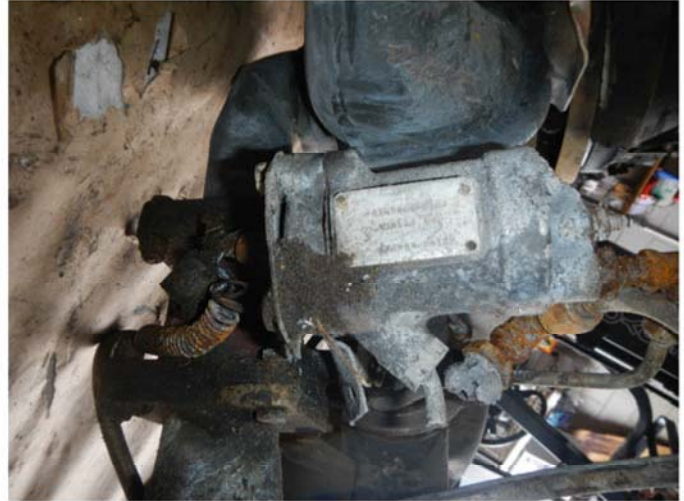
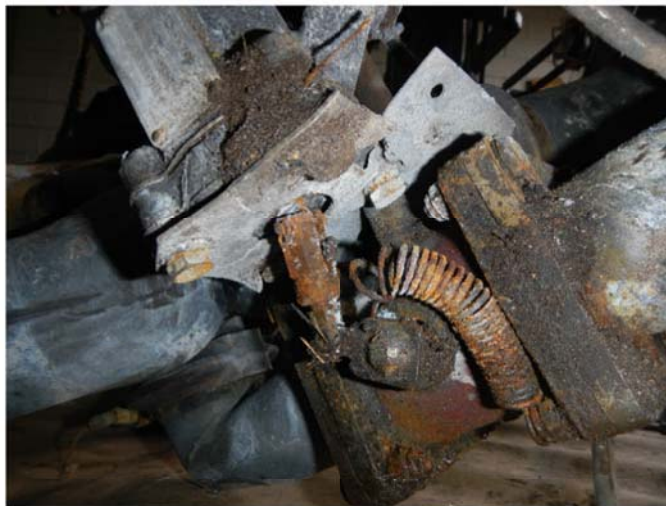
### WASTEGATE

The waste gate actuator linkage remained intact and attached to the wastegate, though deformation and thermal damage were extensive.

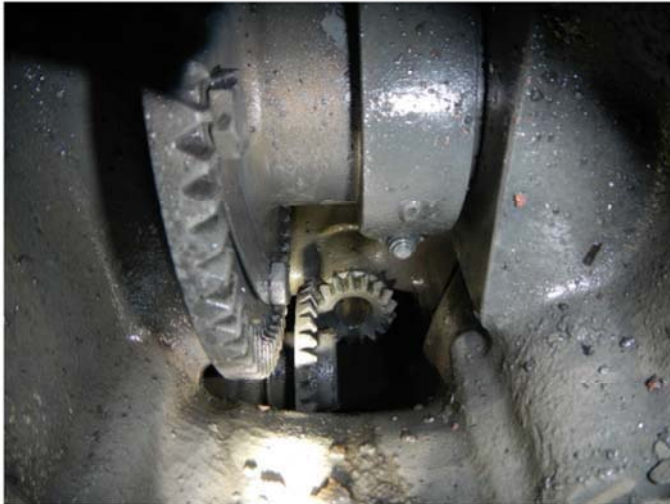
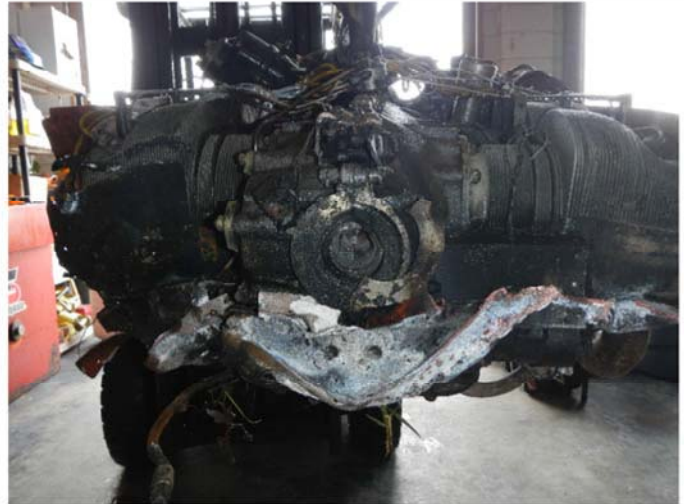
**PAGE 39 of 41****PROPELLER****PROPELLER GOVERNOR**

The propeller governor remained attached to the engine and the drive gear was intact with no pre-accident anomalies noted.
