# Continental Motors

## ENGINE EXAMINATION REPORT

| ENGINE MODEL | TSIO-520-NB1A |
| FILE NUMBER | 17-361 |

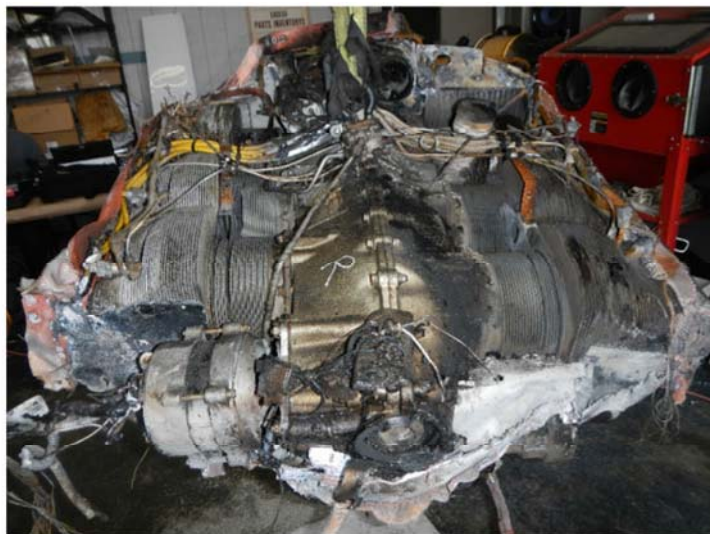
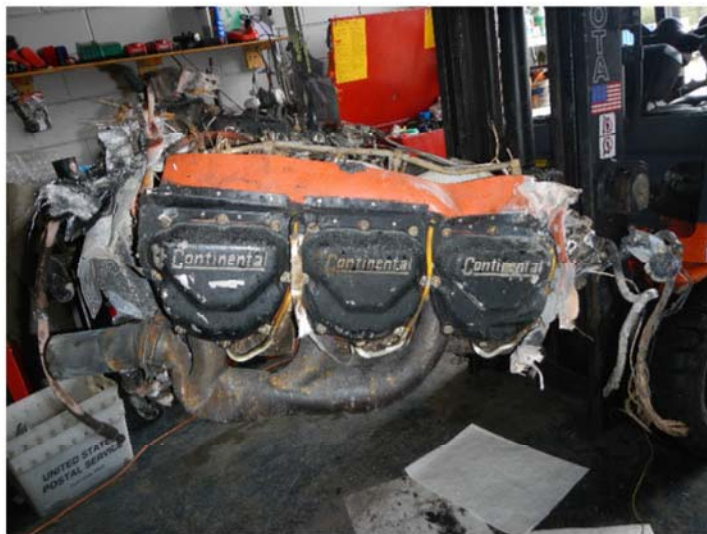
The engine was separated from the airframe and was labeled as the right engine based on the data plate and the aircraft maintenance records. The crankshaft was fractured at the nose oil seal and the propeller flange remained attached to the propeller hub. The crankshaft fracture surface displayed tearing, shear lips, and discoloration features consistent with overload. The engine sustained thermal and impact-related damage.

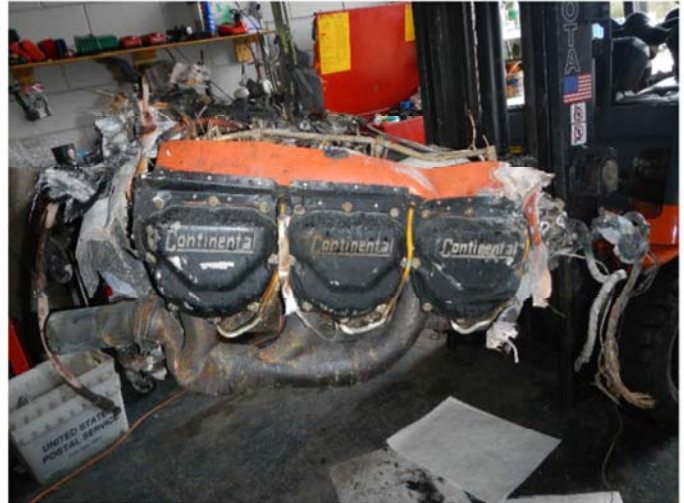
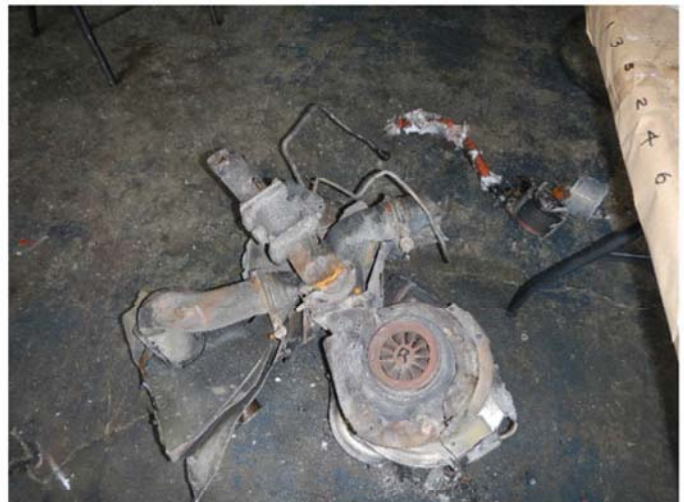
#### EXHAUST SYSTEM

Condition: The exhaust system sustained impact-related deformation and separation damage. There were no pre-accident anomalies noted with the v-band clamps, bolted couplings, or slip joints. The waste gate actuator linkage did not display and pre-accident anomalies. The aft exhaust risers were displaced forward.

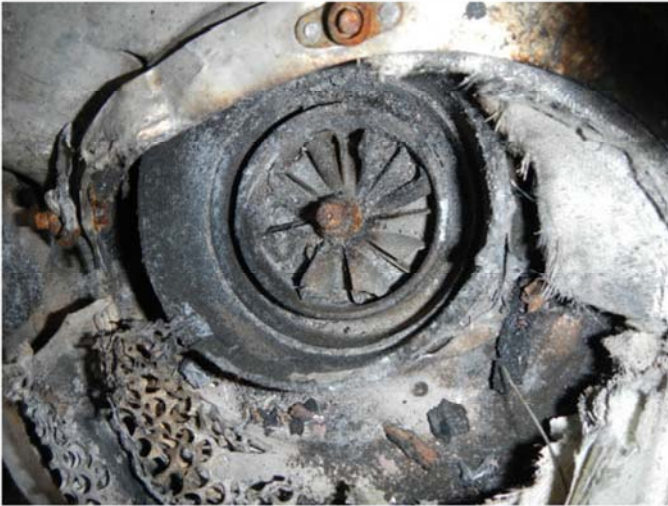
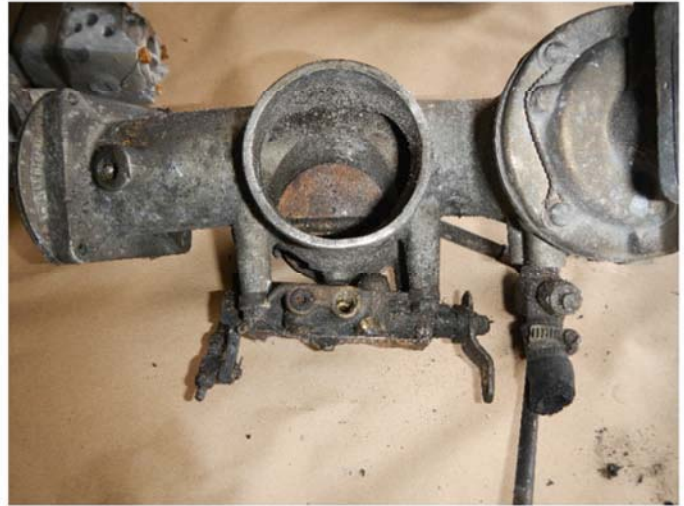
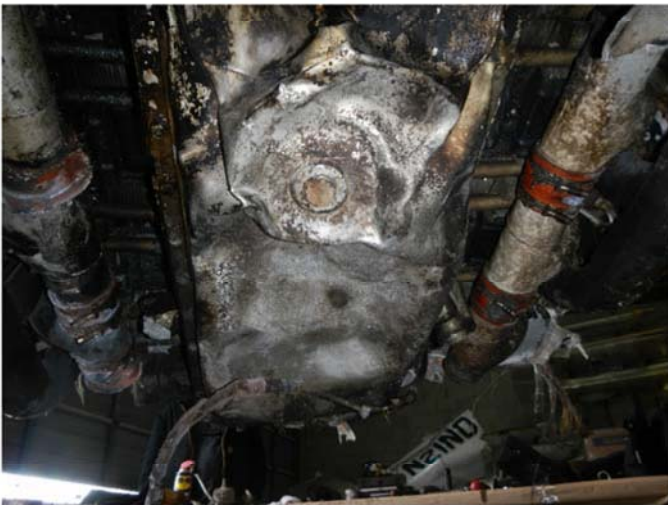
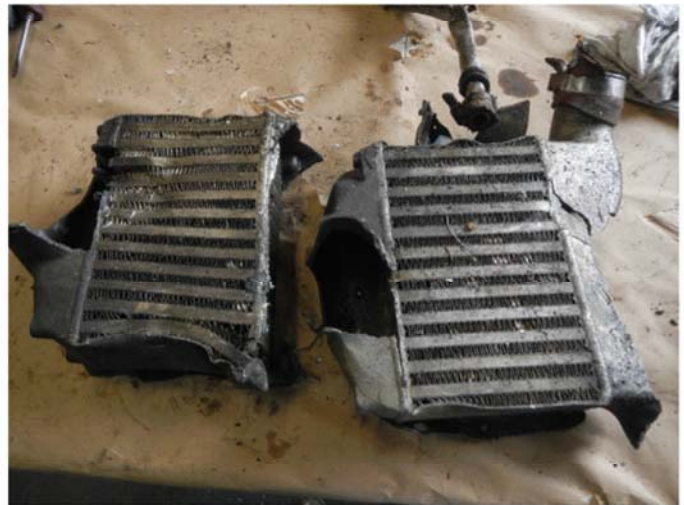
### INDUCTION SYSTEM

Condition: The induction system was impact and thermally damaged. The turbocharger intake was unobstructed. The intercooler was separated from the engine nacelle (it should be noted that the intercooler for both the left and right engines were separated and it was not clear as to which one belonged to which engine. Regardless, they displayed similar impact-related damage with no pre-accident anomalies noted). The intake system sustained impact and thermal damage with no pre-accident anomalies noted.

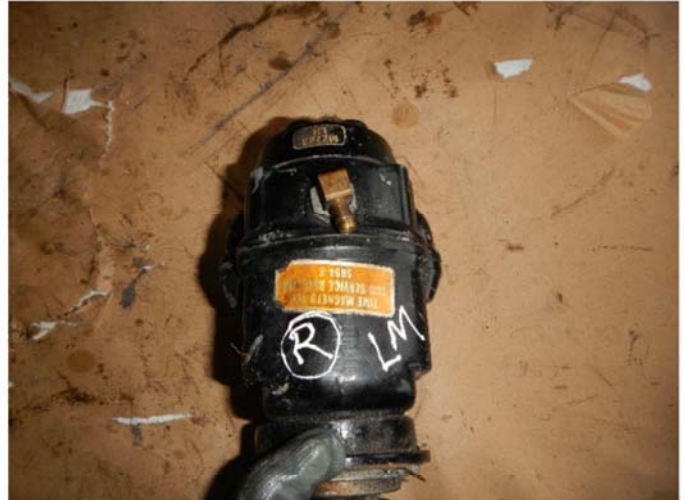
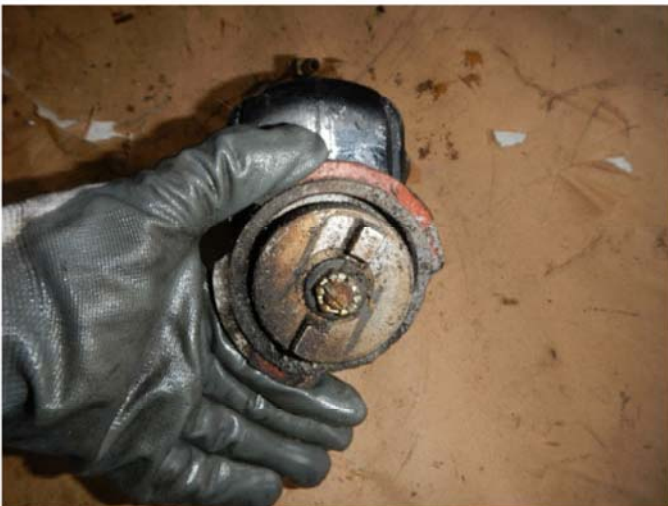
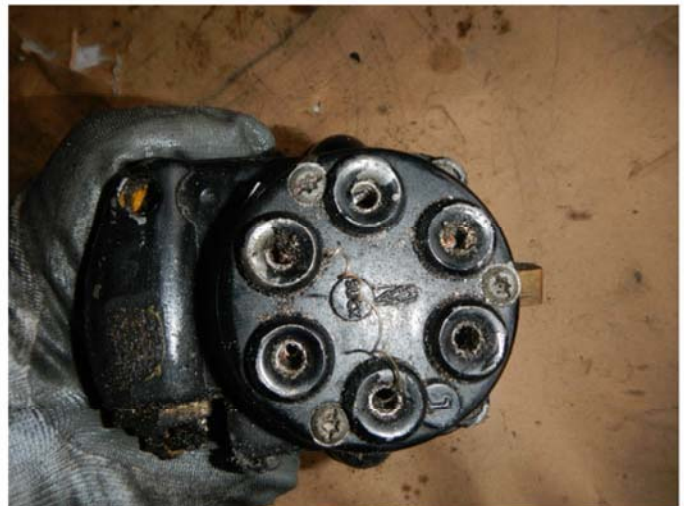
#### LEFT MAGNETO

Condition: The magneto was separated from the mounting pad and was located within the wreckage. The magneto drive shaft was manually rotated and it produced a spark from each lead in firing order when an audible snap of the impulse coupling was heard (the left ignition harness cap was removed for the testing due to damage sustained in the accident sequence, and the right engine's right magneto's ignition harness cap was utilized for testing).

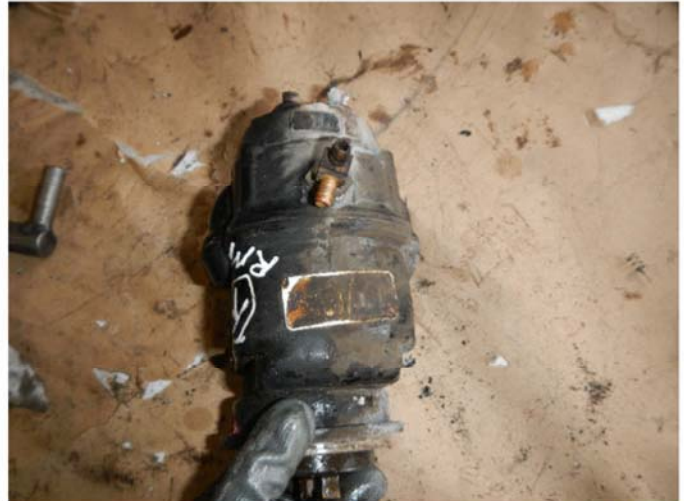
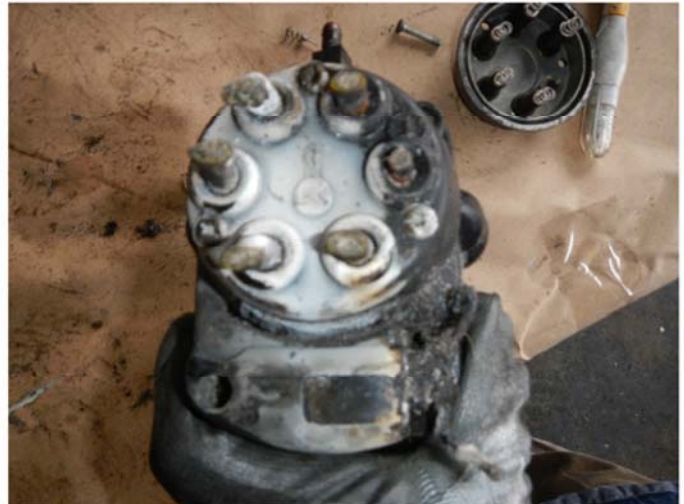
## RIGHT MAGNETO

**Condition:** The right magneto remained secured to the top side of the engine with its ignition harness attached. The magneto was removed from the engine and the drive shaft was manually rotated. It produced a spark from each lead in firing order when an audible snap of the impulse coupling was heard.

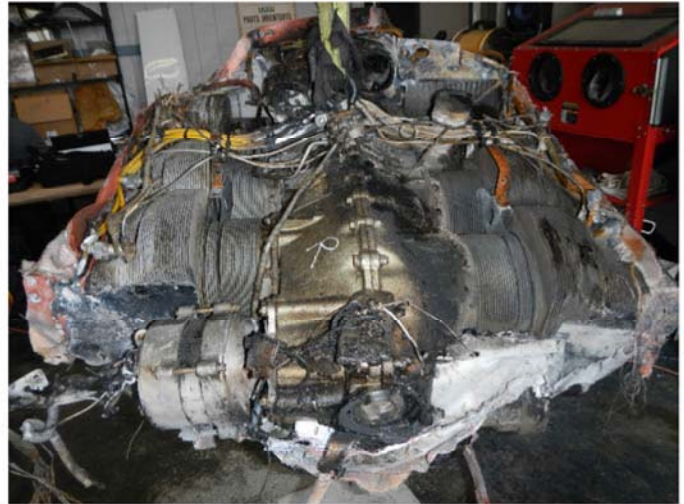
**PAGE 9 of 36****IGNITION  
HARNESS**

The ignition harnesses caps remained attached to the magnetos, and all terminal remained attached to their respective sparkplugs. However, all of the left magneto's leads were pulled from the cap and many of the leads sustained thermal damage. The leads were cut from the right magneto harness cap for the functional testing of the right magneto. No pre-accident anomalies were noted with either harness/cap.

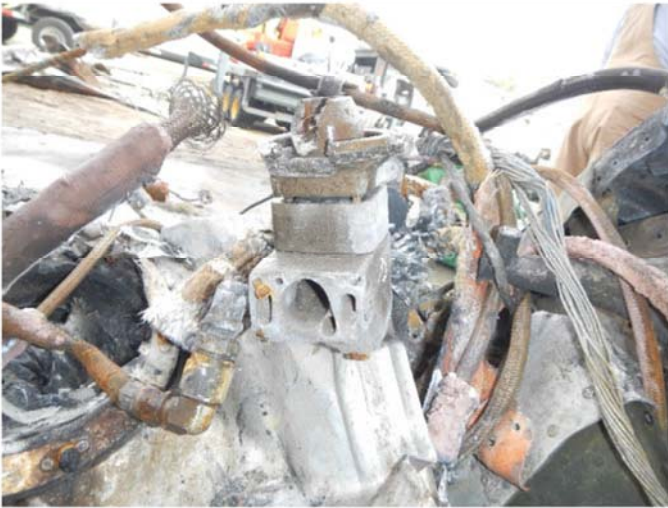
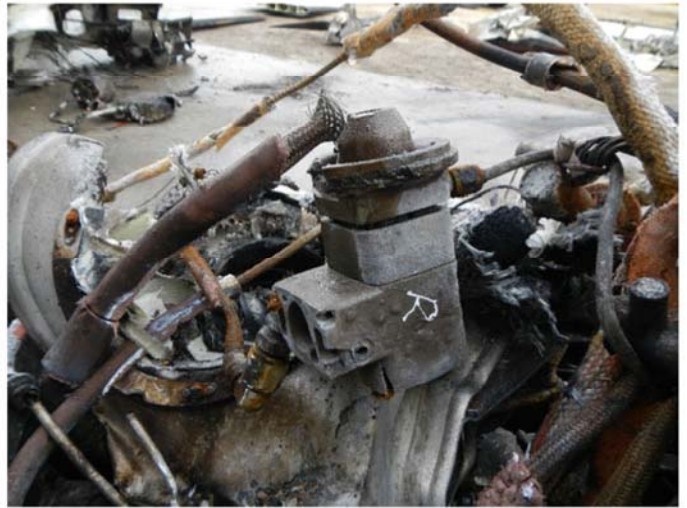
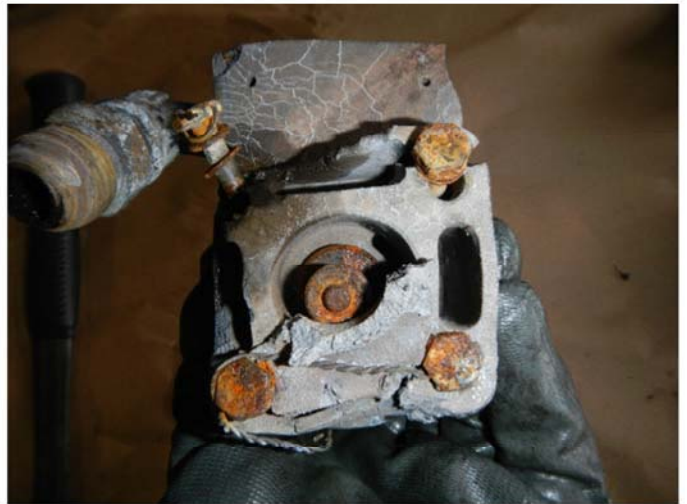
#### FUEL PUMP

The engine-driven fuel pump was separated from the backside of the engine and the mounting flange and drive coupling were displaced to one side and the metal was smeared in the same direction. The pump remained attached to the engine nacelle via the fuel inlet line. The fuel pump was thermally damaged to such an extent that much of the components were destroyed and the housing could not be disassembled.

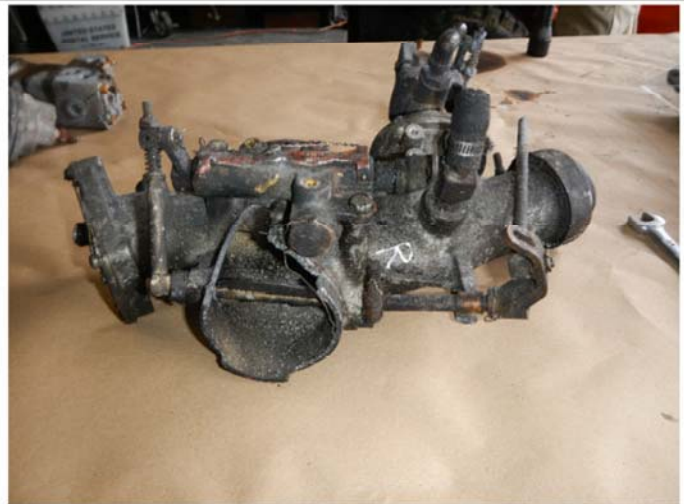
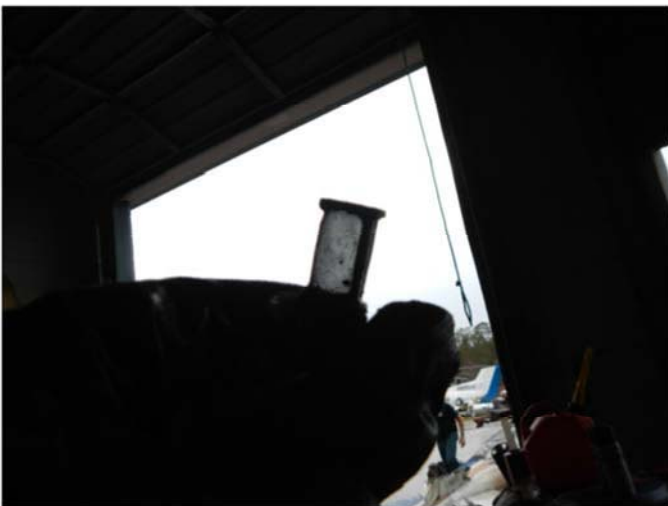
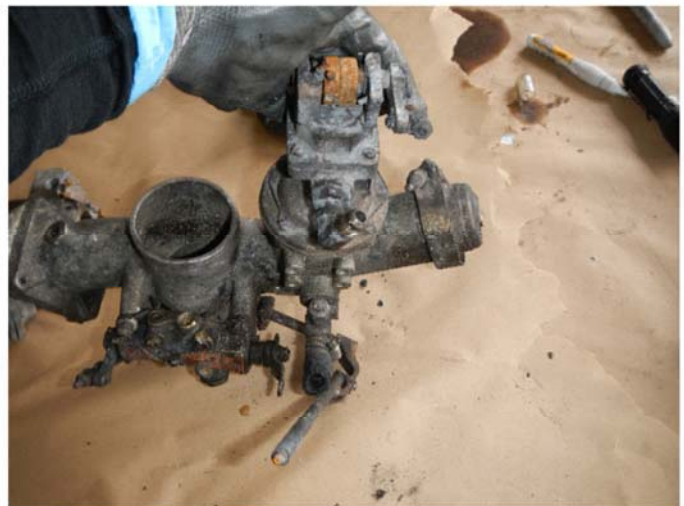
## THROTTLE BODY METERING UNIT

The throttle body/fuel metering unit remained attached to the right engine nacelle and was fractured. The mixture and throttle control cables remained attached to their respective control levers, both of which sustained deformation damage. The throttle valve was found in a near idle position. The interconnect link between the throttle and the turbo wastegate controller was deformed and fractured. The mixture control shaft could be manually manipulated with no binding noted. All of the fittings were fractured on the fuel metering unit. The inlet fuel screen was removed and no obstructions were noted.

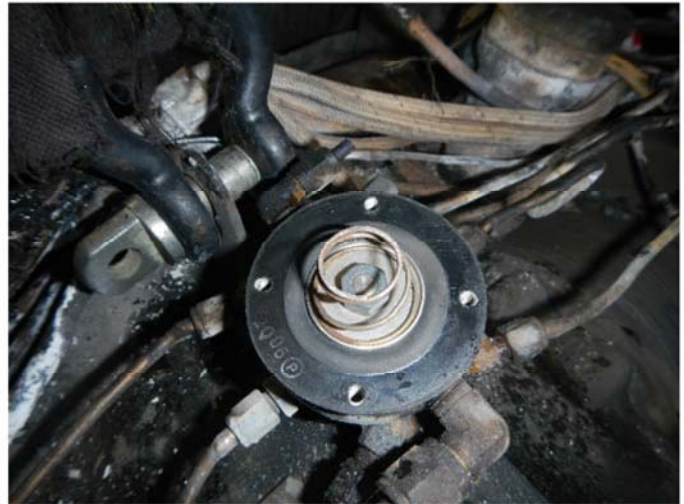
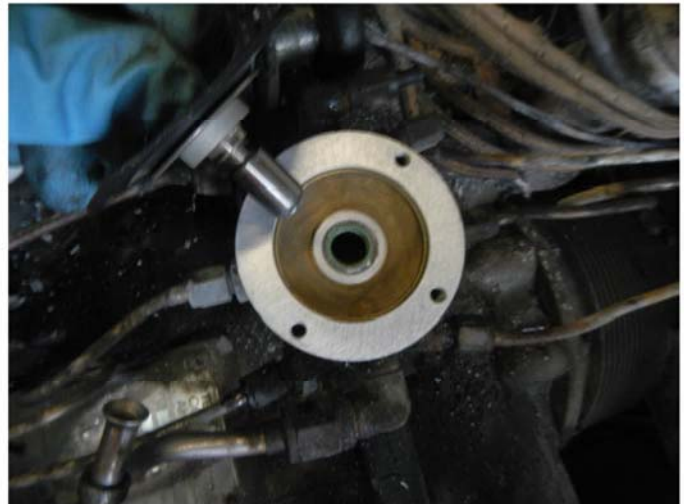
## FUEL MANIFOLD VALVE

The fuel manifold valve remained secured to the topside of the engine and the fuel lines remained attached to the housing except for the #2. The fuel manifold valve cap was removed and the screen was free from obstructions. Residual fuel was observed in the housing.

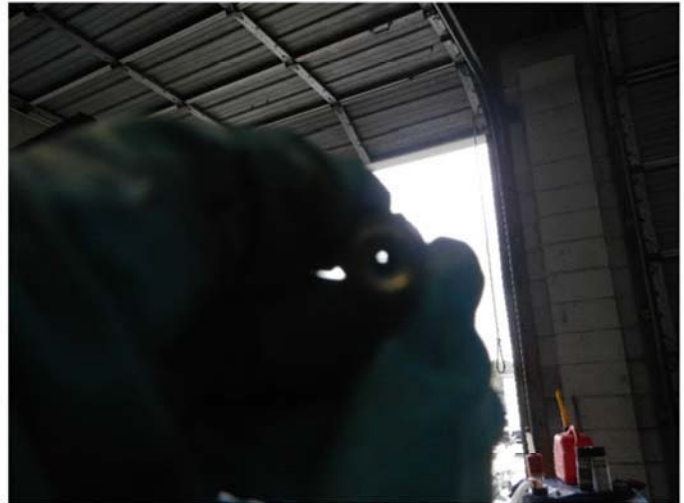
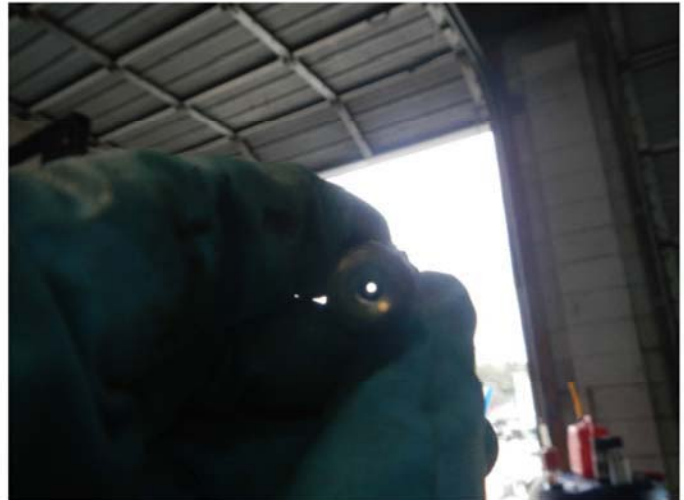
## FUEL NOZZLES AND LINES

The fuel lines and upper deck reference lines remained secured to their nozzles. Removal of the nozzles revealed they were clear and unobstructed.

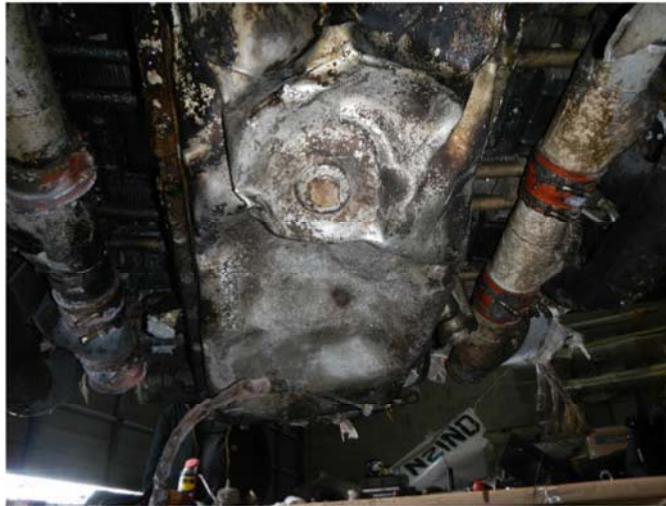
#### OIL SUMP

Condition: The oil sump was displaced up around the bottom of the engine, but did not display any external pre-accident anomalies.

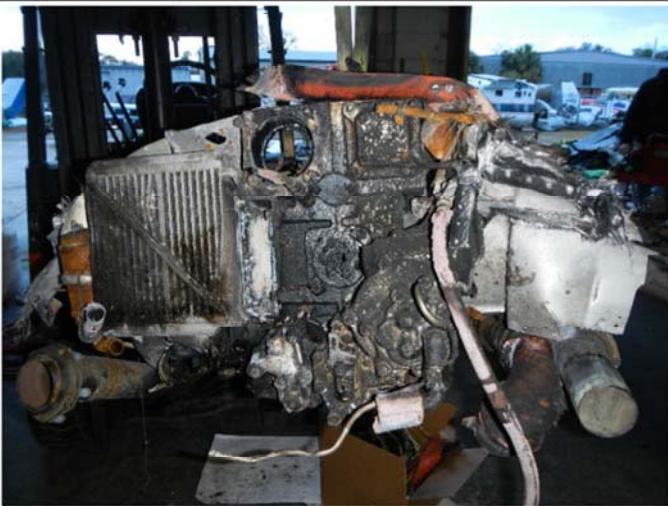
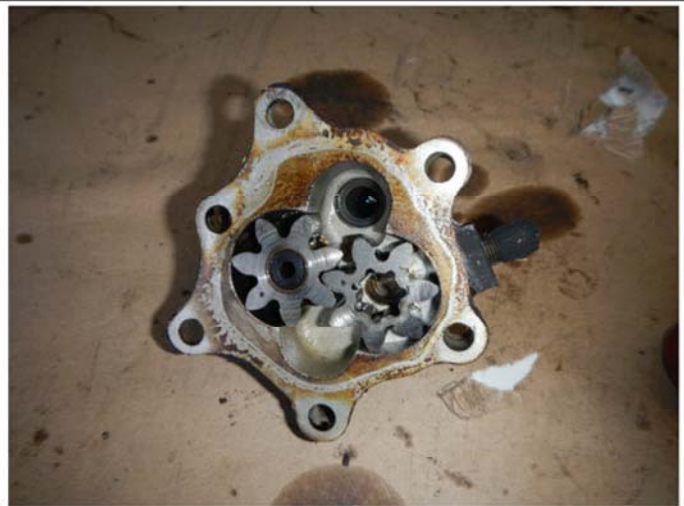
#### OIL PUMP

Condition: The oil pump and scavenge pump caps were removed. Residual oil was observed on the gears and in the gear housings. The oil pump housing displayed light circumferential scoring and signs of hard particle passage at some point in the life of the engine.

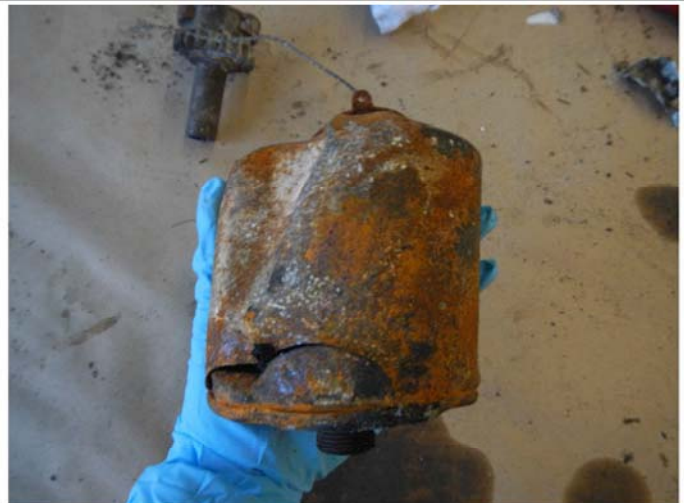
## OIL FILTER

The oil filter was separated from the engine, deformed and thermally damaged.

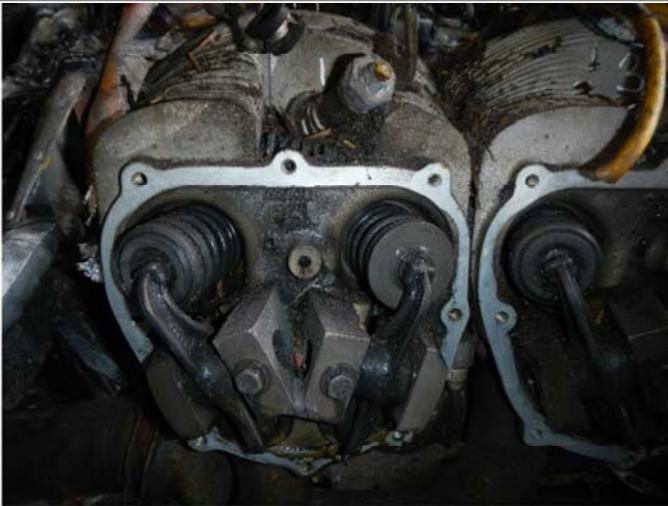
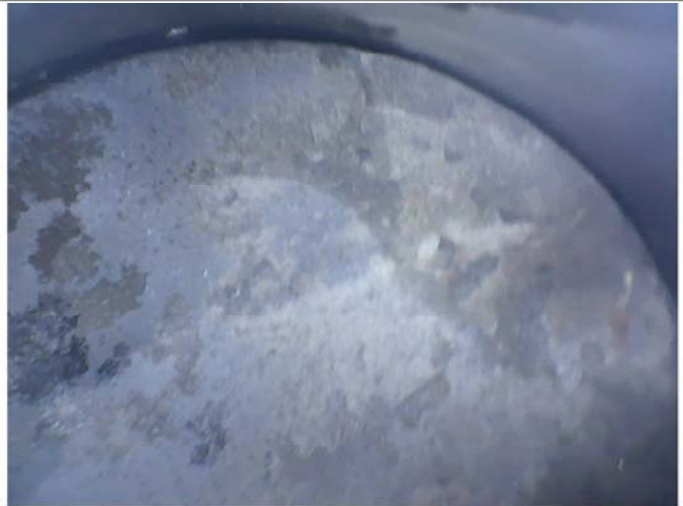
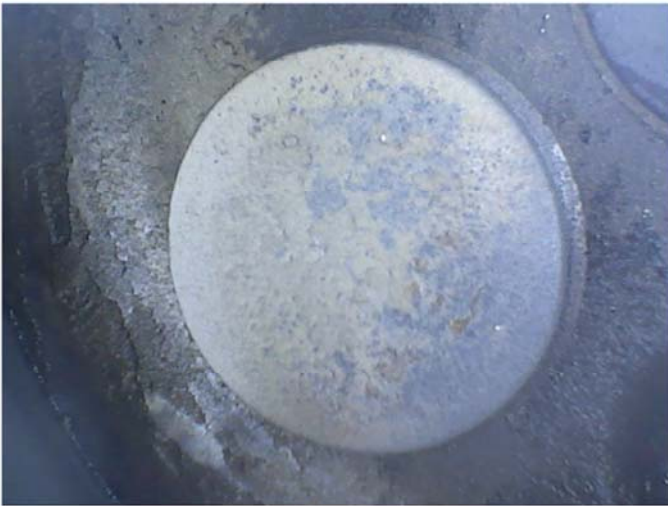
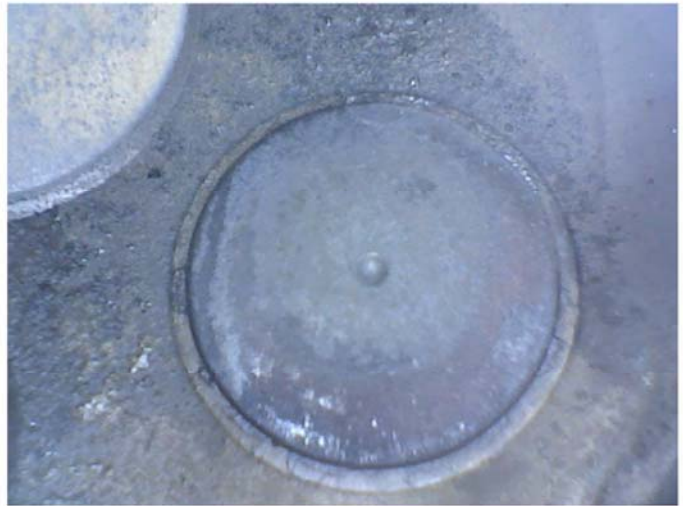
#### CYLINDER #1

Condition: The cylinder remained attached to the crankcase with no external signs of operational distress. The rocker cover was removed and the valve springs remained intact. The cylinder was inspected and documented utilizing a lighted borescope. Oil was pooled at the bottom of the cylinder. The piston, valves, and valve seats were unremarkable.

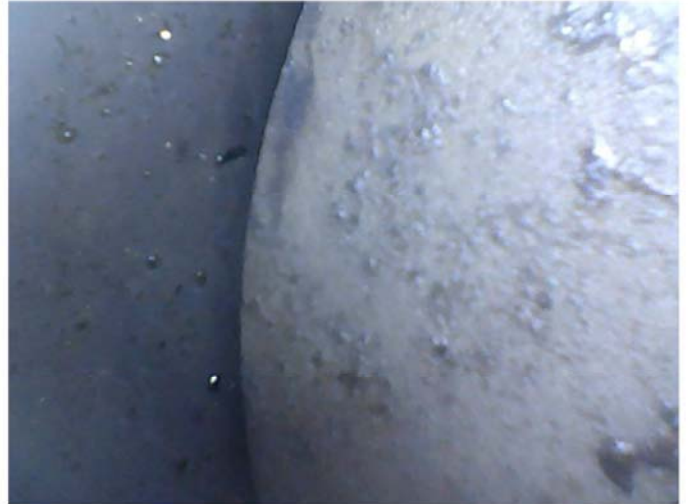
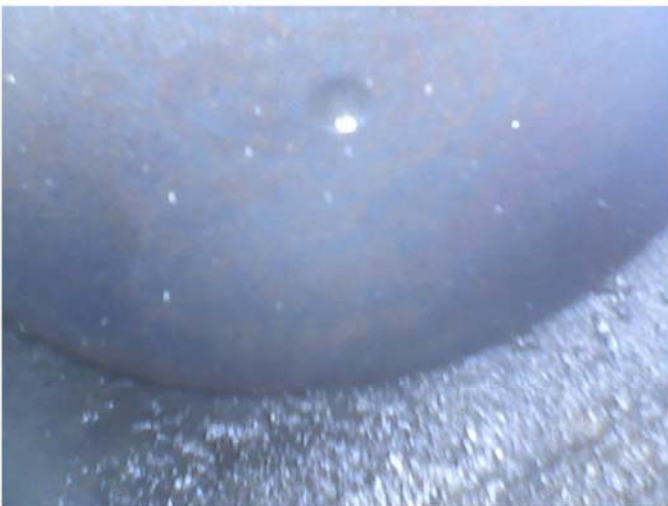
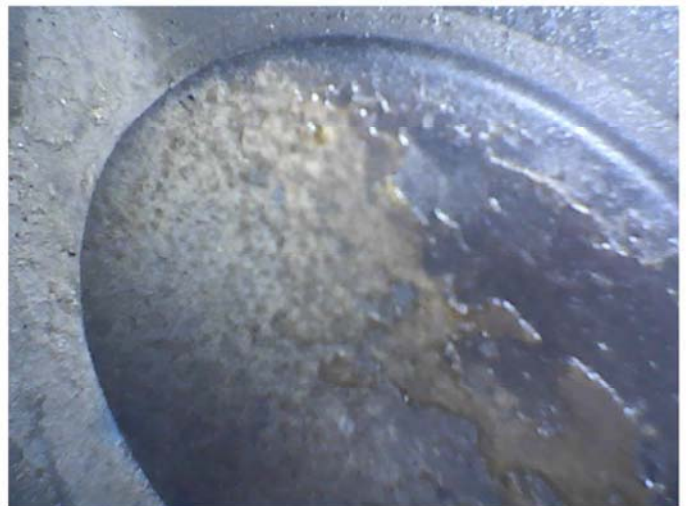
### CYLINDER #3

Condition: The cylinder remained attached to the crankcase with no external signs of operational distress. The rocker cover was removed and the valve springs remained intact. The cylinder was inspected and documented utilizing a lighted borescope. Oil was pooled at the bottom of the cylinder. The piston, valves, and valve seats were unremarkable.

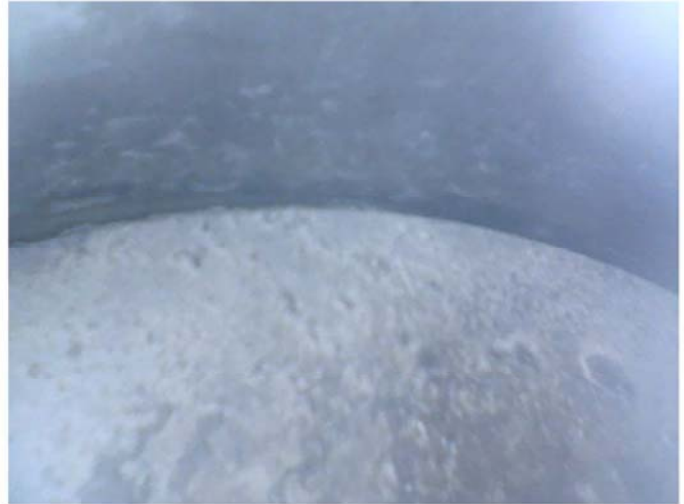
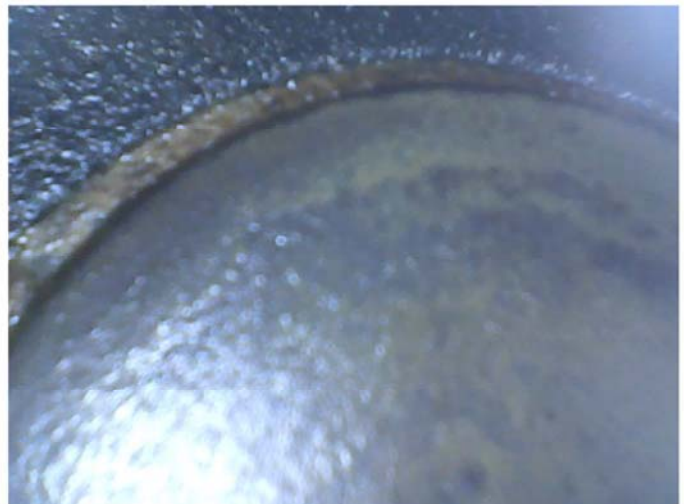
### CYLINDER #5

Condition: The cylinder remained attached to the crankcase with no external signs of operational distress. The rocker cover was removed and the valve springs remained intact. The cylinder was inspected and documented utilizing a lighted borescope. Oil was pooled at the bottom of the cylinder. The piston, valves, and valve seats were unremarkable.

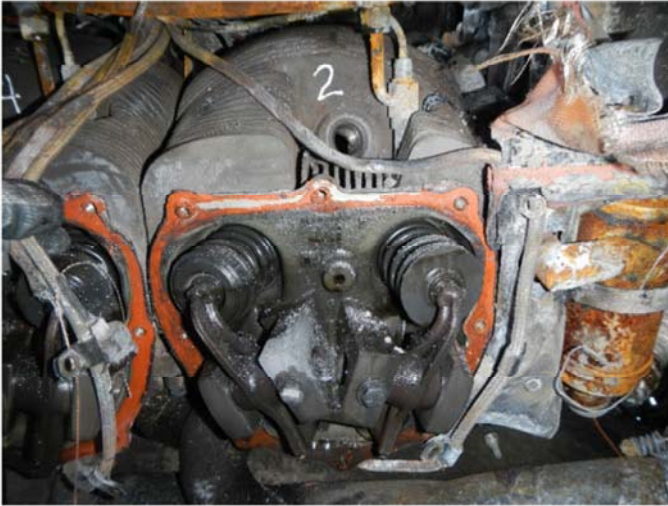
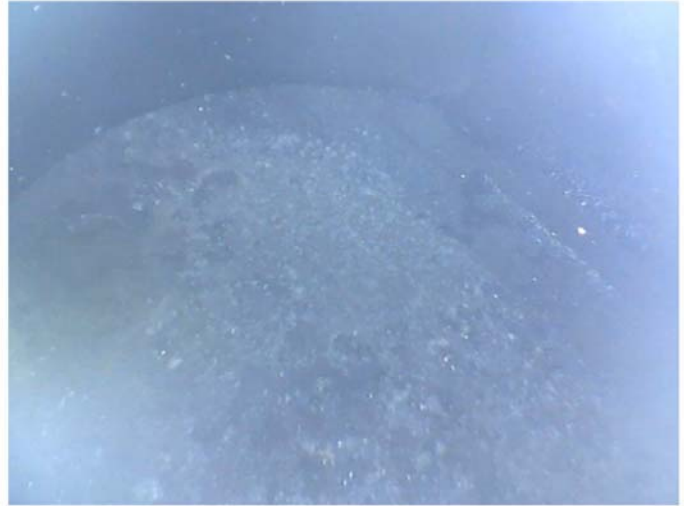
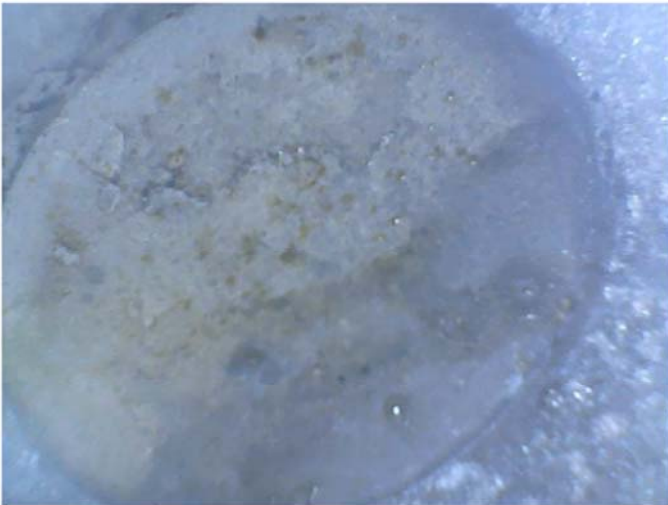
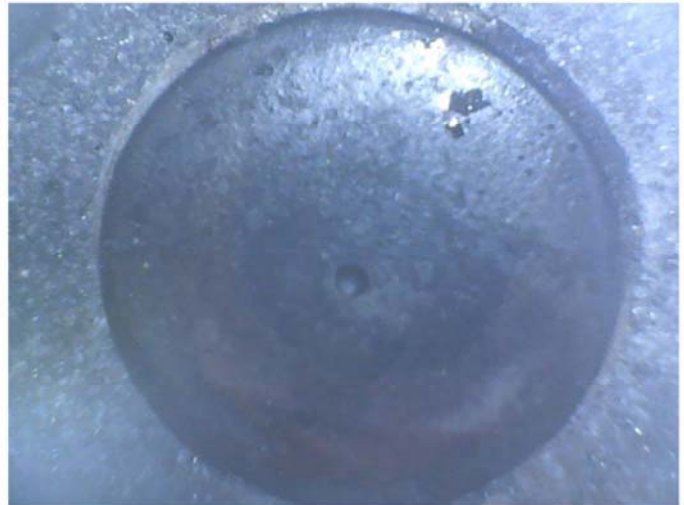
### CYLINDER #2

Condition: The cylinder remained attached to the crankcase with no external signs of operational distress. The rocker cover was removed and the valve springs remained intact. The cylinder was inspected and documented utilizing a lighted borescope. Oil was pooled at the bottom of the cylinder. The piston, valves, and valve seats were unremarkable.

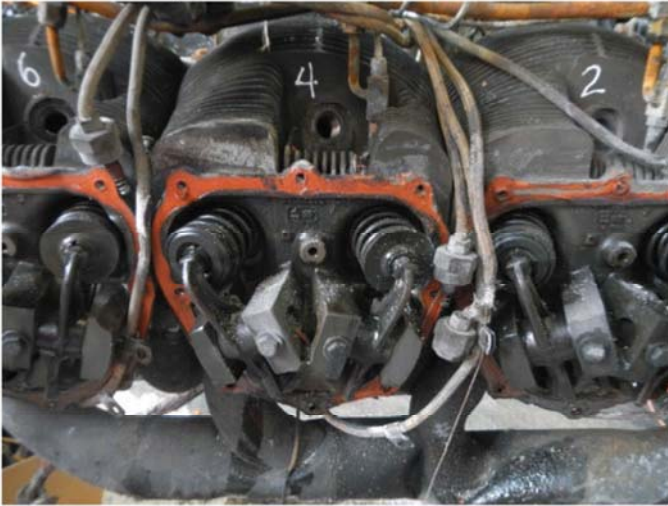
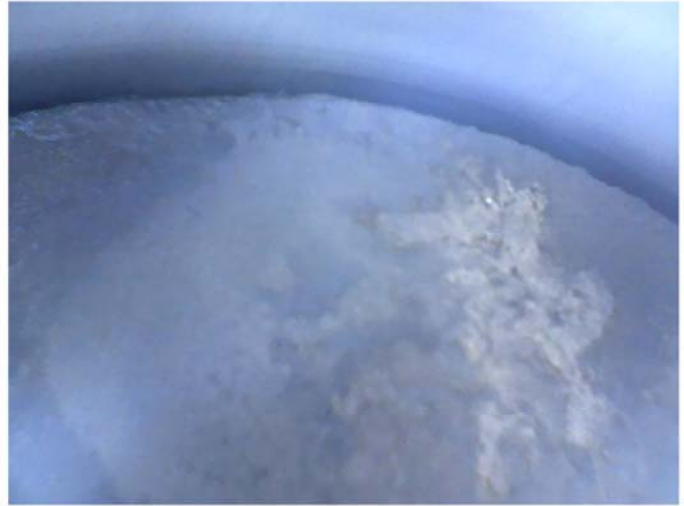
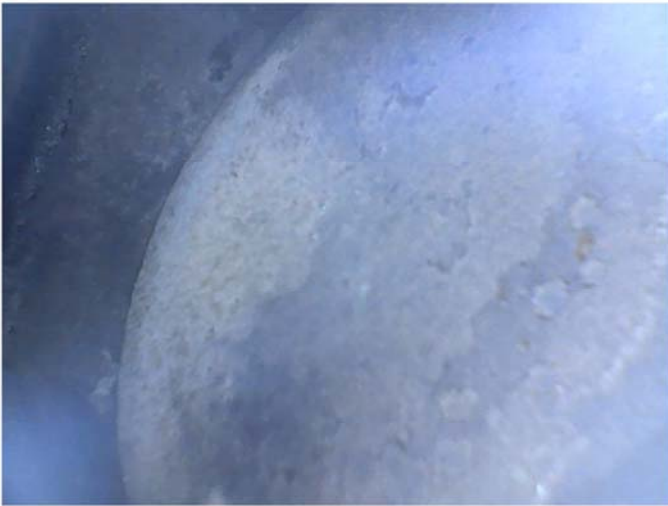
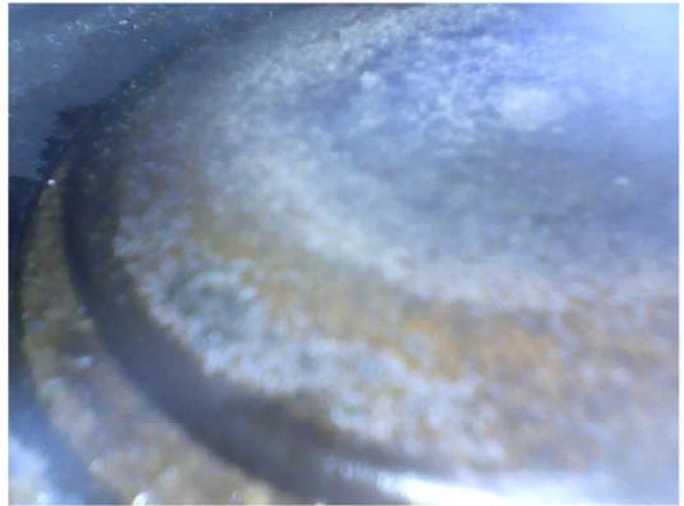
### CYLINDER #4

Condition: The cylinder remained attached to the crankcase with no external signs of operational distress. The rocker cover was removed and the valve springs remained intact. The cylinder was inspected and documented utilizing a lighted borescope. The piston, valves, and valve seats were unremarkable.

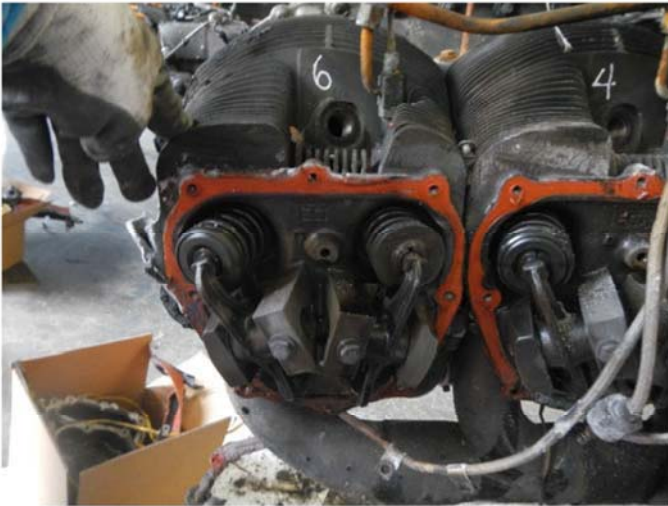
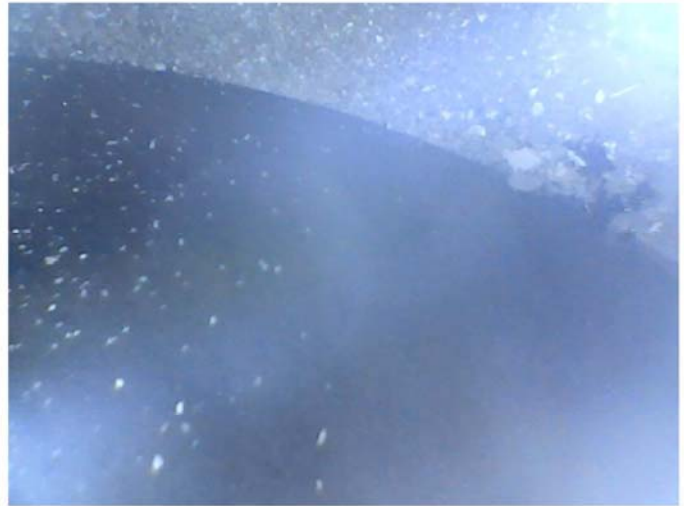
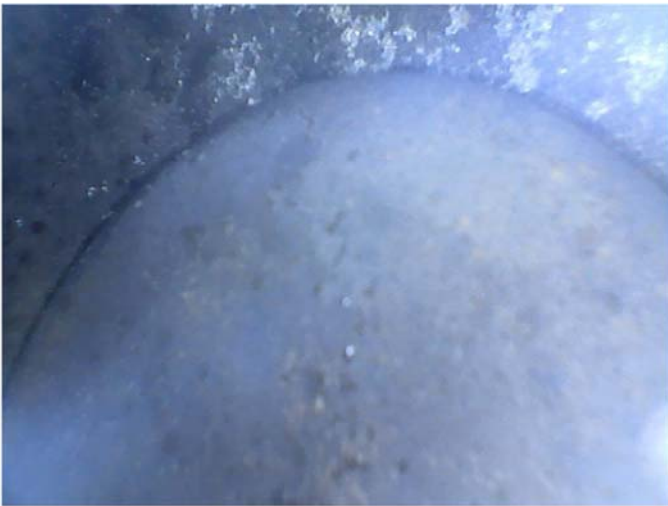
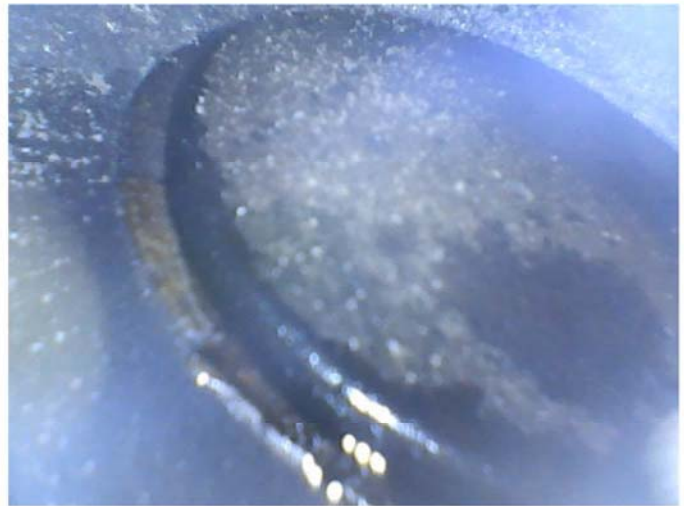
### CYLINDER #6

Condition: The cylinder remained attached to the crankcase with no external signs of operational distress. The rocker cover was removed and the valve springs remained intact. The cylinder was inspected and documented utilizing a lighted borescope. The piston, valves, and valve seats were unremarkable.

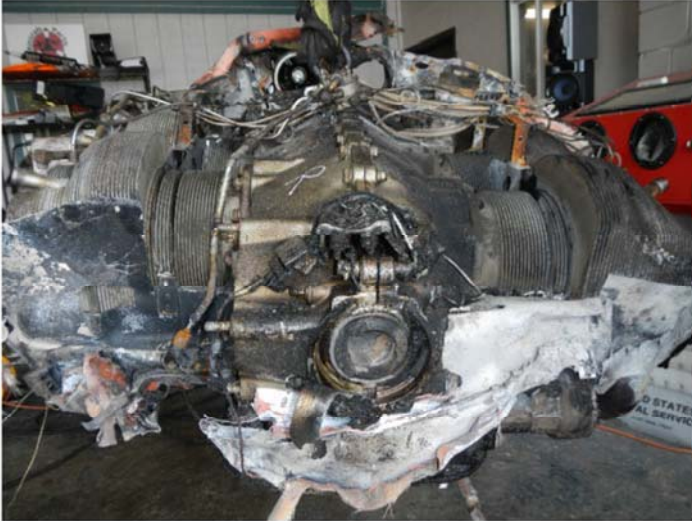
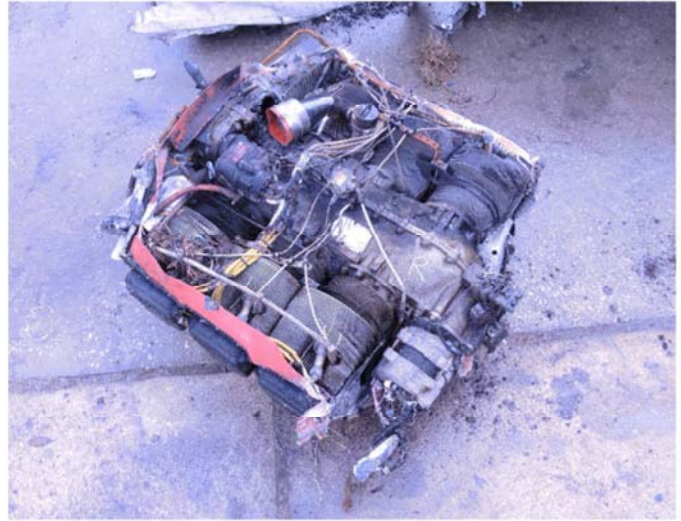
| Condition: | The crankcase remained intact with no signs of operational distress noted. | | | |

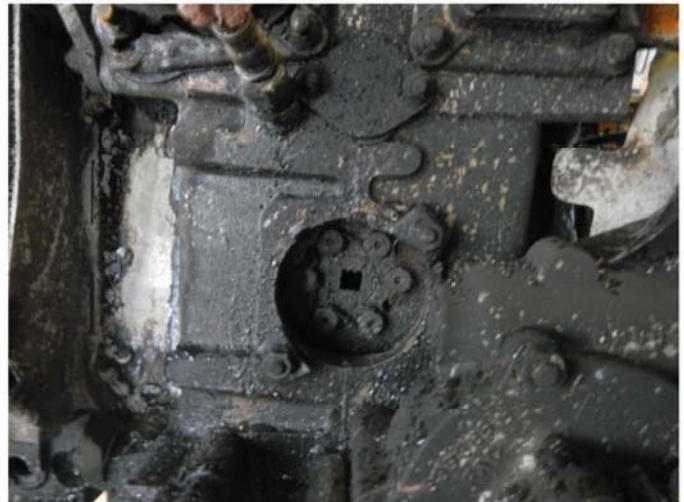
| Condition: | The propeller flange was separated from the crankshaft and the fracture surface displayed tearing, shear lips, and discoloration features consistent with overload. A tool was fitted to the backside of the crankshaft and partial rotation of the crankshaft was achieved with crankshaft continuity confirmed to the front of the engine and out to the connecting rods. Impingements on the crankshaft and camshaft were noted at the front of the crankcase and the oil sump respectively which prevented full crankshaft rotation. | | |

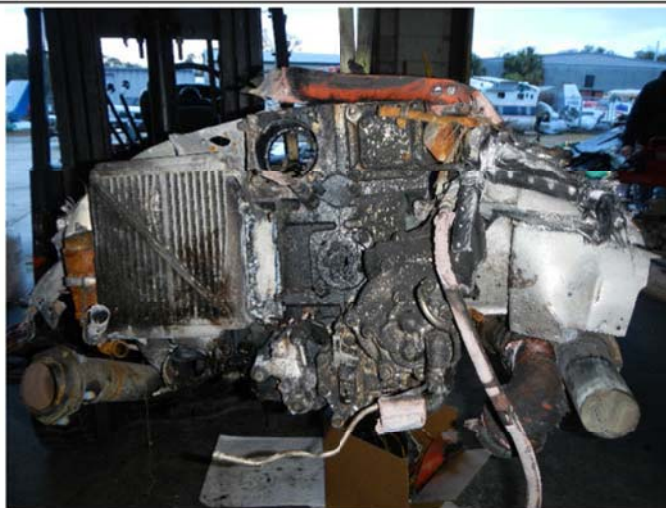
**STARTER  
ADAPTER**

The starter adapter remained attached to the backside of the engine but it was fractured at the motor flange. The scavenge pump remained in place on the adapter. No pre-accident anomalies were noted.

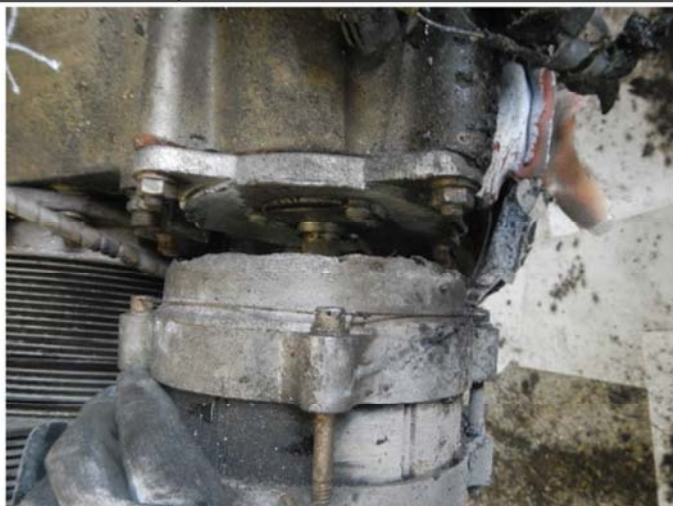
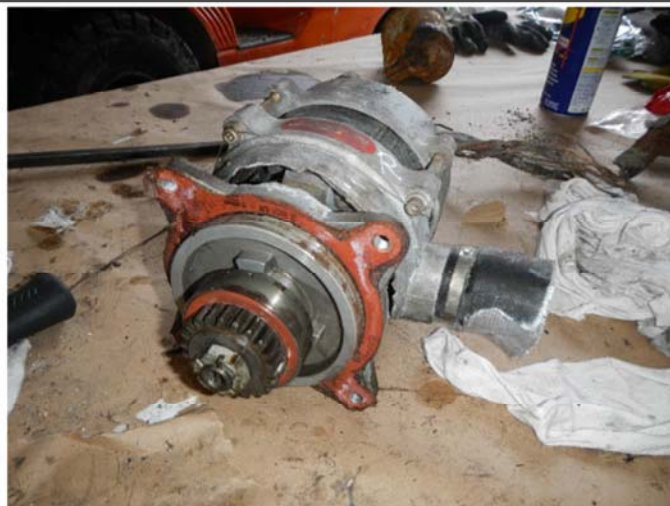
## ALTERNATOR

Condition: The alternator remained attached to the front right side of the engine; however, the alternator housing was fractured and the alternator was displaced from its mounting flange. The alternator was removed and the drive coupling remained intact with no pre-accident anomalies were noted with the unit.

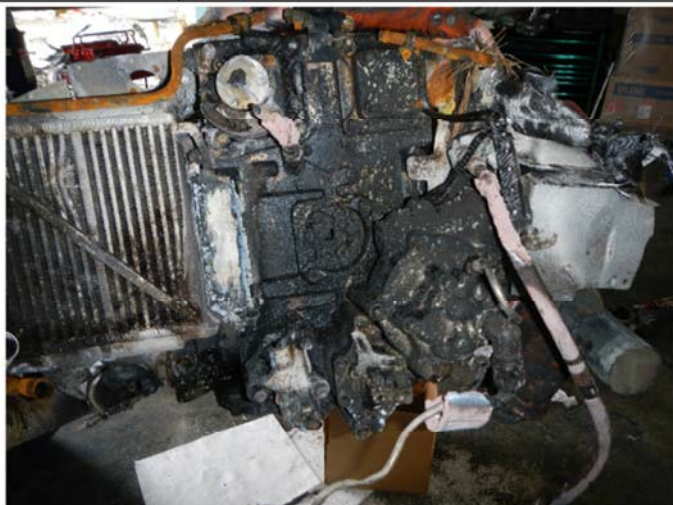
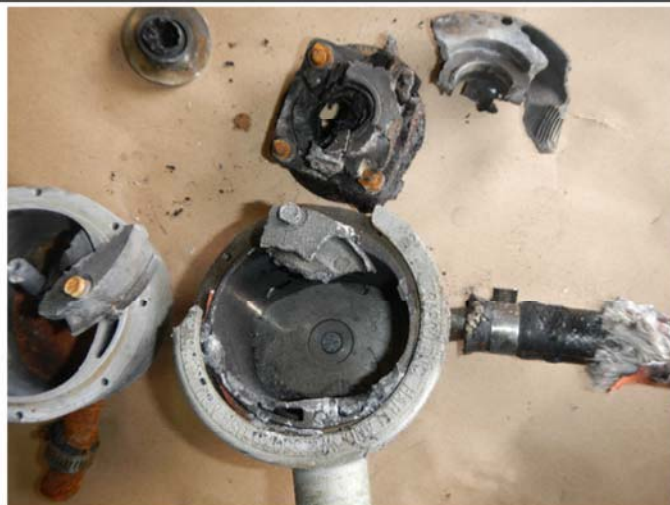
## VACUUM PUMP

Condition: The vacuum pump was separated from the backside of the engine and fragments were noted in the wreckage. The vacuum pump drive coupling was thermally damaged and remained with the engine accessory pad. The pump housing, rotors, and vanes were fractured (the photo on the right shows the burnt remains of the drive coupling and mount).

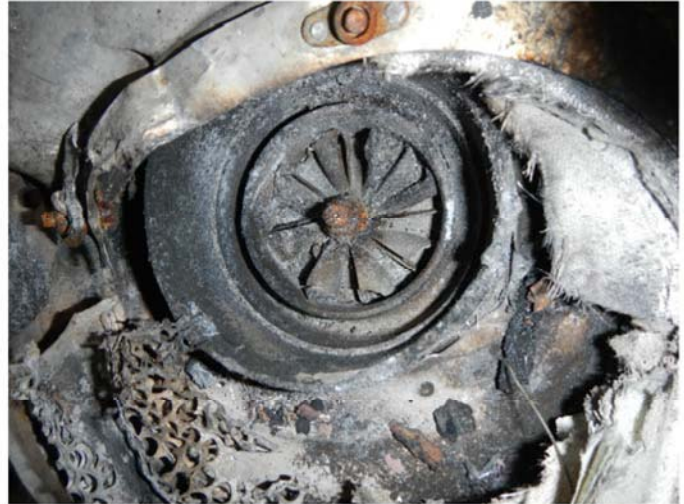
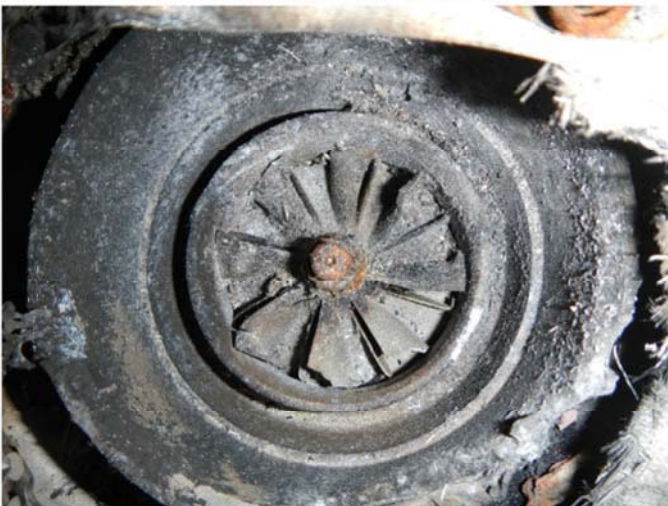
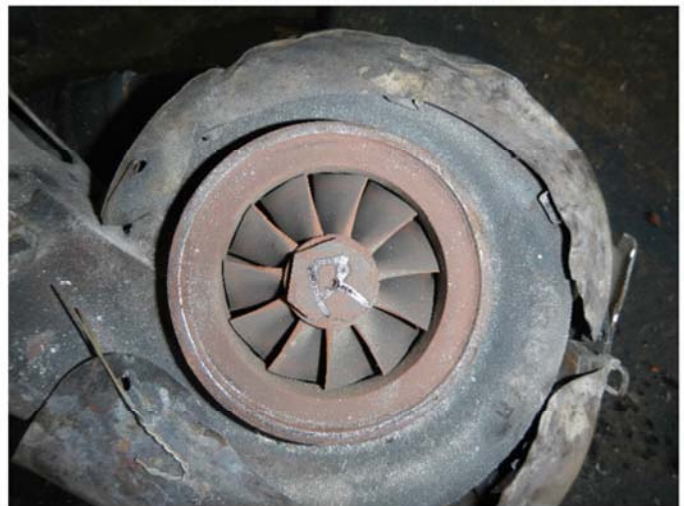
## TURBO

The turbocharger remained with the right nacelle area. The intake filter was burned and the ash was found in the inlet area. The intake impeller blades displayed deformation damage and curling opposite the direction of normal rotation. The turbocharger turbine wheel/blades remained intact.
