# Continental Motors

## ENGINE EXAMINATION REPORT

| ENGINE MODEL | TSIO-520-NB1A |
| FILE NUMBER | 17-361 |

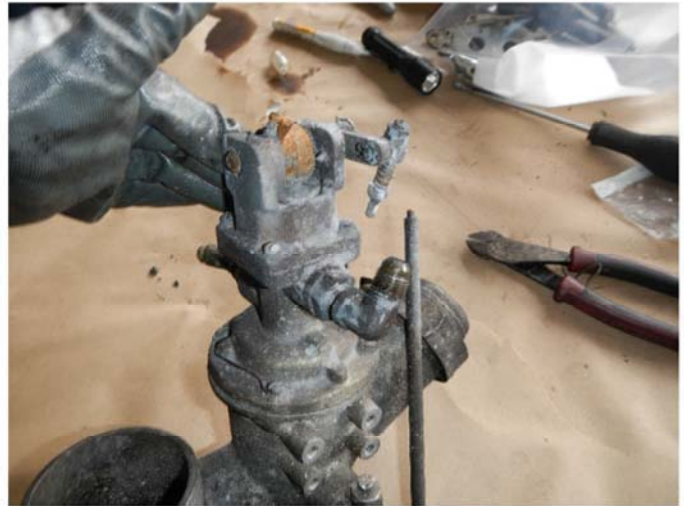
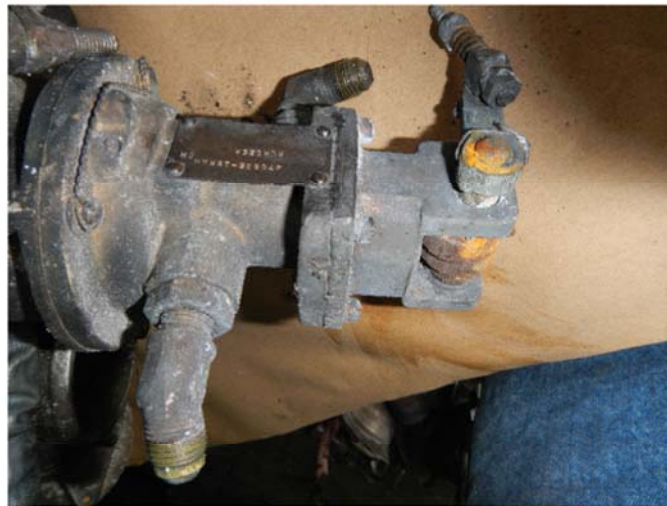
### TURBO CONTROLLER

The turbo wastegate controller was thermally damaged and separated from the engine, but it remained attached to the throttle body which was attached to the nacelle.

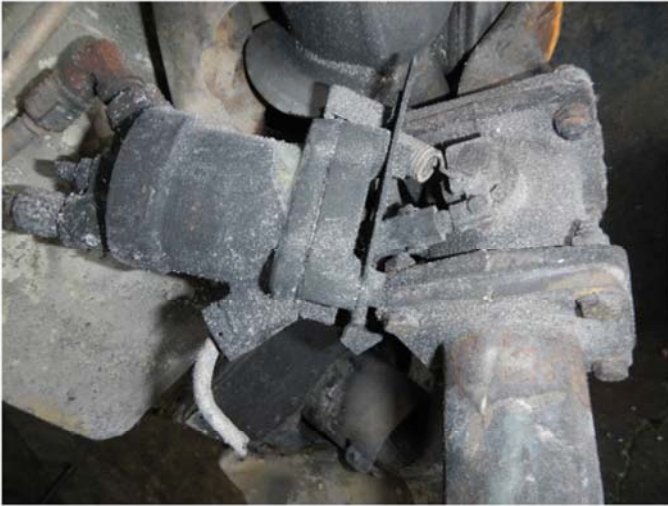
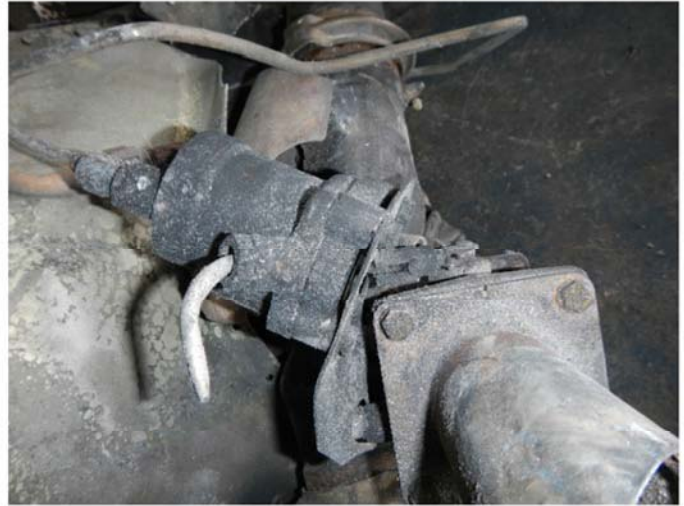
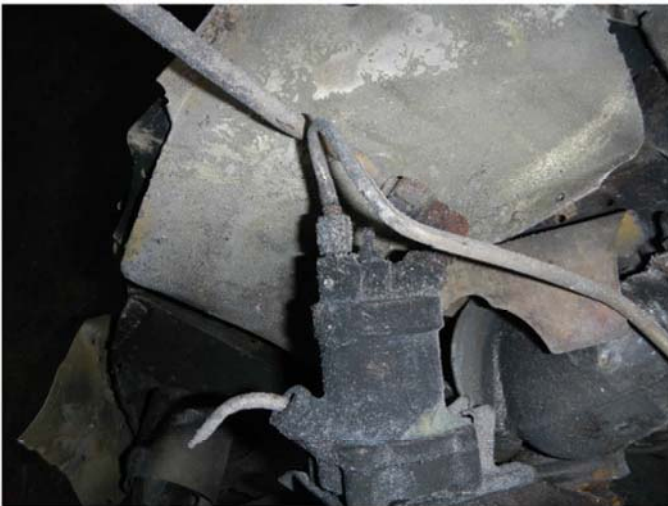
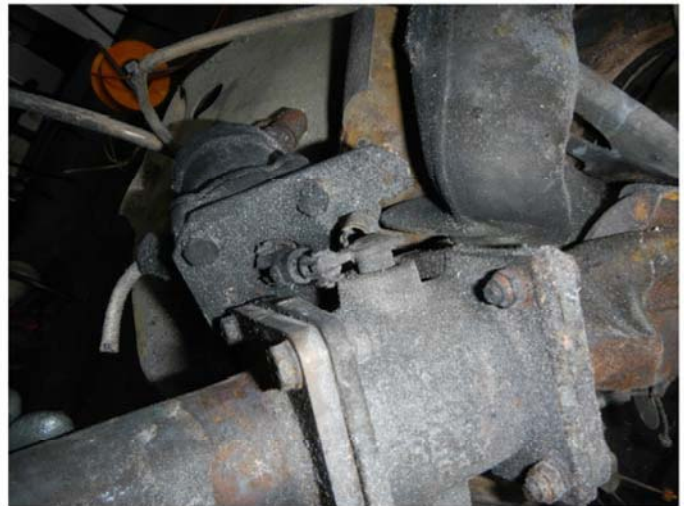
## WASTEGATE

The waste gate actuator linkage remained intact and attached to the wastegate, though deformation and thermal damage were extensive. The oil lines to and from the wastegate actuator remained in place.

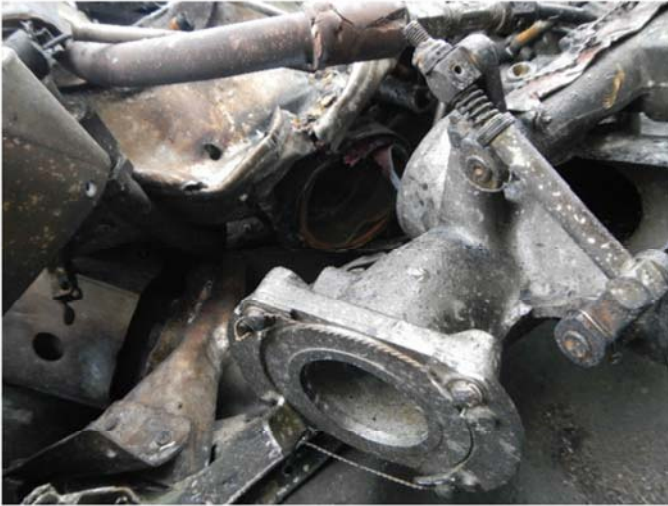
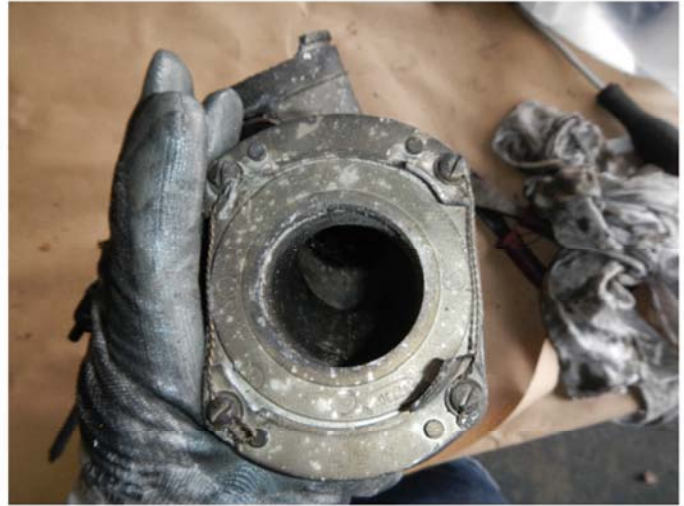
### OVERBOOST VALVE

The overboost valve was thermally damaged and separated from the induction system. Remnants of two overboost valves were identified in the wreckage and the bottom photograph displays those components.

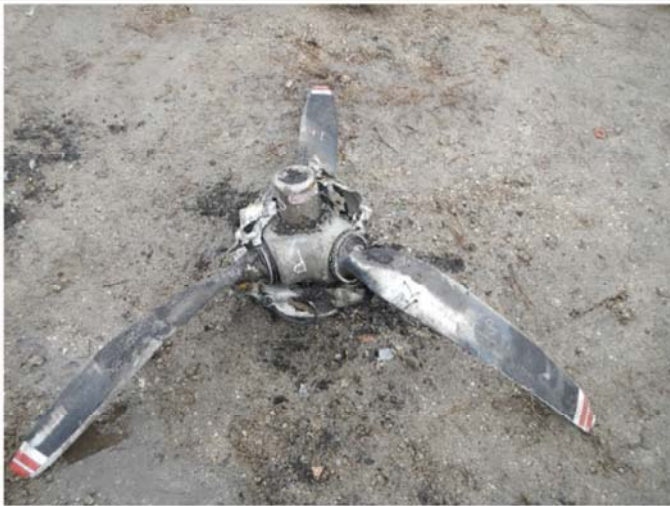
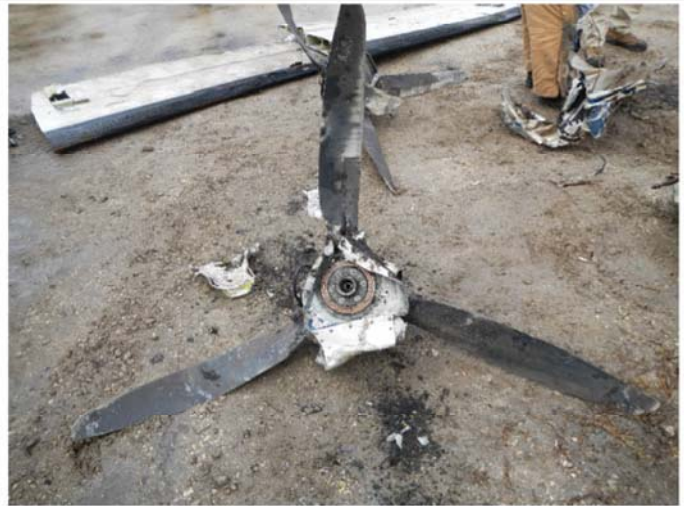
| <b>PROPELLER GOVERNOR</b> | Manufacturer: Not Recorded | P/N: Not Recorded | S/N: Not Recorded |
|---|---|---|---|
| Condition: | The propeller remained attached to the propeller flange, which was separated from the crankshaft at the engine nose seal. The propeller hub remained intact and the spinner dome was crushed aft over the hub. All three blades remained attached to the hub, but they were free to rotate, indicative of a pitch change link fractures. The blades were labeled 1, 2, and 3 according to their hub location. Blade 1 was missing its counterweight and was bent aft slightly. The leading edge displayed some light gouging and the cambered and face sides displayed chord-wise scrapes and paint erosion. Blade 2 displayed a small twist toward low pitch, paint erosion on the cambered side and light leading edge gouges. Blade 3 was missing its counterweight. The blade displayed light chord-wise paint erosion aft of the deice boot, but was otherwise unremarkable. | | |
