## Air Safety Investigations Aircraft Incident/Accident Technical Report

| <b>Aircraft Incident/<br/>Accident Information</b> | Year: 1973 | Make: Cessna | Model: 340 |
| Senior Air Safety Investigator: Andrew L. Hall | | Report #: ASI-18-AB-T | Report date: 10-24-18 |

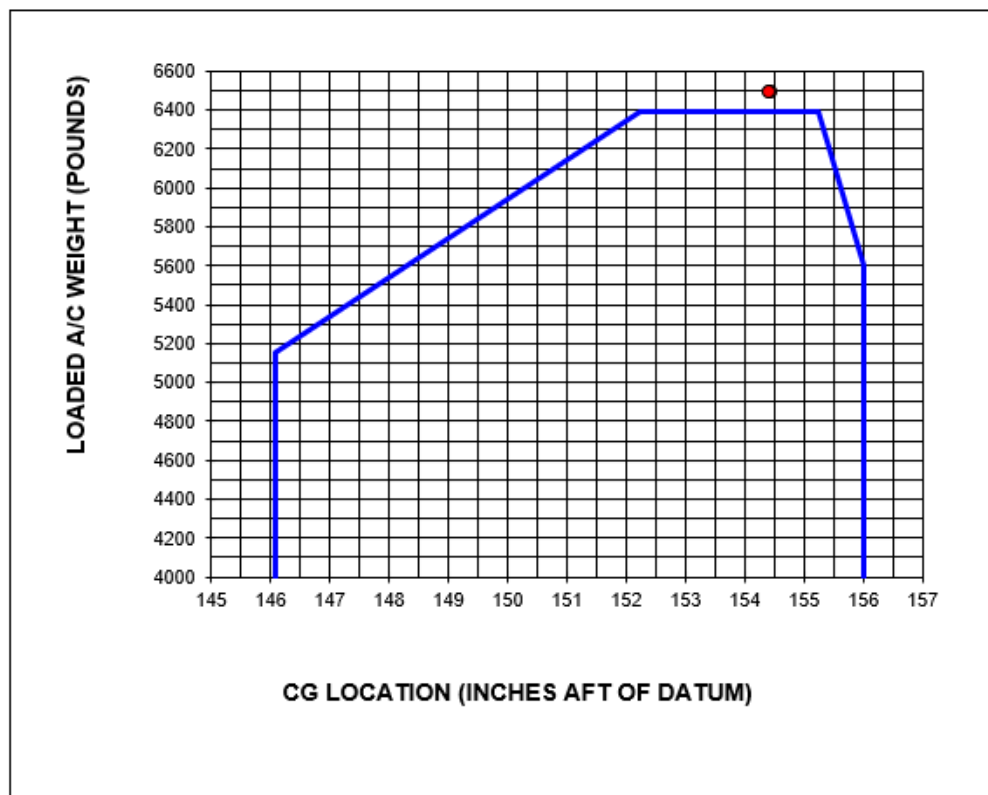
Figure 3 – Center of Gravity Moment Envelope

The airplane maximum gross takeoff weight when delivered from Cessna was 5,975 lbs. An STC was accomplished which increased the maximum gross takeoff weight to 6,390 lbs and the calculated weight during the accident takeoff was about 6,495 lbs. Based on the calculated weight the airplane was 154.4 lbs over new maximum gross weight at the time of takeoff (figure 2) or 520 lbs over the Cessna gross weight. Due to the excessive weight, the airplane was outside of center of gravity moment envelope (figure 3).
