## **NATIONAL TRANSPORTATION SAFETY BOARD**

### **Weather Study**

# **METEOROLOGY**

CEN18FA063

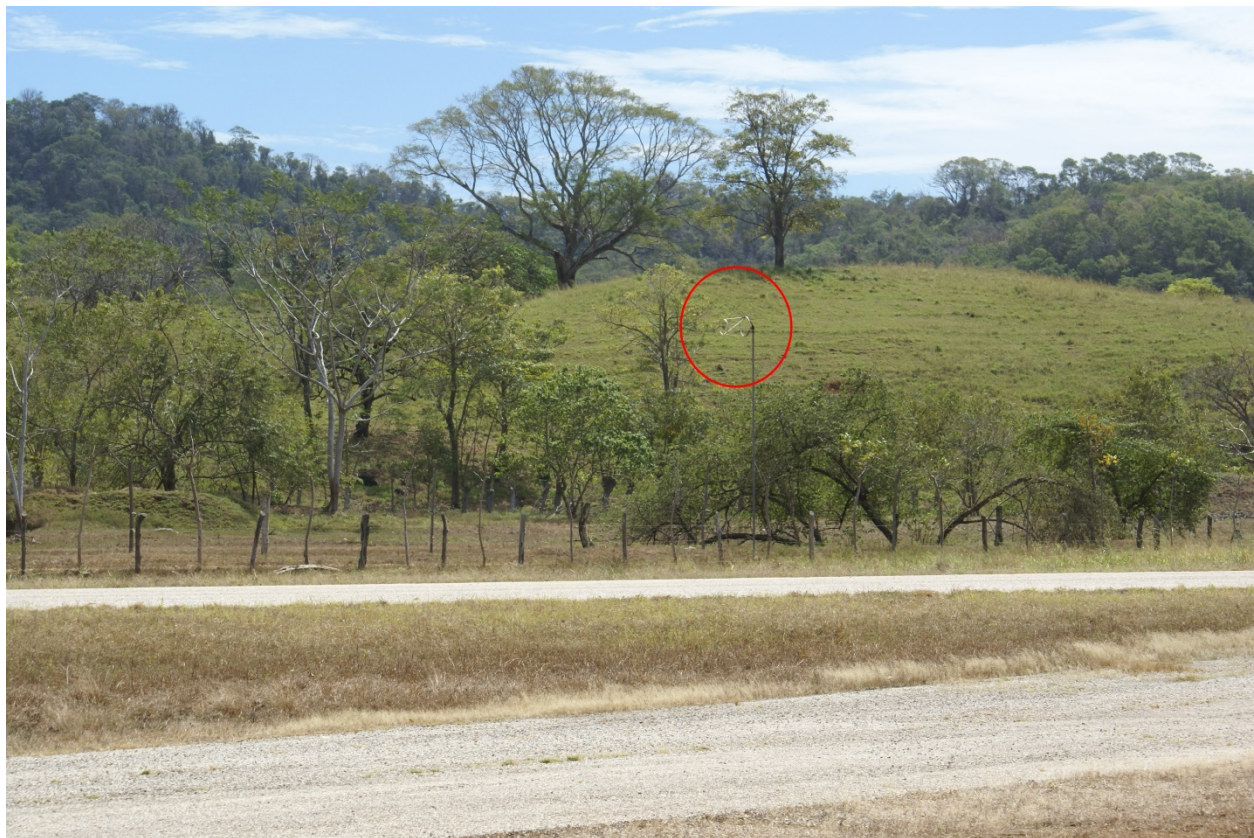
MRIA was equipped with structures to accommodate windsocks. There was one windsock structure at each end of the airstrip's runway pavement. However, investigators believe that at the time of the accident, neither structure was fitted with a windsock.

The following image (figure 8) was taken by Costa Rican investigators the day after the accident and shows the windsock structure located at the departure end of runway 03 at MRIA.

**Figure 8** – Windsock structure at departure end of runway 03 at MRIA with missing windsock on the day following the accident.

With regard to the MRIA missing windsocks and any protocol for monitoring the status of windsocks at Costa Rican airfields, on October 23, 2018, the Dirección General de Aeronáutica Civil (DGAC) in Costa Rica stated to the NTSB (Attachment 3): “The situation of the wind socks [at MRIA] was corrected, both are already one in each runway head and in the place that was recommended. And with respect to a formal monitoring protocol for local aerodromes, nothing has changed. There is no procedure or protocol on the part of the DGAC Authority, nor on the part of the operators.”

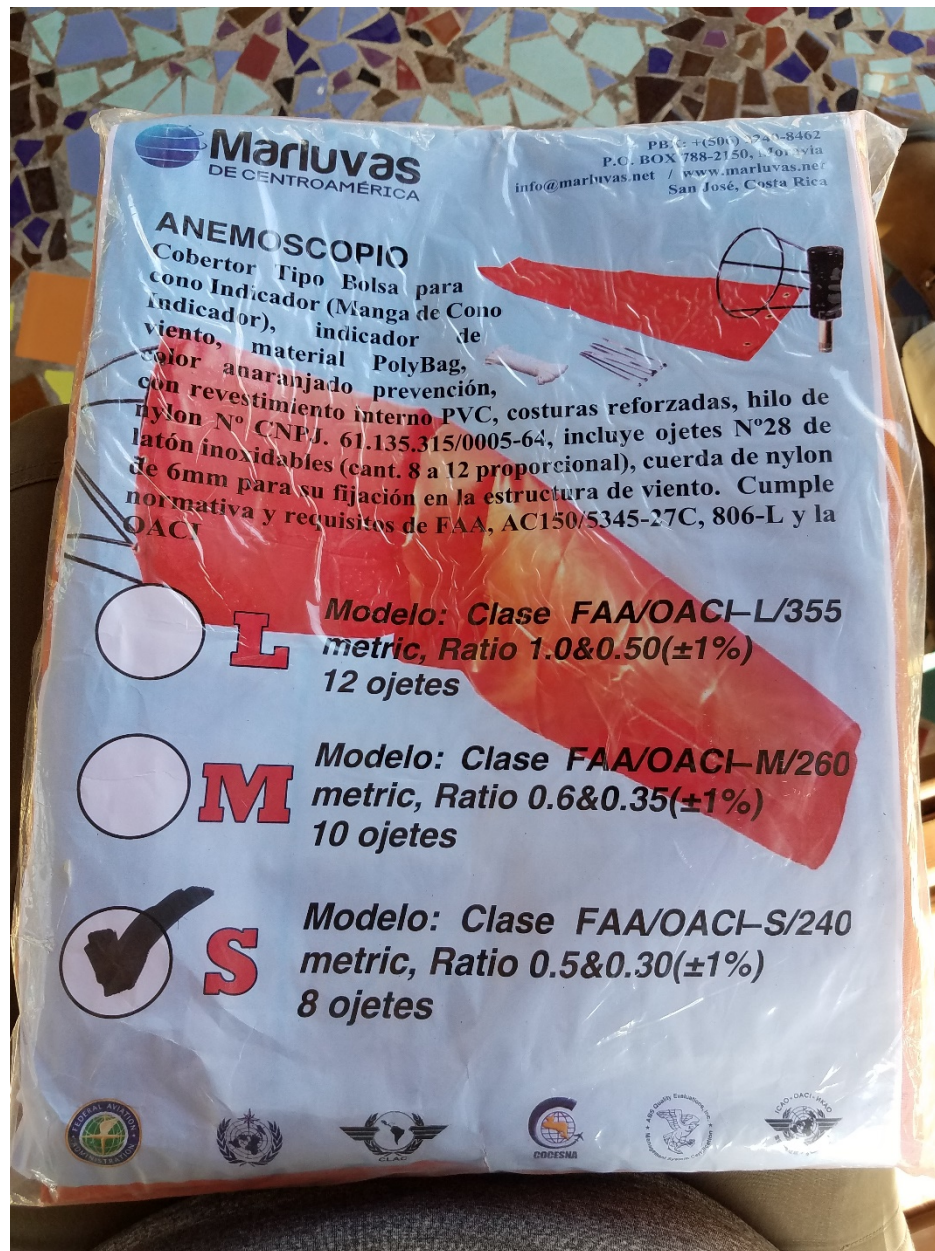
On January 6, 2018, NTSB investigators visited MRJA and noted that the windsock structure located at the arrival end of runway 03 at MRJA was also missing a windsock, and it appeared that the windsock had blown into a tree located adjacent to the windsock structure.

**Figure 9** – Type of windsocks used at MRJA.
