**NATIONAL TRANSPORTATION SAFETY BOARD**  
Office of Research and Engineering  
Washington, D.C. 20594

## **Video Study**

**NTSB Case Number:  
CEN18FA063**

Location: Punta Islita, Costa Rica  
Date: December 31, 2017  
Time: 1756 UTC  
Airplane: Cessna 208B

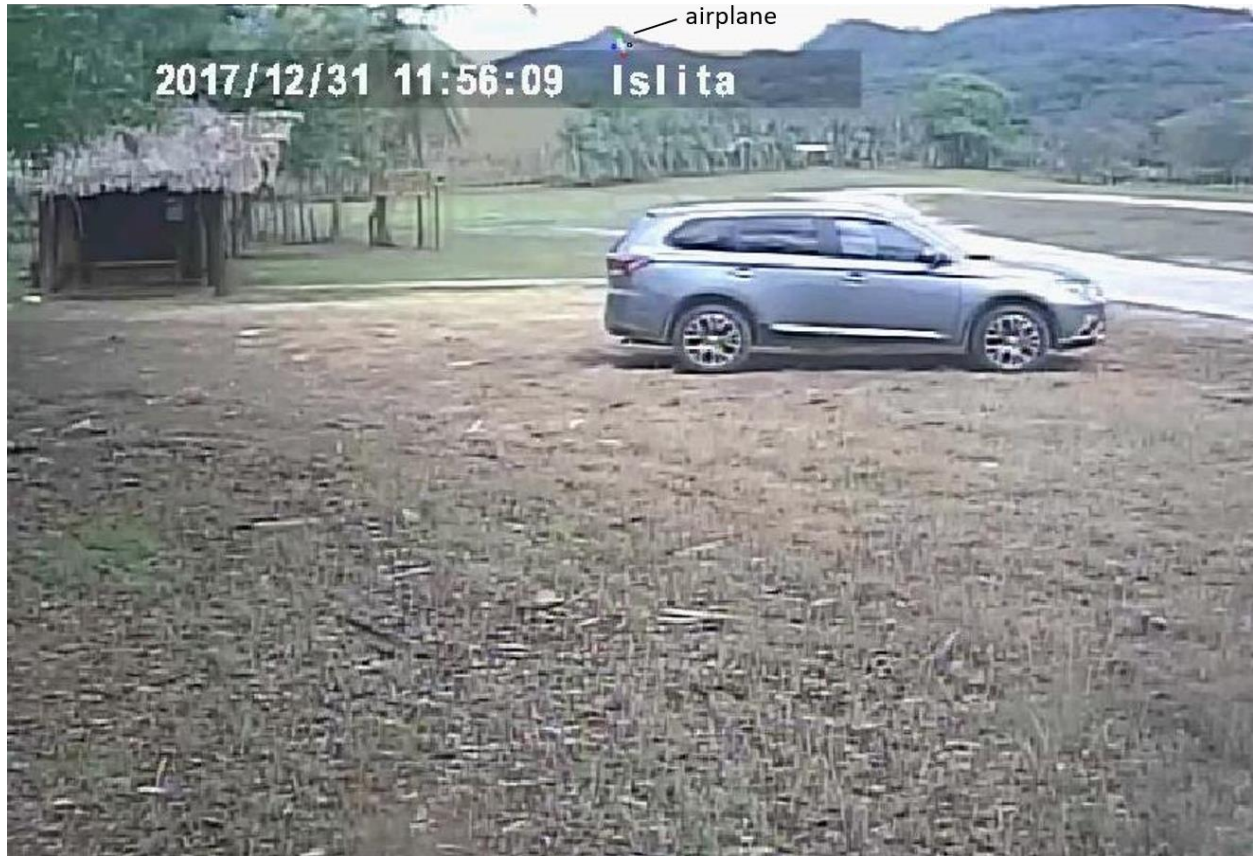
**Figure 3. Video Frame Showing Superimposed Airplane Reference Points**

Figure 3 shows a frame from the video that was used for airplane trajectory estimation. It shows the four reference points superimposed on the image of the airplane. The green reference point closest to the top margin of the video frame is the right wing tip. This video frame corresponds to trajectory point No. 5 marked in the plots below.

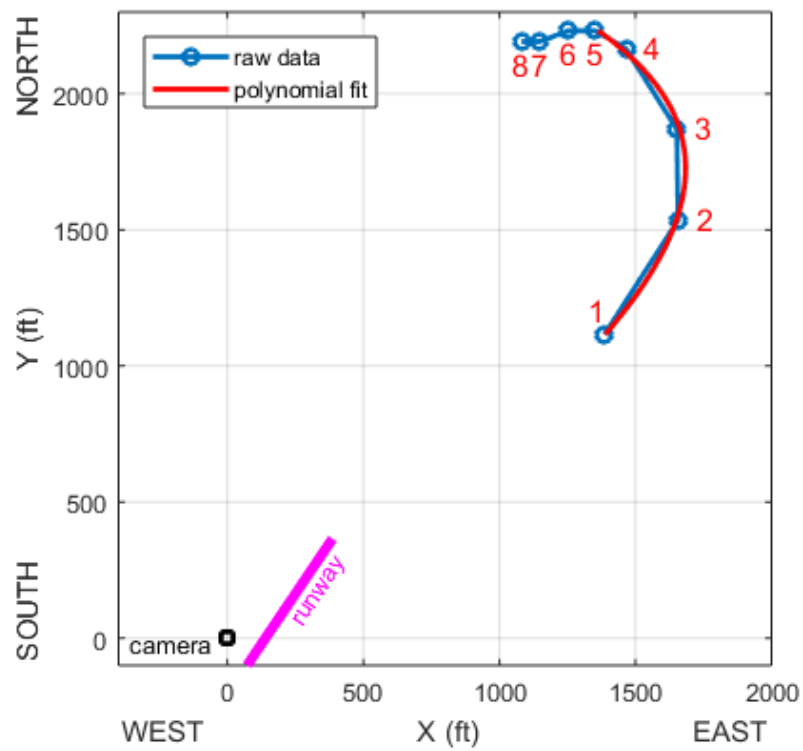
**Figure 4. Estimated Ground Track of the Airplane**

Airplane location and orientation were estimated at eight times, corresponding to eight frames from the video. The time of the first analyzed frame was set to zero. The time of the last analyzed frame was 13.4 seconds. Figure 4 shows the estimated ground track of the airplane. A fourth order polynomial was fitted to the first five raw data points and is shown in red. It provides continuous estimates of the trajectory during the first 11.3 seconds of analysis (up to point No. 5).

The estimated airplane ground speed during the 11.3 seconds long time period corresponding to the polynomial fit was  $68 \pm 3$  knots. It was computed along the fitted continuous ground track. The estimated speed during the last two seconds of analyzed flight, when the airplane was descending, was  $82 \pm 4$  knots.

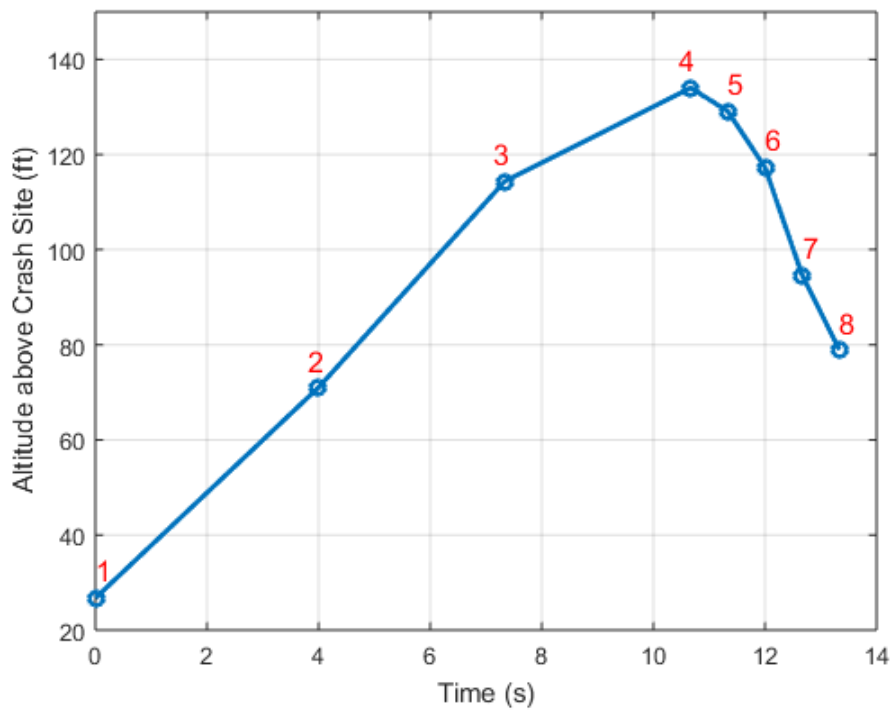
**Figure 5. Estimated Airplane Altitude above the Crash Site**

Figure 5 shows the estimated altitude of the airplane above the crash site. The crash site elevation is about 140 feet higher than the elevation at the northern end of the runway. Therefore, estimated airplane altitude above the runway is about 140 feet higher than the altitude shown in Figure 6. Figure 6 shows a climb rate of approximately 715 feet/minute during the first 7 seconds and a descent rate of approximately 1510 feet/minute during the last two analyzed seconds.

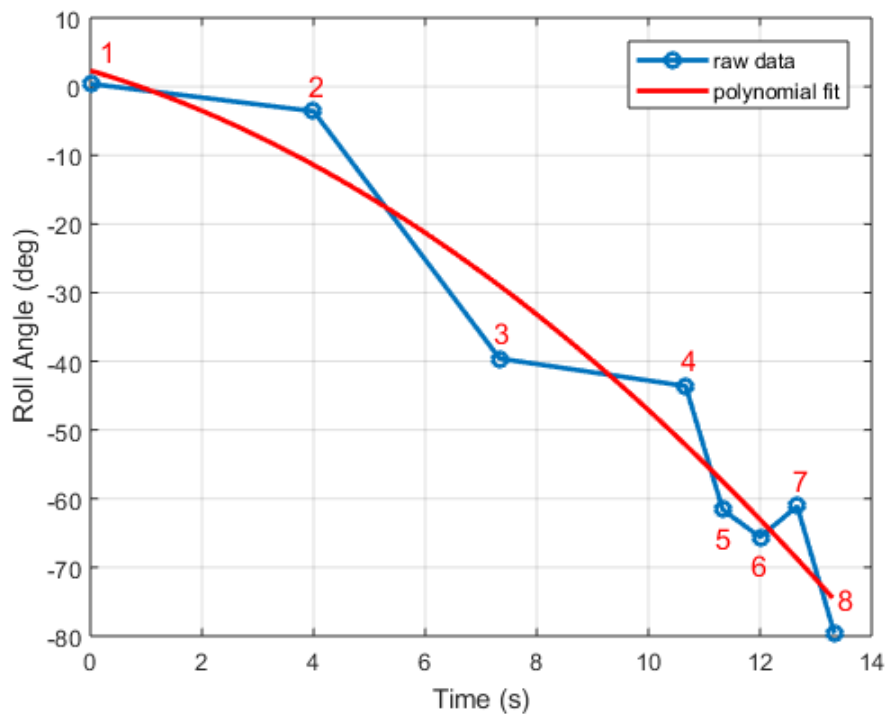
**Figure 6. Estimated Roll Angle of the Airplane (negative is right wing up)**

Figure 6 shows the estimated roll angle of the airplane. The red line is a second order polynomial fit to the raw data. The relatively large deviations of the raw data points from the polynomial fit are indicative of the relatively large roll angle estimation errors caused by the small image of the airplane in the video frames (see Figure 3). The polynomial fit filters out these errors and is a continuous and relatively accurate roll angle estimate.
