## **NATIONAL TRANSPORTATION SAFETY BOARD**

### **Aircraft Performance Study**

CEN18FA063

Location: Corozalito, Costa Rica  
Date: December 31, 2017  
Time: 1156 central standard time (1756 UTC)<sup>1</sup>  
Airplane: Cessna 208B-0900; TI-BEI

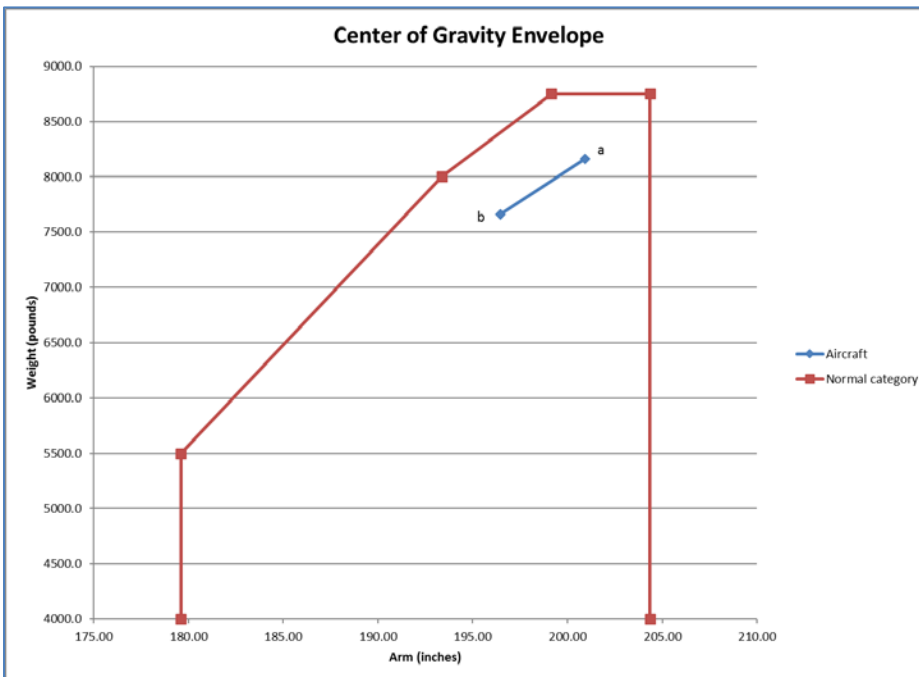
Figure 4-Minimum fuel center of gravity envelope

Since the takeoff fuel load could not be determined, two sets of calculations were performed. First were calculations assuming the airplane had the minimum required fuel to complete the flight (500 lbs). This yielded a loaded weight of 8,163 pounds and the airplane would have been within the weight and balance envelope. Second was a calculation assuming that the airplane had the maximum fuel load that remained within the manufacturer established weight and balance envelope. This yielded a fuel load of 931 lbs, a loaded weight of 8,594 pounds, and the airplane would have been within the weight

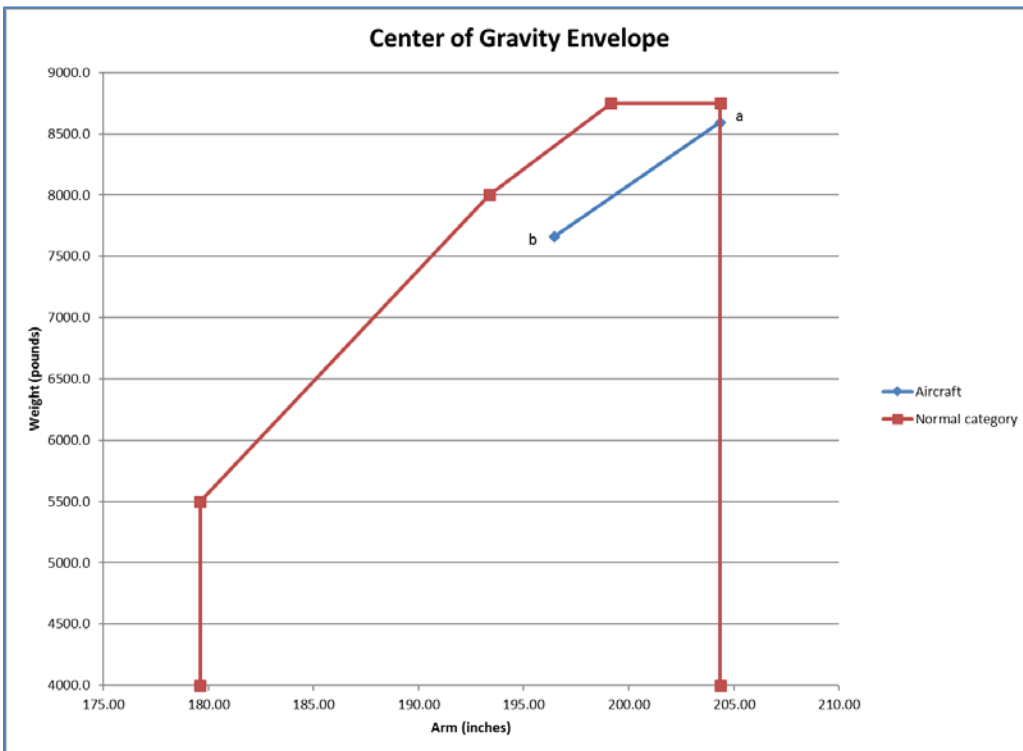
*Figure 6-Maximum fuel center of gravity envelope*

and balance envelope but at the aft end of the envelope. The maximum ramp weight of the airplane was specified as 8,785 pounds and the maximum takeoff weight was specified as 8,750 pounds.

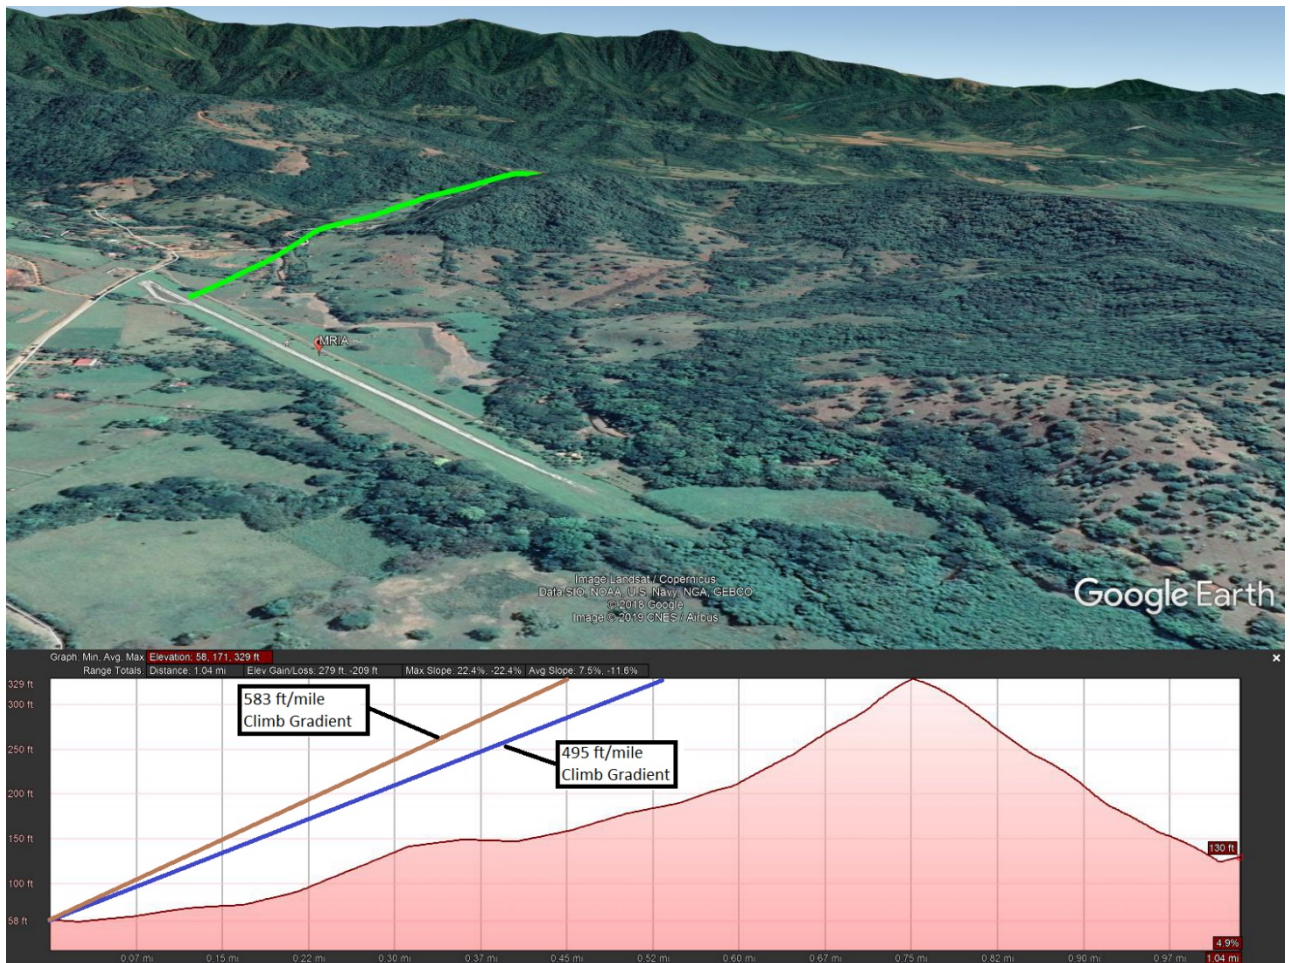
Figure 8-Successful flight path of previous airplane

Elevation profiles were created using Google Earth for the successful path used by the previous airplane and two other possible paths to the north of MRJA. The minimum and maximum airplane climb gradients calculated previously were plotted on the elevation profiles and are shown below. The critical elevation point for the successful path taken by the previous airplane was about 265 ft. above

the airport elevation and 0.75 statute miles from the airport requiring a minimum climb gradient of 353 ft/mile.

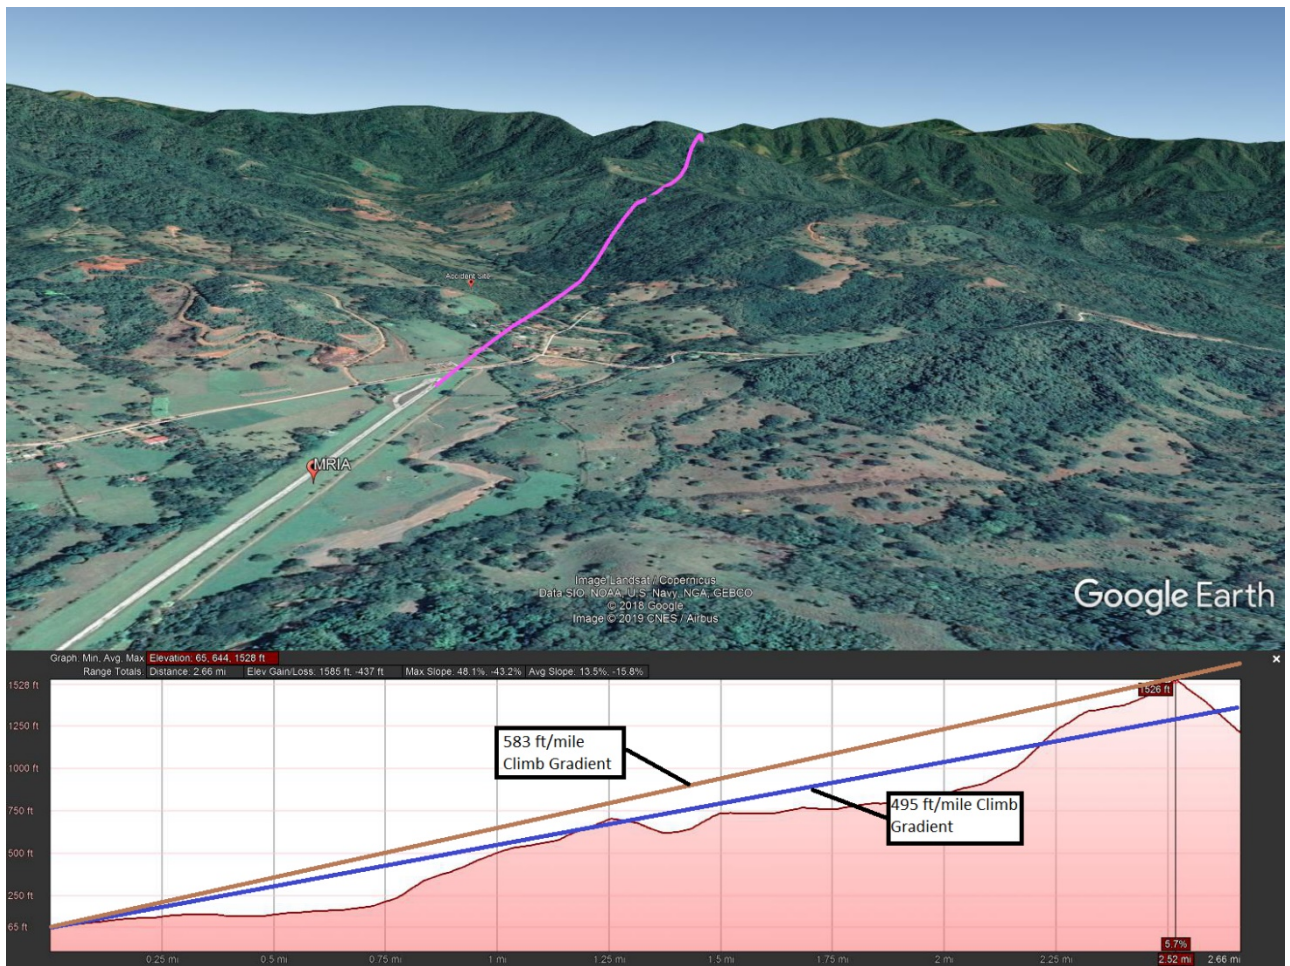
Figure 9-Straight-out departure maintaining runway heading

The second path examined was a straight-out departure maintaining runway heading. For this path, the critical elevation was about 1,454 ft above airport elevation at 2.52 statute miles from the airport requiring a minimum climb gradient of 577 ft/mile.

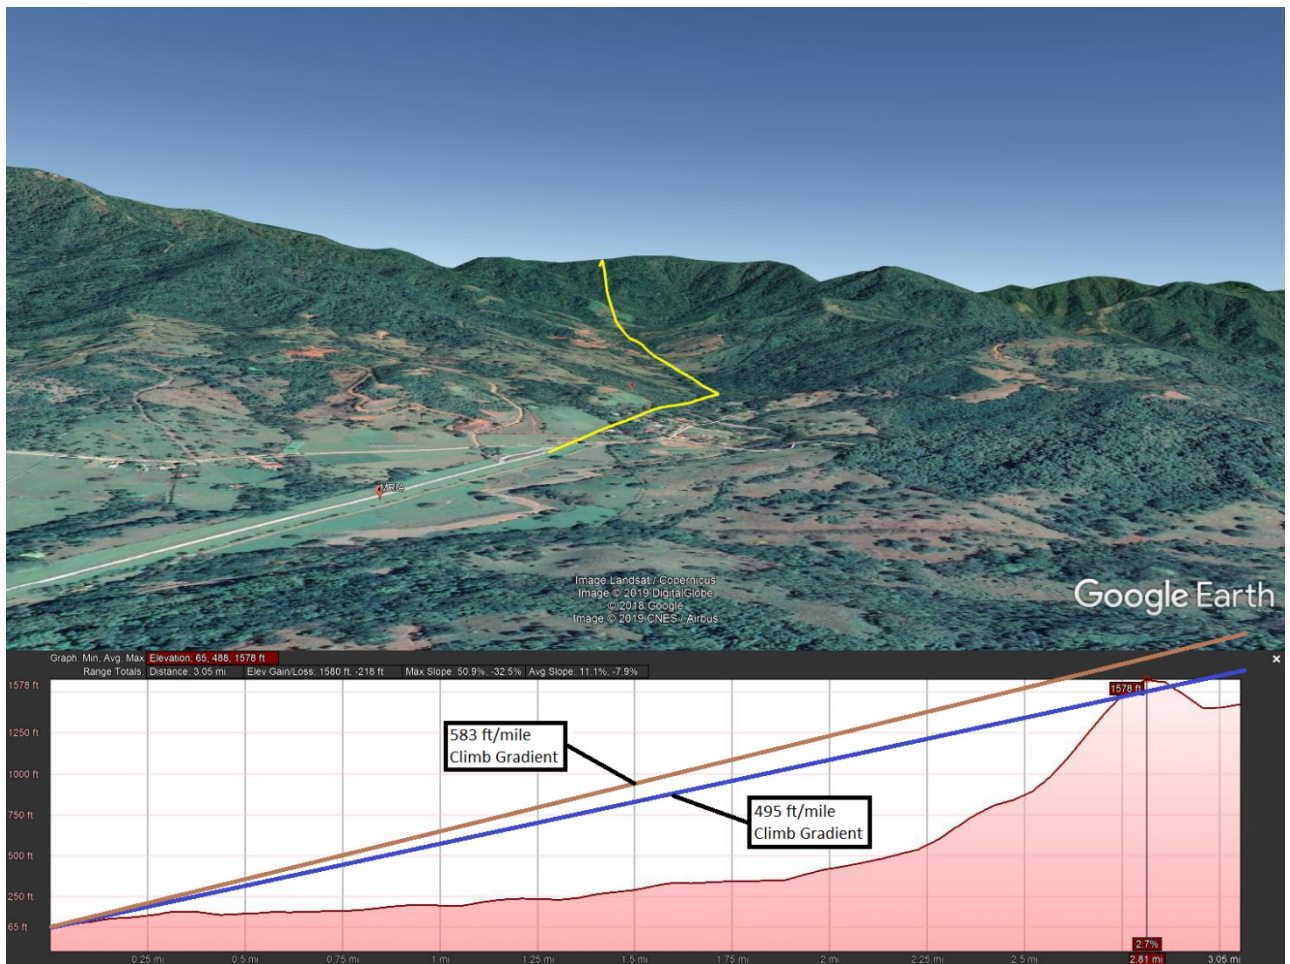
Figure 10-Path following valley floor

The final path examined was a path that turned to the left and approximately followed the valley floor. The critical elevation for this path was about 1,510 ft above the airport elevation at 2.82 statute miles from the airport requiring a minimum climb gradient of 535 ft/mile.
