# NATIONAL TRANSPORTATION SAFETY BOARD

## MATERIALS LABORATORY FACTUAL REPORT

Report No. 18-102

Place : Sauk Centre, MN  
Date : 1/24/2018  
Vehicle : Wittman W-10  
NTSB No. : CEN18FA083  
Investigator : Alexander Lemishko

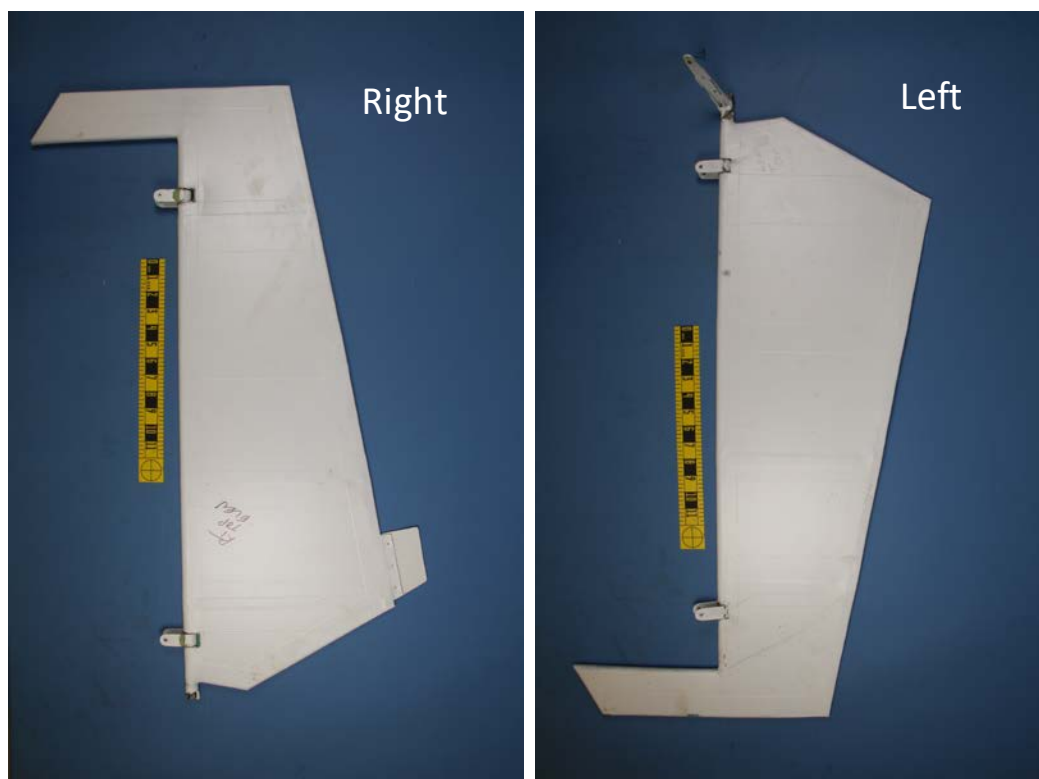
Figure 1: Right and left elevators as received.

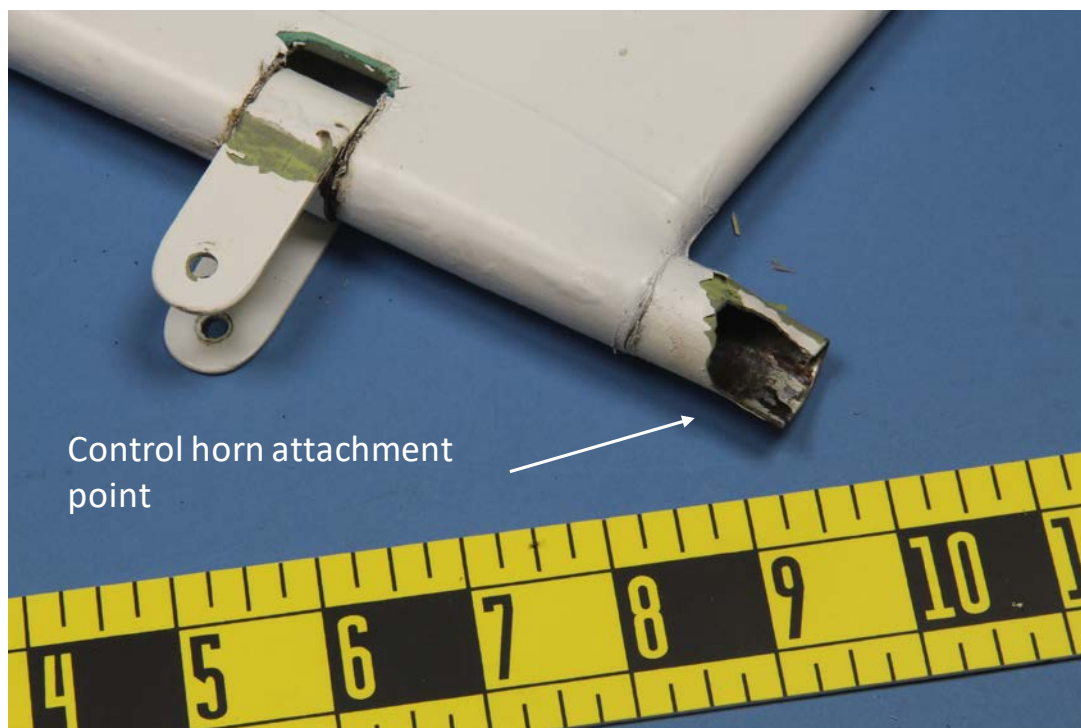
The left and right elevators were submitted for examination. The right elevator was missing the control horn on the inboard end (figure 2). The control horn would have been welded to the elevator's tubular frame in the area that is missing in figure 2. A portion of the tubular frame was cut so that examination of the fracture could be performed (figure 3). Examination of the fracture surface using a stereo microscope revealed fracture features consistent with an overstress fracture. The hinges on the right elevator exhibited evidence of overtravel in both the up and down directions. This evidence was missing paint on the hinge and displacement of the elevator's skin where the components meet (figures 4, 5).

Figure 2: Inboard end of right elevator with missing control horn.

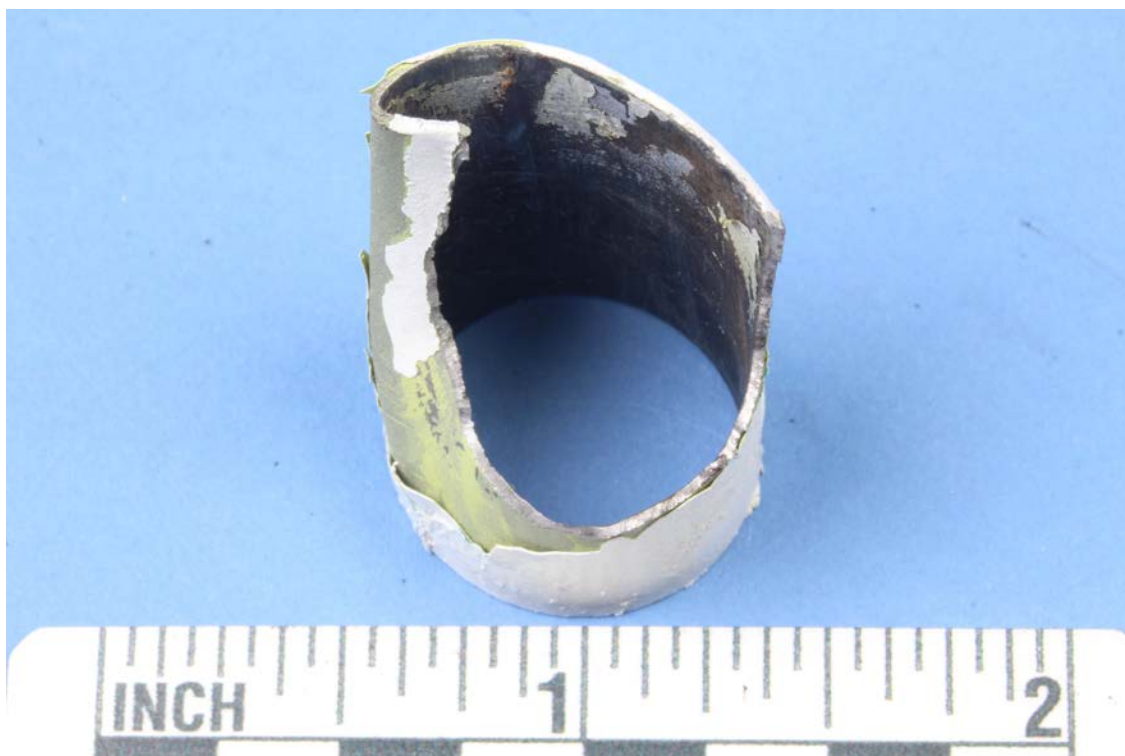
Figure 3: Portion of right elevator's tubular frame with fracture surface.

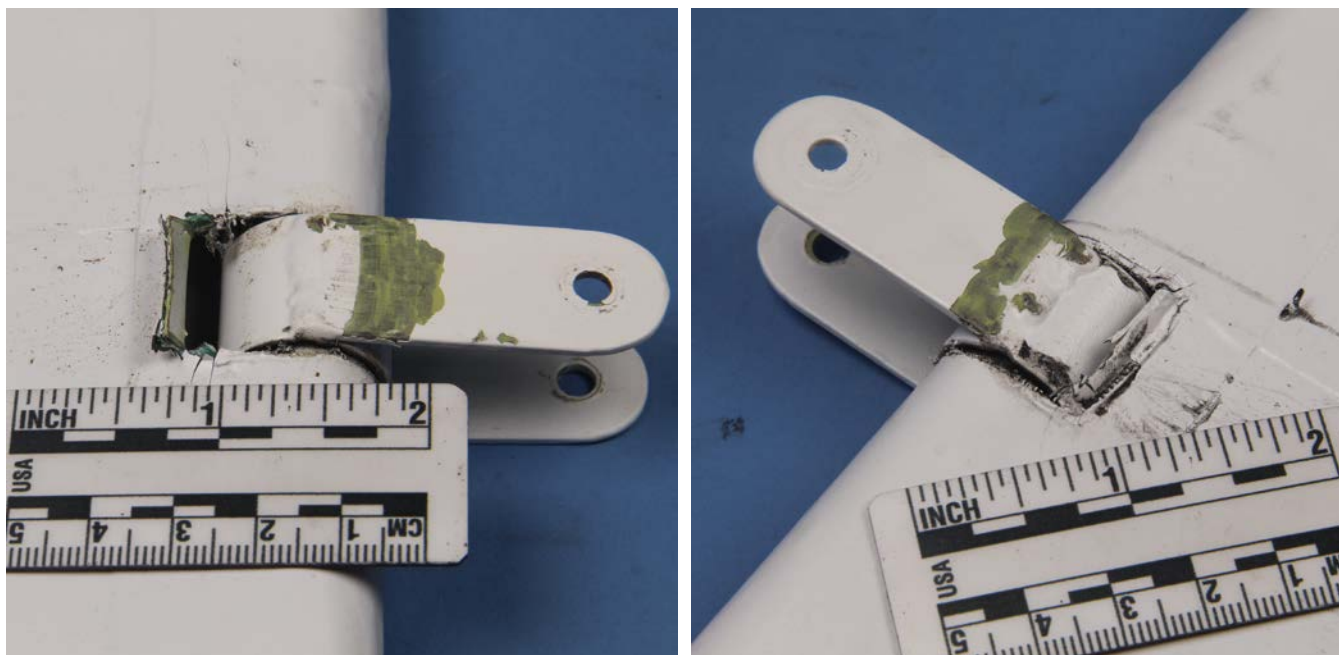
Figure 4: Top and bottom views of the right elevator outboard hinge.

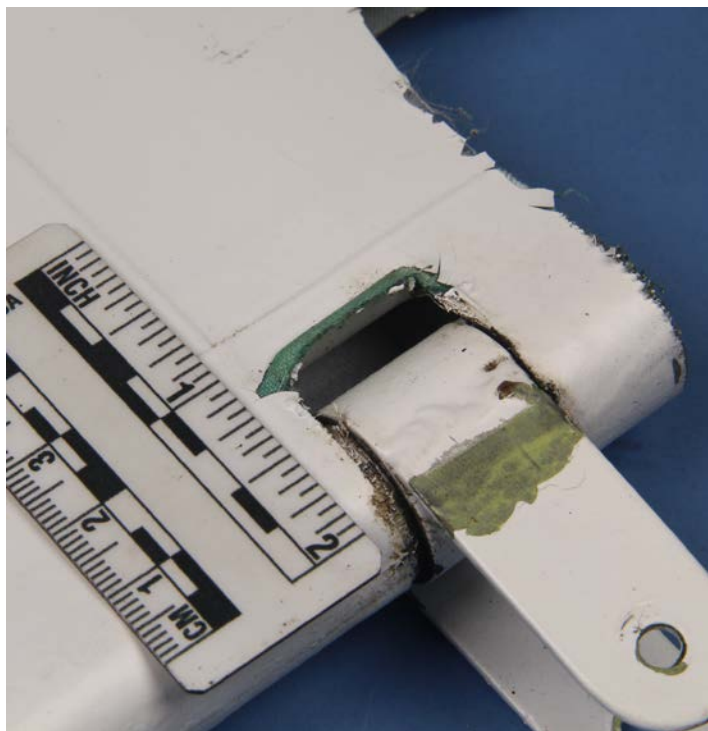
Figure 5: Top and bottom views of the right elevator inboard hinge.

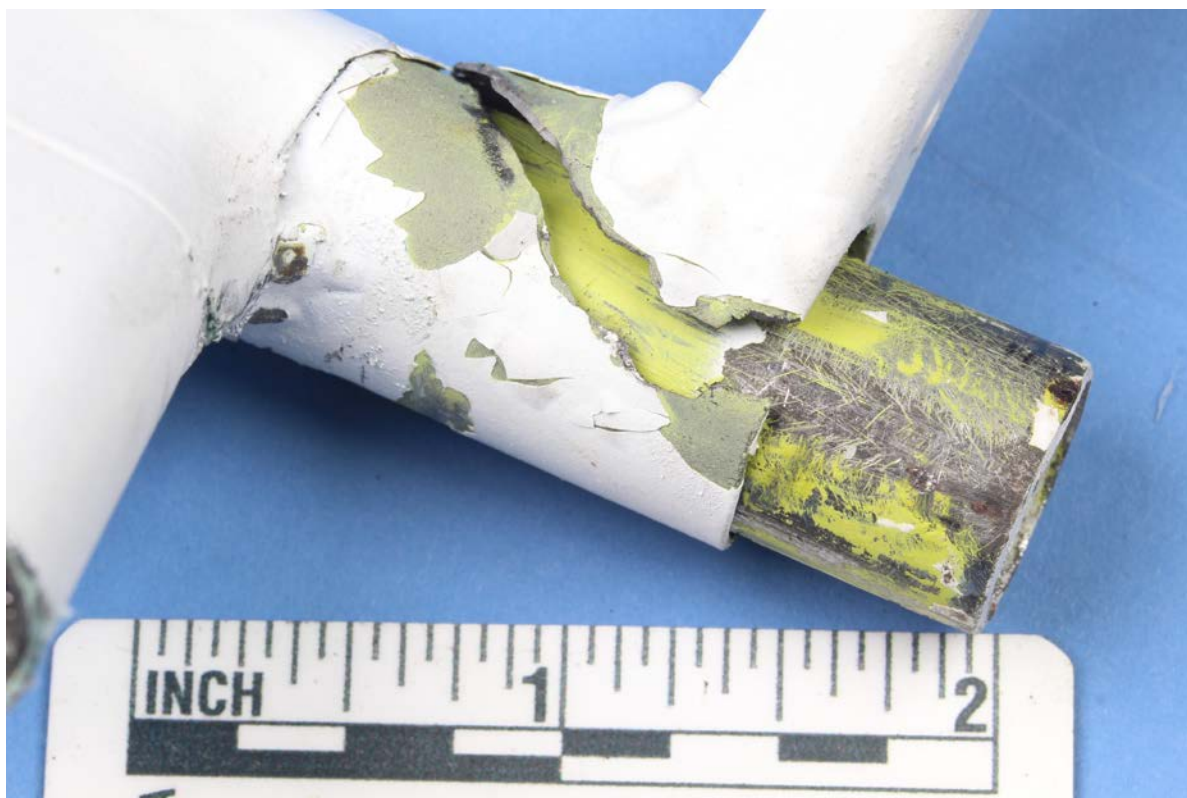
While the left elevator still had the control horn attached, there was a fracture of the tubular frame at the location of the control horn (figure 6). This fracture was consistent with an overstress fracture. Examination of the hinges for the left elevator revealed less evidence of overtravel than the right elevator and only in the downward direction.

Figure 6: Fracture of left elevator tubing at control horn location.
