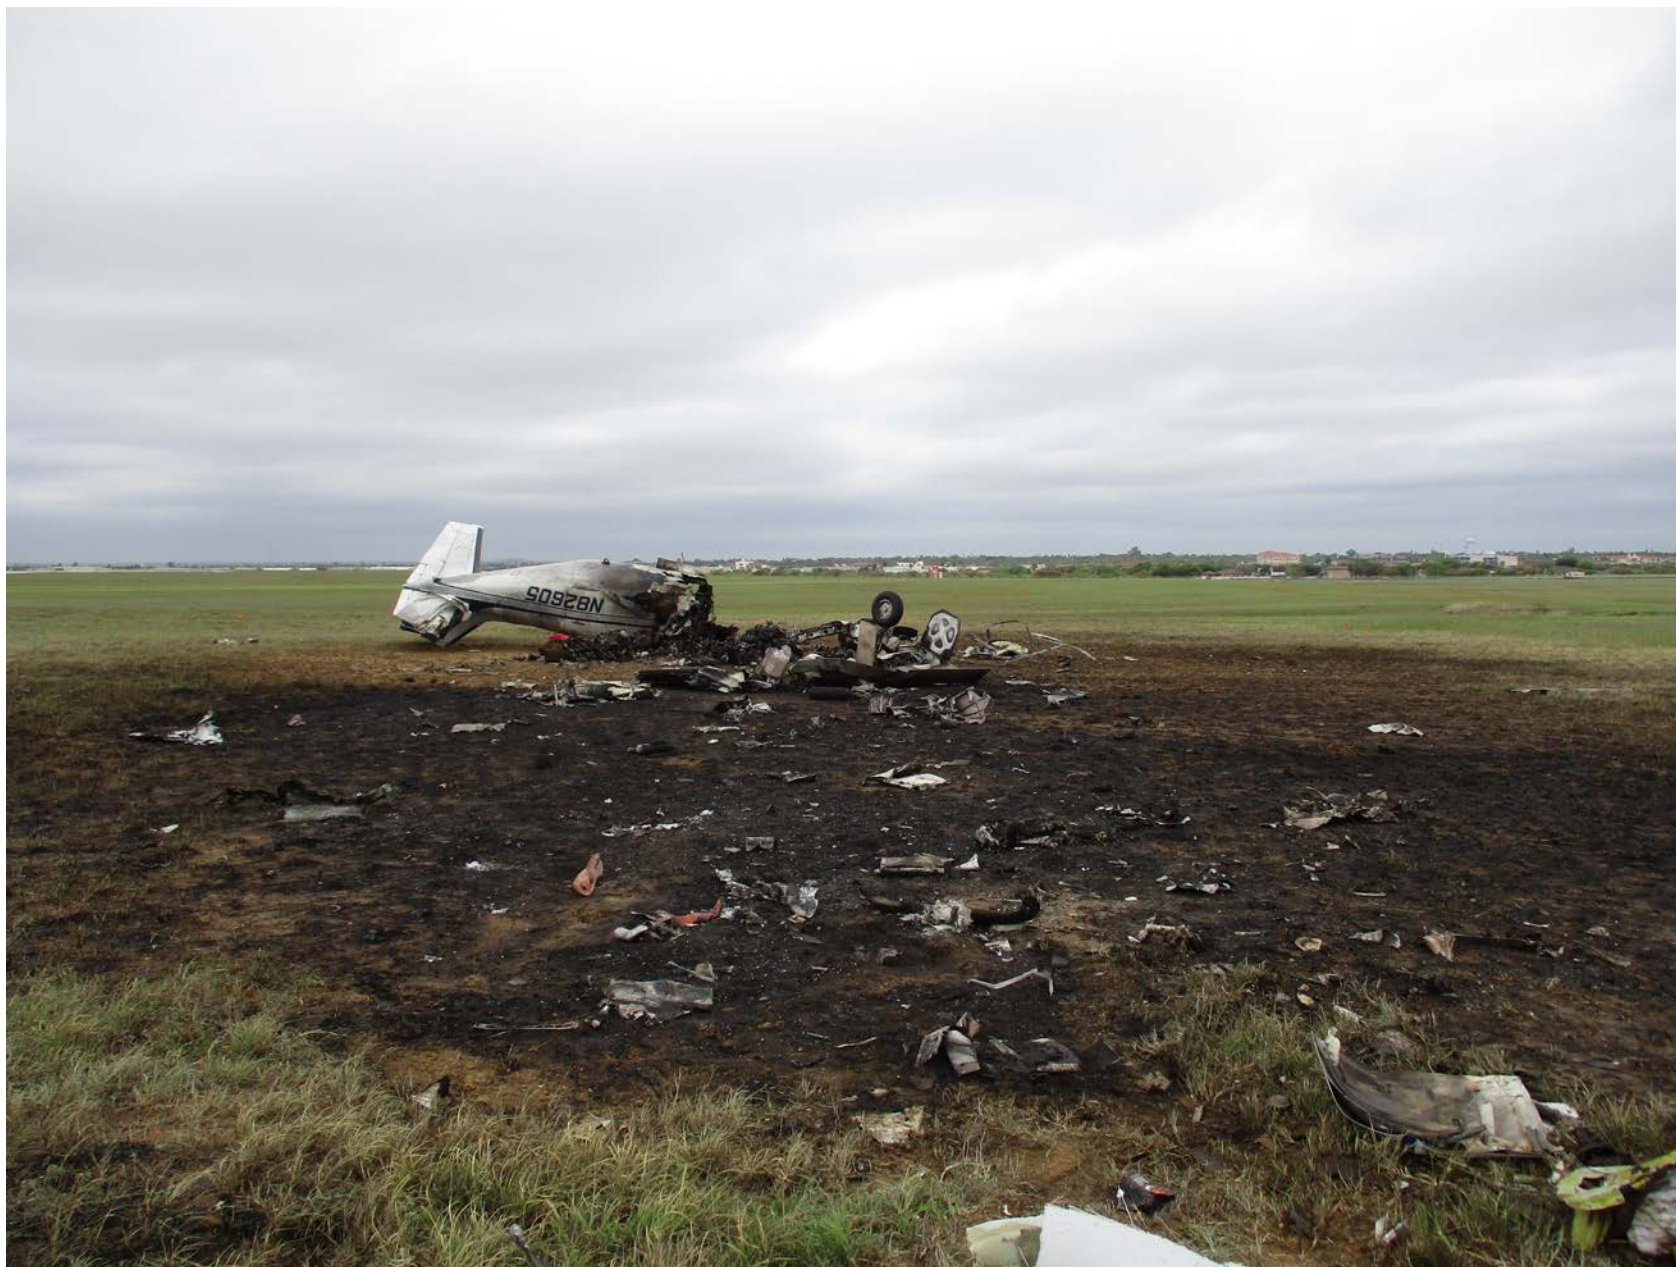
**Photo 1 – Airplane wreckage**

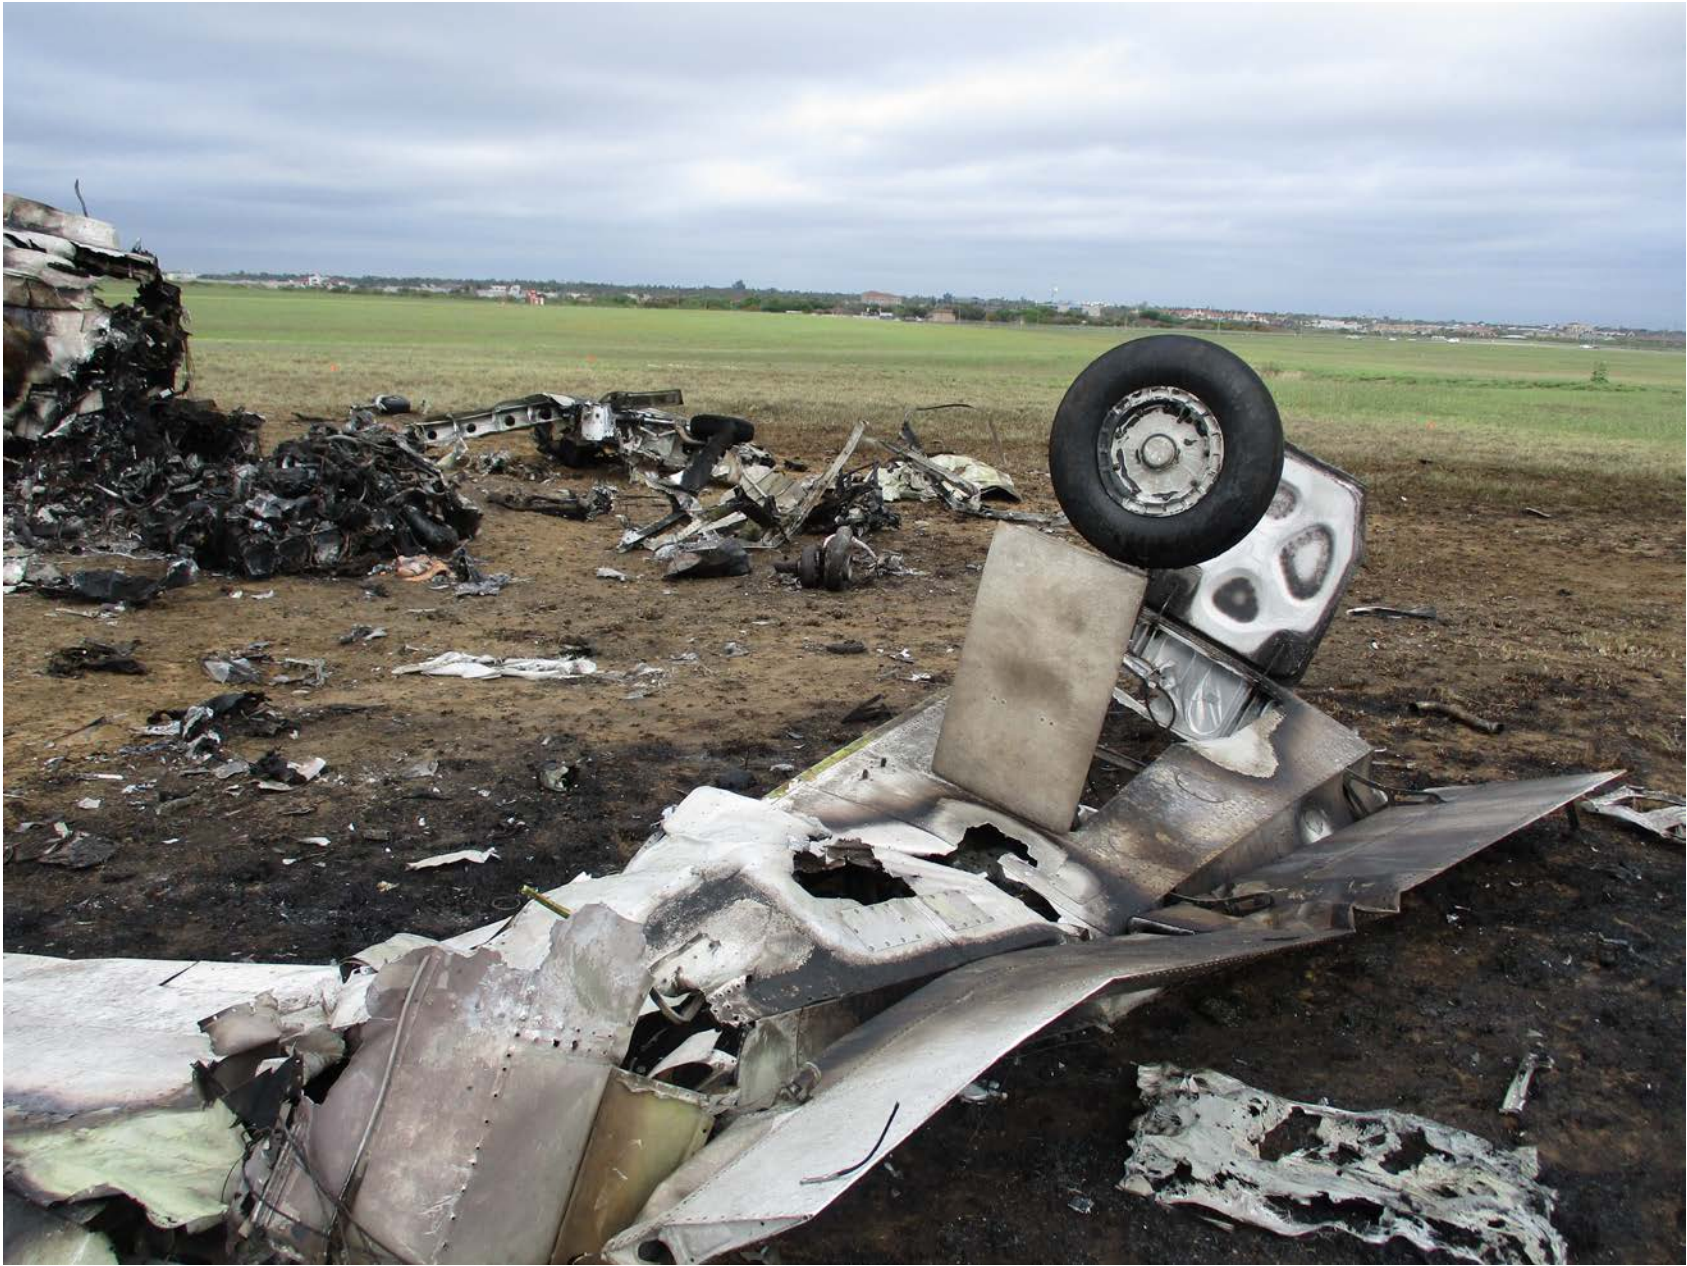
**Photo 2 - Wing, main landing**

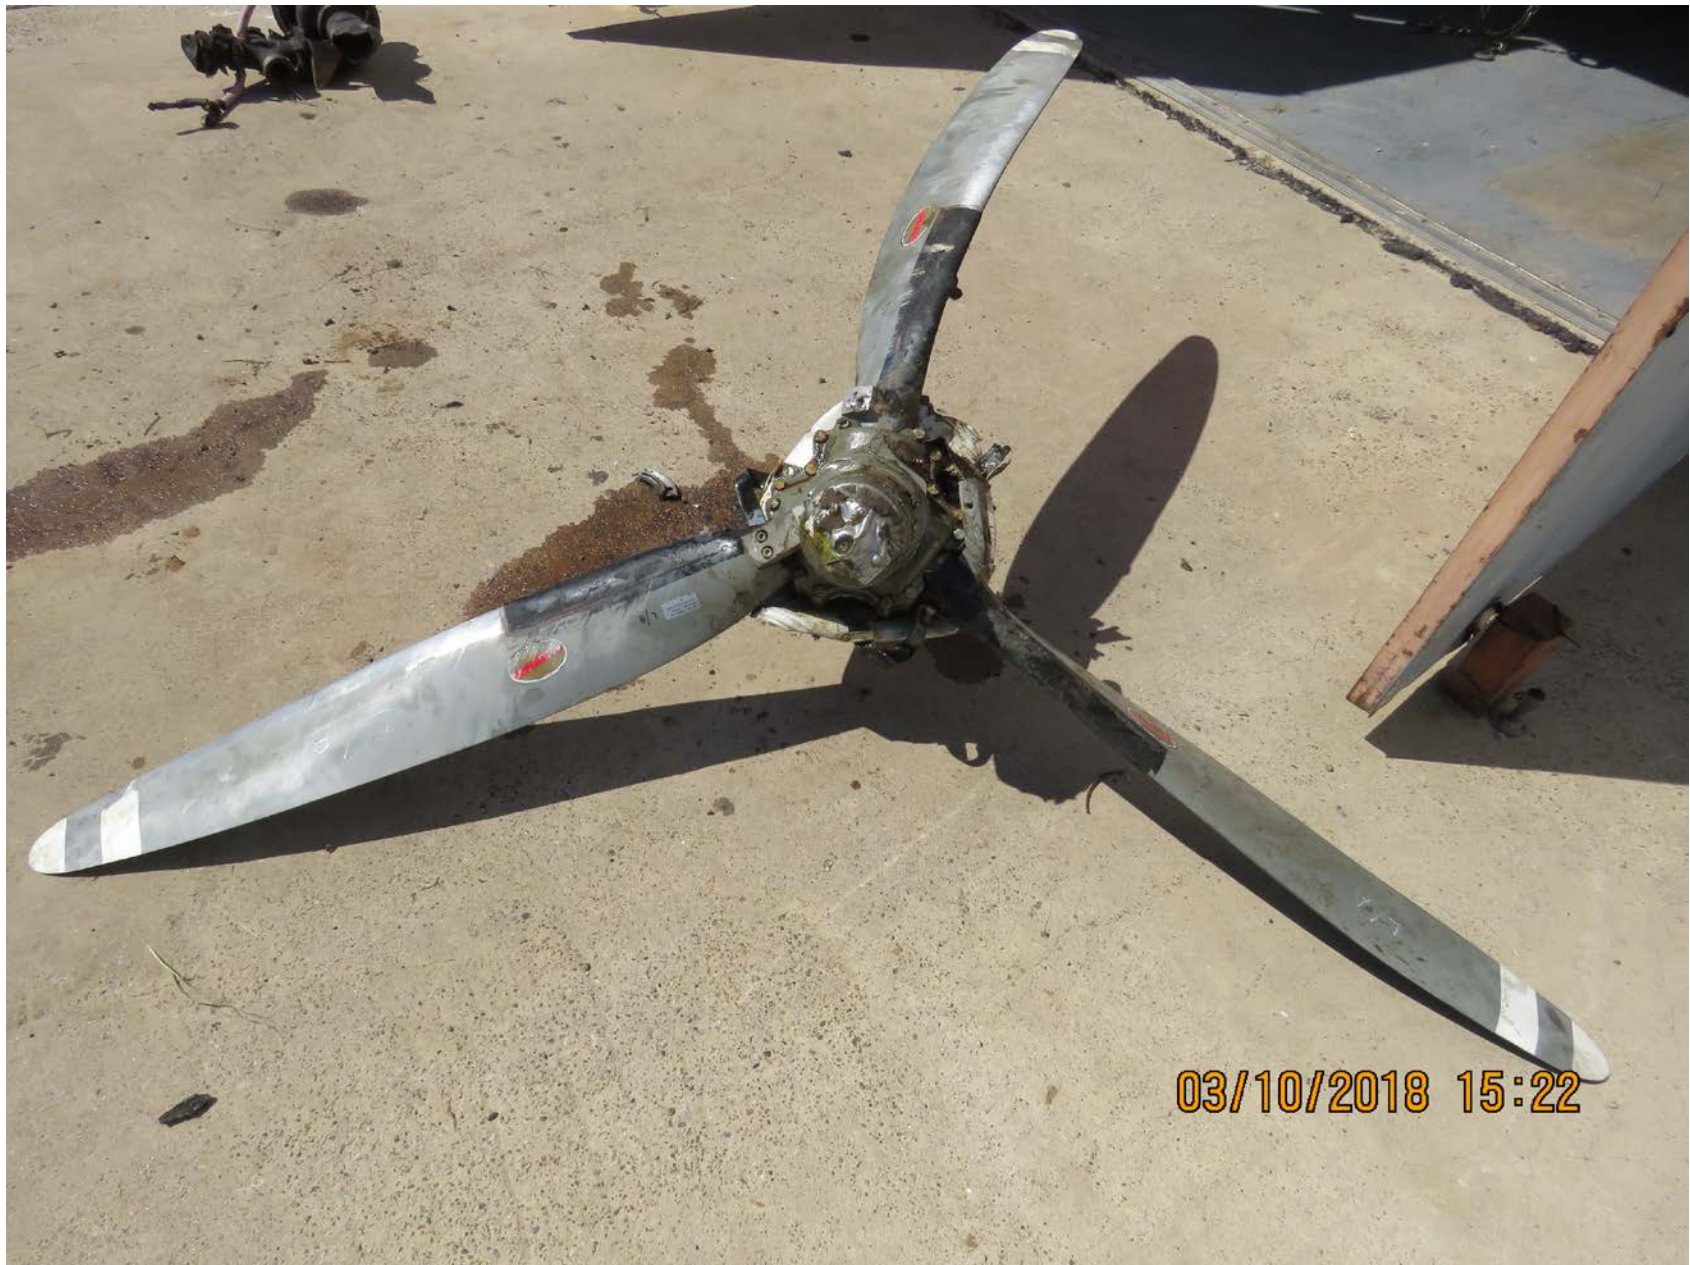
**Photo 3 – Left side, 3-Bladed propeller**

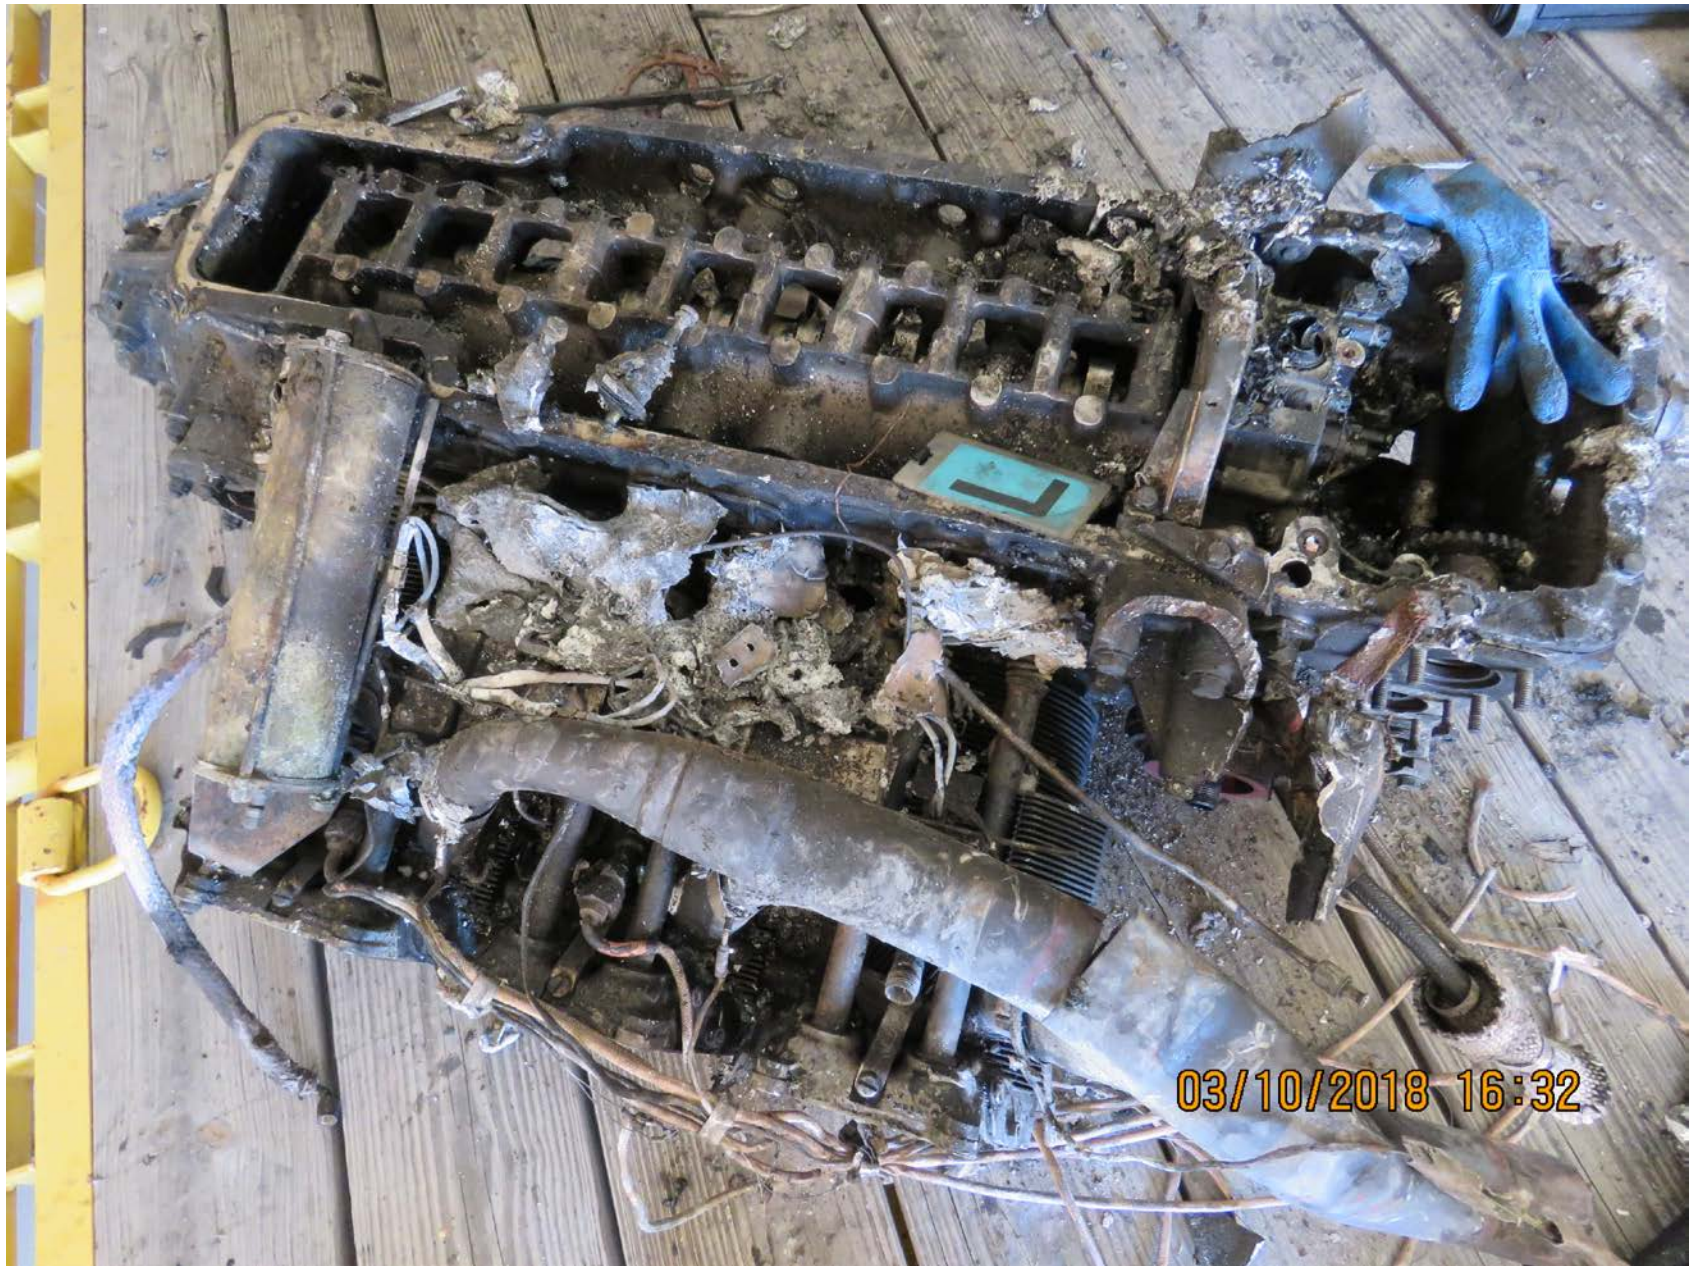
**Photo 4 – Left side engine: Fire and impact damage**

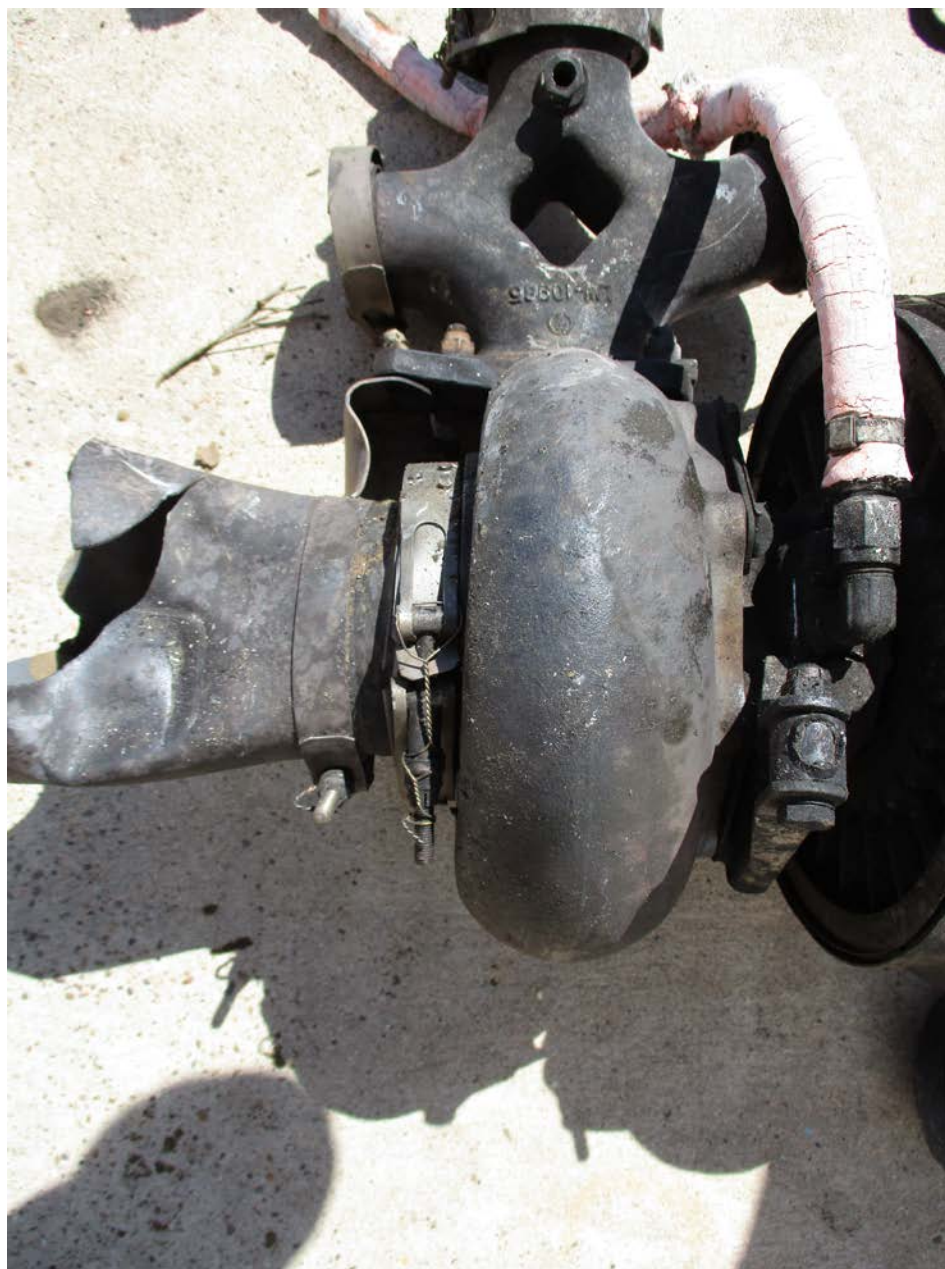
**Photo 5 – Turbo charger**
