South view of the accident site with the helicopter main wreckage

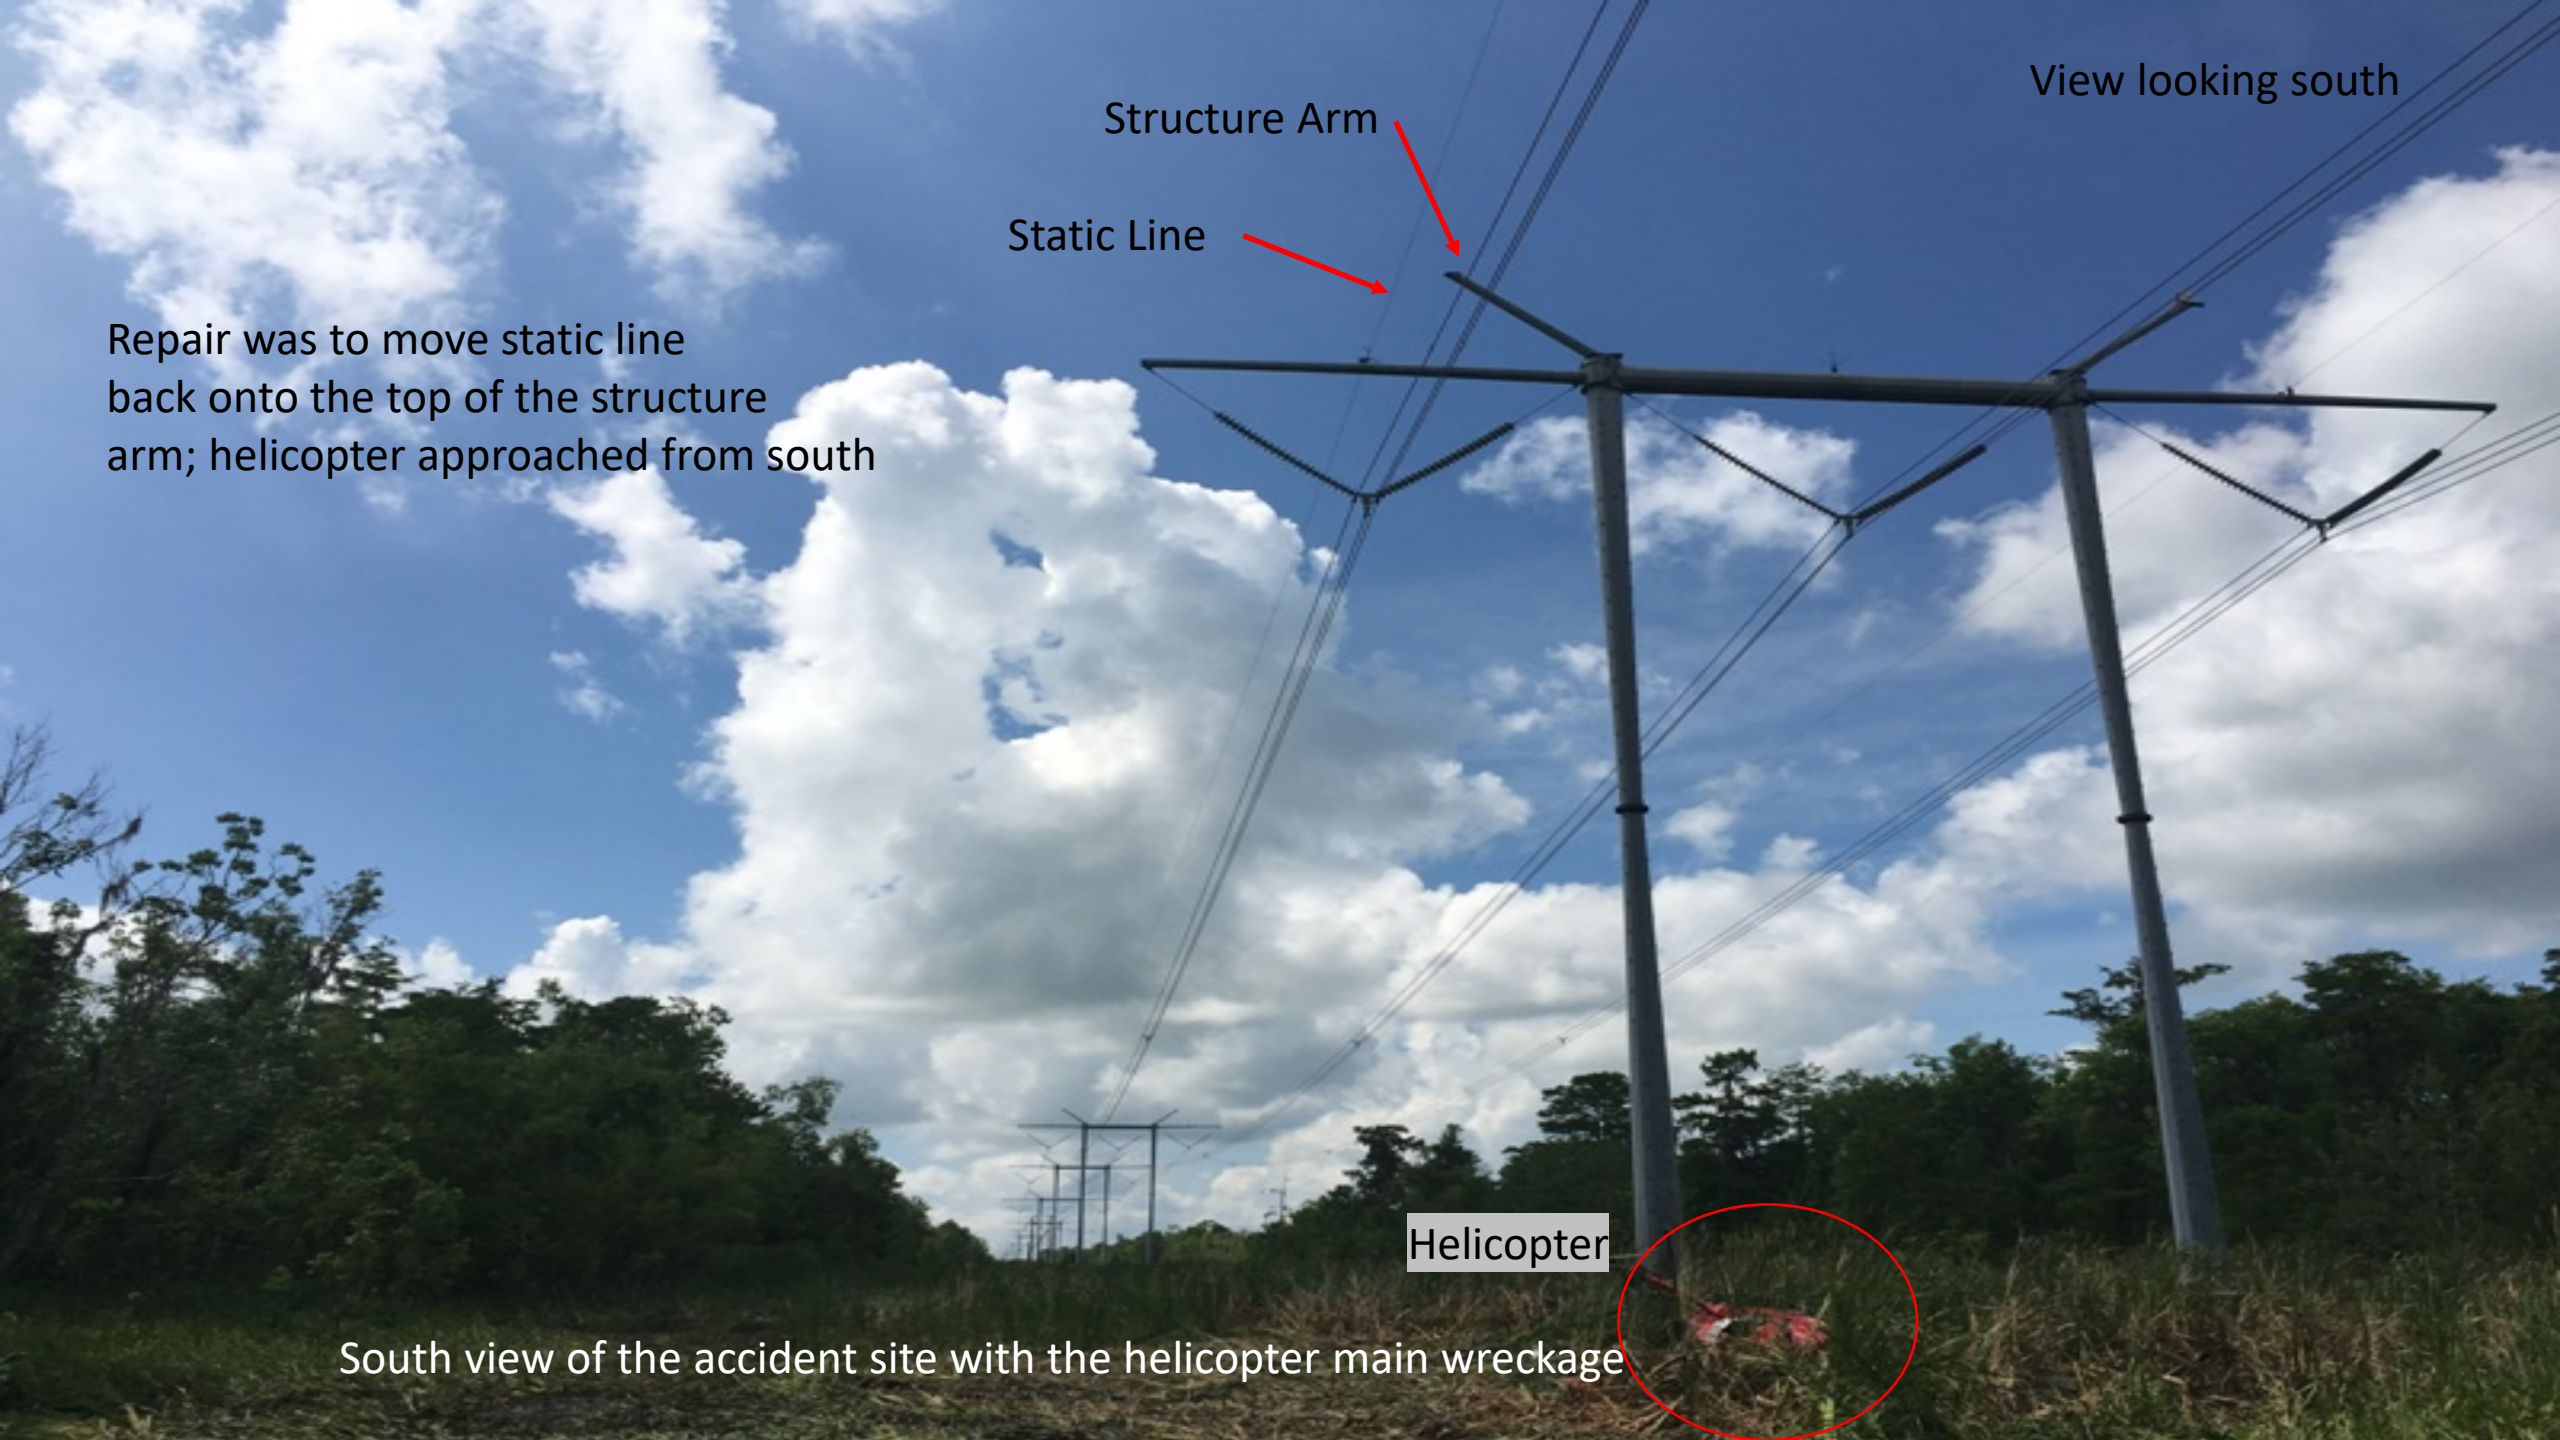
View looking south

Structure Arm

Static Line

Repair was to move static line  
back onto the top of the structure  
arm; helicopter approached from south

Helicopter

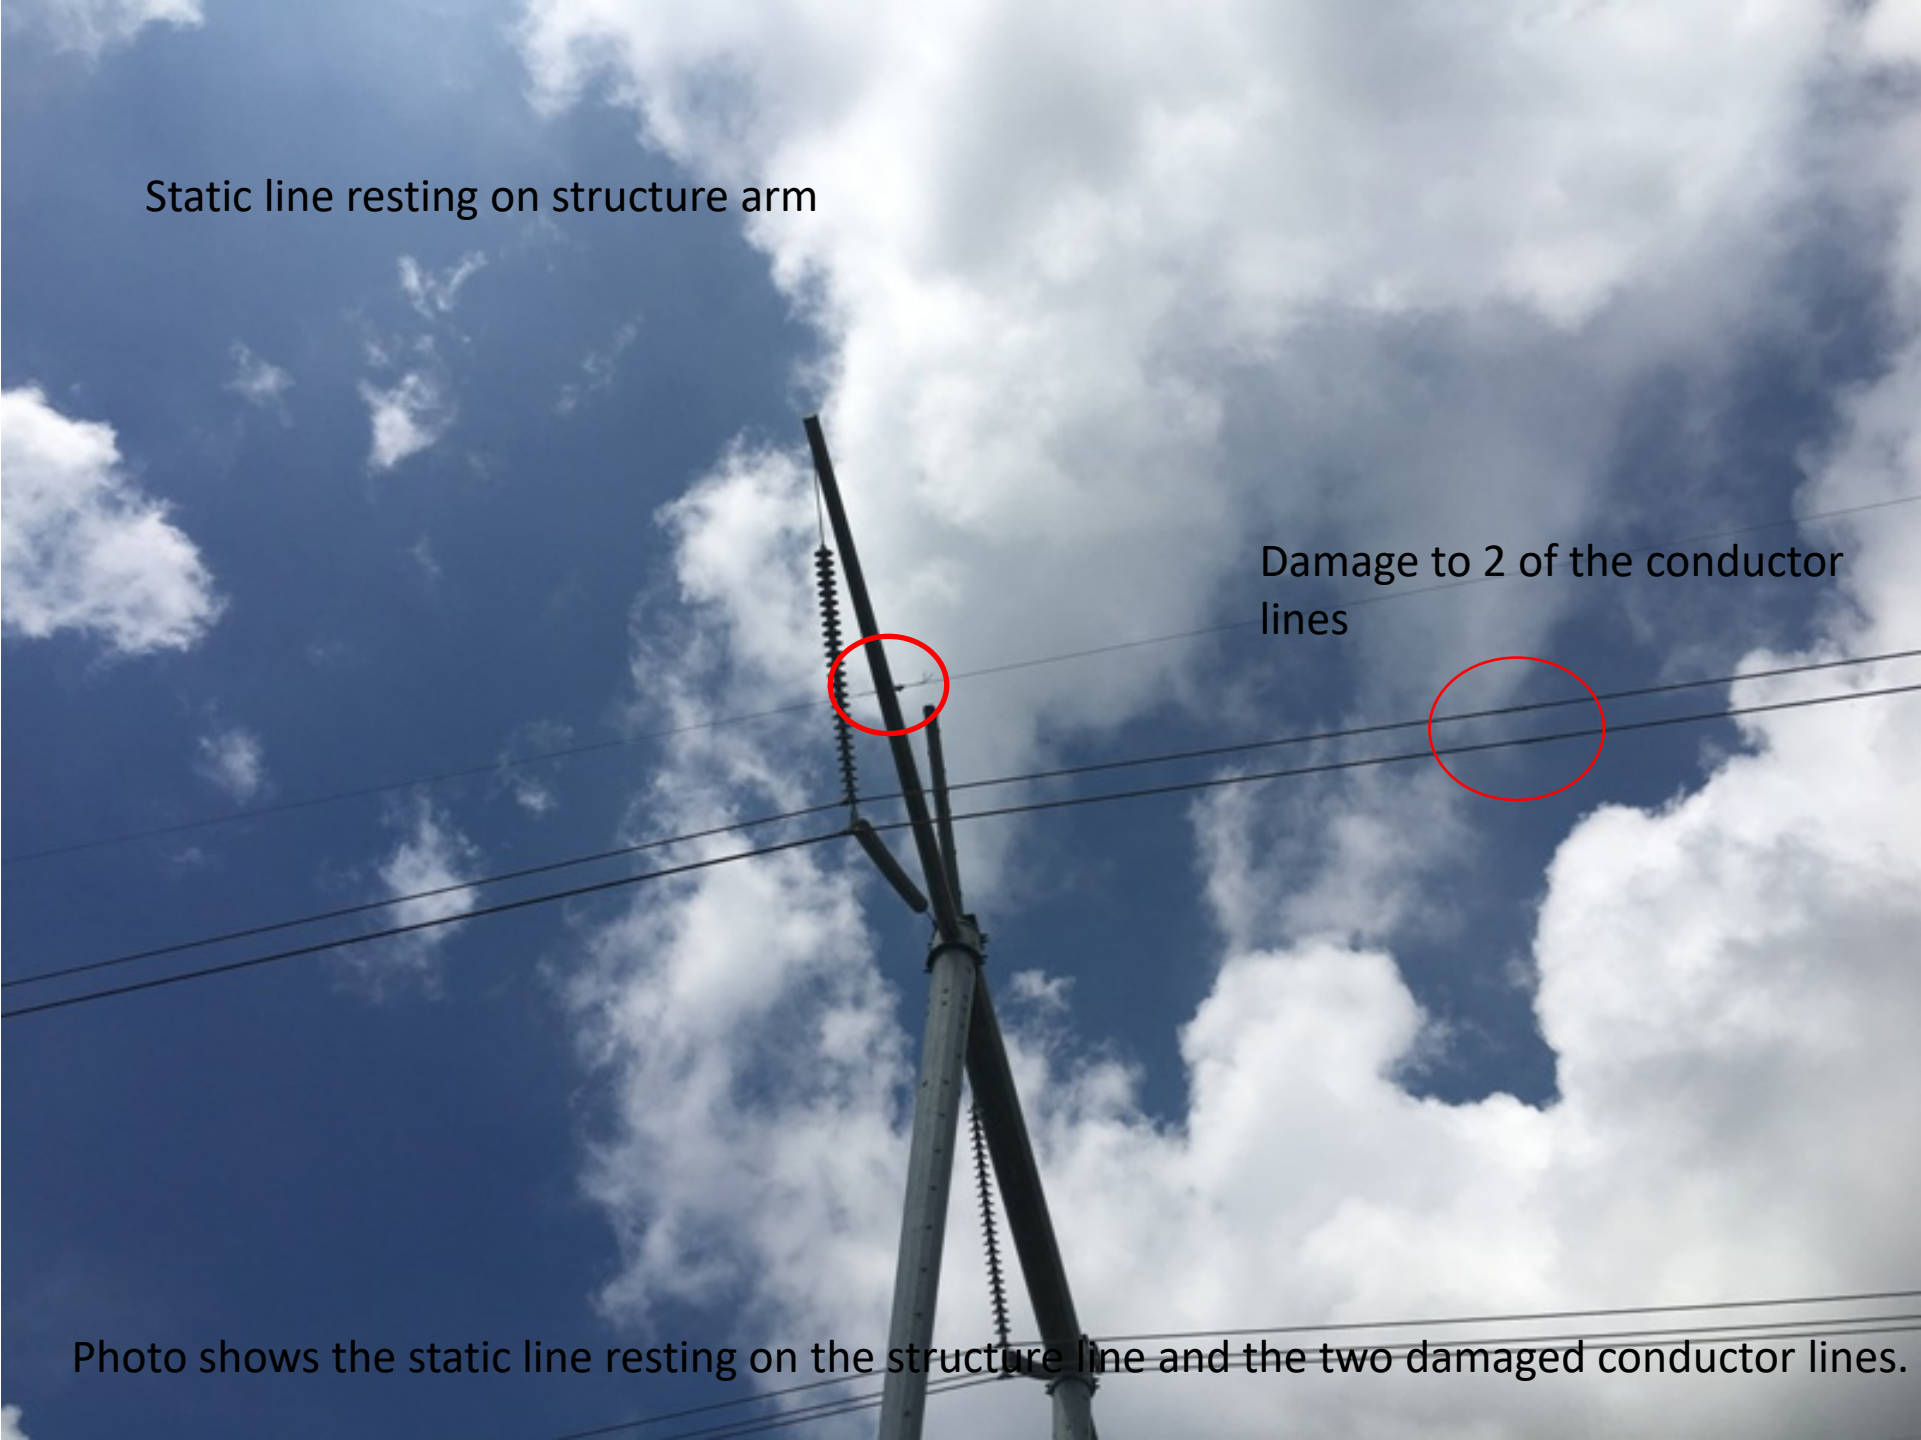
Static line resting on structure arm

Damage to 2 of the conductor lines

Photo shows the static line resting on the structure line and the two damaged conductor lines.

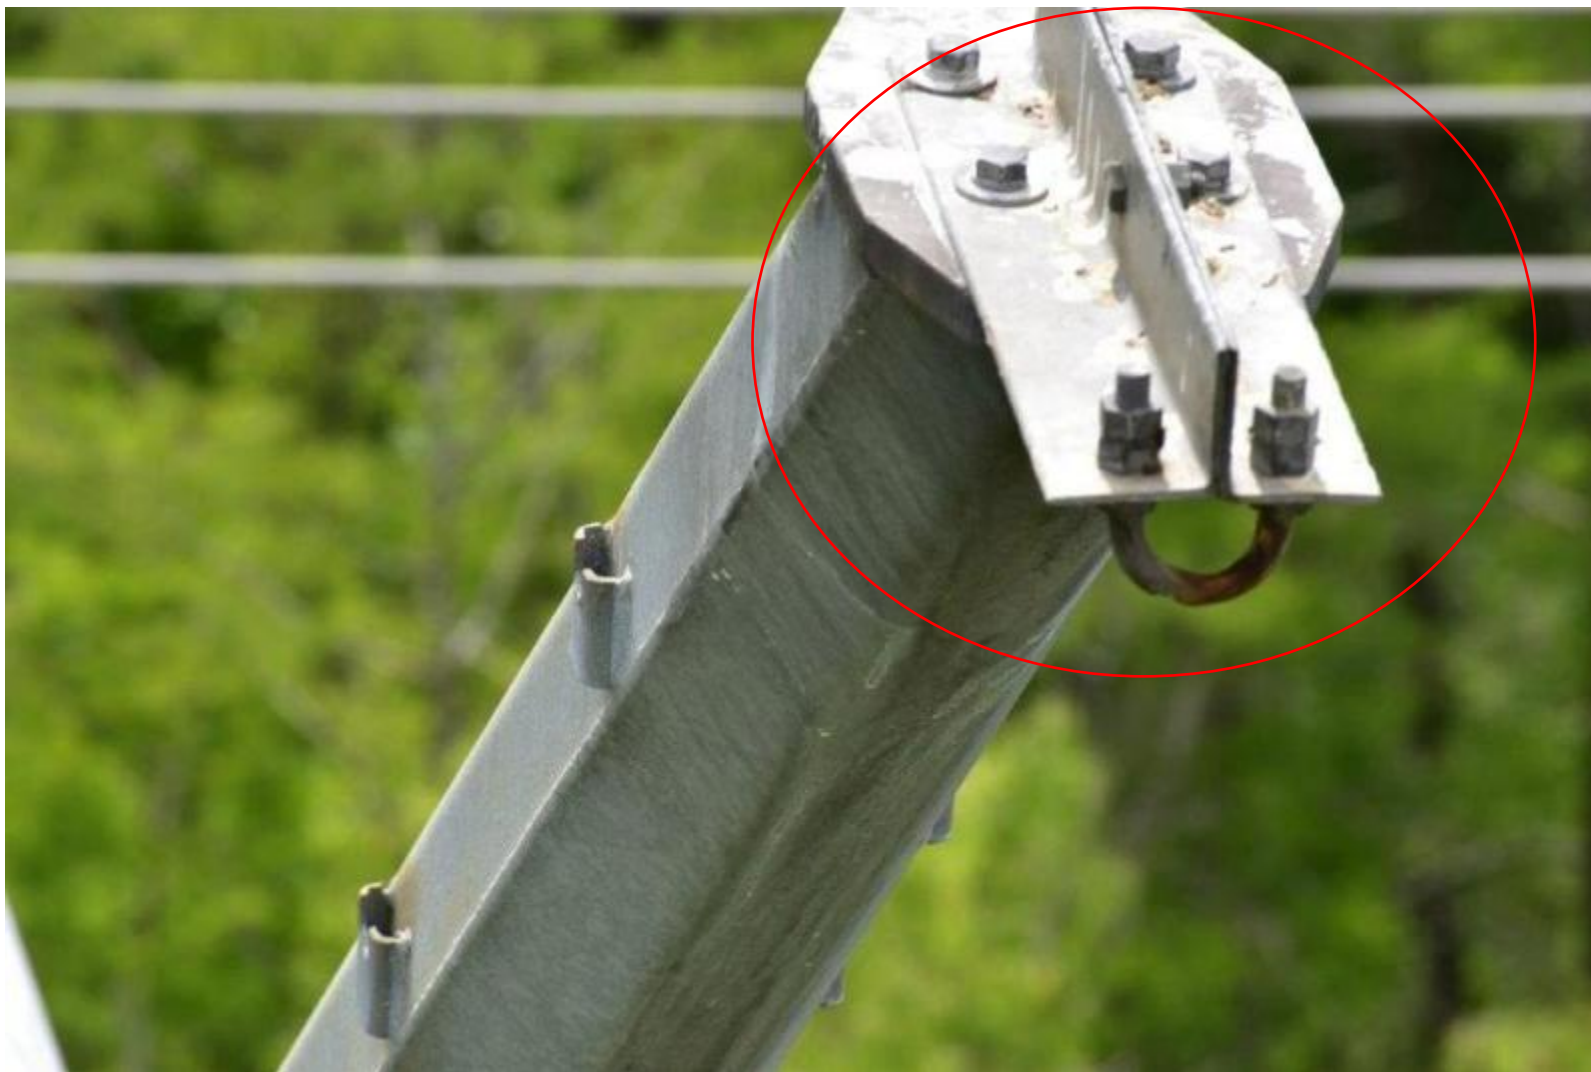
Close up view of the structure arm two days prior to the accident.

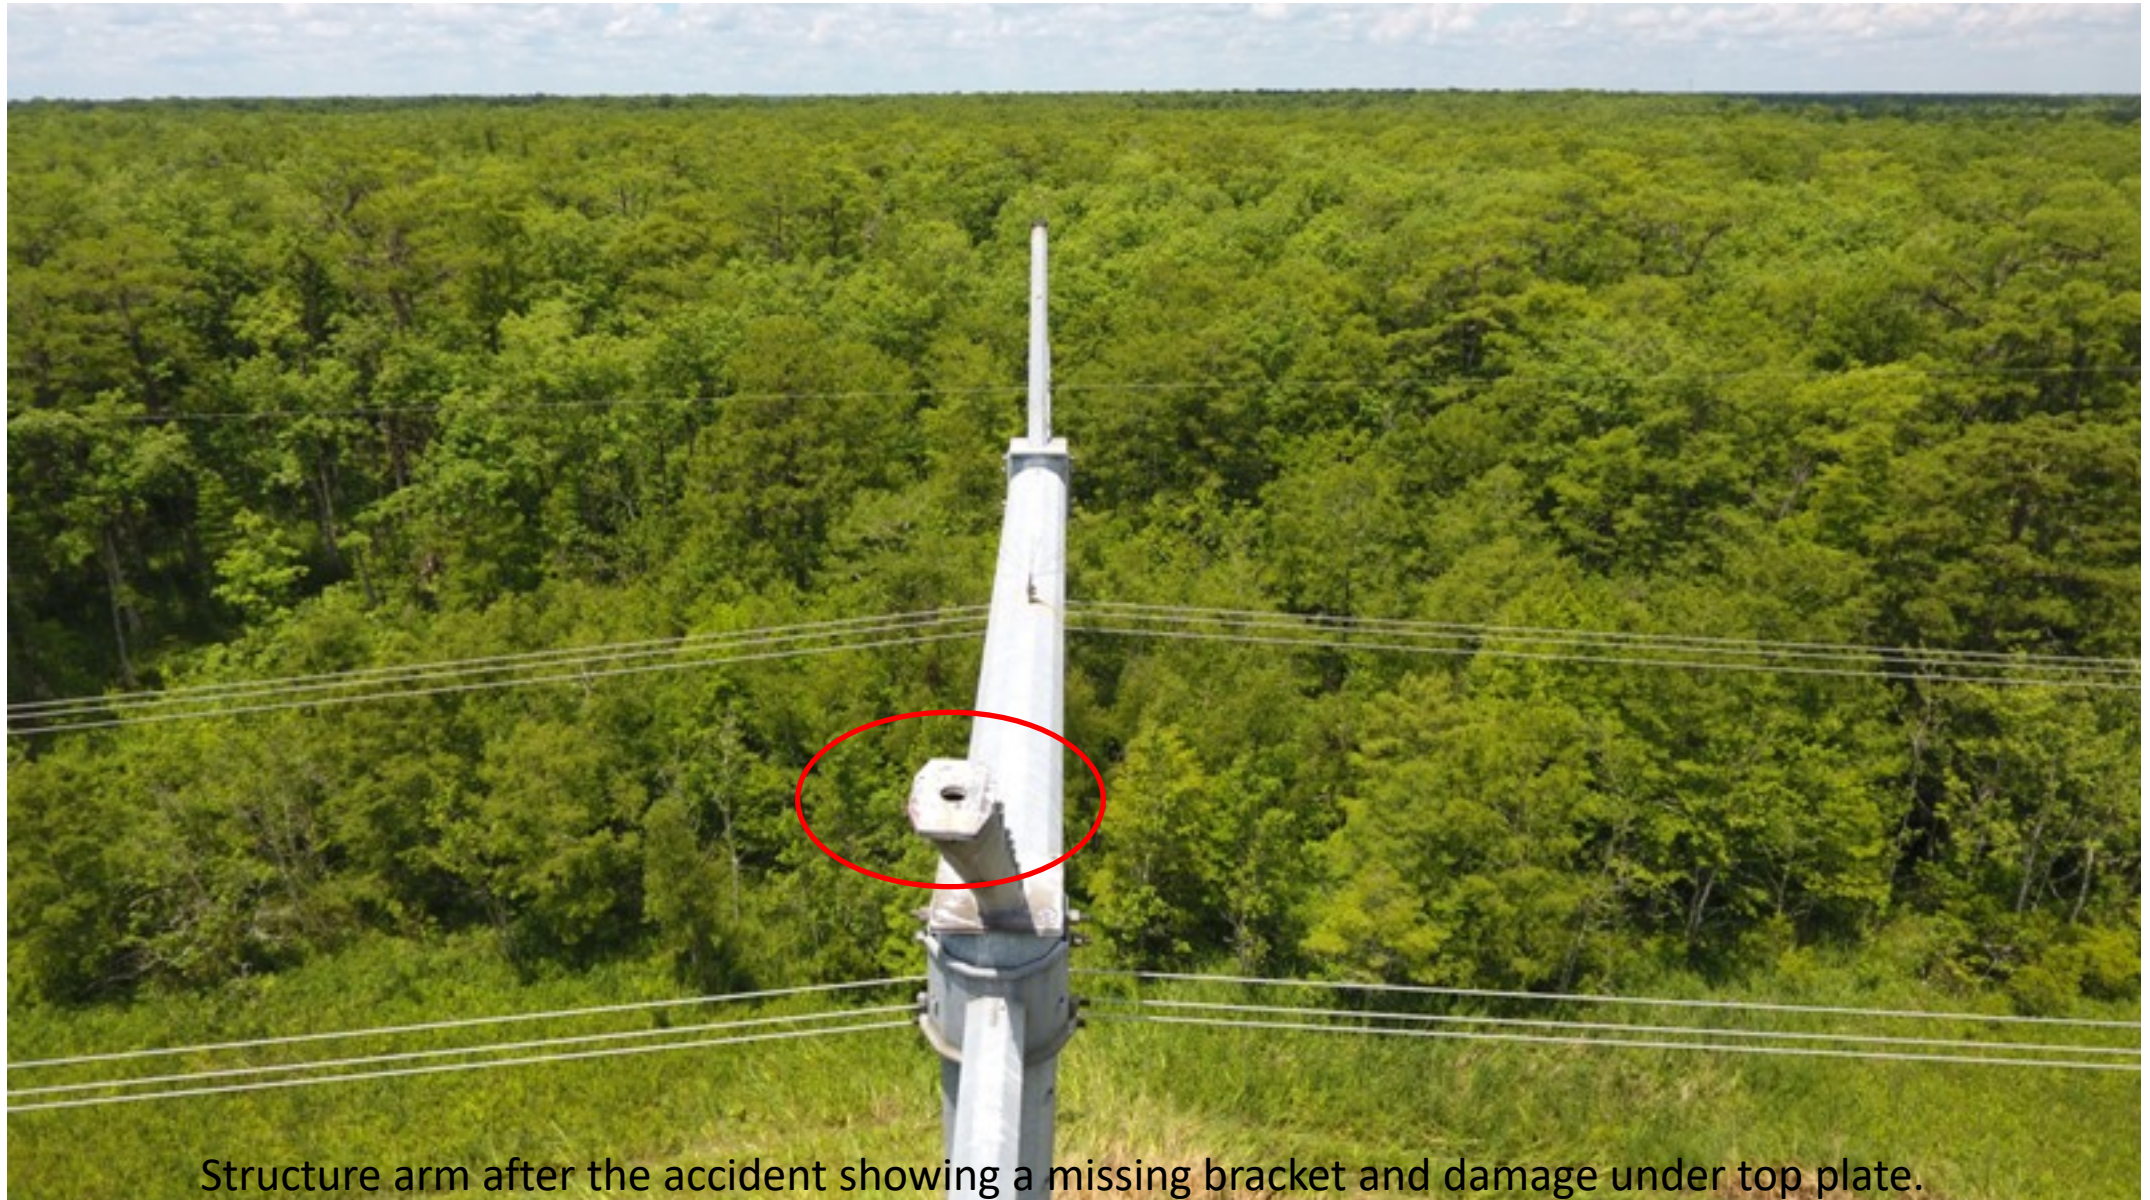
Structure arm after the accident showing a missing bracket and damage under top plate.

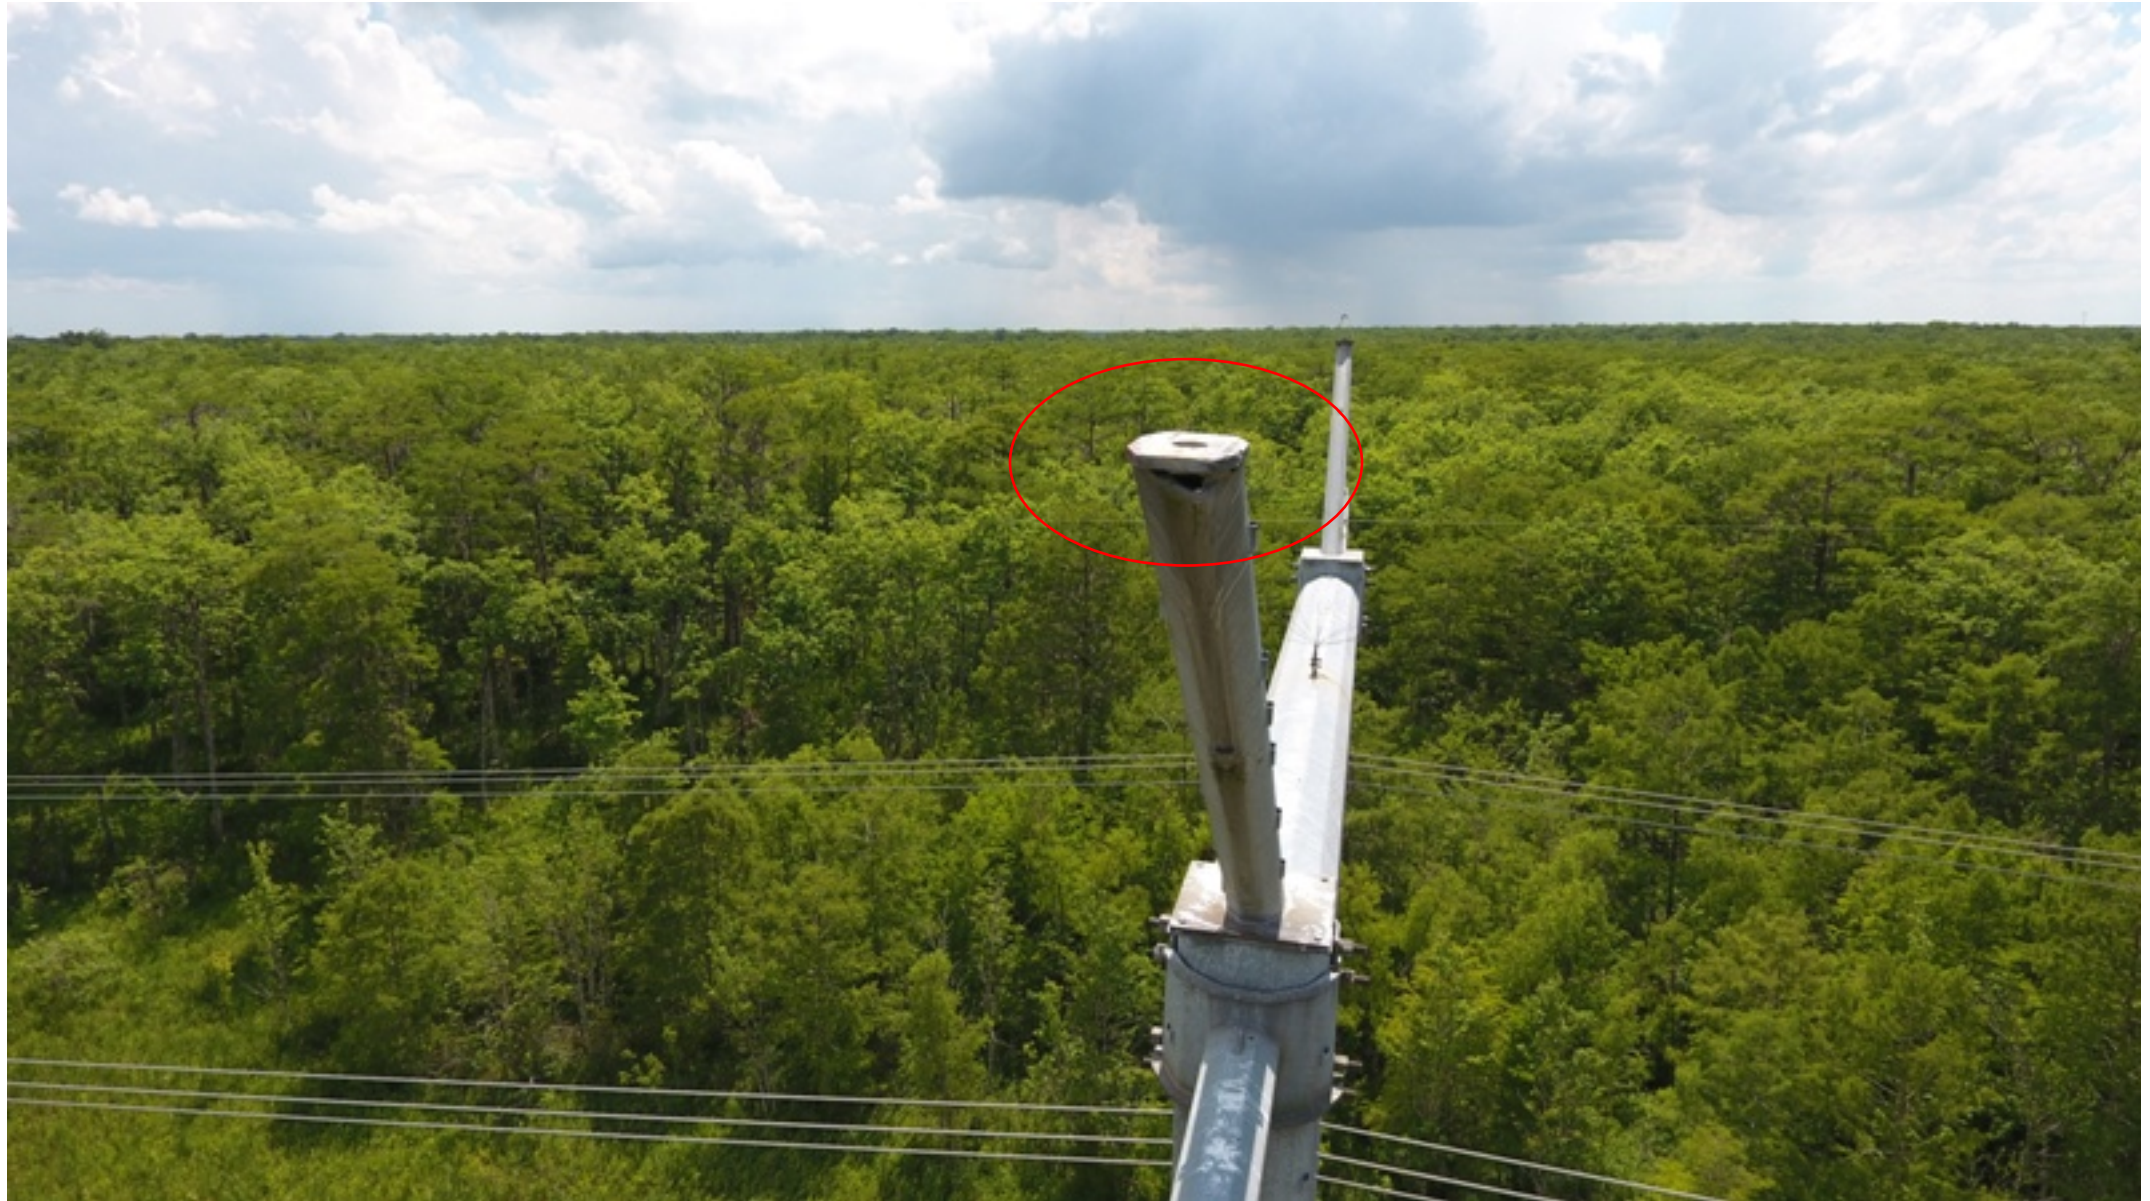
Structure arm after the accident showing a missing bracket and damage under top plate.

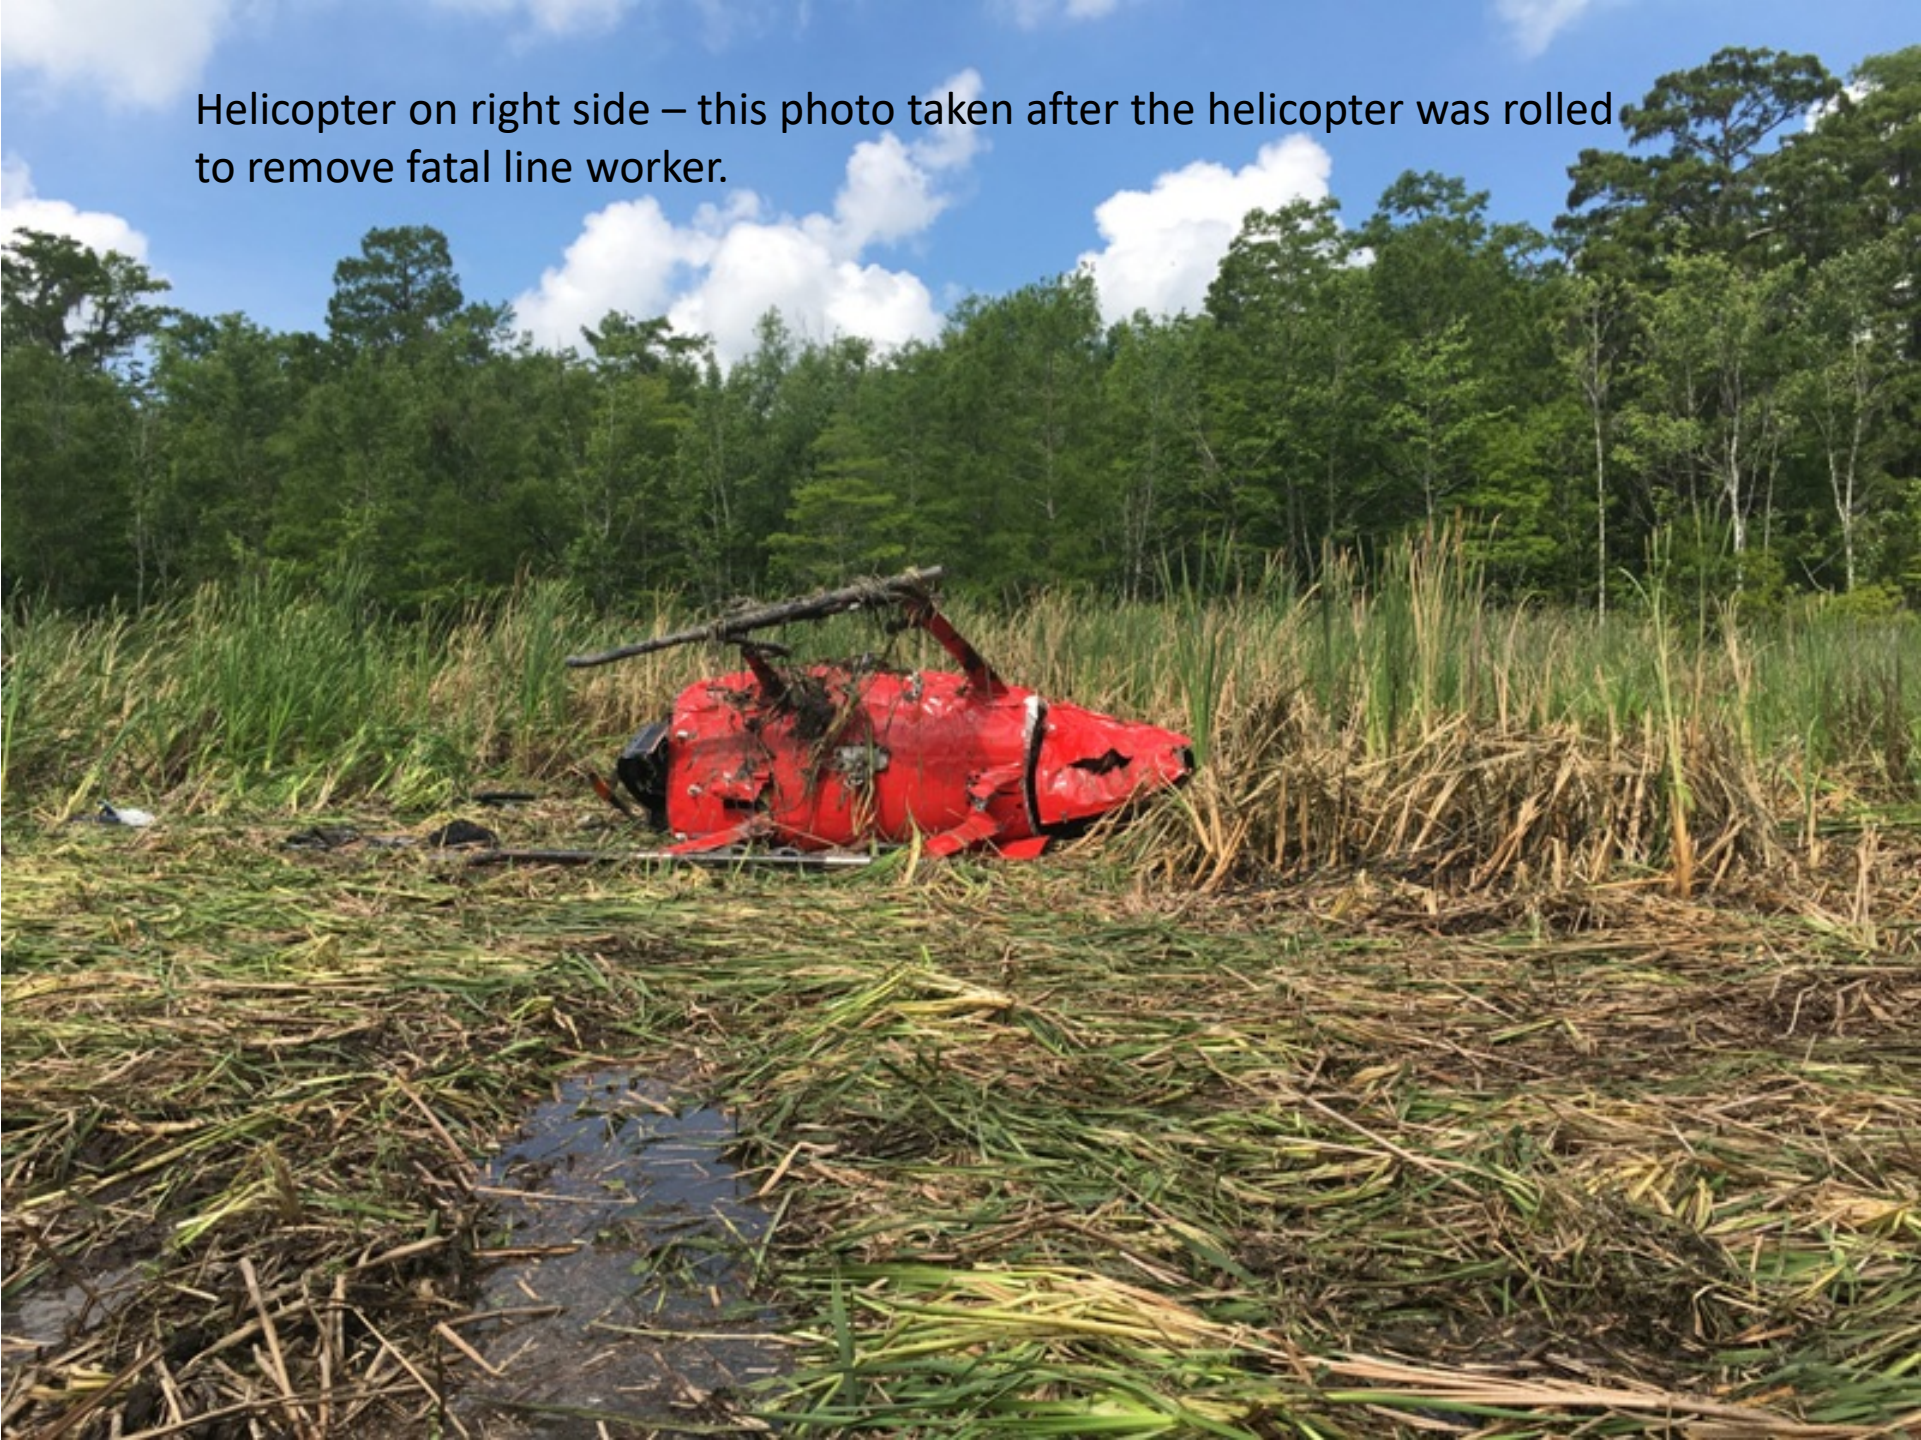
Helicopter on right side – this photo taken after the helicopter was rolled to remove fatal line worker.

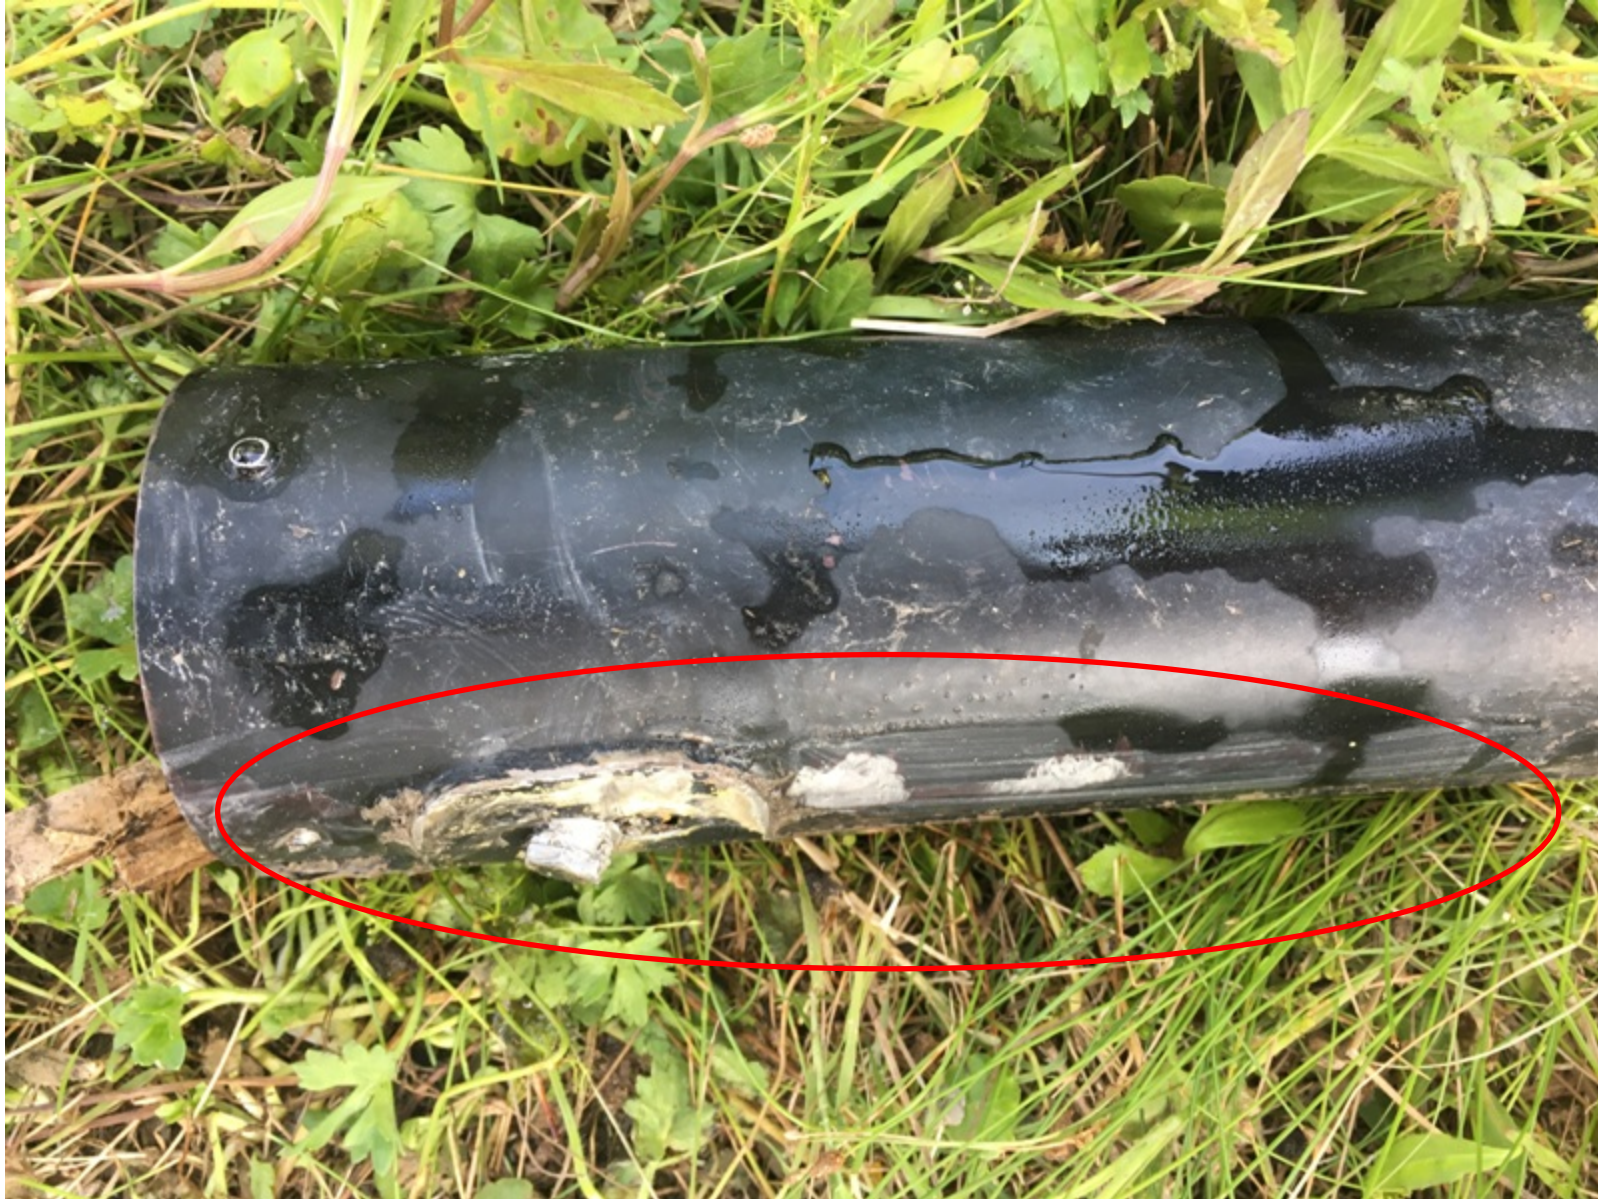
View of aft left side showing damage to the skid shoe bolt and paint scrapes.

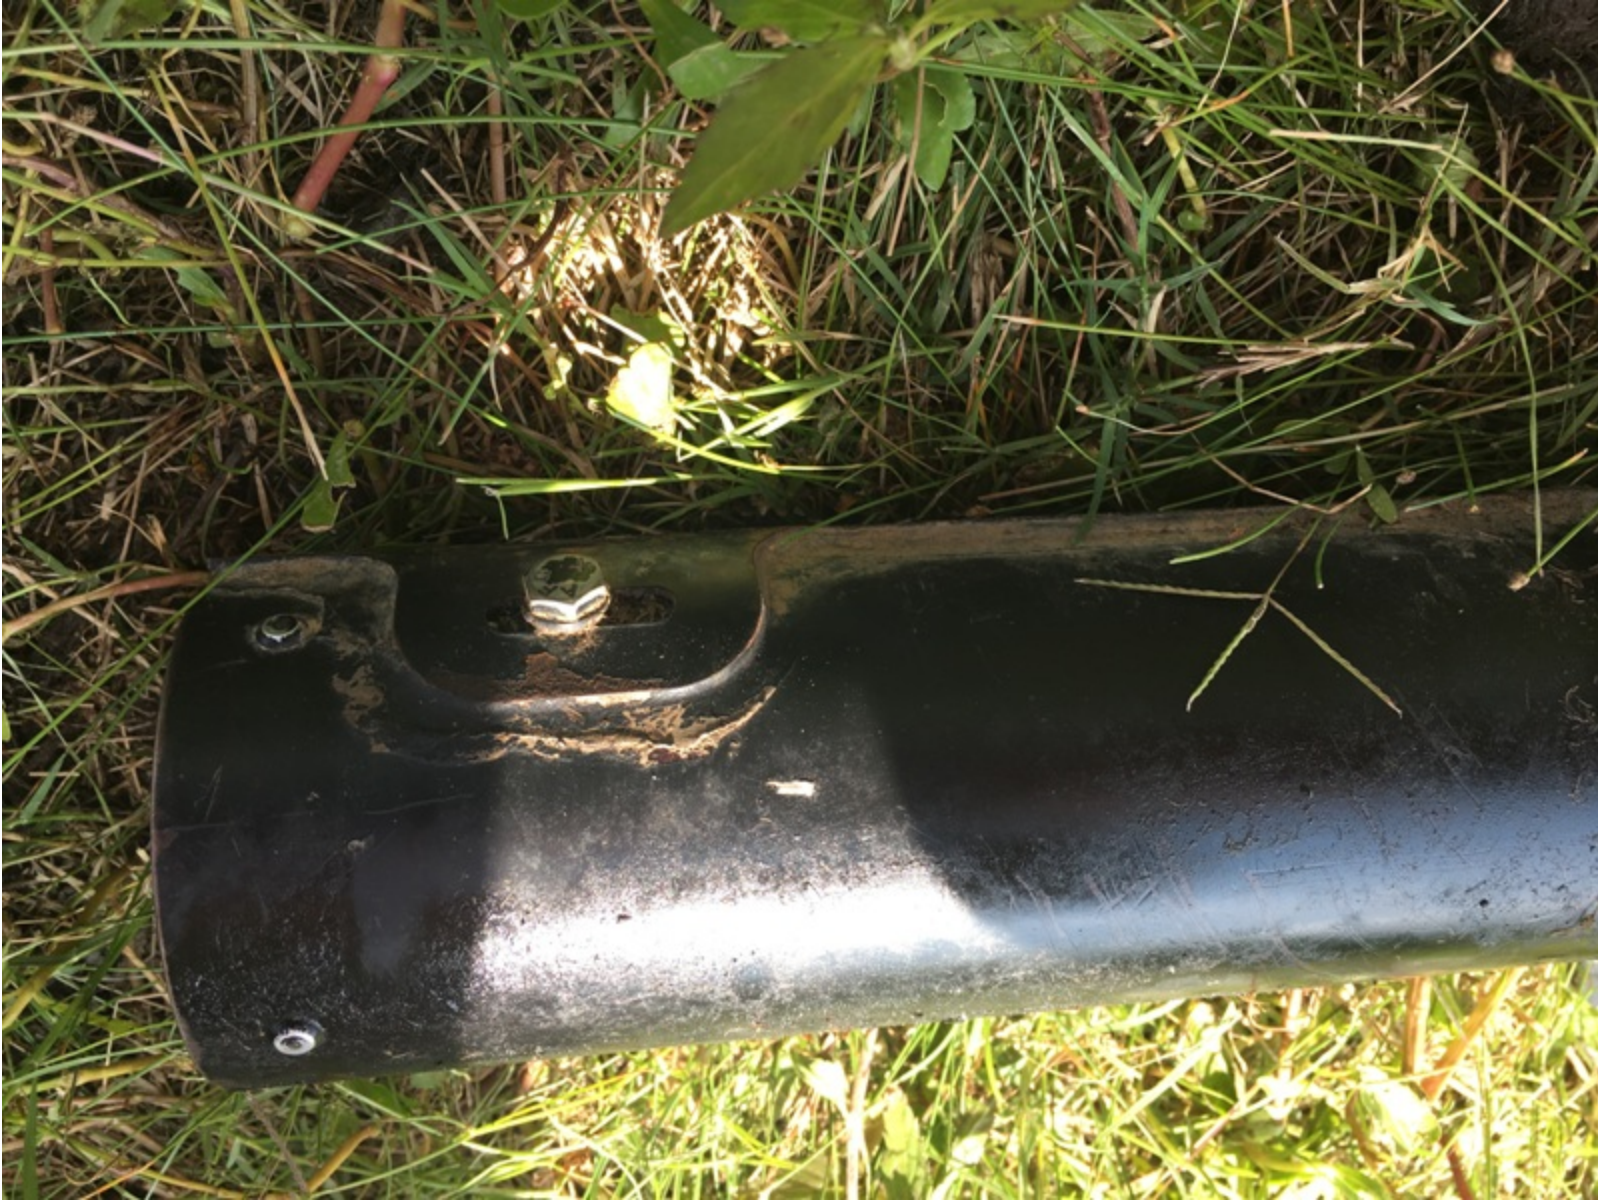
View of right aft skid showing no damage.

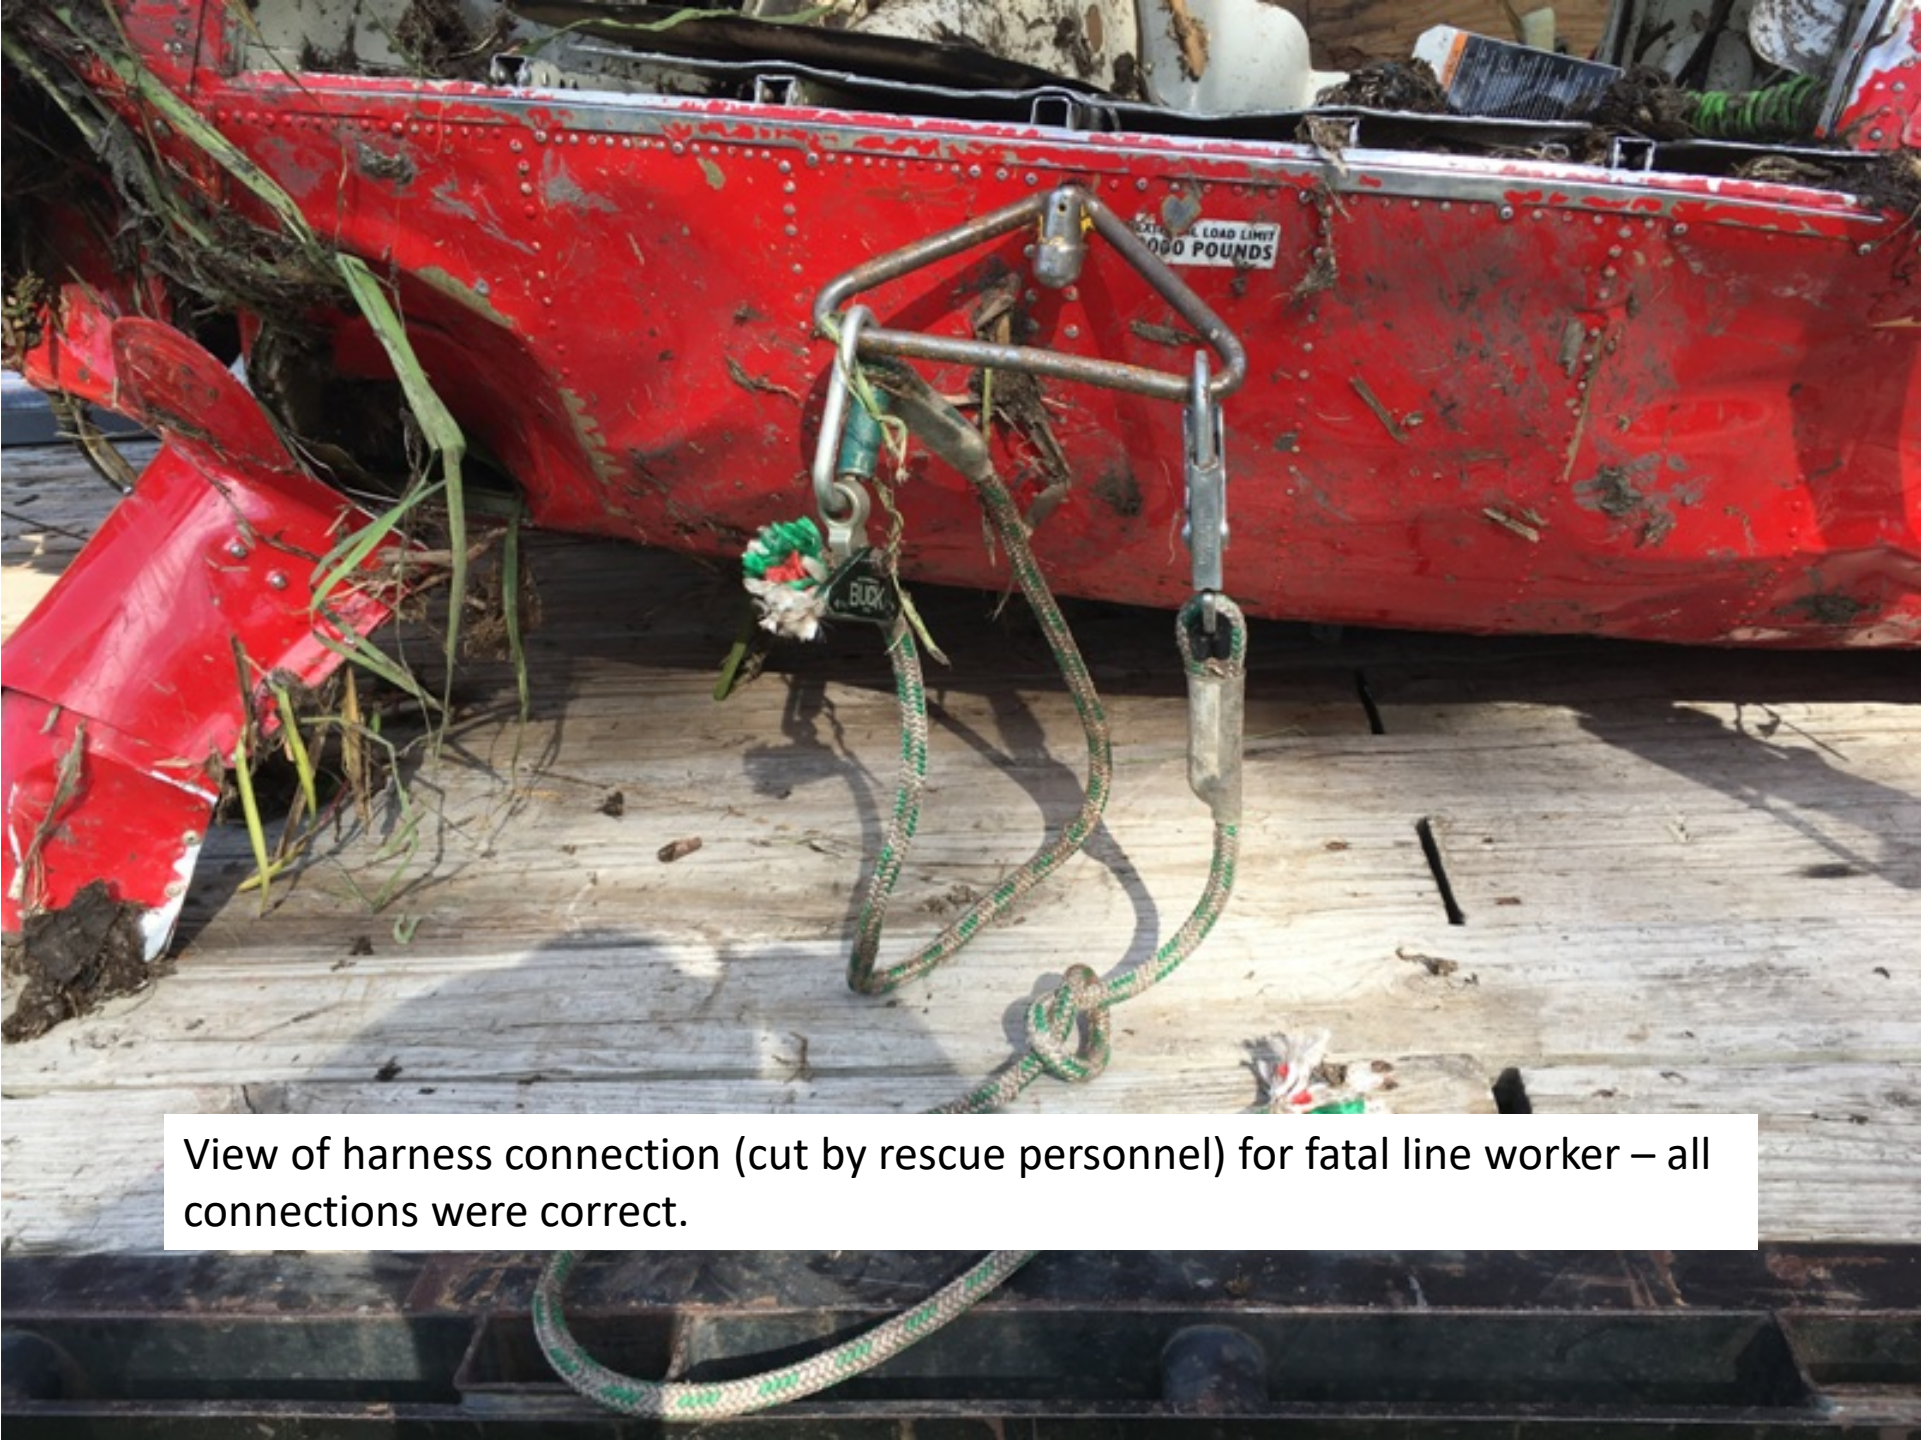
View of harness connection (cut by rescue personnel) for fatal line worker – all connections were correct.
