**NATIONAL TRANSPORTATION SAFETY BOARD**

**Examination Summary**

**CEN18FA227**

On June 15, 2018, at 1538 central daylight time, a Cessna 172N, N734BS, was destroyed when it impacted a powerline and terrain near Rotan, Texas. The pilot and passenger were fatally injured. The aircraft was registered to and operated by Aero Photo under the provisions of 14 *Code of Federal Regulations* Part 91 as a business flight. Visual meteorological conditions existed at the time of the accident. The flight was not on a flight plan. The flight originated from the Midland Airpark (MDD), Midland, Texas, about 1331, and the Spicewood Airport (88R), Spicewood, Texas was the intended destination.

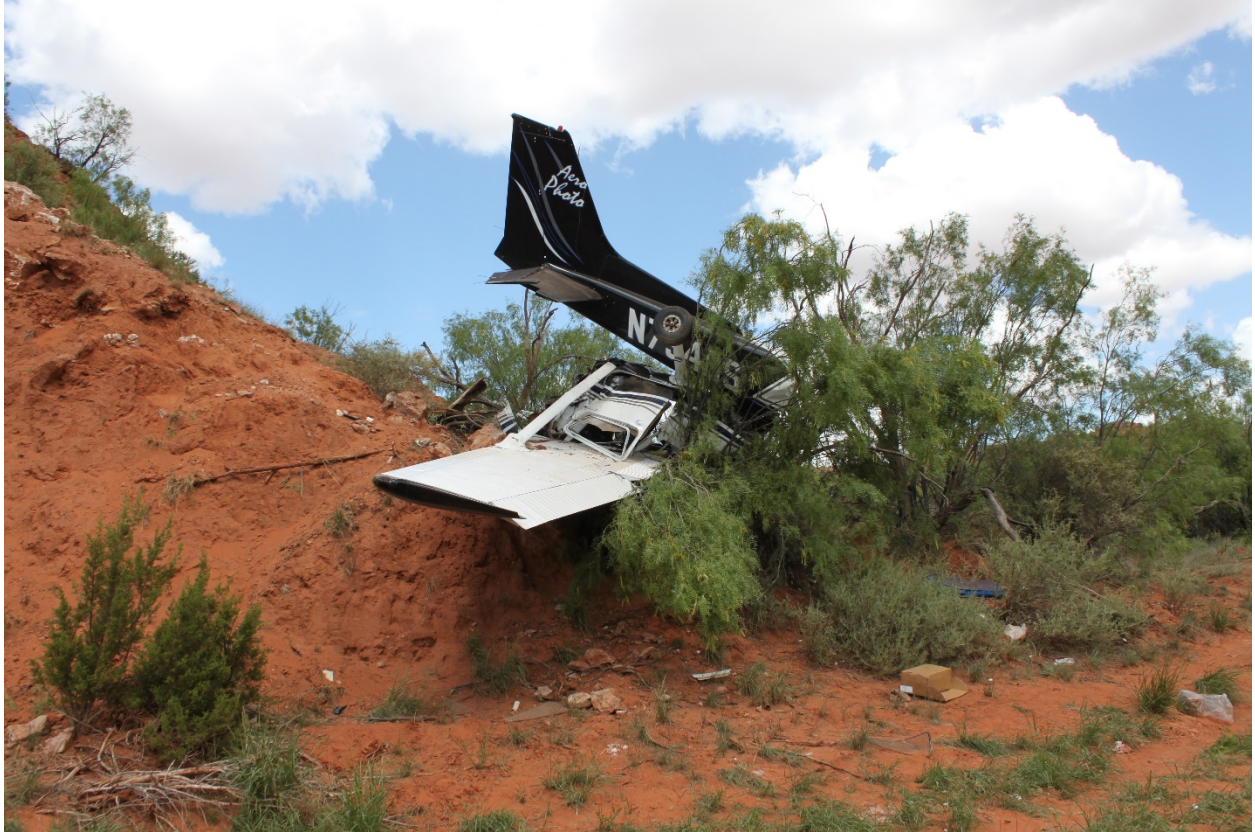
The airplane had departed 88R earlier in the day to perform aerial photography missions. After completing several missions the airplane landed at MDD, reportedly to refuel. After departing MDD on the accident flight, the airplane flew photography missions near Midland, Texas, Odessa, Texas, and Lubbock, Texas. After completing the missions near Lubbock the airplane traveled southeast to return to 88R.

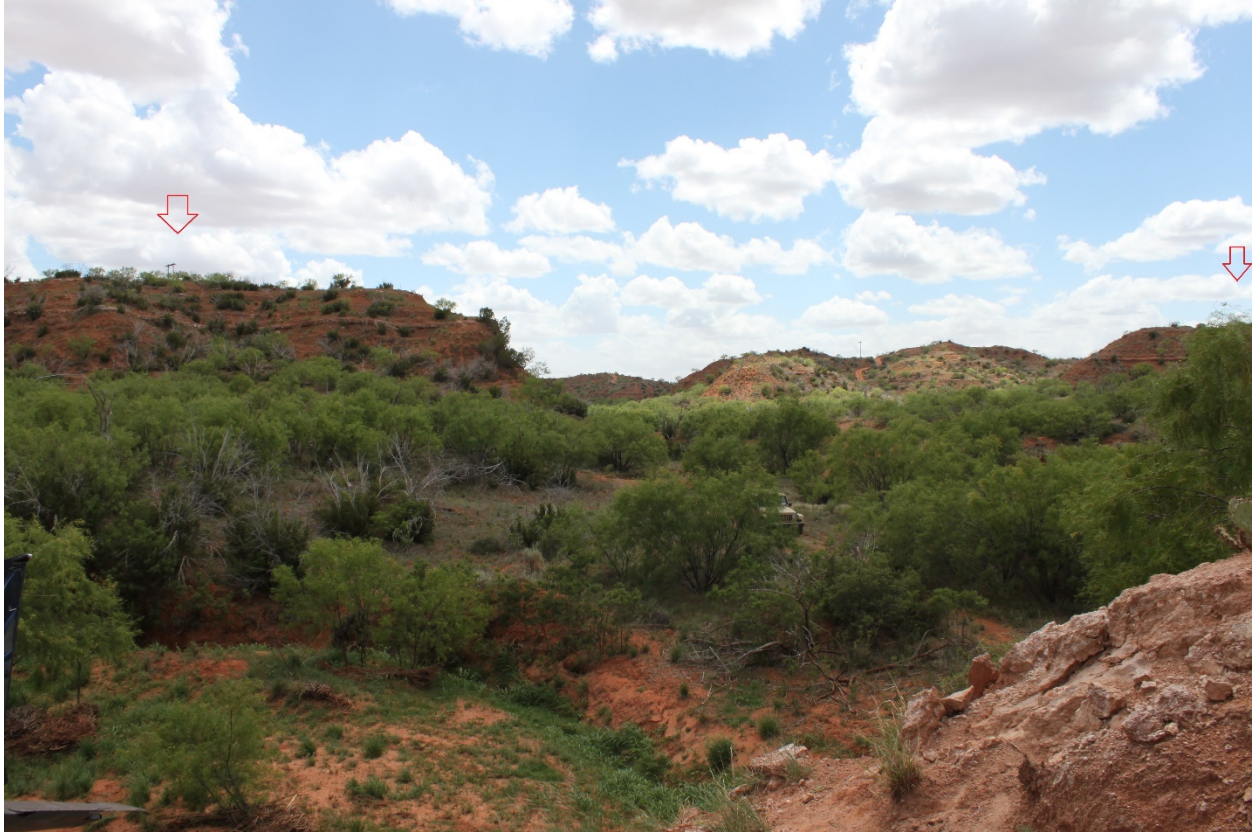
The airplane impacted a powerline that crossed a canyon near Rotan, Texas. The powerline that was struck was suspended from wooden poles about 20 ft tall that were on the peaks of the adjacent ridges forming the canyon. The powerline was estimated to be about 130 ft above the floor of the canyon. The photo above was taken from the wreckage site toward the powerline that was struck and depicts the locations of the poles with red arrows.

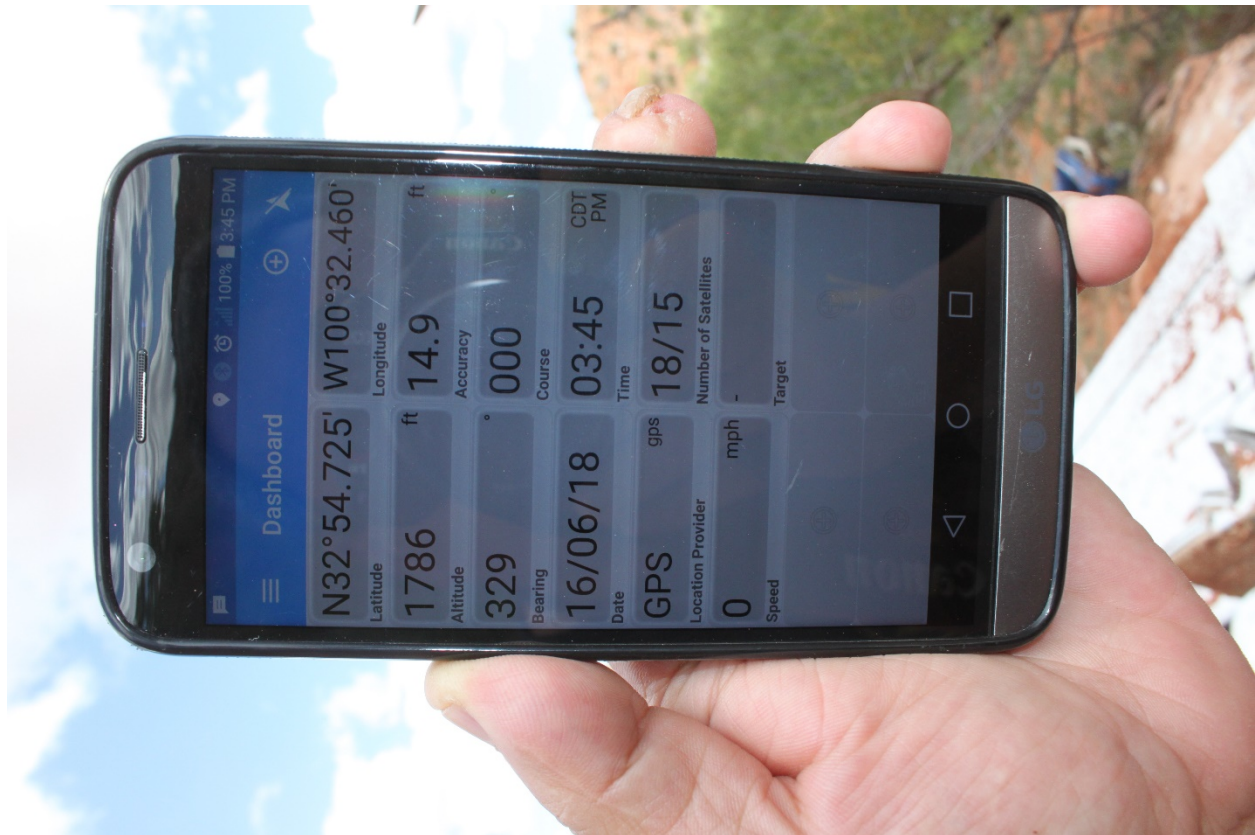
The airplane came to rest on the side of a hill at coordinates as depicted in the above picture.

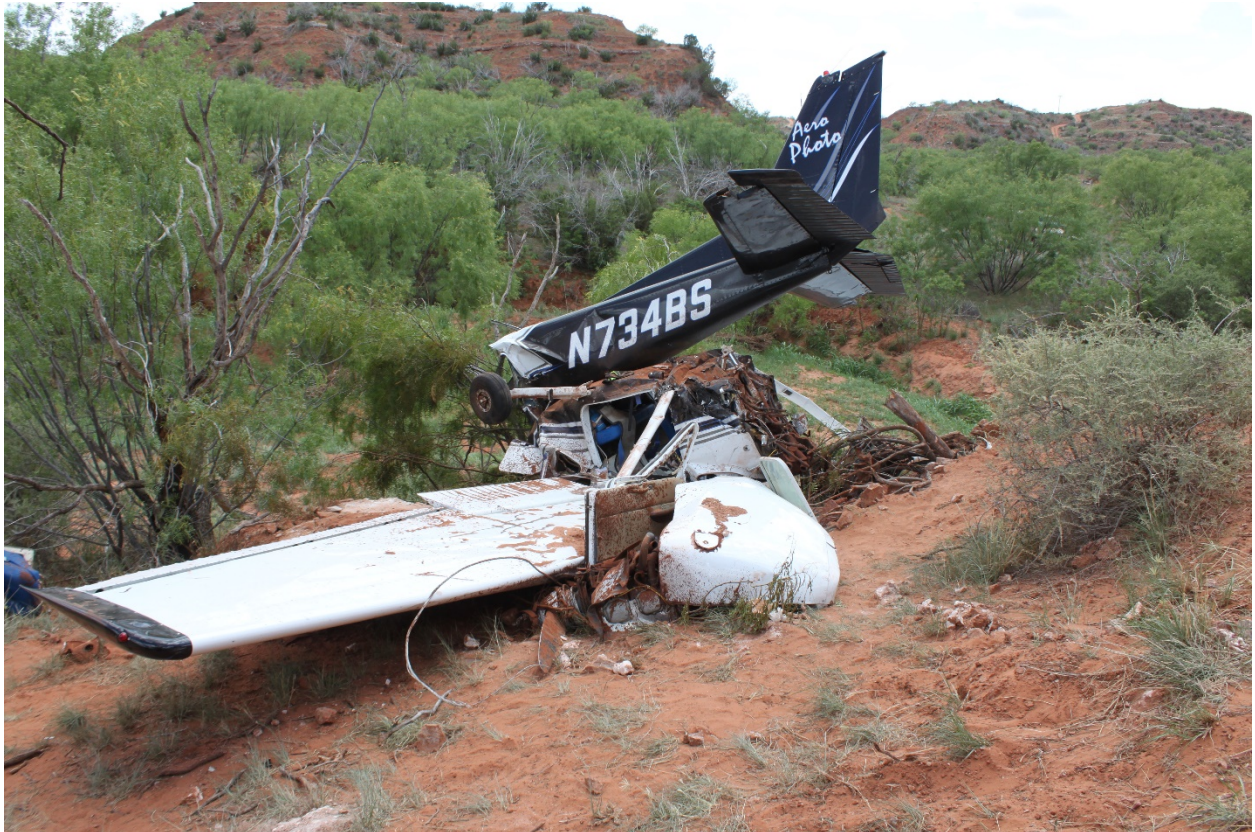
The airplane came to rest inverted. The aft fuselage was broken near the baggage compartment and the entire aft fuselage and tail were bent over the inverted fuselage.

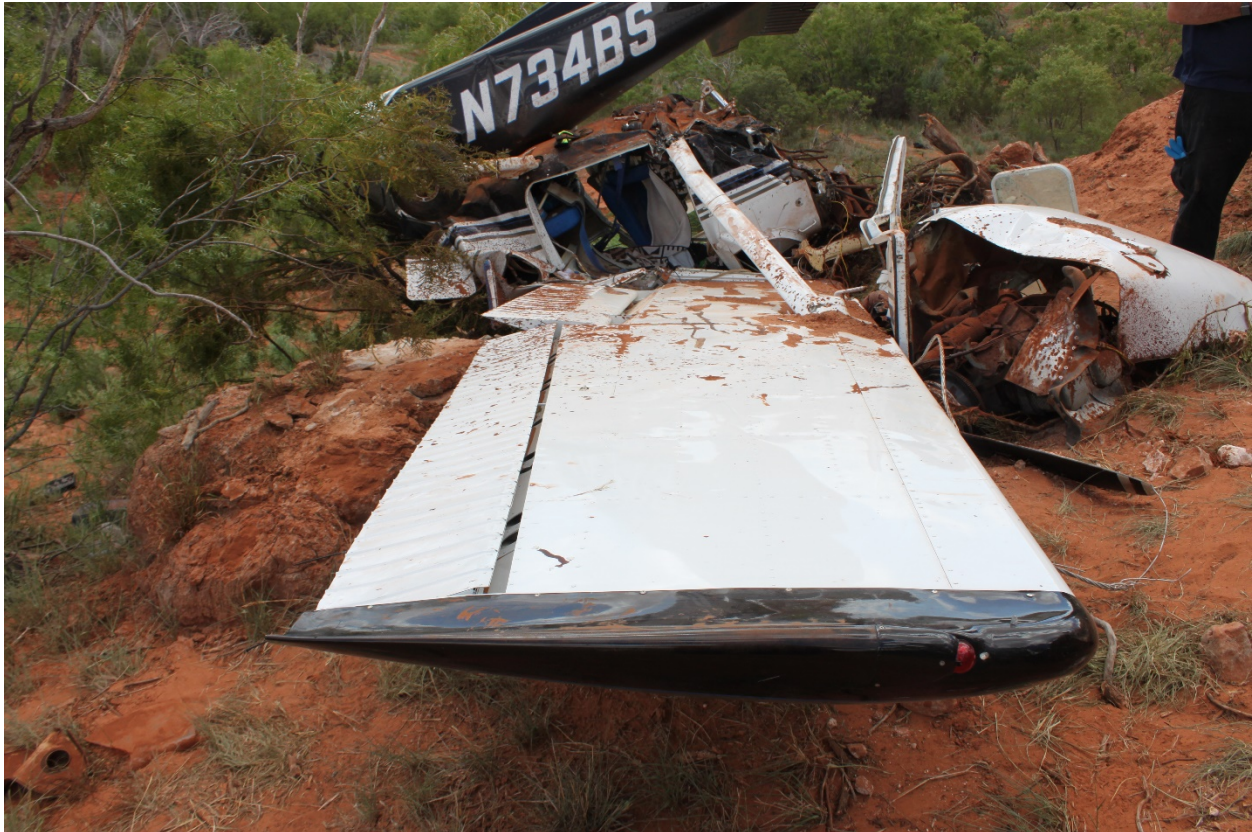
The left wing appeared intact and still attached to the fuselage and wing struts. The ailerons and flaps remained attached to the wing.

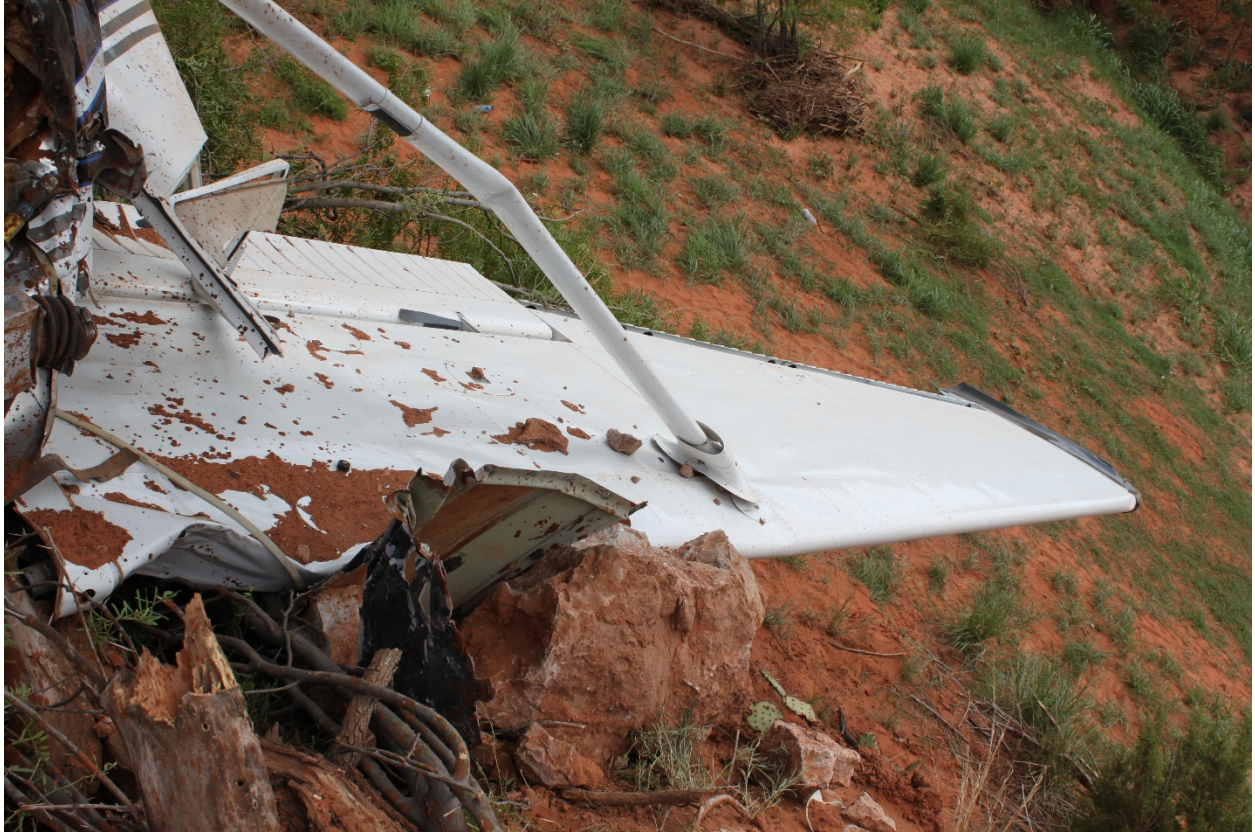
The right wing appeared intact and still attached to the fuselage and wing struts. The ailerons and flaps remained attached to the wing.

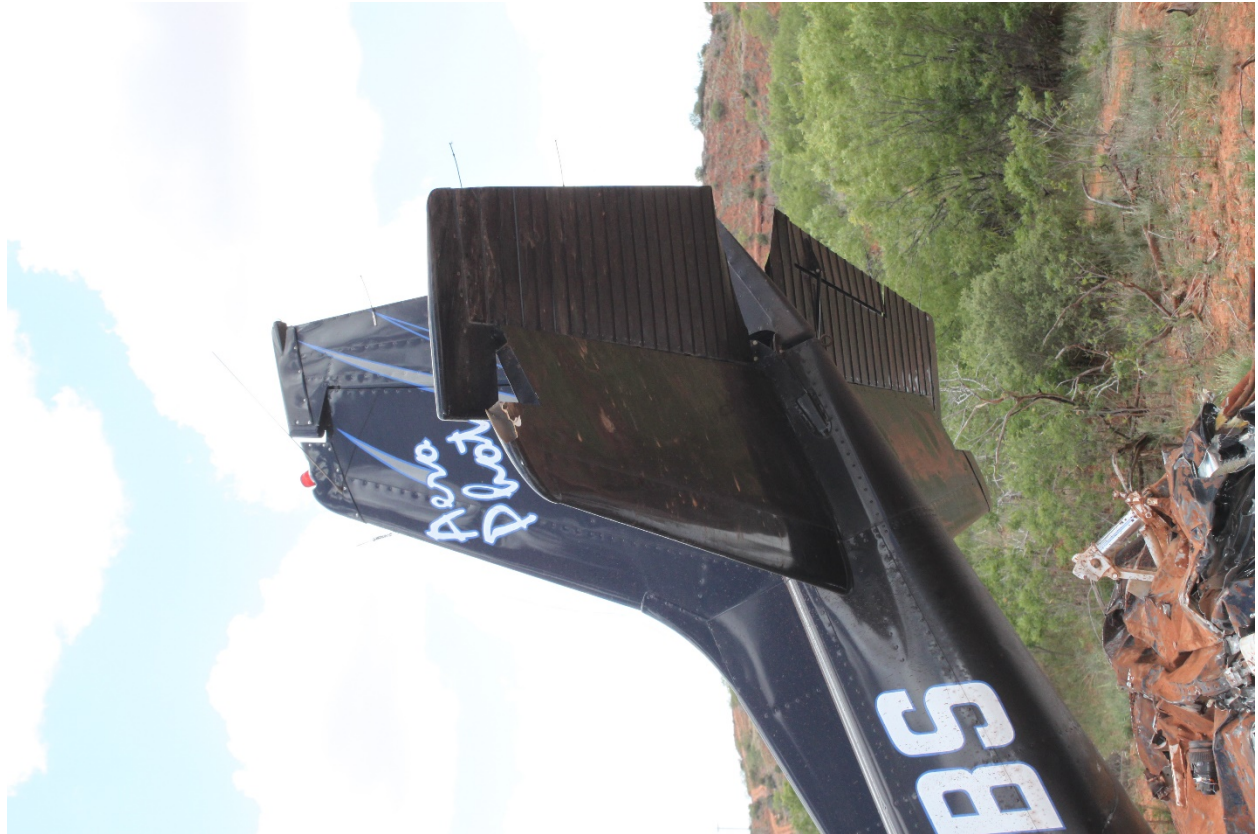
The tail surfaces were intact and the rudder and elevator remained attached.

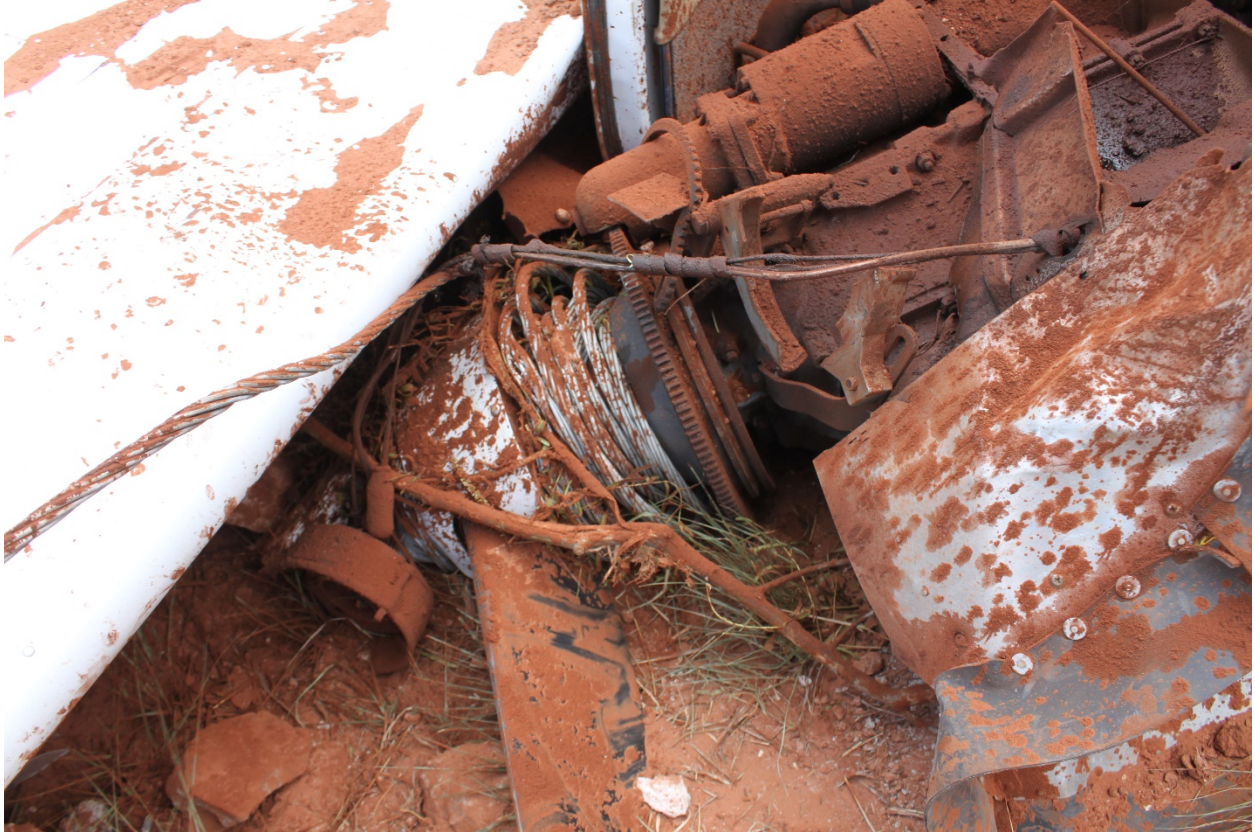
The engine was separated with the prop still attached to the engine. A portion of powerline cable was wrapped around the crankshaft an estimated 15 turns

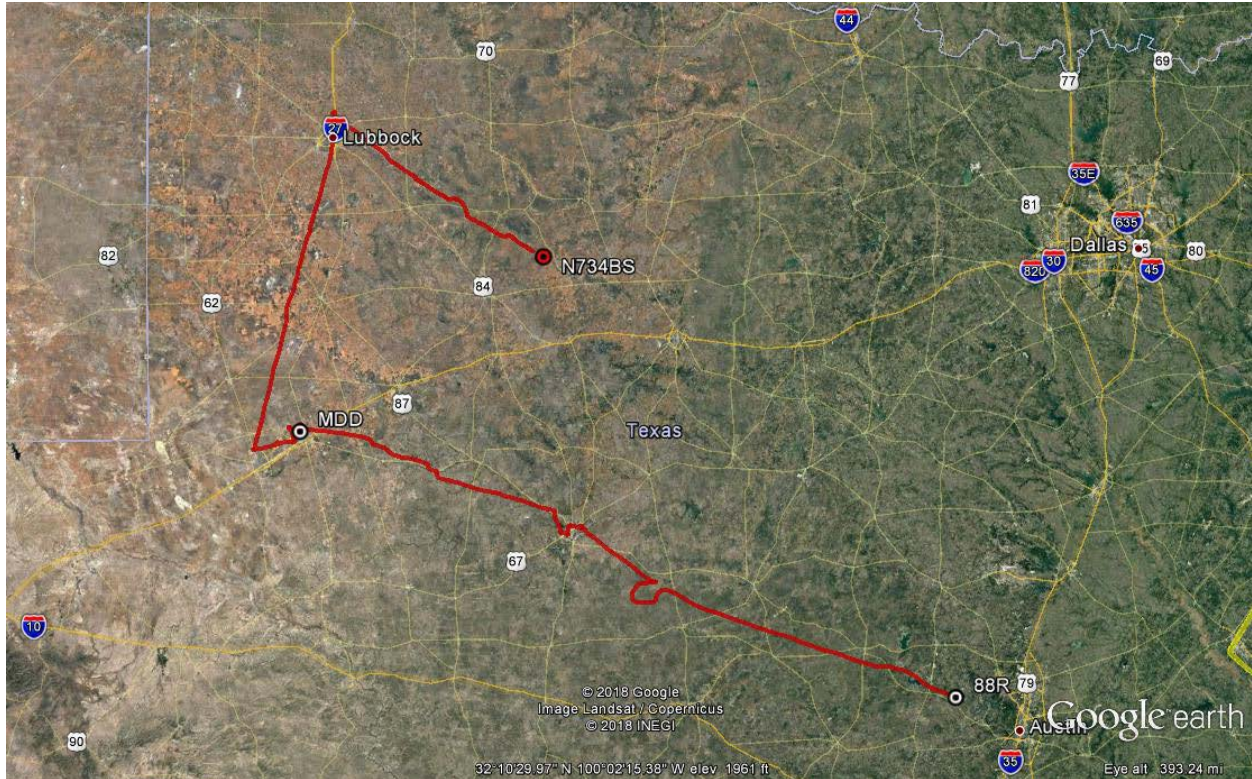
A hand-held Garmin Aera 560 GPS receiver was found within the airplane. The track data from the unit was downloaded using a mini-USB cable to connect it to a laptop computer. The data included track data for the day of the accident which is plotted below. The unit was given to the insurance adjuster for return to the operator.

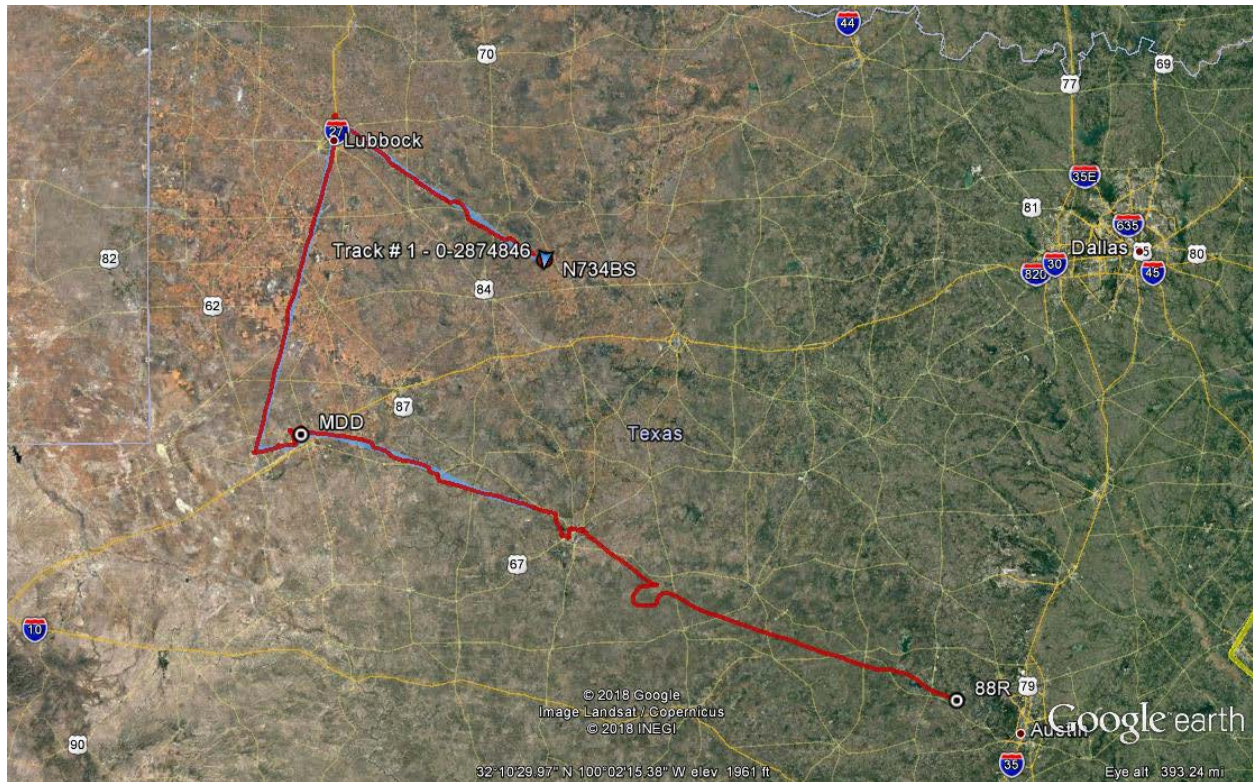
In addition, the airplane owner provided GPS track data from a handheld SPOT GPS receiver that she had employees carry on missions. The SPOT unit sent position information that the company used to remotely track the airplane. The spot data was overlaid on the previous plot as shown here.

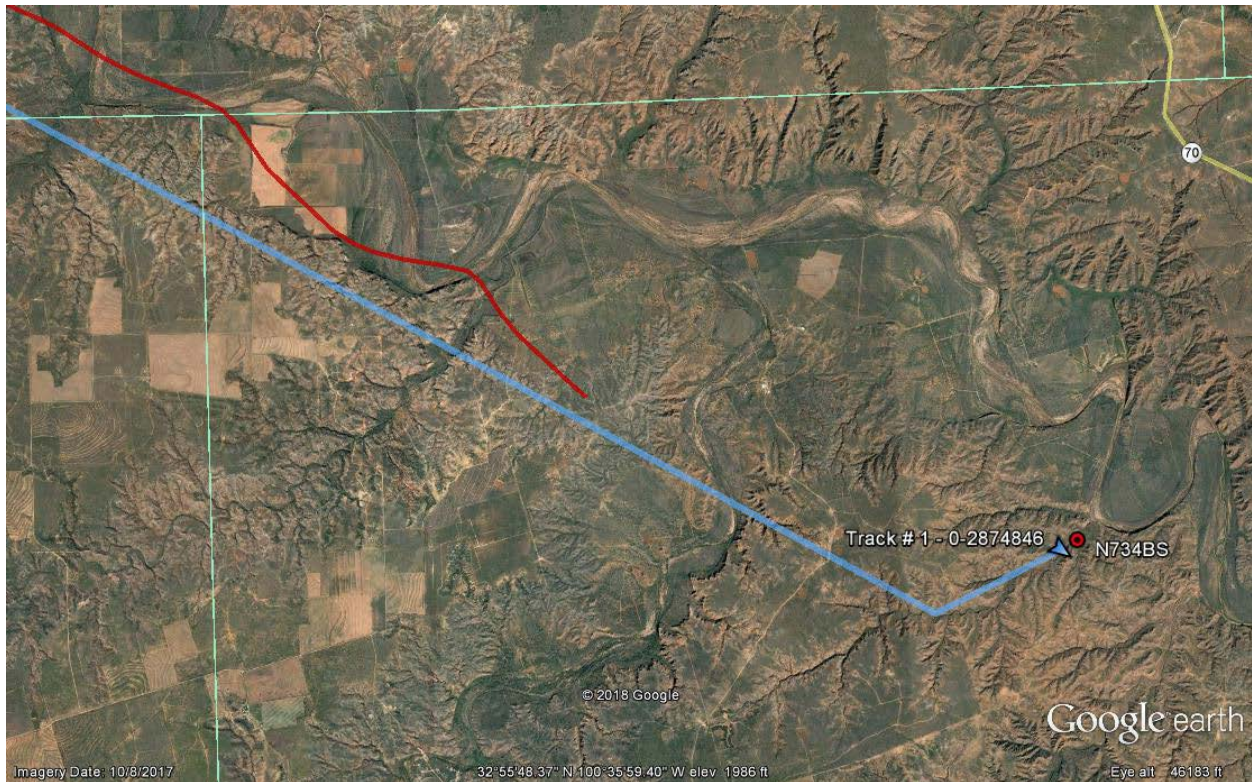
The close up of the final portion of the flight showing the end of the Garmin track in red and the spot track in blue.
