# NATIONAL TRANSPORTATION SAFETY BOARD

Vehicle Recorder Division

### Specialist's Factual Report by Sean Payne

Location: Rotan, Texas  
Date: June 15, 2018  
Aircraft: Cessna 172N  
Registration: N734BS  
Operator: Private  
NTSB Number: CEN18FA227

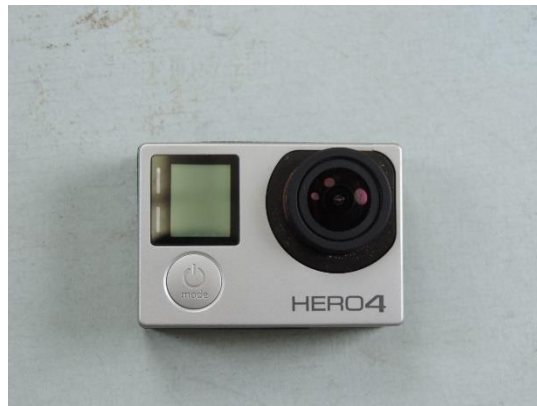
The device was undamaged. The microSD card was found seated in the device's memory card slot. The microSD card was undamaged. Files were copied off the microSD card normally. Figure 1 is a photo of the GoPro Hero 4.

Figure 1. Photo of undamaged GoPro.

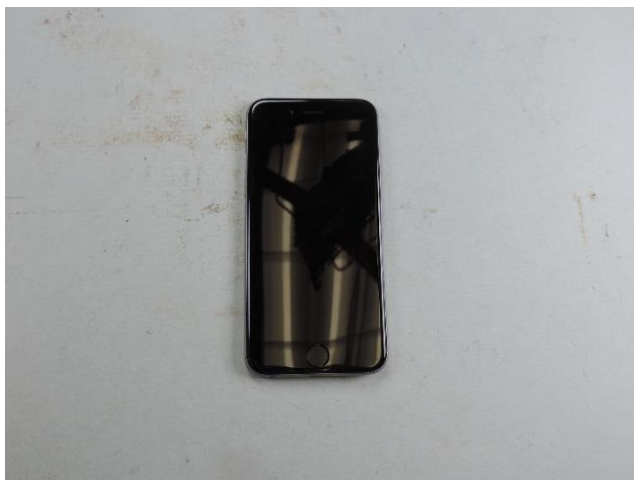
The device's screen was cracked and the aluminum chassis was bent. The iPhone 6 is shown in figure 2. The device was opened, the internal memory board was found to be slightly bent. The device's internal memory board was removed and placed in a surrogate device. The surrogate device powered the screen but the device would not boot. No data was recovered from the device.

Figure 2. The damaged iPhone as received by the lab.
