## **NATIONAL TRANSPORTATION SAFETY BOARD**

# **ENGINE EXAMINATION**

**CEN18FA235**

Location: Monmouth, IL (accident site)  
Date: June 25, 2018  
Aircraft: Ercoupe 415 D, N94070  
NTSB IIC: Josh Lindberg

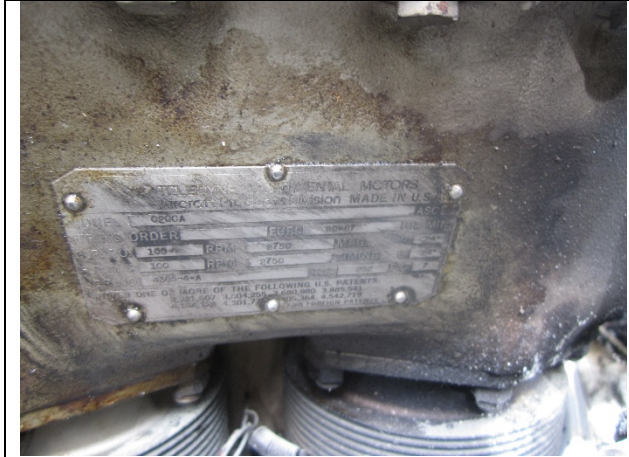
Engine identification plate:  
Continental O-200A

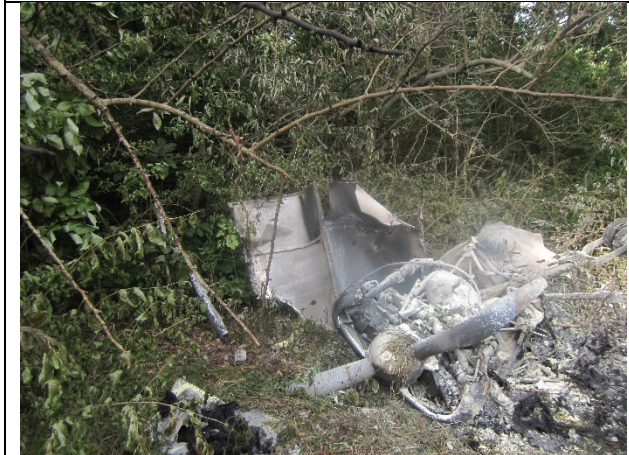
The engine as found on site: The engine is upside down, the two-bladed, fixed pitch propeller is still attached. The oil sump was punctured and absent engine oil. Extensive fire damage is noted to the engine and components.

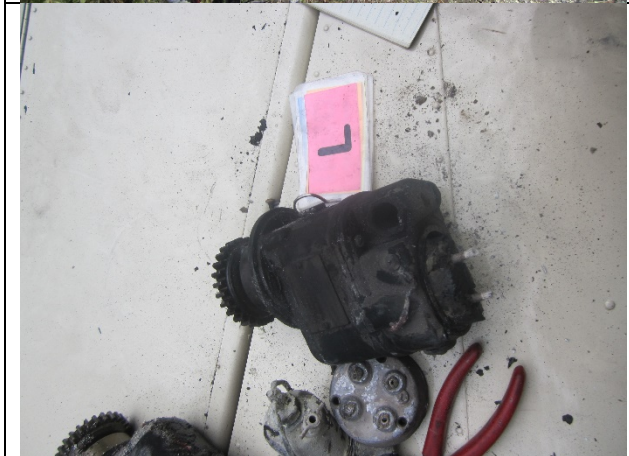
The engine was equipped with two impulse coupled Slick magnetos. The magnetos were removed from the engine, both magnetos rotated and the impulse coupling triggered when the mag was turned by hand. Neither magno produced a ignition spark, however, both magnetos internal components were melted.

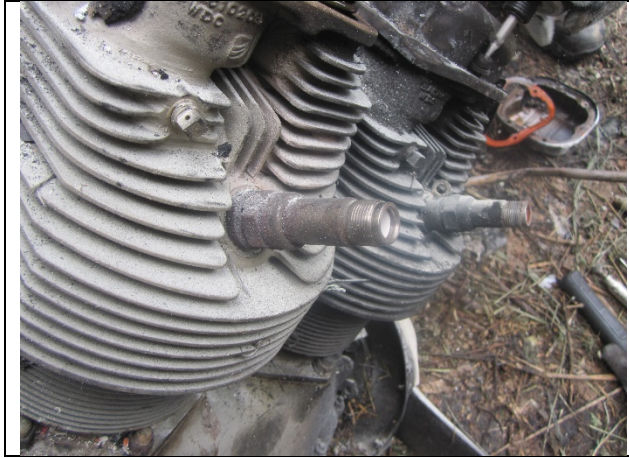
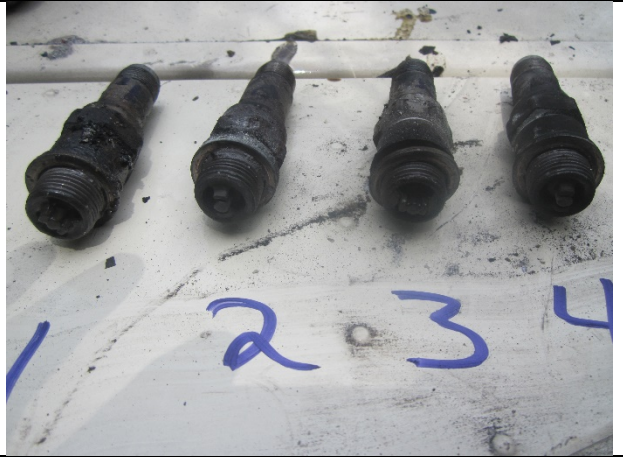
The top set of sparkplugs were removed; the plugs had normal wear; two of the four plugs were oil soaked from the presence of engine oil in the cylinders.

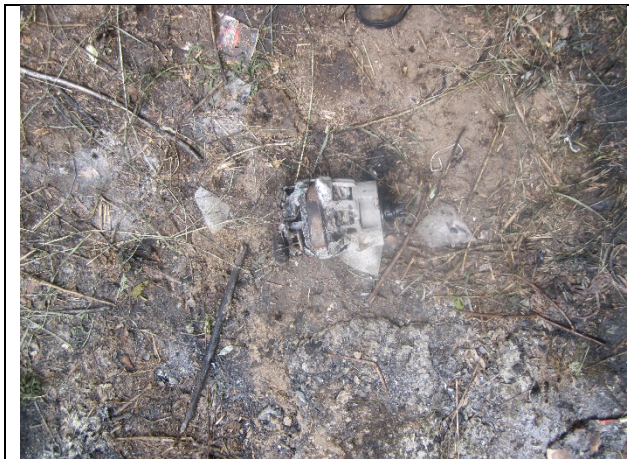
The rear mounted alternator was removed. The alternator had heavy thermal and impact damage. The unit would not rotate, by hand.

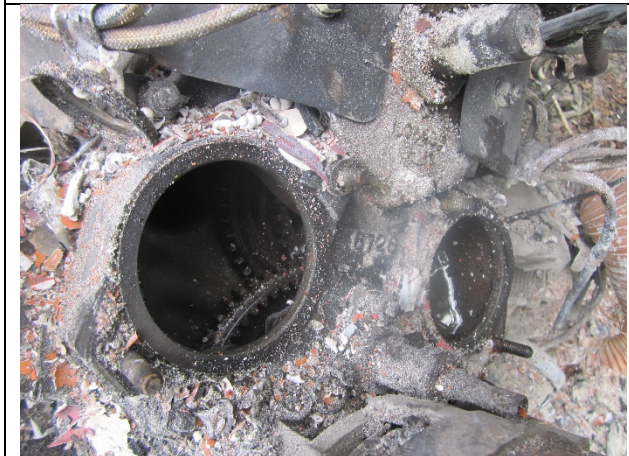
The accessory drive gears, had a light coating of oil on them. No mechanical abnormalities were noted to the gears.

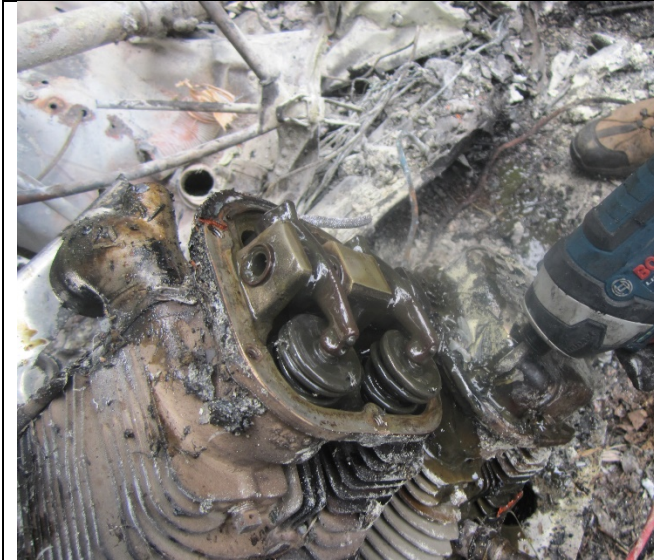
The four valve covers were removed, the two cylinders on the down side of the engine, as it laid, contained engine oil. When the propeller was rotated by hand, the valves operated: Continuity was confirmed thru the valve train to the accessory section.

A thumb compression and suction test was performed and each cylinder exhibited compress/suction.

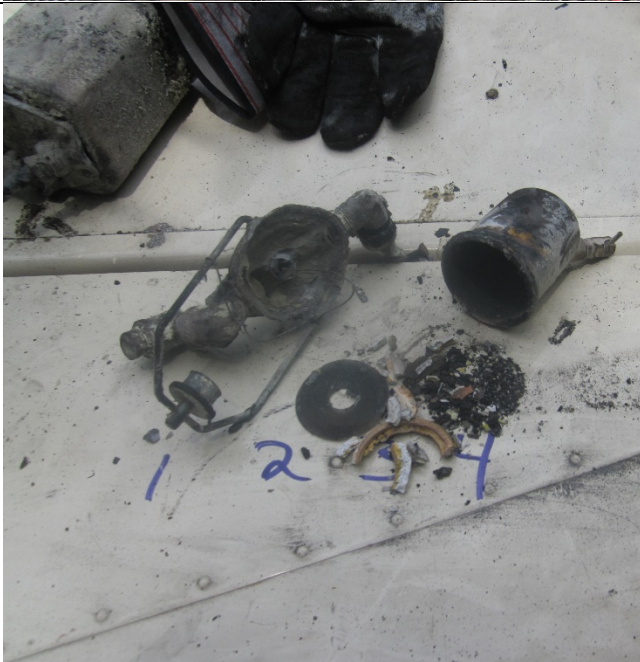
The gascolator was found next to the carburetor, and not attached.

The unit was fire damaged and the bowl was open to the environment.

The screen was clear; however, fire debris was found in the bowl.

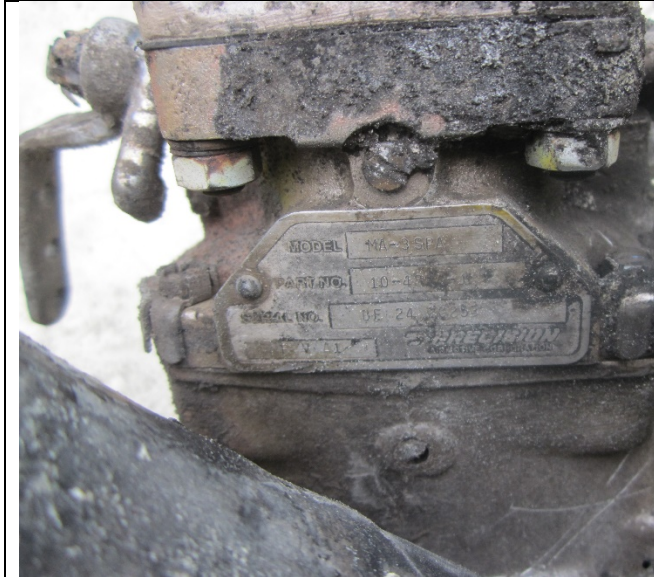
The carburetor was identified as a Precision MA-3 SPA

The carburetor's mounting flange was broken and the carburetor was on top of the engine, as the engine laid. The carburetor had thermal and impact damage.

The throttle cable was still attached to the carburetor.

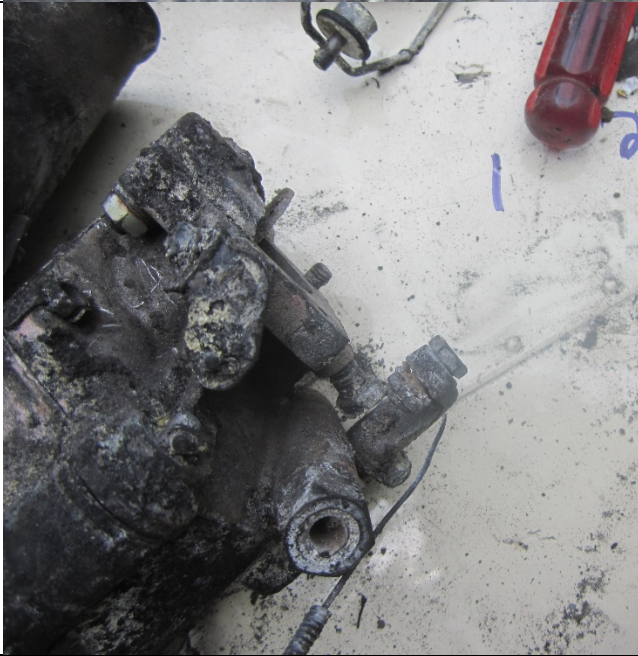
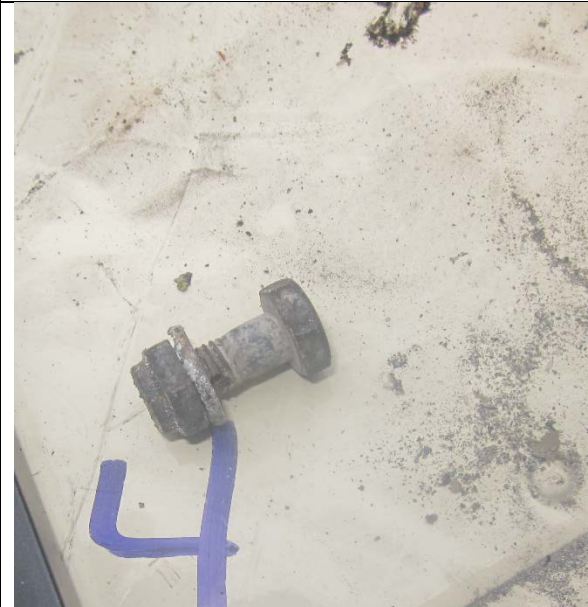
The mixture control cable was not attached. The cable end had slight serrated marks on it, but absent stretch marks.

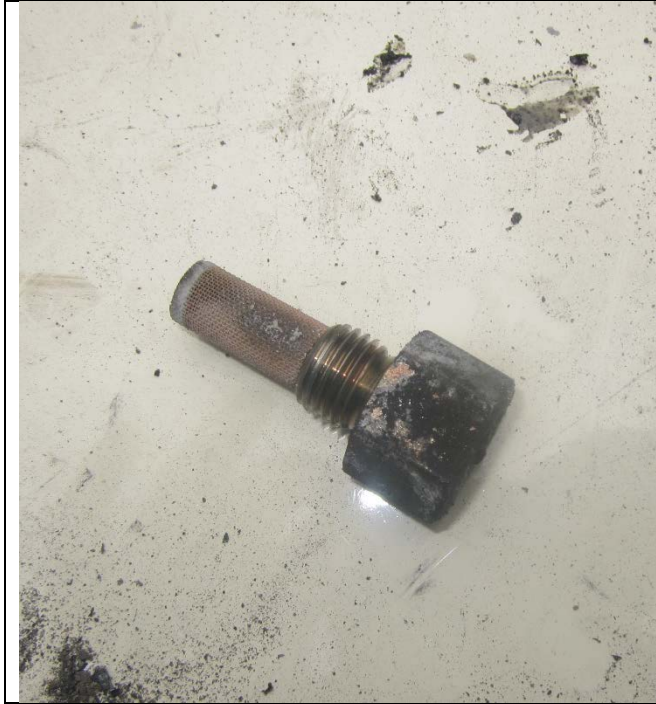
The carburetor finger screen, contained only a small amount of debris.

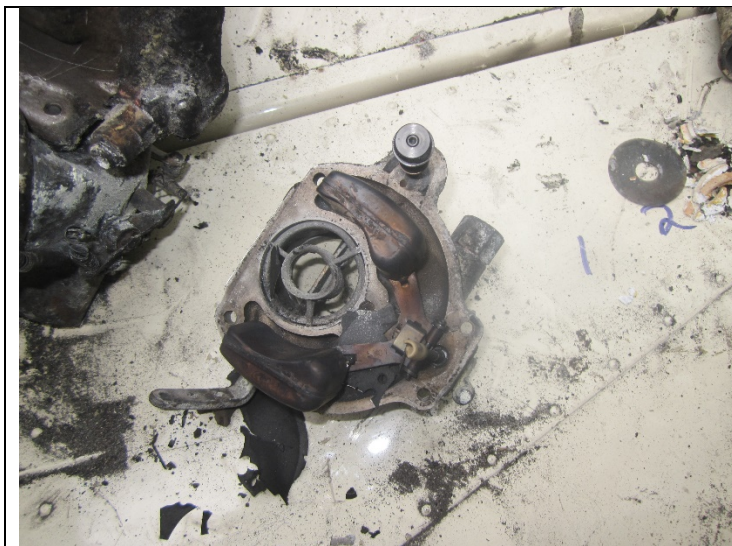
The carburetor was partly disassembled. The floats were in place, and the bowl was absent contaminants and debris.

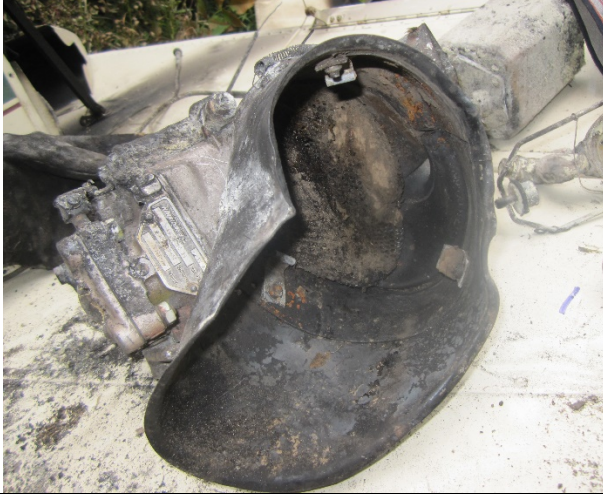
The carburetor inlet screen: initially, the inlet was packed full of dirt during the accident sequence. The dirt was removed; the screen was displaced from its original mounting location.

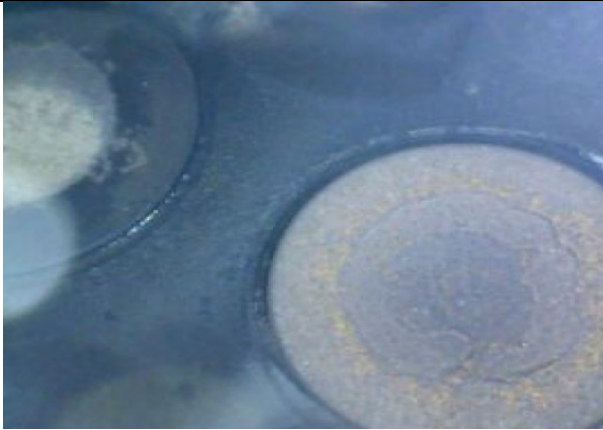
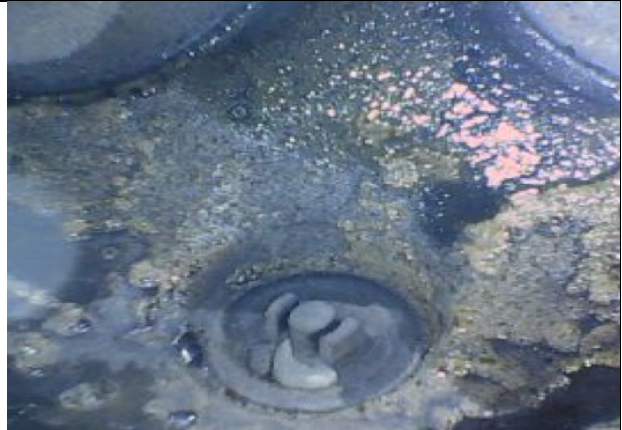
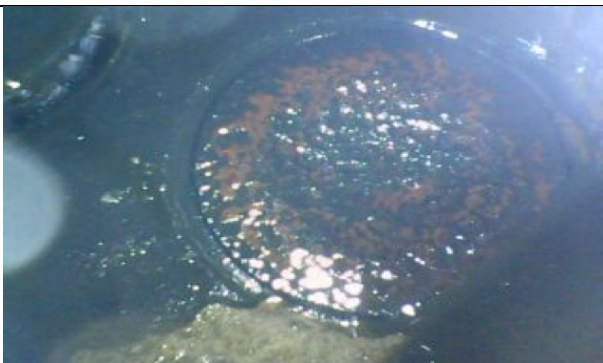
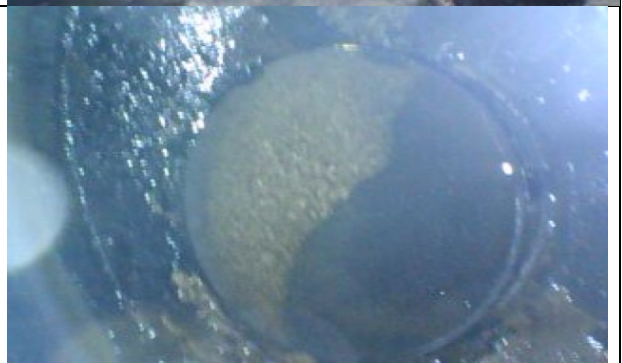
Each cylinder was inspected using a lighted borescope. The cylinders contained normal combustion deposits, engine oil was noted in two cylinders and attributed to the engine position, after the accident. No abnormalities were noted to either the intake or exhaust valves.

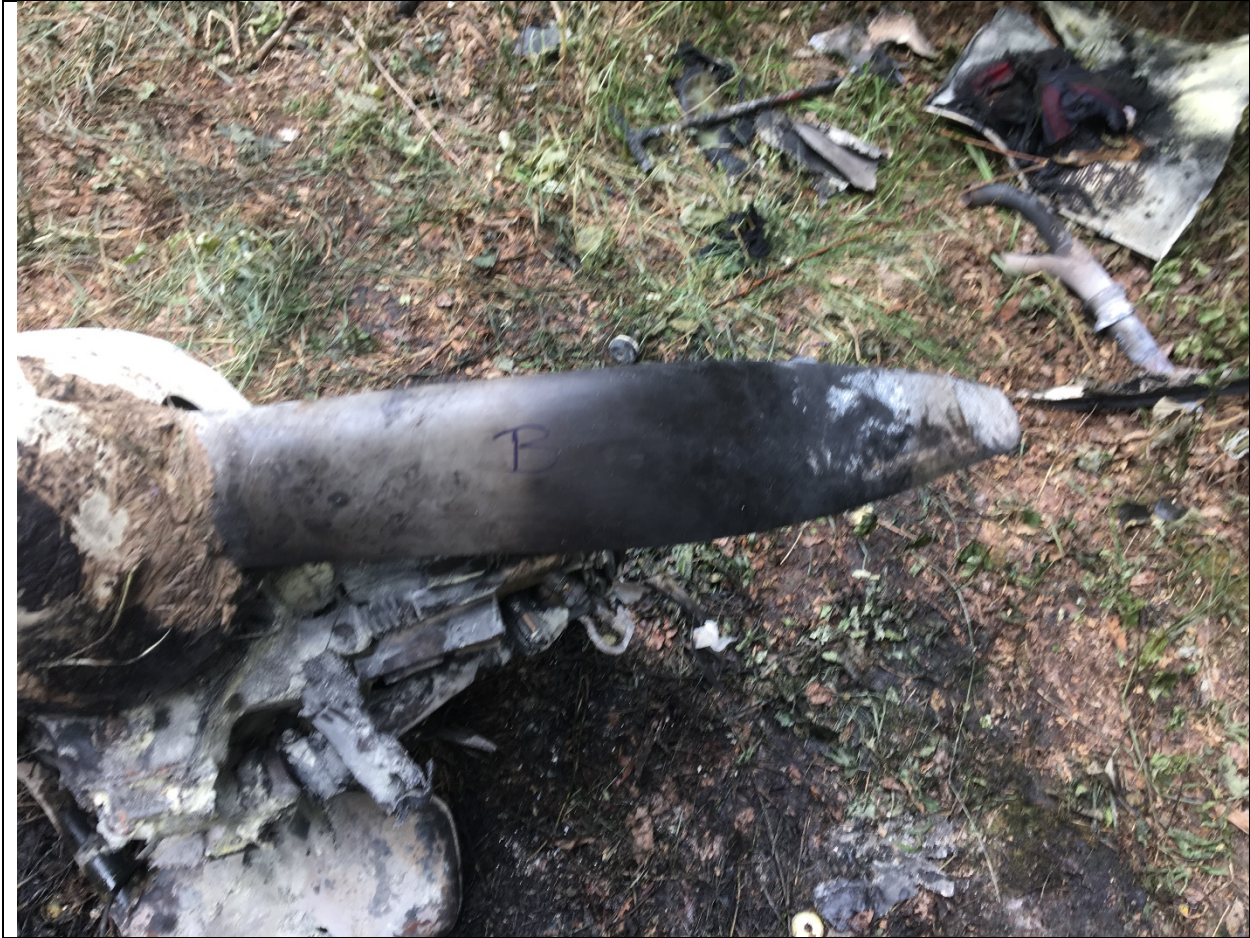
The blades on the propeller were labeled as “A” and “B” for identification purposes.

Blade “B” was bent aft, starting about mid-span, the tip had fire damage. The blade was absent twisting, cordwise scratches and leading edge polishing.

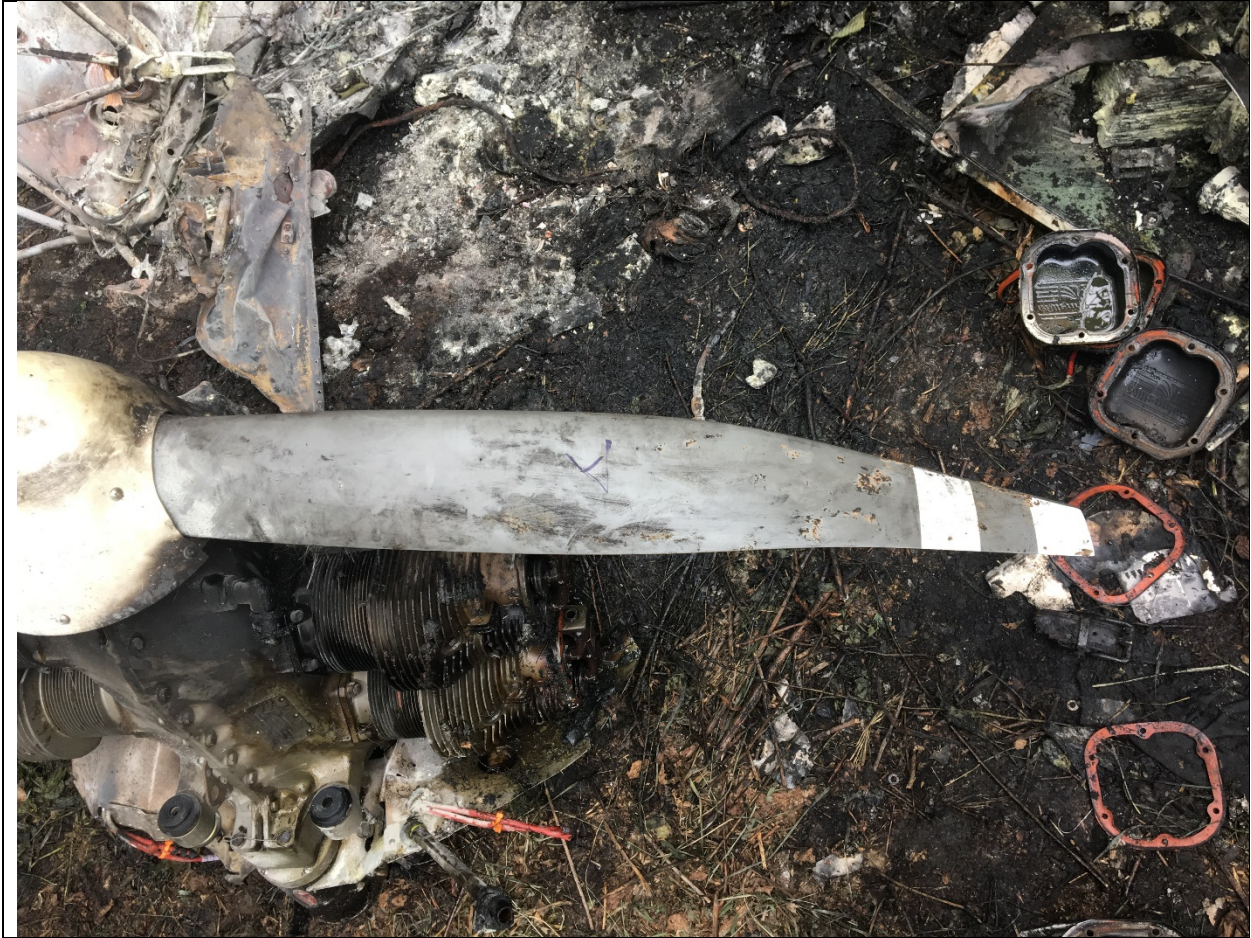
Blade “A” as bent aft, outboard. The blade was absent twisting, cordwise scratches and leading edge polishing.
