**NATIONAL TRANSPORTATIONS SAFETY BOARD**  
**Office of Aviation Safety**  
**Washington, DC 20594**

**SUMMARY OF AIRCRAFT EXAMINATION**

-- CEN18FA258 --

Location: Arlington, Indiana  
Date: July 6, 2018  
Time: 1720 Eastern Daylight Time  
Aircraft: Bell 47G-2, N96195

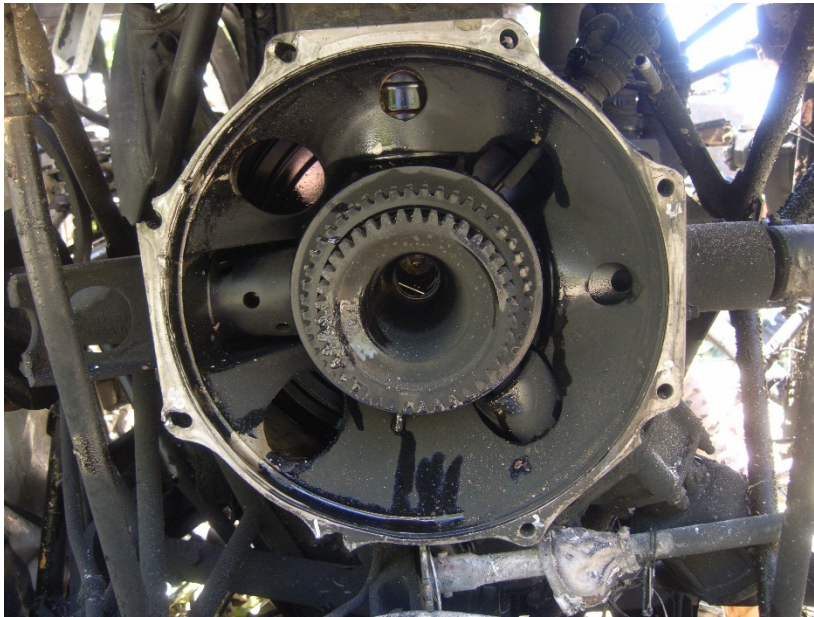
*Figure 1. Lower Transmission*

The lower portion of the transmission remained attached to the engine. The internal gears of the transmission rotated without hesitation when rotated at the engine and at the tail rotor spline. A large scar or witness mark was observed on the inside well of the transmission. The mounting holes on the housing of the transmission were labeled 1 through 8 for identification purposes in the report. (See figure 1) The #1 and #7 holes were torn and partially separated, and no fasteners remained. The #2 and #3 holes were unremarkable, and no fasteners remained. The #4 and #5 holes were elongated, and no fasteners remained. The #6 and #8 holes were elongated, and the material exhibited tearing on the outer edge of the hole. No fasteners remained.
