# National Transportation Safety Board

## Performance Study

### Specialist Report

| NTSB Number: | CEN18FA258 |

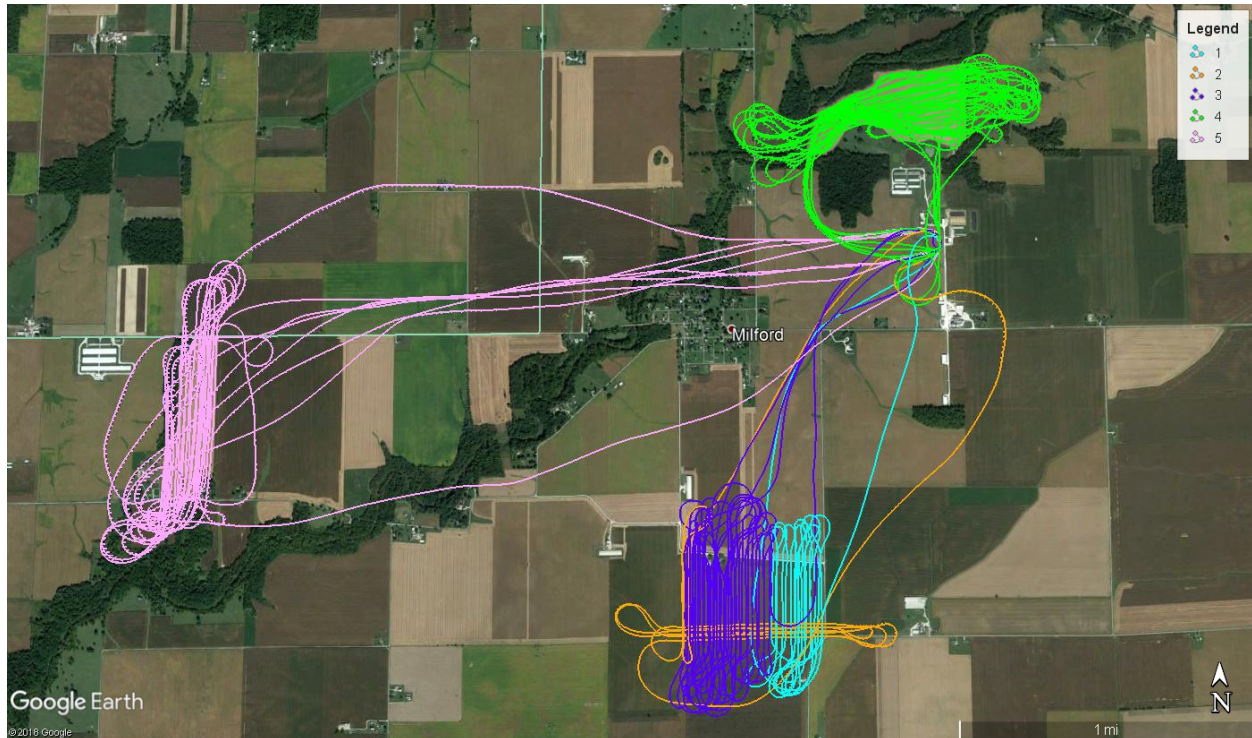
The five earlier flights were from July 6, 2018 near Milford, Indiana, about 20 miles south of the accident. The respective flight lengths were 15 minutes, 47 minutes, 12 minutes, one hour 17 minutes, and one hour two minutes. Figure 1 shows these flights.

**Figure 1:** Five flight paths from July 6, 2018 on the Trimble Trim Flight 3.

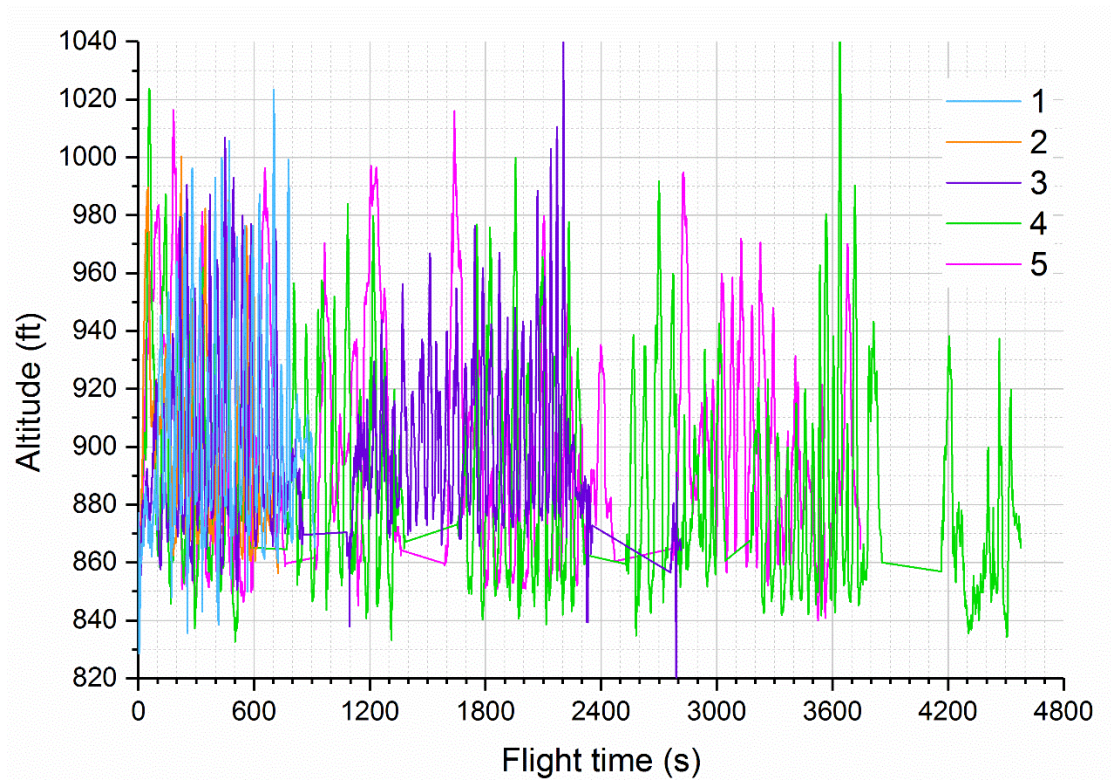
Altitude (Figure 2) and groundspeed (Figure 3) were consistent for the five flights. The aircraft stayed between 100 and 150 ft above the ground and groundspeeds varied between 40 and 60 kts. The aircraft's reported cruise airspeed is 73 kts and its maximum speed is 91 kts.

**Figure 2:** Altitude versus flight time. Ground level in the area was between 820 ft and 850 ft.

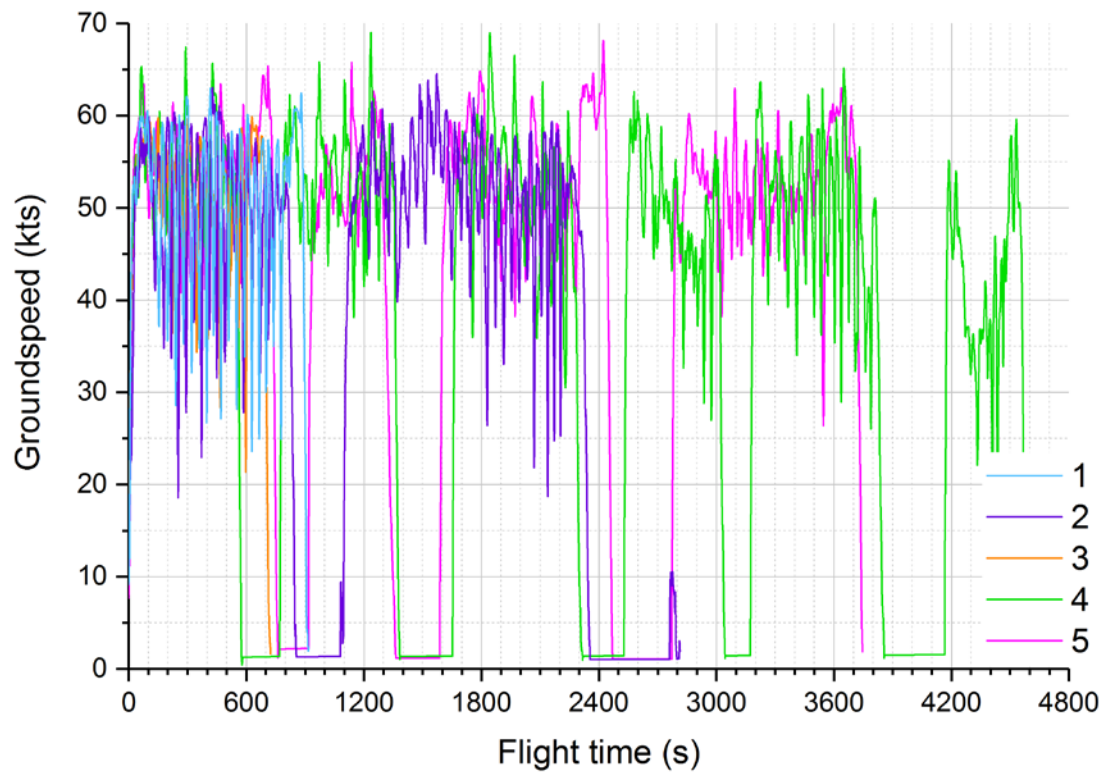
**Figure 3:** Groundspeed versus flight time.

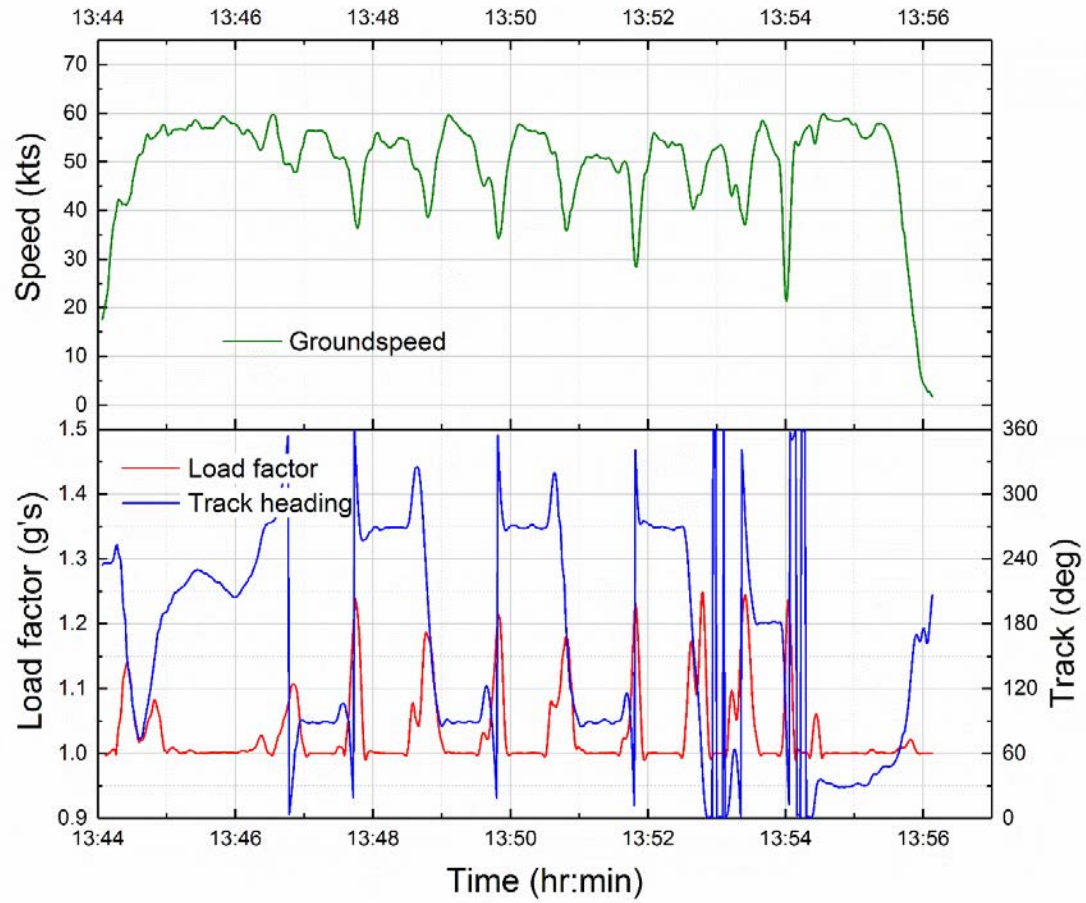
Figure 4 shows the groundspeed, load factor, and track angle for flight 3, the shortest of the recorded flights. The load factor increased during turns when the track angle was changing. For this flight, the smoothed load factor did not exceed about 1.25 g's. Figure 5 through Figure 8 show the groundspeed and load factor for the other four flights. The track angle was omitted from these long flights for clarity. Some flights show peak turning load factors of 1.45 g's, but this is considered within the range of normal flight as most helicopters can sustain a load factor between 2 and 2.5 g's.

**Figure 4:** Groundspeed, load factor, and track angle versus flight time for flight 3.

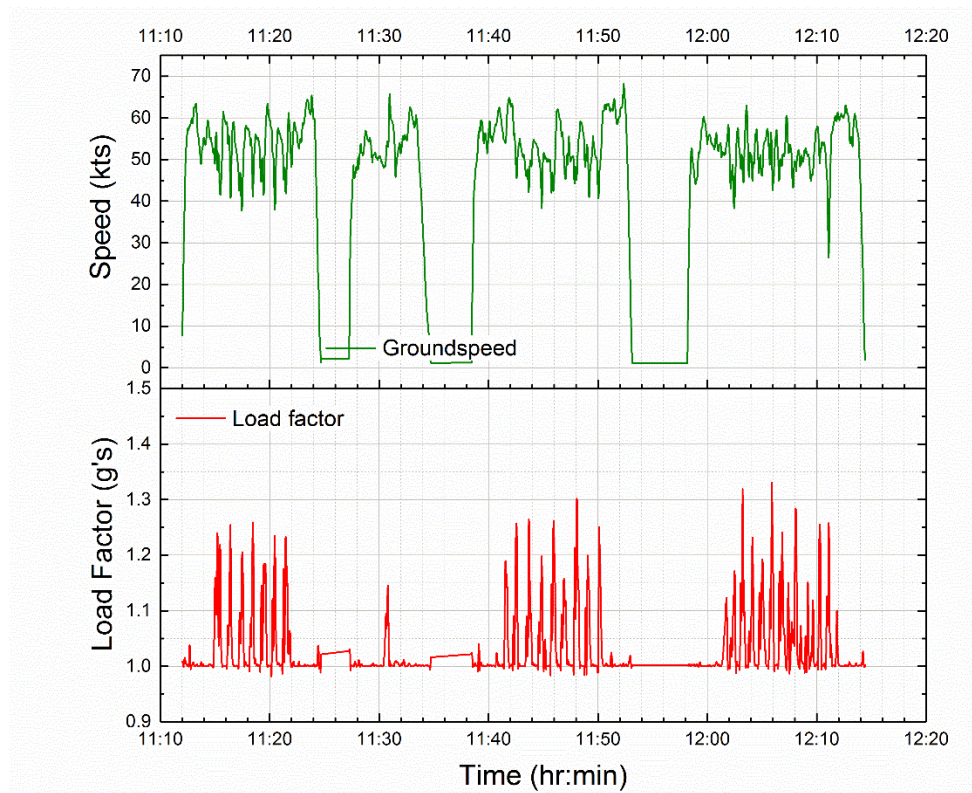
**Figure 5:** Groundspeed, load factor, and track angle versus flight time for flight 1.

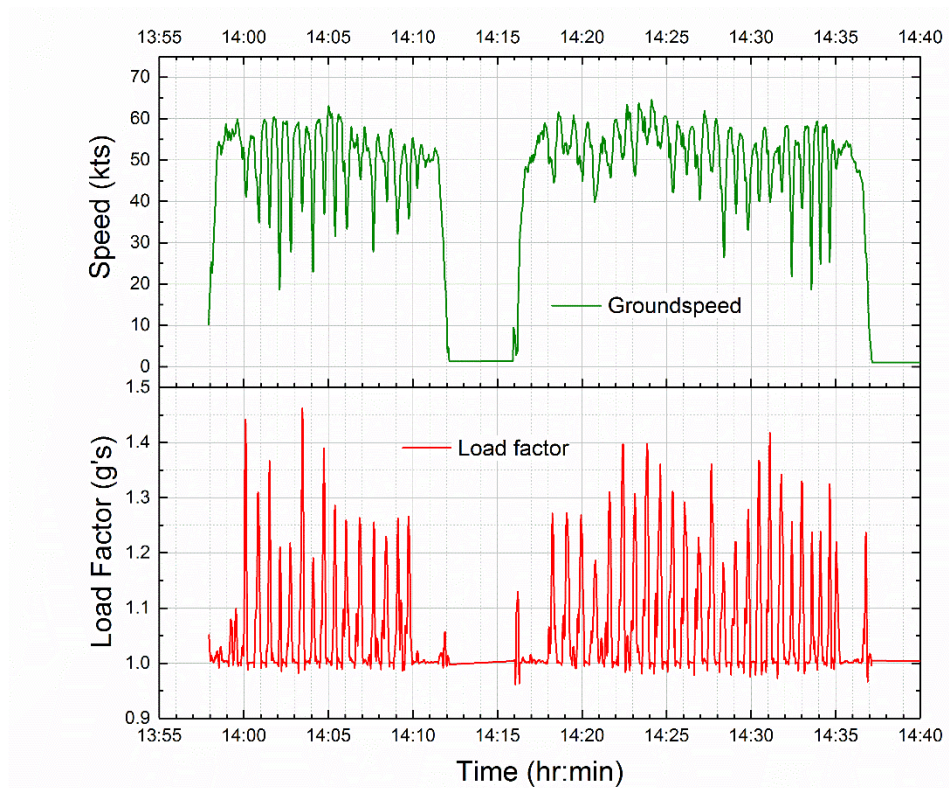
**Figure 7:** Groundspeed, load factor, and track angle versus flight time for flight 4.

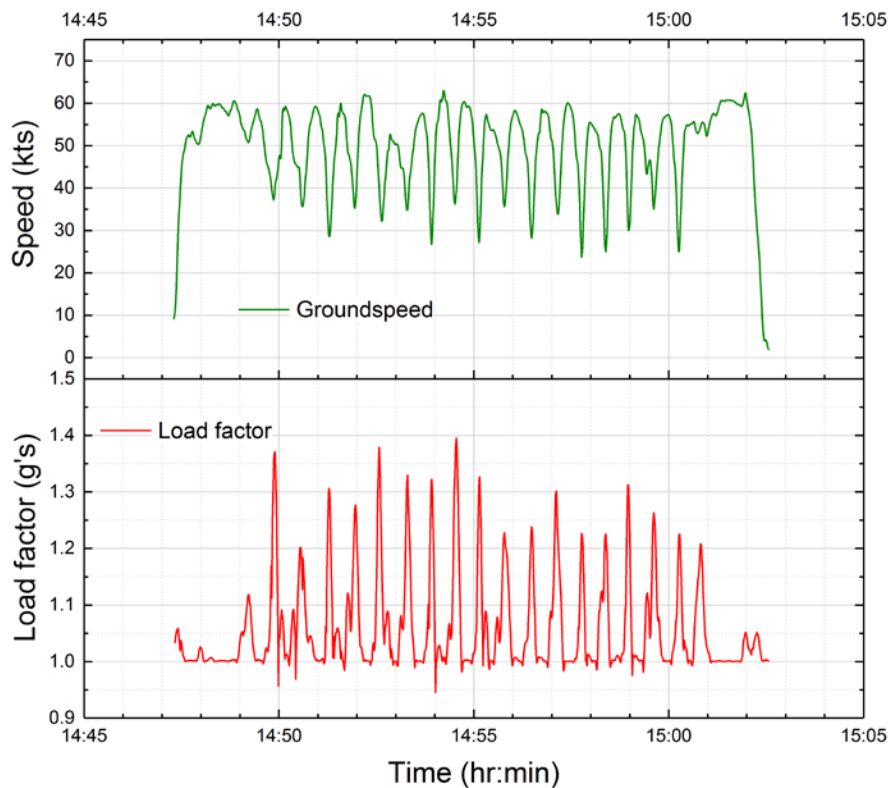
**Figure 8:** Groundspeed, load factor, and track angle versus flight time for flight 5.
