# NATIONAL TRANSPORTATION SAFETY BOARD

MATERIALS LABORATORY FACTUAL REPORT

Report No. 18-074

Place : Arlington, Indiana  
Date : July 6, 2018  
Vehicle : Bell 47G-2  
NTSB No. : CEN18FA258  
Investigator : Jennifer Rodi, AS-CEN

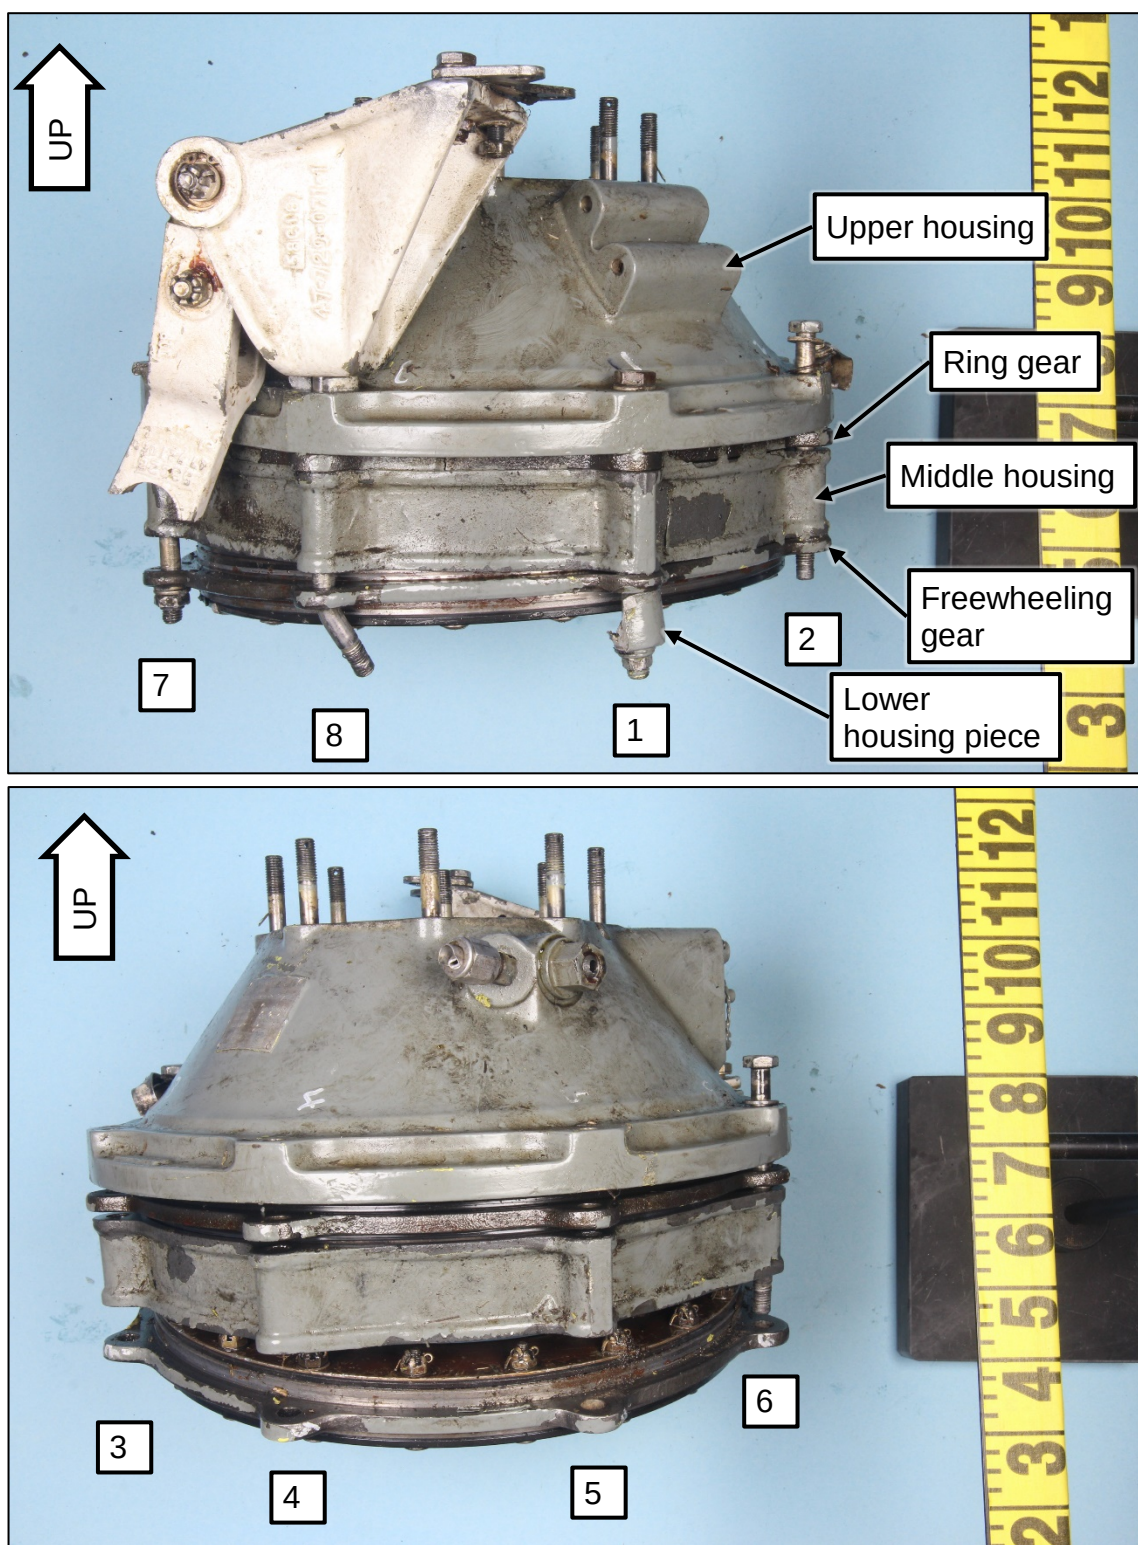
Overall views of the submitted main rotor housing assembly components are shown in figures 1 and 2. The eight attachment bolts for attaching the pieces of the housing, ring gear, and freewheeling gear are shown, and the corresponding attachment locations are numbered counterclockwise as viewed from above, consistent with markings noted on the as-received components. The threads on 6 of the attachment bolts were fractured, and the corresponding nuts were separated from the bolt. Nuts remained in place on attachment bolts 1 and 7. A fractured piece of the lower housing remained attached at the bolt 1 location. Attachment bolts 3, 4, and 5, a washer, and a lock nut shown in figure 2 were received separated from the housing assembly pieces shown in figure 1.

Figure 1. Overall views of the main rotor transmission assembly components as-received.

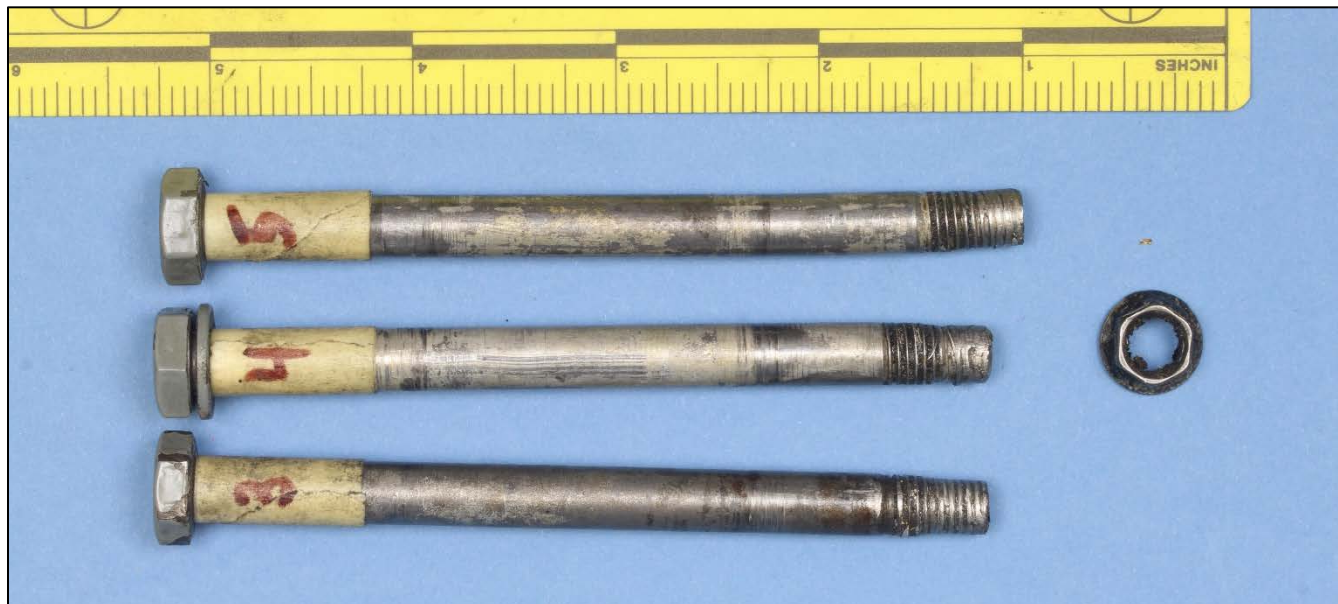
Figure 2. Overall view of main rotor housing assembly attachment bolts, washer (on bolt 4), and nut received separately.

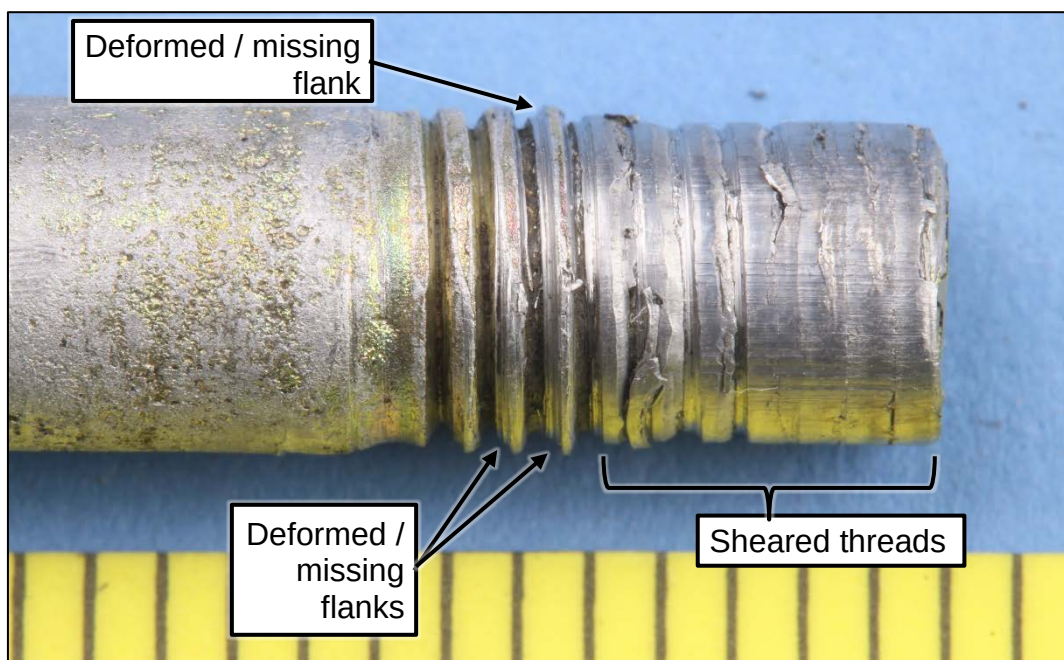
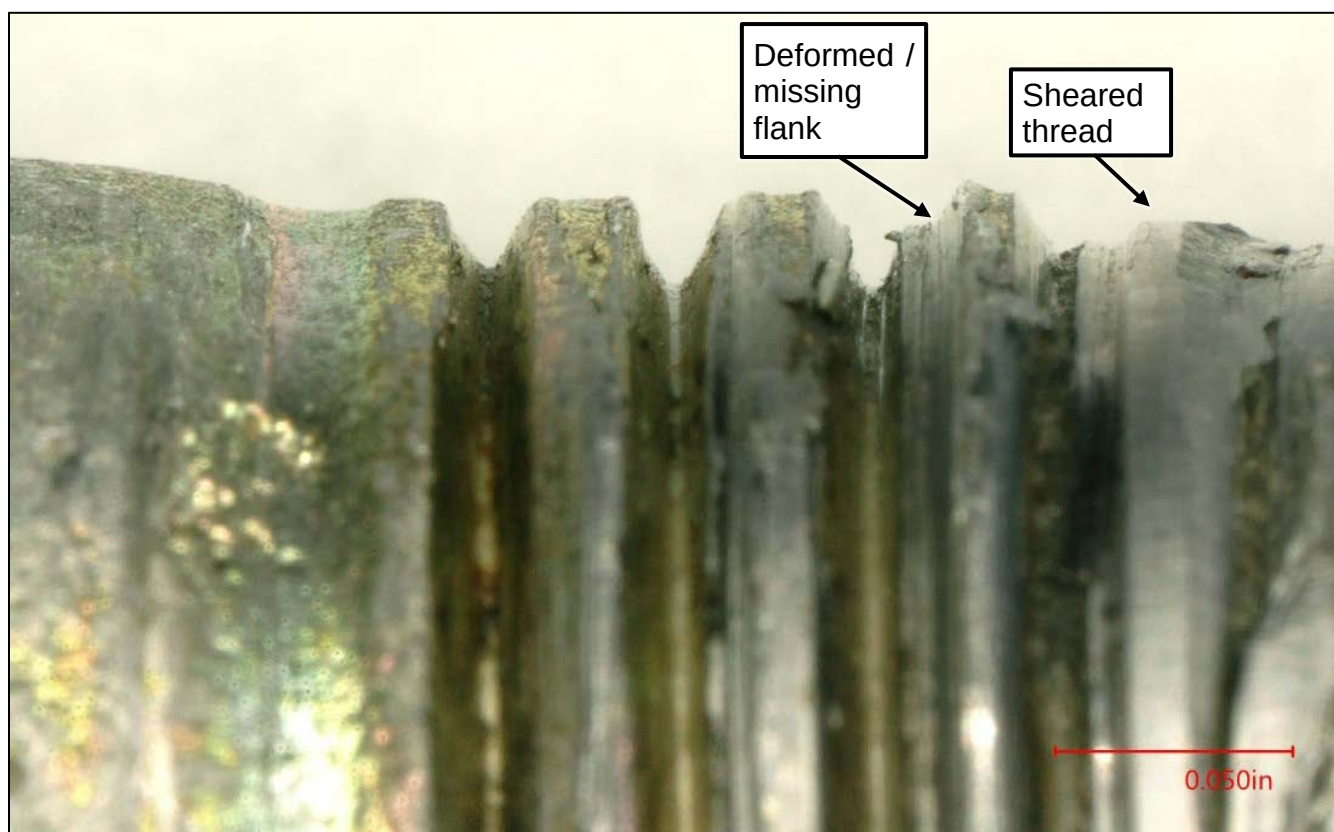
Closer views of the threaded ends of bolts 2 and 3 are shown in figures 3 and 4. In both cases, intact but damaged threads were observed between the shank and the completely sheared threads. As shown in figures 2 and 3, the pressure flanks of 1 to 3 of the mostly intact threads were deformed and missing with a profile shape corresponding to the nut thread peak profile. Circumferential sliding contact marks were observed in the contact surfaces of the damaged pressure flanks where the deformed and missing bolt thread was observed.

Figure 3. Close views of attachment bolt 2 threads after cleaning and degreasing.

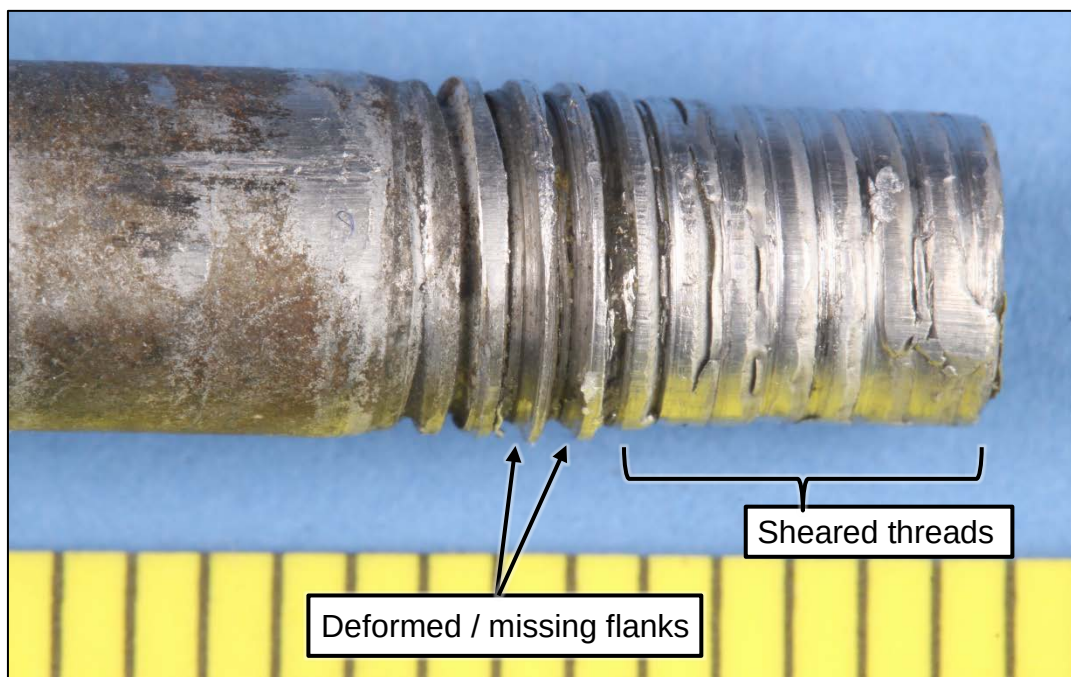
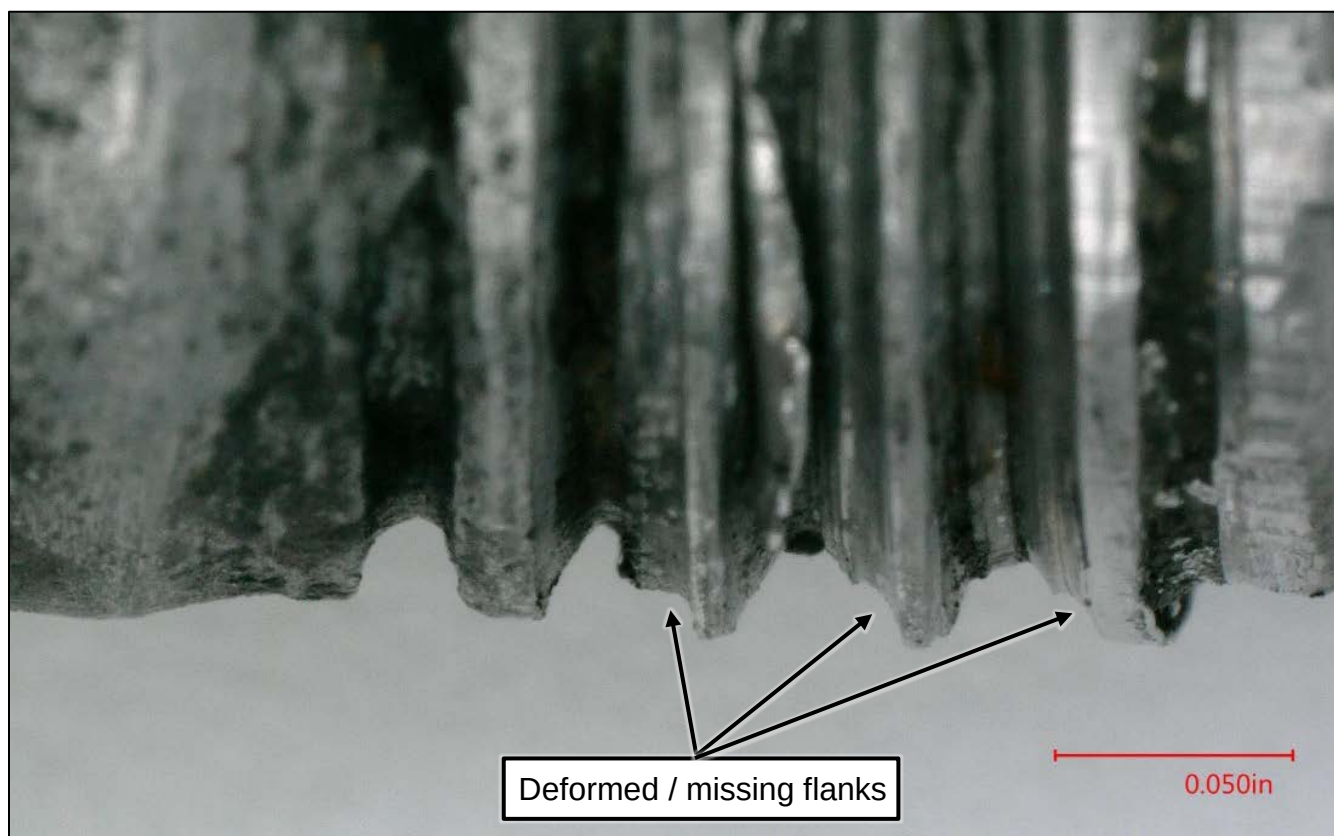
Figure 4. Close views of attachment bolt 3 threads after cleaning and degreasing.

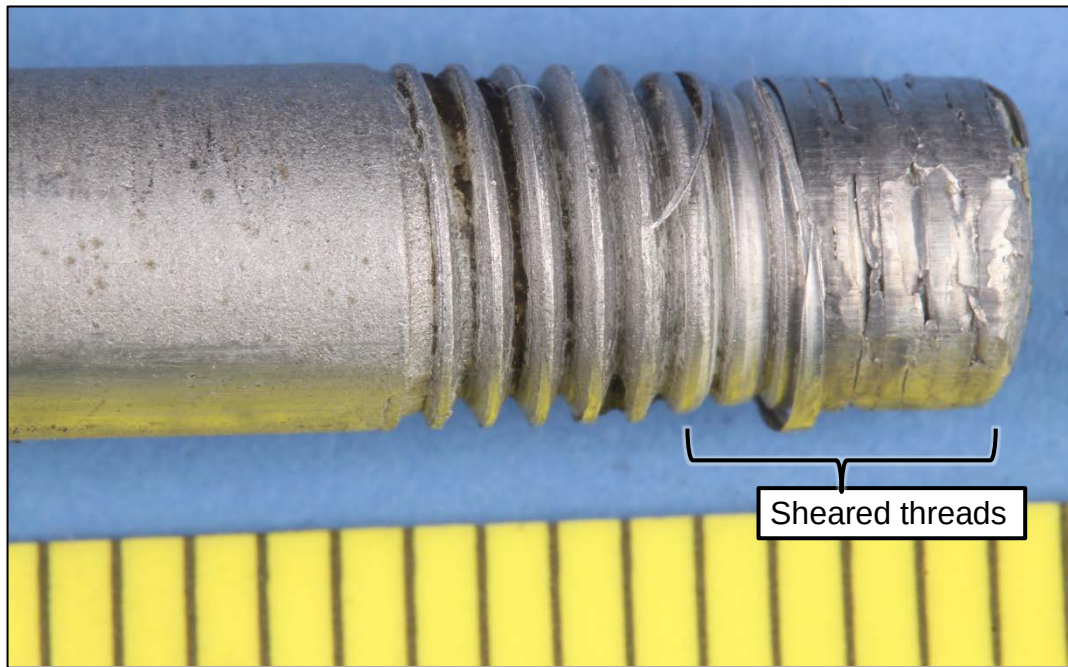
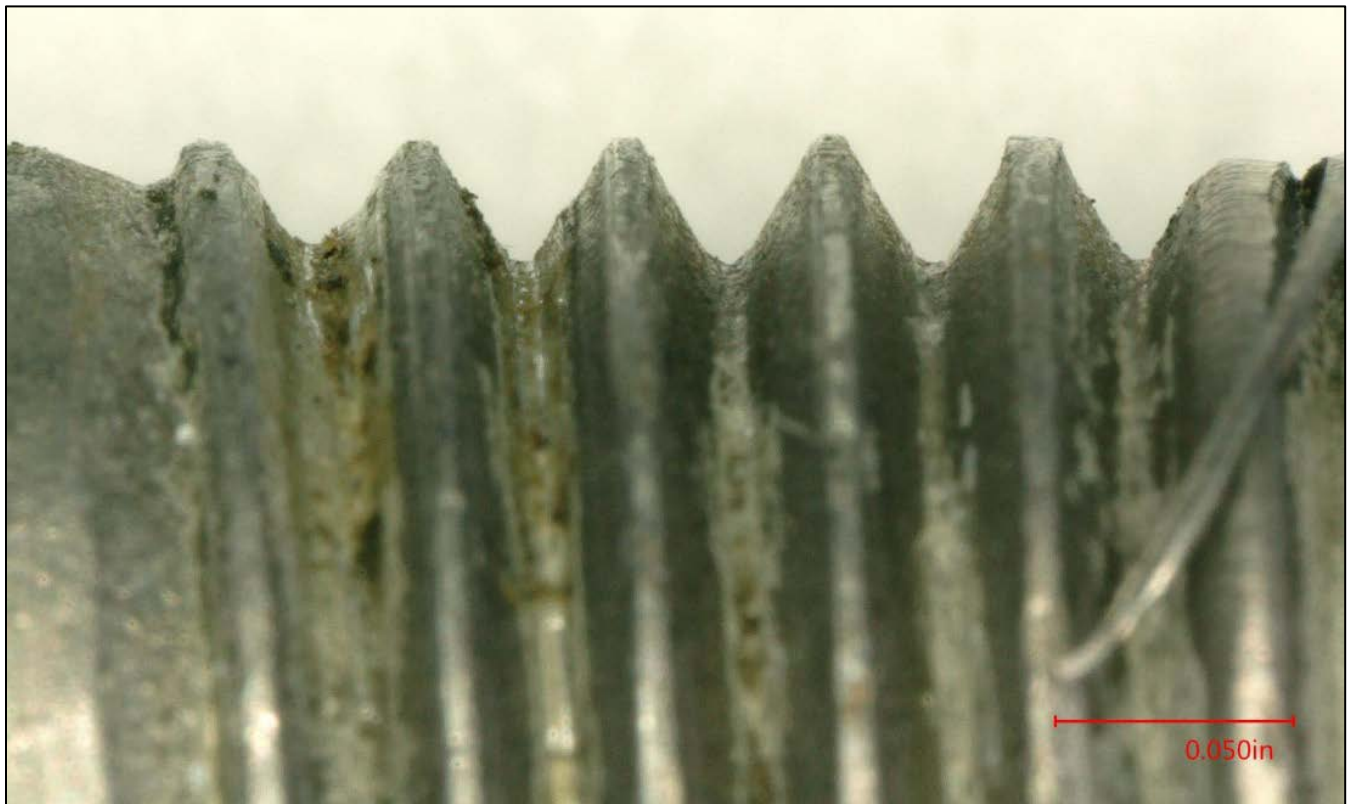
Closer views of the threaded ends of bolts 4 and 5 are shown in figures 5 and 6. The pressure flanks on several intact threads on bolt 5 had circumferential contact marks as indicated with unlabeled arrows in figure 6 but appeared free of substantial deformation or missing material. The pressure flanks of the intact threads on bolt 4 were free of circumferential contact marks or circumferential contact damage.

Figure 5. Close views of attachment bolt 4 threads after cleaning and degreasing.

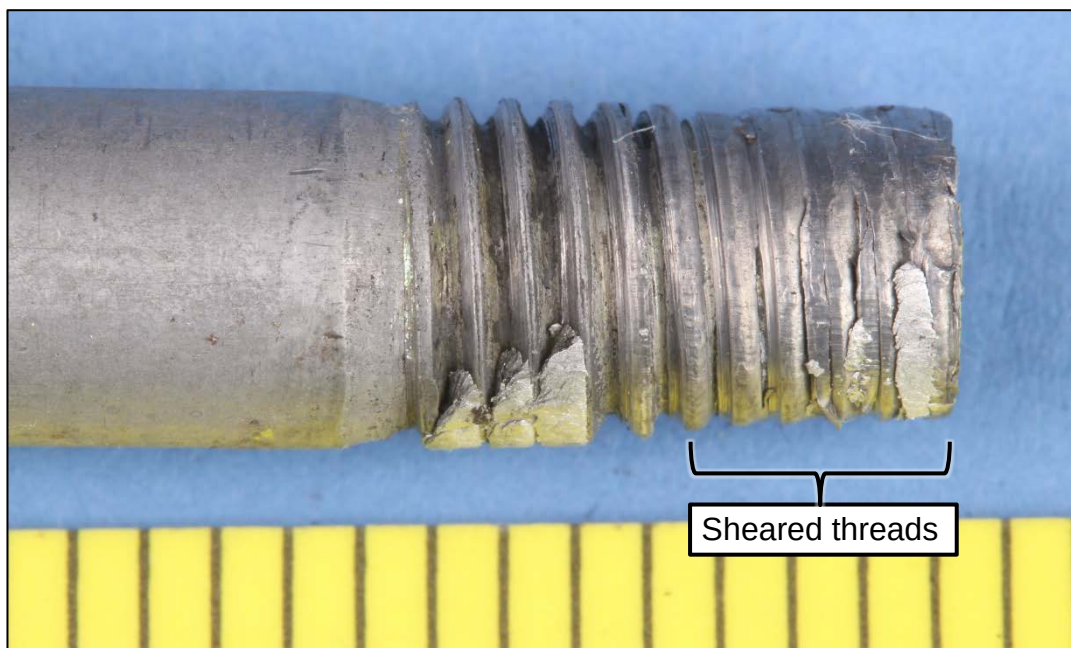
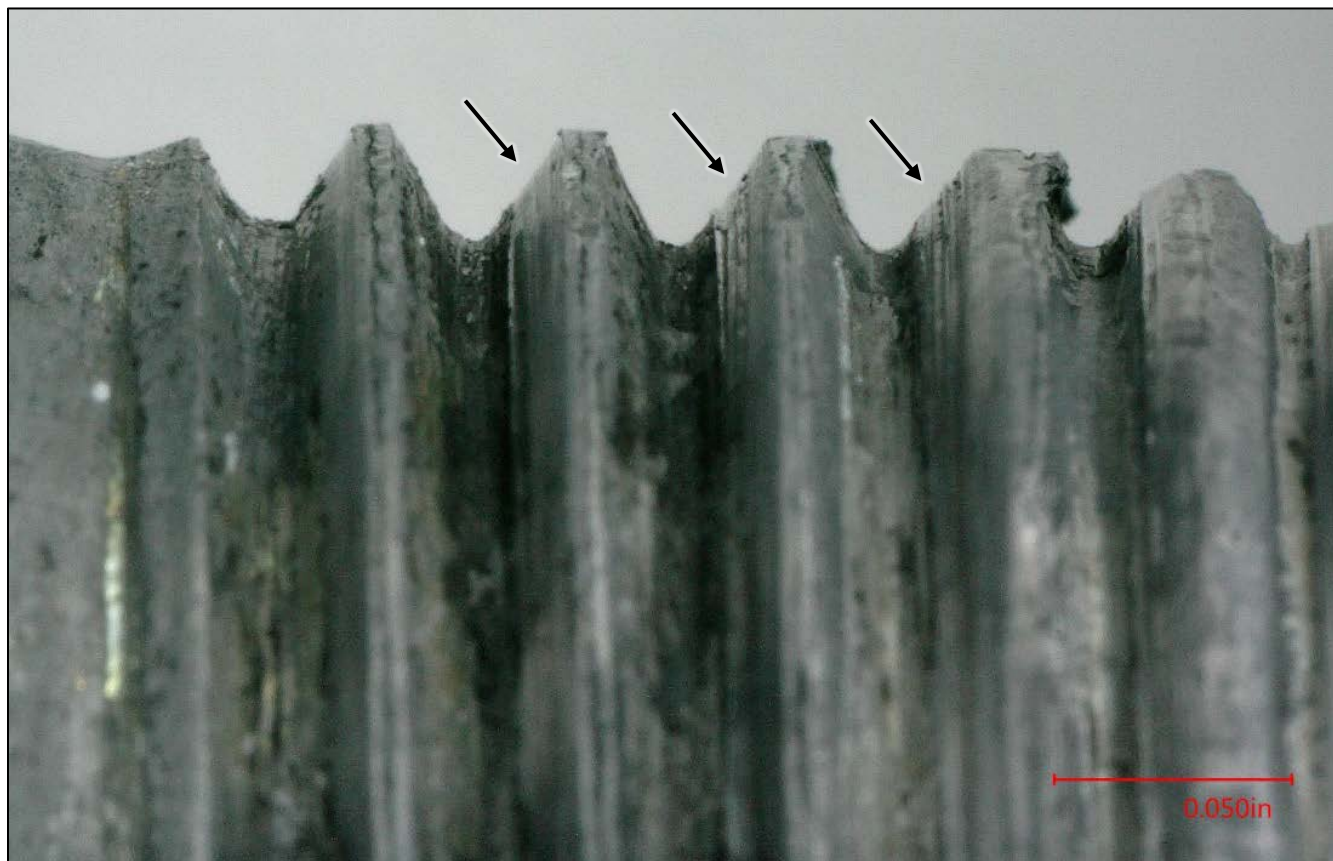
Figure 6. Close views of attachment bolt 5 threads after cleaning and degreasing. Unlabeled arrows point to circumferential sliding contact marks on pressure flanks of the threads.

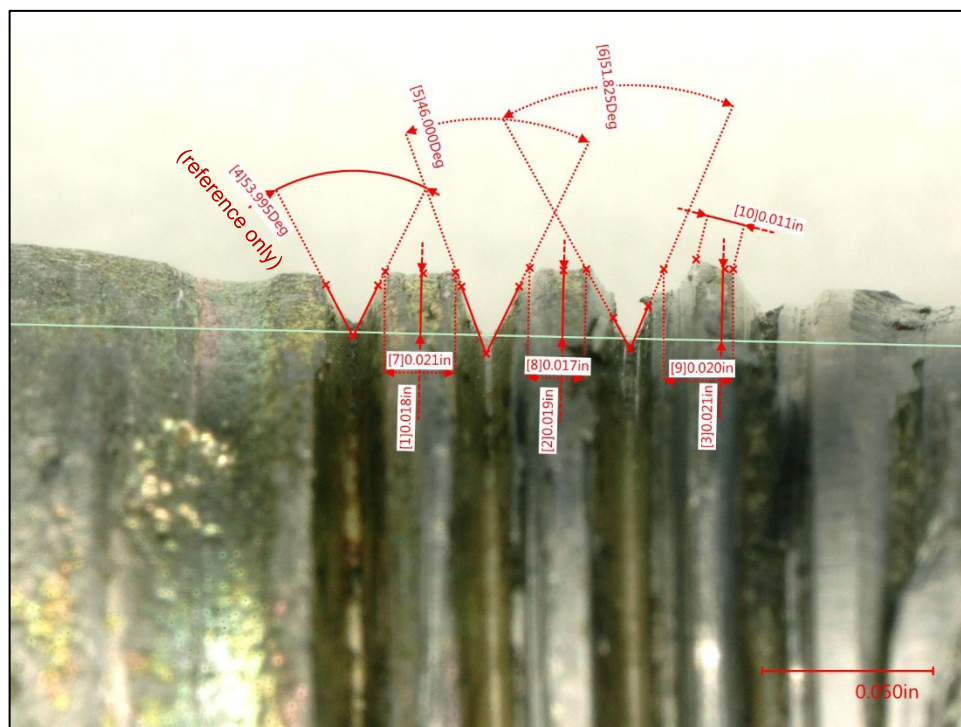
Bolts 3 through 5 had thread profile measurements that were generally comparable to the thread specification given the limited precision of the measurements and estimations made due to thread damage and use. However, measured values for bolt 2 showed larger deviations from the specified thread profile. The average flank angle for bolt 2 was approximately 11 degrees less than the specified angle of 60 degrees. The average thread depth for bolt 2 was 0.0055 inch less than the specified value of 0.02481 inch. Finally, the average width of the thread peaks in bolt 2 was approximately double the maximum thread peak width calculated from the thread form at the minimum major diameter of 0.3053 inch. The thread peaks for bolt 2 had a gold hue consistent with the original plating, indicating variations in thread depth and peak width were not due to wear or damage to the thread peak.

Figure 7. Thread profile measurements on intact threads on bolt 2.

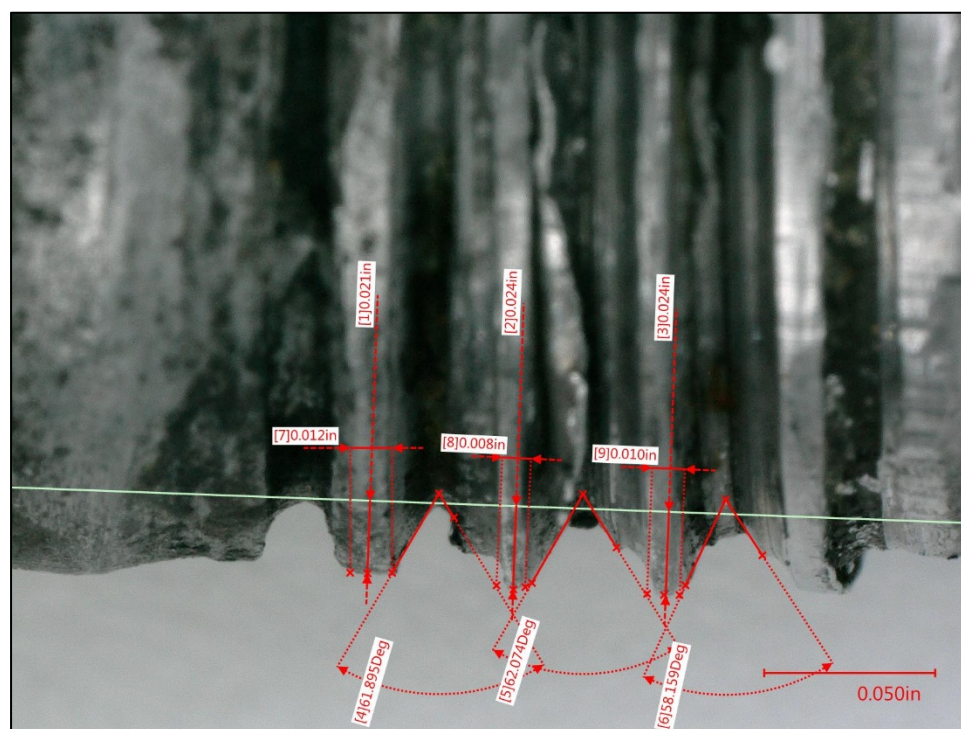
Figure 8. Thread profile measurements on intact threads on bolt 3.

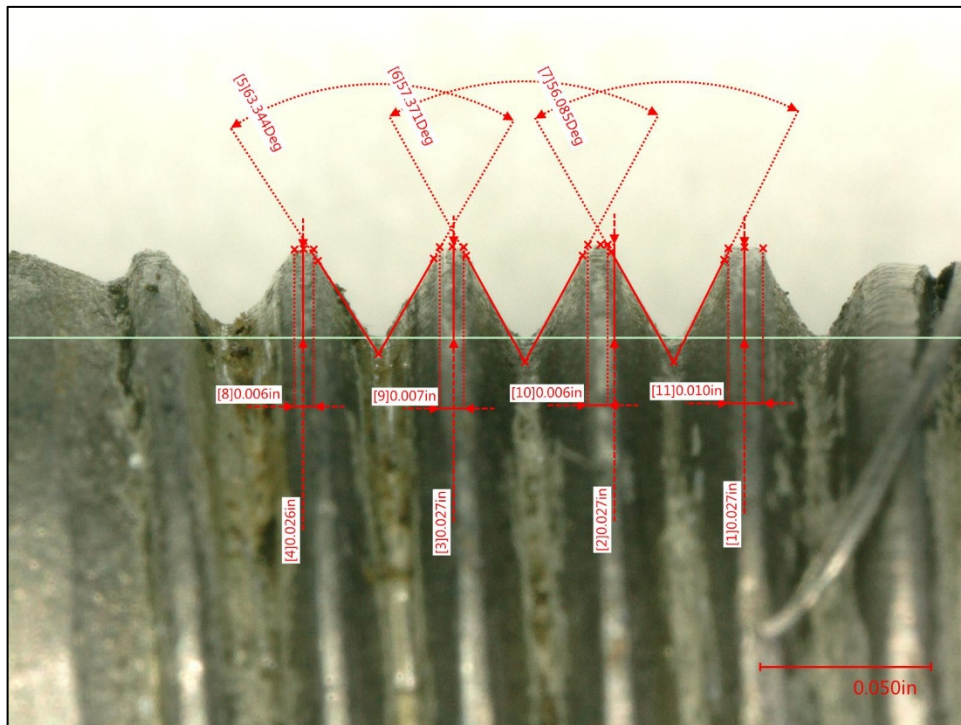
Figure 9. Thread profile measurements on intact threads on bolt 4.

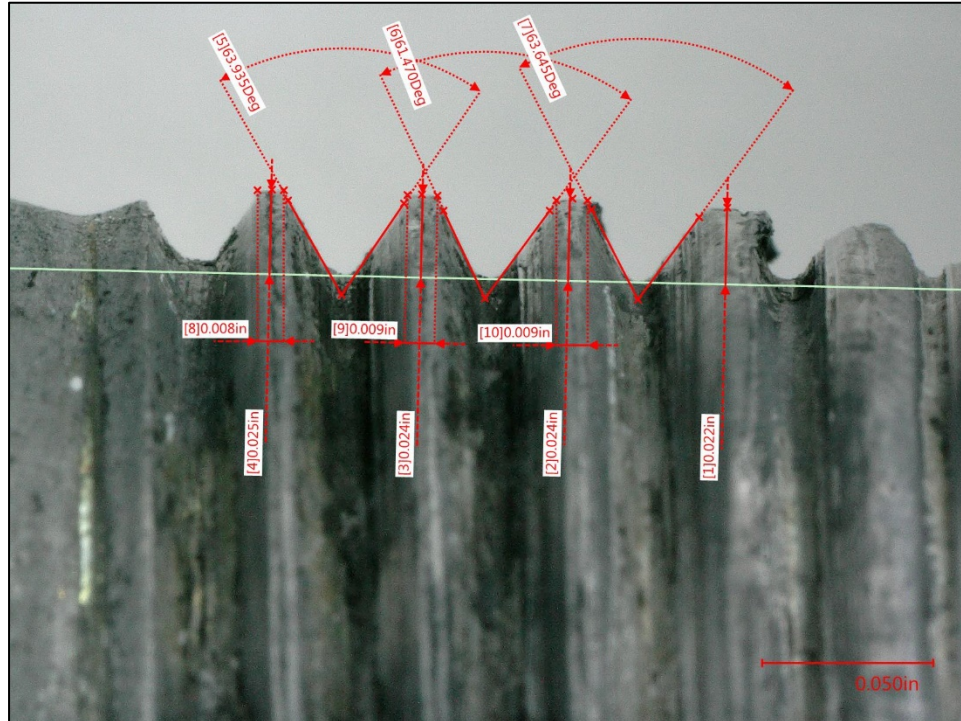
Figure 10. Thread profile measurements on intact threads on bolt 5.
