**Accident / Incident Report**

**Pratt & Whitney Canada**

**Report No.:18SIE00239**

**Pentastar Aviation Charter Inc (Owner: Bennett Aviation LLC)**  
**EC135P1 & Registration # N312SA**  
**Chicago, Illinois**  
**July7, 2018**  
**PW206B**  
**S/N BB0049 and BB0045**

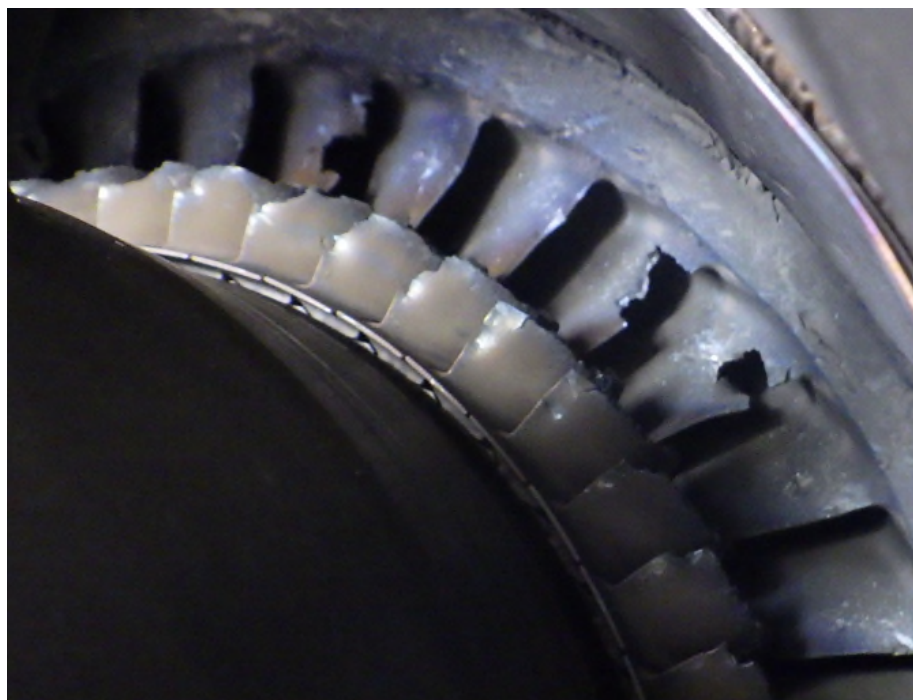
All of the PT blades were fractured at  $\frac{1}{3}$  span by tensile overload consistent with a fracture due to overspeed. The blade release caused an imbalance and movement of the PT disc which caused the retaining ring to completely disengage. Once disengaged, the retaining ring was dragged due to contact friction on the disc, resulting in scoring on the disc and causing the retaining ring to break into multiple pieces.

When viewing the PT blades through the exhaust it was observed that they were all fractured at the same height from the platform (Photo No. 5).

Photo No. 5: PT blades all fractured at  $\frac{1}{3}$  span

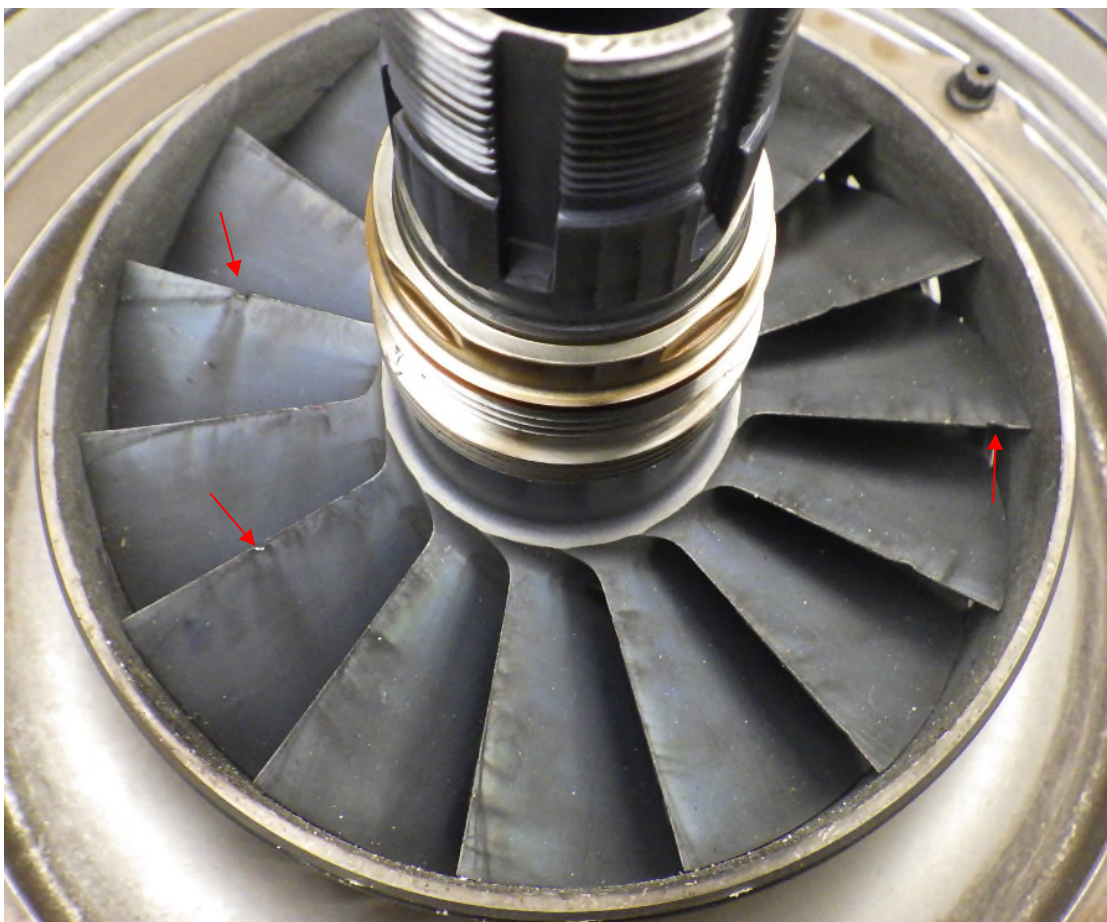
The impeller showed minimal damage, however there were some minor nicks on the blades leading edges (red arrows on Photo No. 8).

Photo No. 8: Centrifugal impeller leading edge

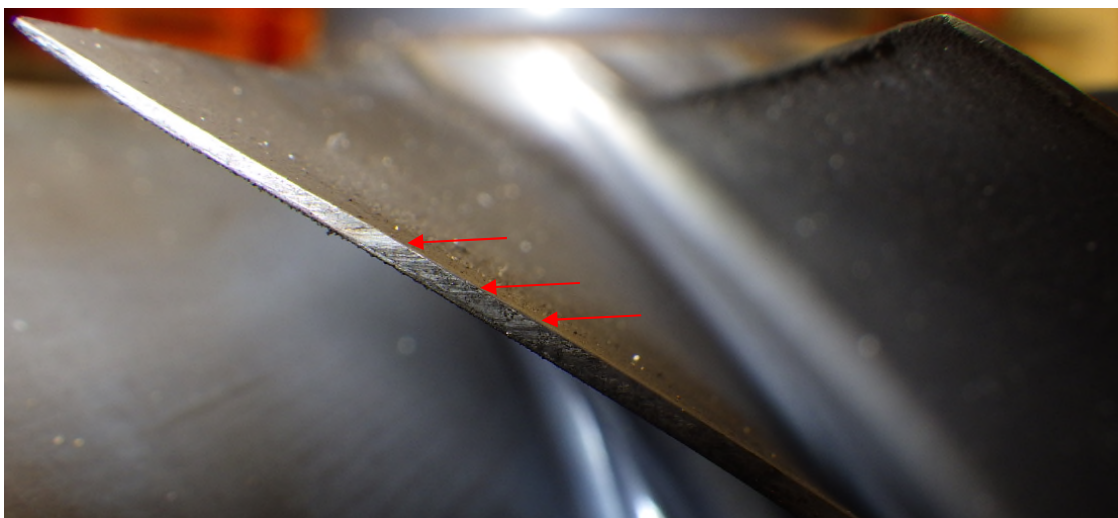
The Compressor Turbine (CT) blade tips rubbed against the CT shroud as a result of the overspeed and engine unbalance. Similarly the centrifugal impeller also rubbed its shroud as a consequence of the event.

The blade-tips were undamaged although there was some evidence of rubbing as seen on Photo No. 9 (red arrows).

Photo No. 9: Centrifugal impeller rubbing

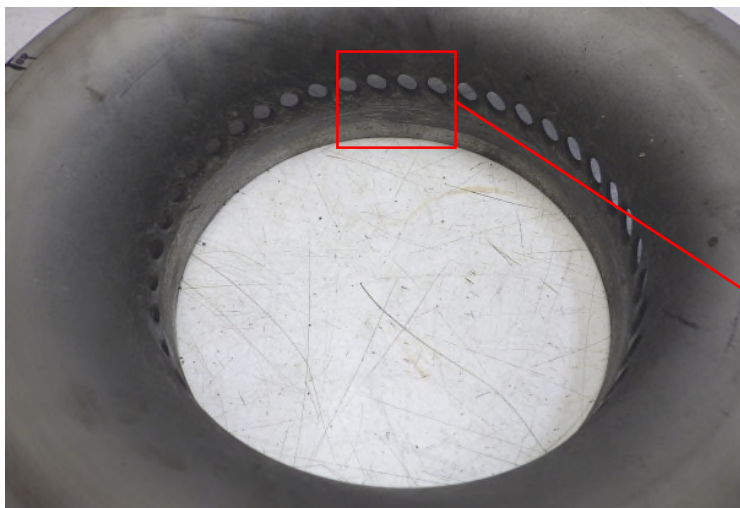
The shroud was intact but showed rotational scoring near the impeller inlet between the 12 and 6 o'clock positions as seen in Photo's No. 10 and 11. The deepest scoring marks were between the 3 and 5 o'clock position which is in the region of the red arrows on Photo No. 11.

Photo No. 10: Centrifugal impeller shroud rubbing

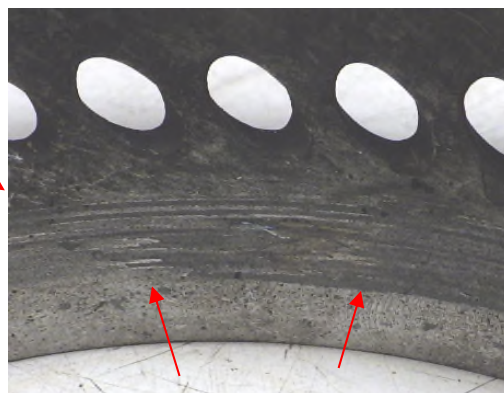
Photo No. 11: Rubbed shroud

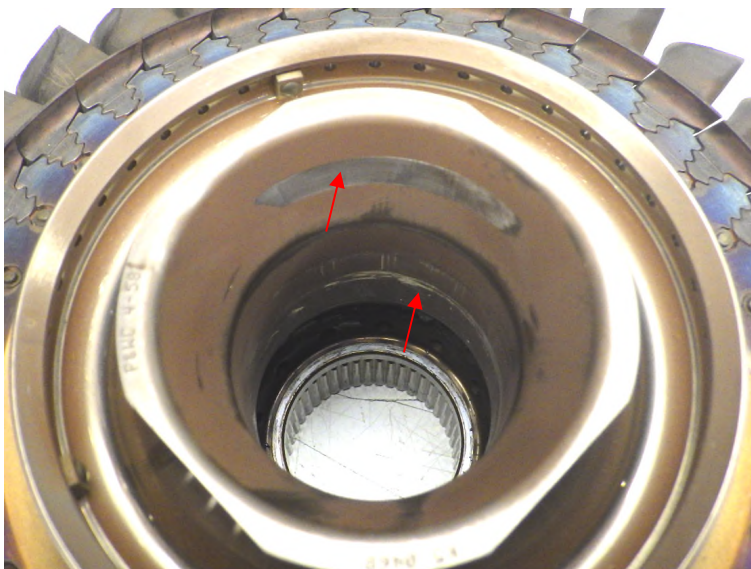
The No. 3 and 4 bearings were inspected and found to be intact and undamaged. There were some contact marks in the bore (indicated by red arrows on Photo No. 14) due to impact with the PT shaft.

Photo No. 14: CT disc bore

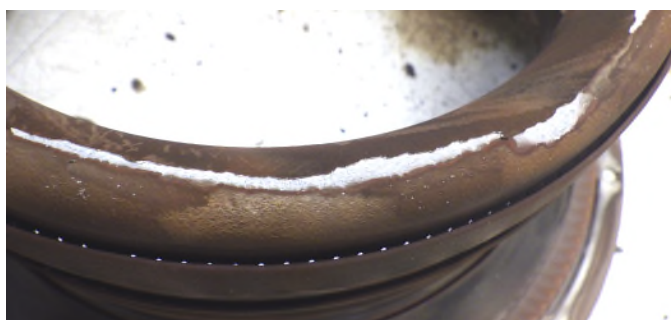
The outer and inner combustor liners were intact and undamaged. Approximately 10% of the coating of the inner duct exit lip was cracked and missing as seen in Photo No. 15. This would have had no impact on the engine operation.

Photo No. 15: Coating loss on the inner liner exit lip

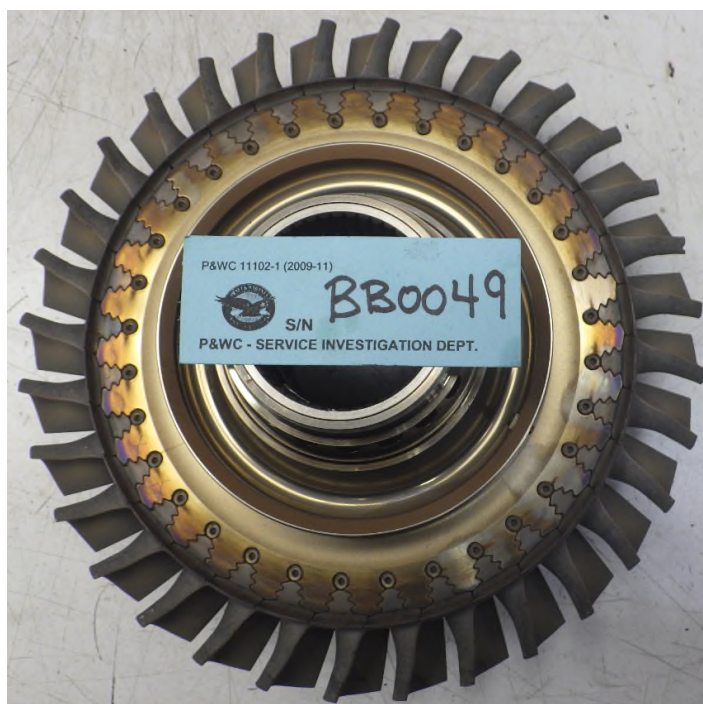
The CT disc and blade assembly was intact and undamaged as seen in Photo No. 22. The CT blade tips showed evidence of rotational scoring as indicated by the red arrows in Photo No. 23. The disc was de-bladed and the blade growth was measured to be an average of 0.0017 inches, which is within the CIR manual (Cleaning, Inspection, and Repair) limit.

Photo No. 22: CT disc and blades

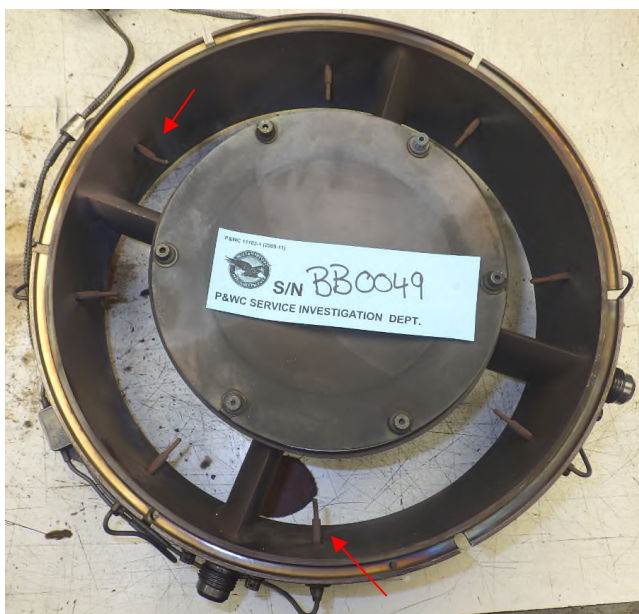
Two of the T6 probes in the turbine exhaust nozzle were bent due to impact damage (red arrows on Photo No. 24). The harness and busbar appeared undamaged.

Photo No. 24: Damaged T6 probes

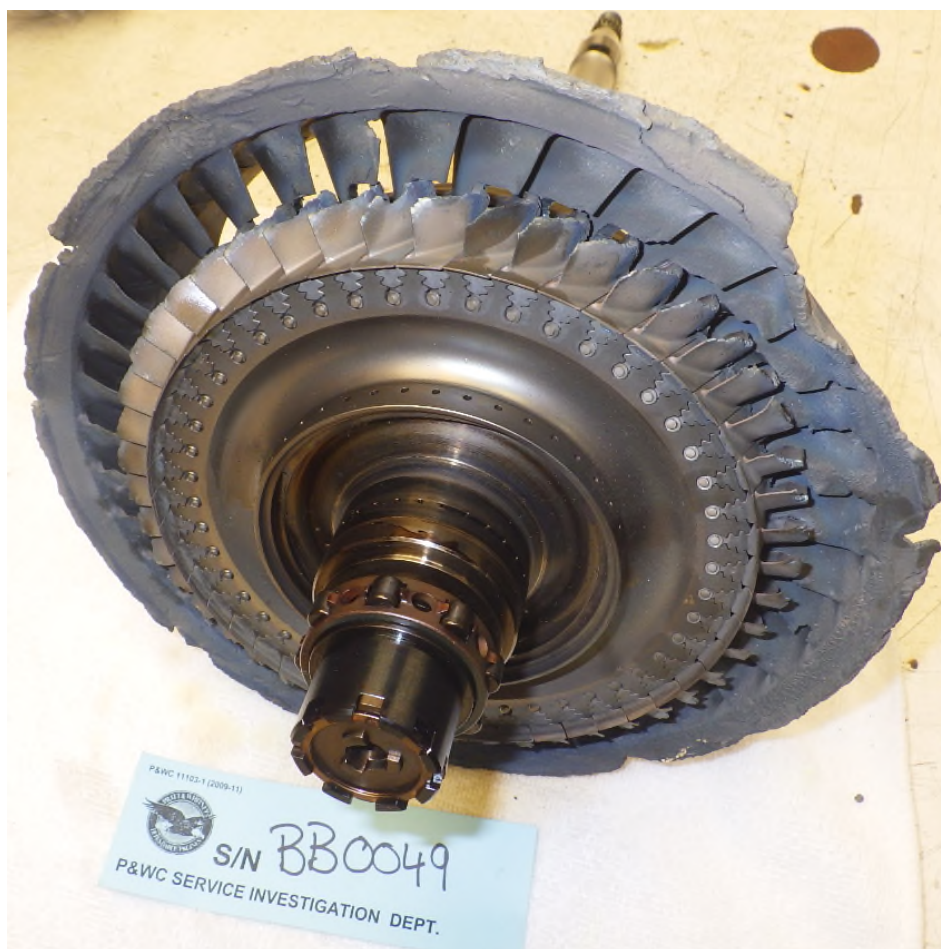
The power turbine stator outer mounting flange was fractured, dented and deformed. This allowed the vane section to become loose and offset in the core, allowing it to move aft and contact with the PT disk assembly blades and platform. During disassembly the PT stator vane section and PT disc assembly had seized together and had to be removed at the same time (Photo No. 25).

Photo No. 25: PT stator vane ring and PT disc assembly removed together

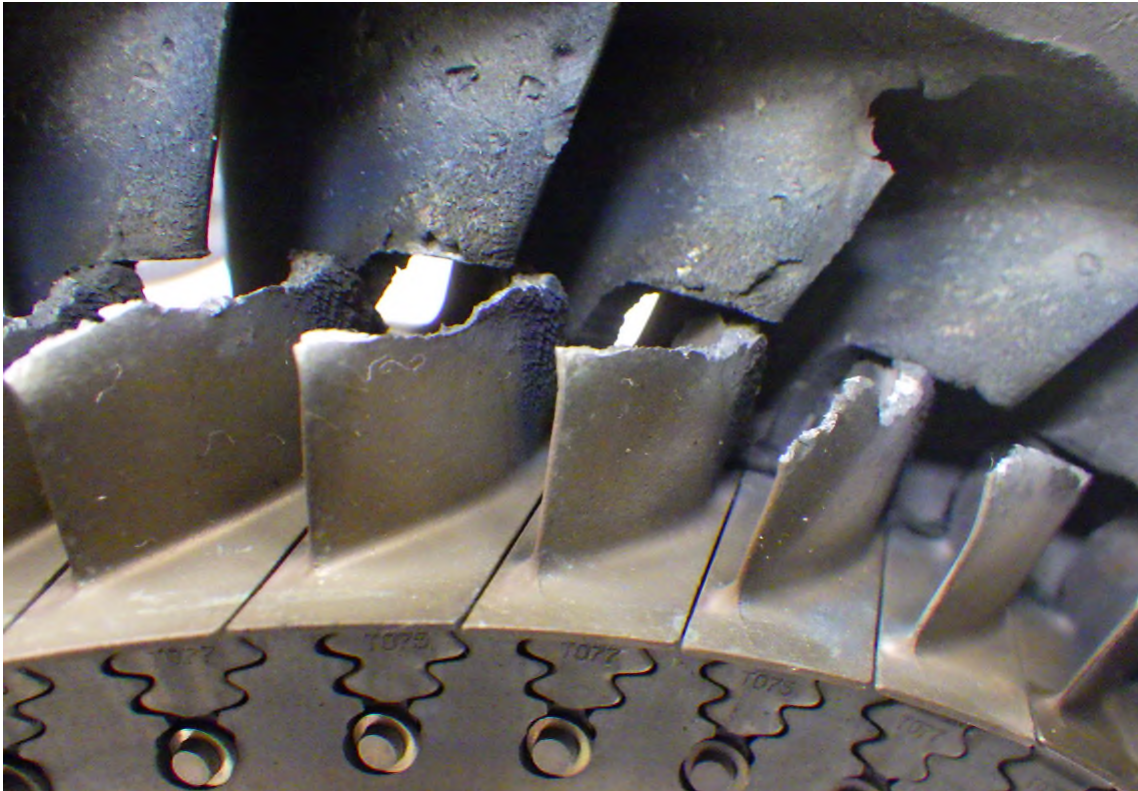
After the PT blades had fractured, the PT blades contacted the inner third span of approximately half of the trailing edges of the stators (Photo No. 26). This machined a groove, the deepest of which was approximately  $\frac{1}{2}$  inch, into the stators. The blue discolouration seen on the PT stator and blades is due to high temperature exposure in that area. The high temperature exposure was the result of contact friction between the PT blades and the stator. Damage to the PT stator baffle and honeycomb seal was revealed once the stator vane section was separated from the PT blade assembly.

Photo No. 26: PT blades contacting the PT stator trailing edge

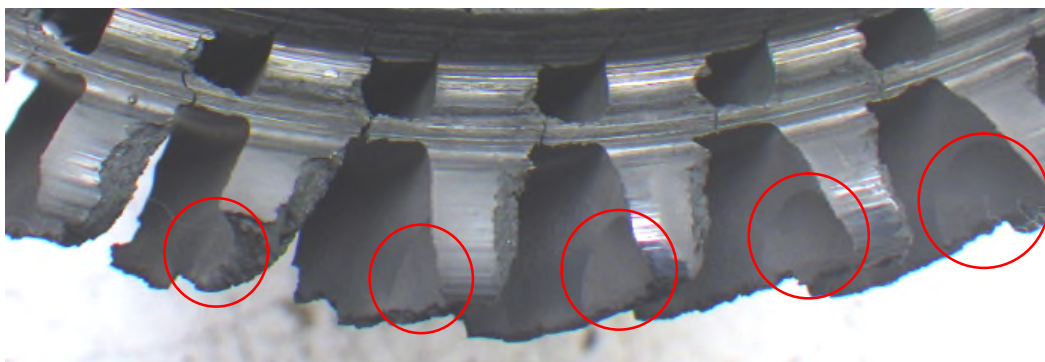
The power turbine blades were all fractured at the dimples (at  $\frac{1}{3}$  span from the platforms) as seen in photo's No. 29 and 30. This is representative of a loss of blades due to an overspeed. PT blades are designed to release at the dimpled area (circled in red on Photo No. 29) at a speed of approximately 150% NPT in order to preserve the integrity of the PT disc. All of the PT blades' fracture surfaces showed signs of tensile overload (no signs of fatigue could be found). The disc was de-bladed and was measured for disc growth. The disk grew to 0.0057 inches over the factory limit which is characteristic of an overspeed condition.

Photo No. 29: Blade fracture at dimples

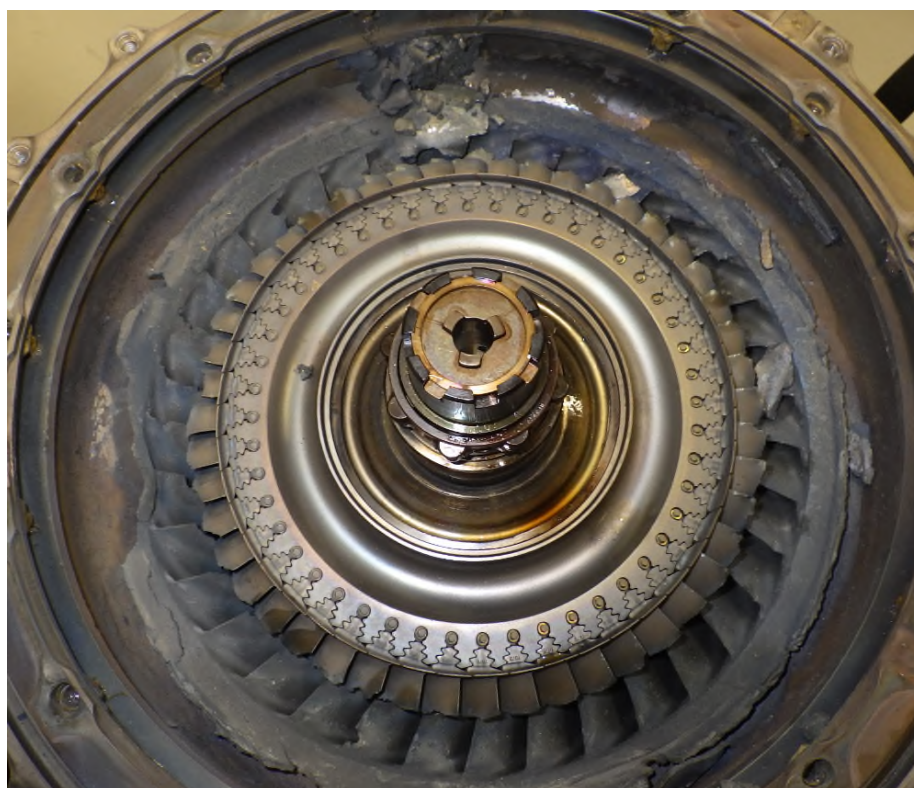
Photo No. 30: PT blades all missing at 1/3 span

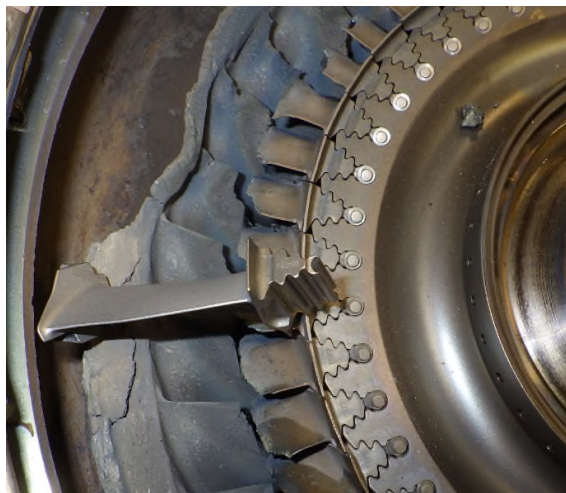
The fractured blades along with a new blade overlaid can be seen in Photo No. 31. The purpose of this is to visually demonstrate the remaining portion of PT blades in comparison to the original length.

Photo No. 31: Broken PT blades and a new PT blade

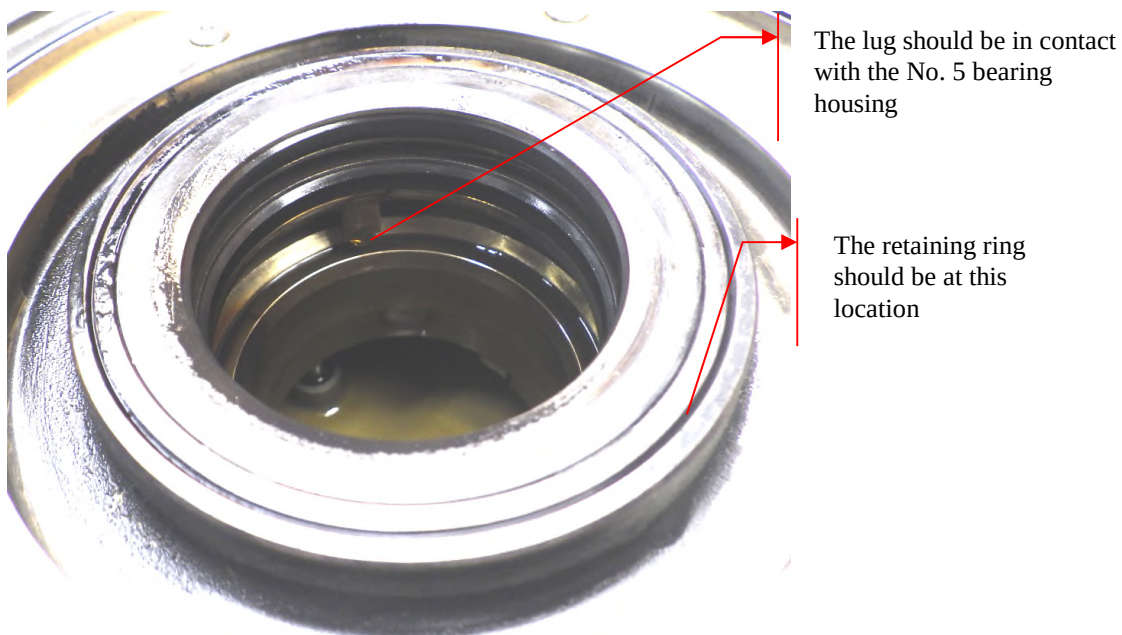
With the retaining ring gone, the No. 5 bearing carbon seal housing moved forward and came into contact with the backside of the PT disc. This contact caused the carbon seal to disintegrate and break into pieces. As the seal moved forward the disintegrated seal allowed oil to leak across it due to improper sealing. Due to the temperature increase in the No. 5 bearing cavity, the oil leaking across the seal into the gas path likely caught fire. The oil continued to be pumped to the No. 5 bearing cavity thus sustaining the fire until the engine was shutdown.

Photo No. 34: No. 5 carbon seal

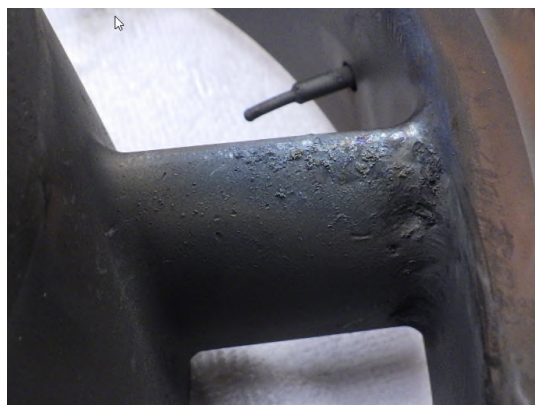
There was minor impact damage found on the struts as can be seen in Photo No. 35.

Photo No. 35: Impact damage to exhaust strut

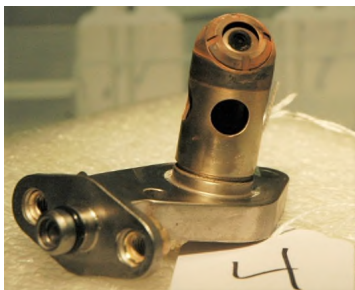
Carbon deposits were present on each nozzle tip, which caused some streaking or voids (as shown on nozzle seen in Photo No. 41) and an uneven flow pattern on one nozzle. The other nozzles were satisfactory.

Photo No 41: Fuel nozzle

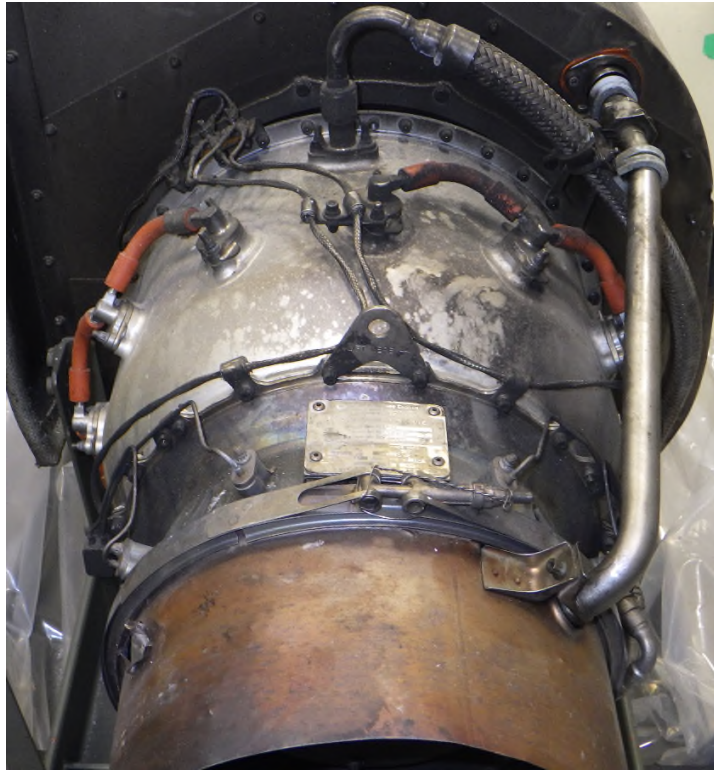
Photo No. 46: Soot residue on BB0045

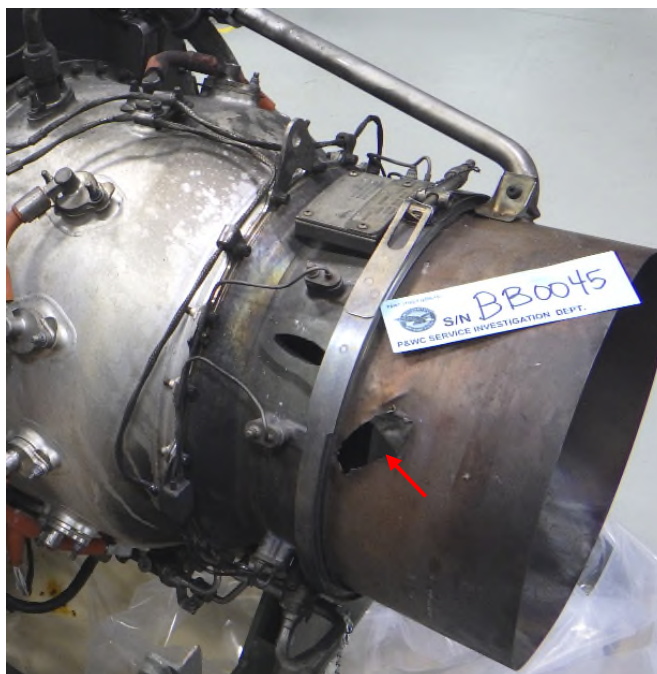
There was partially separated and dislodged sheet metal from the exhaust cone, which was deformed and covering the air flow path in the exhaust duct. Viewing the PT blades through the exhaust revealed that they were all fractured at the same height from the platform. The exhaust exhibited multiple pock marks consistent with high speed impact from small internal released material. There was one hole (red arrow on Photo No. 50) at approximately the 10 O'clock location exhibiting petalling which is consistent with an inside to outside perforation direction as seen on Photo No. 50. The size of the puncture hole was approximately 1.5 in x 1 in.

Photo No. 50: BB0045 soot and exhaust puncture

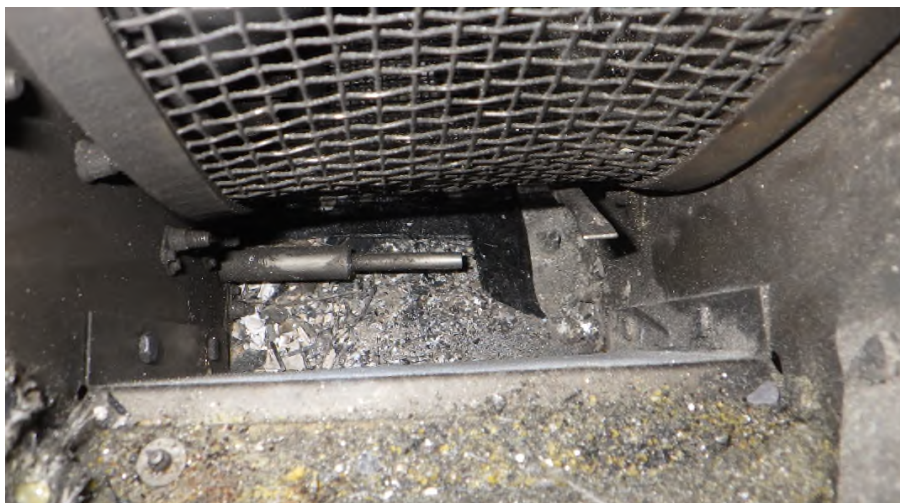
The air inlet was clear, however flakes consistent with burned ash were found in the plenum as seen in the following Photo No. 53.

Photo No. 53: Debris and soot in the inlet

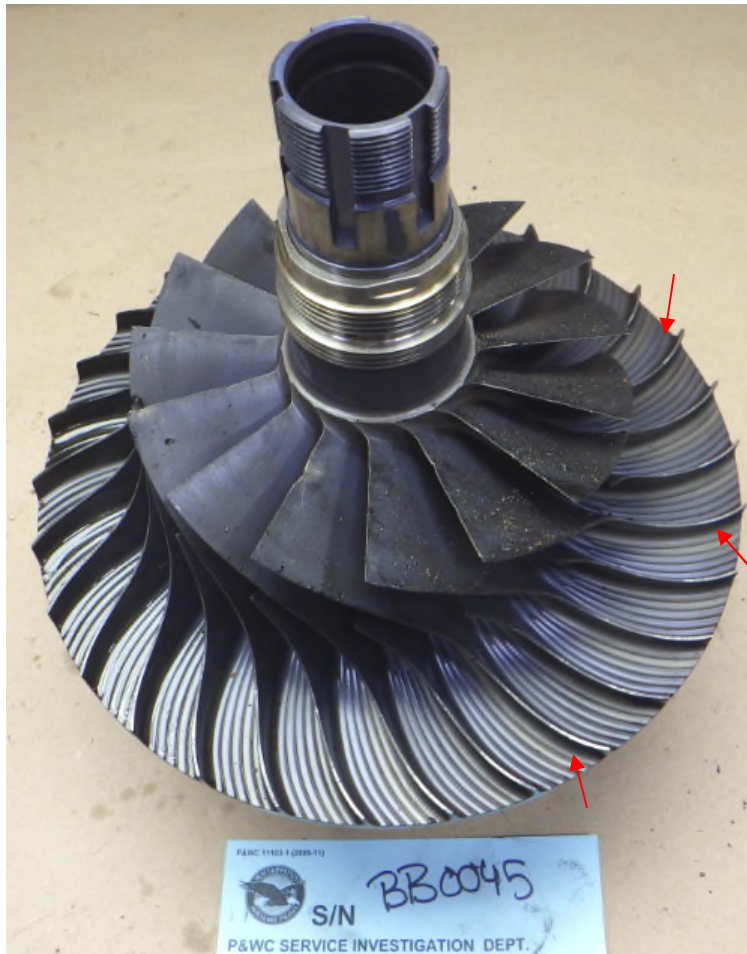
The inlet case was intact and undamaged. The impeller showed minimal damage to the leading edges, however there was evidence of a previous blend repair (yellow arrow) and some minor nicks (red arrows) as seen on Photo's No. 56 and 57. The vanes tips were undamaged although there is some evidence of rubbing due to contact with the impeller shroud. This can be seen in Photo No. 58, where the red arrows point to a few locations where the shiny material represents the location that the impeller vanes tips contacted the impeller shroud.

Photo No. 58: Impeller with rub marks

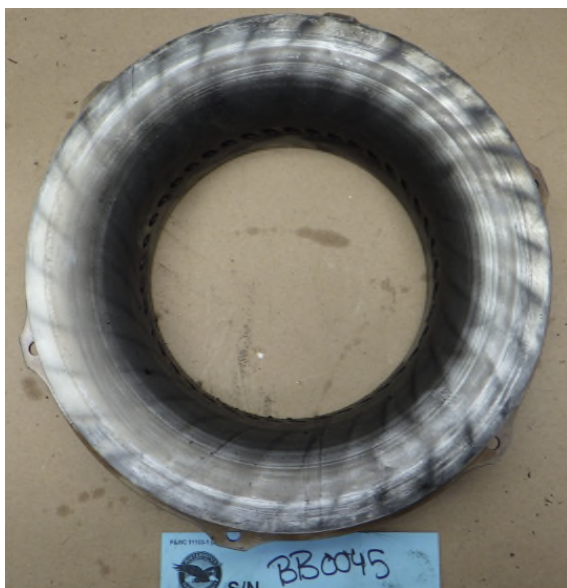
The shroud was intact but showed rotational scoring near the impeller inlet across the entire 360 degrees as seen in Photo's No. 59 and 60.

Photo No. 59: Impeller shroud

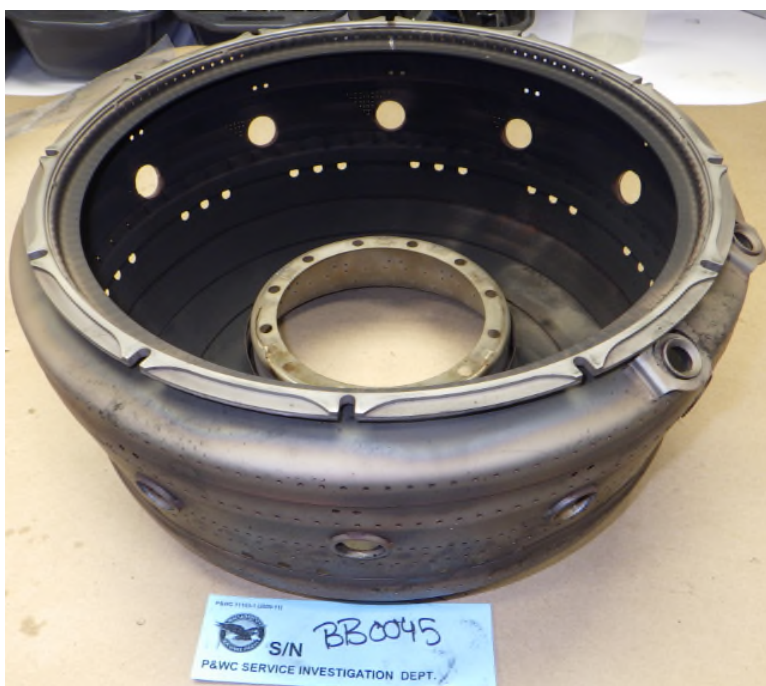
The outer liner was examined and found undamaged however, had a high concentration of soot deposit as a result of an oxygen-starved fire that occurred post shutdown as seen in the following Photo No. 64. The ceramic coating was in good condition.

Photo No. 64: Outer liner

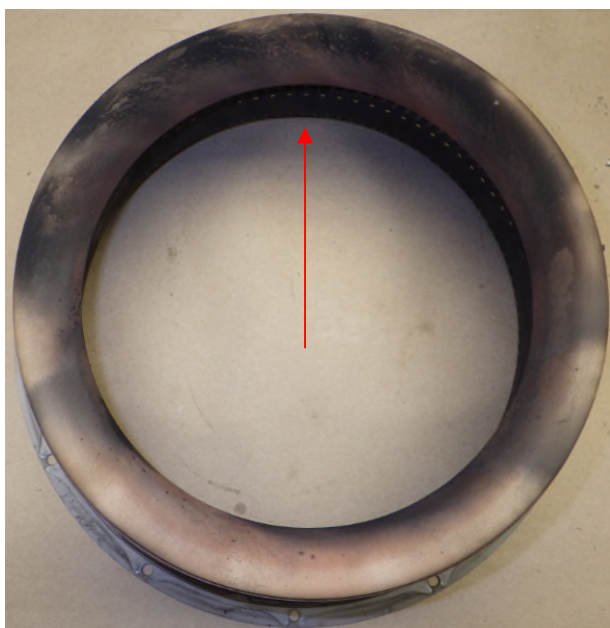
The inner liner also showed an accumulation of soot. The red arrow on Photo No. 65 points to the 12 O'clock position, where it can be seen that there is more apparent soot around this location than the 6 O'clock location. The side view of the inner liner shows further evidence of soot accumulation (Photo No. 66). The ceramic coating was in good condition.

Photo No. 65: Inner liner exit lip

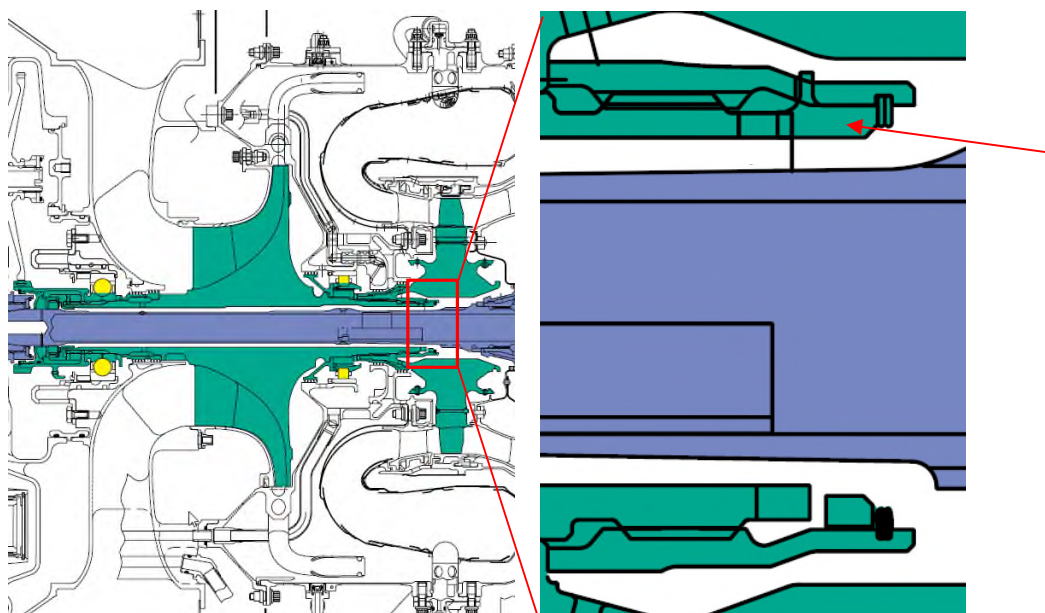
Sketch No. 1

The compressor spool assembly is shown in sketch No. 1. The rear section comprised of the compressor impeller, a front No. 4 bearing air seal, the No. 4 bearing, the aft No. 4 bearing air seal and the compressor turbine assembly. These components are all rigidly retained in the axial direction with a retaining nut (red arrow) and key lock washer on the compressor impeller shaft.

Upon inspection it was found that the retaining nut and key lock washer were correctly installed, however the assembly was no longer rigidly retained and the compressor turbine could be moved when loaded radially. The retaining nut's outer diameter was measured and it was found to be 0.11 inches larger than the factory dimension. The expansion of the nut is consistent with the release of the clamping load on the turbine spool assembly. The retaining nut had been exposed to elevated temperatures which caused the nut to grow.

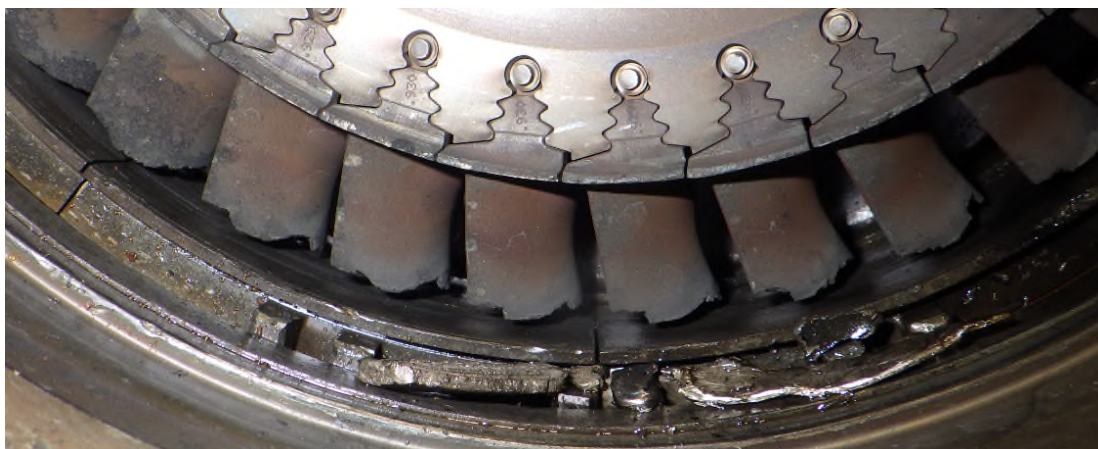
The CT disc was intact and undamaged. The CT blades tips were all fractured by overload due to heavy contact with the CT shroud. The extensive blade tip damage, as seen in Photo No. 72, made it impossible to measure the blade growth.

Photo No. 72: CT blade tip damage

The blade tip damage was due to contact caused by non-concentric rotation as a result of the loss of the compressor spool clamping load. The leading edges of the CT blades, as seen on Photo No. 73, were heavily covered in soot.

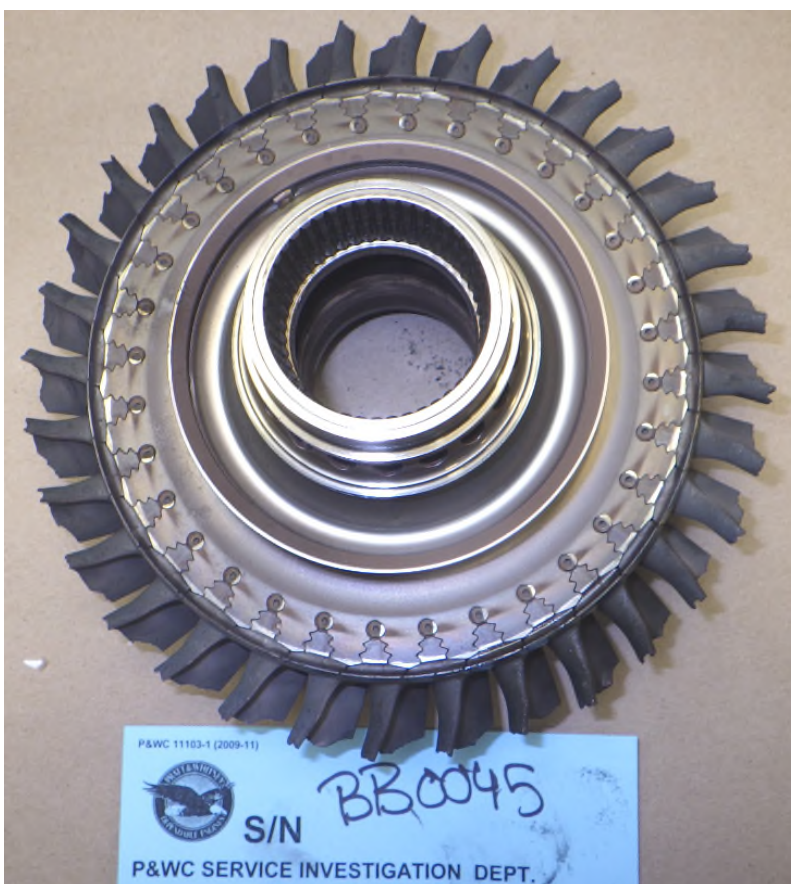
Photo No. 73: CT blades leading edges

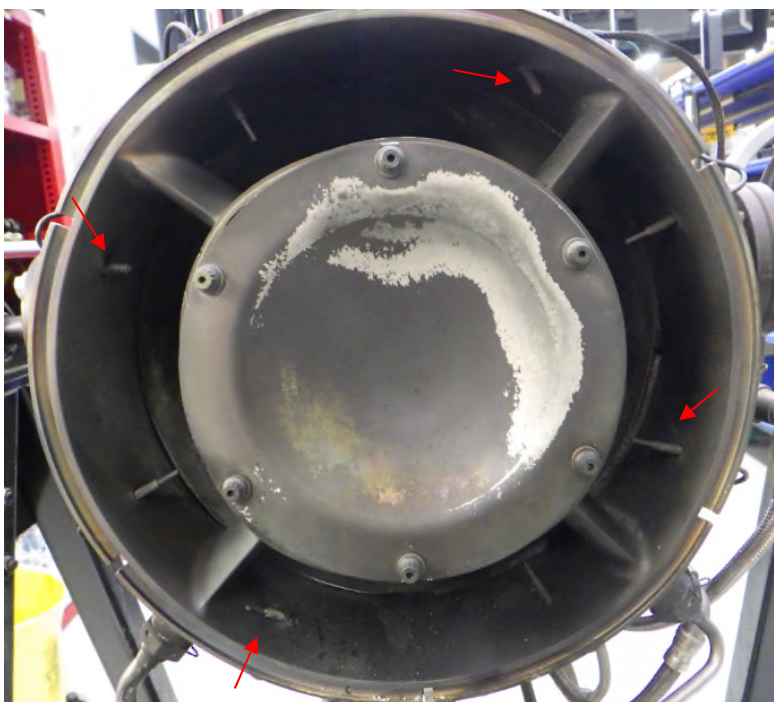
Four of the T6 probes in the exhaust, which are identified with red arrows in Photo No. 74, were bent due to impact damage. The harness and busbar appeared undamaged.

Photo No. 74: Exhaust with damaged T6 probes.

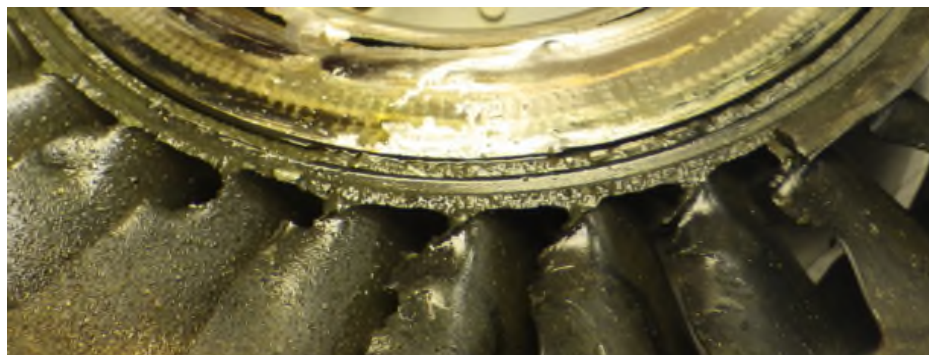
Photo No. 76: Grooved TE of PT stator vanes

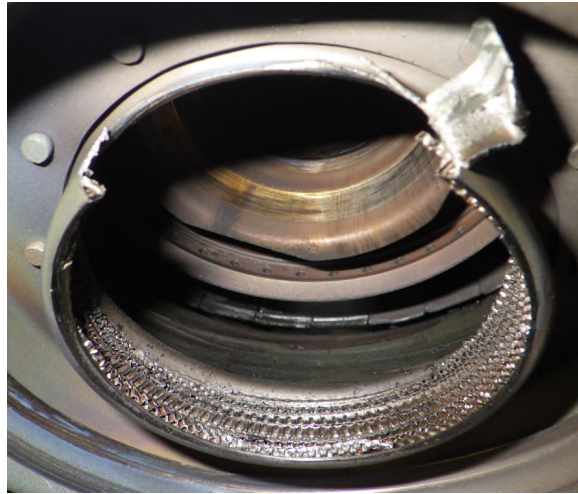
The power turbine stator outer mounting flange was fractured, dented and deformed (Photo No. 77). Consequently, this allowed the vane section to become loose and offset from the core, permitting it to move aft into the PT blade/disk assembly and platforms. After the PT blade fracture, the PT blades contacted and machined a groove into the inner third span of approximately half of the trailing edge of the vane (Photo No. 76). The deepest groove was approximately  $\frac{1}{4}$  inch. The No. 4 bearing front seal was grooved and fractured due to the PT disc assembly unbalance (Photo No. 78).

Photo No. 78: Damage due to PT shaft movement

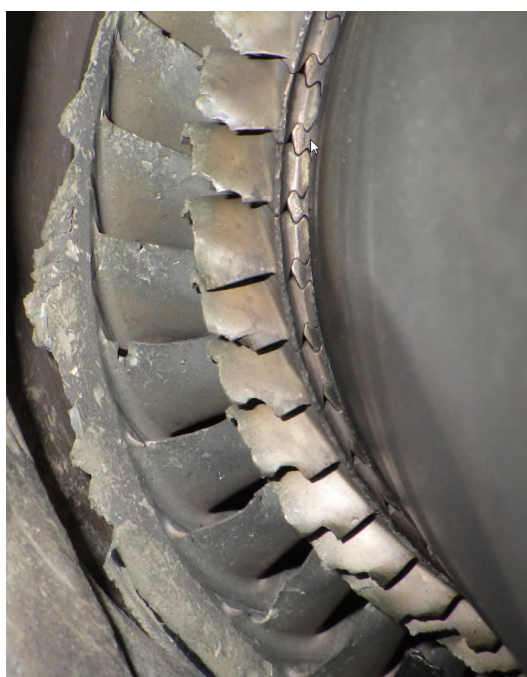
The power turbine blades were all fractured in the dimpled area at approximately 1/3 the airfoil height above the platform as seen in Photo No. 80. This is representative of blade-loss due to an overspeed. PT blades are designed to release in the dimpled area at a speed of approximately 150% NPT in order to preserve the integrity of the PT disc. All fracture surfaces showed signs of tensile overload (no signs of fatigue could be found). The disc was de-bladed and measured for disc growth. The disk grew to 0.0026 inches over the factory limit which is characteristic of an overspeed condition.

Photo No. 80: PT blades fractured

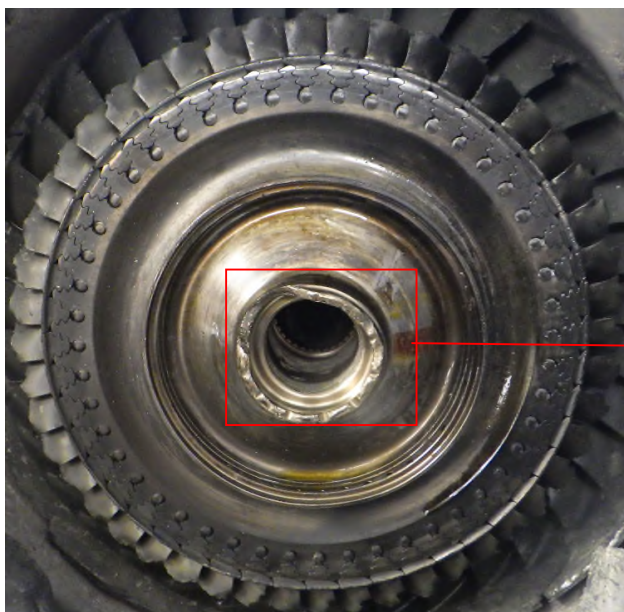
The PT disk aft side had heat discoloration and severe rotational scoring (Photo No. 81). The aft crenelated flange was fractured from the disk and the fracture surface was smeared (red arrow on Photo No. 82). The yellow arrow on Photo No. 82 shows the rotational scoring due to the damaged PT shaft misalignment.

Photo No. 81: Rear PT disc with scoring

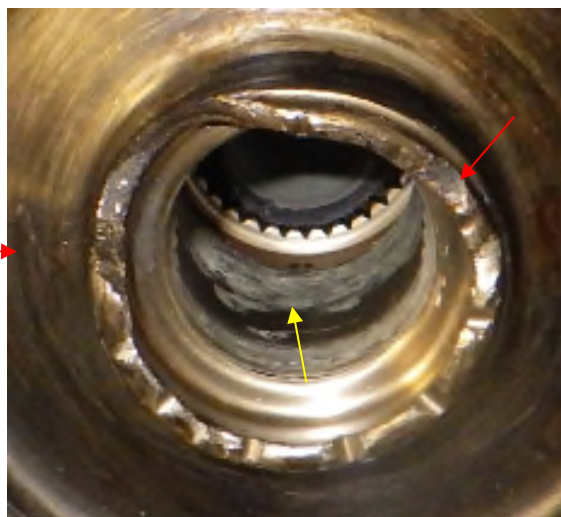
Photo No. 82: PT disc flange fractured

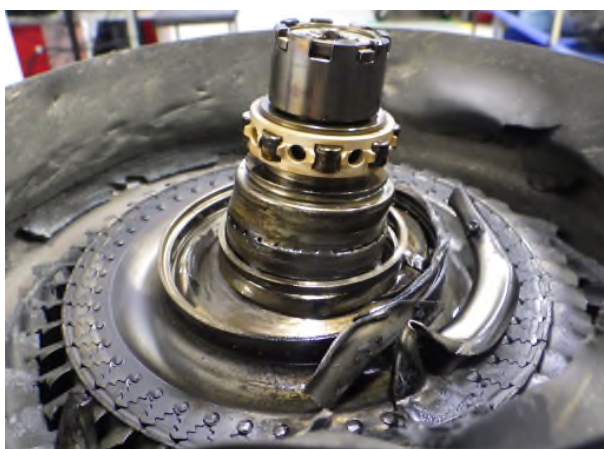
Examination of the engine as received revealed that the PT shaft was misaligned at an angle, as seen in Photo No. 83.

Photo No. 83: PT shaft off-center

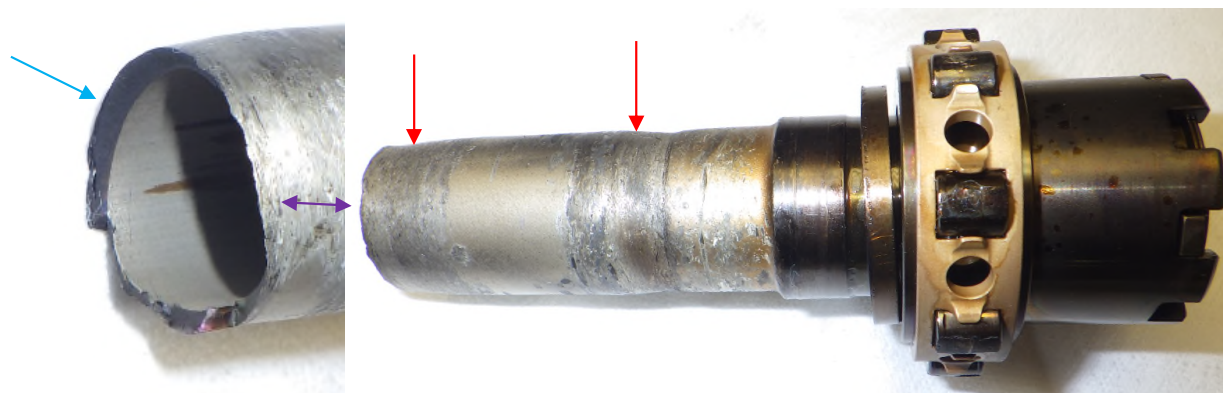
The PT shaft was fractured at approximately 4 inches from the aft end as seen in Photo No. 84. The 45 degree shear lip on the fracture surface along with the twisting path of the fracture, is characteristic of torsional tensile overload (blue arrow). Severe rubbing marks were found in the fractured area (red arrow, Photo No. 84) which corresponded to the rubbing marks observed on the PT disc bore (yellow arrow, Photo No. 82).

Photo No. 84: Sheared section of PT shaft

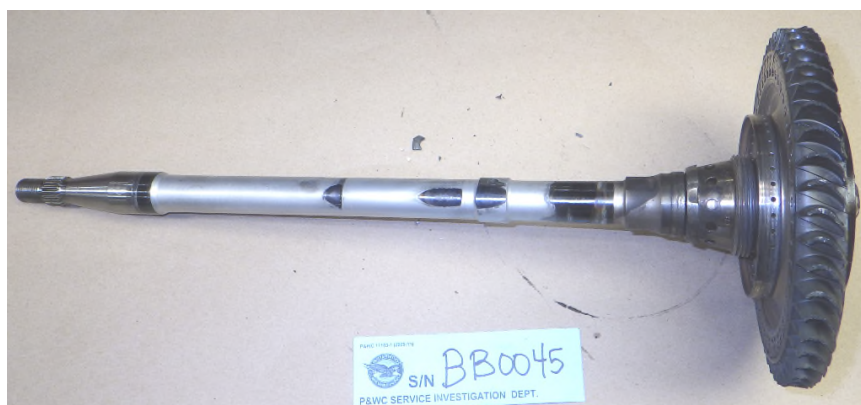
The forward fractured PT shaft section had four sets of rotational contact marks along its length (see photo No. 85), which is consistent with a temporary elastic bending having occurred on the shaft.

Photo No. 85: Power Turbine Shaft

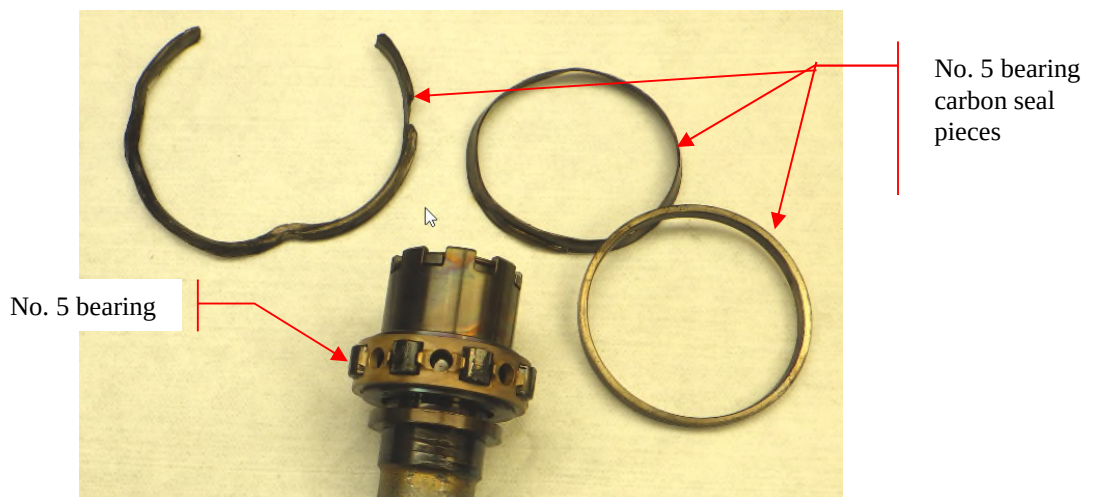
The No. 5 bearing rollers showed flattened surfaces and the No. 5 bearing carbon seal was completely disintegrated (Photo No. 86). The No. 5 bearing seal runner was severely machined resulting in a through-crack (Photo No. 87). The No. 5 bearing housing was intact, however the rear bearing housing cylinder was distorted (Photo No. 88). The aft cover plate appeared to be offset from the housing because the housing had deformed as shown by the yellow arrows on Photo No 89. The forward cavity of the No. 5 bearing surface was coated in oily soot which is consistent with an oil fire.

Photo No. 86: No. 5 bearing and No. 5 bearing carbon seal

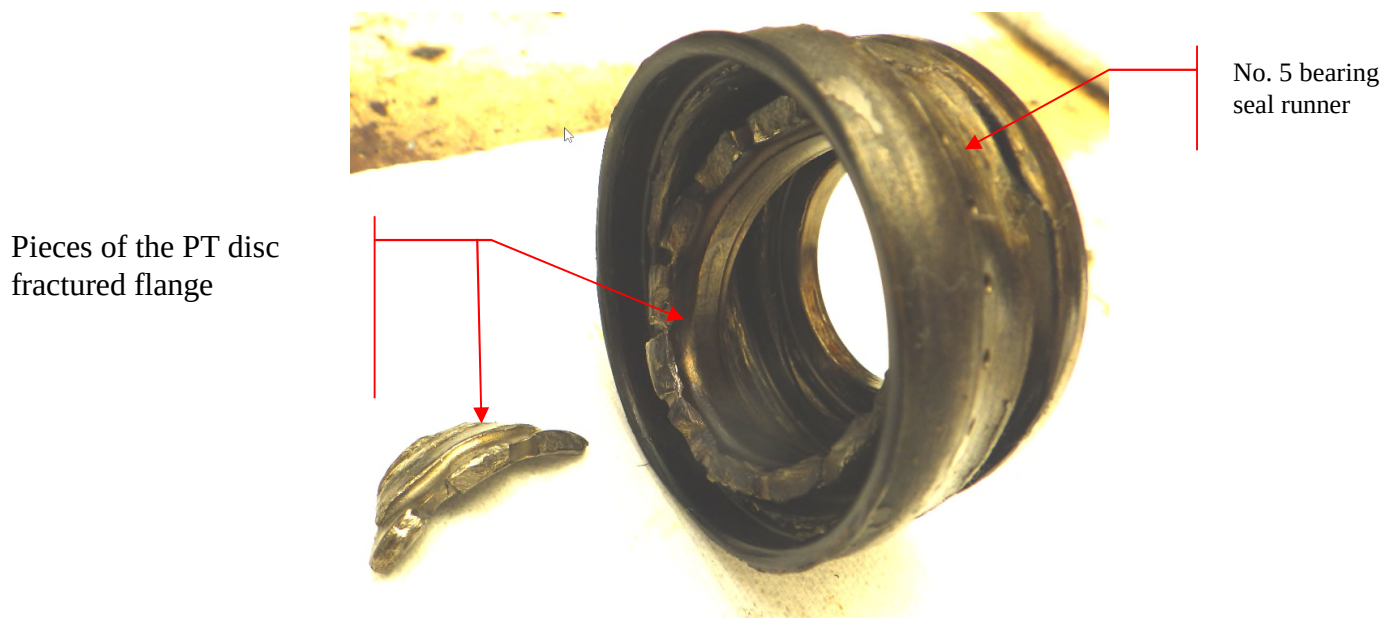
The No. 5 bearing seal runner was rotationally scored and partially fractured which is consistent with an uneven contact against the No. 5 bearing carbon seal (Photo No. 87).

Photo No 87: No. 5 bearing seal runner

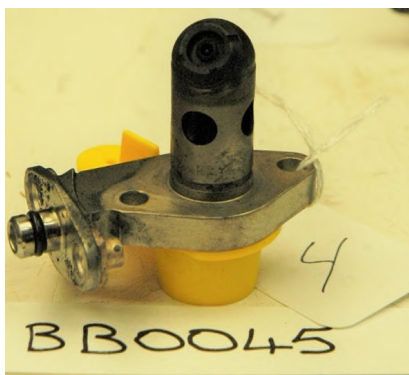
The 12 fuel nozzles were removed from the gas generator case and found undamaged but with heavy sooting/carbon. It was decided not to test the nozzles due to the carbon present on the nozzles, which may have affected the flow test results. Three nozzles are shown in Photo's No. 95 through 97.

Photo No. 95: Nozzle 4
