**Accident / Incident Report**

**Pratt & Whitney Canada**

**Report No.:18SIE00239**

**Pentastar Aviation Charter Inc (Owner: Bennett Aviation LLC)**  
**EC135P1 & Registration # N312SA**  
**Chicago, Illinois**  
**July7, 2018**  
**PW206B**  
**S/N BB0049 and BB0045**

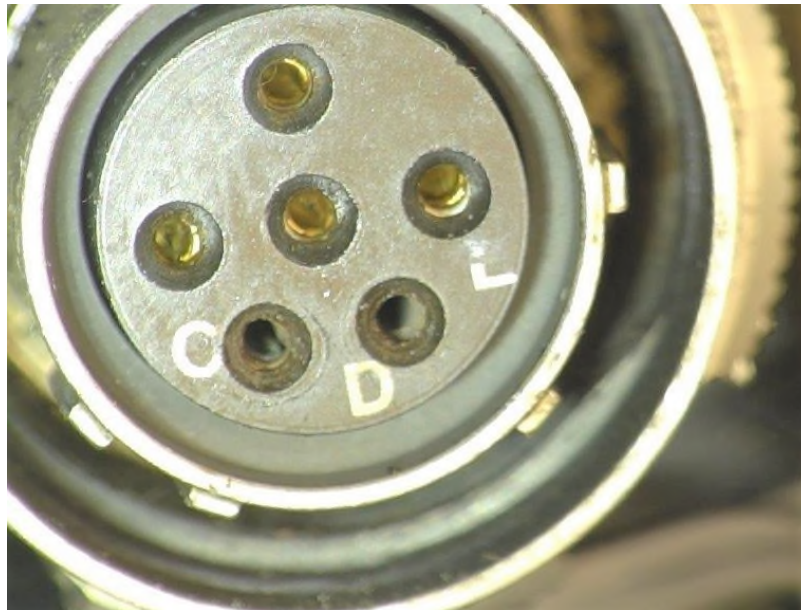
The harness P/N 3121134-01 was visually inspected and generally clean, however had two tines missing from the connector P3. It is believed they went missing during the removal because these missing tines resulted in a test exceedance, which had they been missing during operation would have caused an indication to the cockpit. Additionally there was some barrel coating peeling on the external side of connector P1.

Figure 5  
P3 connector socket C and D missing tines
