**NATIONAL TRANSPORTATION SAFETY BOARD**  
Vehicle Recorder Division  
Washington, DC 20594

## **Onboard Image Recorder and Other Devices**

**Specialist's Factual Report**  
**By Christopher Babcock**

| NTSB Number: | CEN18FA277 |

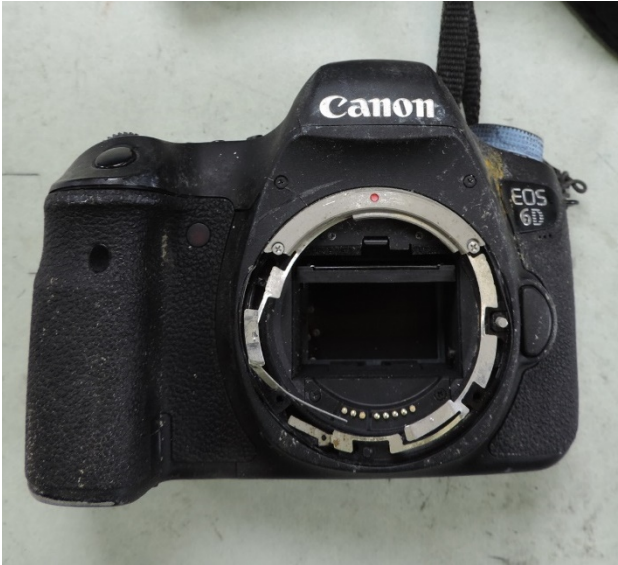
The camera and SD were wet when they arrived in the lab (Figures 1-2). The SD card was cleaned and dried and images were recovered normally. Most of the 110 recovered pictures contained images of farms and farm equipment taken at a low angle. GPS data was not found in the metadata for any image.

**Figure 1.** Canon EOS 6D, as recovered.

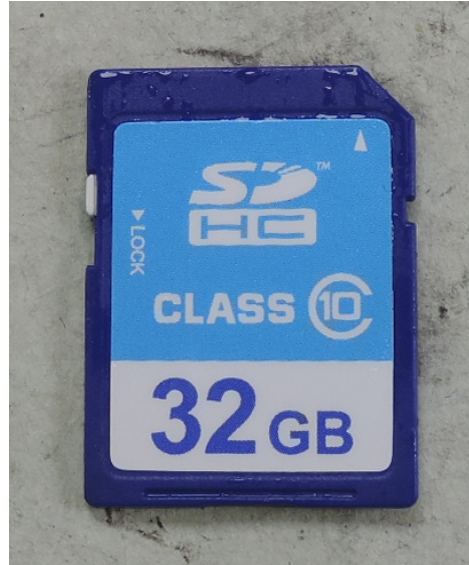
**Figure 2.** SD card, as recovered.

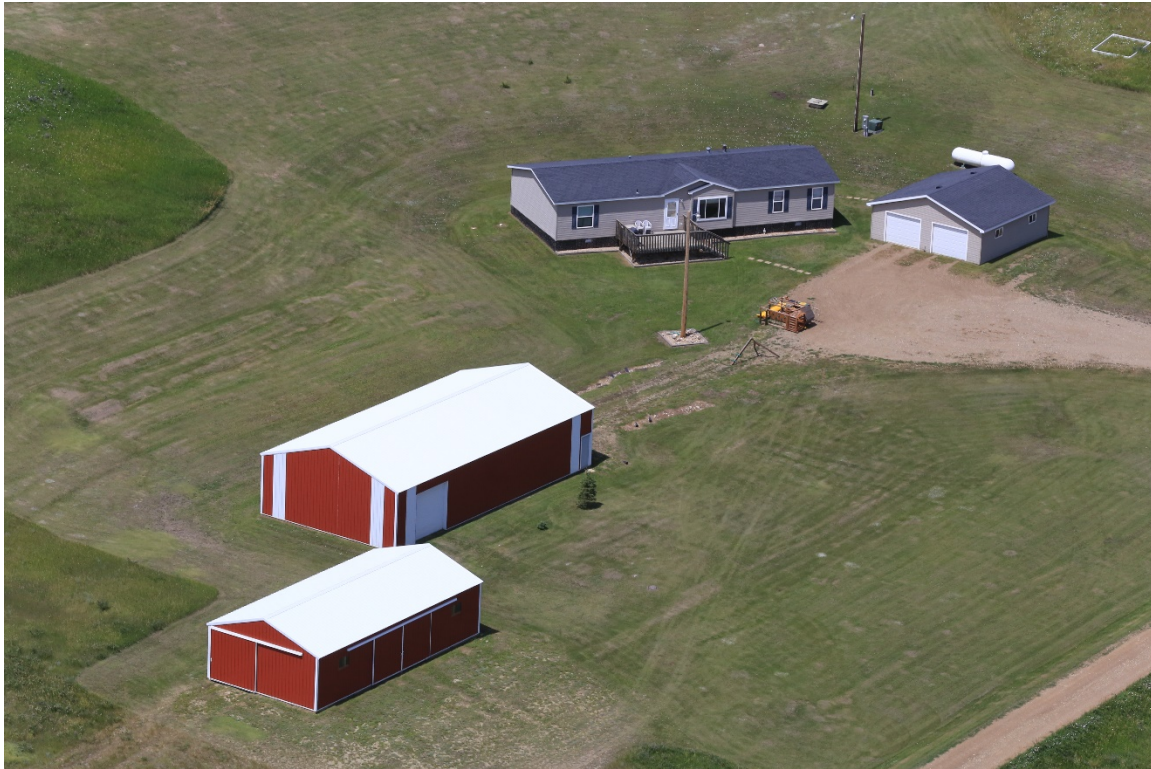
The time on the camera is set by the user and may not be aligned with any common time reference. The images were captured between 9:09 AM and 2:27 PM camera time with a gap between 12:33 PM and 1:58 PM camera time. Figure 3 contains an exemplar image of one of the farms taken at 2:04:47 PM camera time. Comparison of the photo with the aircraft's flight path from recorded FAA surveillance data showed the aircraft was in a position to capture the image in Figure 3 (taken at 2:04:47 PM camera time) at about 1:54:34 PM CDT (Figure 4). Therefore, 10 minutes and 13 seconds was subtracted from the camera time to convert to local CDT.

**Figure 3.** Image of farm taken at 2:04:47 PM camera time (1:54:34 PM CDT).

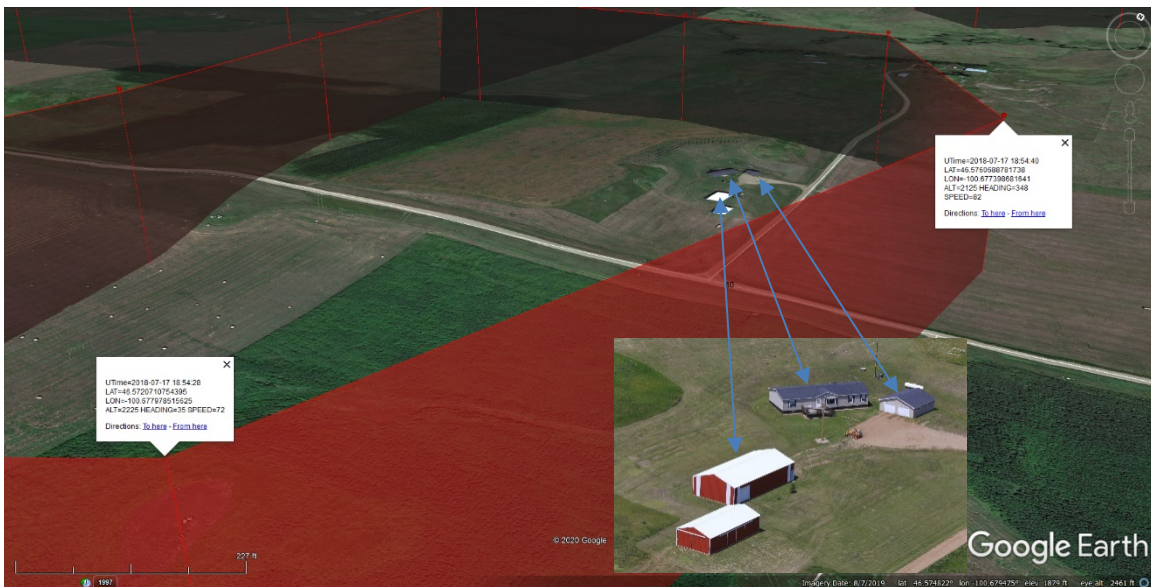
**Figure 4.** Flight path data showing time when the aircraft was in a position to capture inset image.

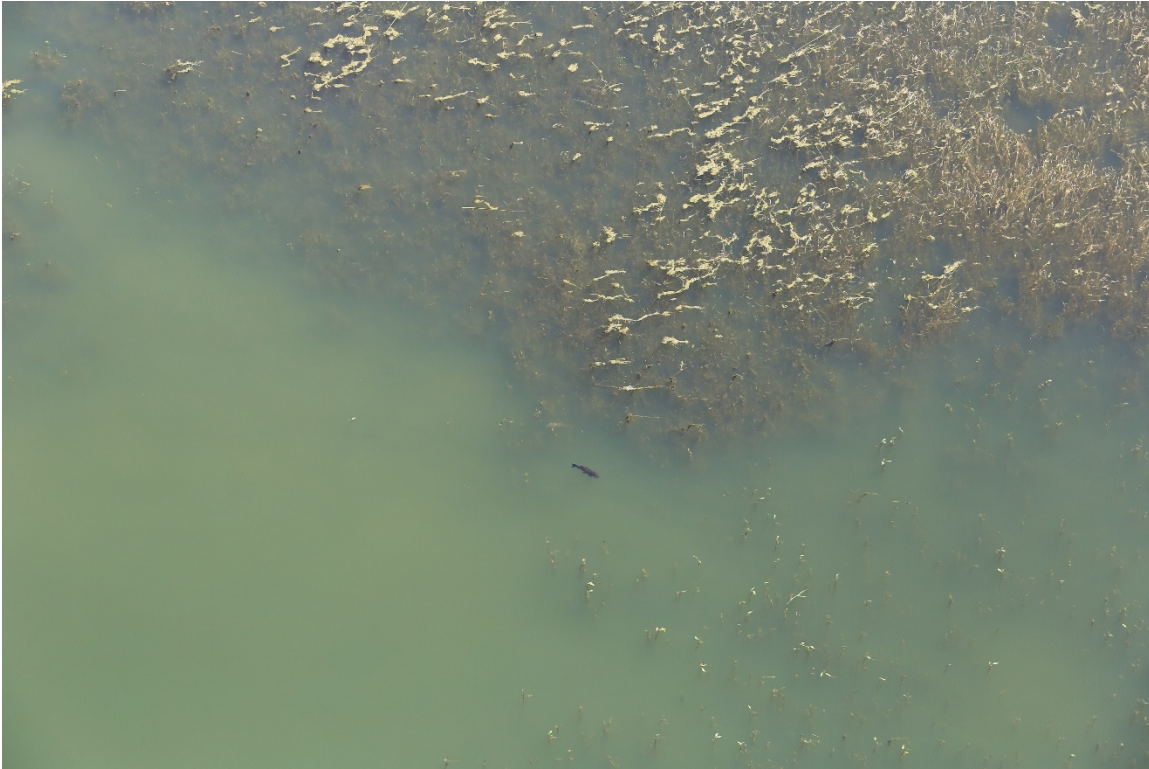
Between 2:21:57 PM CDT and 2:23:12 PM CDT (2:32:10 PM and 2:33:25 PM camera time), a series of 7 images were captured at a high angle, almost straight down. The images captured water and debris such as downed trees. Several large fish were visible in most of the images. Figure 5 contains an exemplar image. Figure 6 shows the location and time of the nearest aircraft position when the

**Figure 5.** Image taken at 2:22:46 PM CDT

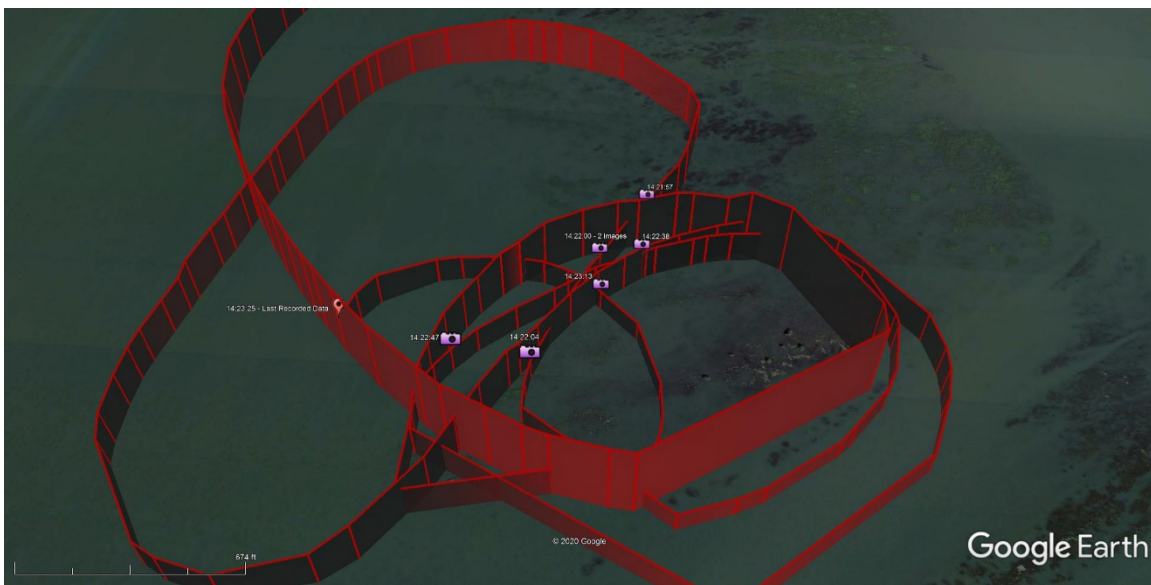
images were captured overlaid on a plot the aircraft's flight path along with the last recorded position data at 2:23:25 PM CDT.

**Figure 6.** Locations and times of the last 7 images captured overlaid on the flight path.

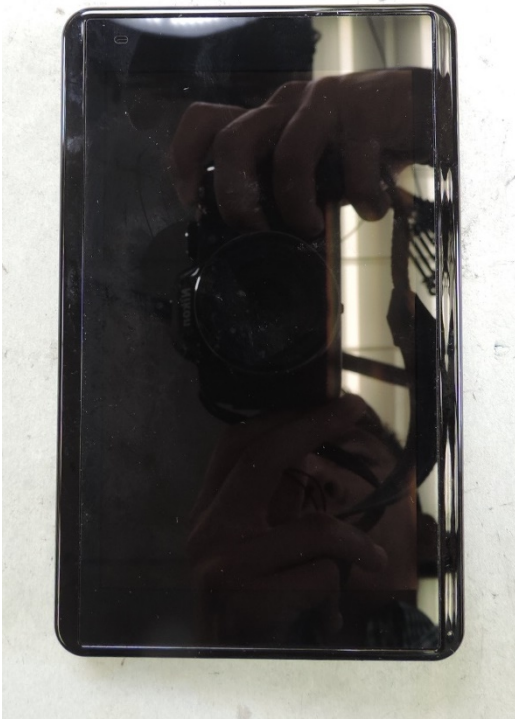
The Garmin Aera 660 displayed evidence of water immersion (Figures 7-8). The Garmin Aera would not connect to a PC to download track data normally. The

memory device was removed from the internal printed circuit board and imaged on laboratory equipment. The image was forensically imaged and examined and no GPS track data was found.

**Figure 7.** Front of Garmin, as recovered.

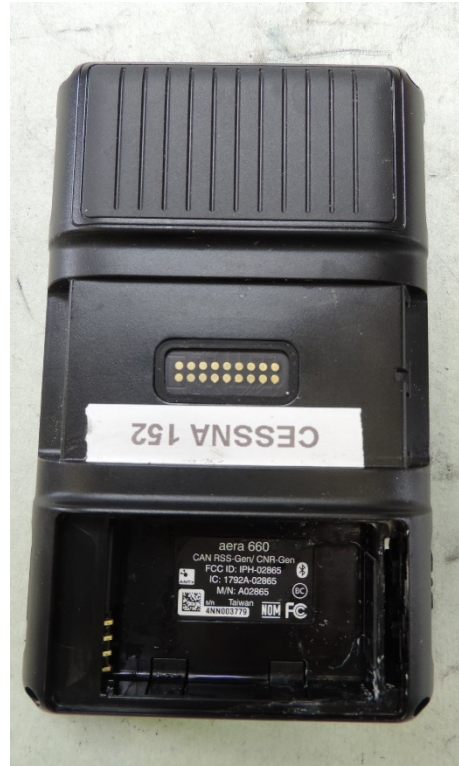
**Figure 8.** Rear of Garmin, as recovered.

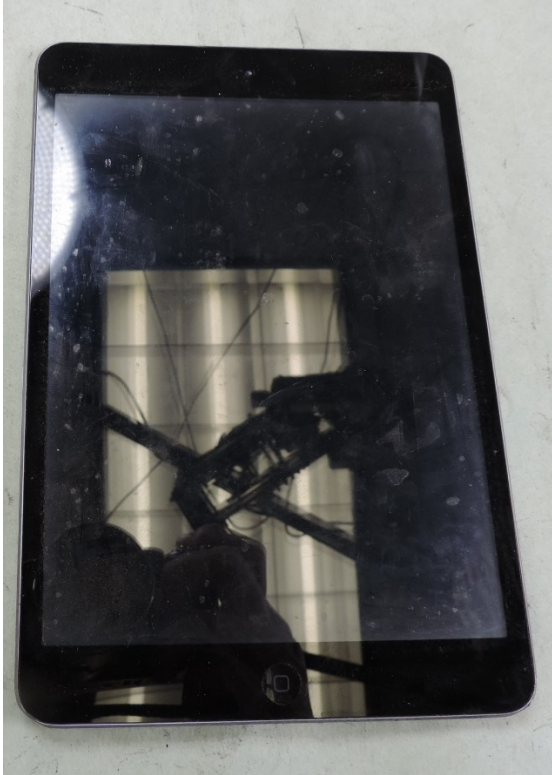
The iPad Mini was showed evidence of water immersion (Figure 9-10). When powered, the device's digitizer was not functional. In agreement with the investigator in charge, there were no further attempts to recover data

**Figure 9.** Front of iPad, as recovered.

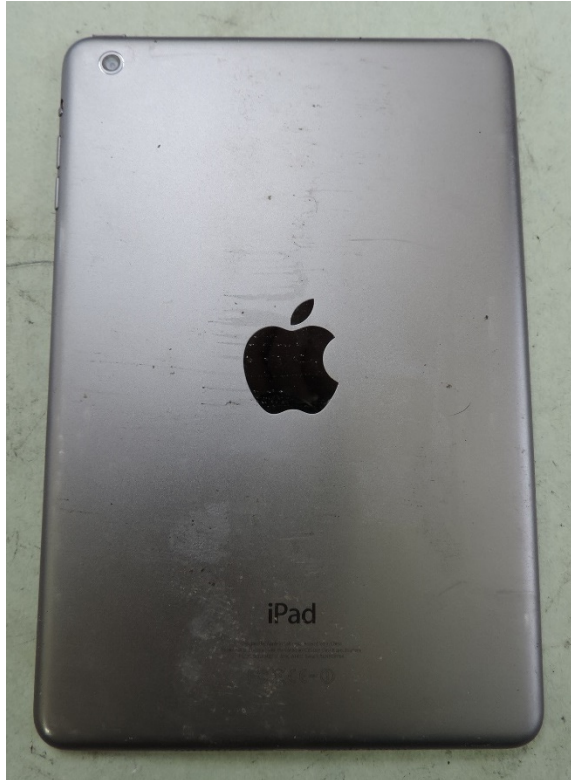
**Figure 10.** Rear of iPad, as recovered.

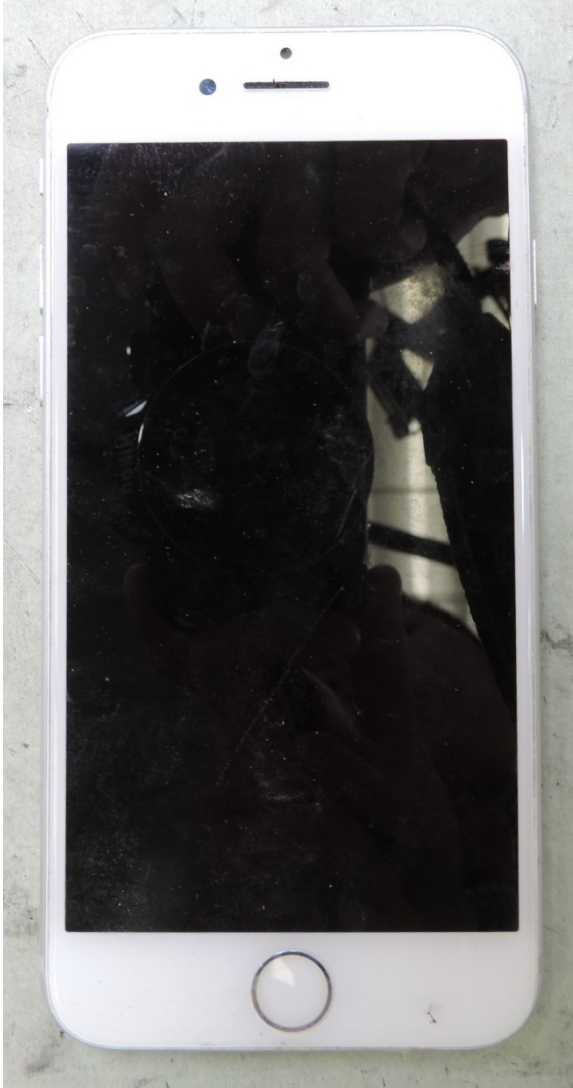
The iPhone 7 was showed evidence of water immersion (Figure 11-12). The phone would not maintain connection with a computer for data recovery, so the internal circuit board was removed and installed on a laboratory surrogate where data was recovered. Content relevant to the investigation included images taken of the aircraft tachometer and Hobbs meter display. The tachometer gauge read zero for each image. Table 1 indicates the Hobbs meter reading for each image.

**Figure 11.** Front of iPhone, as received.

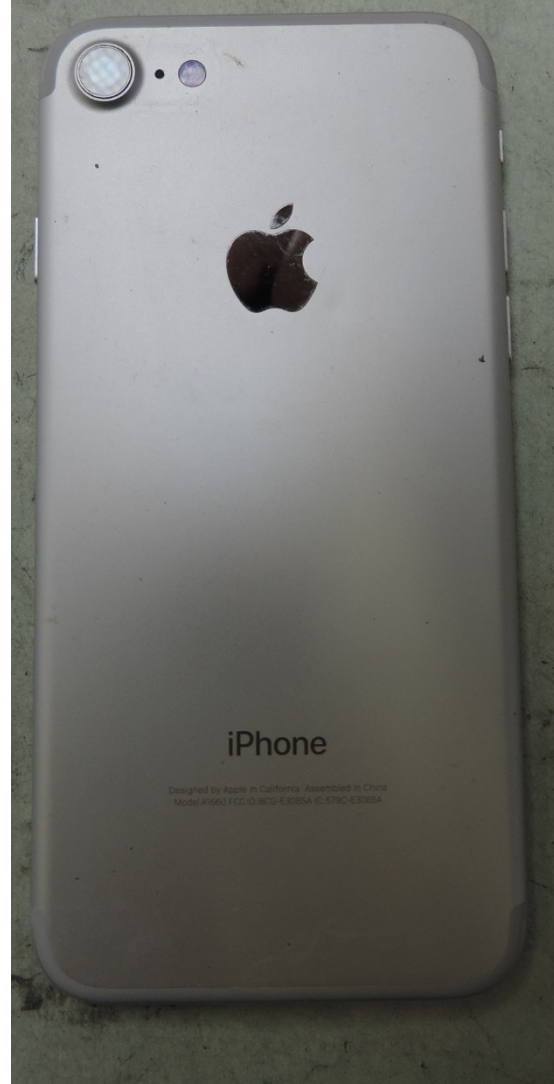
**Figure 12.** Rear of iPhone, as received.
