# NATIONAL TRANSPORTATION SAFETY BOARD

## MATERIALS LABORATORY FACTUAL REPORT

Report No. 19-002

Place : Patriot, Indiana  
Date : July 18, 2018  
Vehicle : Fisher Celebrity  
NTSB No. : CEN18FA282  
Investigator : Arnold Scott, AS-CEN

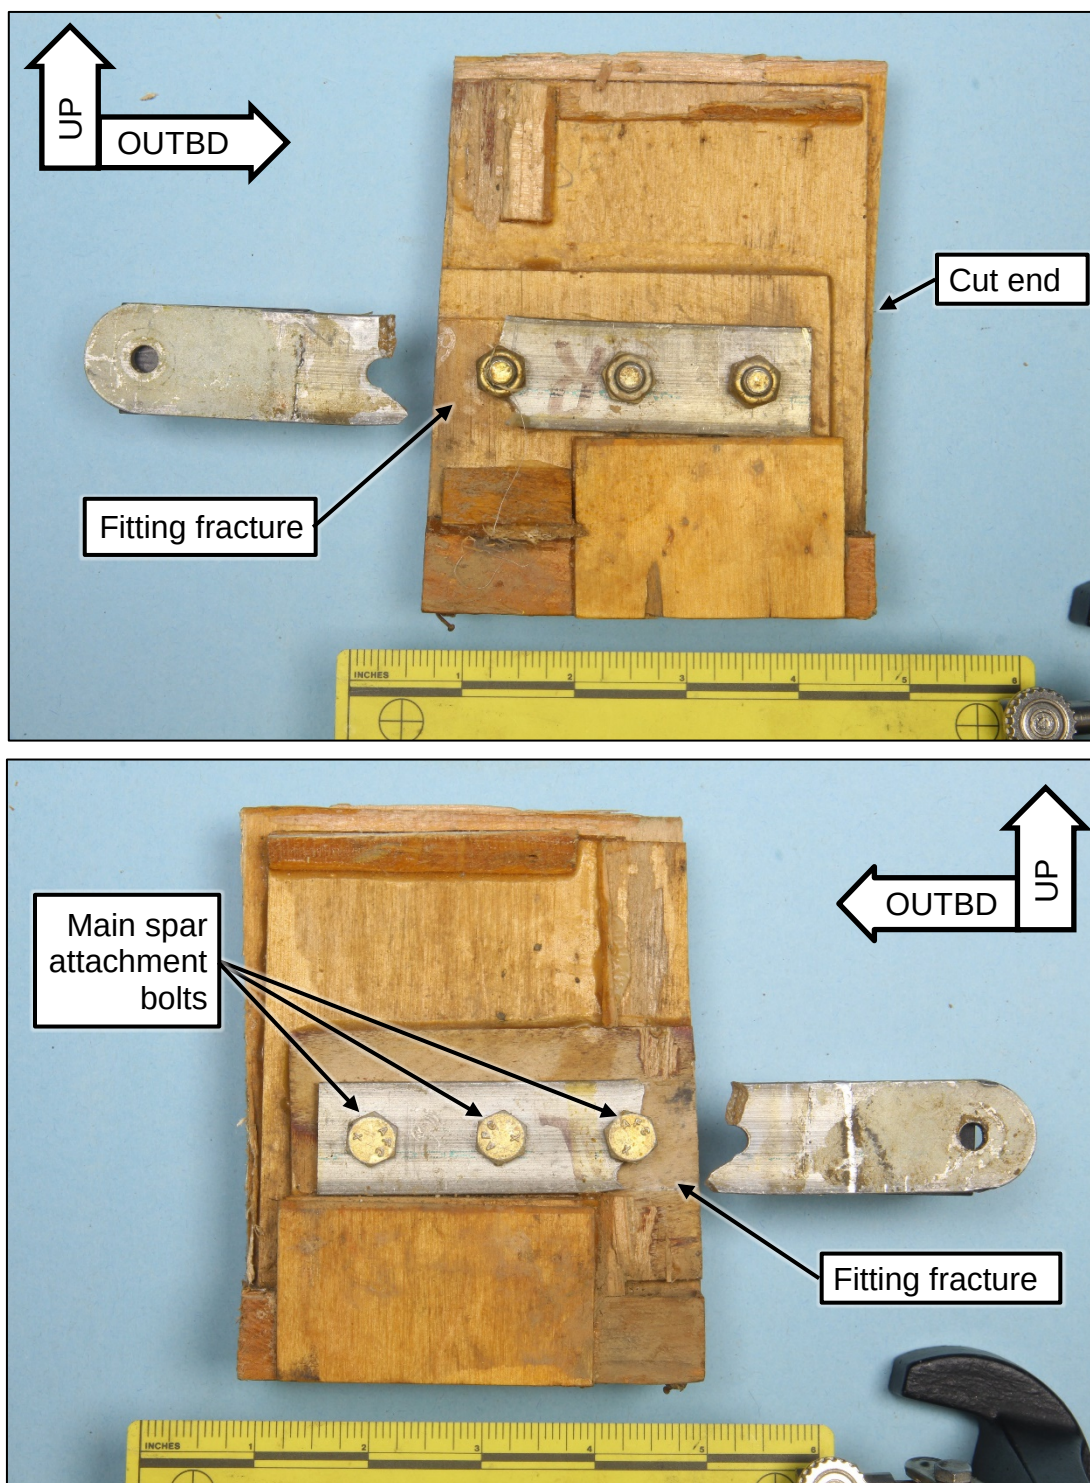
Each of the submitted attachment fittings had fractures intersecting the inboard wing spar attachment bolt hole. The fracture features for each attach fitting were rough and matte gray in appearance, consistent with ductile overstress fracture. Overall deformation patterns associated with the fractures were consistent with upward bending of the wing at the attachment location. The outboard end of the attachment fitting piece for the aft spar was also bent to the aft relative to the inboard end. No evidence of any preexisting damage was noted on the wing spar attachment fittings.

The outboard ends of the main spar attachment fittings were bolted to the main spar pieces shown in figure 1. The spar had been cut outboard of the attachment fittings as indicated in figure 1 to facilitate shipment to the NTSB Materials Laboratory. The upper spar cap was fractured from the upper side of the main spar piece.

Figure 1. Overall views of the right wing main spar attachment fittings at the aft (upper image) and forward (lower image) sides of the spar.

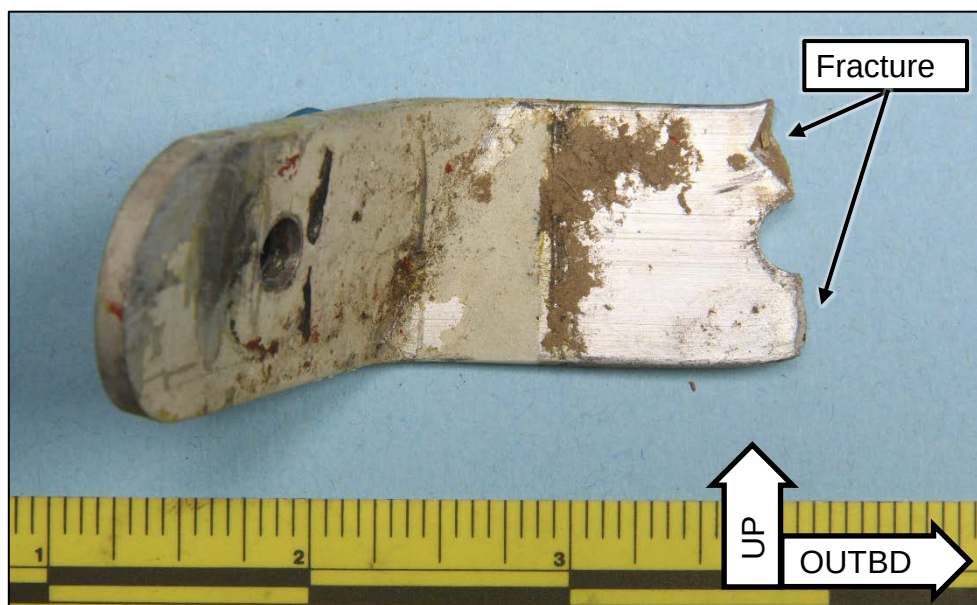
Figure 2. Inboard portion of the fractured aft spar attachment fitting.

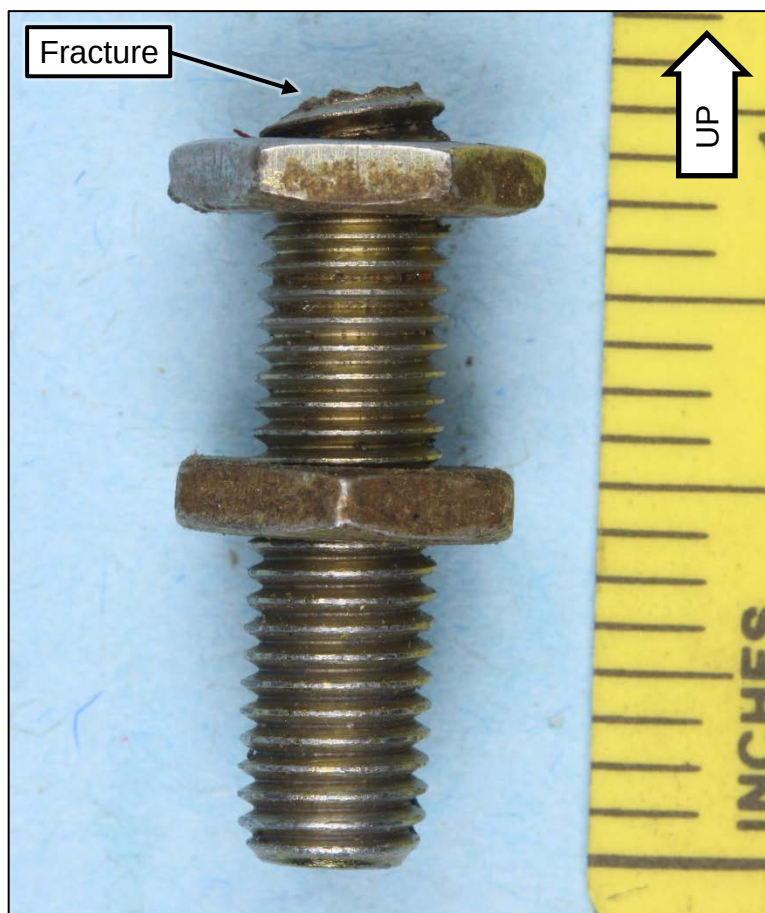
The threaded shank from the right aileron control rod was fractured through the threads as indicated in figure 3. The fracture surface had rough features, and the shank

adjacent to the fracture was deformed, features consistent with ductile overstress fracture under bending loads. The fracture surface was partially covered by reddish orange oxides consistent with post-fracture oxidation. No evidence of any preexisting damage was noted on the threaded shank.

Figure 3. Right aileron control rod threaded shank with attached jam nuts.
