I participated in the examination of the wreckage of the Fisher Celebrity N228LC at the AMF hangar facility in Springfield TN. Also present were Mr. Arnold Scott of the NTSB and a representative from the FAA.

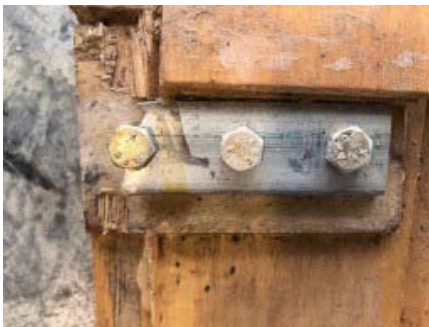
The first failed components that were of interest and generated a lot of discussion were the lower right wing spar brackets (3). All failed in a similar manner as shown in Images 1-3.

Image 1: Front Attach Bracket – Lower Right Wing Main Spar

These are all shown in the upright position. The failure of the bracket indicates that the top portion failed in tension and the bottom portion below the attach bolt failed in compression indicating that the wing was experiencing a negative load in excess of its ultimate strength limits. The other four wings failed across the wooden spar consistent with being torn away from the aircraft due to an impact load - presumably from contacting the ground or near-ground obstacles. Image 4 shows one of the other main spar failures representative of them all. It is my opinion that the initial structural failure was in the brackets shown above.

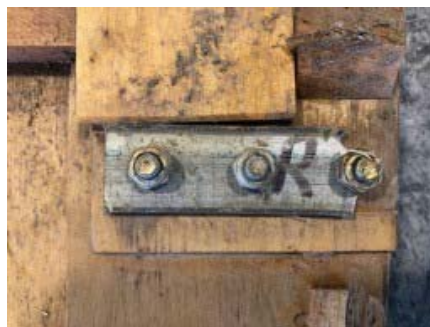
Image 2: Rear Attach Bracket – Lower Right Wing Main Spar

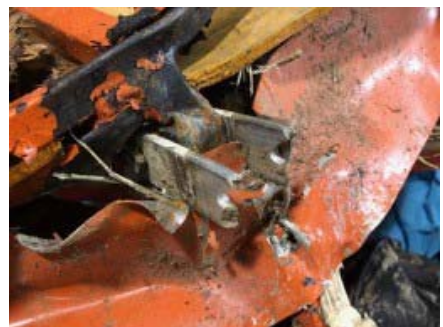
Image 3: Inboard Both Attach Brackets – Lower Right Wing Main Spar

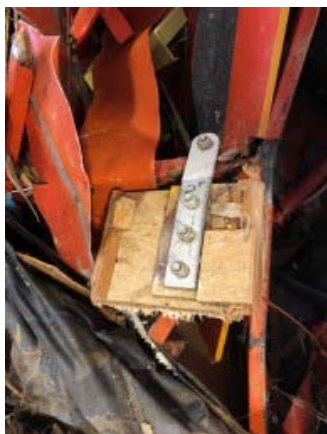
Image 4: Main Spar Severed Just Outboard of the Attach Bracket

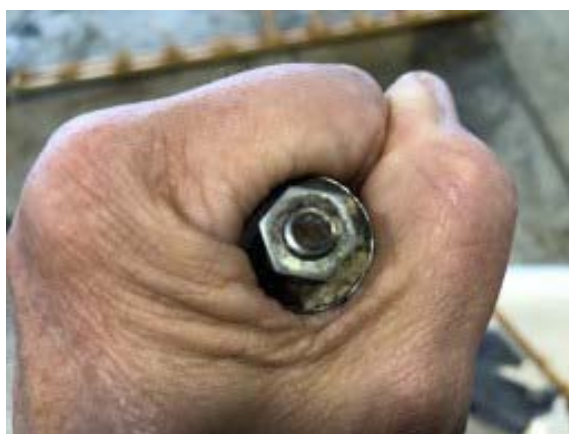
Another failure that was notable was in the threaded portion of the upper rod end on the left aileron connecting rod. It appeared to have internal corrosion that may have been antecedent to the accident and also may have contributed to the cause of the accident. This component has been sent to the laboratory for analysis to determine if there was corrosion in this component that could have caused its failure in flight. Images 5 & 6 show the severed threaded portion of the rod end with the set and jam

nuts still in place. Failure occurred just above the set nut. Another question for the lab to answer is the composition of the threaded portion and the composition of the nuts – could the nuts have caused some galvanic corrosion due to incompatible materials. Were the nuts and the rod end both AN hardware?

Image 5: End View Severed Rod End

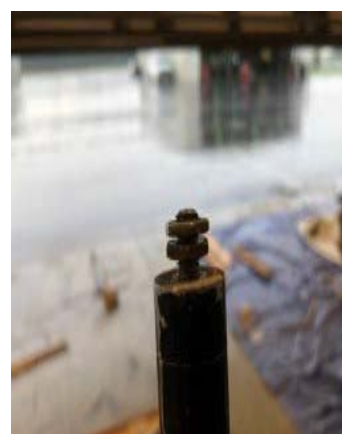
Image 6: Side View – Severed Rod End
