# NATIONAL TRANSPORTATION SAFETY BOARD

## Global Positioning System Device

### Specialist's Factual Report

Location: Bronson, Michigan  
Date: August 18, 2018  
Aircraft: Air Tractor 502B  
Registration: N502RL  
Operator: Lutes Flying Service  
NTSB Number: CEN18FA339

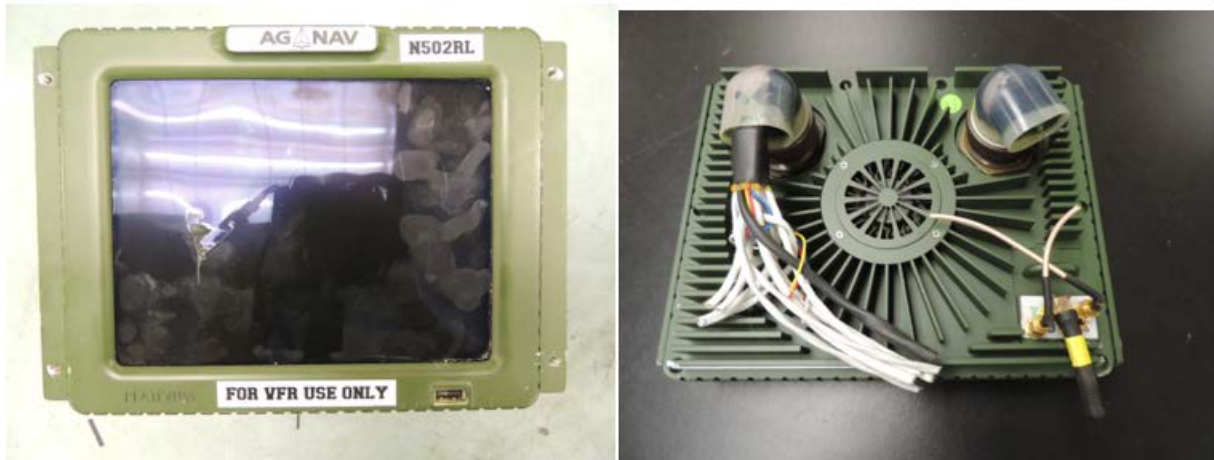
Upon arrival at the Vehicle Recorder Division, an exterior examination revealed the device sustained minor damage on the touch screen, as shown in Figure 1. The device did not power on normally.

**Figure 1: Front and Back of AgNav GUIA PLATINUM as received.**

After further examination, several internal wire connections were found disconnected, and the USB port was broken internally as well. After repairing the damaged parts, the device powered on normally and data was downloaded via USB, as shown in Figure 2.

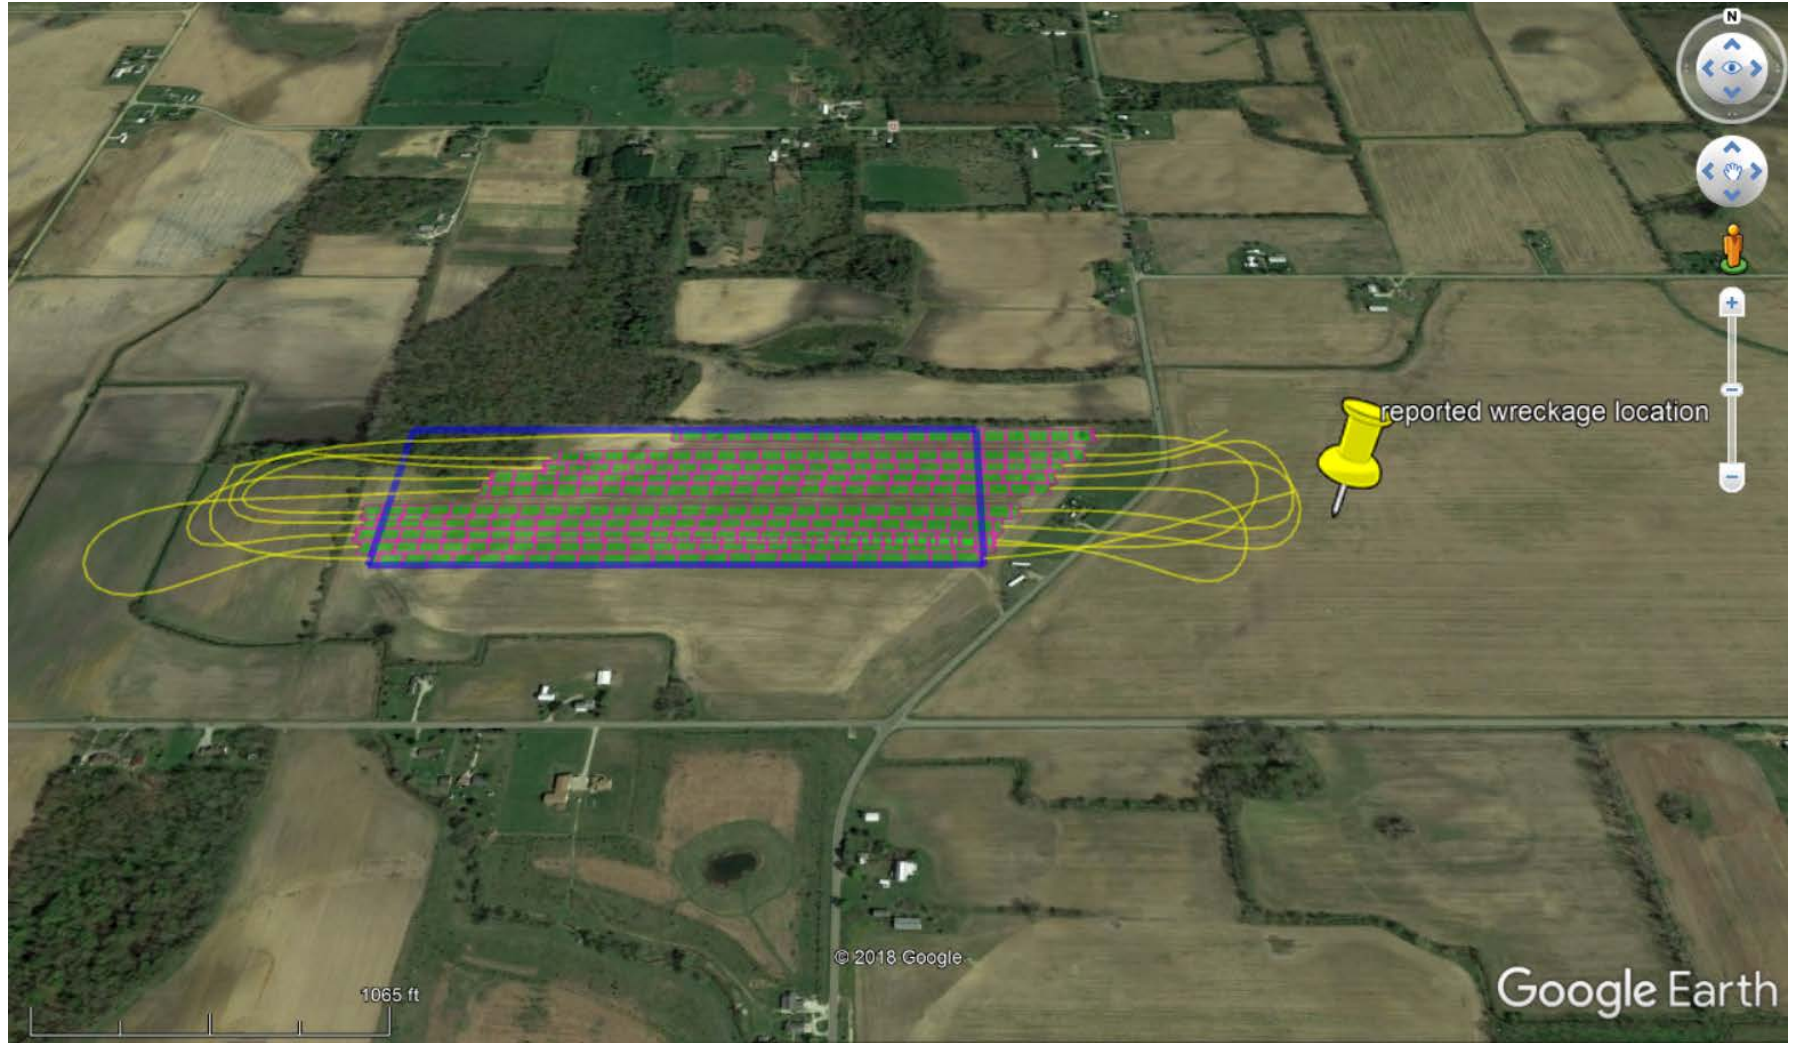
Figure 3 is a graphical overlay generated using Google Earth for the accident flight. The data plot was generated from the manufacturer's software. The blue outline shows the aerial application boundary that the user set in the AgNav device. The light green and pink areas show regions of aerial application. The yellow lines show the flight path. Altitude is not depicted. The weather and lighting conditions in Google Earth are not necessarily the weather and lighting conditions present at the time of the recording.

**Figure 3: Google Earth overlay showing the entire flight with spray area and spray coverage.**

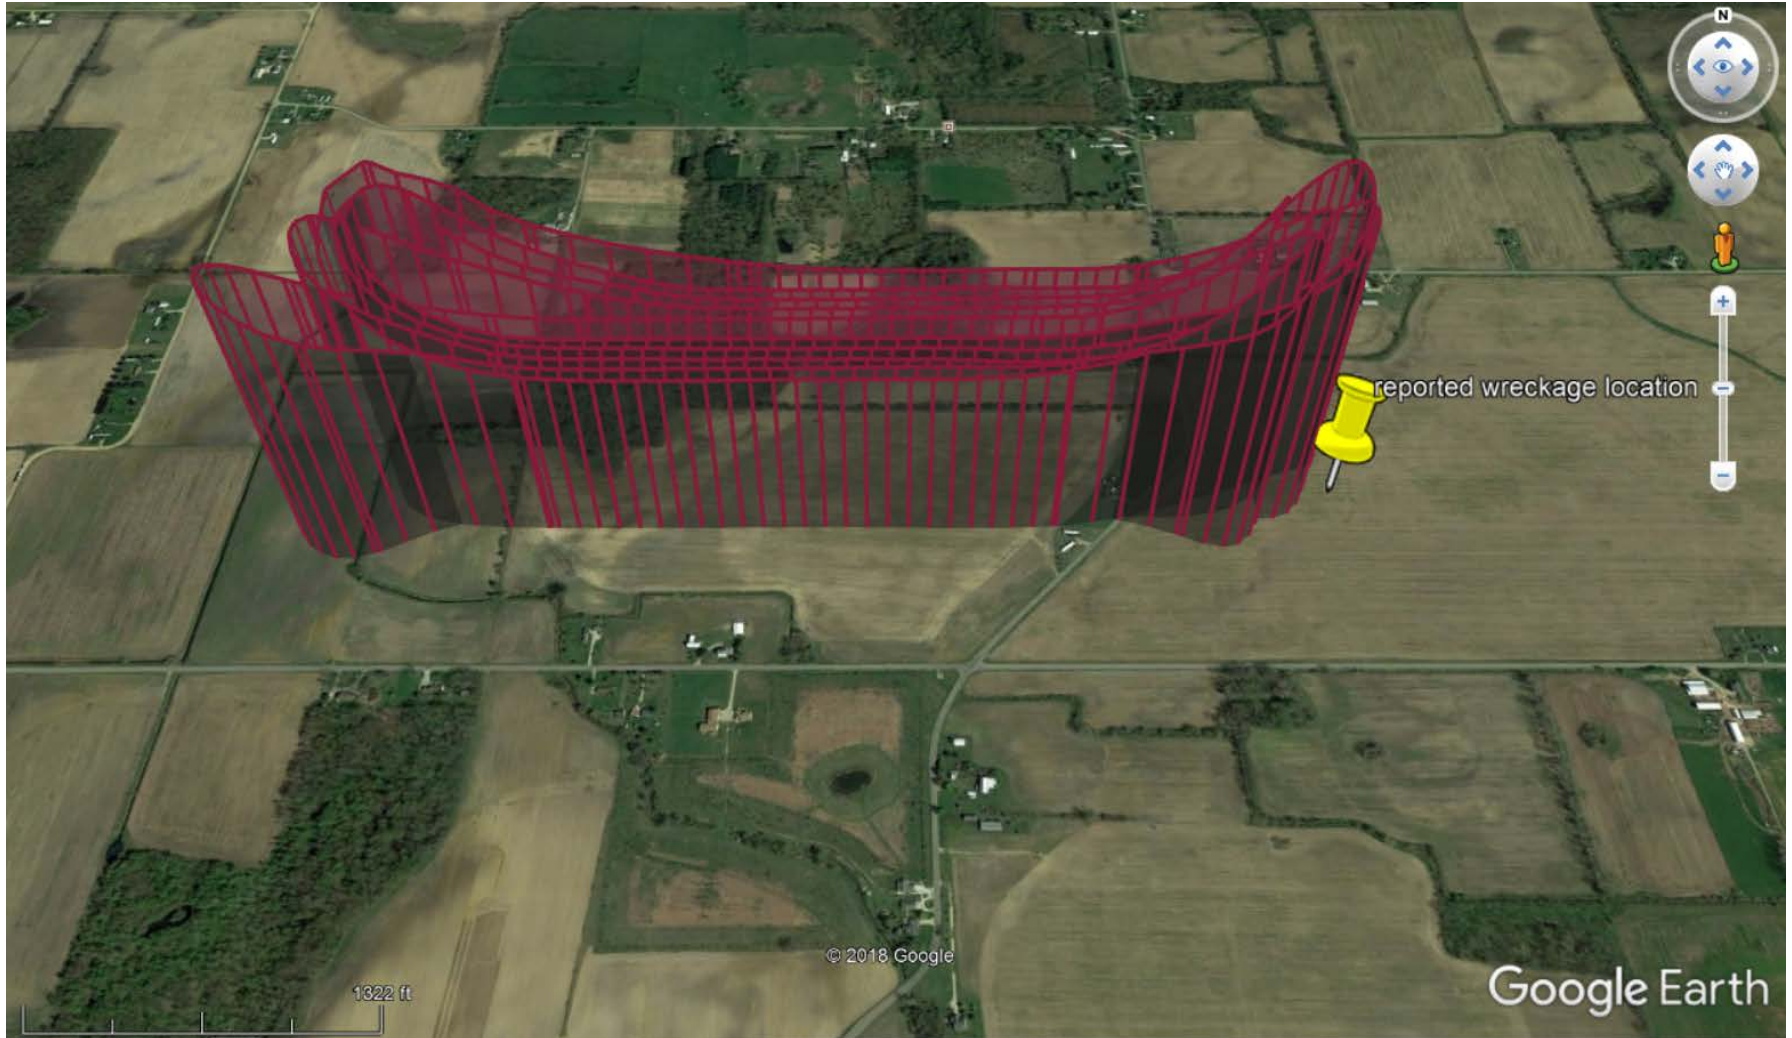
Figure 4 is a graphical overlay generated using Google Earth for the accident flight generated using NTSB software tools. The aircraft's altitude is depicted.

Figure 4: Google Earth overlay showing the entire flight with altitude.

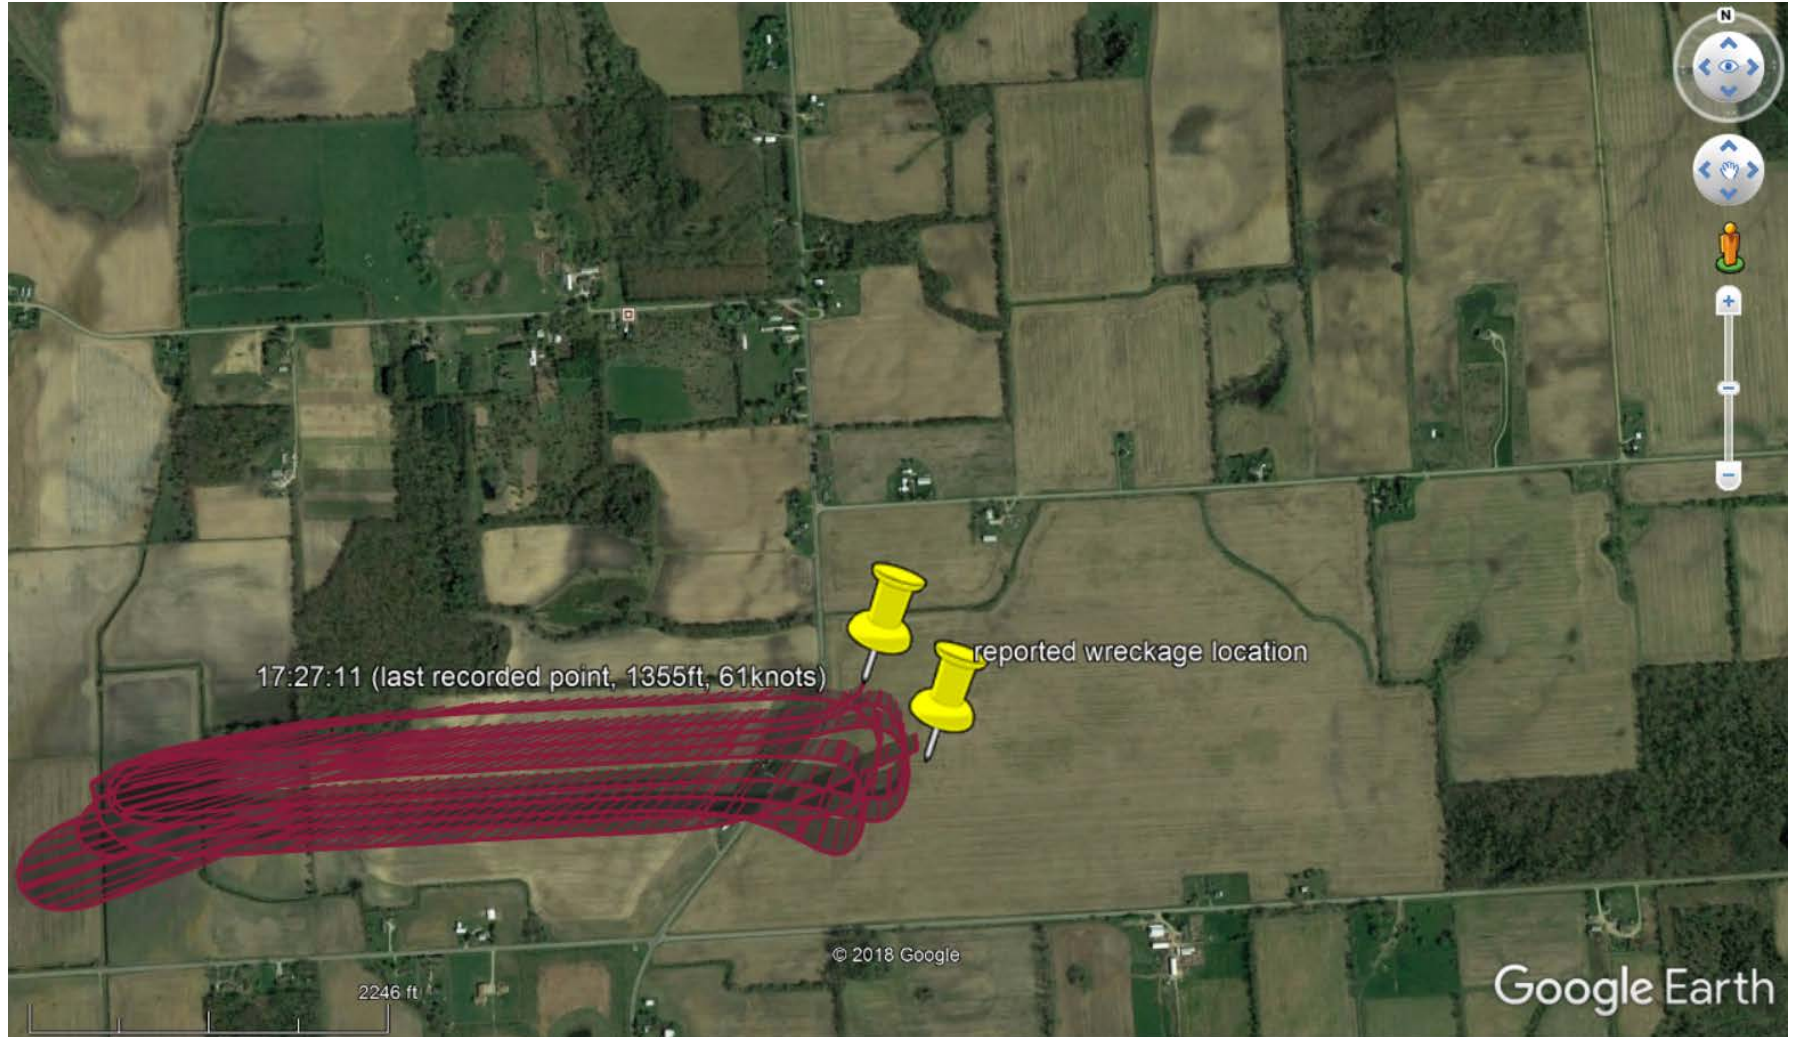
Figure 5 is a graphical overlay generated using Google Earth for the accident flight generated using NTSB software tools. The data of the last recorded point is depicted.

**Figure 5: Google Earth overlay showing the last recorded point with time, altitude and derived speed.**

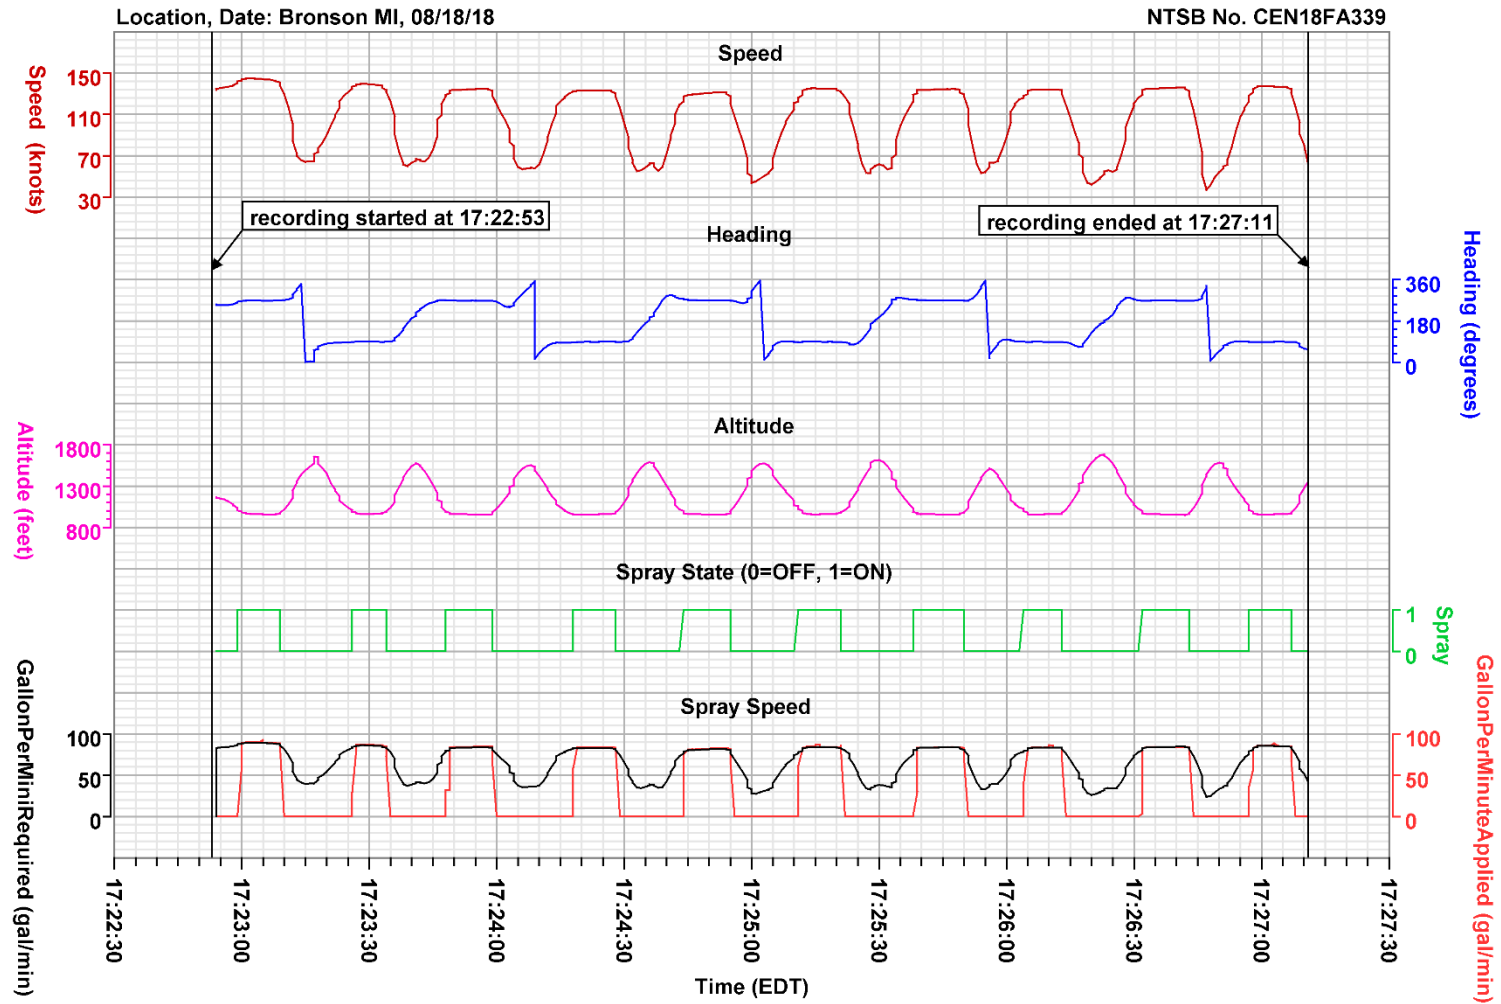
Figure 6 is a plot of parameters from the AgNav device for the accident flight. The time interval is 17:22:30 to 17:27:30 EDT on August 18, 2018.

Figure 6: Data Plot of the accident flight.
