**Air Tractor, Inc.**  
**Accident Investigation**

**AIRFRAME ACCIDENT REPORT**

**CEN18FA339**

**8/18/18**  
**Bronson, MI**

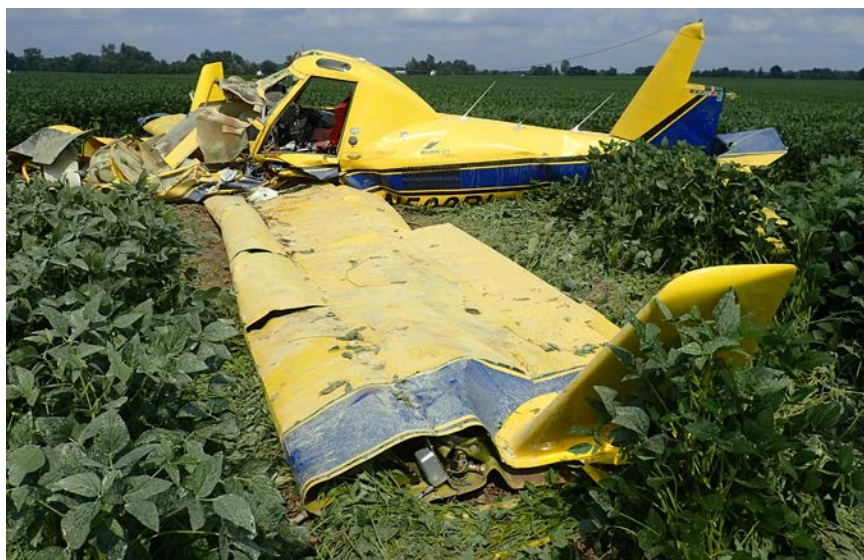
**Overview of Wreckage as viewed from the left side**

The aircraft was found in a generally upright position and the fuselage was oriented on a 350 degree (magnetic) heading. The wings, empennage and all control surfaces were present and in their normal locations. The wing orientation was measured to be oriented on a line of 50-230 degrees (magnetic), which is about 30 degrees from the normal pre-impact position (perpendicular to the fuselage). No horizontal debris trail or ground scars were discernible. The wreckage and debris patterns were consistent with a high angle, nose-low impact. There were linear wing impact marks radiating from the center impact mark. The crush and impact damage on the airframe was generally in a direction of aft and upwards.

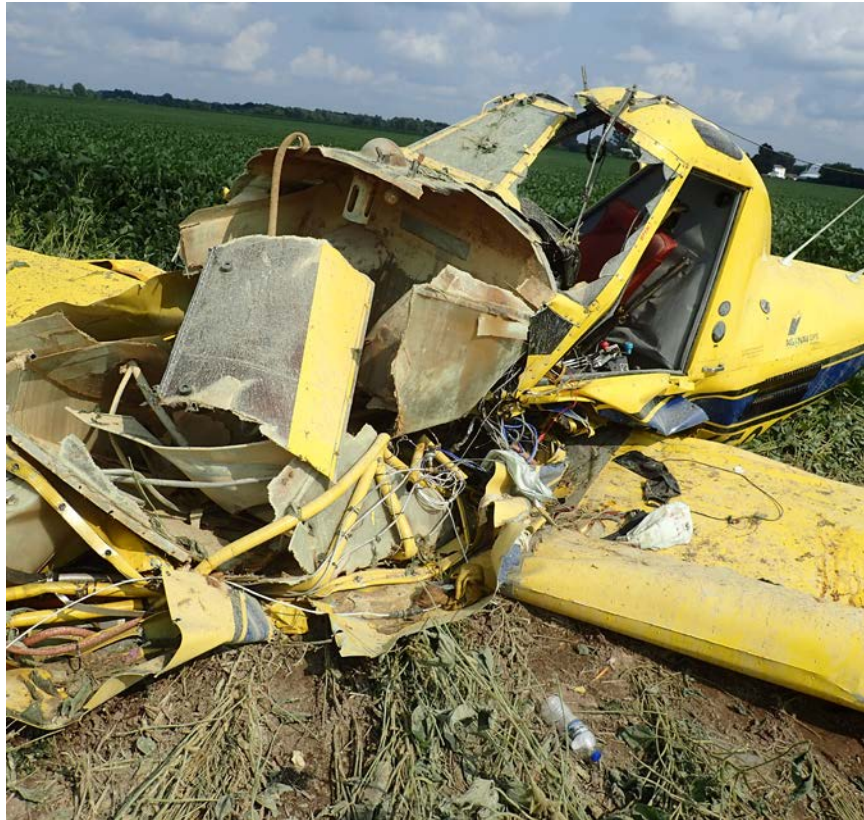
**Overview of Mid Fuselage Wreckage**

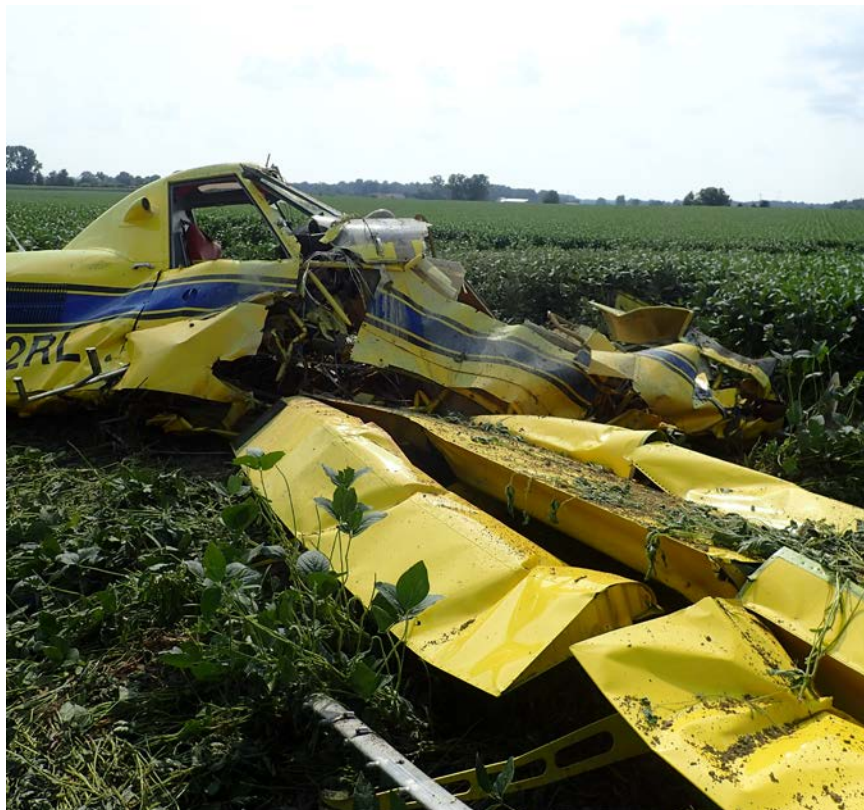
**Overview of Wreckage viewed from right side**

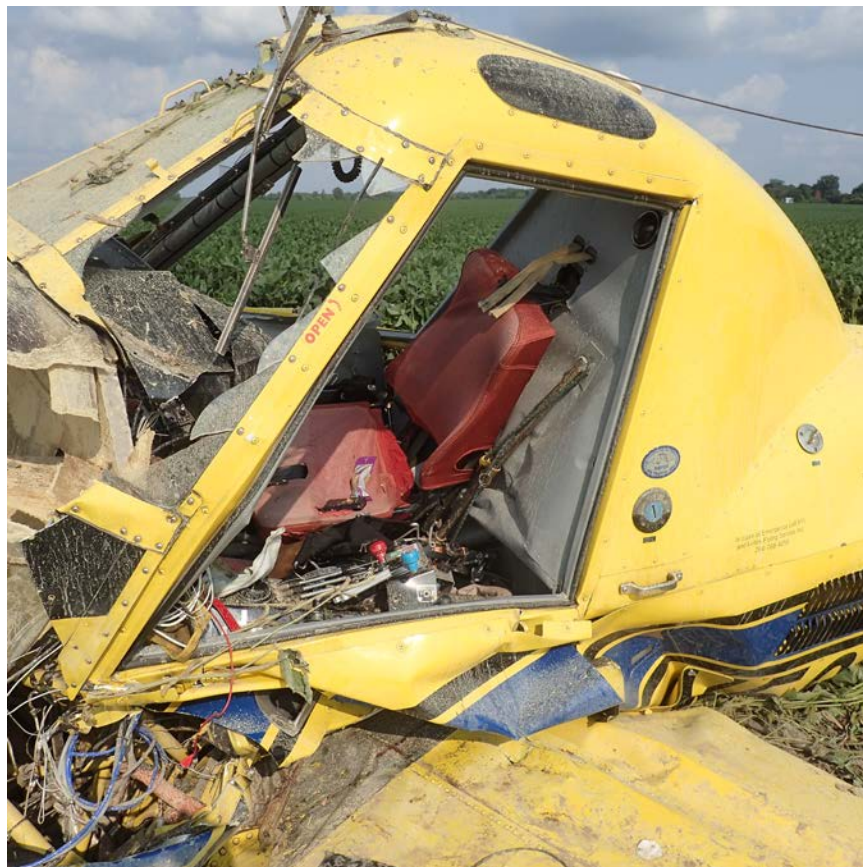
The fuselage was found upright and generally intact. The area of the fuselage forward of the cockpit was heavily damaged and crushed upwards and aft. The cockpit area was found to have maintained an occupiable space. The seat pan was deformed downward and the pilot restraints were found unbuckled. The airplane was equipped with AmSafe Inflatable Restraints (airbags), which were found in the deployed state. The shoulder harness and airbag inflation hoses were found to have been cut cleanly.

**Cockpit Area Wreckage**

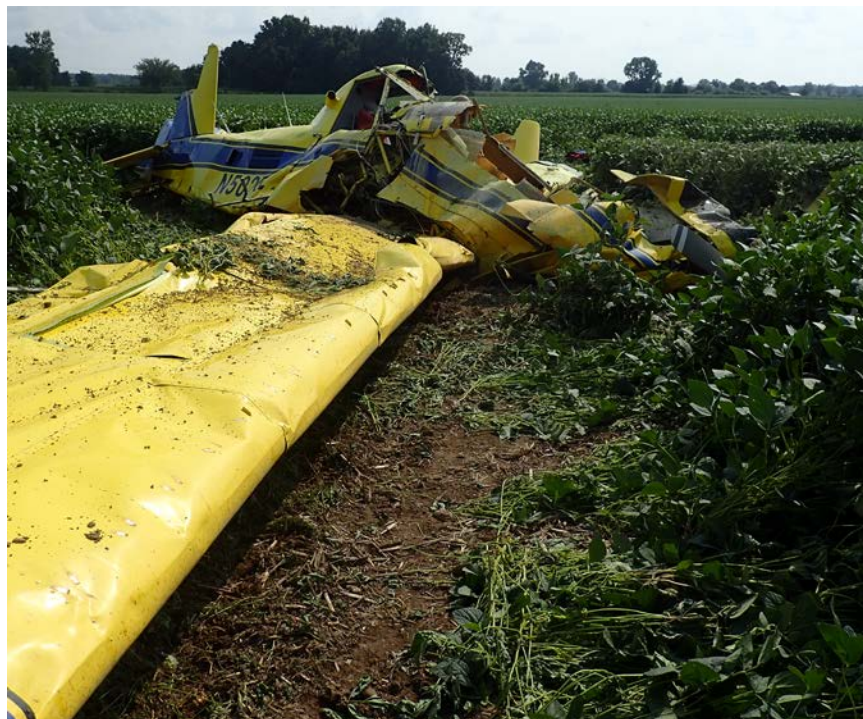
Both wings were found in place on the fuselage. The center splice wing connection remained intact. The leading edges of both wings were displaced in the upward and aft direction. These leading edge skins appeared to be ballooned upward, with most of the aftermarket vortex generators missing. The lefthand wing leading edge appeared to have slightly more damage than the right.

**View of Right Wing Wreckage**

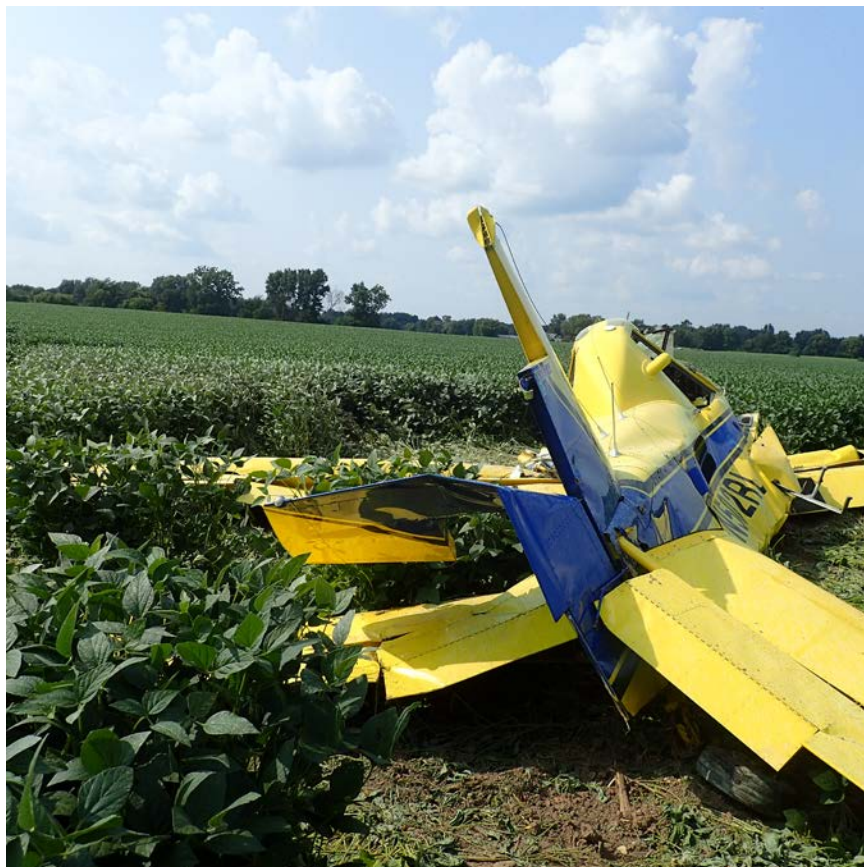
All of the empennage surfaces were located in their correct locations on the tail of the aircraft. Each of these surfaces were heavily damaged. The vertical fin remained attached to the fuselage at the front and rear spars. The rudder was connected to the vertical fin by the lower two hinges. The upper hinge remained attached to the vertical fin but was no longer installed in the rudder. The rudder was folded over approximately 90 degrees to the left.

**Overview of Wreckage viewed from the rear**

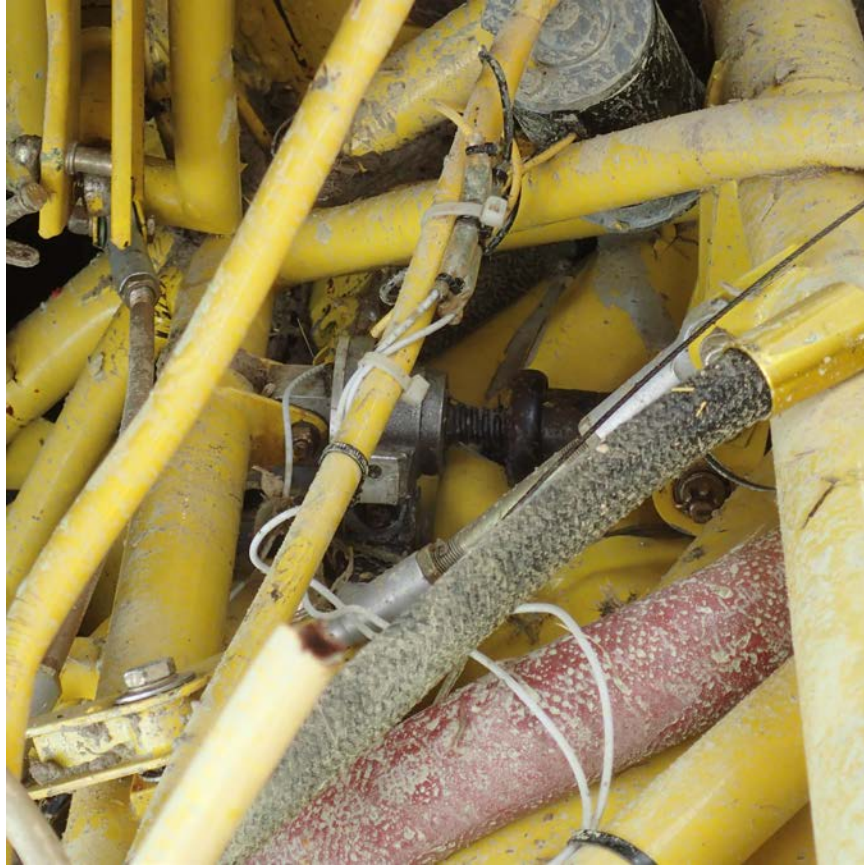
The flap control system was found to be continuous and all control system hardware was found to be in place. The extension of the flap actuator was measured and found to be about 0.9". This corresponds to a flap position of approximately 5°, which is considered within the normal range for flap position during an agricultural turn maneuver.

**Flap Actuator Extension**

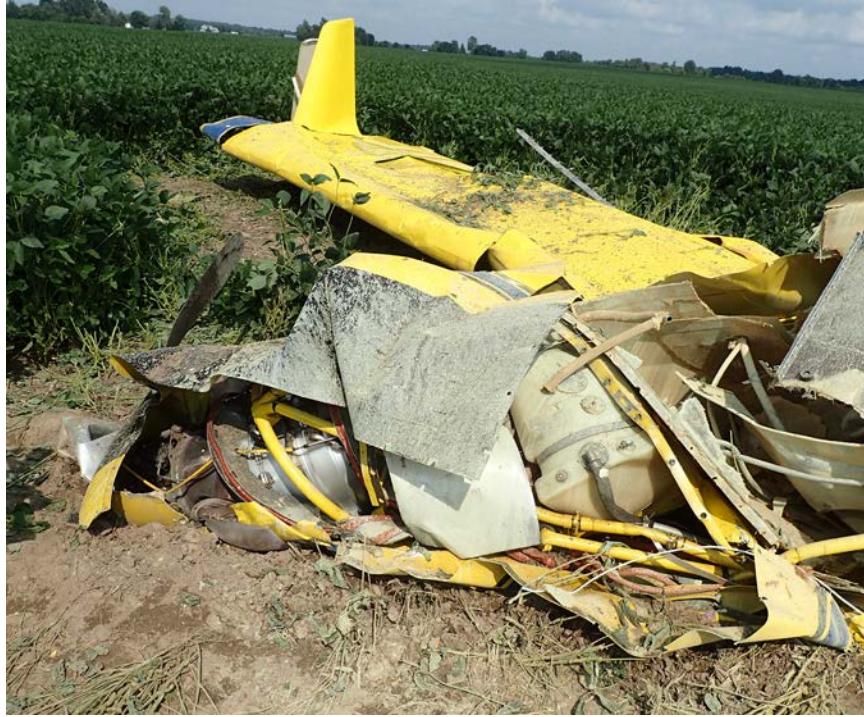
The powerplant remained attached to the forward portion of the fuselage. There was heavy damage to all of the firewall forward systems that was consistent with upward and aft crush damage. The engine was confirmed to be a Pratt & Whitney PT6A-34AG engine, serial number PCE-PH0761. The engine was separated at the "F" Flange.

**Overview of Powerplant Wreckage**

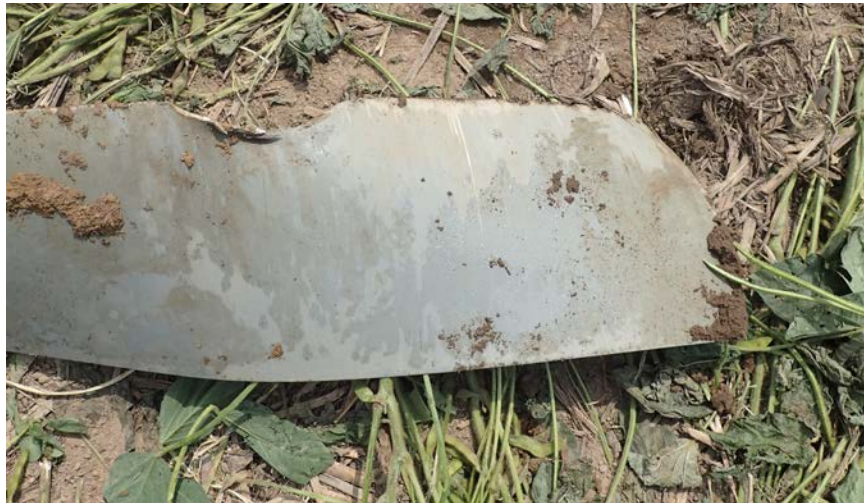
One propeller blade was visible above ground and remained attached to the hub. The two other blades were found buried. One blade remained attached to the hub and the other had been separated. The separated blade showed chordwise scoring and a deep gouge in the leading edge. This gouge was consistent in size and shape with several stones that were found in the dirt near the propeller.

**Detail of Separated Propeller Blade**
