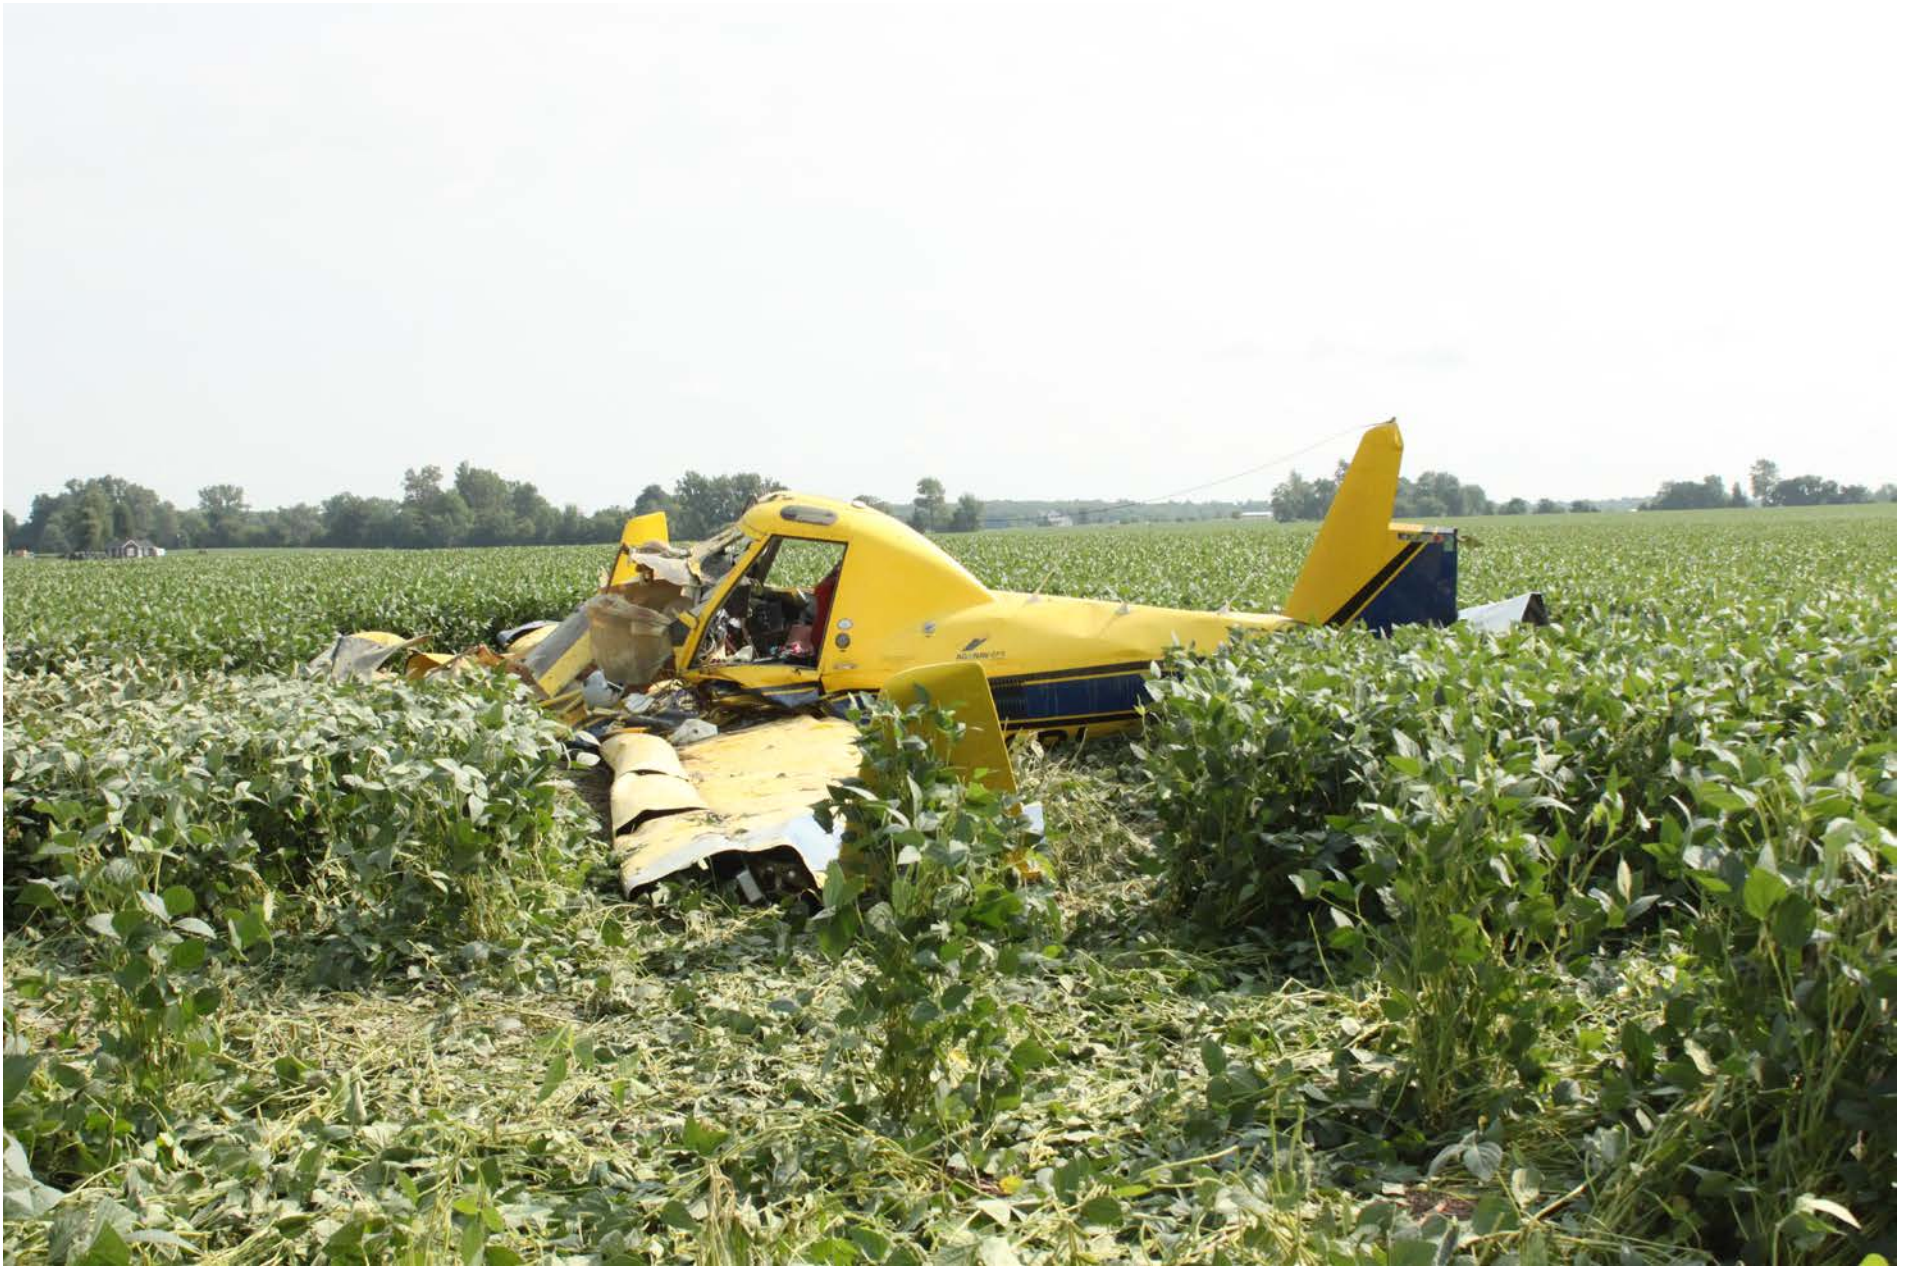
**Photo 1 – View of Wreckage from Left Side**

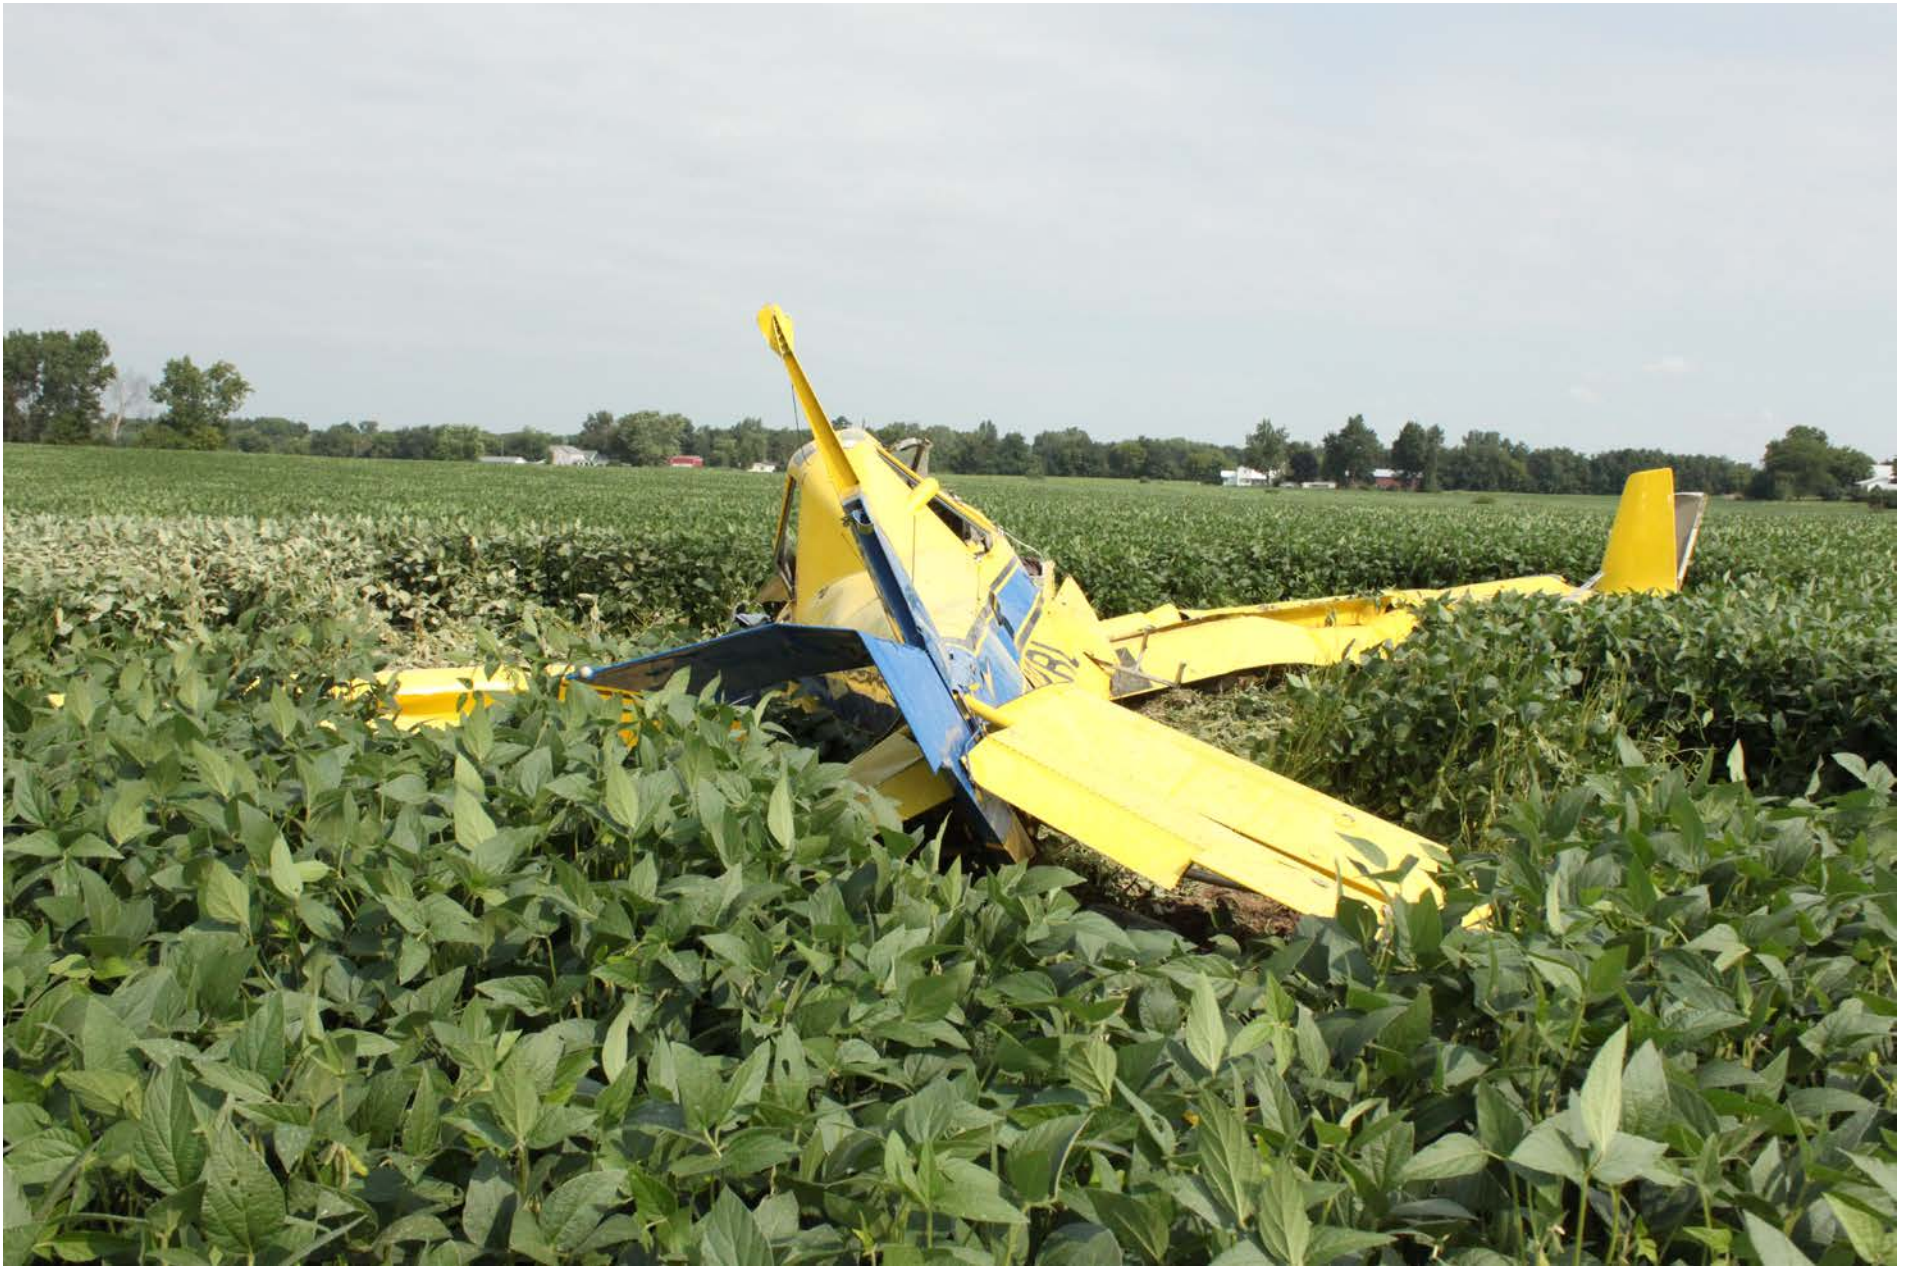
**Photo 2 – View of Wreckage from Rear**

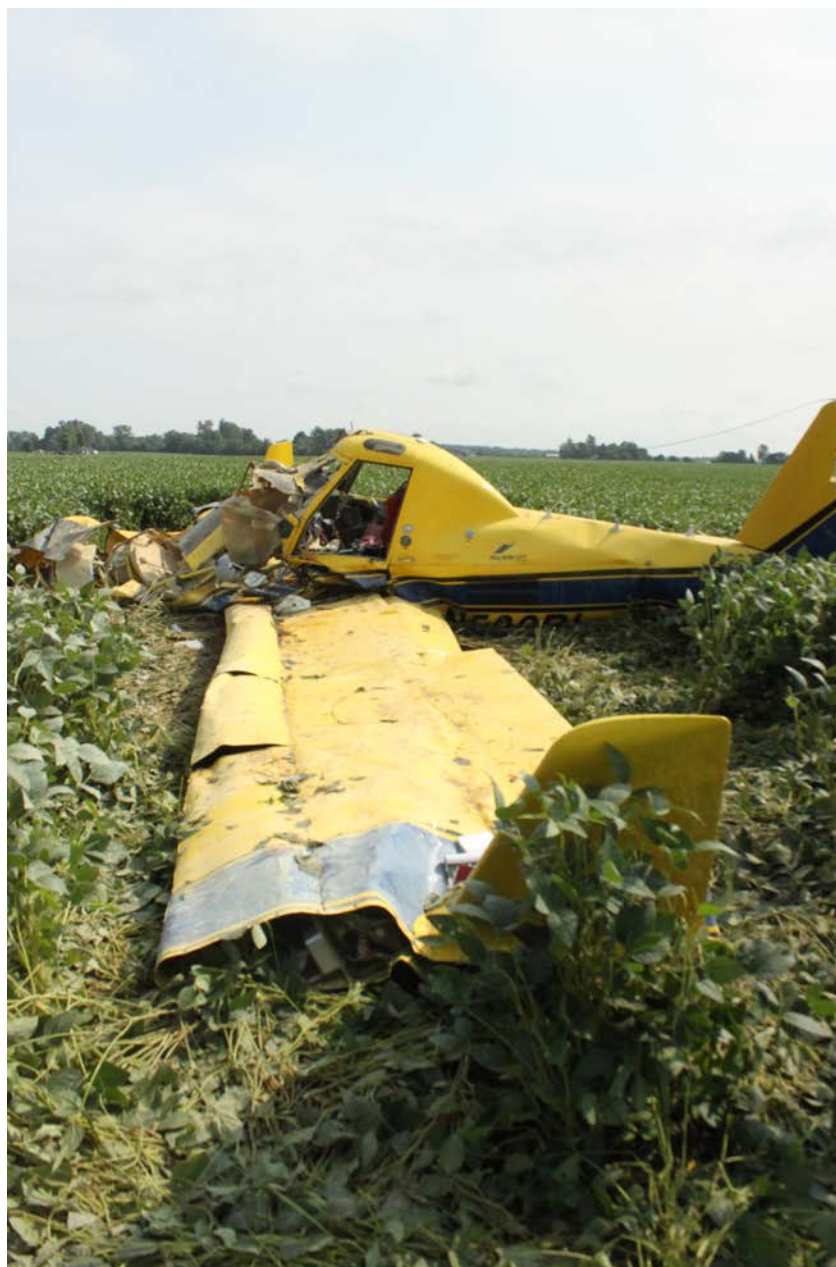
**Photo 3 – Left Wing Leading Edge Crushing**

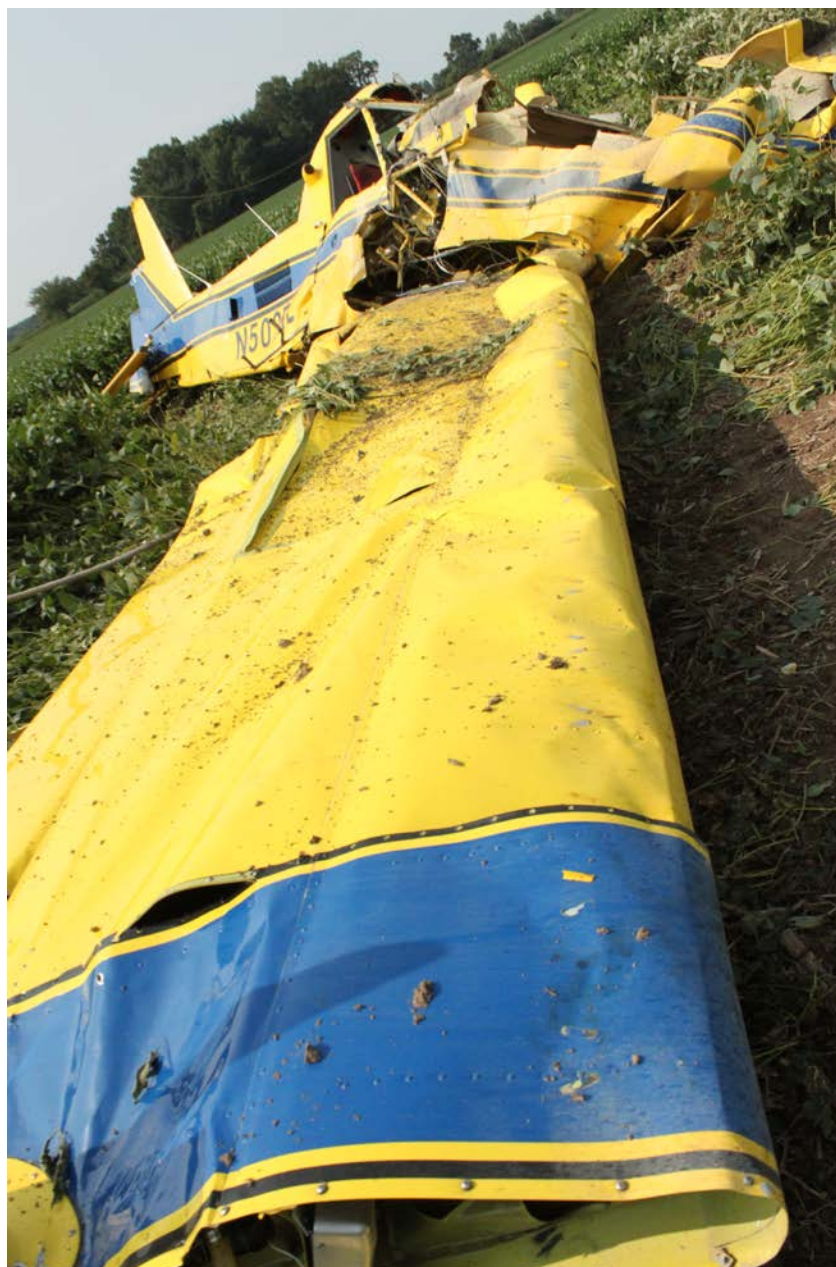
**Photo 4 – Right Wing Leading Edge Crushing**

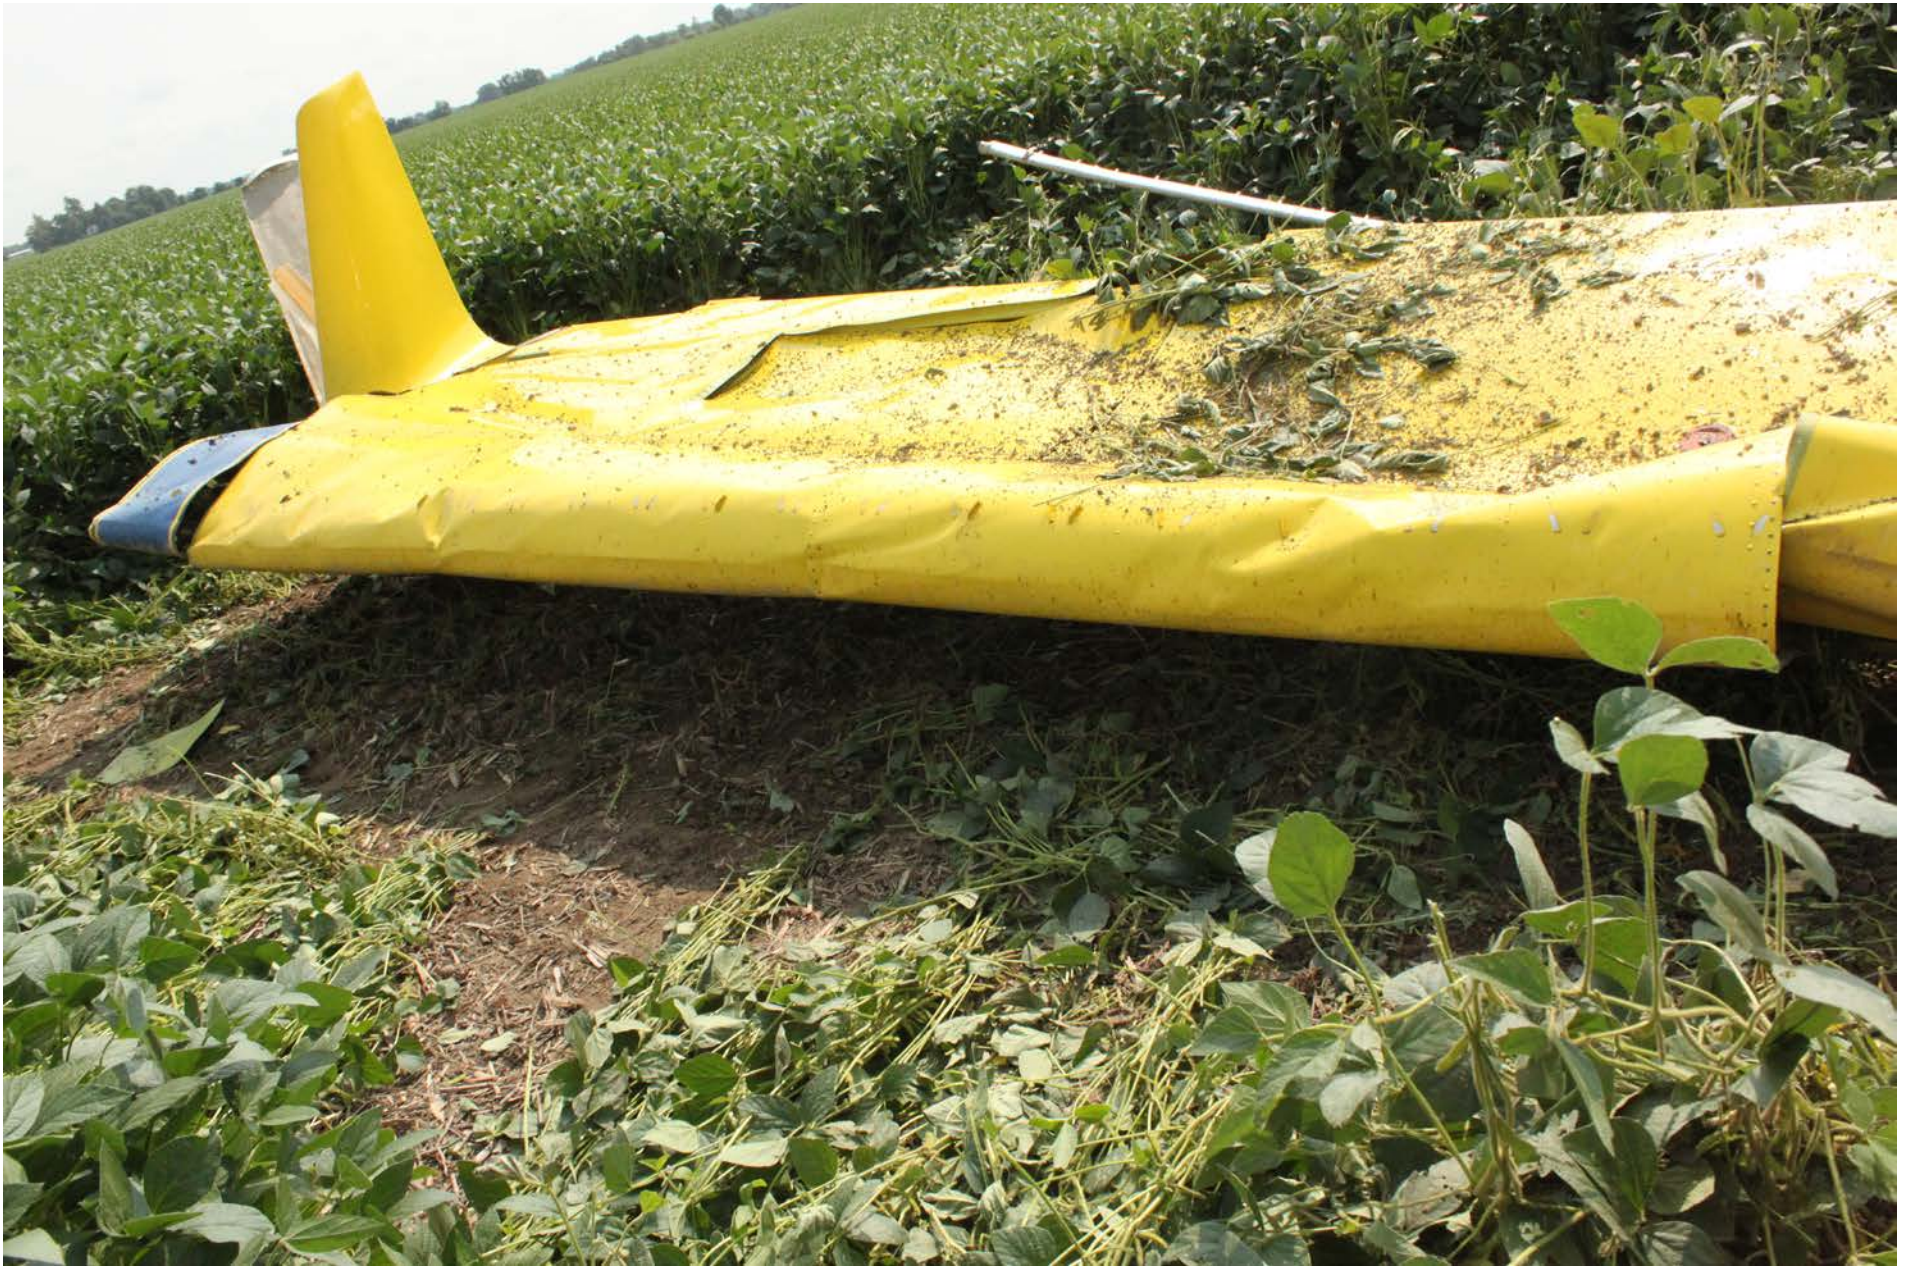
**Photo 5 – Right Wing Leading Edge Crushing**

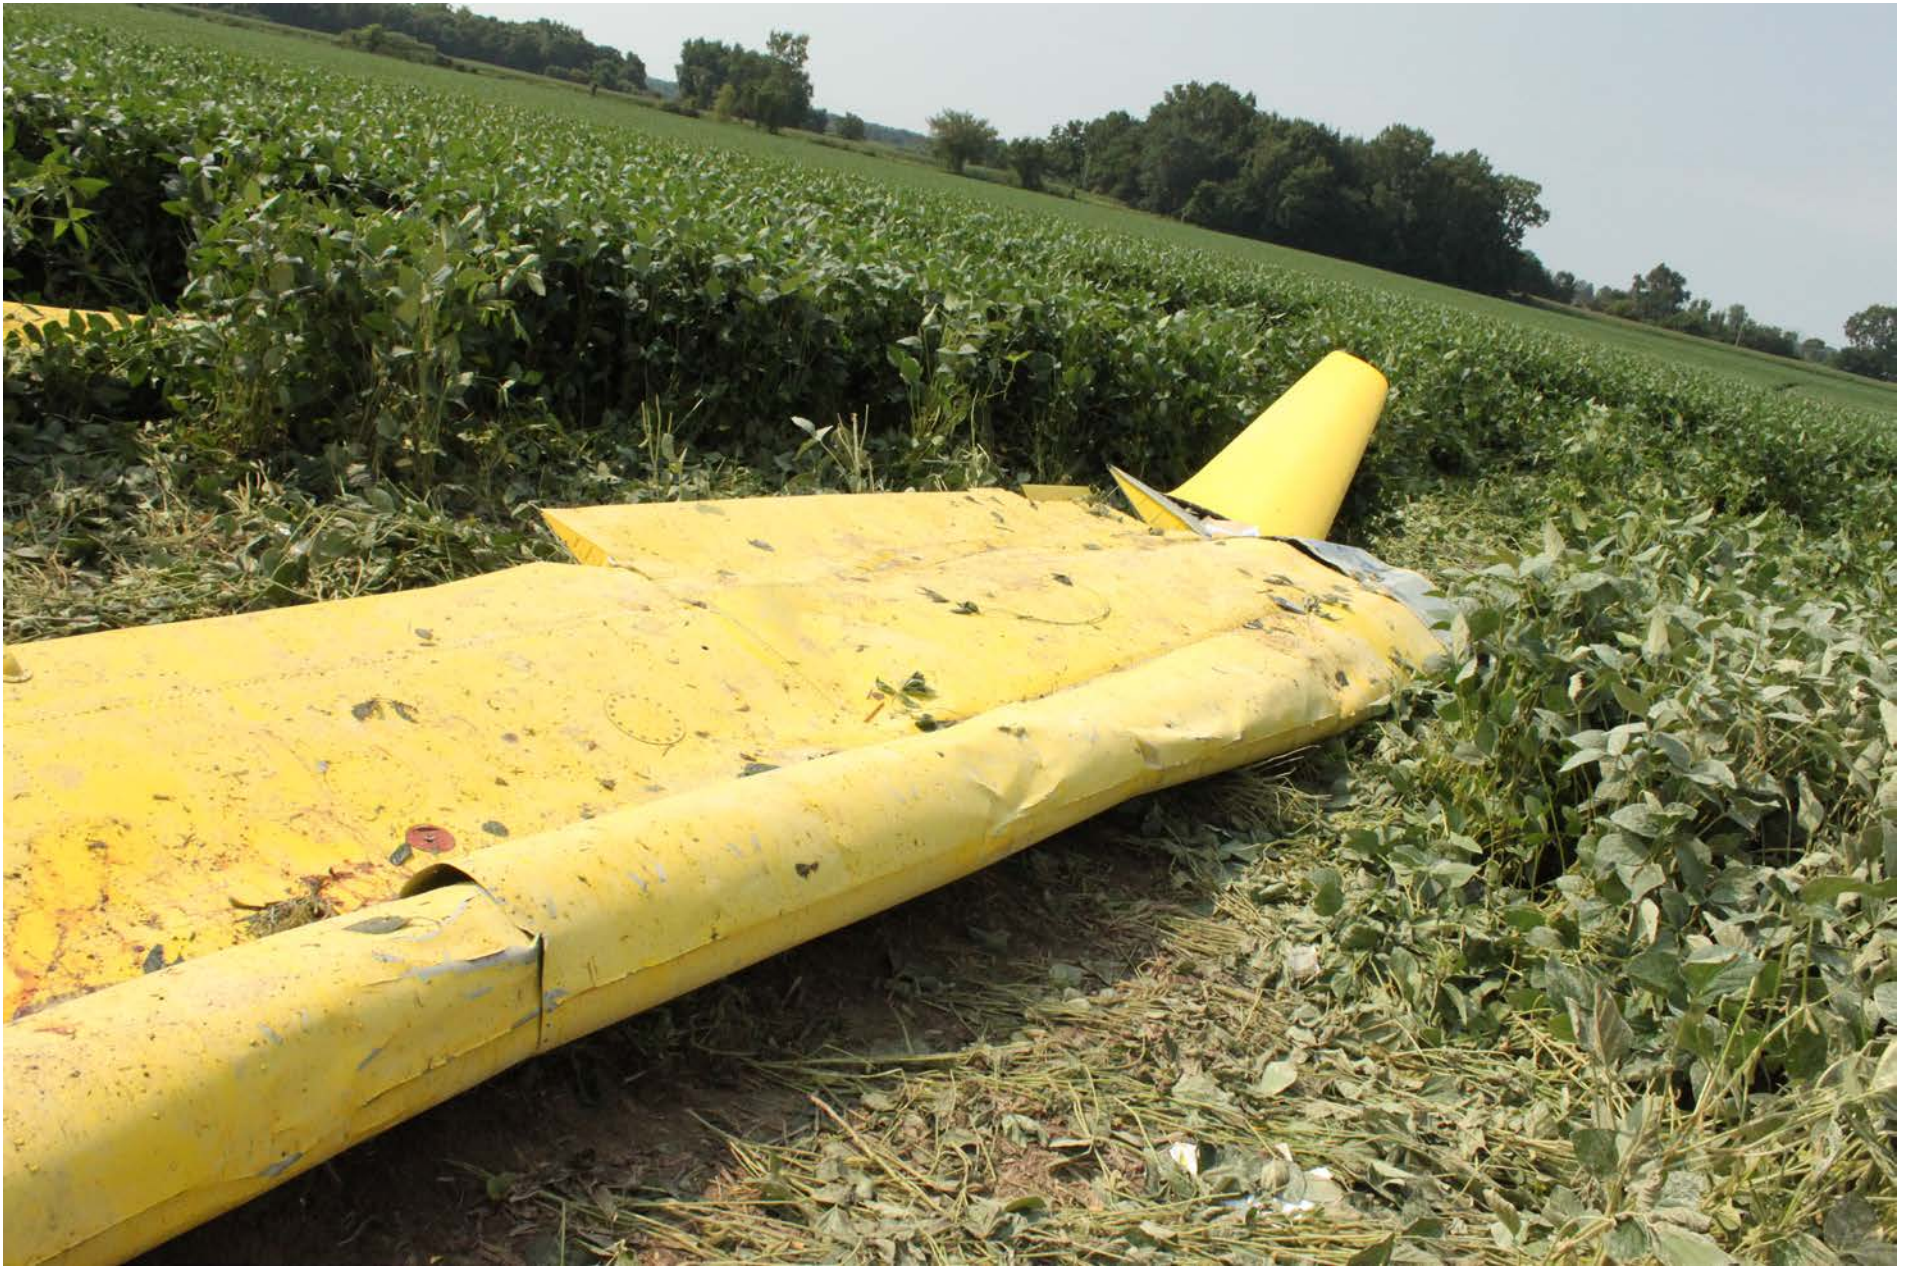
**Photo 6 – Left Wing Leading Edge Crushing**

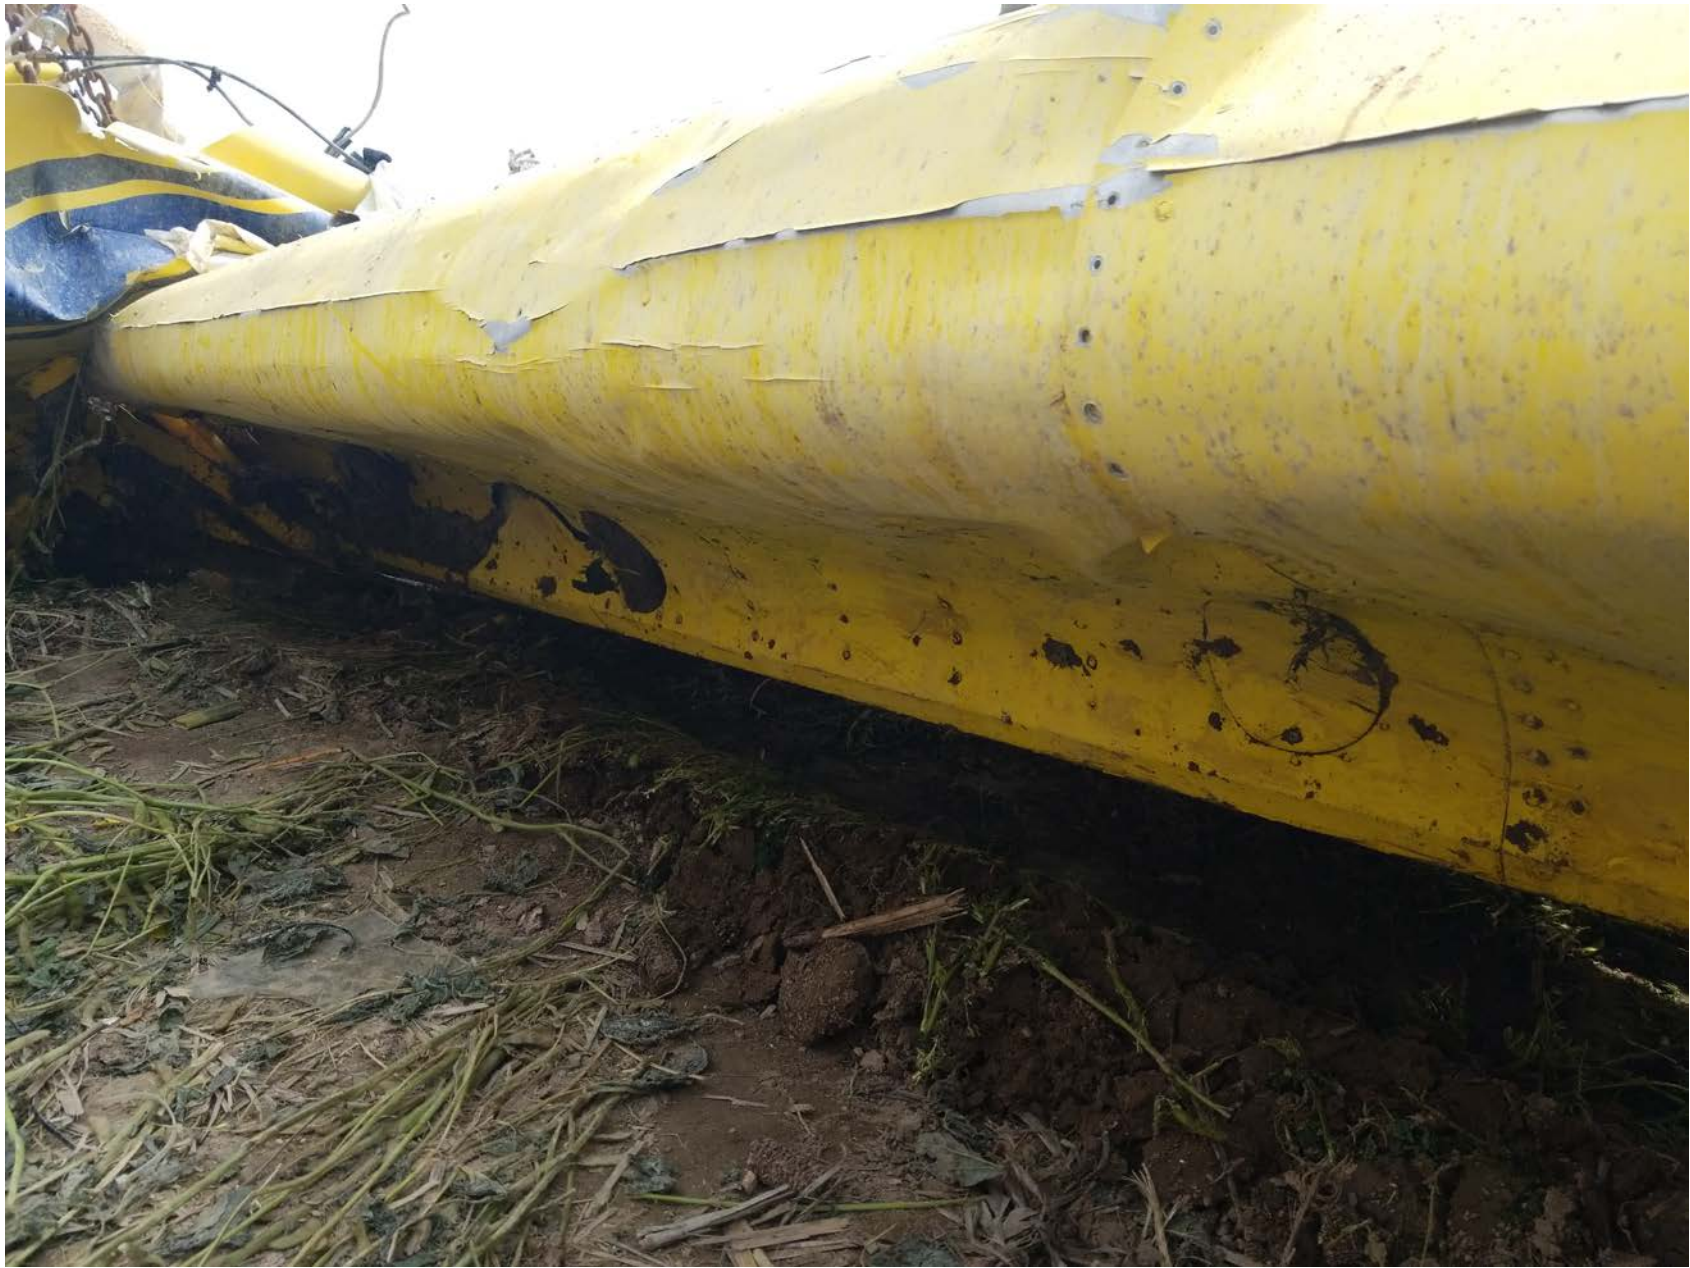
**Photo 7 – Left Wing Leading Edge Crushing**
