## **NATIONAL TRANSPORTATION SAFETY BOARD**

### **Weather Study**

# **METEOROLOGY**

CEN18FA358

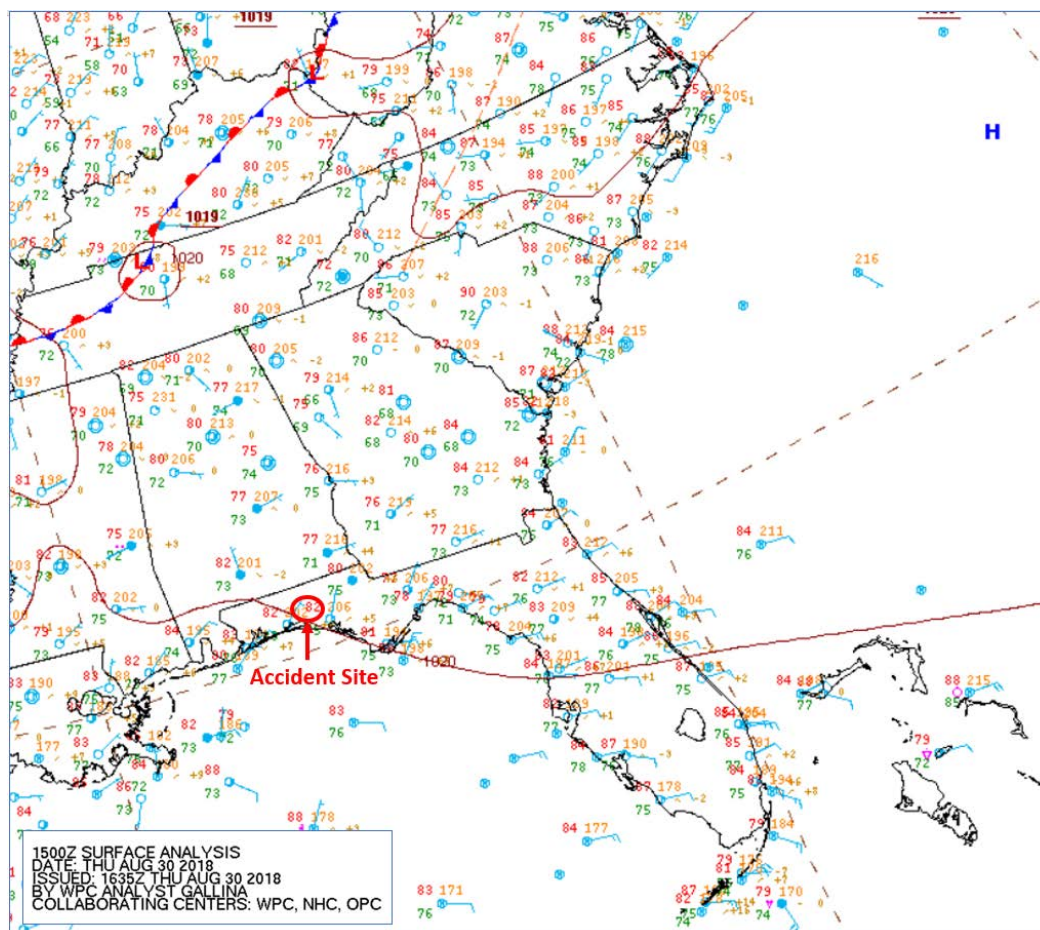
Figure 1 - Eastern section of the NWS Surface Analysis Chart for 1000 CDT

The eastern section of the NWS Surface Analysis Chart for 1000 CDT is included as figure 1 with the accident site located within the red circle. The chart depicted a low pressure system over southern Ohio at 1019-hectopascals (hPa) along a stationary front which stretched across West Virginia, extreme southern Ohio, Kentucky, and into Tennessee where another low-pressure system at 1019-hPa was located. The Azores-Bermuda high-pressure system was located off the North Carolina coast with a ridge of high pressure extending southwestward across northern Florida.

The chart depicted a weak pressure gradient across the Florida panhandle. The closest station model depicted a northeast wind of about 5 knots, scattered to broken cloud cover, with a temperature of 82° Fahrenheit (F), with a dew point temperature of 75° F.

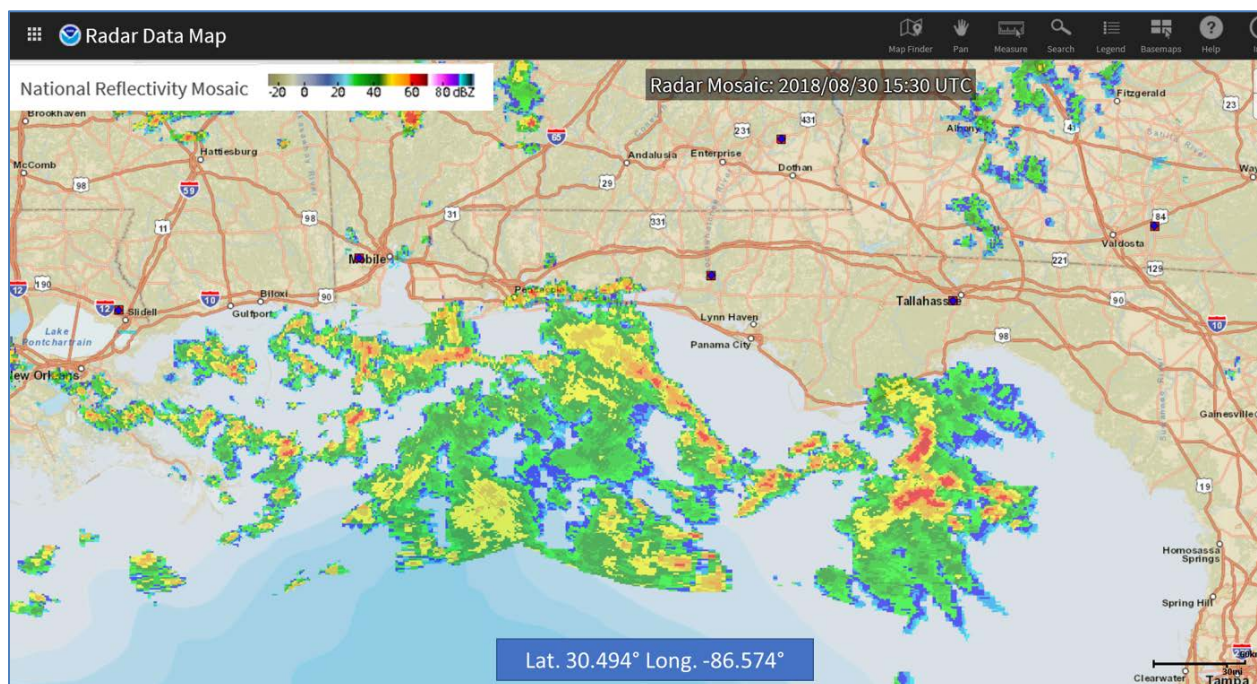
**Figure 2 – Southcentral section of the National Composite Radar Mosaic for 1030 CDT**

The southcentral display of the National Composite Radar Mosaic for 1030 CDT is included as figure 2 which depicted numerous heavy to extreme intensity echoes off the Louisiana, Mississippi, Alabama, and Florida Gulf Coast, with a few moderate to extreme cells over southern Alabama west of the flight route. A short band of echoes were also depicted reaching the coastal section from Pensacola eastward towards Destin, Florida.

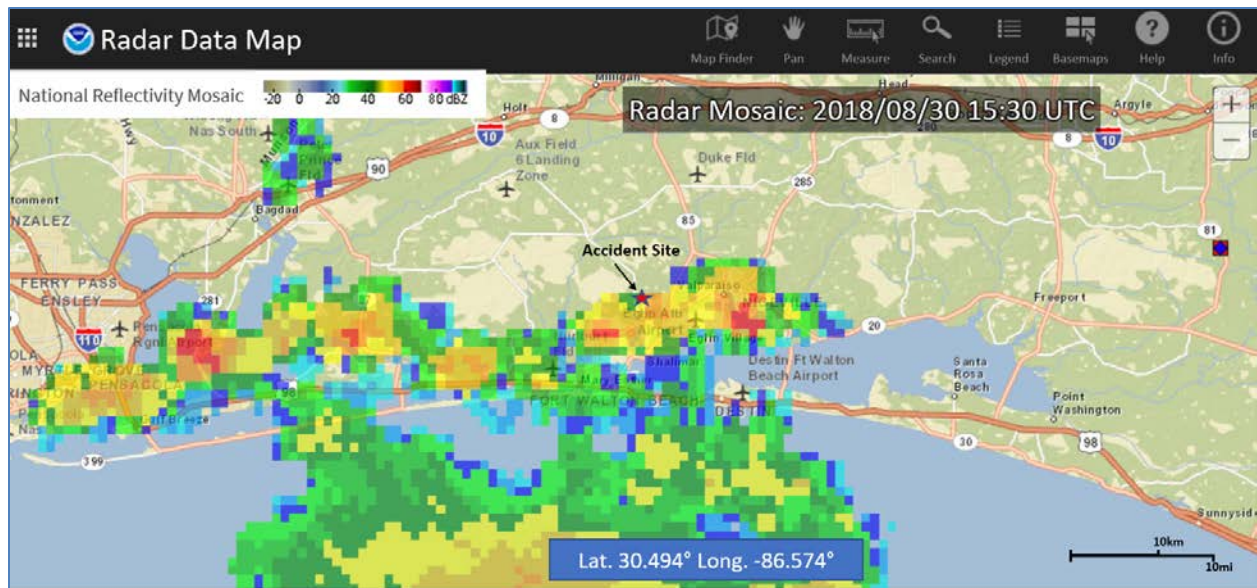
**Figure 3 – Enlarged image of the Composite Radar Mosaic for 1030 CDT with the accident site marked**

Figure 3 is a close up of the 1030 CDT radar mosaic with the approximate accident site marked by a red star. The composite radar mosaic depicted a small line of several discrete heavy intensity echoes extending from near the coast of Pensacola eastward to the Valparaiso and Destin, Florida, with another larger area of echoes further south in the Gulf of Mexico. The accident site was located under one of the heavy echoes in the line.

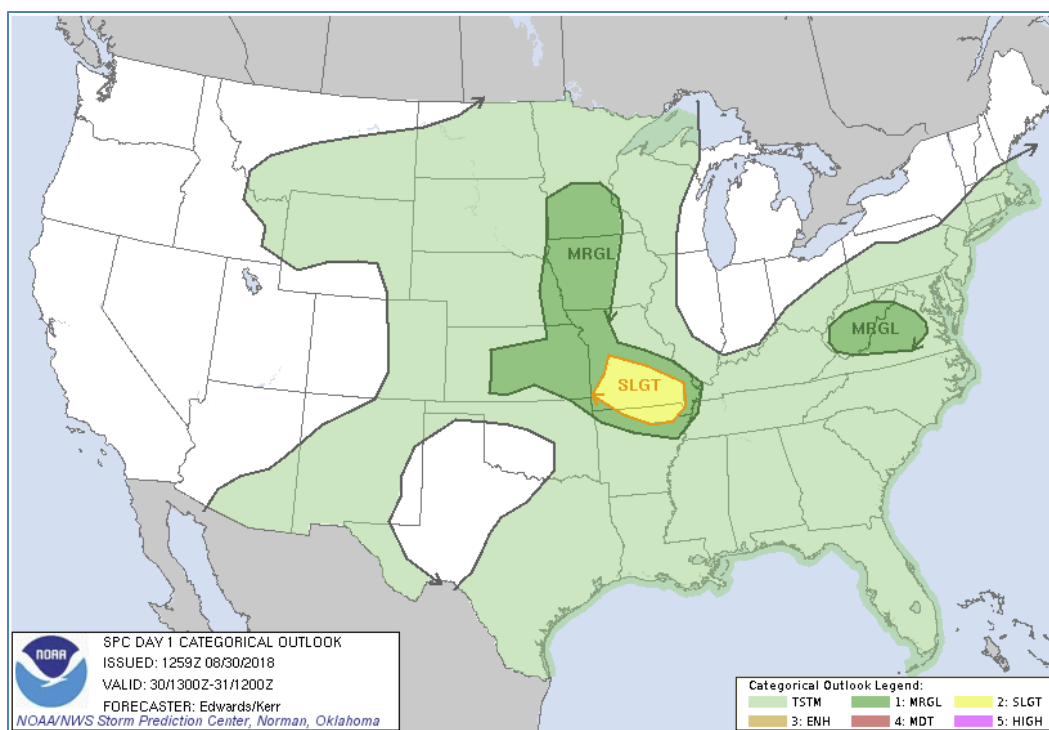
**Figure 4 - Convective Outlook issued at approximately 0800 CDT**

The NWS Storm Prediction Center (SPC) Convective Outlook issued at approximately 0800 CDT is included as figure 4. The intent of the chart is to identify to users like NWS forecasters, emergency managers, media, and pilots where the NWS SPC expects organized thunderstorms and severe thunderstorms<sup>1</sup> to form. On the day of the accident the outlook expected a slight risk of organized severe thunderstorms over Missouri and northern Arkansas, with general airmass type thunderstorms over the general route of flight and over the accident site during the period.

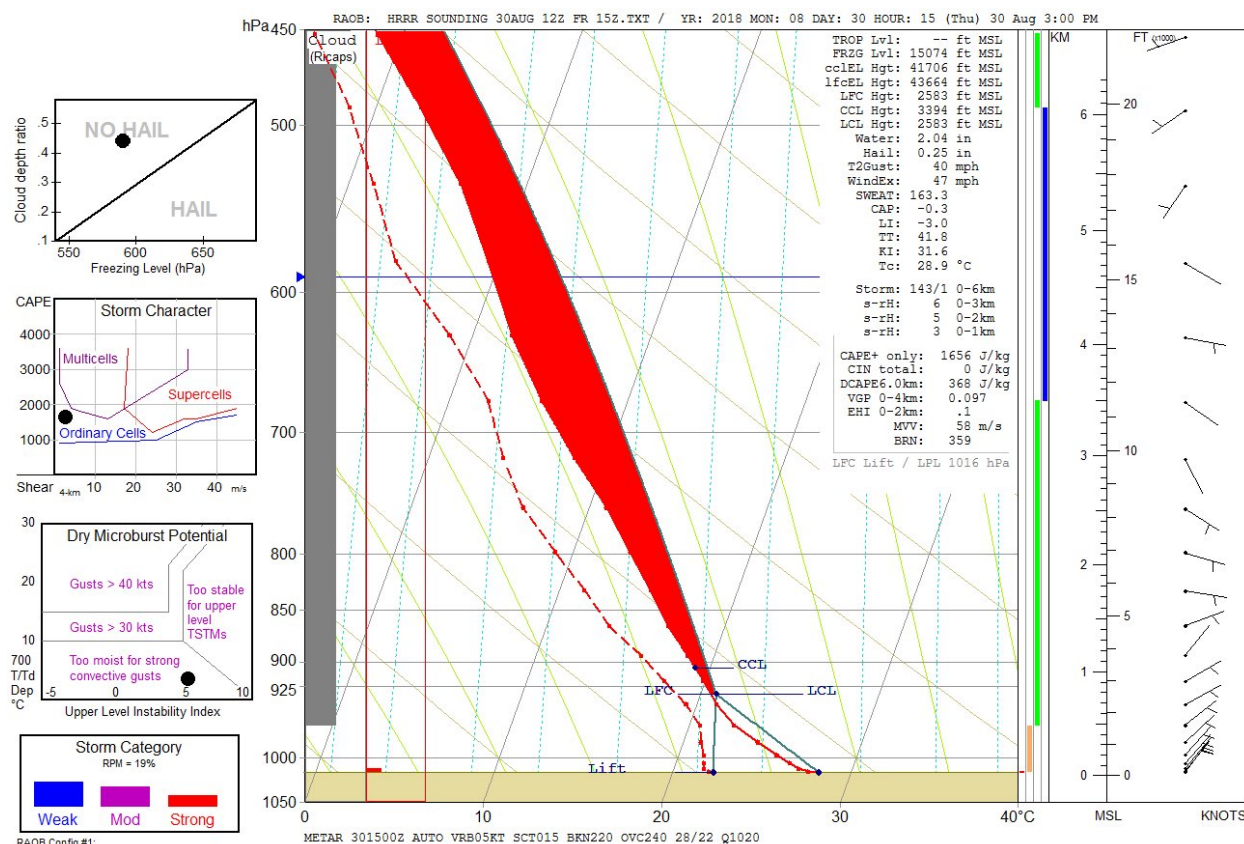
Figure 5 - HRRR numerical model sounding for 1000 CDT over the accident site

To determine the vertical structure and state of the atmosphere over the accident site a High-Resolution Rapid Refresh (HRRR)<sup>3</sup> numerical model data was retrieved from archive data from the NOAA Air Resources Laboratory for 1000 CDT on August 30, 2018. The model data was then plotted on a standard Skew T log P diagram<sup>4</sup> using the complete Rawinsonde Observation RAOB program software<sup>5</sup> from the surface to 450-hPa or approximately 21,000 ft. Figure 5 is the 1000 CDT HRRR model sounding which depicted the elevation as 105 ft, with a near-surface temperature of 28° C, a dew point temperature of 22° C, with an approximate relative humidity of 80%. The precipitable water content was 2.04 inches. The lifted condensation level (LCL)<sup>6</sup> and the level of free convection (LFC)<sup>7</sup> were identified at approximately 2,500 ft agl, with the

convective condensation level (CCL)<sup>8</sup> at approximately 3,300 ft agl. The freezing level was identified above 15,000 ft. The sounding was characterized as conditionally unstable with a Lifted Index (LI)<sup>9</sup> of -3, a Convective Available Potential Energy (CAPE)<sup>10</sup> of 1,656 Joules/kilogram, and a K-index of 31.6, which indicated a probability of 60% of airmass type convection. The CAPE and vertical wind shear support ordinary non-severe airmass type convection, with the maximum potential outflow winds (T2Gust) estimated at 35 knots (40 mph). The maximum vertical velocity (MVV) of the updrafts was estimated at 58 meters/second or 116 knots.

The HRRR wind profile indicated a near-surface wind from the northeast at 5 knots with wind direction veering to the east through 15,000 ft with wind speeds under 10 knots. The wind shifted

to the southwest above 17,000 ft. The wind profile did not depict any strong vertical shears supporting any significant layers of moderate or greater turbulence outside of convective clouds.

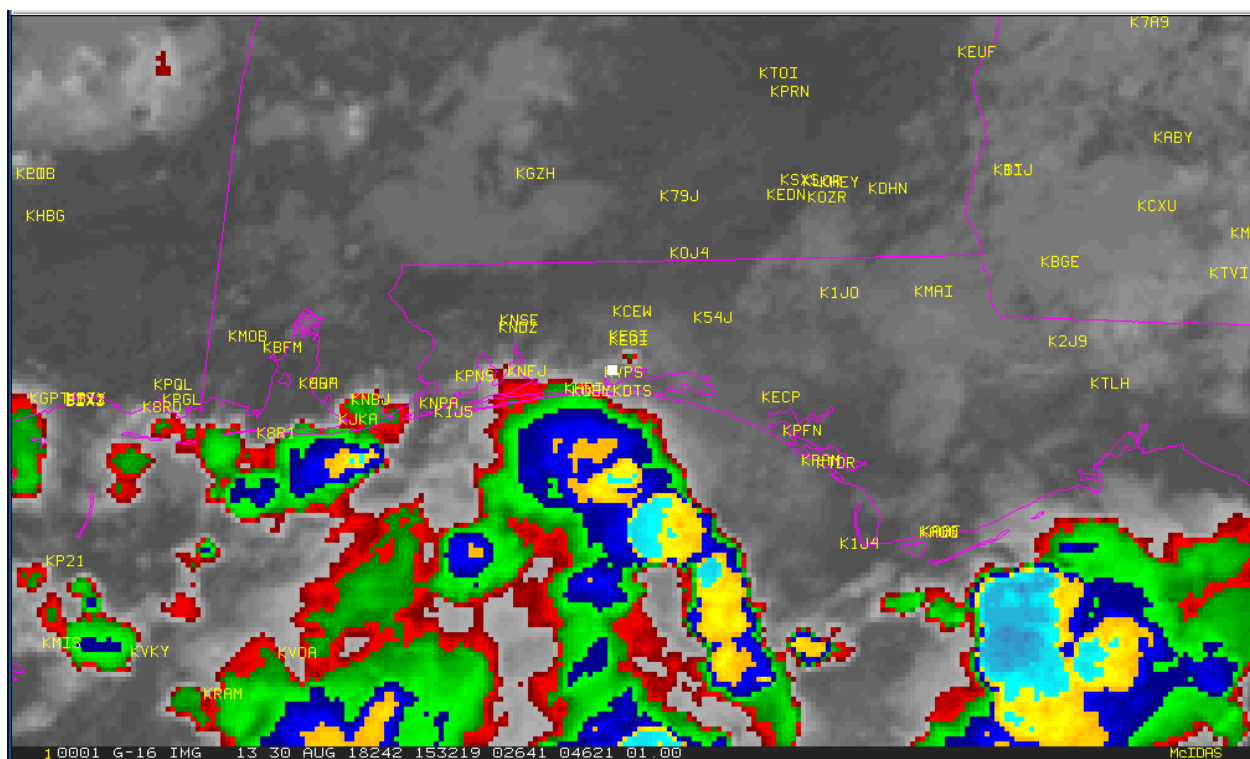
**Figure 7 - GOES-16 visible image at 2X magnification at 1032 CDT**

Figure 7 is the GOES-16 visible image for 1032 CDT at 2X magnification and depicted a band of cumulus congestus type clouds extending west-to-east along the Florida panhandle and the accident site. Off the Alabama and Florida coast multiple large cumulonimbus cloud systems can be observed with extensive anvils and overshooting cloud tops. The cumulus congestus clouds over the accident site did not display any extensive anvil and were of limited size as compared to the well-defined cumulonimbus cloud systems in the Gulf of Mexico to the south of the accident site.

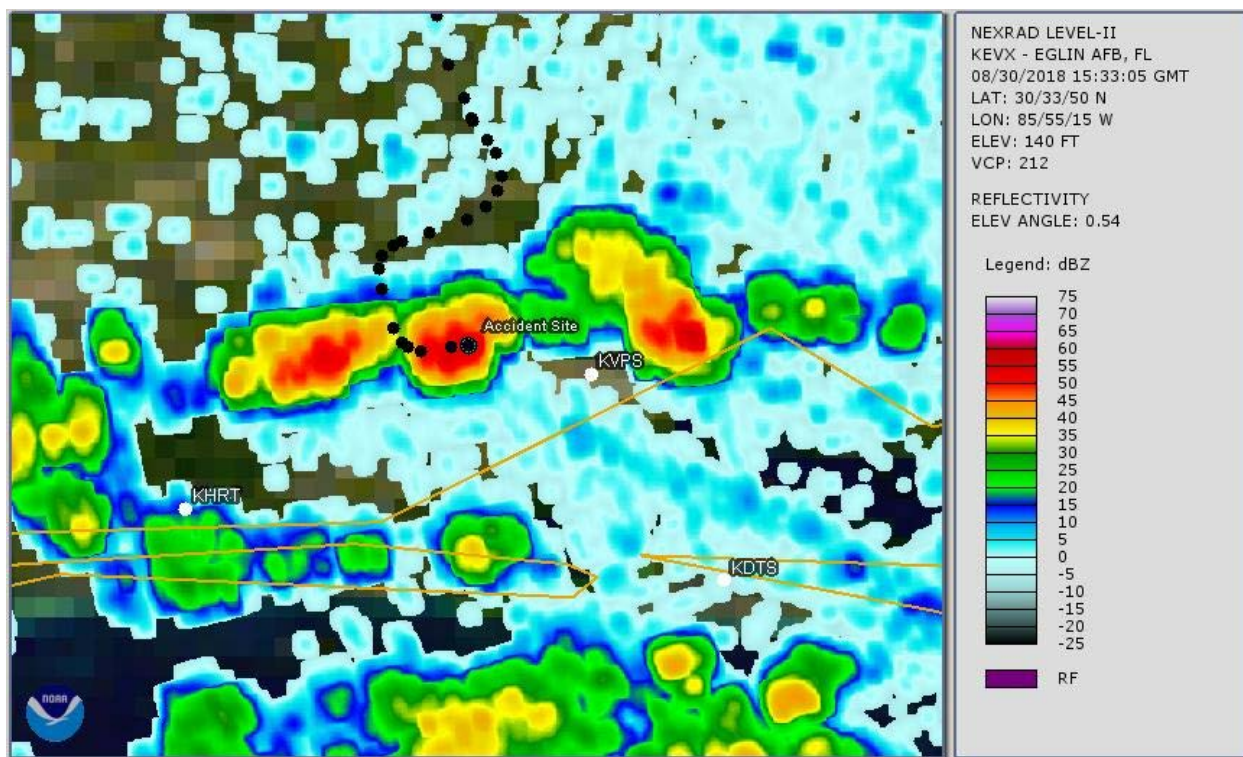
**Figure 8 - KEVX 0.54° Base Reflectivity image for 1033 CDT with flight track overlaid**

Figure 8 is the KEVX WSR-88D 0.54° base reflectivity image for 1033 CDT with the flight track of N1876L overlaid. The flight track is observed operating under a cell with maximum reflectivity of 56.0 dBZ or an extreme intensity echo. The echo tops product indicated that the maximum height of the echo was to 24,000 ft at that time.

The KEVX WSR-88D image also shows that at 1033 CDT the surrounding airports KVPS and KDTs were outside of any strong reflectivity echoes, while KHRT bordered an echo 30 dBZ and was reporting light rain. KVPS was between extreme intensity echoes of 50 dBZ which were located approximately 2 miles east and 4 miles west. This corresponds to the KVPS SPECI observation at 1023 CDT included in section 2.1 of this report.

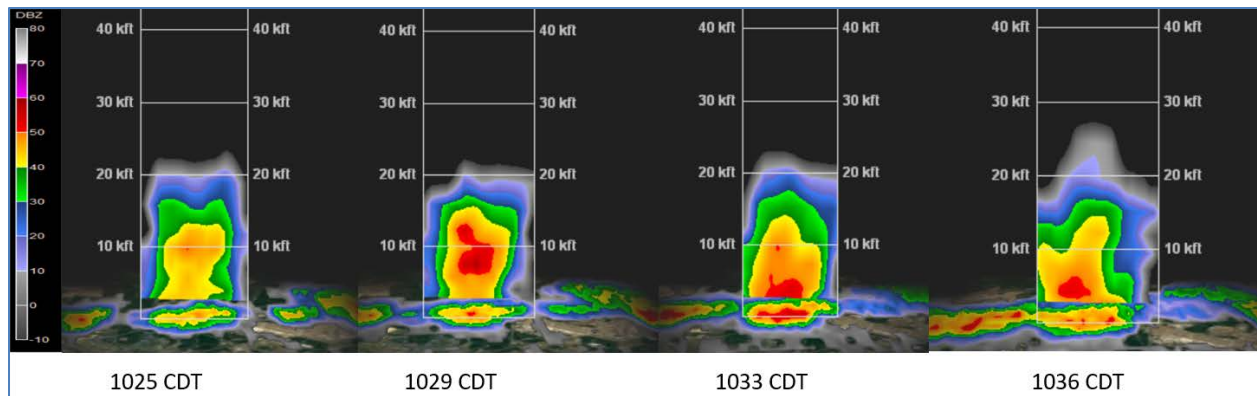
**Figure 9 – Cross-section analysis of the echoes between 1025 and 1036 CDT over the flight track**

The GR2Analysis Radar software<sup>15</sup> was also used to examine the echoes in the vicinity of the accident site. Figure 9 is a cross section along the approximate flight track as the accident aircraft turned eastward and was descending between 1,200 and 500 ft, and shows the echoes at 1025, 1029, 1033, and 1036 CDT. The image shows an echo of 50.0 dBZ develop at 10,000 ft at 1025 CDT, and by 1029 CDT was well-defined with the echo of 50 dBZ reaching 12,000 ft with another large area of echoes from 50-64 dBZ between 5,800 and 10,000 ft. At 1033 CDT the heavy precipitation core of 50 dBZ is descending below 5,300 ft to the surface, at 1036 CDT the general shape and the depth of the high precipitation core continues to collapse. The cross section indicated the cell developing or building with predominate updrafts at 1025 and 1029 CDT, with the high precipitation core reaching its greatest height and collapsing, with predominate downdrafts, between 1029 through 1036 CDT. The heaviest low-level precipitation was occurring near the 1033 CDT period with echoes of 50 dBZ below 5,400 ft.

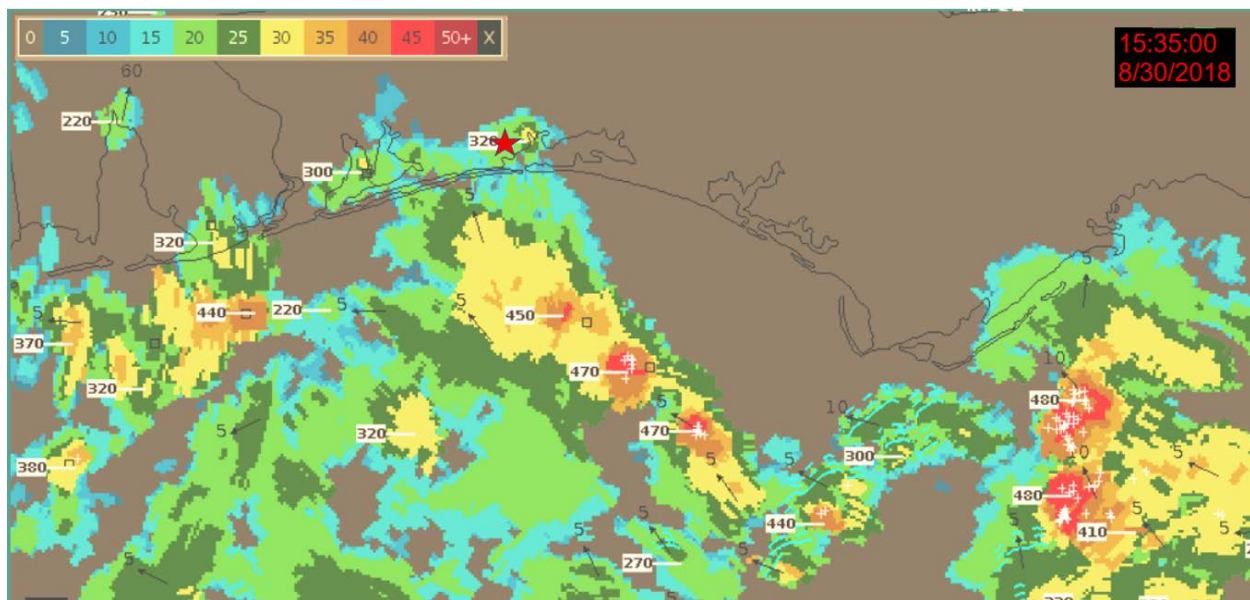
Figure 10 - FAA CoSPA radar composite image for 1035 CDT with lightning, cloud tops, and movement

The Federal Aviation Administration (FAA) Consolidated Storm Prediction for Aviation (CoSPA) display of composite weather radar data for 1035 CDT over the area is included as figure 10 with the approximate accident site marked by the red star. The image depicts the Vertical Integrated Liquid Water (VIL) levels similar to reflectivity values, lightning, echo tops, and storm movement which available to Air Traffic Control (ATC) managers and other users. The image depicted the west-to-east band of echoes over the Florida coastal sections with tops between 30,000 ft and 32,000 ft immediately west and east of the accident site. No lightning activity was detected in the band along the coast surrounding the period. The intense echoes off the coast indicated in brown and reds were depicted producing significant lightning during the period with tops as high as 47,000 ft and were moving northward at 5 knots.
