## **NATIONAL TRANSPORTATION SAFETY BOARD**

### **Group Chairman's Factual Report**

# **AIR TRAFFIC CONTROL**

CEN18FA371

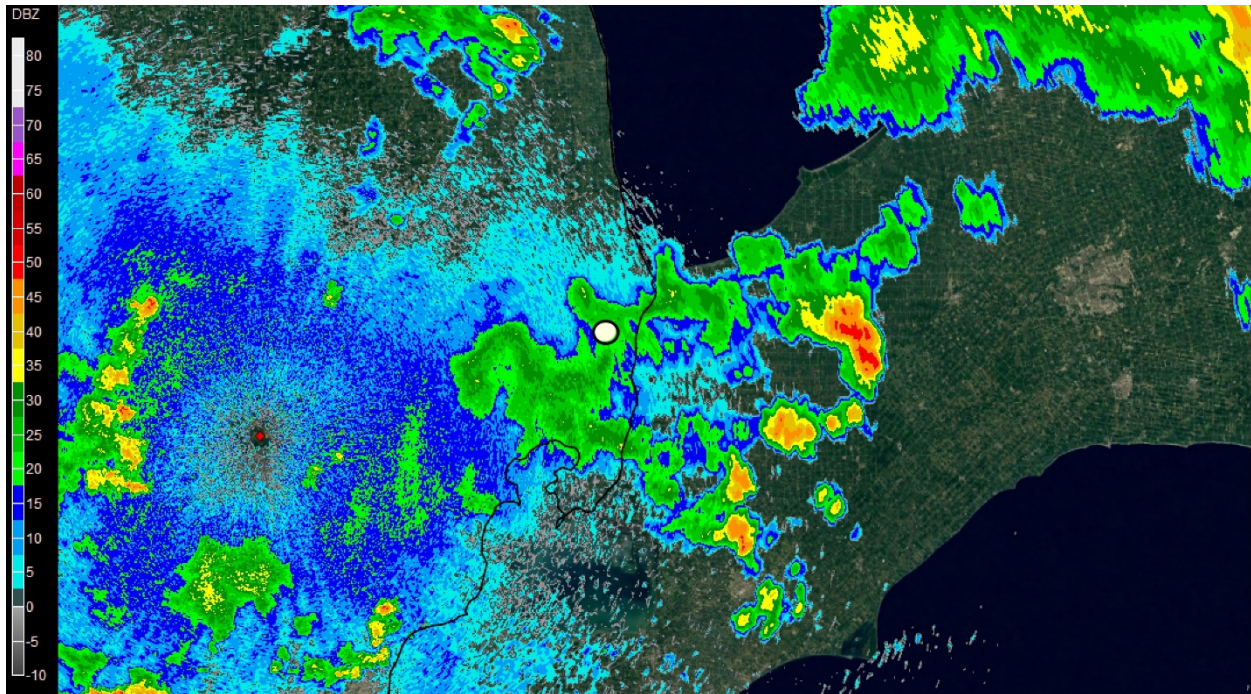
WSR-88D Level-II reflectivity weather radar imagery from Detroit, Michigan (KDTX), is presented in figure 5 below. KDTX was located approximately 42 miles west-southwest of the accident site at an elevation of about 1,065 feet. Assuming standard refraction and considering the 0.95° beam width for the WSR-88D radar beam, the KDTX 0.468° tilt would have “seen” altitudes between about 2,100 and 6,300 feet above mean sea level over the accident location. The KDTX weather radar depicted reflectivity values consistent with light rain at the accident location about the accident time.

Figure 5 – KDTX 0.44° Level-II reflectivity product from 2348 EDT. Accident location denoted by white circle.
