## ENGINE EXAMINATION REPORT **N1738R**

| ENGINE MODEL | IO520F (9A) |
| AIRCRAFT MAKE & MODEL | Cessna U206G |
| AIRCRAFT REGISTRATION | N1738R |

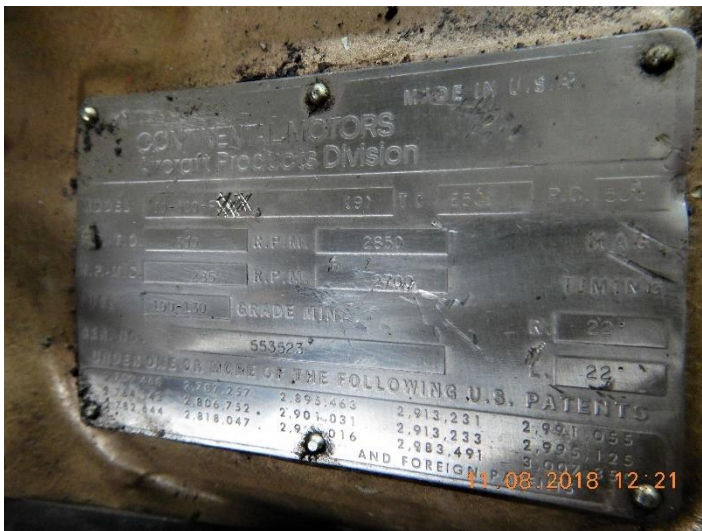
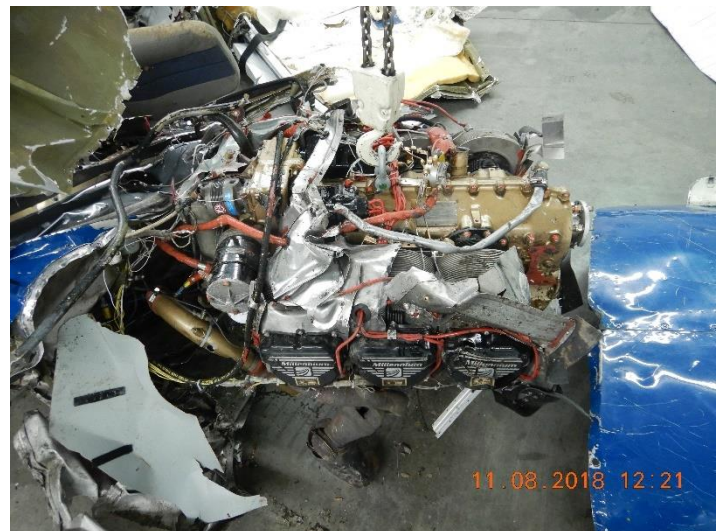
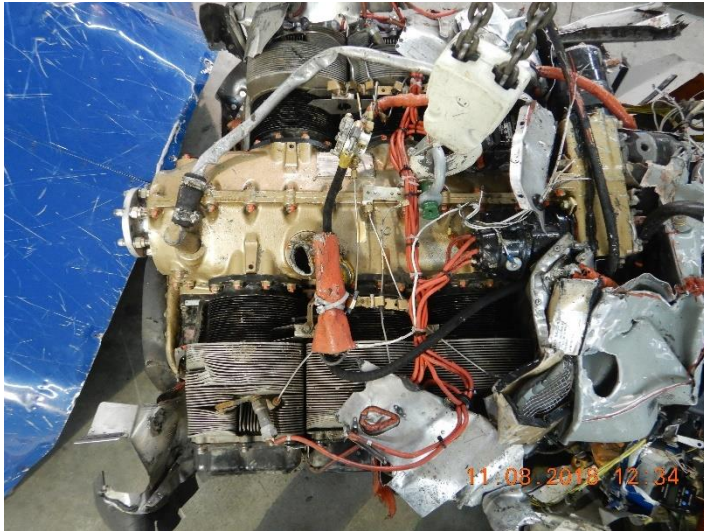
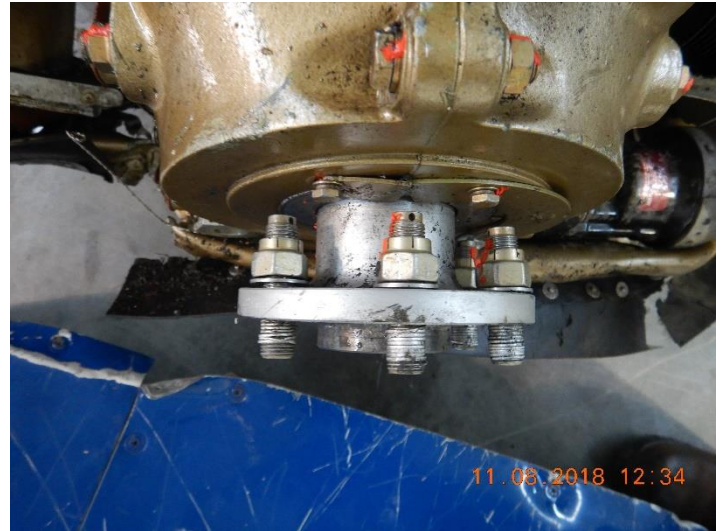
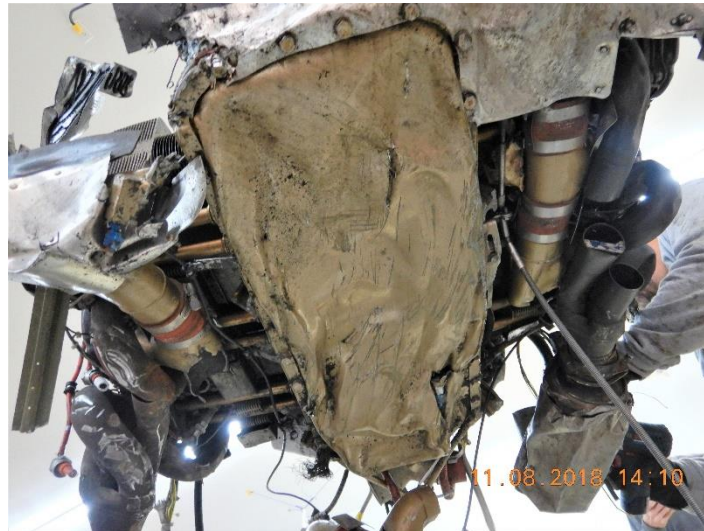
The engine remained attached to the damaged airframe by control cables, electrical harnesses and impact damaged engine mounts. The propeller separated from the engine crankshaft flange. The propeller mounting studs had pulled from the propeller hub leaving the mounting studs and nuts attached to the damaged crankshaft propeller flange.

All six cylinders remained attached to the crankcase assembly and the installation hardware exhibited orange-colored torque putty. All six rocker covers remained intact except cylinder 6 which exhibited impact damage. Each rocker cover exhibited the brand logo "Millennium" which is the trade name of cylinders produced by Superior Air Parts.

The exhaust system components were impact damaged but remained attached to each cylinder exhaust port. The oil sump was crushed and forced upward due to impact damage. The oil filler cap separated from the filler neck located on the top of the engine crankcase.

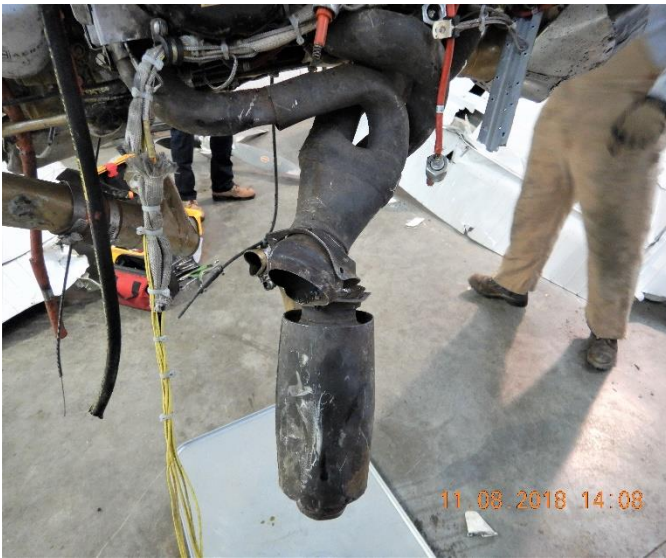
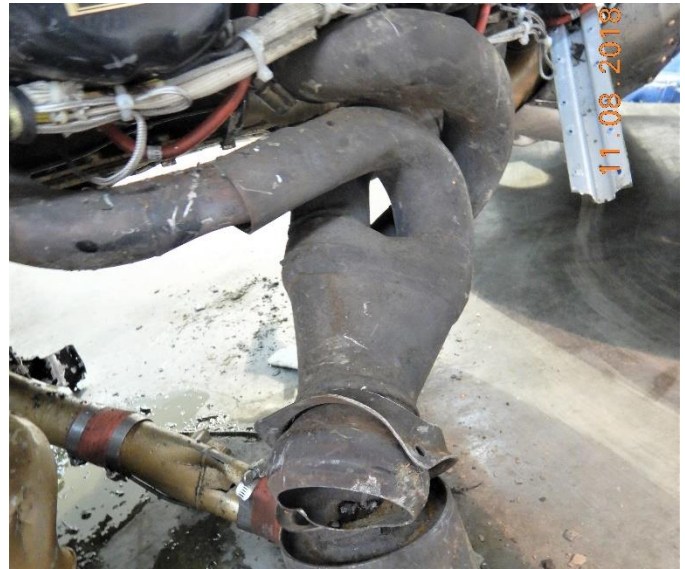
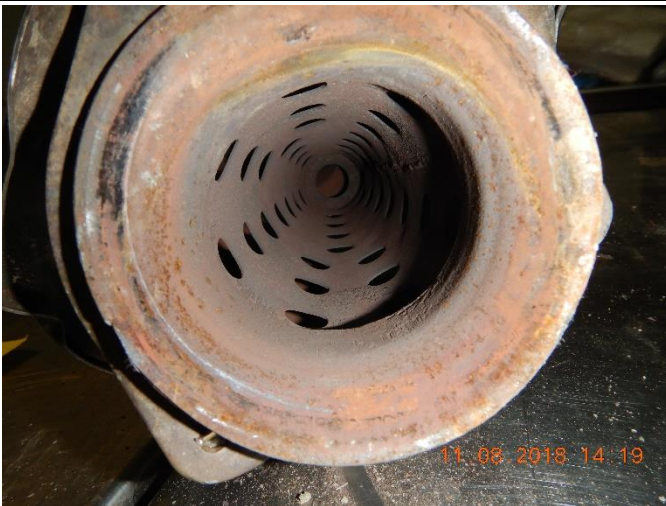
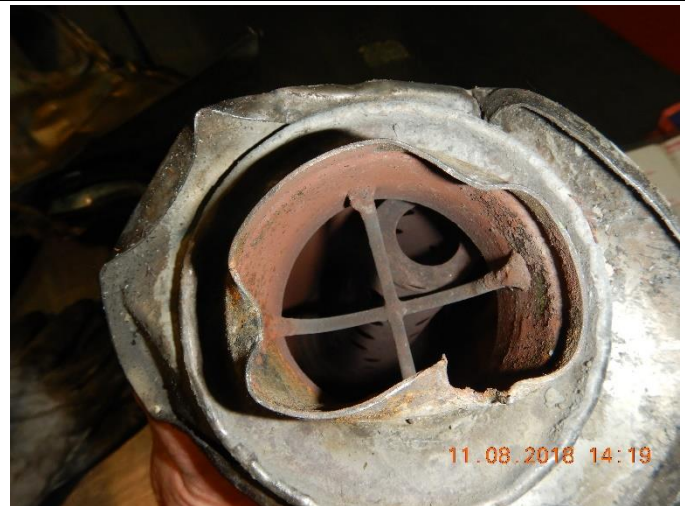
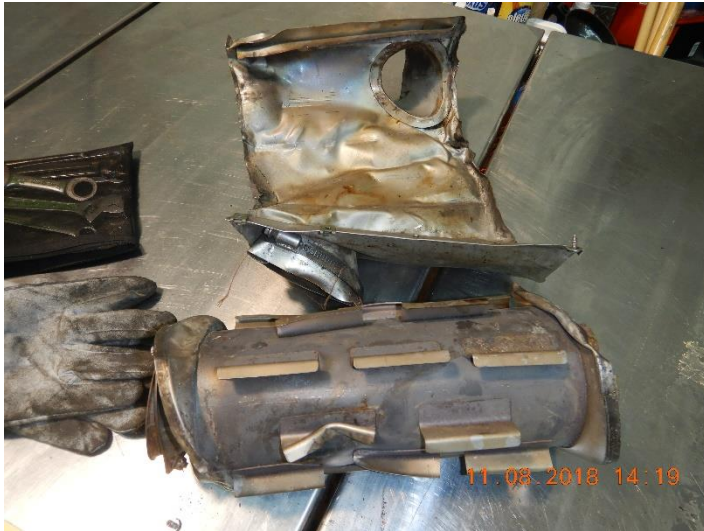
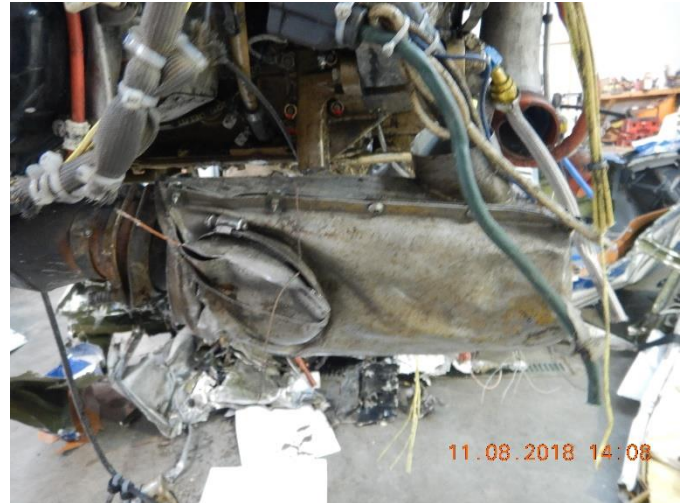
Condition: The exhaust system components were impact damaged but remained attached to each cylinder exhaust port. The left muffler and heat muff were removed and inspected. The internal flame cone remained intact but slightly distorted due to impact forces. The bale remained intact and no thermal deterioration was noted. The right muffler was crushed but remained attached to the right exhaust manifold.

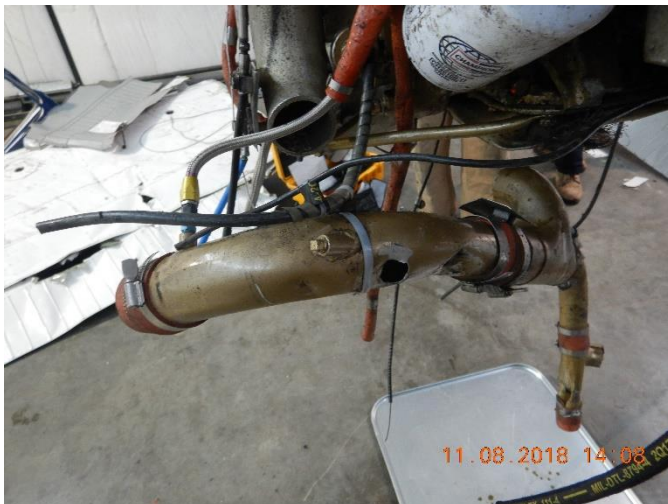
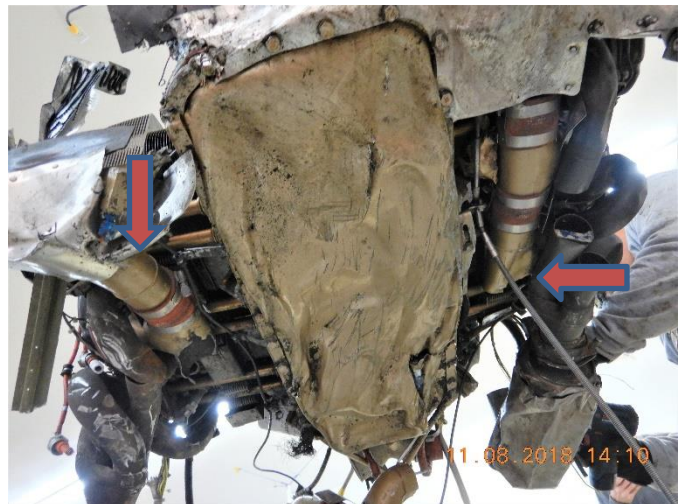
Several induction system elbows, connectors and hoses separated by impact forces allowing dirt, snow and other contaminations to enter each cylinder intake port.

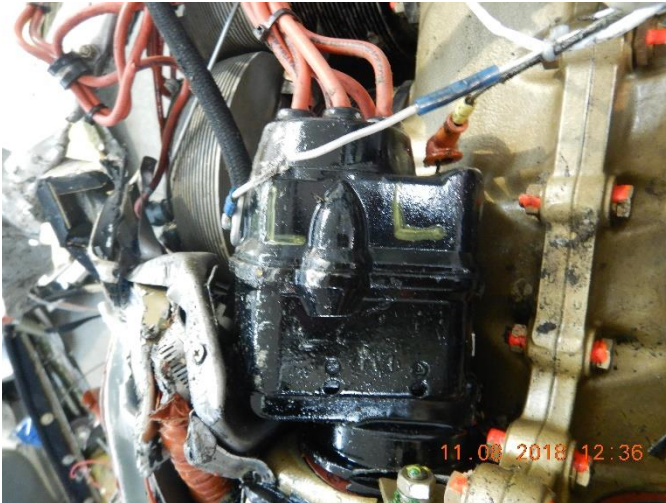
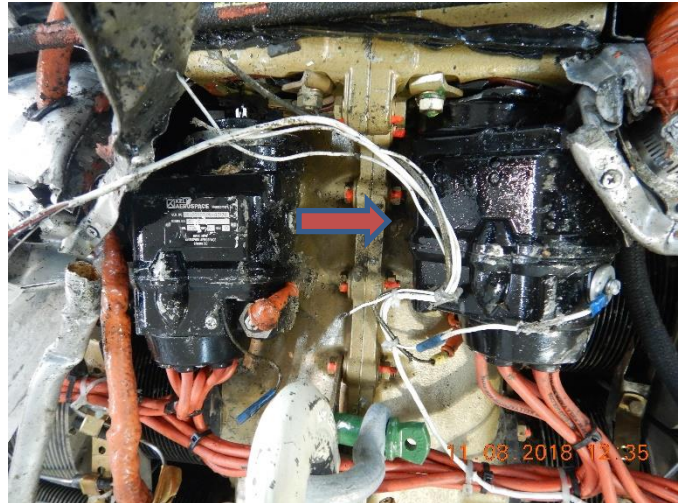
| Condition: | The left magneto remained attached, but the mounting flange was damaged by impact forces. The impulse coupling was heard to release normally, and the magneto produced spark at the individual ignition leads when manually rotated using an electrical drill motor. | | |

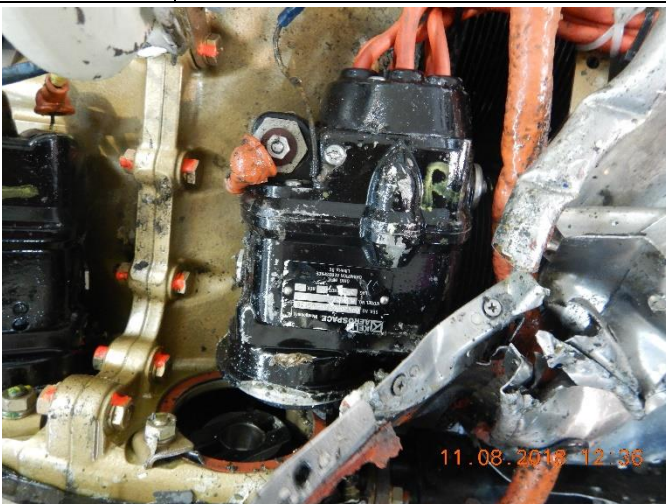
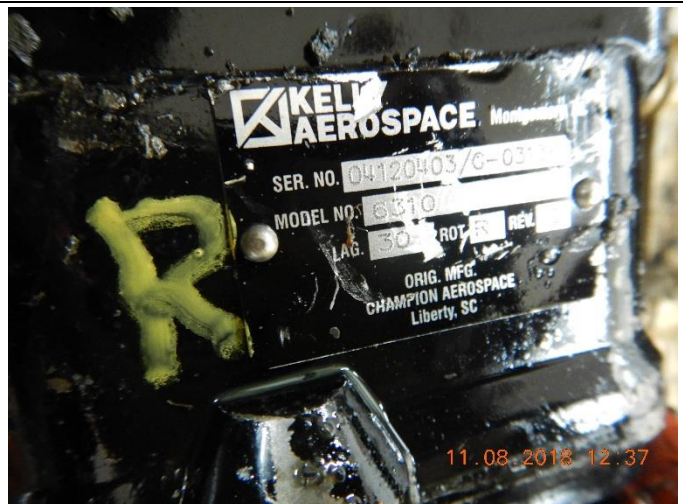
| Condition: | The right magneto separated at its mounting flange but was held in place by the ignition harness leads. The impulse coupling was heard to release normally, and the magneto produced spark at the individual ignition leads when manually rotated using an electrical drill motor. | | |

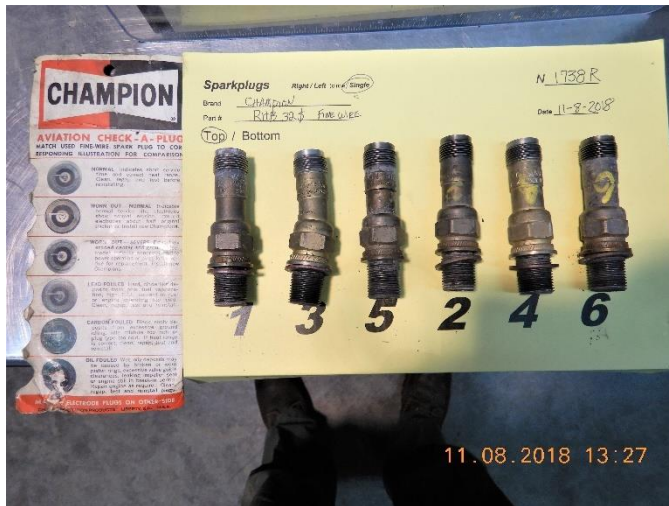
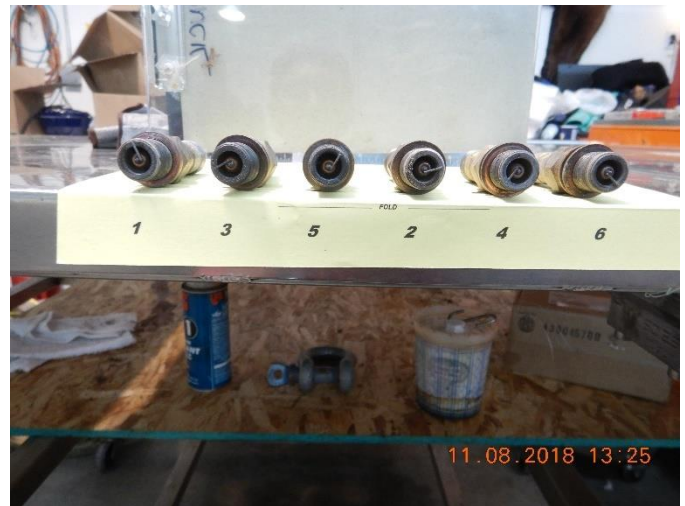
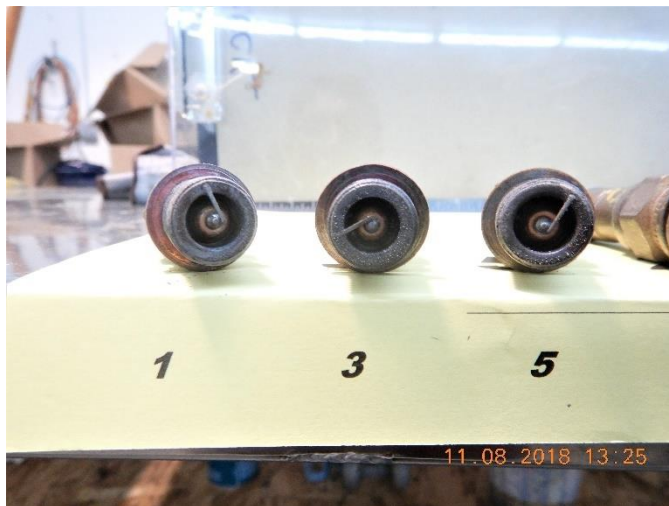
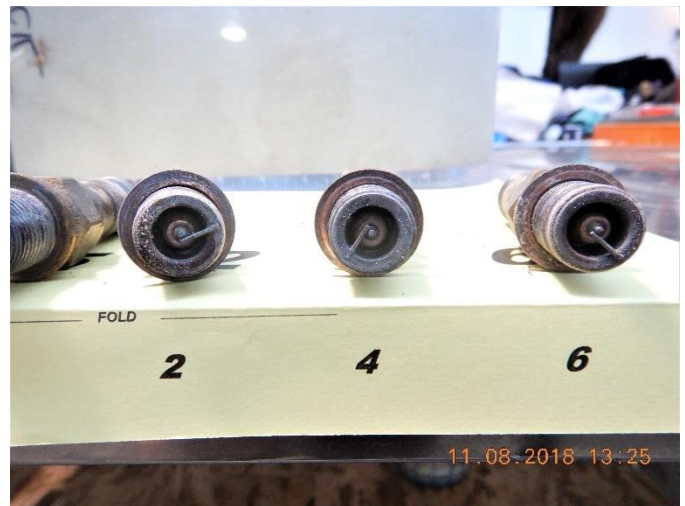
| Condition: | Several ignition harness leads were cut and pinched. | | | |
| Condition: | When compared to a Champion Spark plug chart, all six top sparkplugs were “normal” in both condition and coloration. | | | |

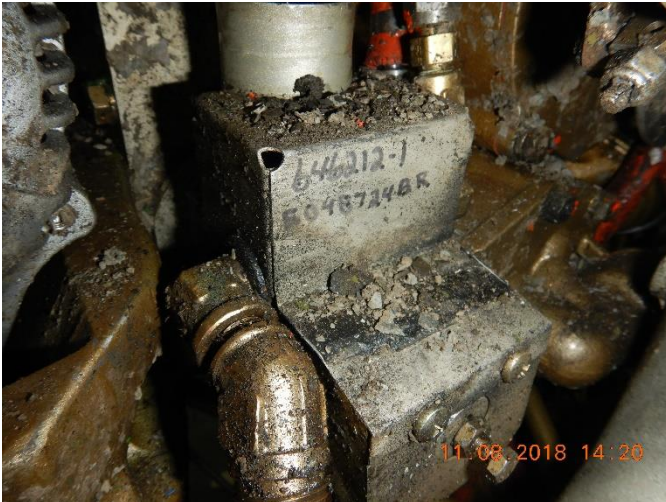
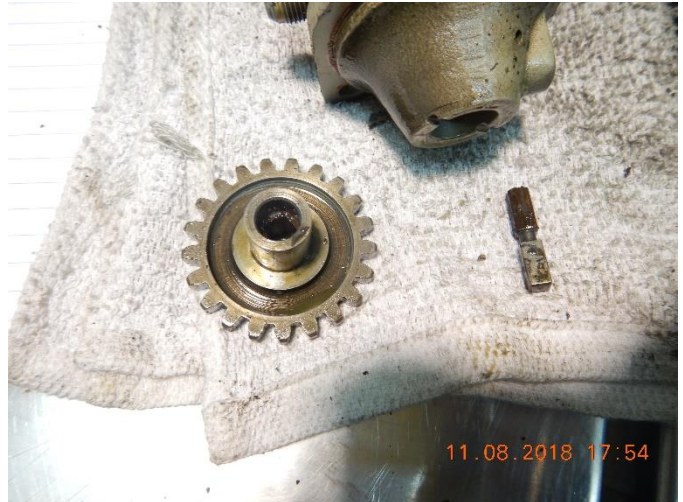
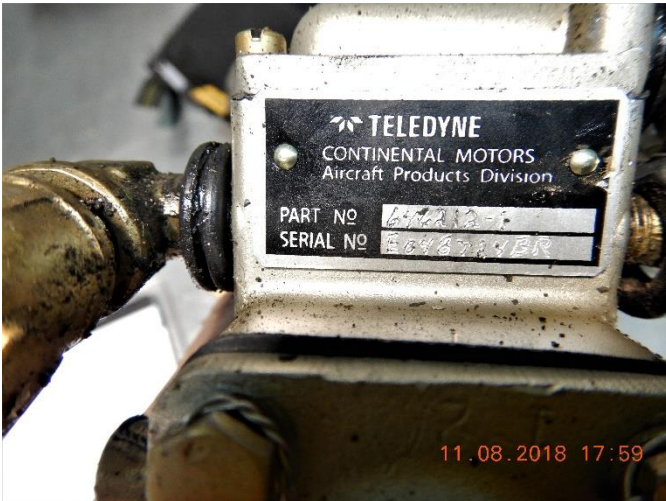
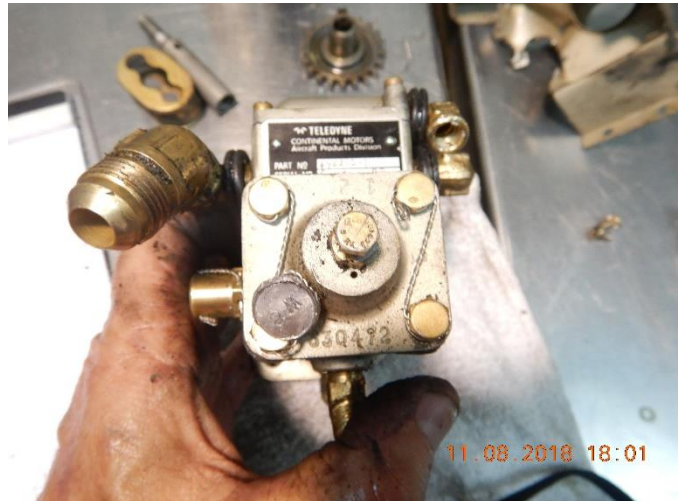
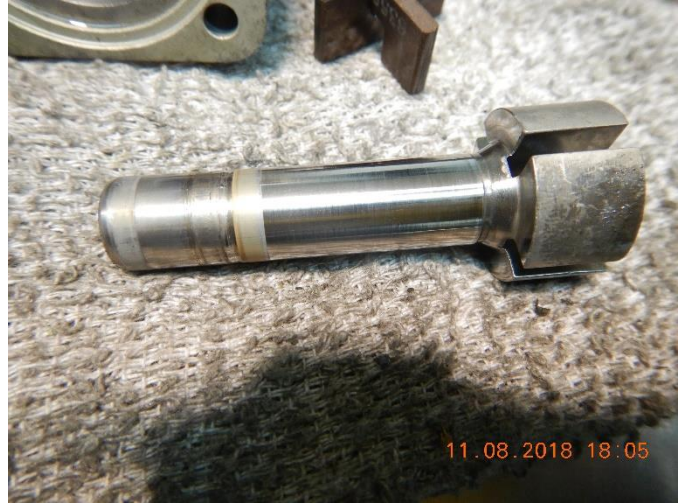
The drive coupling was intact, and the fuel pump operated smoothly when manually rotated. The shaft, blades and pump body cavity were intact and appeared normal.

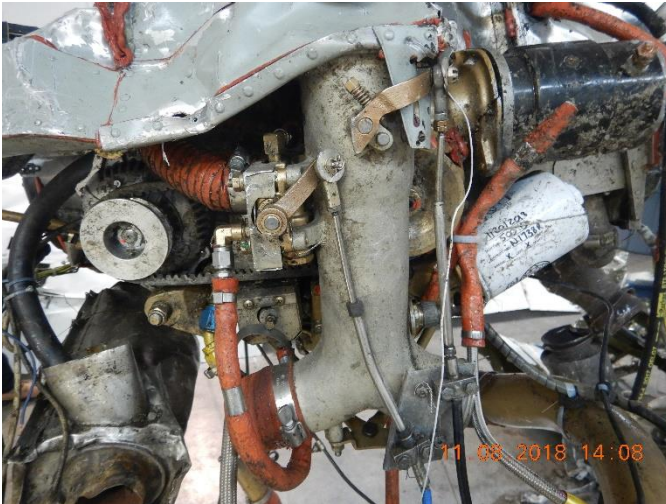
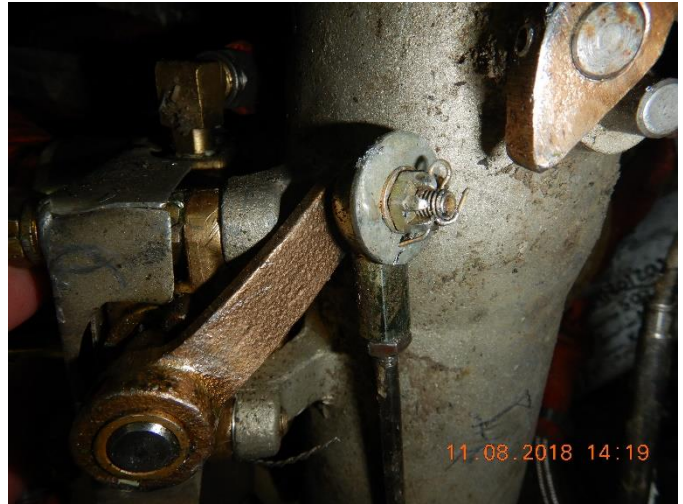
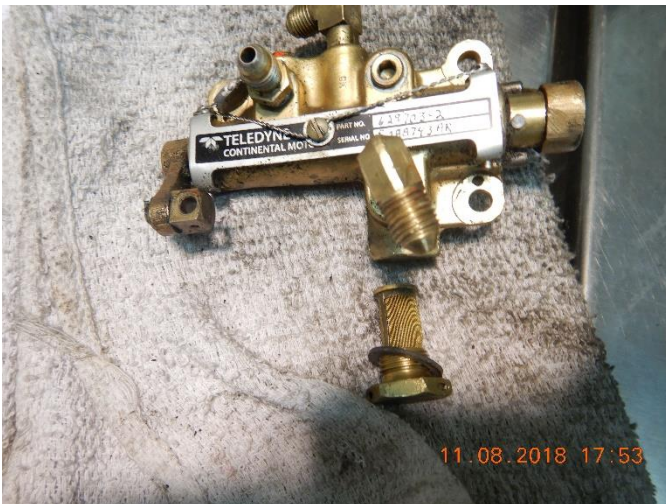
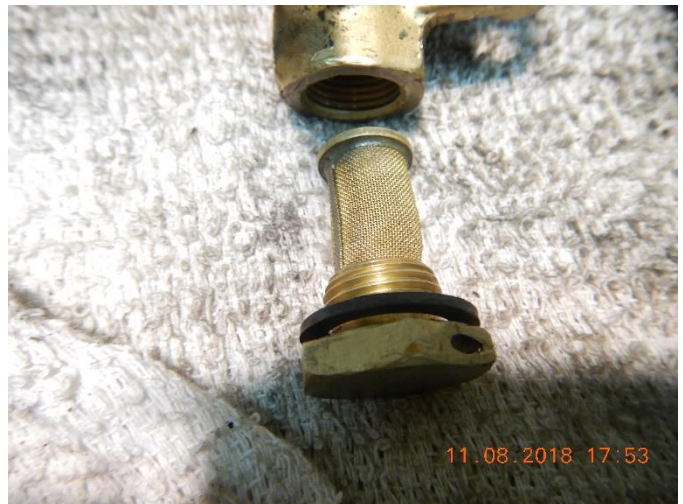
**Condition:** The fuel screen was secured properly with safety wire. The fuel screen was removed, examined and found to be uncontaminated. The mixture control unit control arms were intact and the damaged control cable ends remained secured with proper bolts, castellated nuts and cotter pins.

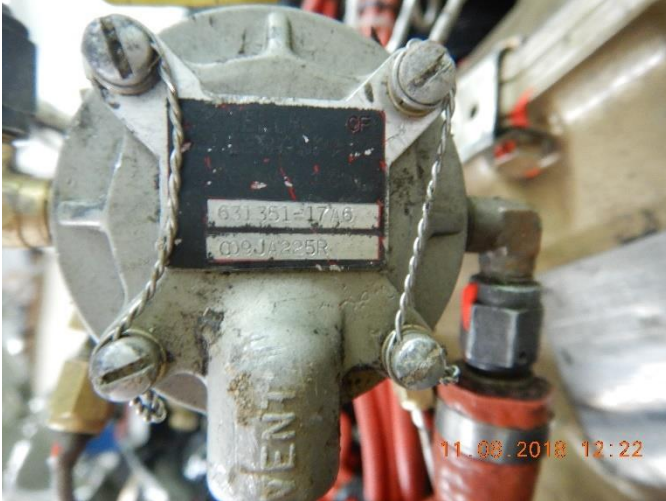
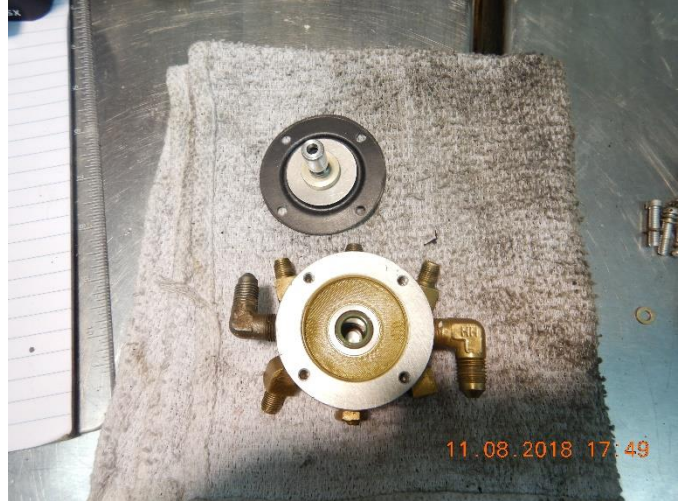
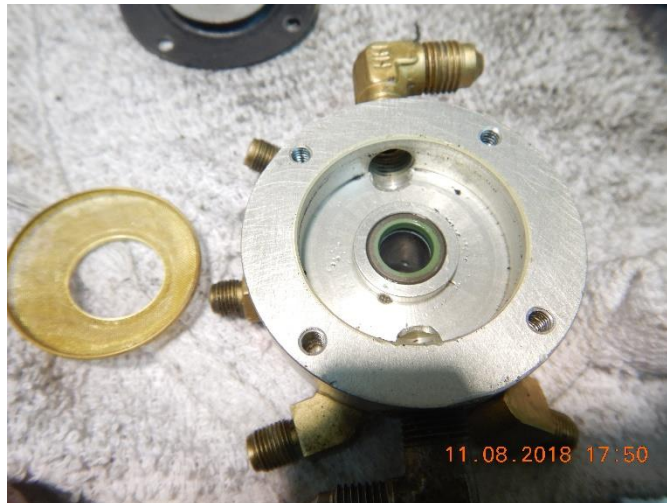
The assembly screws remained properly secured with safety wire and lead seal. The assembly screws and cover were removed. The spring and diaphragm were intact. The valve body and internal fuel screen were intact and uncontaminated. A small amount of fuel escaped when the fuel inlet hose was removed.

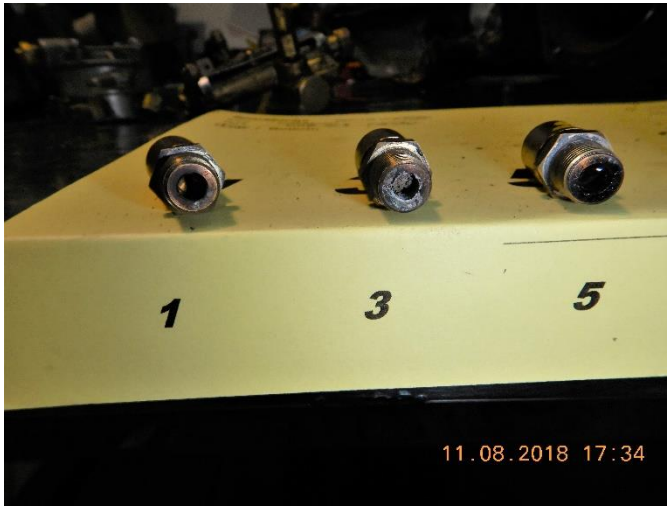
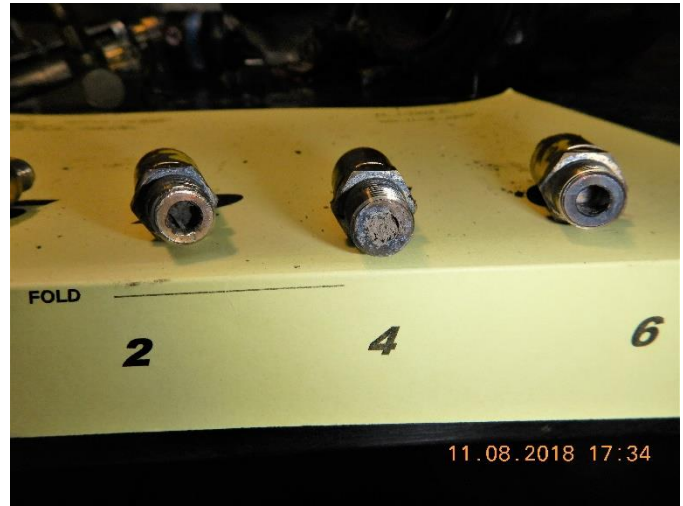
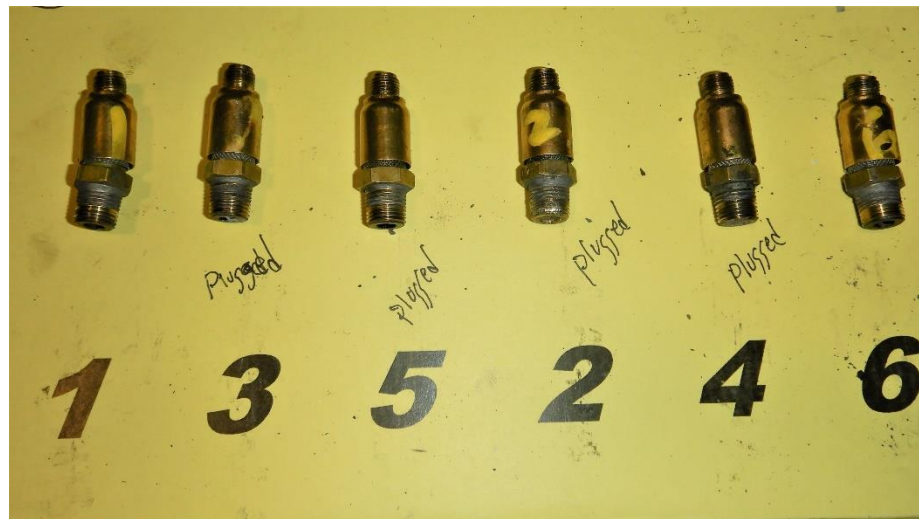
The modified, aftermarket fuel injectors were removed from each cylinder head. The fuel injector orifices were contaminated and blocked on fuel injectors removed from cylinders 2, 3, 4 and 5. The contamination was consistent with dirt/mud. The induction system elbows, connectors and hoses separated by impact forces allowing dirt, snow and other contaminations to enter each cylinder intake port.

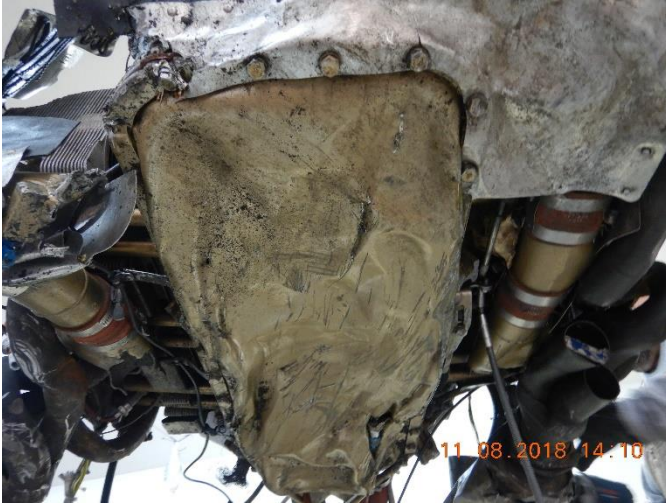
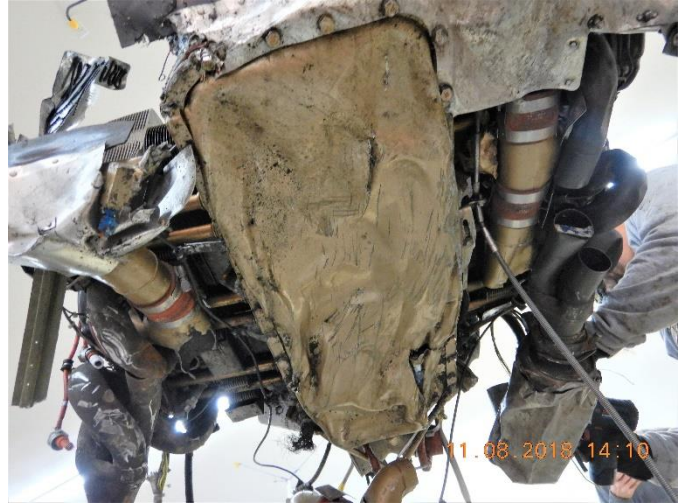
The oil sump was crushed and forced upward due to impact damage.

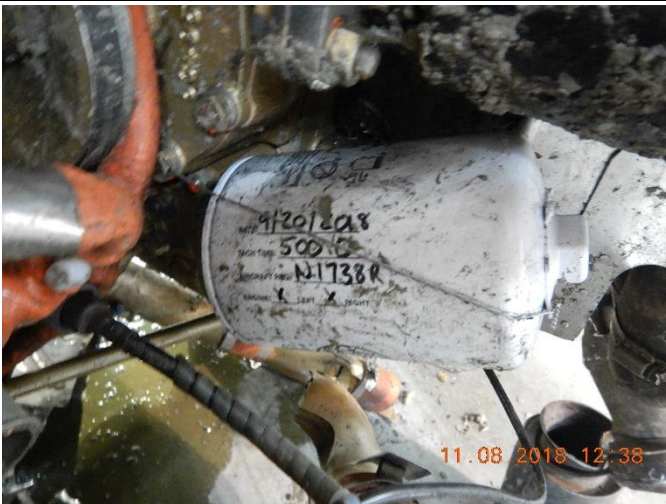
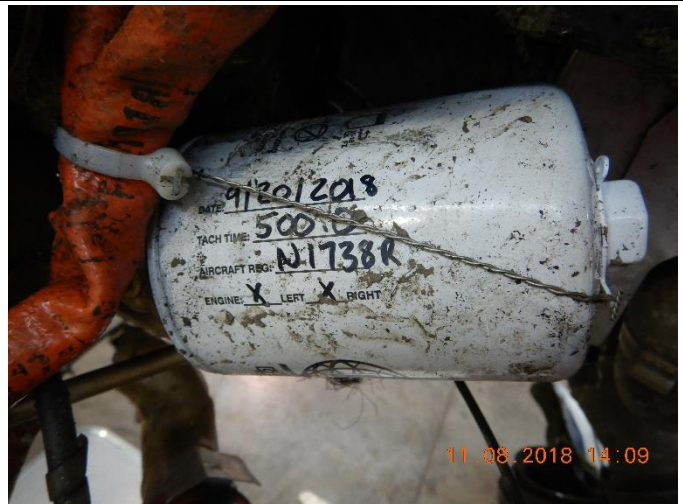
The spin-on oil filter remained attached and properly secured with safety wire. The oil filter was not removed or internally examined.

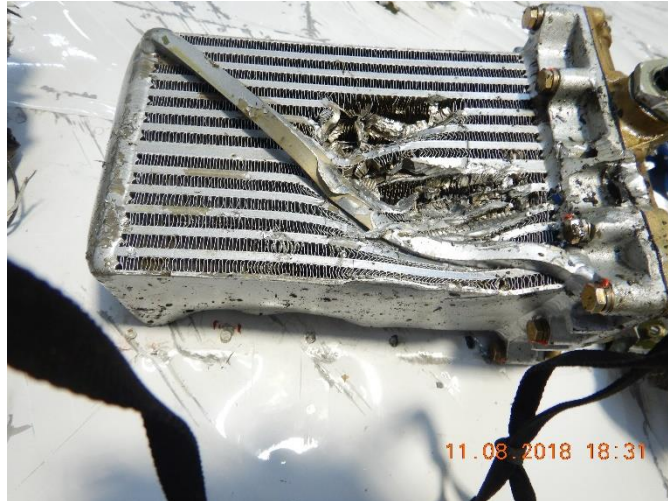
The oil cooler separated but was recovered. The oil cooler core, brace and end cap exhibited impact damage.

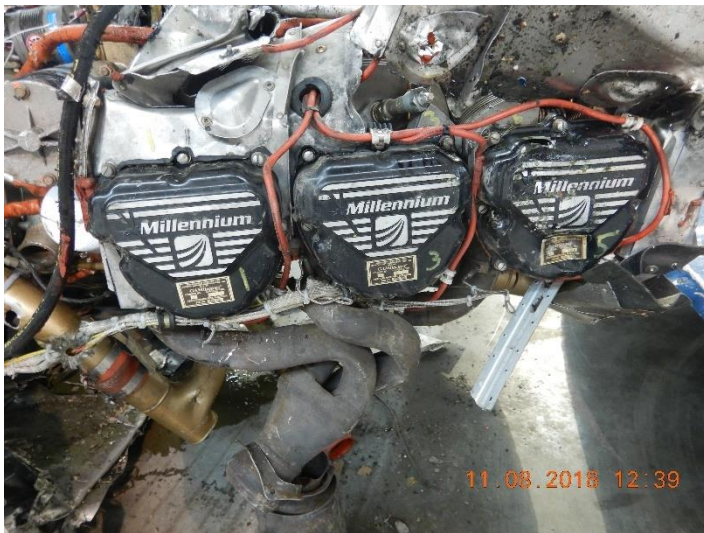
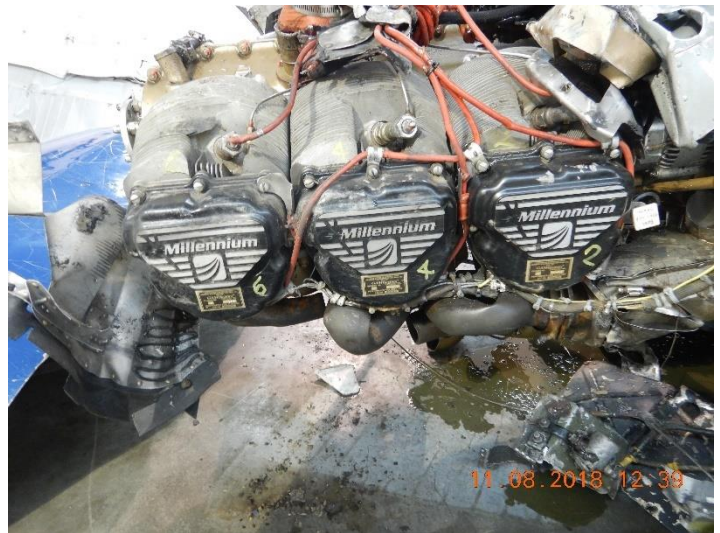
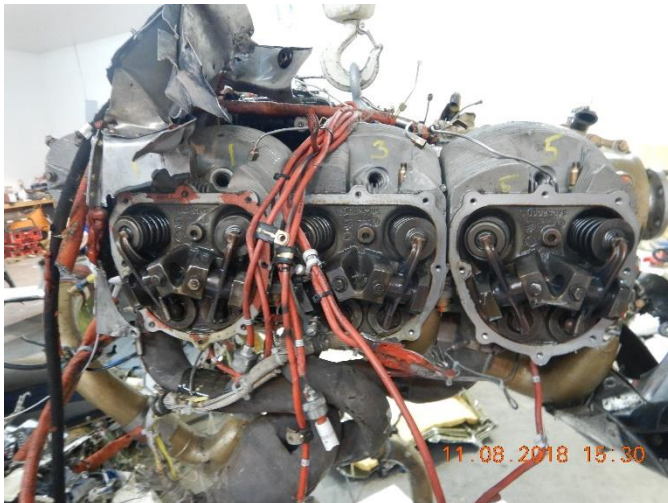
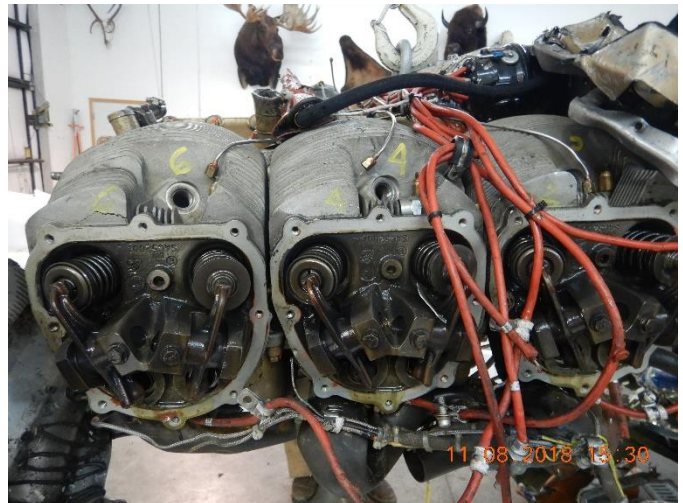
A turning bar was used to manually rotate the engine. Thumb compression was achieved at all six cylinders. A lighted electronic borescope inspection was performed on each cylinder. All intake valves, exhaust valves and piston domes were intact and exhibited normal combustion signatures.

| CYLINDER ASSEMBLIES | P/N: SAC 52001 | S/N: Undetermined | Head Date: Undetermined |
|---|---|---|---|
| Condition: | All cylinders were Superior Parts PMA aftermarket cylinders. Installation hardware exhibited orange-colored torque putty. All rocker covers remained intact except cylinder 6 which exhibited impact damage. Each rocker cover exhibited the brand logo "Millennium". Cooling fins were impact damaged on cylinders 5 and 6. | | |

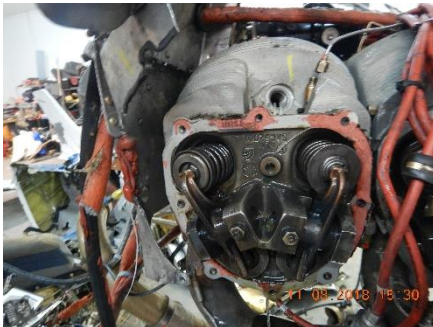
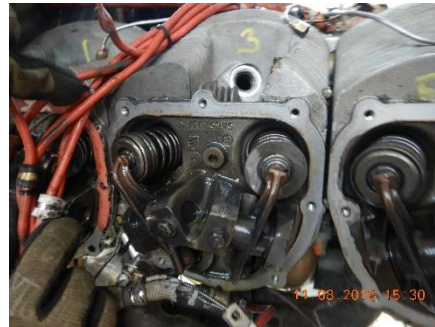
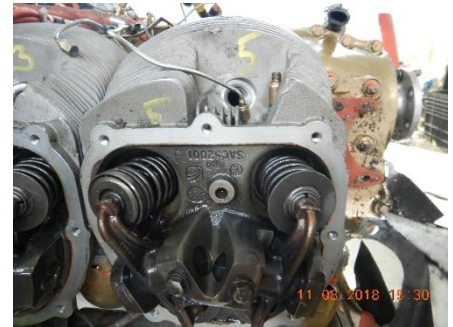
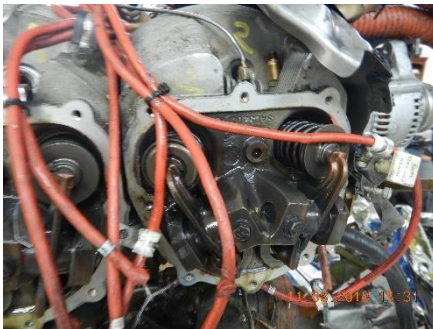
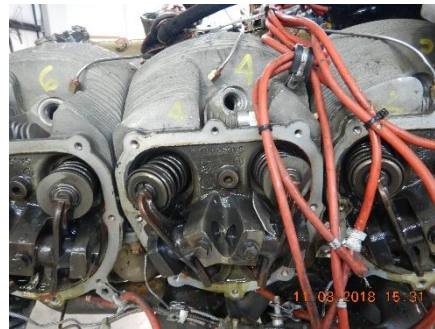
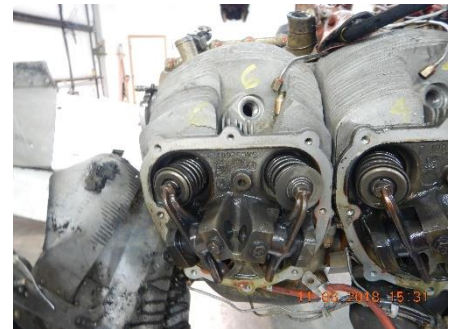
Condition: A lighted electronic borescope inspection was performed on each cylinder. All intake valves and exhaust valves were intact and exhibited normal combustion signatures.

Condition: All rocker arms and shafts were undamaged and operated normally when the engine was manually rotated.

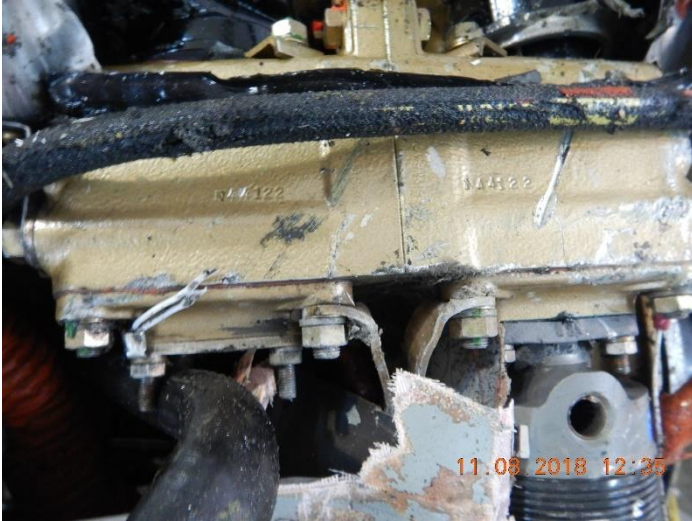
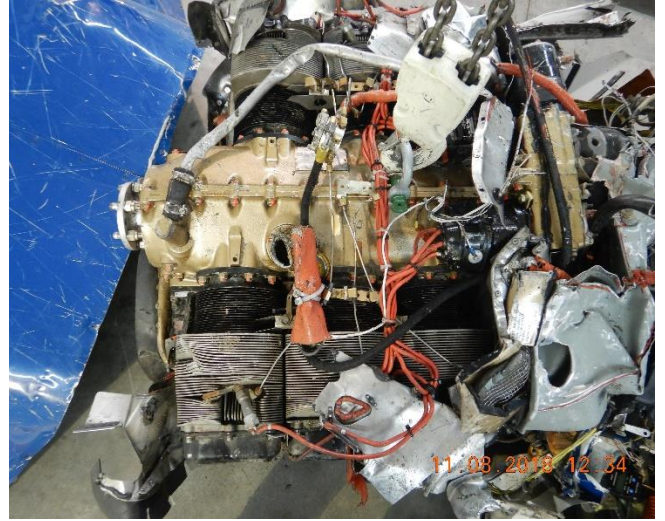
| Condition: | The crankcase assembly remained intact. | | | |

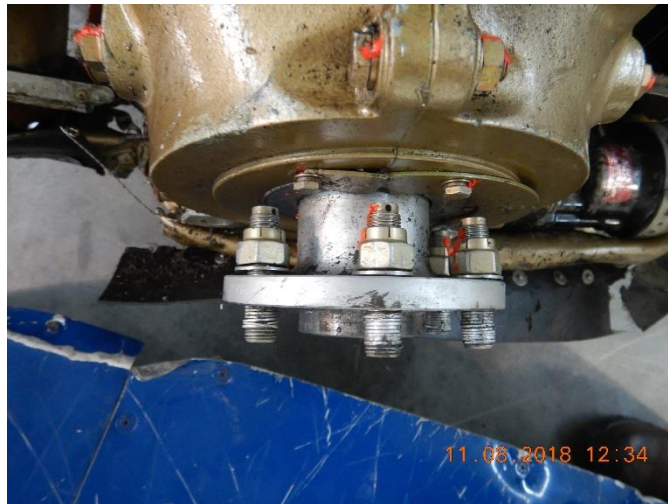
| Condition: | The propeller flange was misaligned due to impact forces. | | |

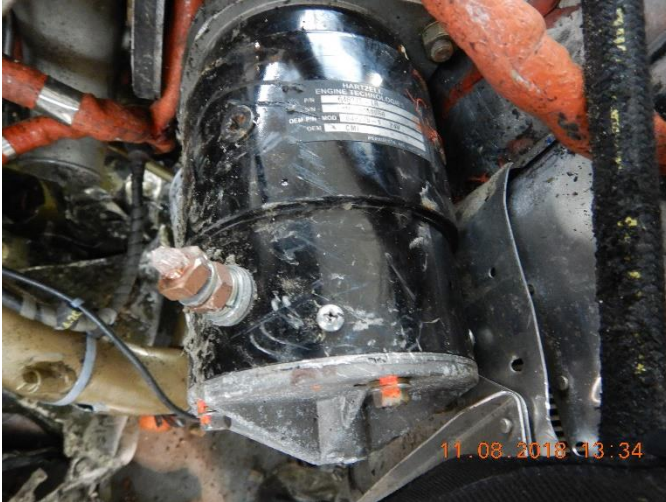
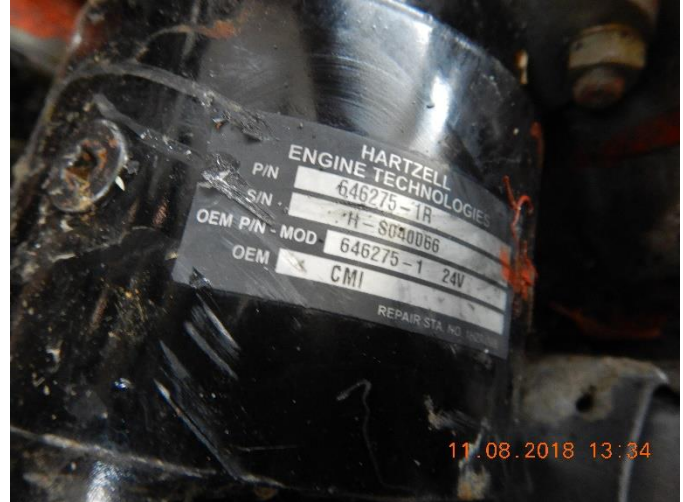
| Condition: | The electric starter motor remained attached but received impact damage. | | |

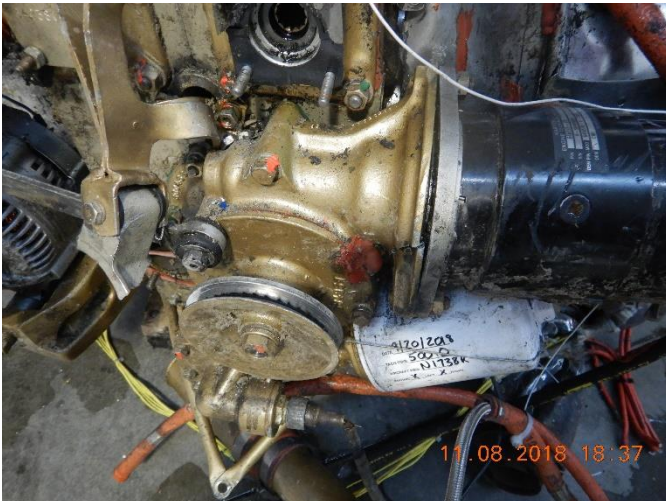
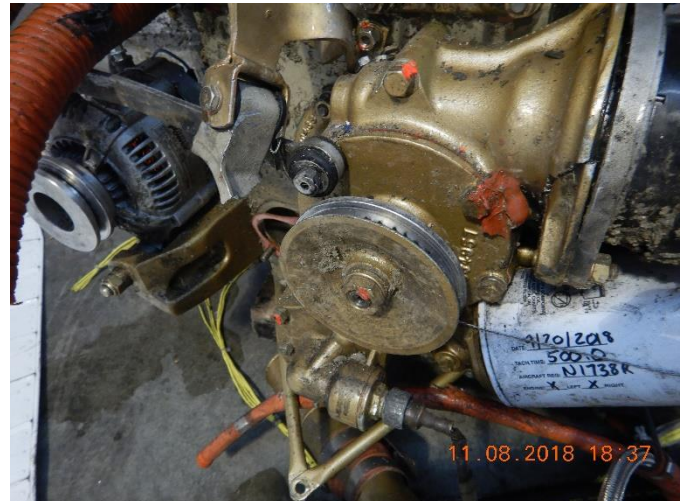
| Condition: | The starter adapter was damaged at the starter attach flange. The starter adapter pulley and accessory v-belt were intact. |

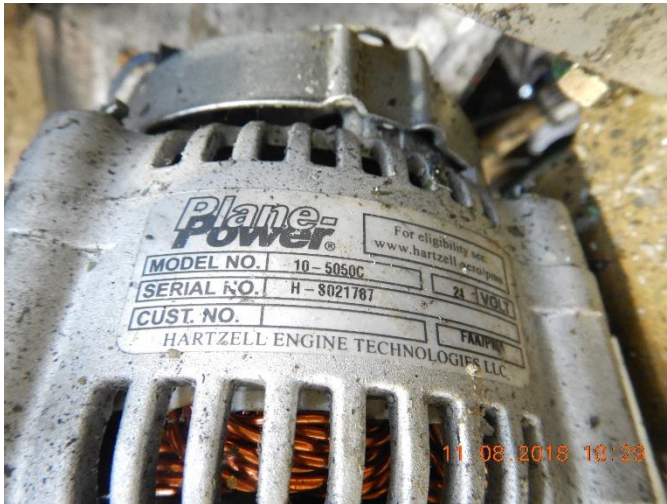
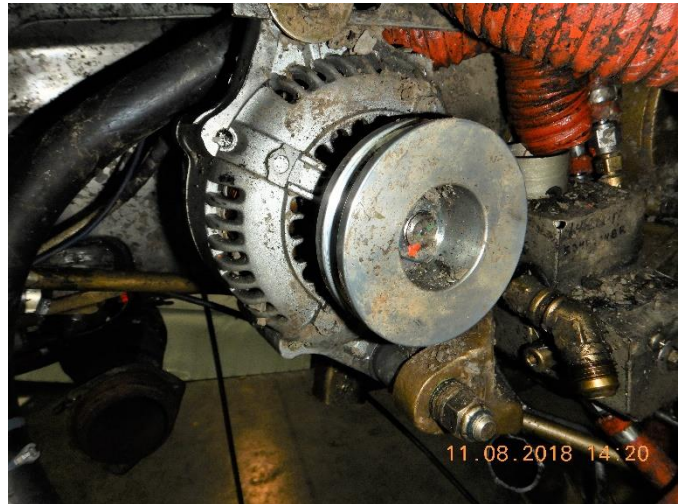
The belt driven alternator remained attached and appeared to be undamaged.

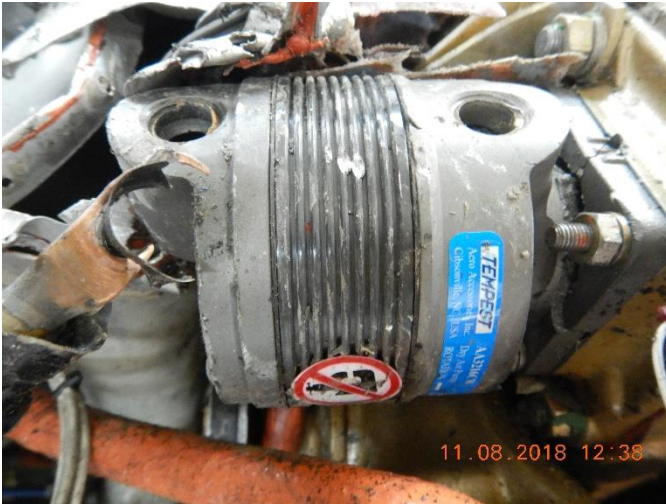
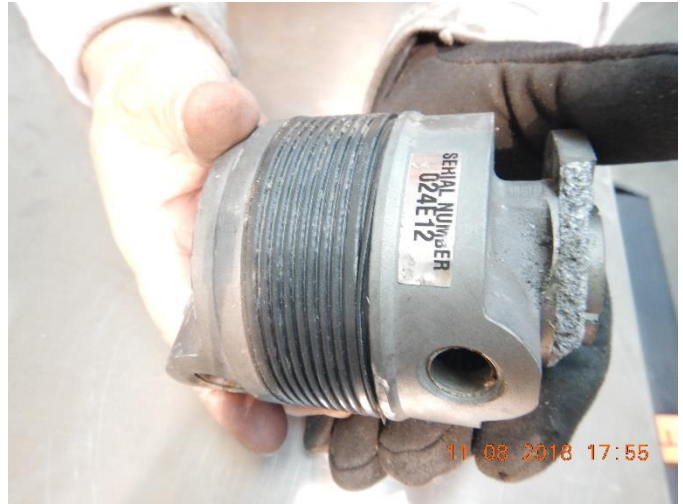
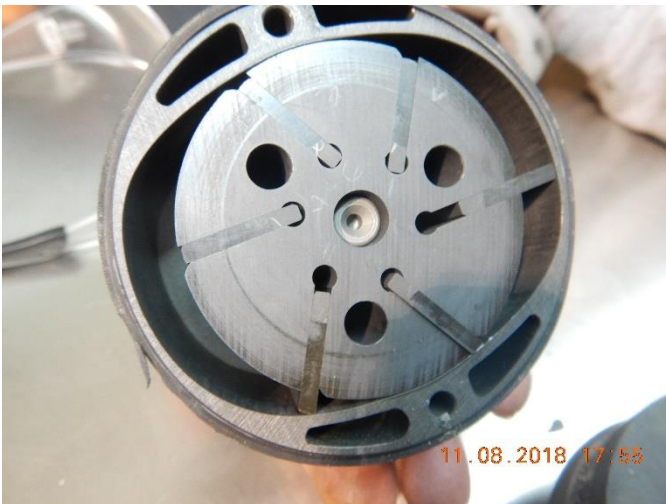
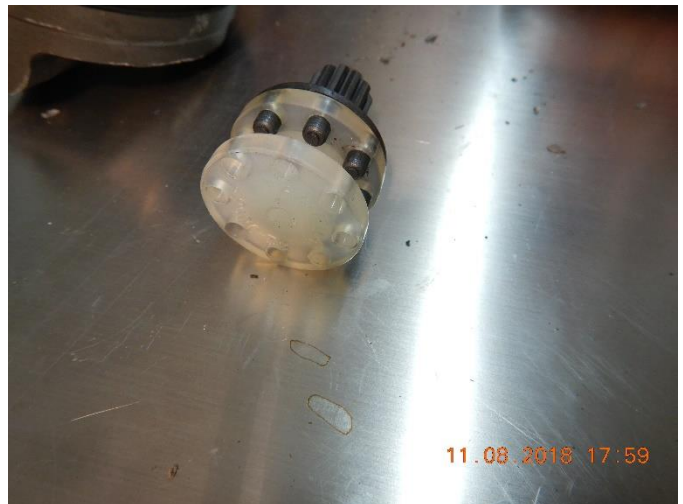
**Condition:** The instrument air pump remained attached but received impact damage to the outer case and cooling fins. The plastic drive coupler (shear drive) was intact. The carbon rotor and blades were intact, and the pump operated smoothly when manually rotated producing suction and pressure at the corresponding ports.
