## ENGINE EXAMINATION REPORT **N1738R**

| ENGINE MODEL | IO520F (9A) |
| AIRCRAFT MAKE & MODEL | Cessna U206G |
| AIRCRAFT REGISTRATION | N1738R |

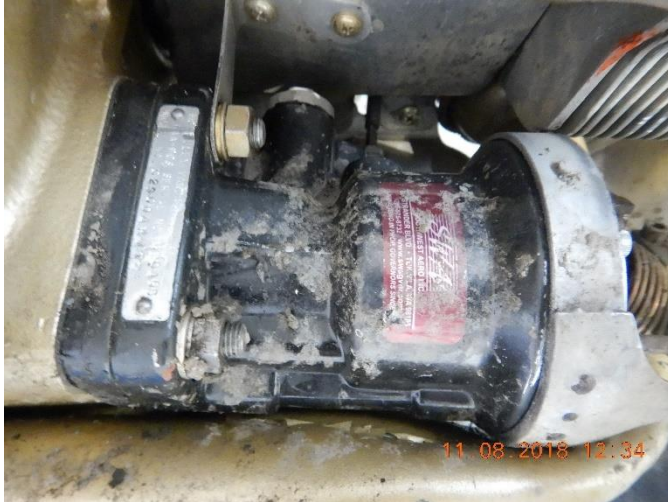
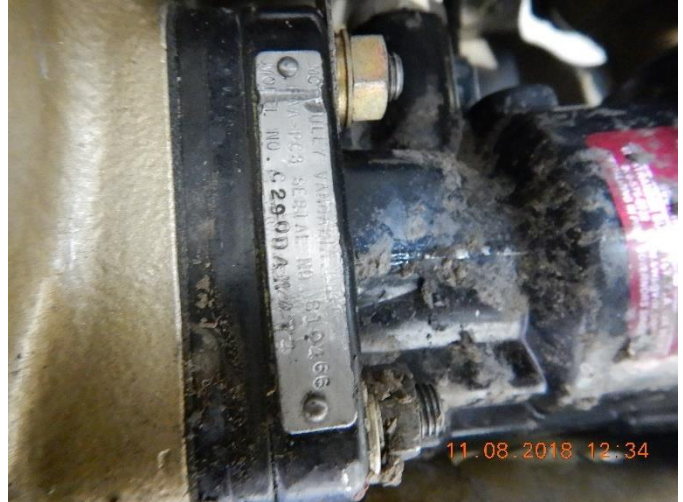
| Condition: | The governor received impact damage to the pitch change arm and spring. | | |

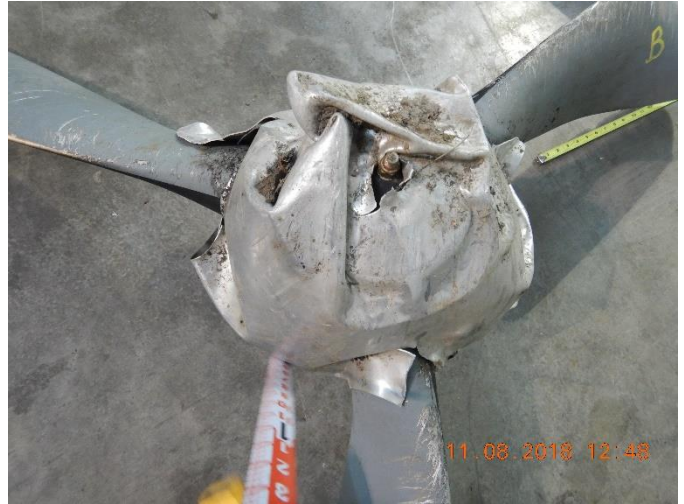
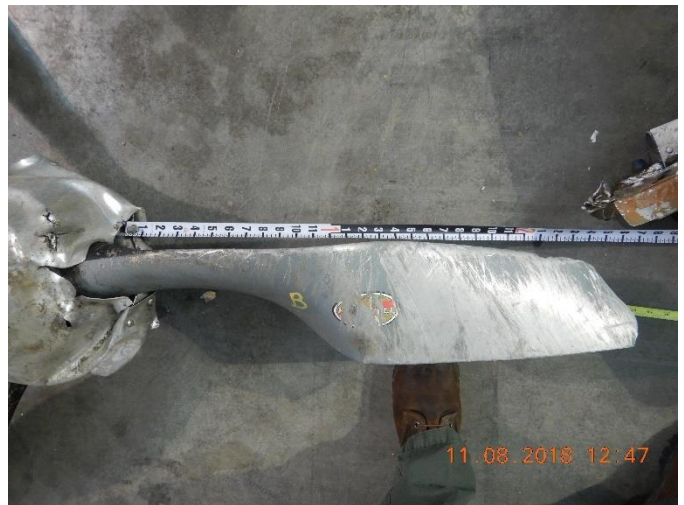
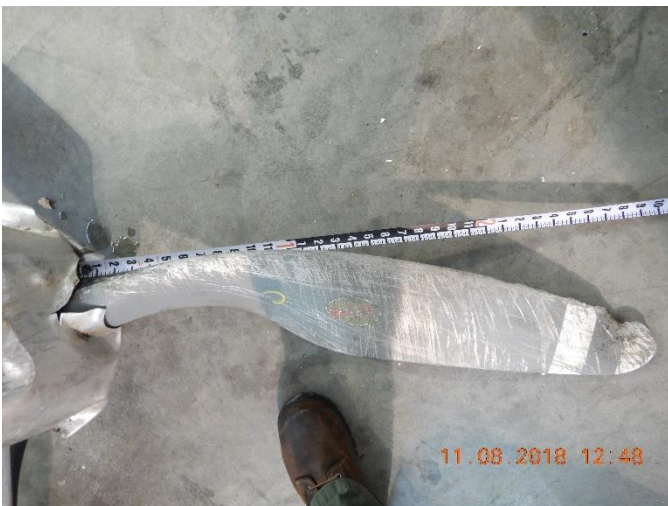
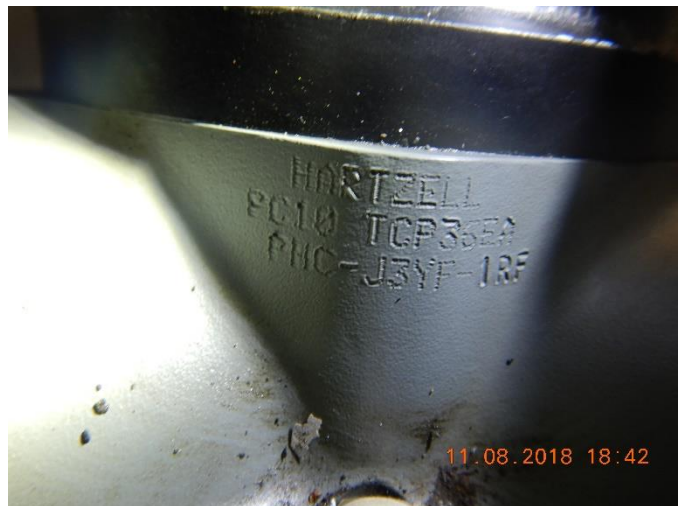
| Condition: | The constant speed three blade propeller received impact damage crushing the spinner. Each damaged propeller blade was marked with a letter "A, B, or C" for photo identification. Blade A was loose inside the propeller hub and exhibited impact damage beginning approximately 27" outboard of the blade root with the blade tip curled rearward and significant gouging and paint transfer. The inboard 28" of blade A exhibited only minor scratching across the cambered surface. Blade B was also loose in the propeller hub and exhibited a clockwise twist beginning approximately 10" outboard of the blade root. The outboard section of blade B exhibited heavy paint transfer and gouging of the cambered surface. Blade C exhibited impact damage with clockwise twisting beginning approximately 9" outboard of the blade root with significant cordwise scratching and a large gouge at the blade tip. | | |
