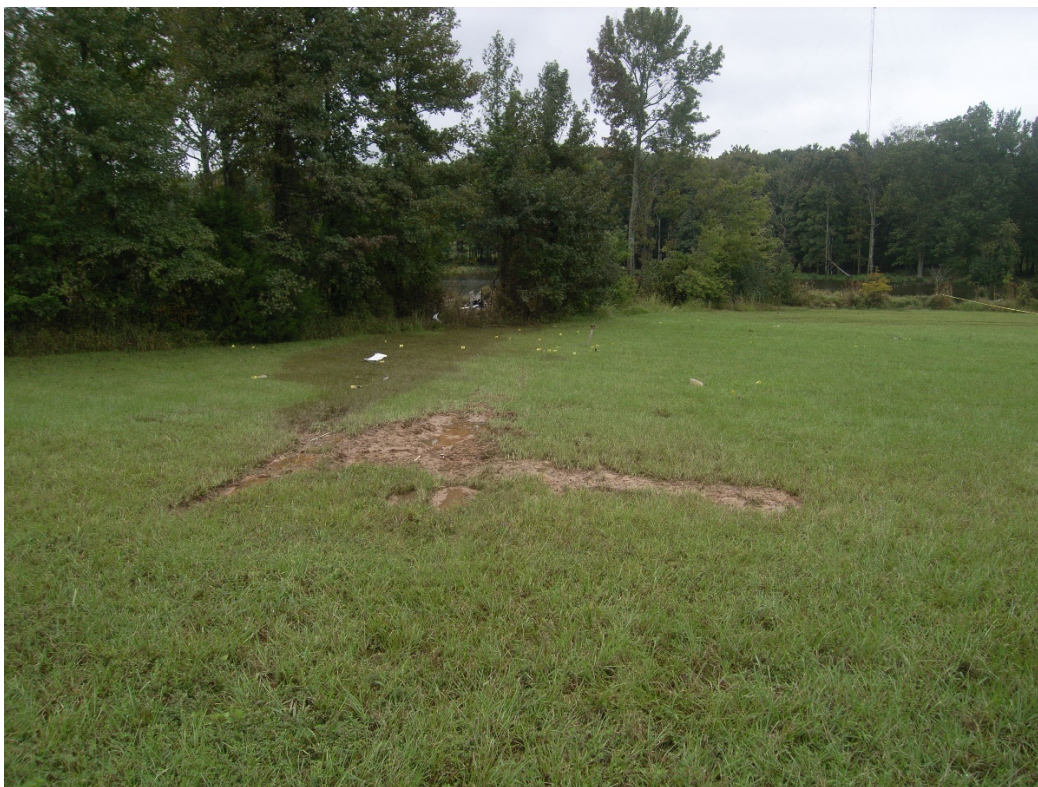
Figure 1: Photograph of Initial Point of Impact

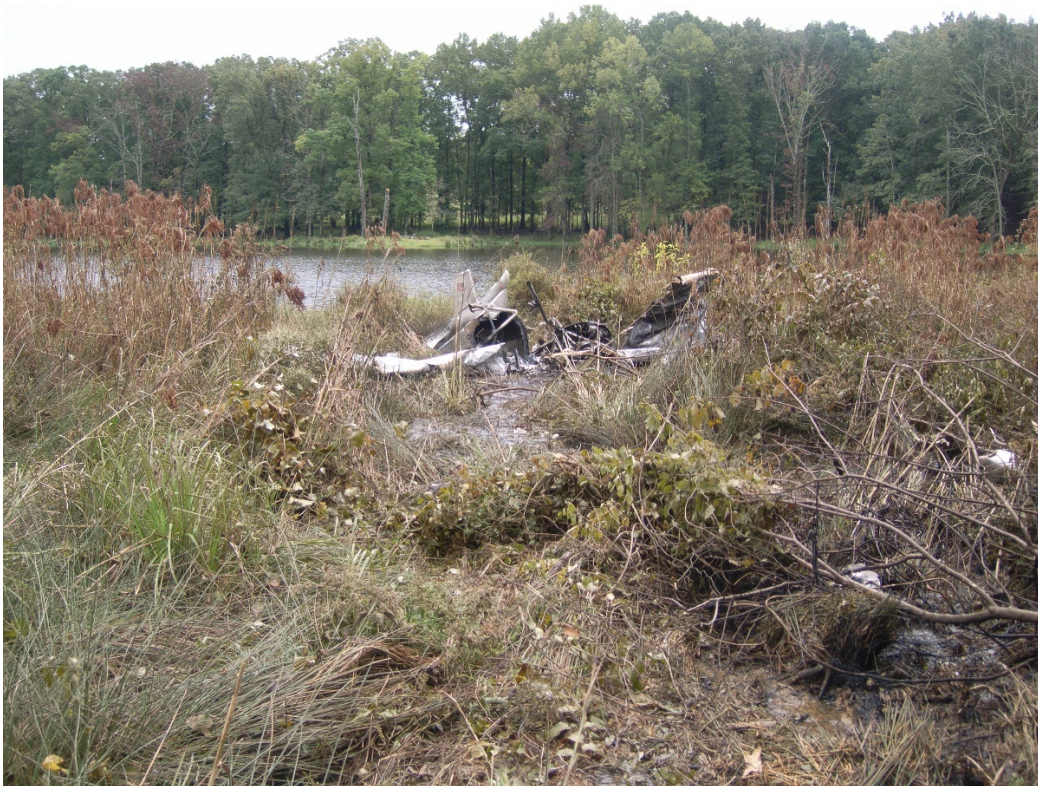
Figure 2: Photograph of Main Wreckage

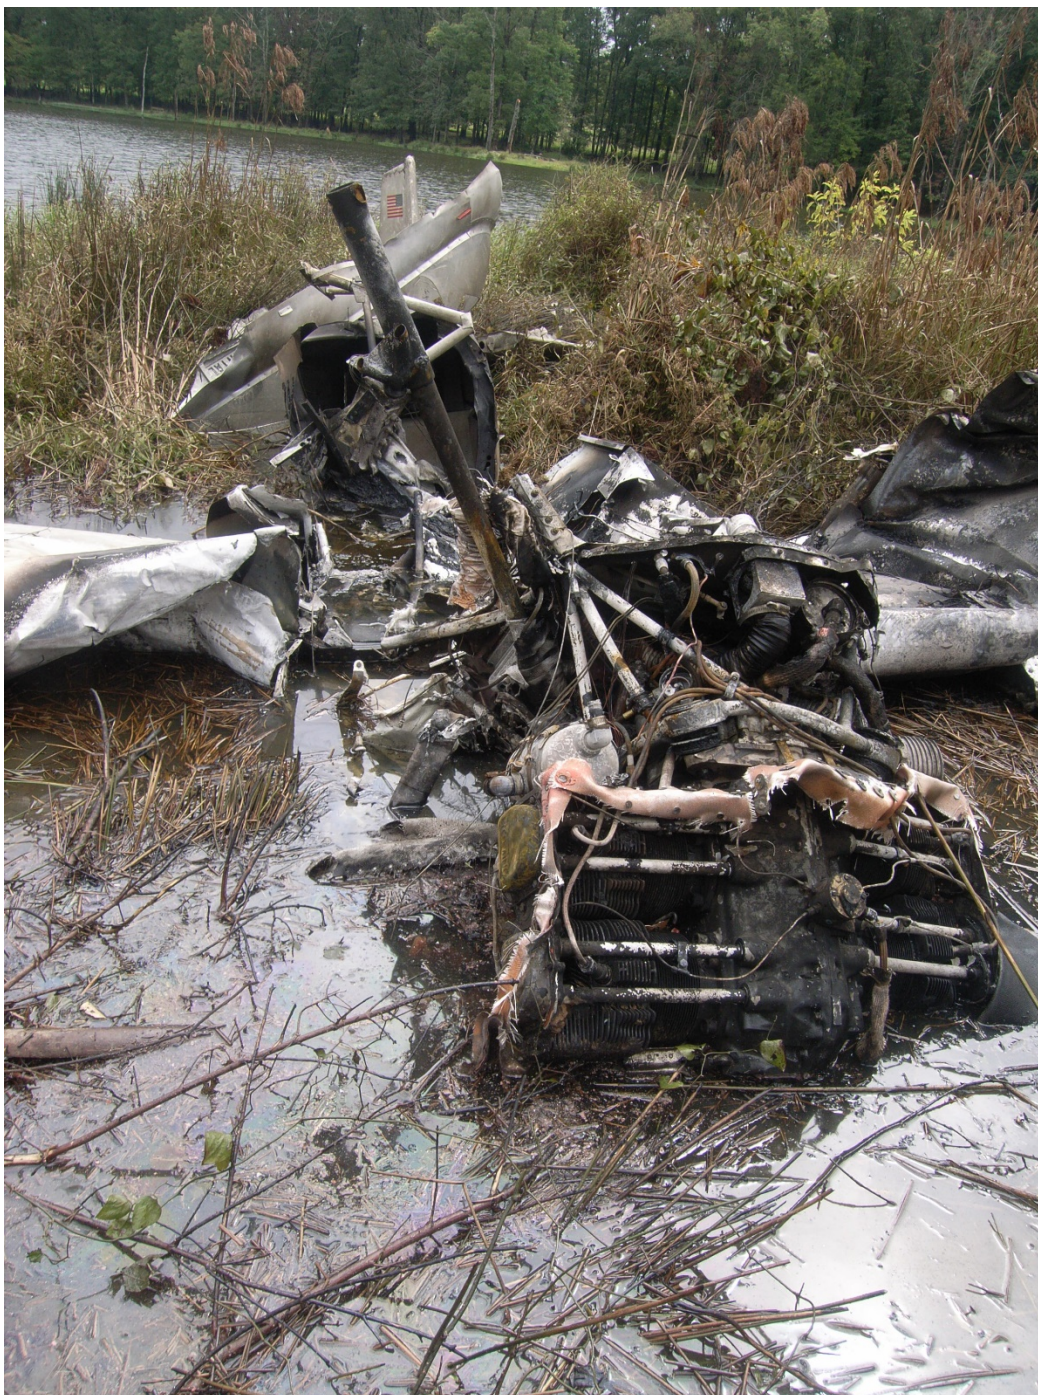
Figure 3: Close-Up Photograph of Main Wreckage
