**NATIONAL TRANSPORTATION SAFETY BOARD**  
**Office of Aviation Safety**  
**Washington, D.C. 20594**

**System's Group Chairman's Factual Report**

**NTSB No: CEN18FA400**

Aircraft: Cirrus SR22T, registration number N325JK  
Location: Gulf of Mexico  
Date: January 3, 2018  
Time: 1830 Central Daylight Time

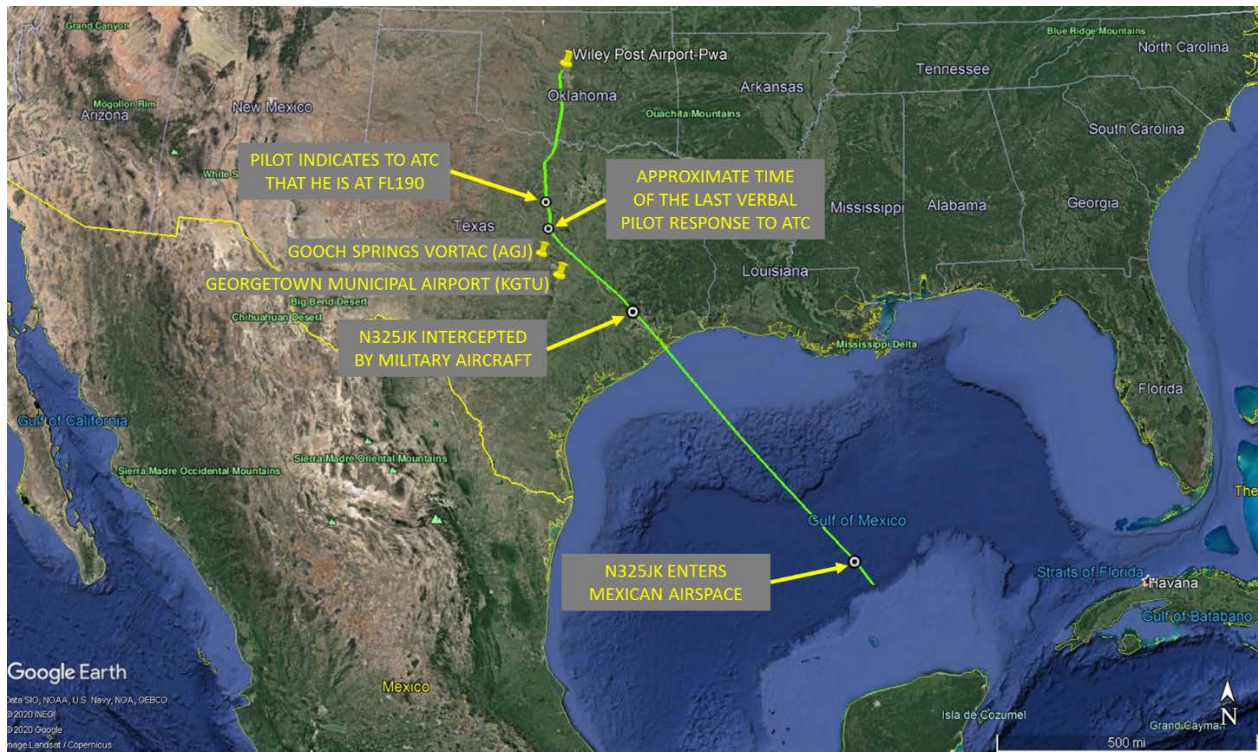
**Figure 1 Flight Track for N325JK**

According to data provided by the FAA, about 15:09:53 (local time), the pilot of N325JK contacted the Fort Worth Air Route Traffic Control Center (ZFW ARTCC) Ednas-low sector radar (EDN-LR) controller and advised that he was at Flight Level<sup>5</sup> (FL) 190. At 15:10:06, the pilot was then advised by the EDN-LR controller that he was cleared direct to Gooch Springs (AGJ) and then direct to Georgetown; the pilot acknowledged (see Figures 1 and 2)<sup>6</sup>. About 15:15:47, the EDN-LR controller instructed the pilot of N325JK to descend and maintain 15,000 ft and issued an altimeter setting of 30.30; the pilot acknowledged (see Figure 3). At 15:16:57, the EDN-LR controller transmitted *“and uh five juliet kilo it’s still not looking like you’re direct gooch springs there uh vector for gooch springs alpha golf juliet fly heading one nine zero”*. The pilot replied *“okay, vector for gooch springs um heading one niner zero for five juliet kilo.”* At 15:17:09, the EDN-LR controller instructed the pilot of N325JK to descend and maintain 13,000 feet. At 15:18:13, the EDN-LR controller repeated the instruction. At 15:18:18, the pilot replied *“one three thirteen thousand five juliet kilo.”* At 15:18:21, the EDN-LR controller confirmed with the pilot of N325JK that he was the one that had responded to the descent instruction to 13,000 feet; the pilot replied in the affirmative. The controller then advised he had requested because he had not seen him start his descent; the pilot did not acknowledge. At 15:19:06, the EDN-LR controller queried *“and three two five juliet kilo are you at flight level one nine zero or are you descending;”* the pilot did not respond (see Figure 4). The controller attempted to contact the pilot three more times with no response. A review of radar data showed that about 15:19:15, while the airplane remained at FL190, its heading changed from about 180 to 140. At 15:20:09, the EDN-LR controller transmitted *“and five juliet kilo i see you identing can you hear me.”* At 15:20:19, the EDN-LR controller transmitted *“three two five juliet kilo ident observed i need you to fly heading two zero zero vector for your descent two zero zero acknowledge by ident;”* the pilot did not respond. The EDN-LR controller continued multiple attempts over several minutes to contact N325JK with no response. At 15:33:52, the EDN-LR controller transmitted *“november three two five juliet kilo fort worth center i can see your ident there please descend and maintain thirteen thousand three two five juliet kilo descend to one three thousand and if you have oxygen please switch it uh put it on right now;”* the pilot did not respond. At about 15:34, N325JK entered Houston (ZHU) ARTCC airspace. The EDN-LR and CUGAR-R controllers both continued with multiple attempts to contact N325JK with negative results. A review of radar data indicates that upon reaching FL190 at about 14:34:50, the aircraft then remained at about that altitude until radar data was lost at 18:06:16.

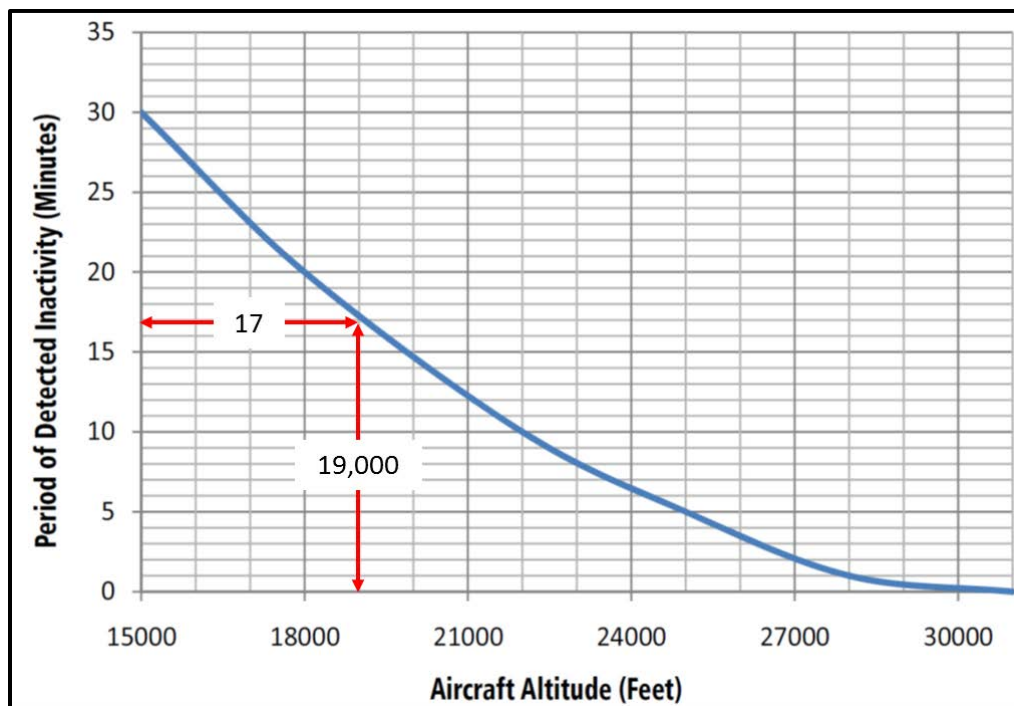
Figure 5 Hypoxia Recognition Activation Times

The system is only operative when the airplane's altitude is above 14,900 ft (pressure altitude) and the Garmin automatic flight control system (AFCS) is engaged. Pilot interaction with the Perspective+ system is monitored by detecting key presses and turns of the knobs (Audio Panel and push-to-talk switch excluded). If a period of inactivity, time dependent on altitude, is detected, the hypoxia recognition system will initiate the Emergency Descent Mode. The accident airplane was at an altitude of approximately 19,000 ft which would result in an activation time of about 17 minutes (Reference Figure 5)

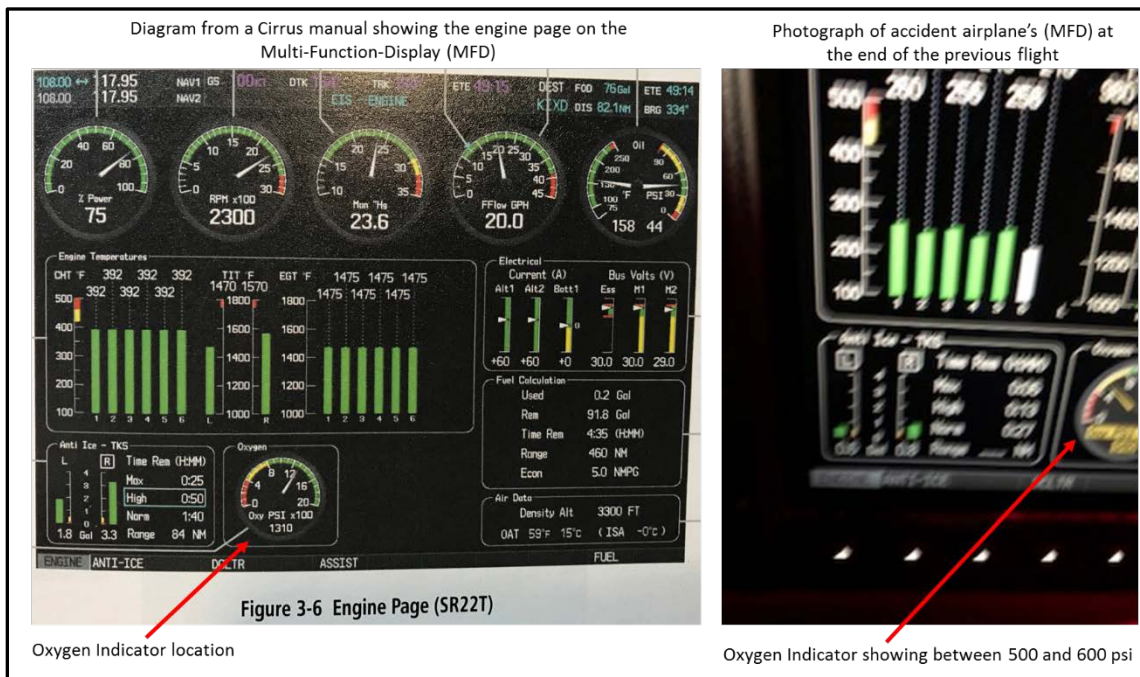
**Figure 8 Photograph of an exemplar oxygen indicator and indicator from accident aircraft**

The NTSB was provided with a photograph showing a partial image of the oxygen indicator on the accident airplane. The photograph, taken after the end of the flight prior to the accident flight, shows the oxygen indicators pointer between 500 and 600 psi (Reference Figure 8).
