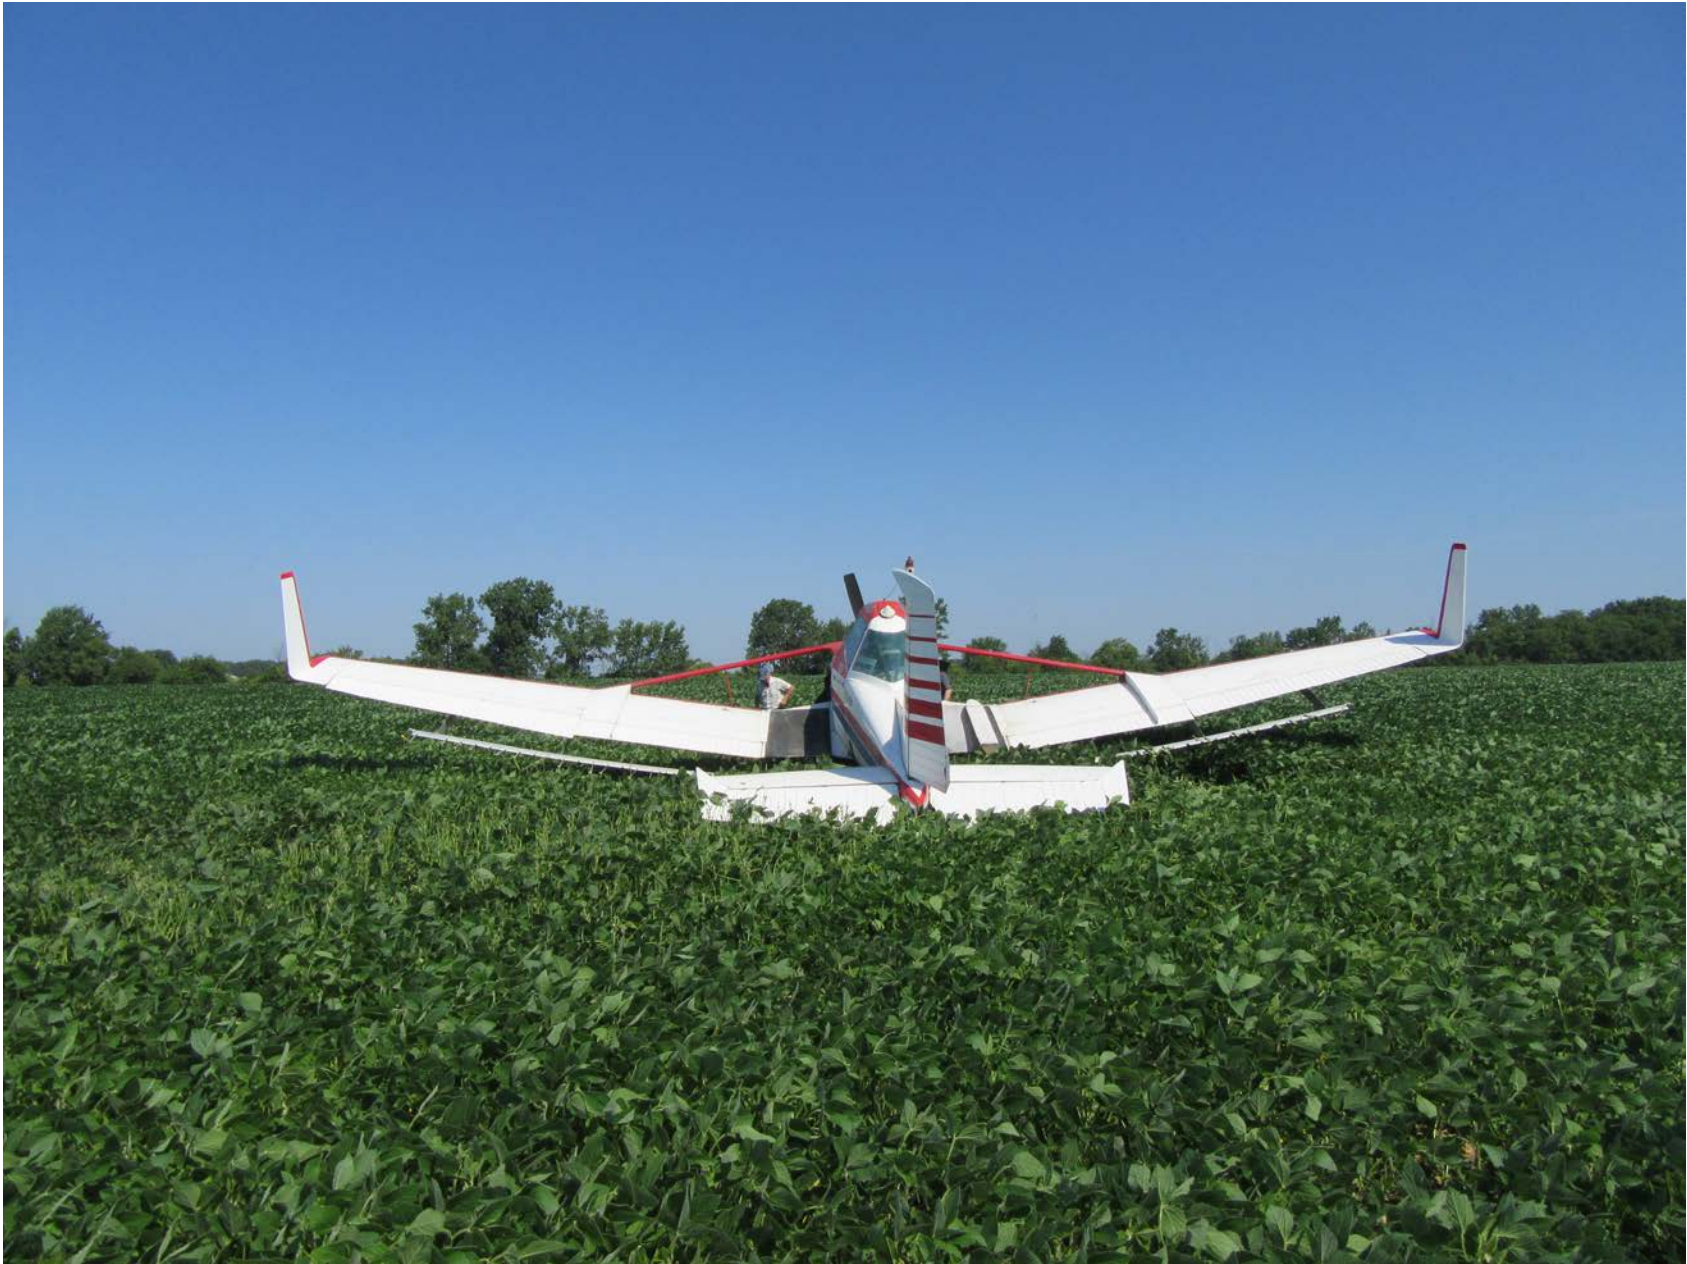
**Photo 1 – View of airplane in the bean field (FAA Photo)**

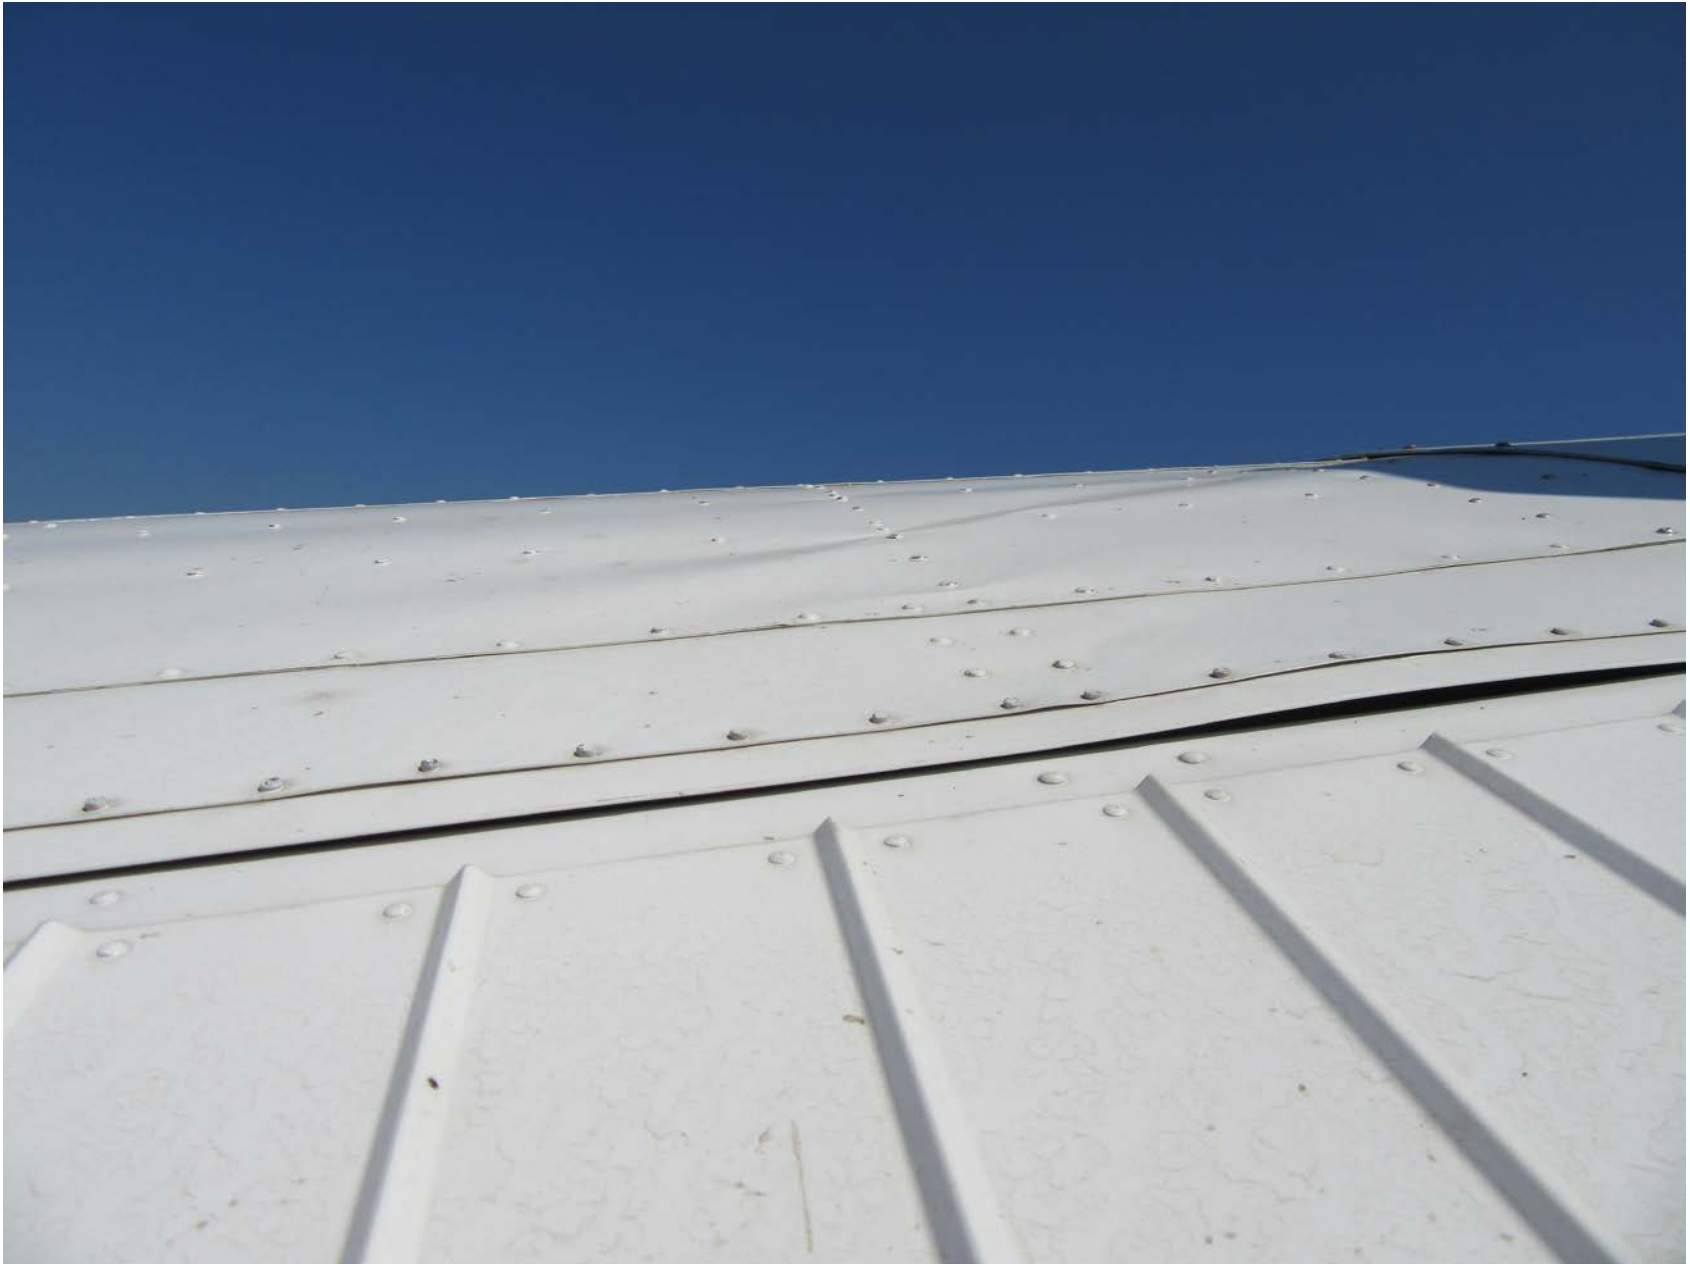
**Photo 2 – View of minor damage to the right wing (FAA Photo)**

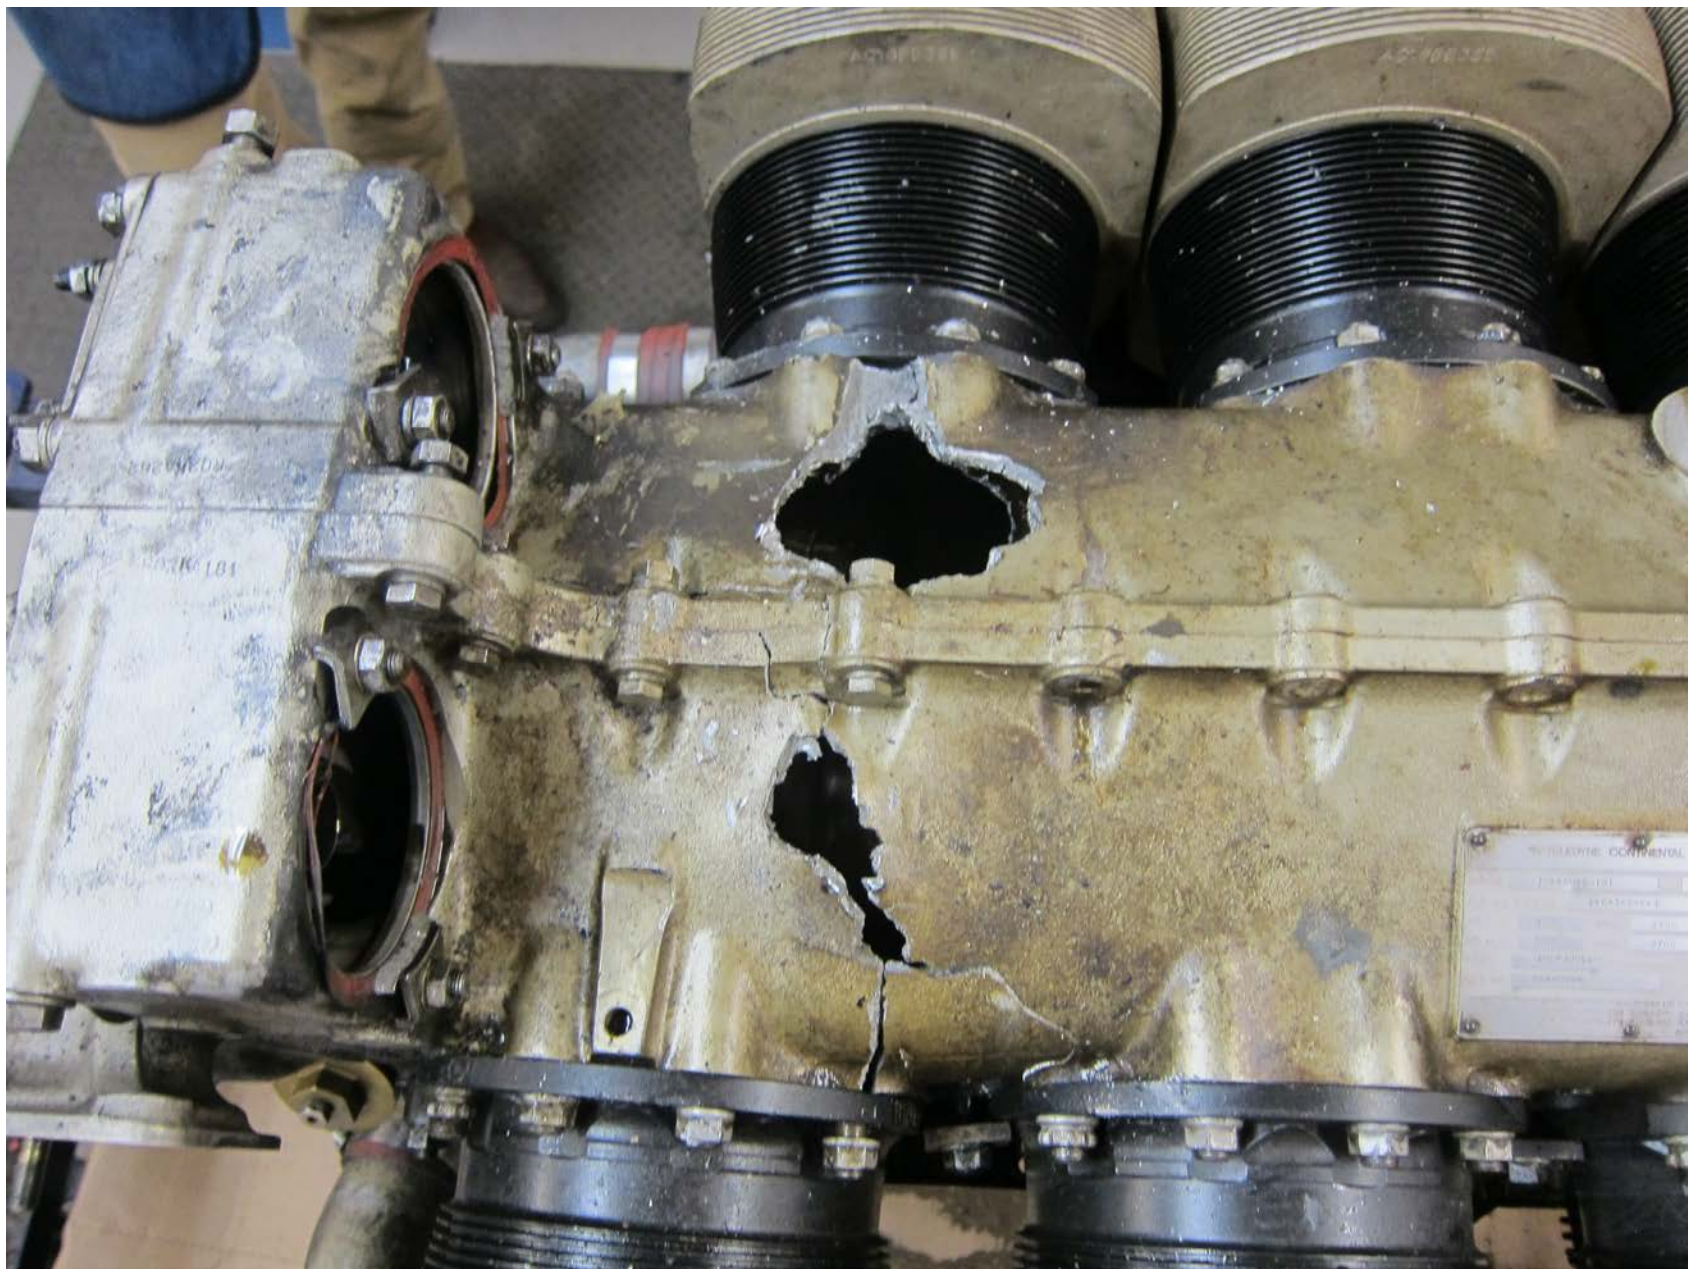
**Photo 3 – View of the hole in the crankcase (CM Photo)**

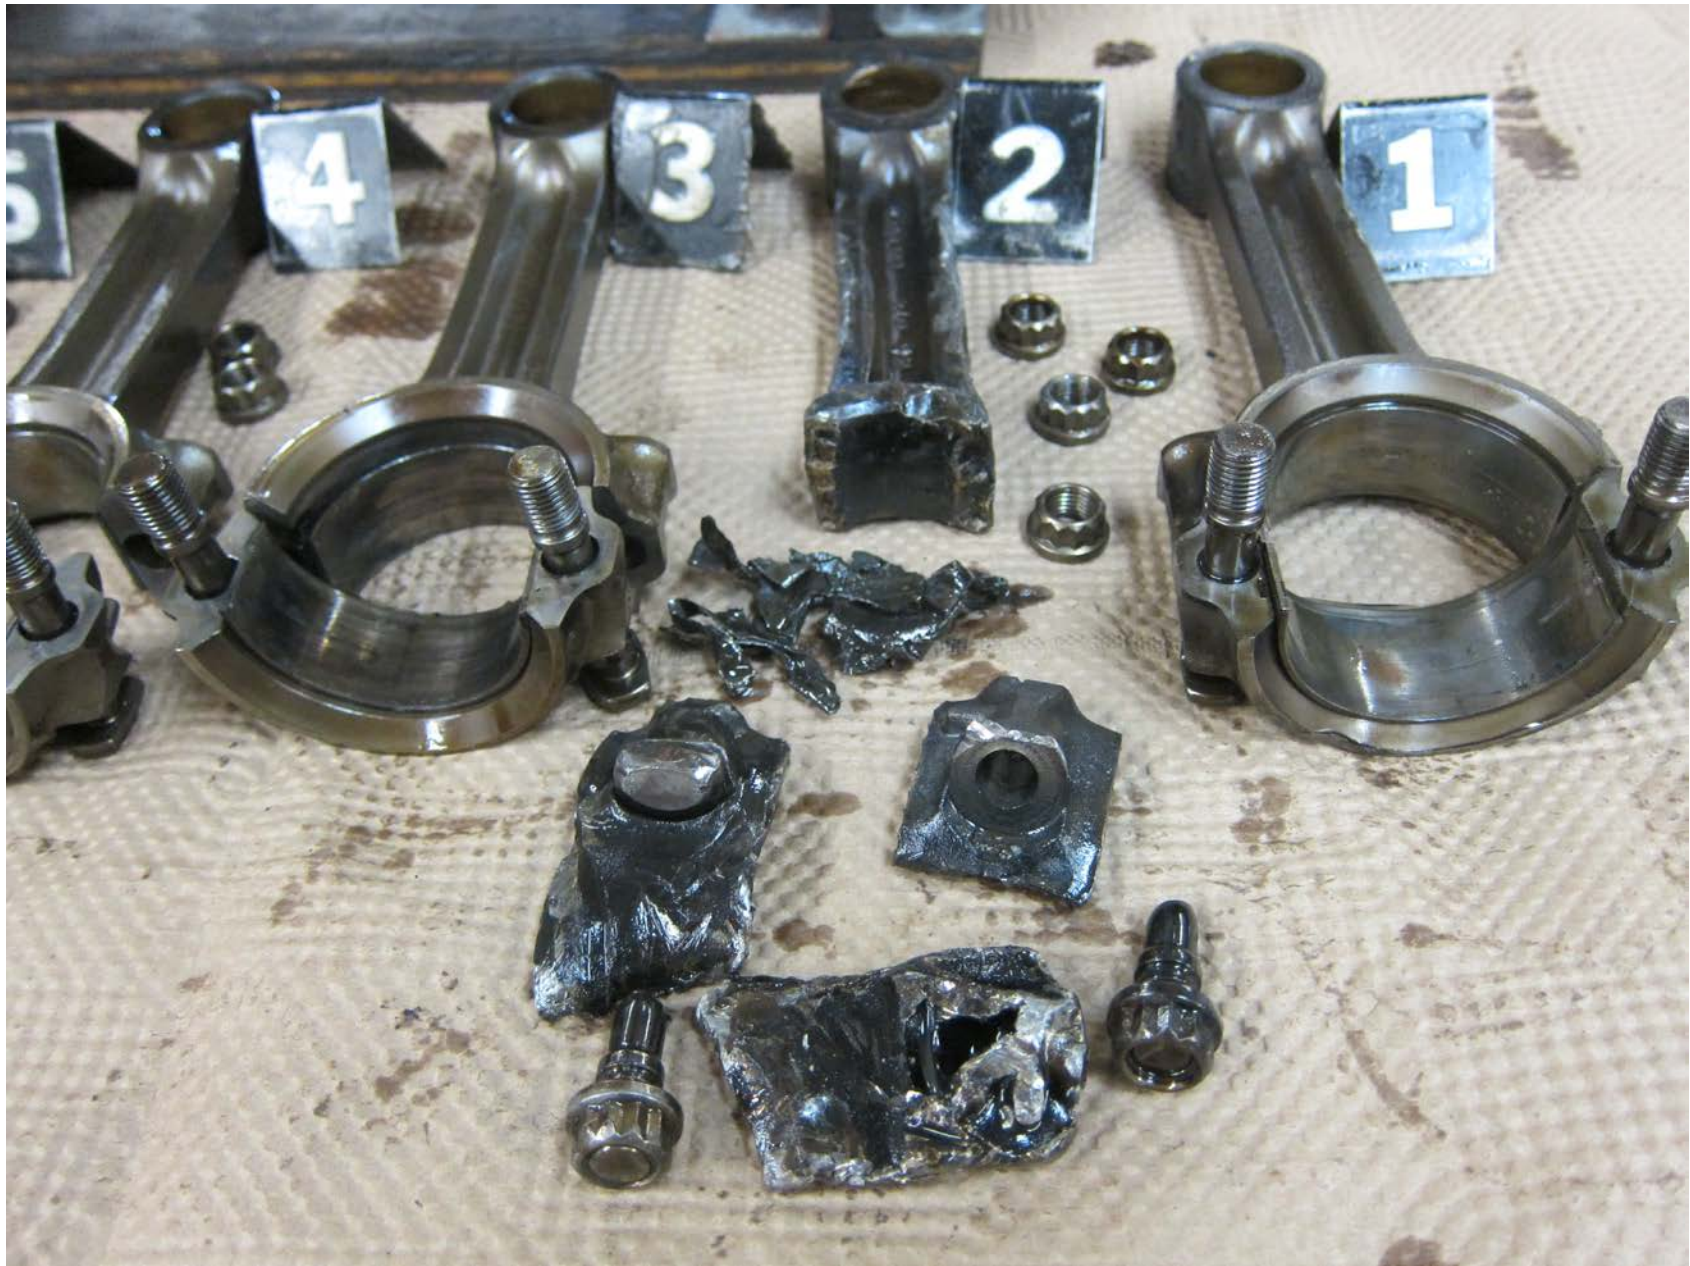
**Photo 4 – View of damage to the No. 2 piston connecting rod (CM Photo)**

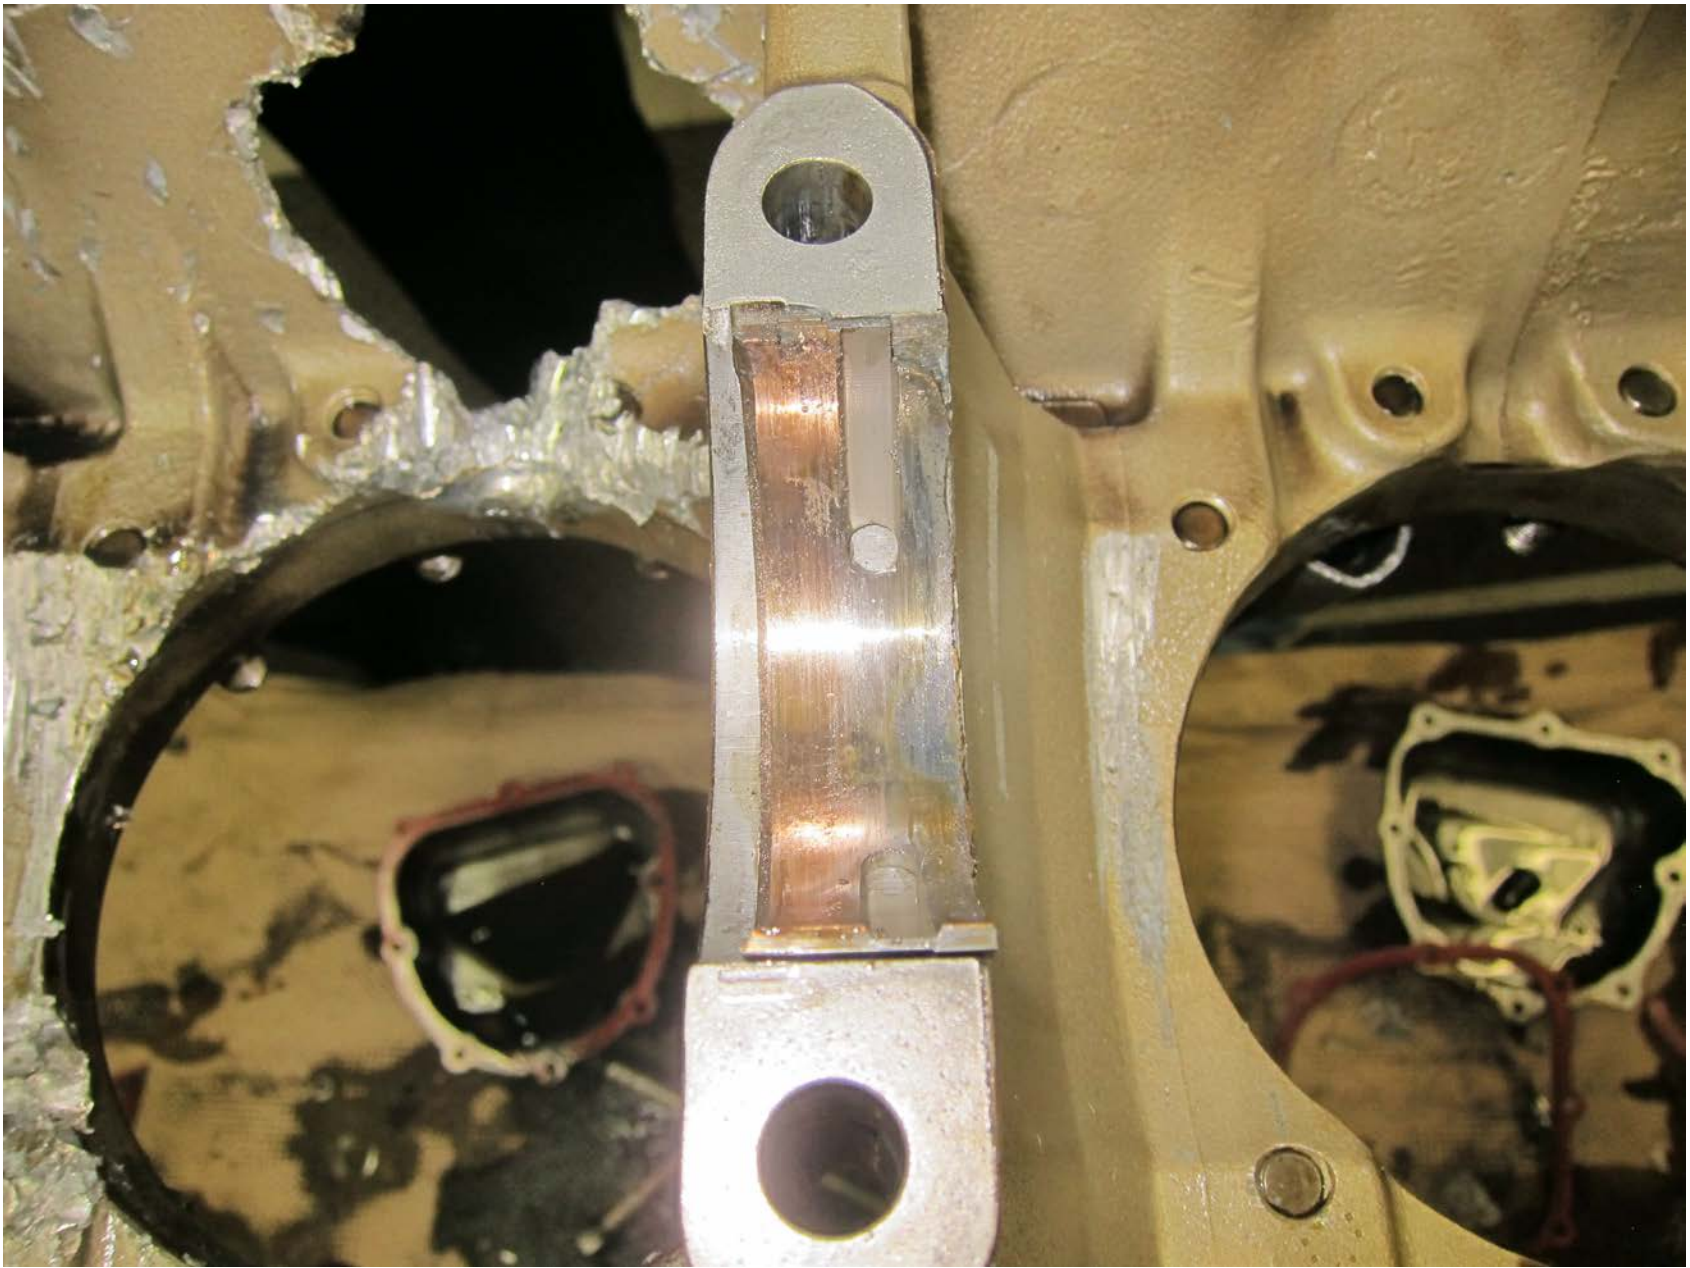
**Photo 5 – View of No. 2 main bearing (CM Photo)**

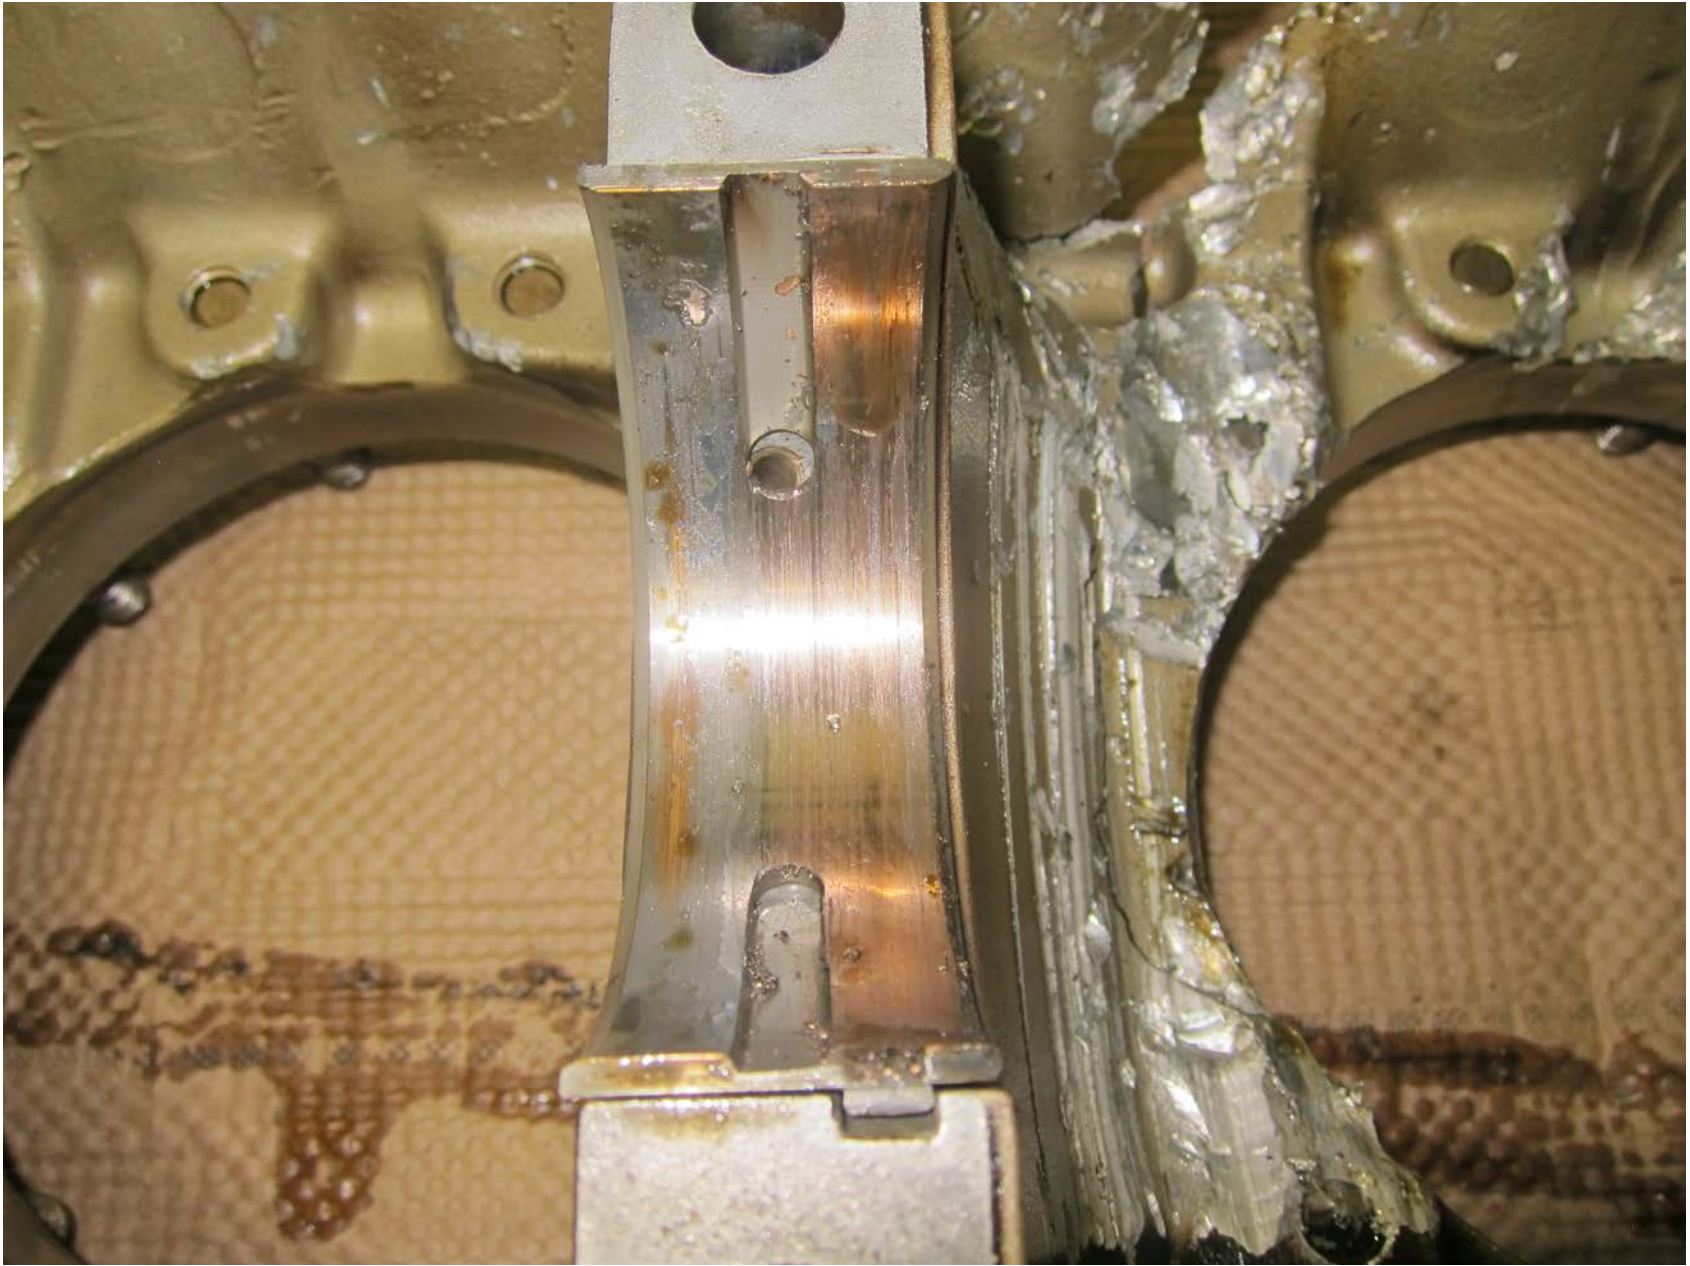
**Photo 6 – View of No. 2 main bearing (CM Photo)**

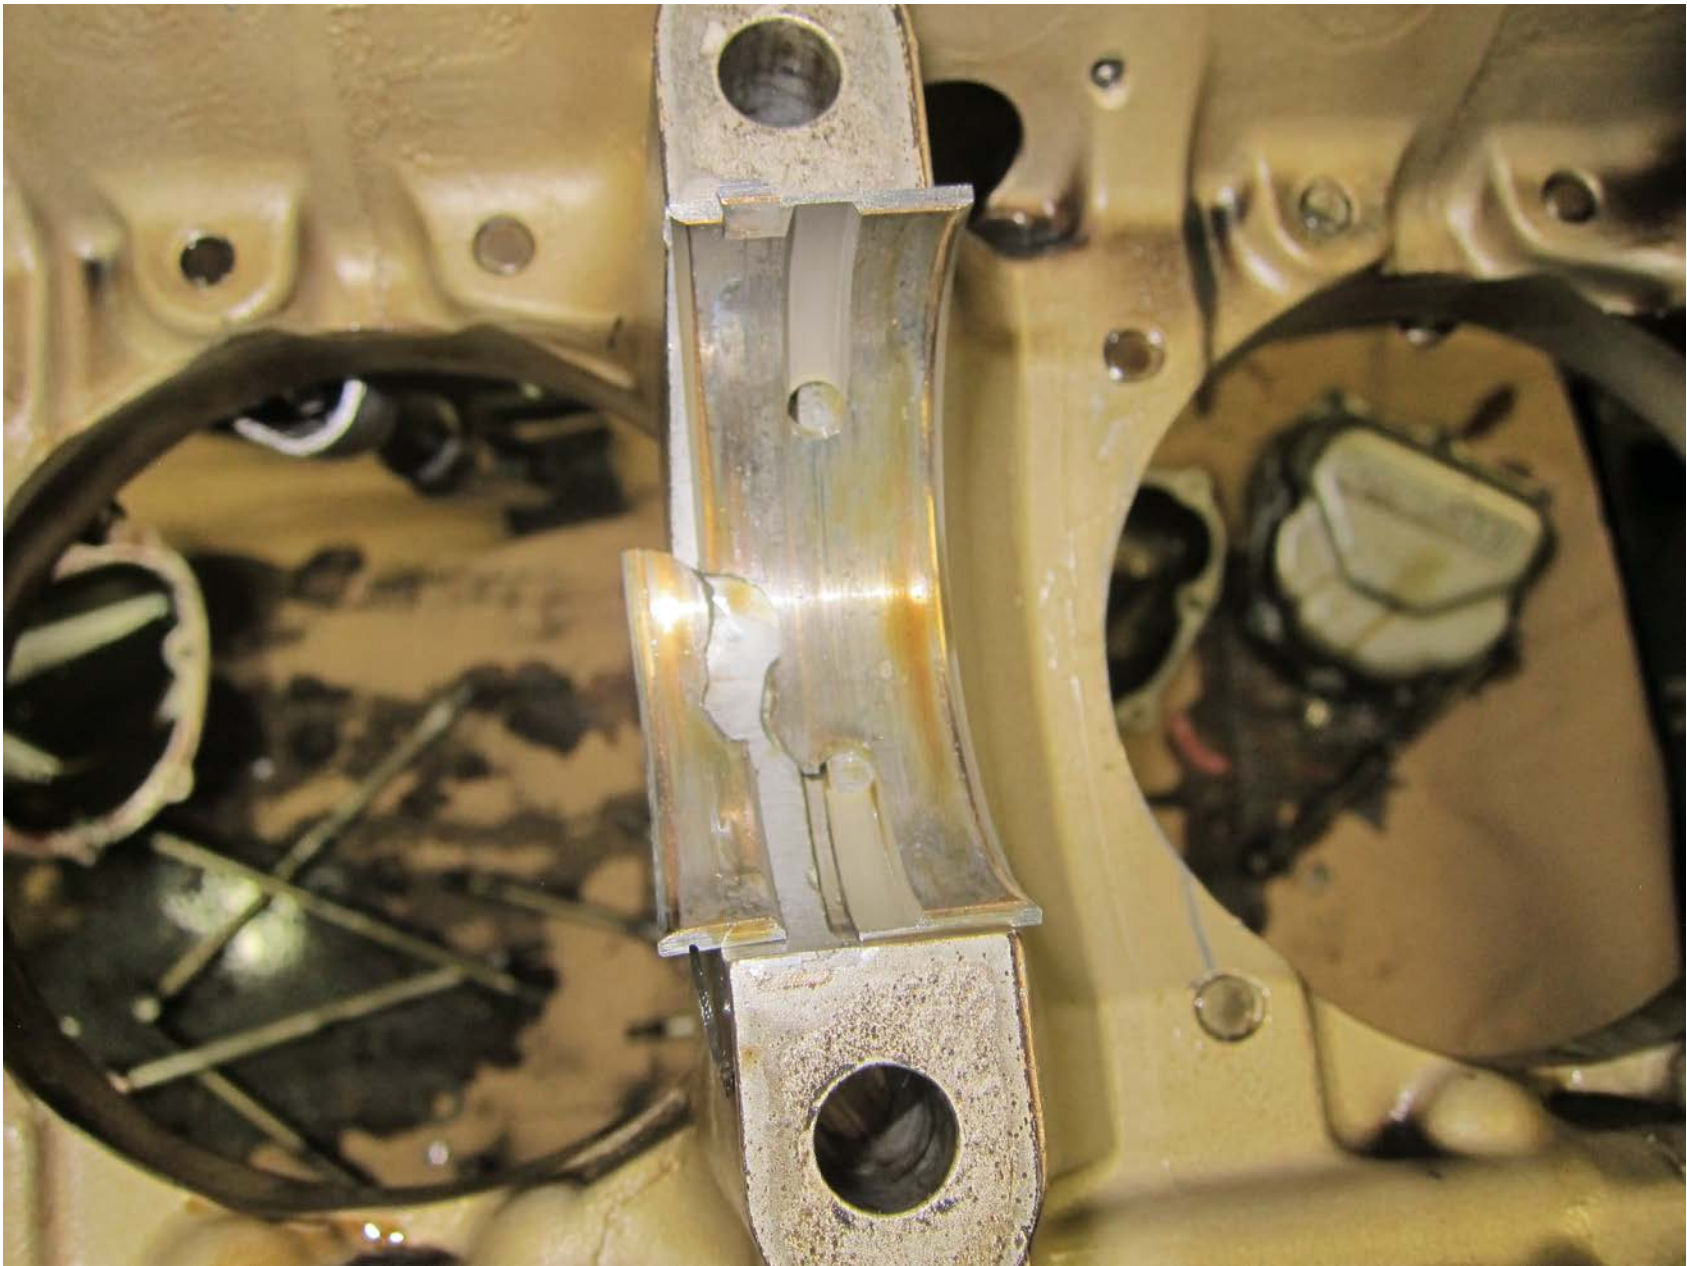
**Photo 7 – View of No. 3 main bearing (CM Photo)**

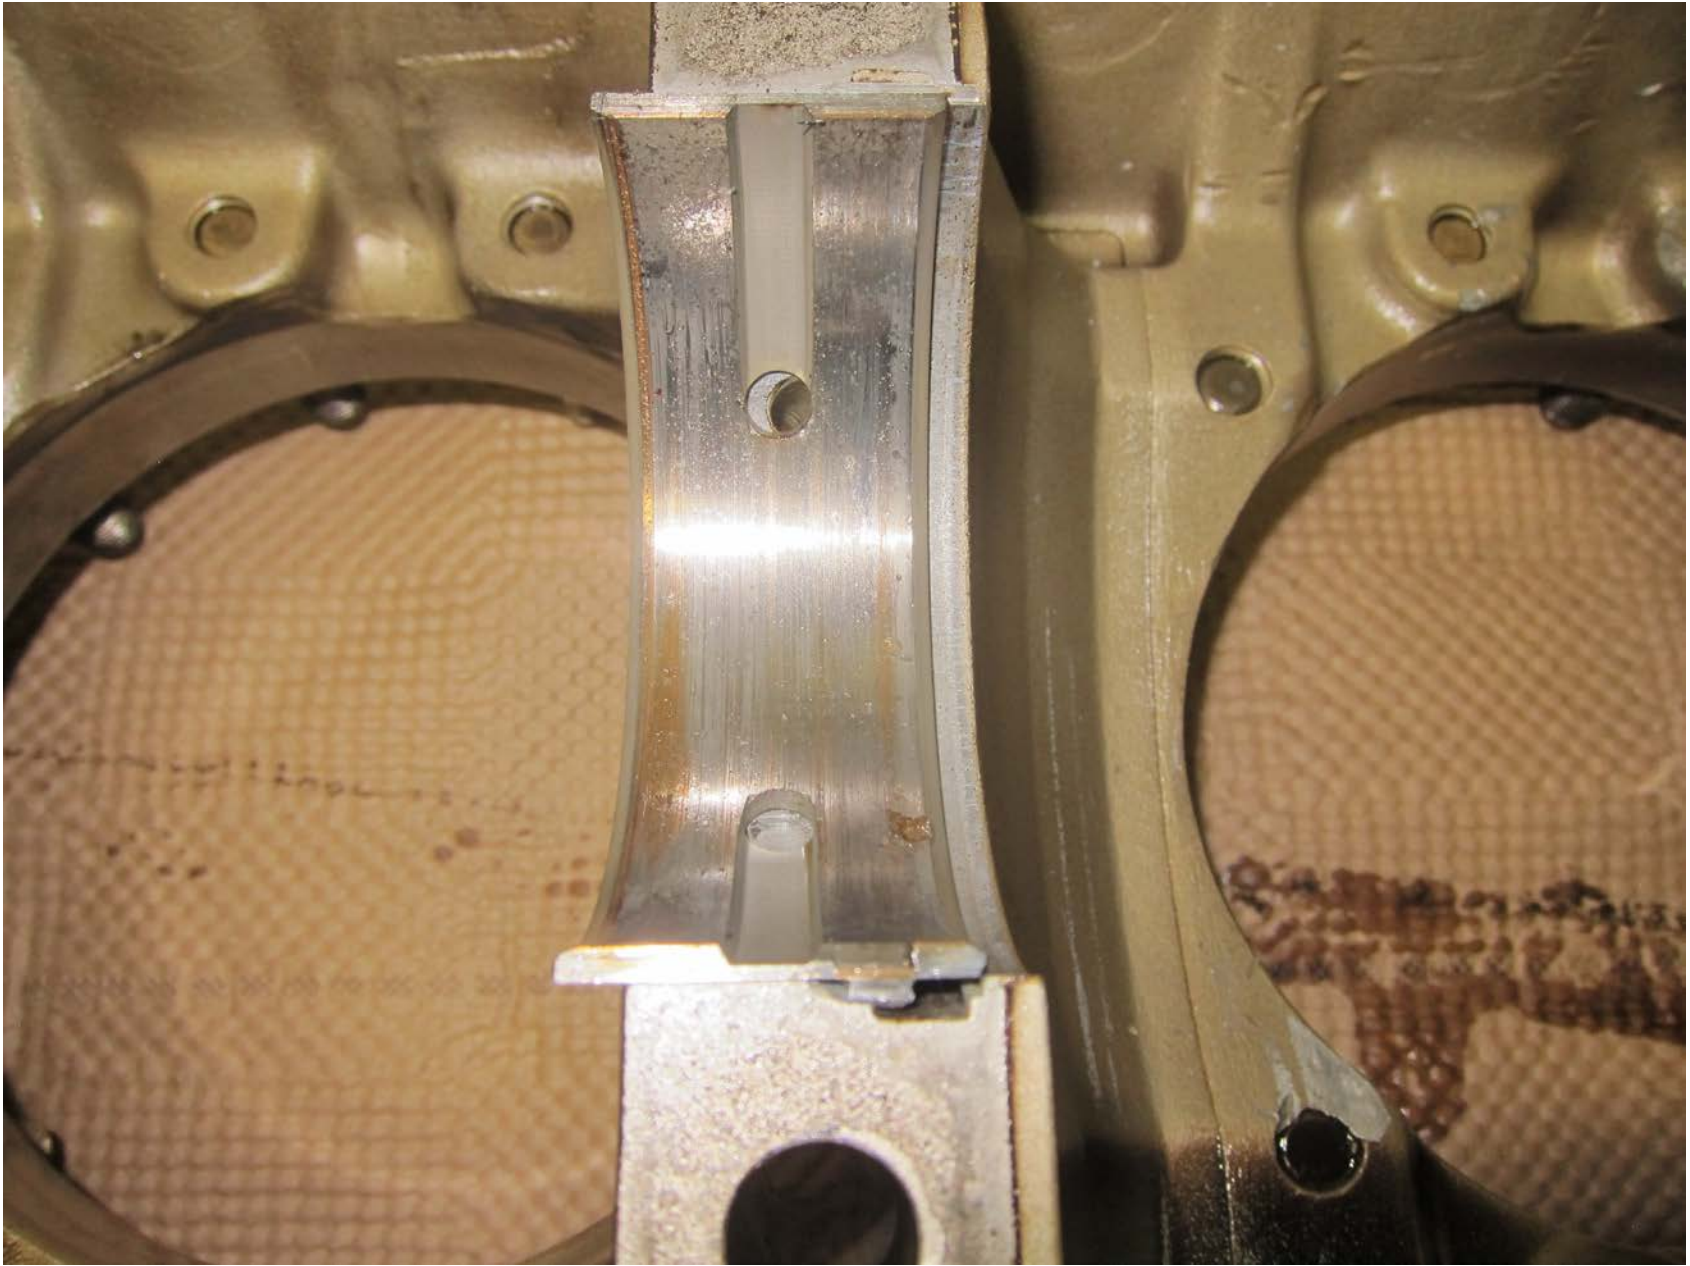
**Photo 8 – View of No. 3 main bearing (CM Photo)**

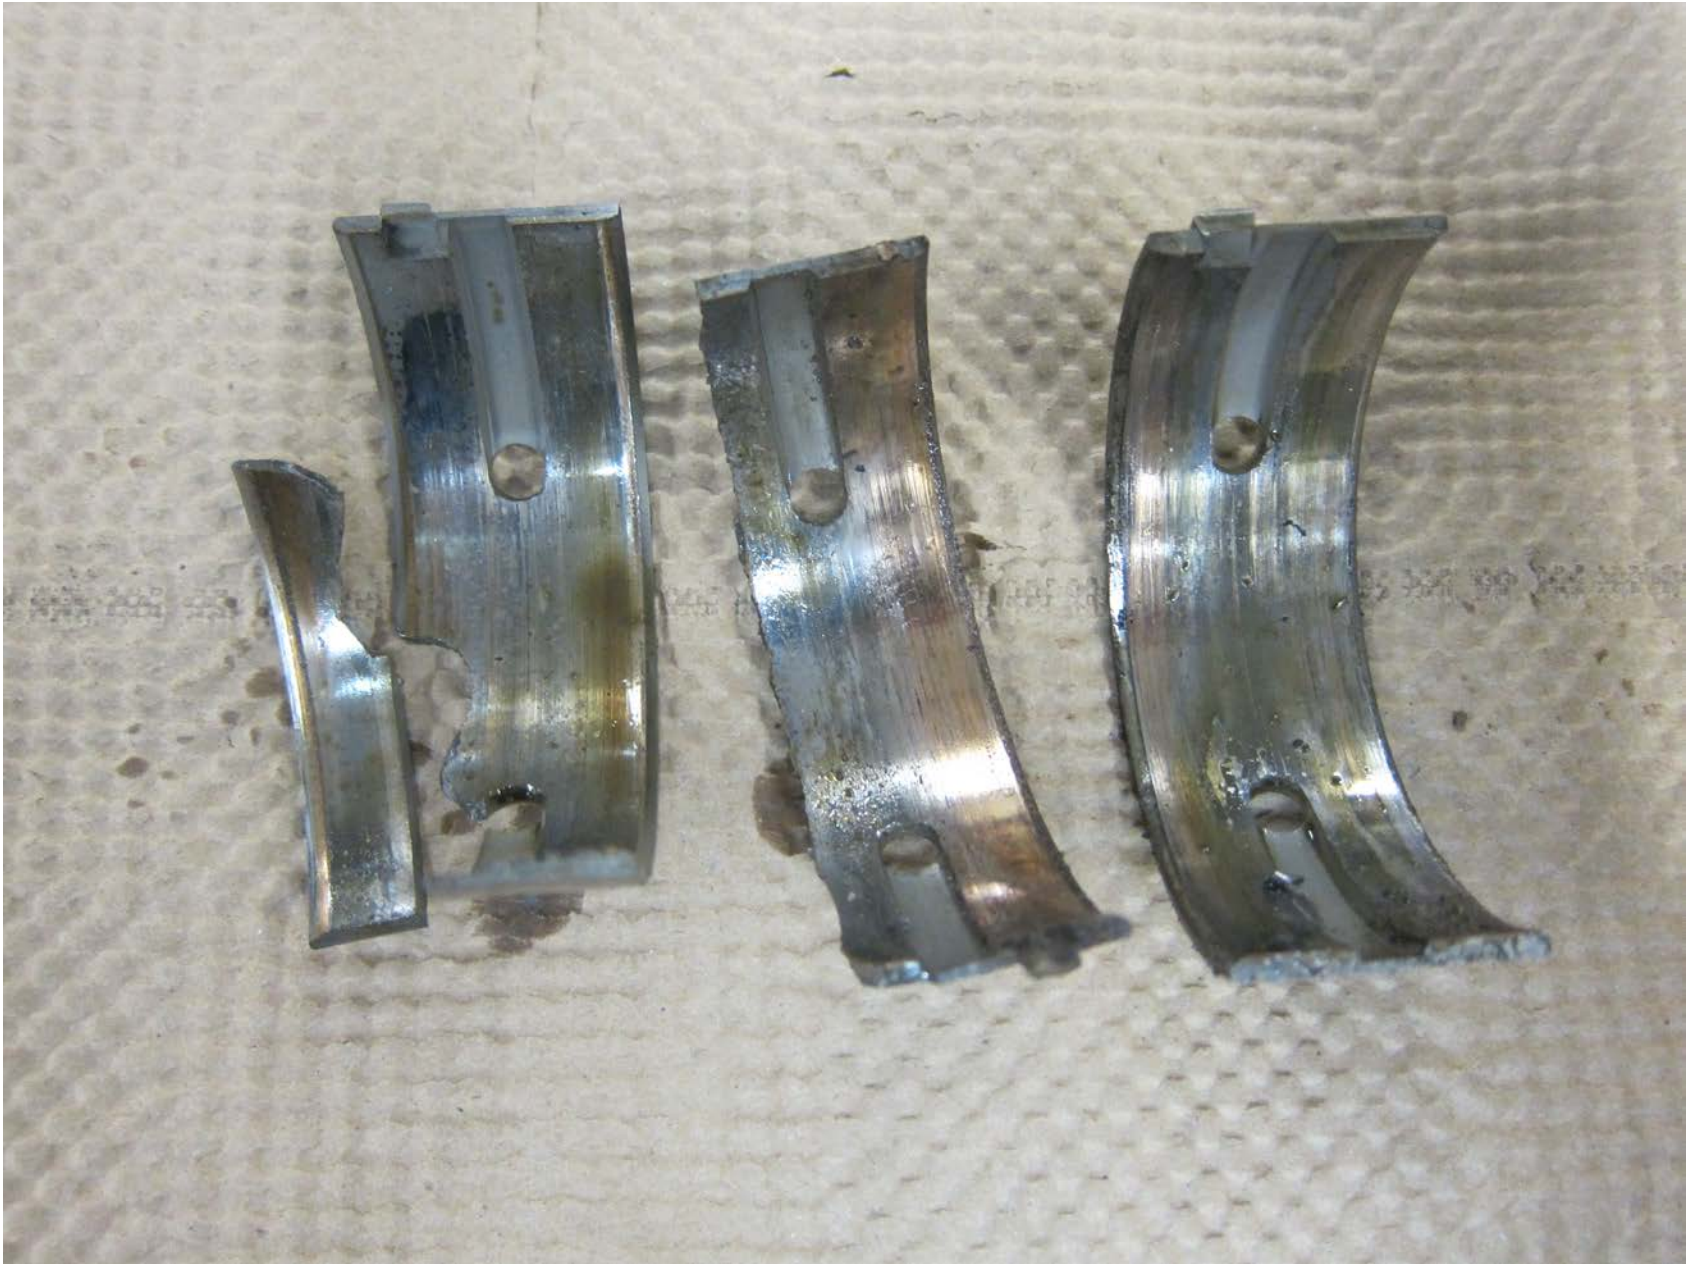
**Photo 9 – View of No. 2 and No. 3 main bearings (CM Photo)**

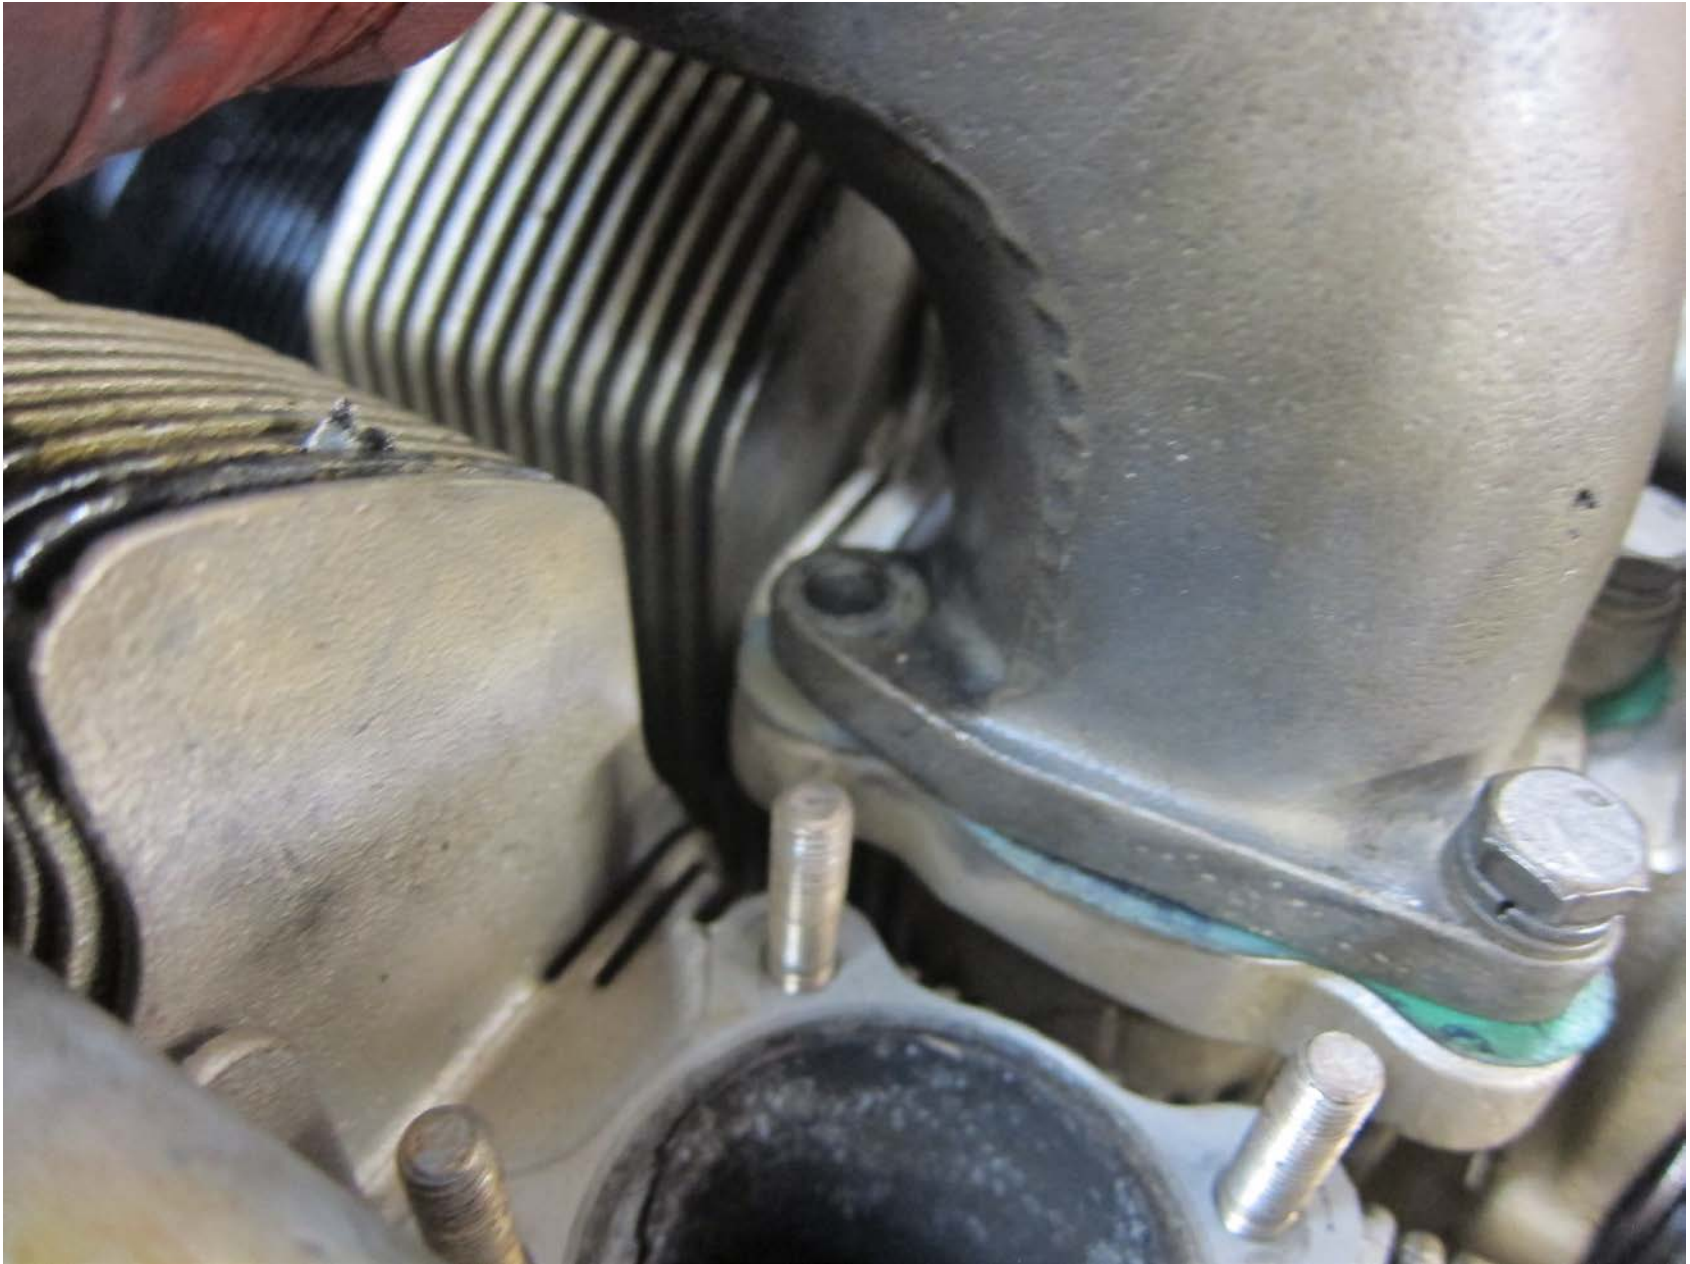
**Photo 10 – View of one of the missing induction riser bolts (CM Photo)**
