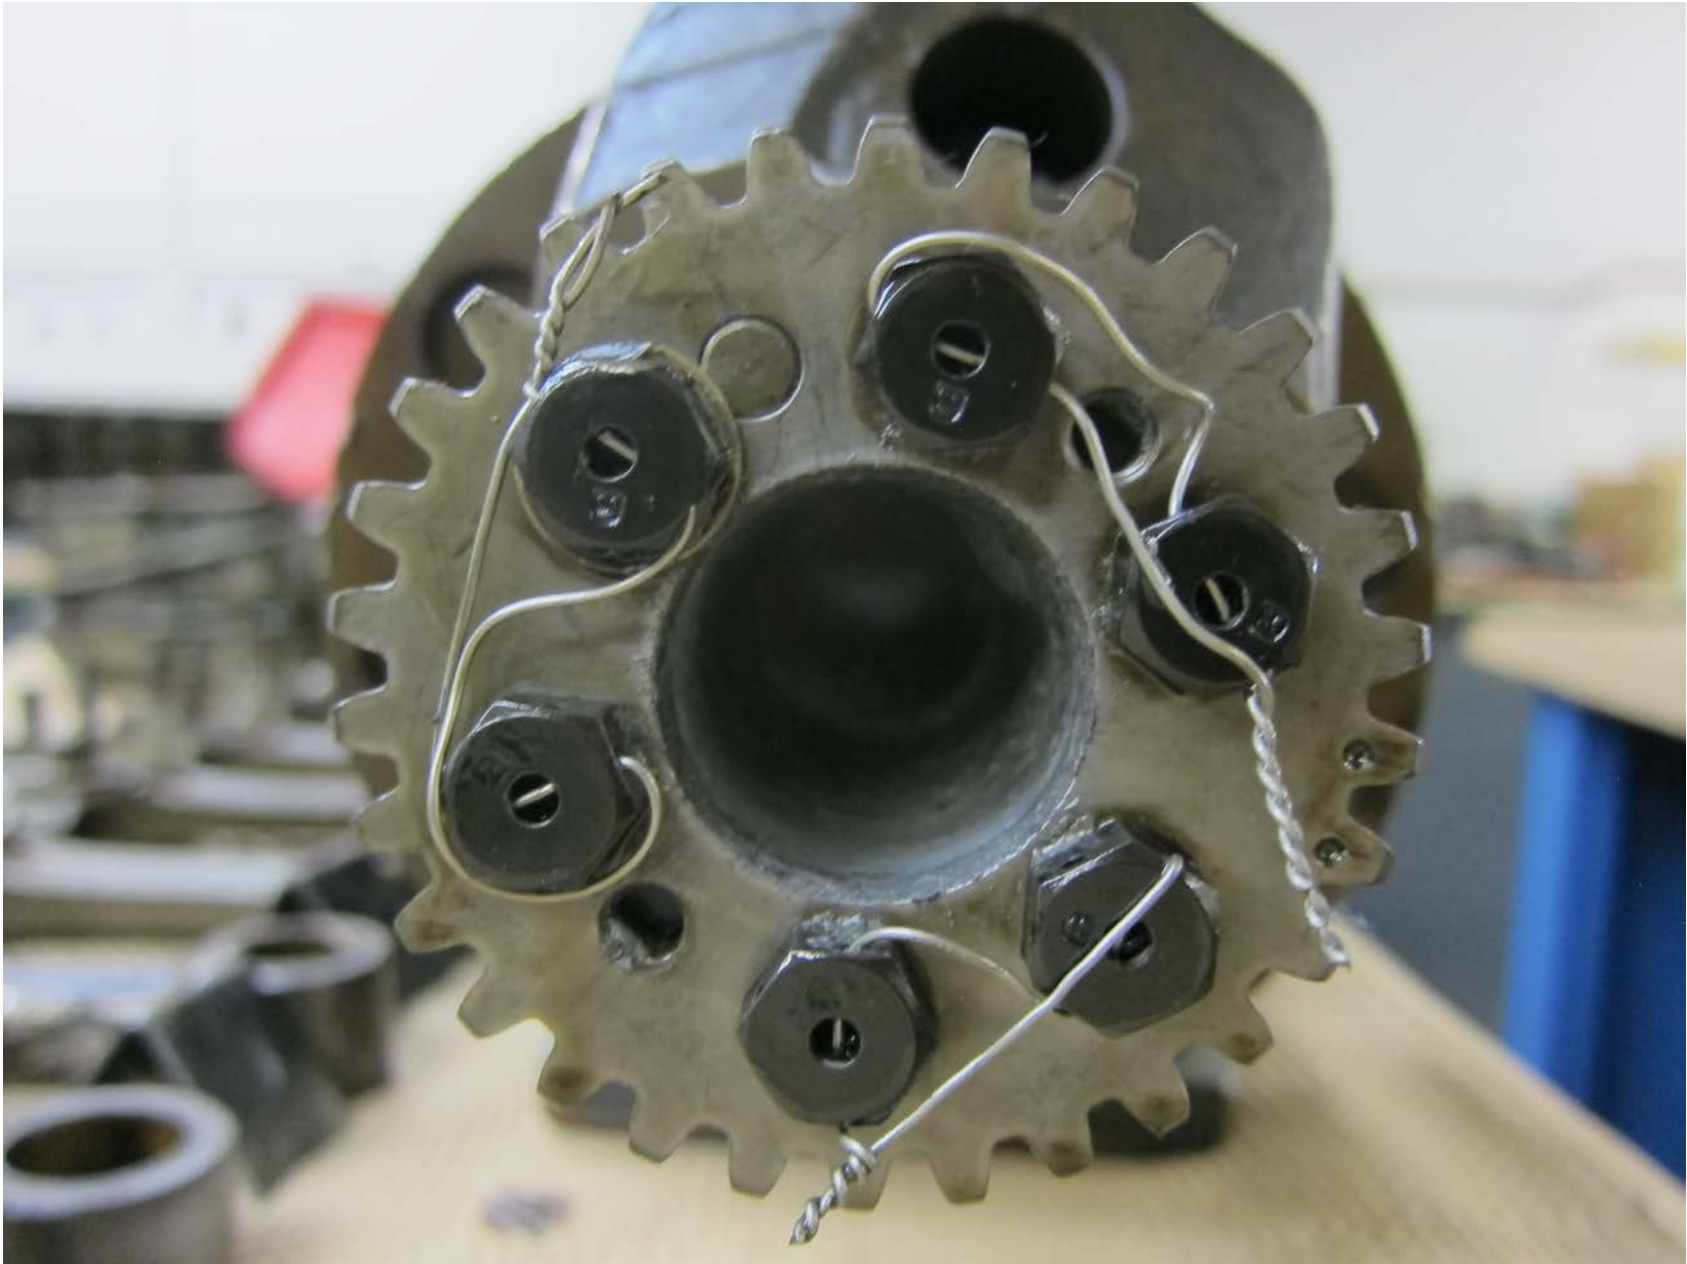
**Photo 11 – View of the crankshaft gear and the safety wire (CM Photo)**
