# **NATIONAL TRANSPORTATION SAFETY BOARD**

## **MATERIALS LABORATORY FACTUAL REPORT**

Report No. 18-025

Place : Port Mansfield, TX  
Date : 10/19/17  
Vehicle : Piper PA-32RT-300T, N663CB  
NTSB No. : CEN18LA017  
Investigator : Mitchell Gallo

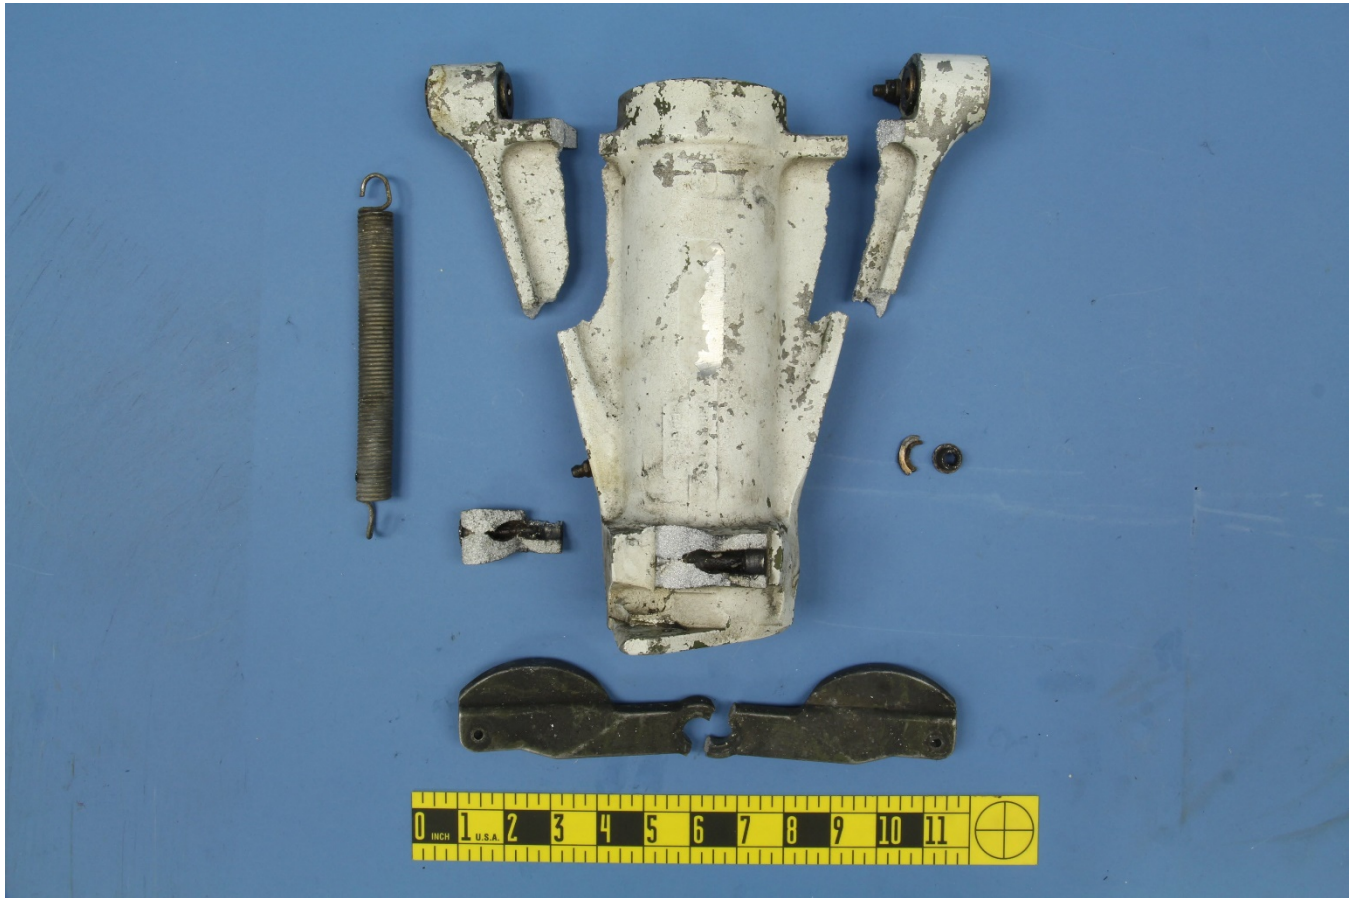
Portions of nose landing gear (figure 1).

Figure 1: Portions of nose landing gear as received.

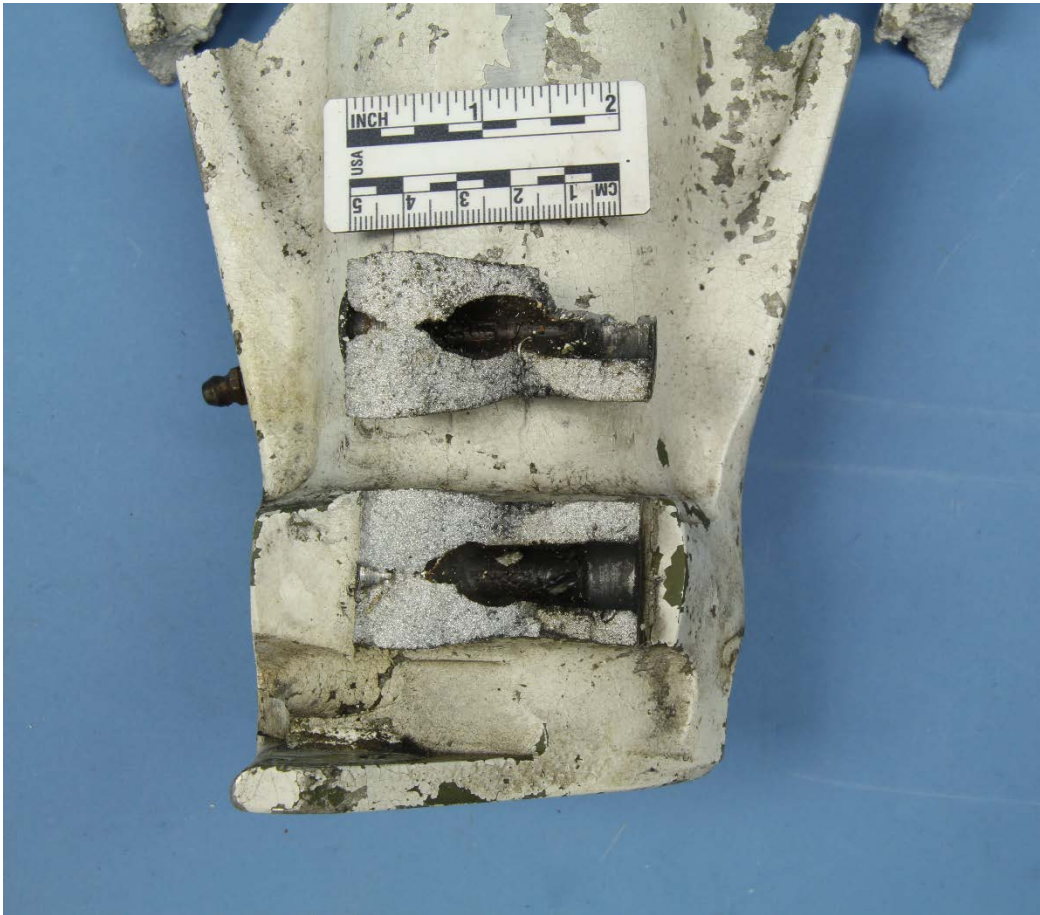
Figure 2: Both halves of bolt hole fracture on trunnion casting.

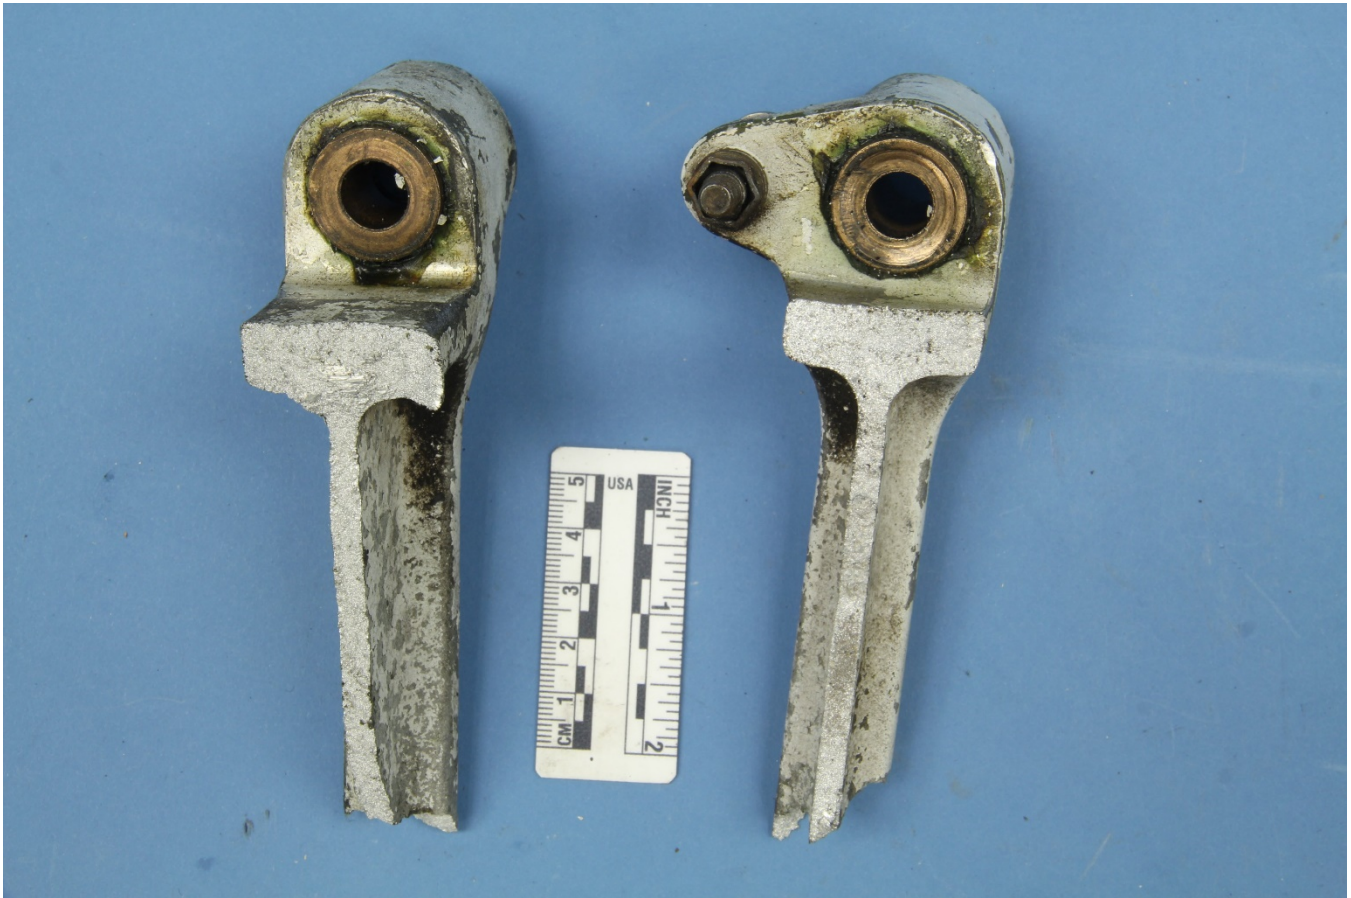
The primary portion of the nose landing gear components submitted for examination consisted of a trunnion exhibiting multiple fractures (figure 1). Examination of the fracture surfaces on the trunnion casting (figures 3, 4) revealed fractures consistent with overstress. No evidence of preexisting cracks was observed on any of the fracture surfaces.

Figure 3: Fractures pivot arms of trunnion casting.
