**Air Tractor, Inc.**  
Accident Investigation

**AIRFRAME EXAMINATION REPORT**

**CEN18LA019**

**10/24/17**  
**Olton, TX**

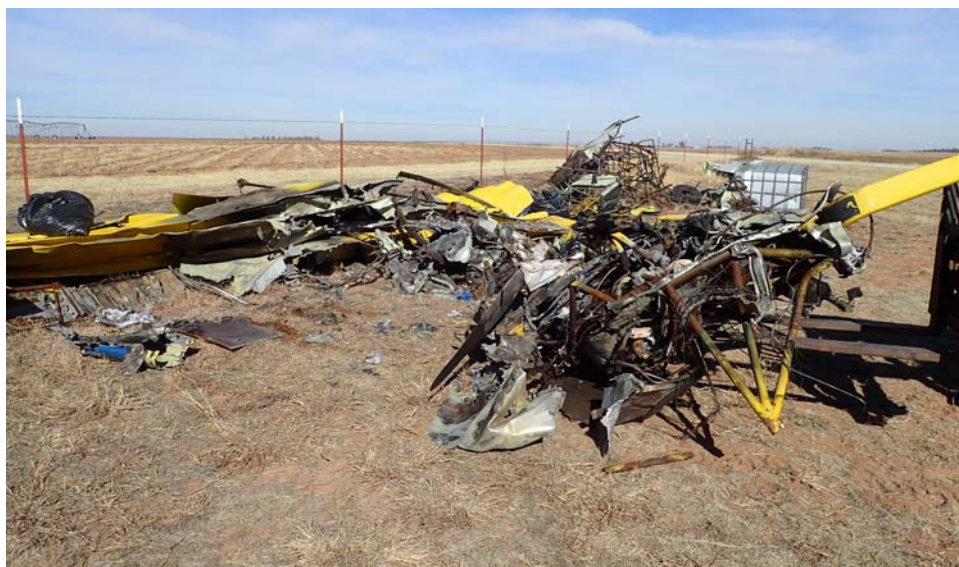
The wreckage was segregated from other aircraft wreckage at the north side of the George's Aircraft facility in an open area. The wreckage had been stored outside since its recovery and was therefore weathered as expected. Much of the aircraft, primarily the fuselage and inboard wings were heavily damaged by post-crash fire. The forward portion of the fuselage, including the engine compartment, was crushed by impact forces.

**General Condition of the Wreckage during Examination**

The leading edges of both wings were crushed aft from the leading edge to the main spar. The outboard portions of both wings exhibited chordwise crushing and buckling. There were multiple containers and plastic bags of small debris located with the wreckage.

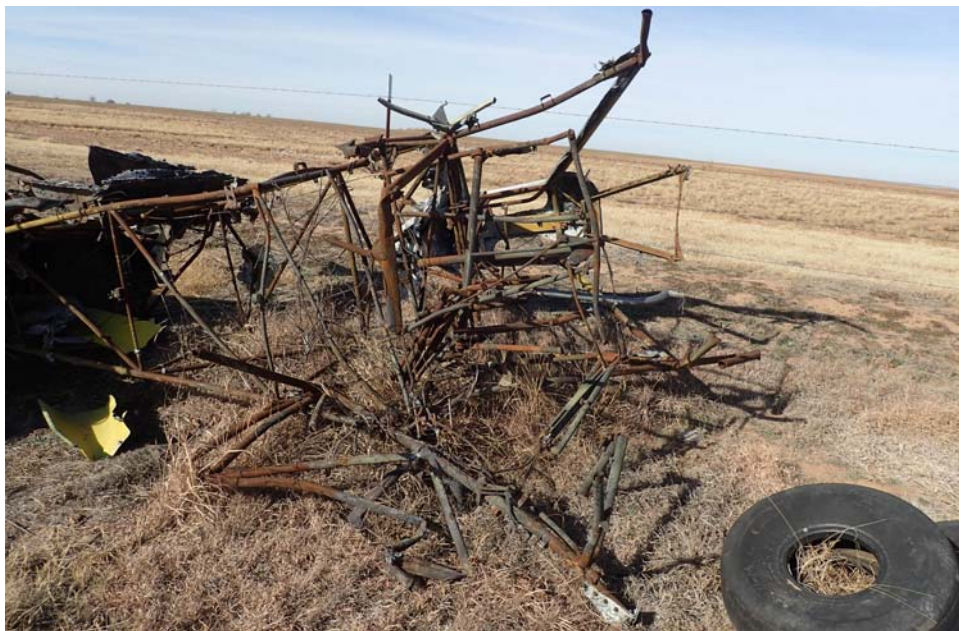
The firewall forward portion of the fuselage was found separated from the remainder of the fuselage and exhibited substantial fore-aft crush damage. The remainder of the fuselage was found with heavy impact and fire damage from the cockpit to the aft fuselage. The cockpit windshield frame remained in place and did not exhibit any obvious impact damage. The windshield glass was not in place in the frame.

The cockpit seat frame was found intact and connected to the fuselage seat rails. All mounting points of the 4-point pilot harness were found installed. The aircraft was not equipped with the AmSafe Inflatable Restraint airbag system. The harness webbing had been destroyed by fire. The seat belt buckle assemblies and adjusters were found in the wreckage and were not found buckled together.

**Fuselage Wreckage with Aileron Controls**

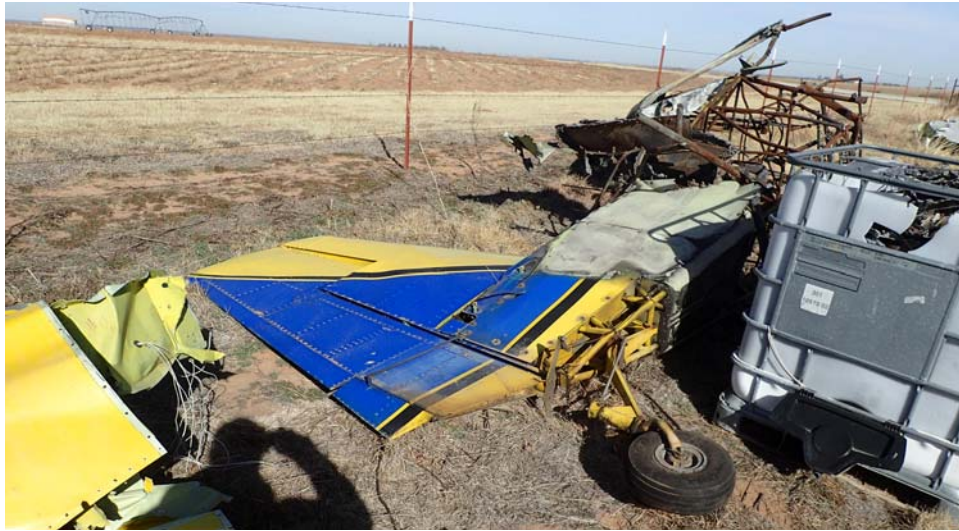
**Fuselage Wreckage viewed from Rear with Vertical Fin and Rudder**

The empennage and control surfaces were intact and removed from the fuselage wreckage during recovery. According to the FAA Investigator who had visited the accident scene, the empennage and control surfaces had been in place prior to recovery. Both elevators remained attached to the stabilizers and the trim tabs remained in place on the elevators.

The vertical fin and rudder exhibited no obvious damage.

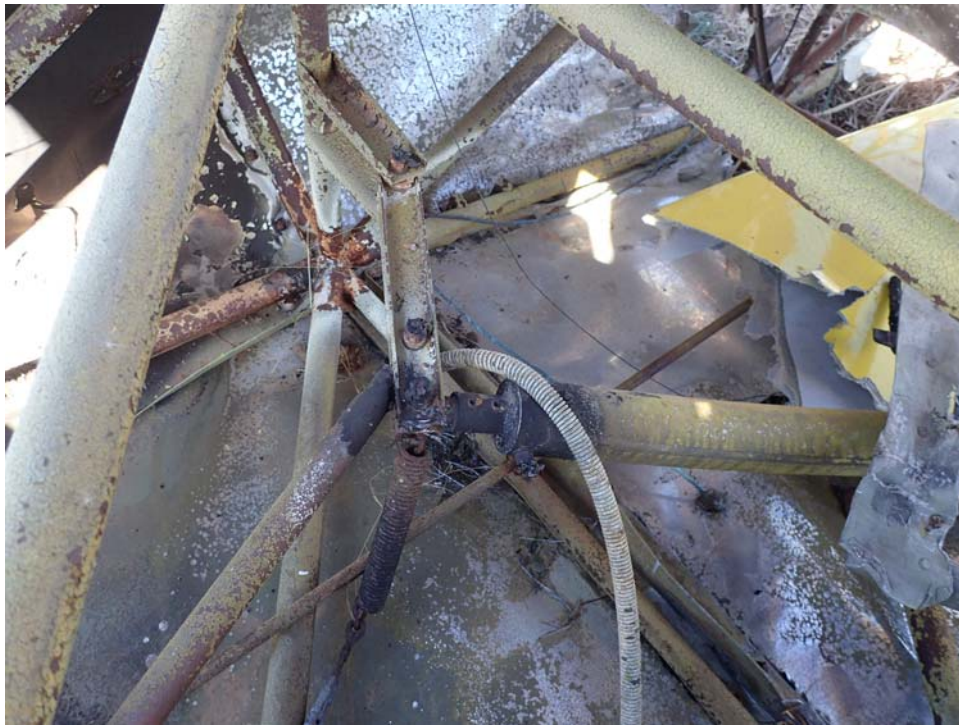
The elevators are controlled by a system of pushrods and idlers. The controls were found to be continuous from the control stick to the elevator horn connection except for heat/fire damage to the aluminum components in the system. All control rod hardware was found to be in place.

**Elevator Controls at Rear Idler**

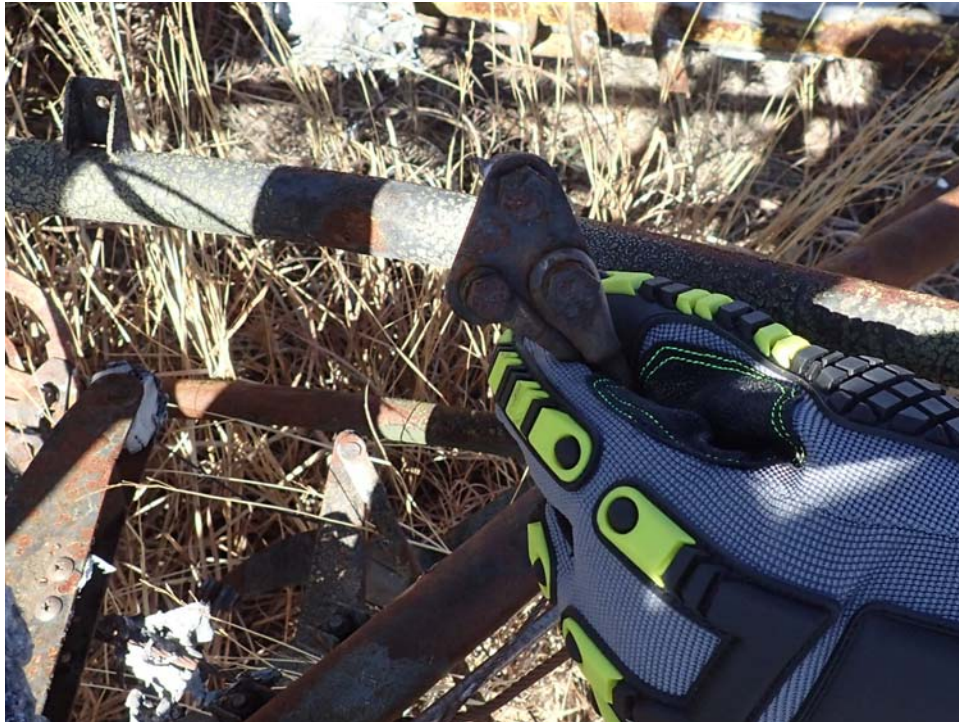
The rudder controls are cable operated and were found to be continuous and free. The rudder cables were attached at the aft end to the rudder control horn and routed through the fuselage to the cockpit. The forward ends of the cables were attached to their anchor points on the pedal adjustment channels. The aluminum adjustment channels and the aluminum rudder pedal castings had been destroyed by heat/fire. The rudder pedal hangers and their attachment to the fuselage frame were found to be intact.

**Example of Rudder Cable Attachment at Forward End**

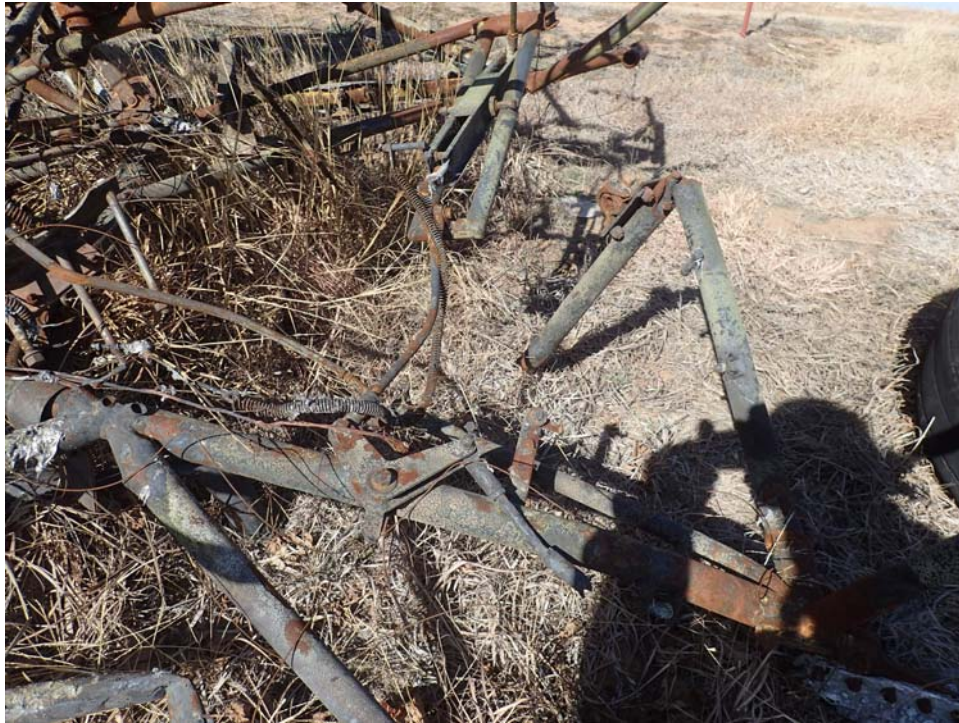
The ailerons are equipped with a drooping mechanism that droops (i.e "lowers") both ailerons when the flaps are deployed. The drooping system for the lefthand aileron was intact except that a rodend was fractured where it attached to the flap torque tube. This fracture was consistent with tensile overload and the hardware remained intact and installed.

**Lefthand Aileron Drooping System**

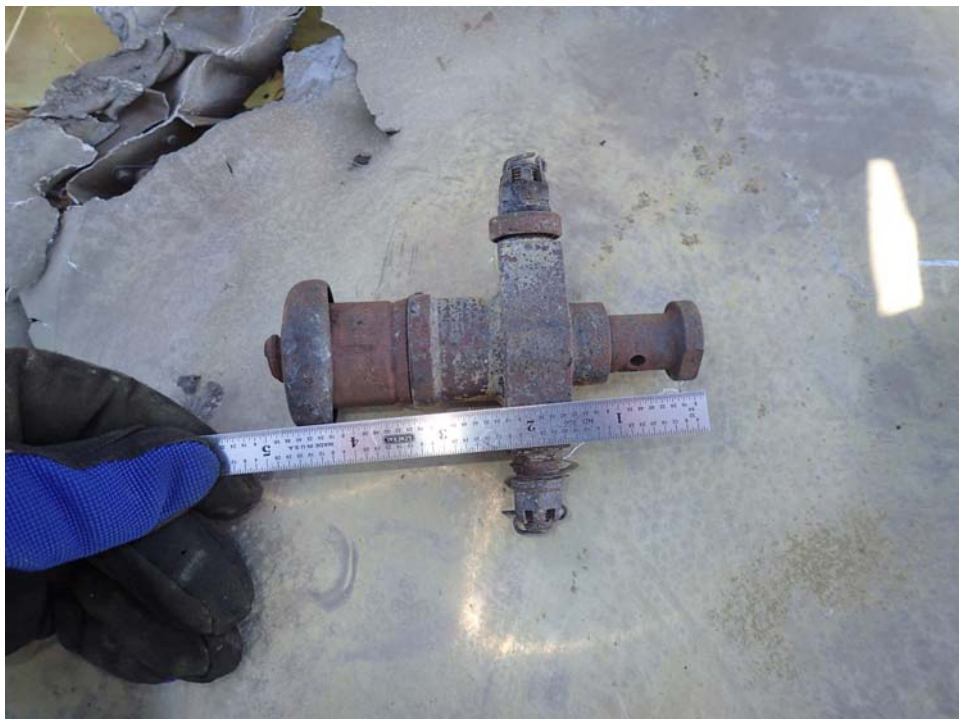
A portion of the flap actuator assembly was found in the wreckage. Measurements were taken of the flap actuator shaft and it was found that the flaps had been extended to a position corresponding to approximately 22 degrees of flap extension at the time of impact. This flap setting is significantly more than the 5 to 8 degrees specified in the AT-502B Airplane Flight Manual (AFM) for agricultural turns.

## Measurement of Flap Actuator Components

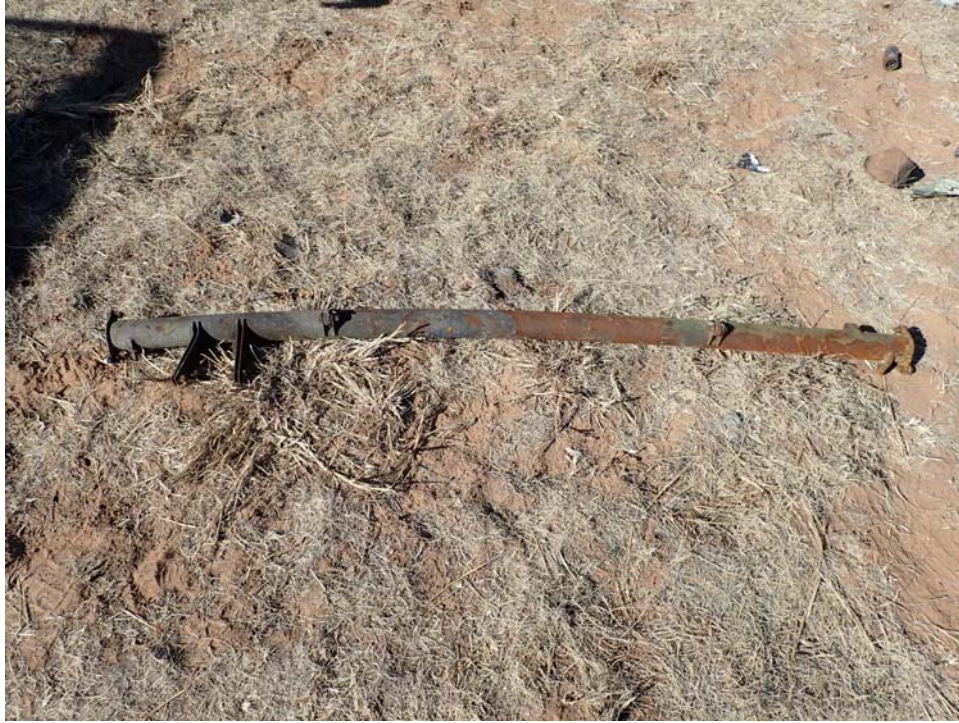
**Flap Torque Tube with Hardware Intact**

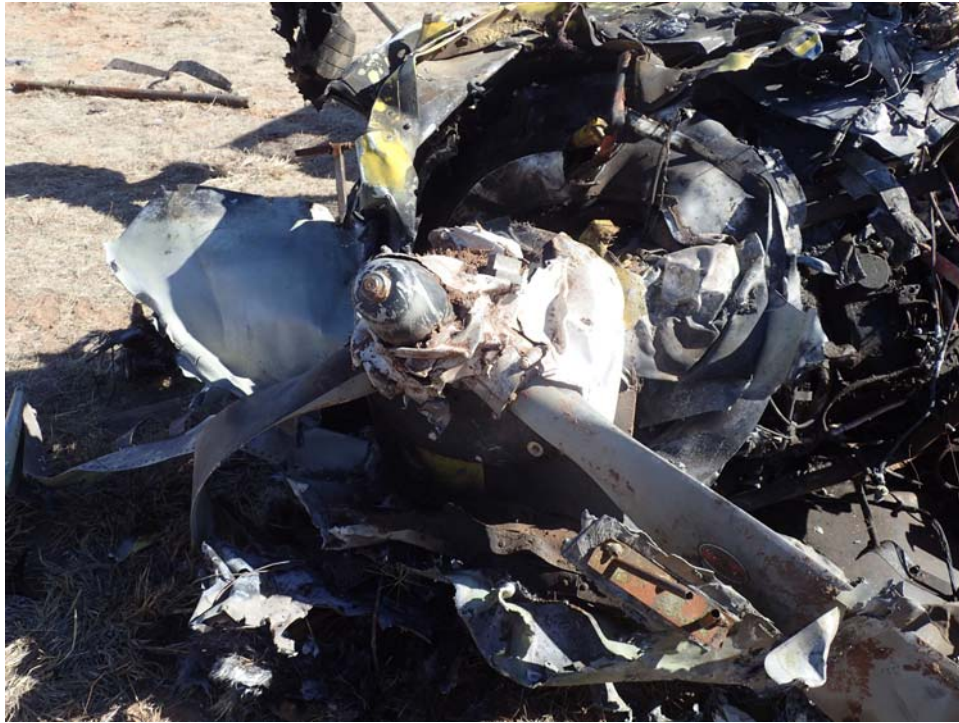
The engine and propeller remained attached to the engine mount and firewall and were found with significant crush and fire damage. The position of the engine did not allow the data plate to be read without significant disassembly, which was not performed. The propeller was found attached to the engine propeller flange and had two (of three) blades attached. The third blade had been dislocated and was found within the wreckage debris. The tip of this third blade had separated.

**Propeller and Engine Wreckage**

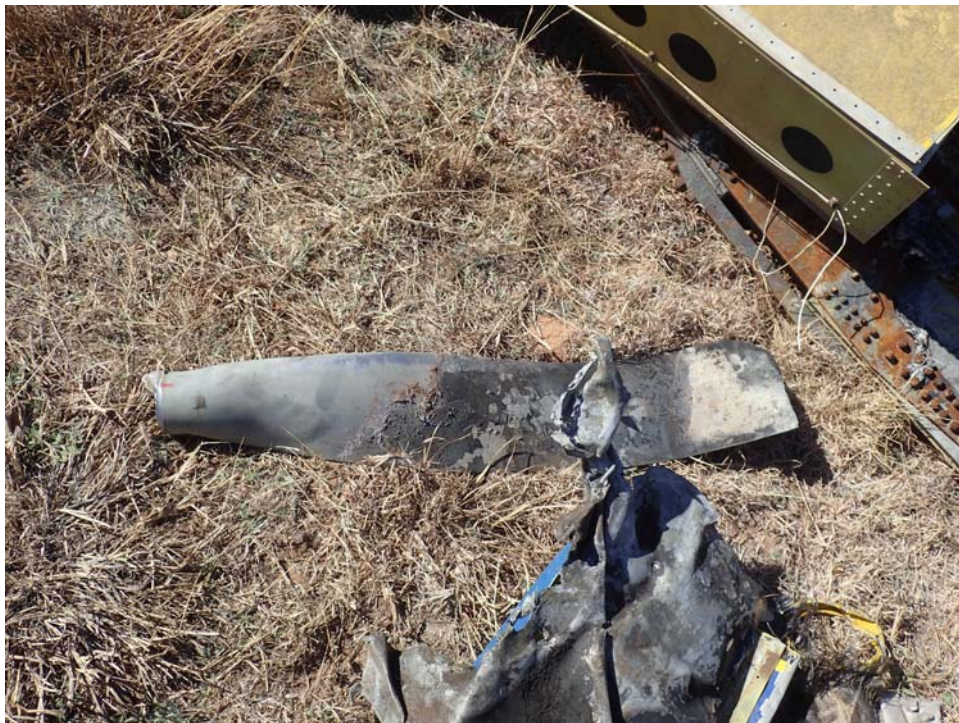
**Separated Propeller Blade**

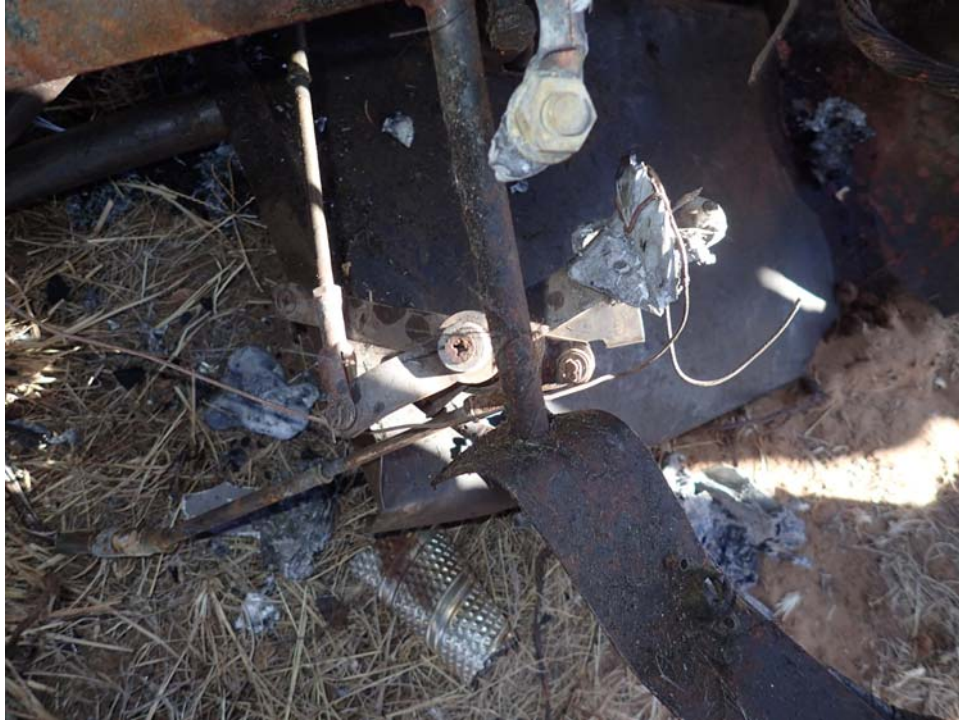
The engine powerplant controls were located and found to be continuous to the extent possible from the wreckage condition. The cockpit power quadrant was found to be heavily fire damaged with all three push-pull cables attached (power, propeller, and fuel condition levers). The length of these cables were traced to the extent possible with no discontinuities noted. The position of the engine controls prior to impact could not be determined.

**Remaining Portion of the Cockpit Engine Controls with Cables Attached**
