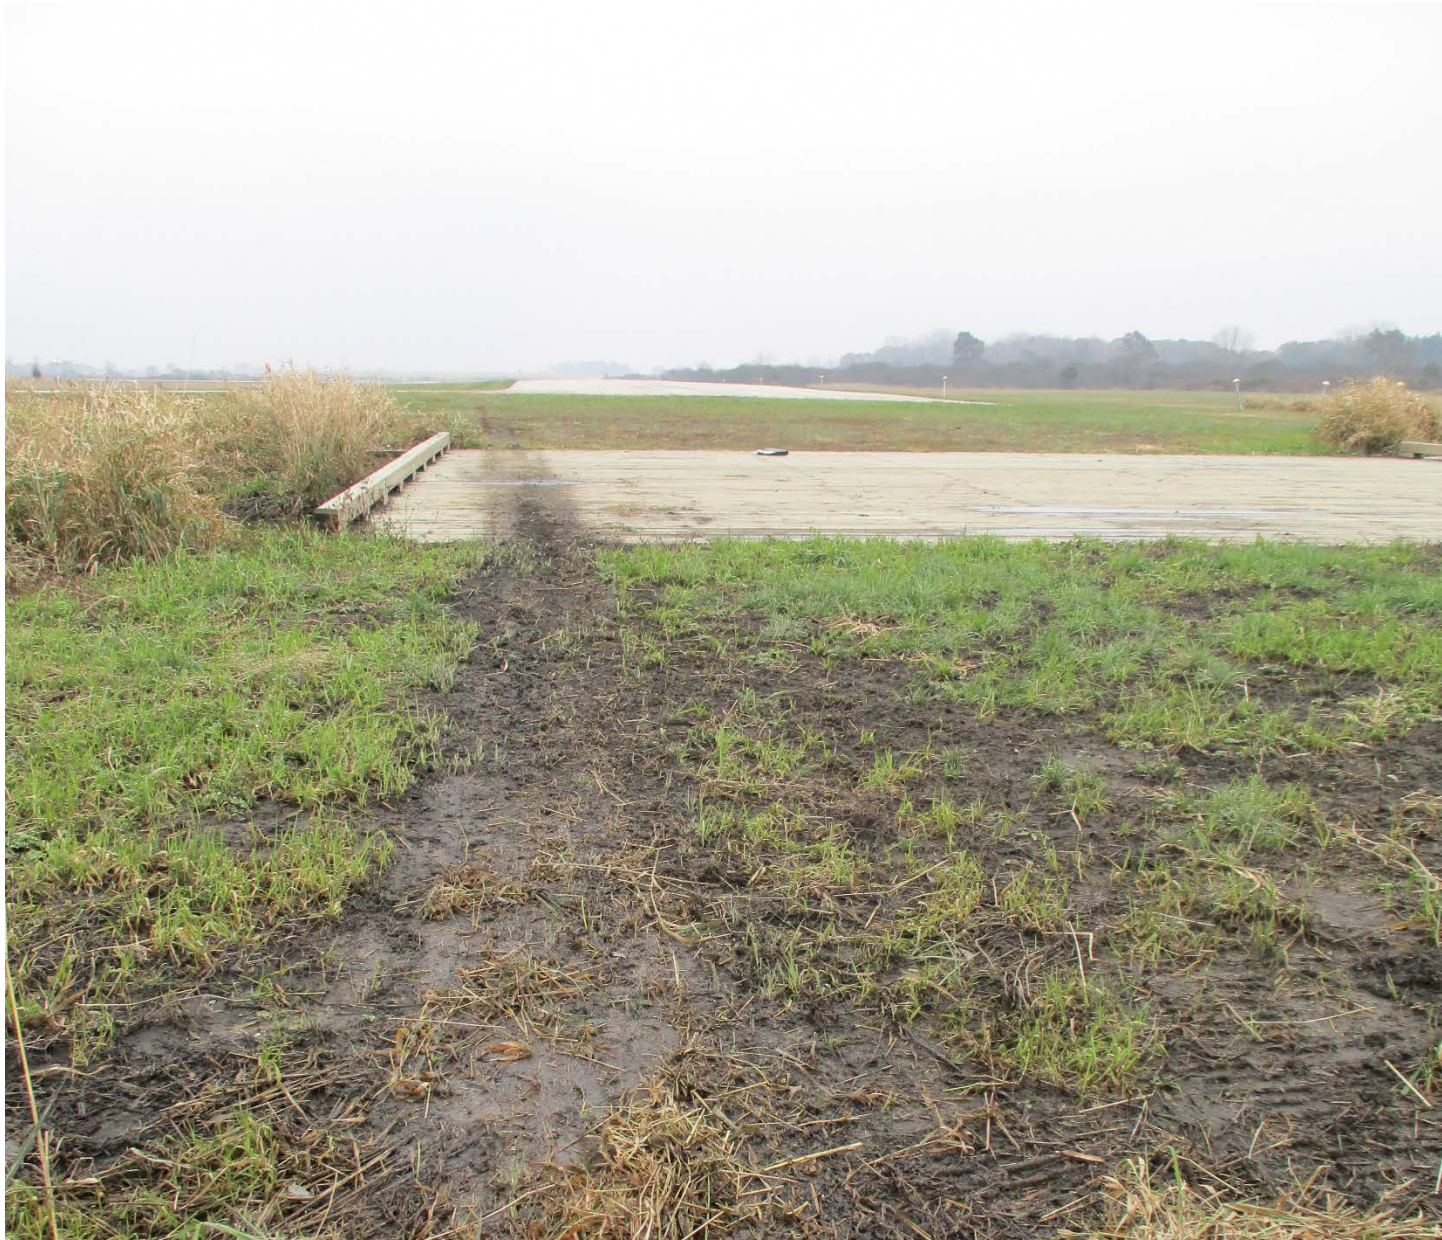
**Photo 1 – Airplane landed gear up in the grass leading to the runway**

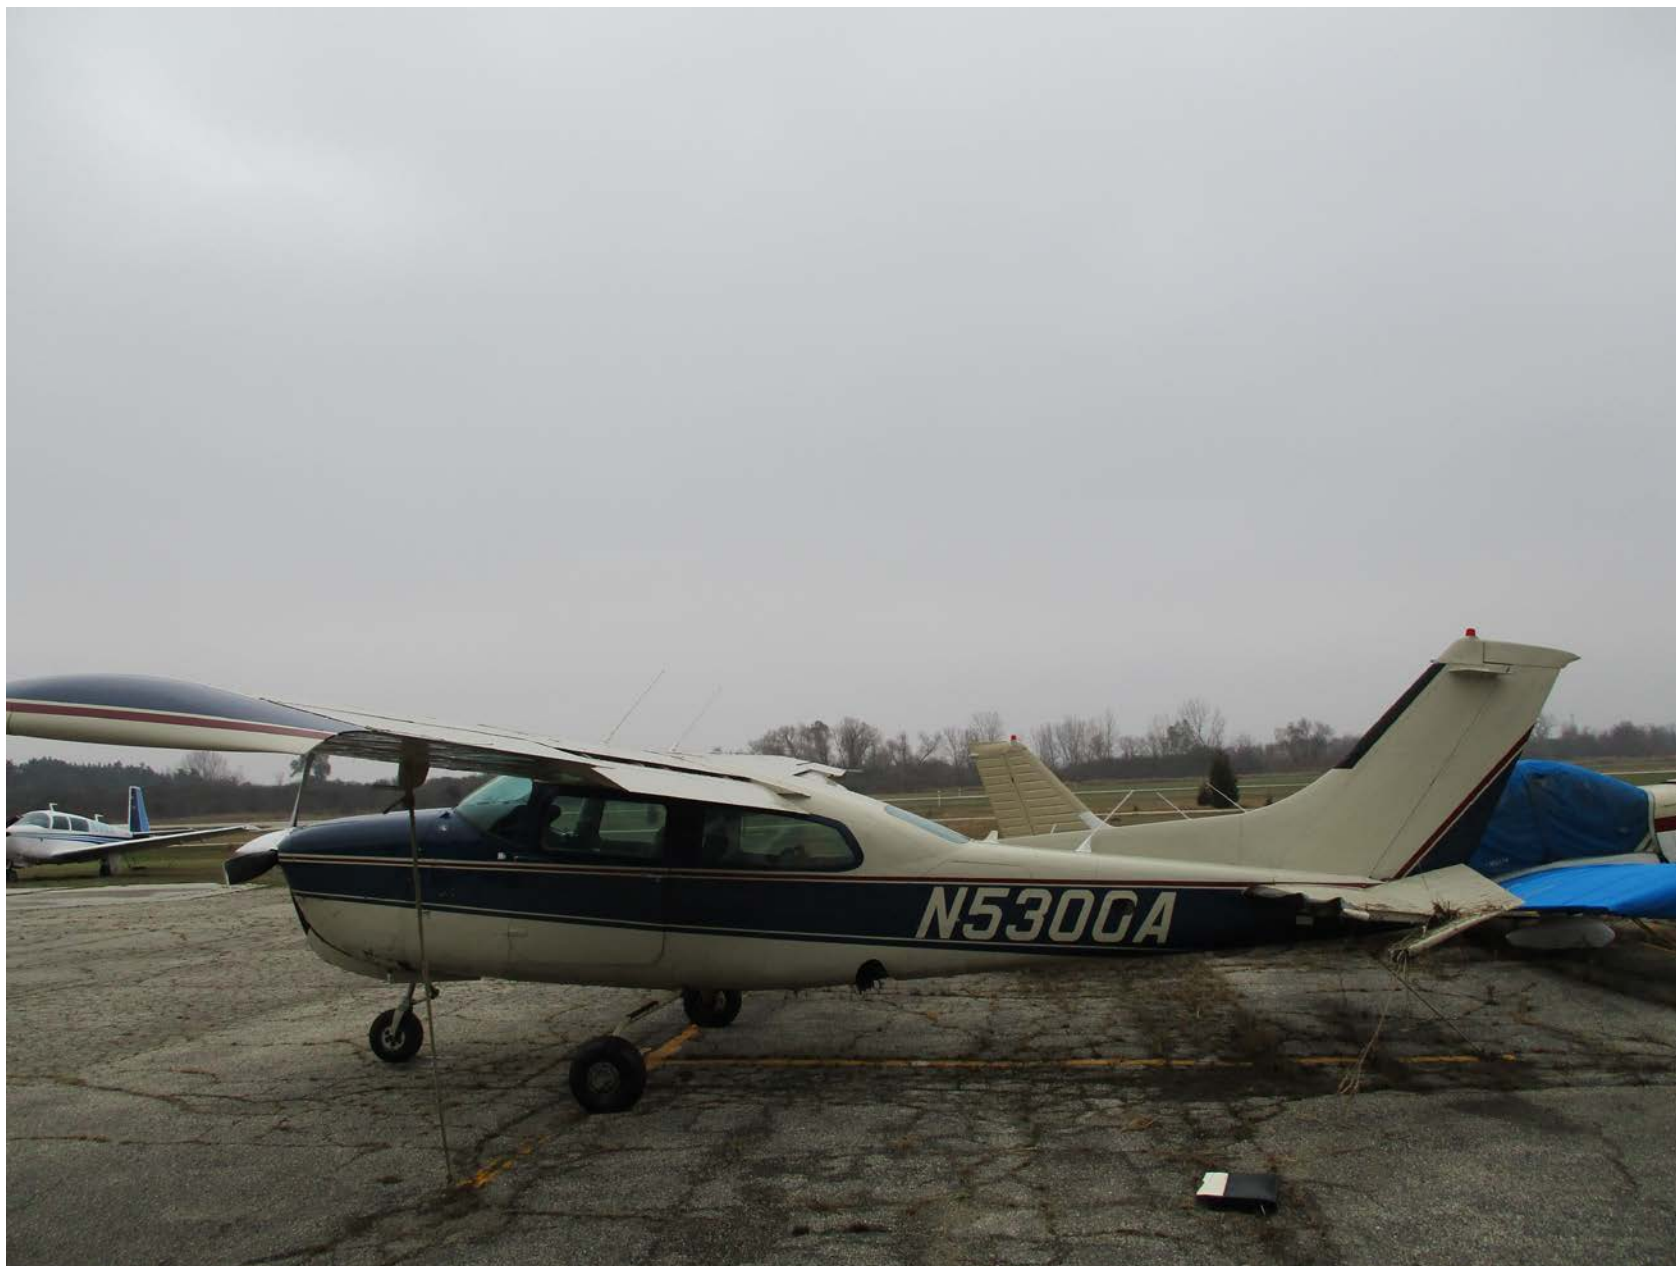
**Photo 2 – Accident airplane parked on the ramp**

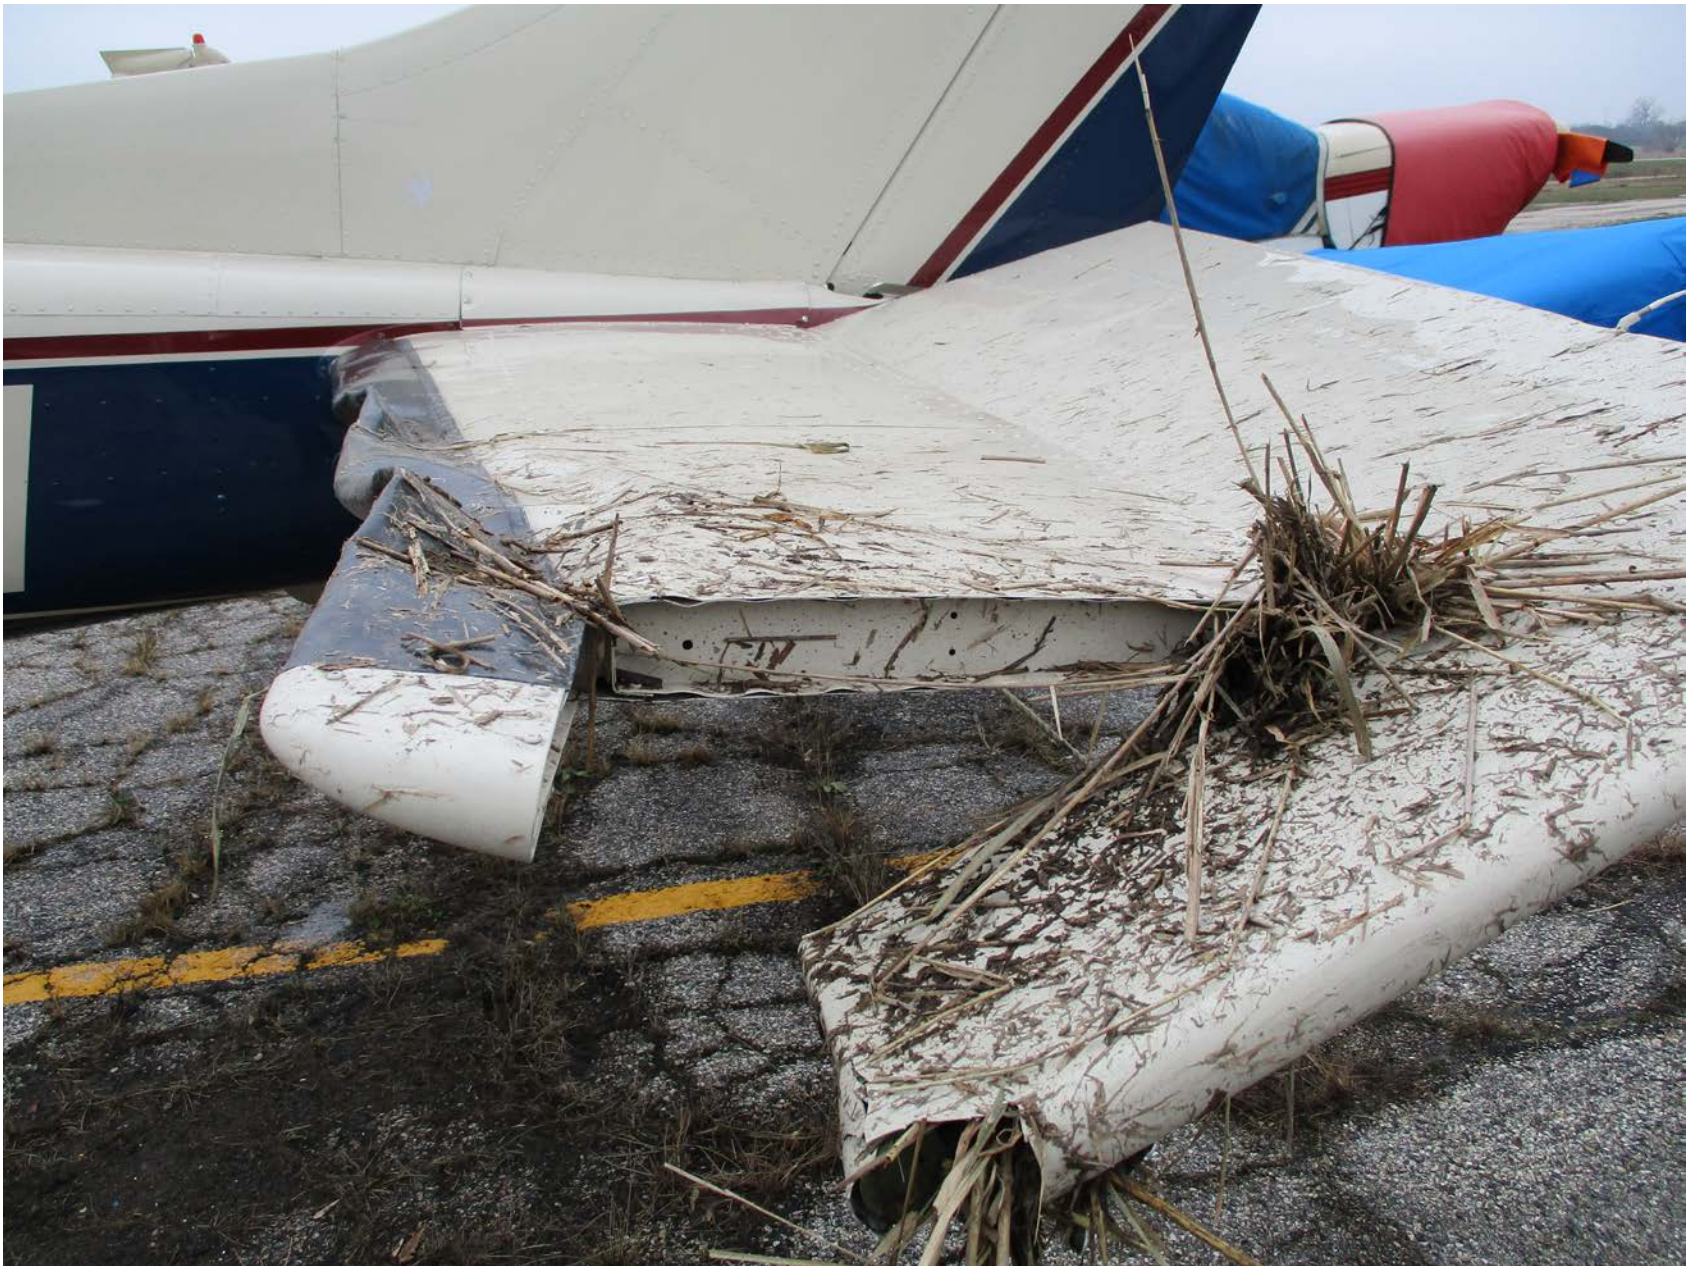
**Photo 3 – Damaged left elevator**

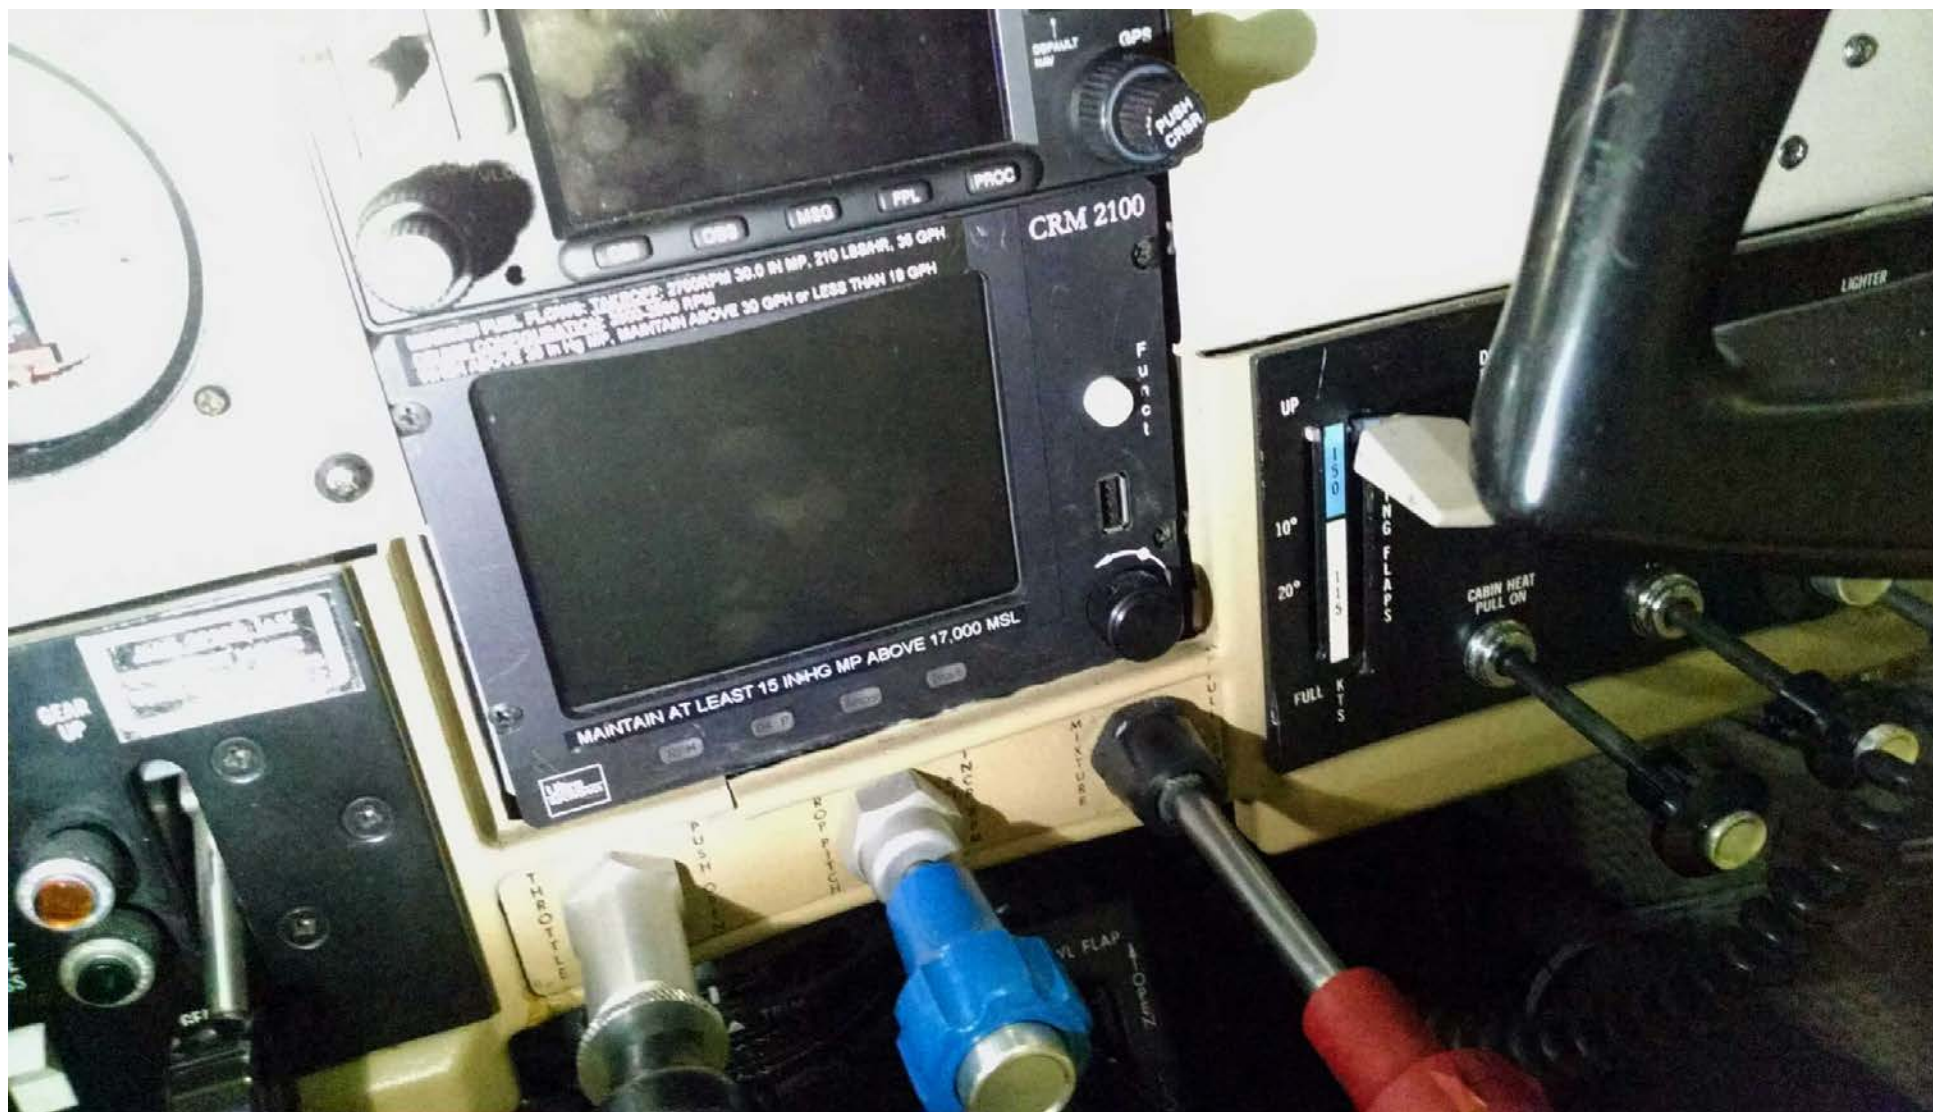
**Photo 4 – CRM 2100 installed in the instrument panel**

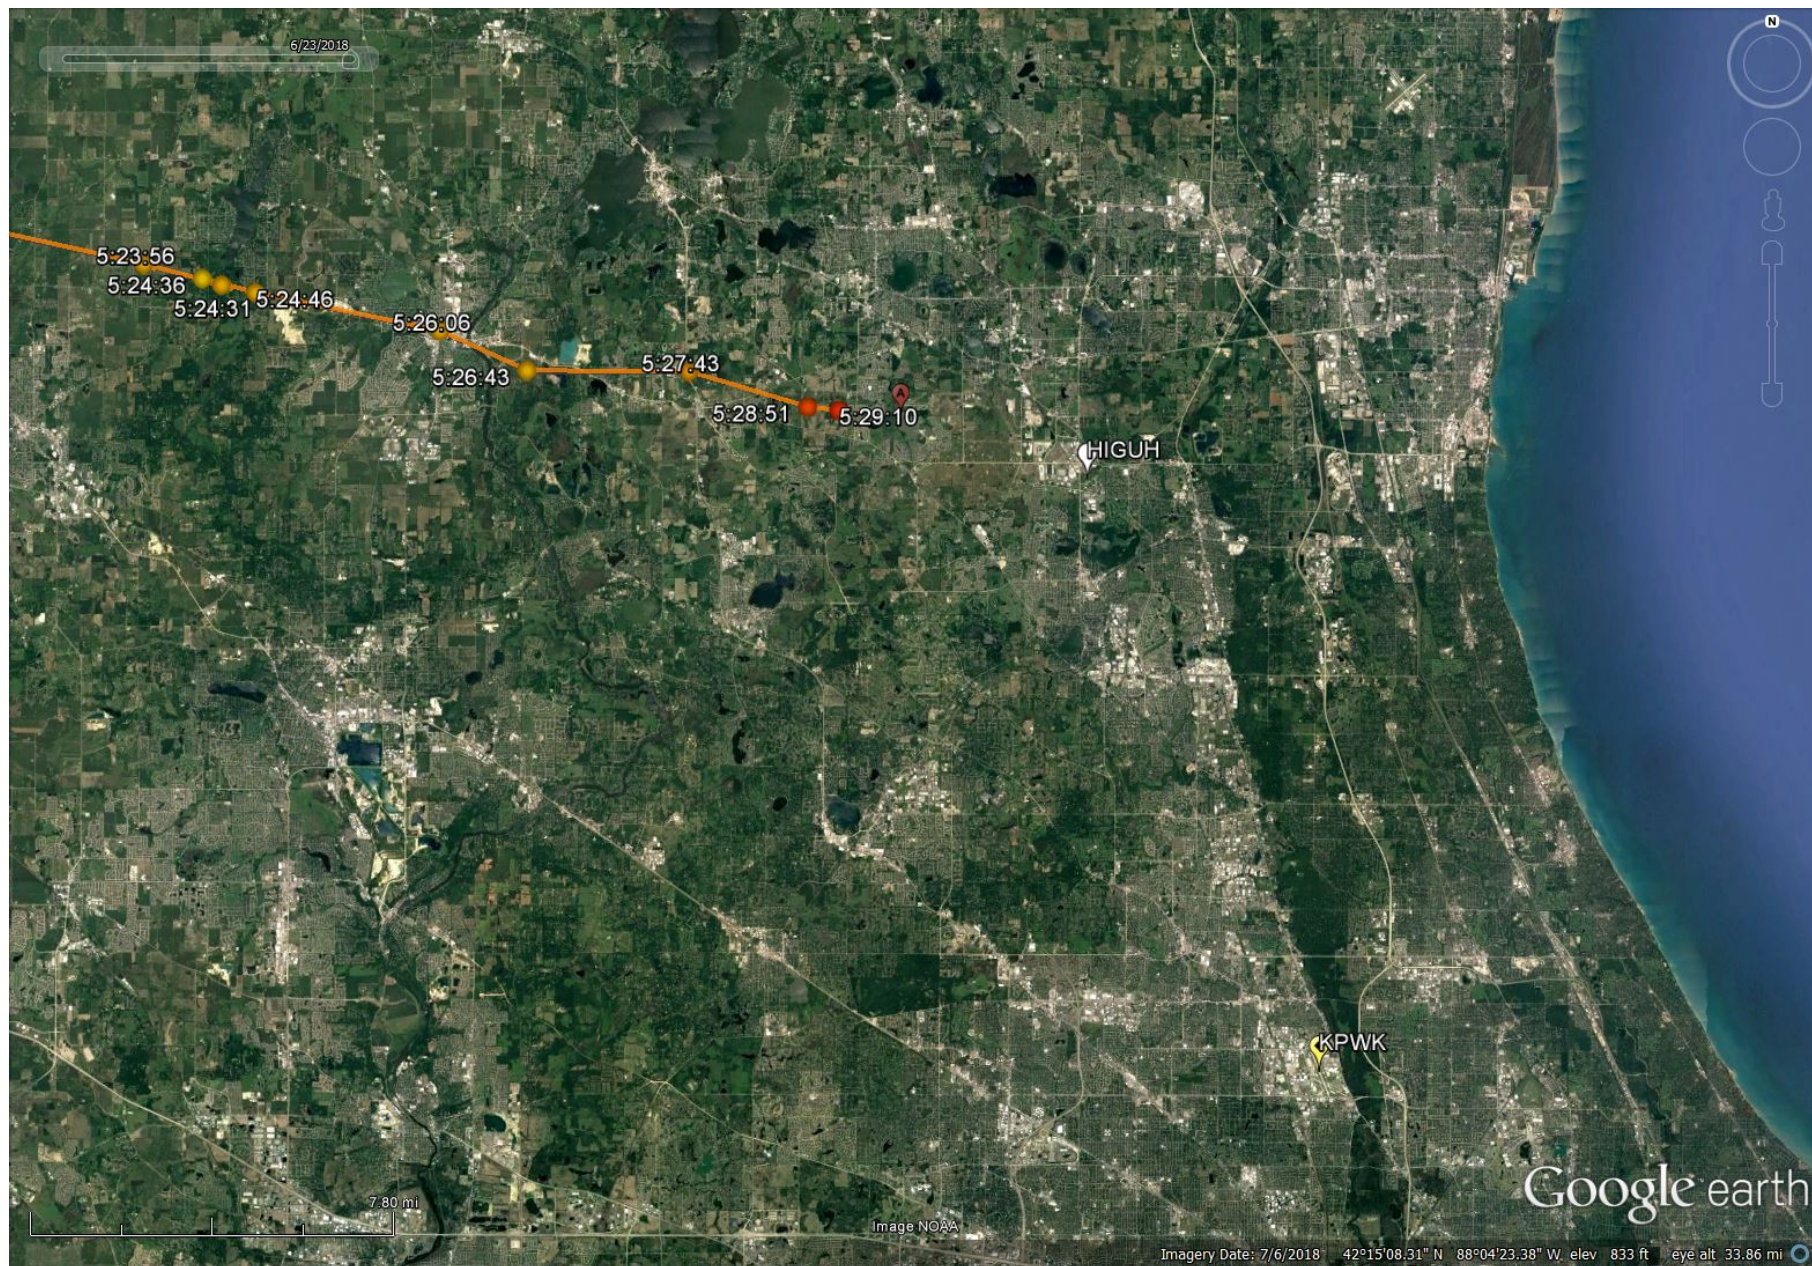
**Photo 5 – Google Earth overview with flight track and PWK**

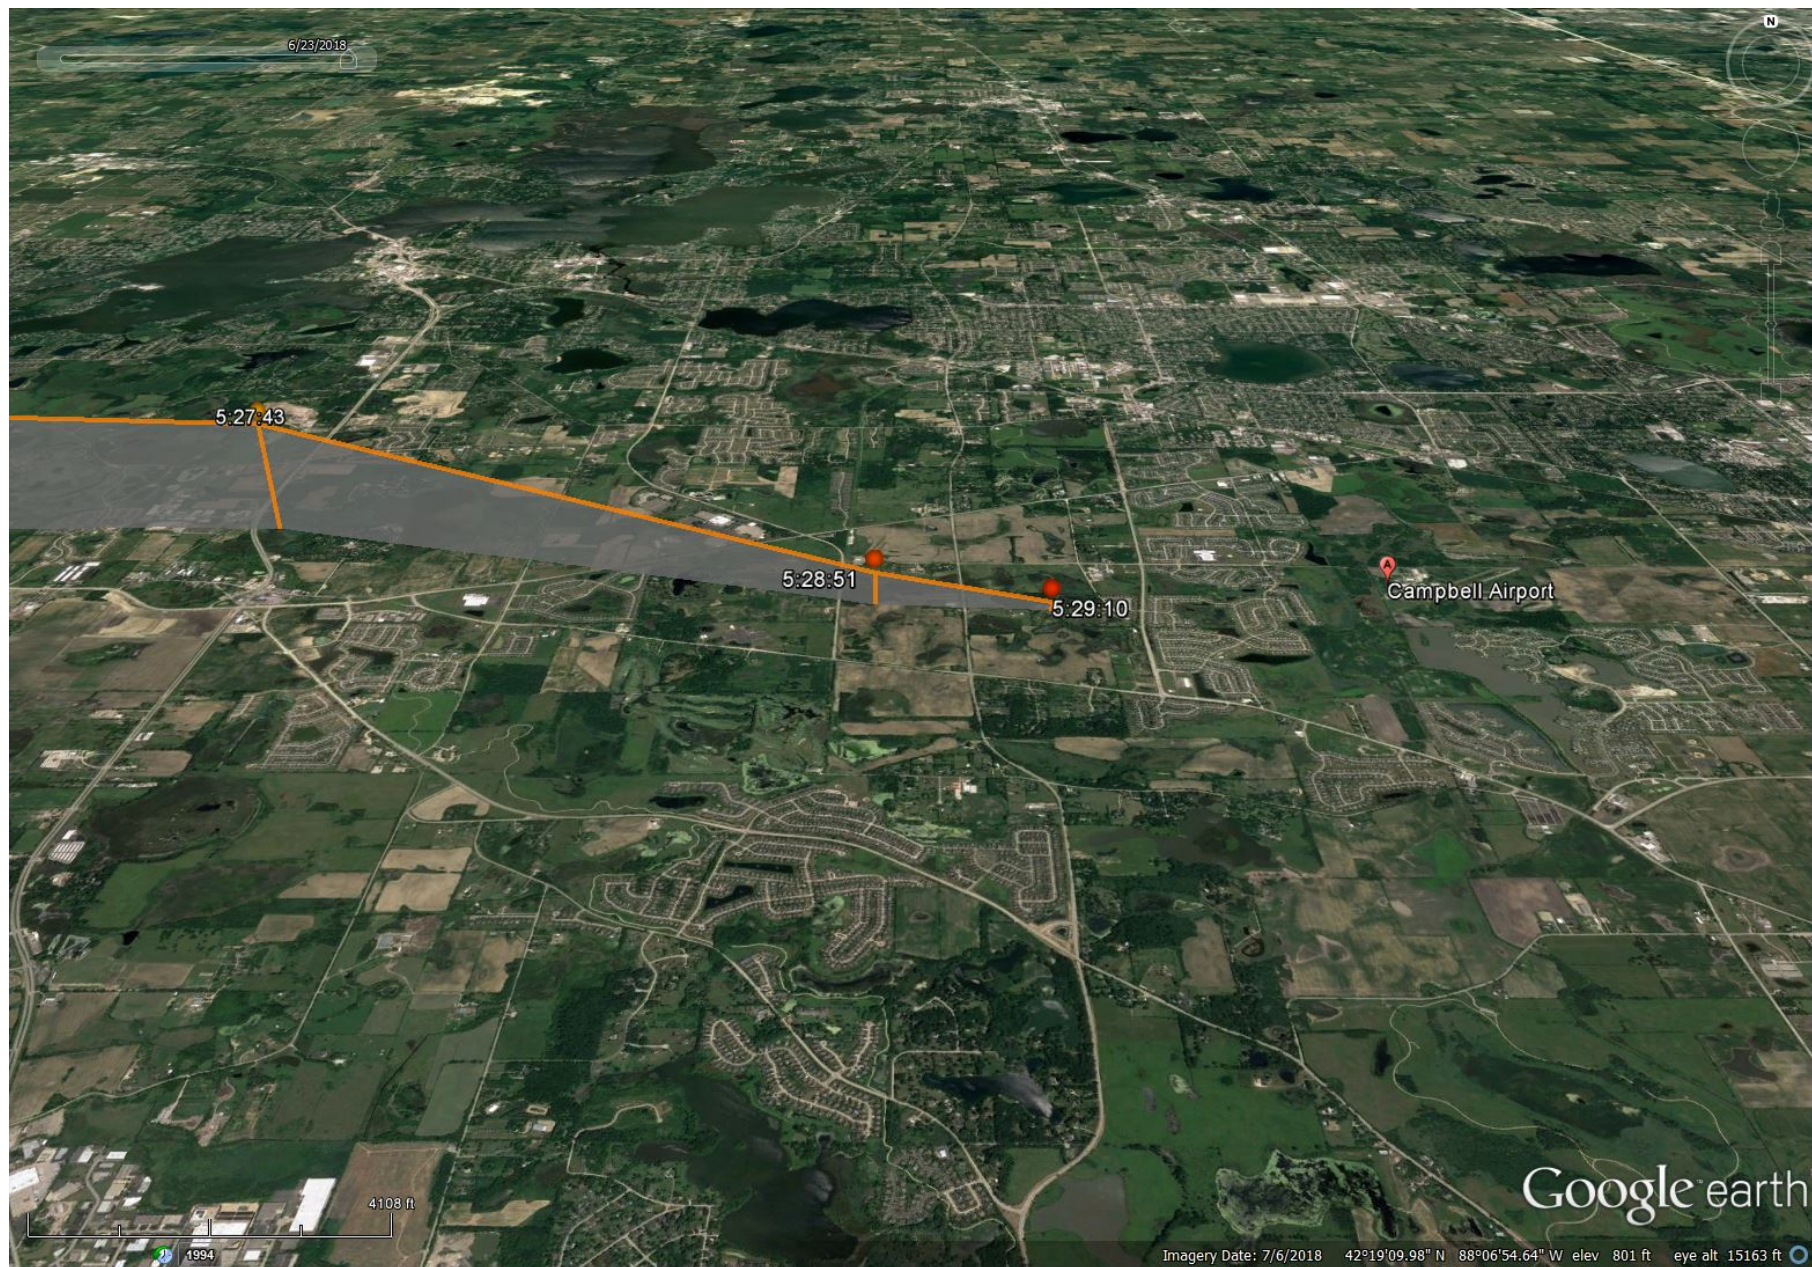
**Photo 6 – Google Earth overview with flight track and C81**
