# Continental Motors

## ENGINE EXAMINATION REPORT

| ENGINE MODEL | IO-550-P (converted to turbo-normalized by Vitatoe) |
| FILE NUMBER | 17-294 |

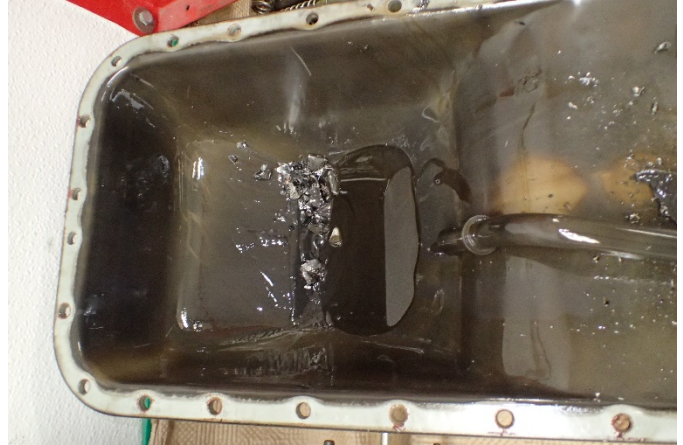
The oil sump remained intact and was undamaged. The oil sump was removed and it was noted that the oil sump contained a significant amount of metallic material within the oil sump.

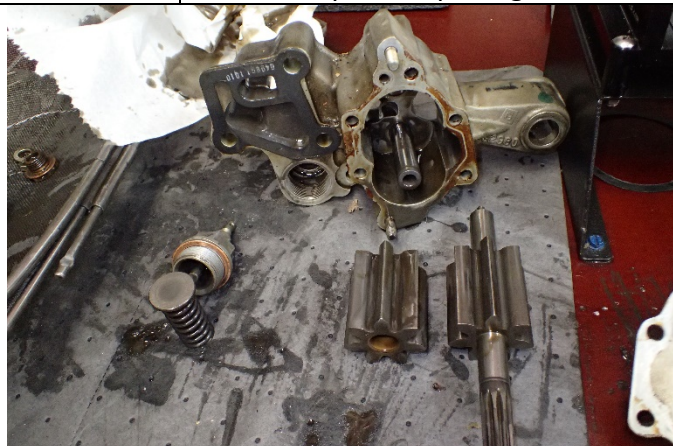
The oil pump remained intact and undamaged. The oil pump was disassembled and the internal components were visually inspected. There were a few flakes of metallic material within the oil pump and a small amount of gouging along the oil pump housing consistent with hard particle passage.

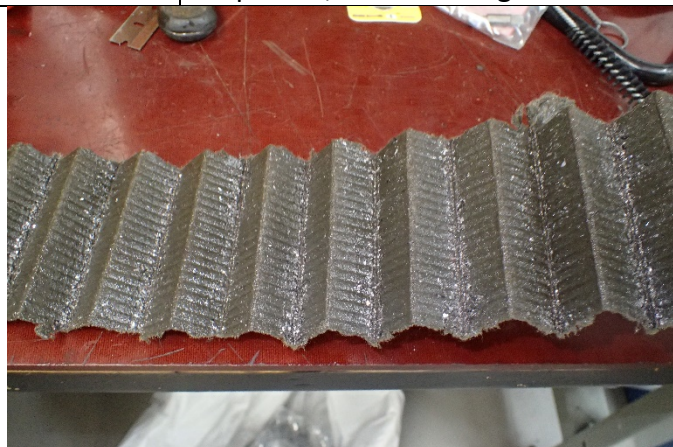
The oil filter remained attached to the oil filter adapter and was undamaged. The oil filter was removed and the filter housing was cut open. The oil filter pleats were visually inspected; there was significant metallic material noted within the filter pleats.

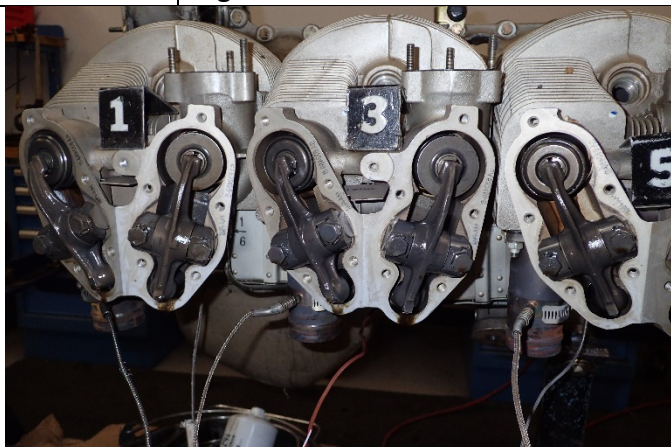
| CYLINDER #3 | P/N: 658595A1 | S/N: AC16GB331 | Head Date: Not observed |
|---|---|---|---|
| Condition: | The cylinder remained attached to its installation point and displayed mechanical damage to the cylinder skirt. The cylinder was removed and visually inspected. The cylinder bore and valve heads displayed normal operating and combustion signatures. The overhead components (valves, springs, and rocker arms) displayed normal operating and lubrication signatures. | | |

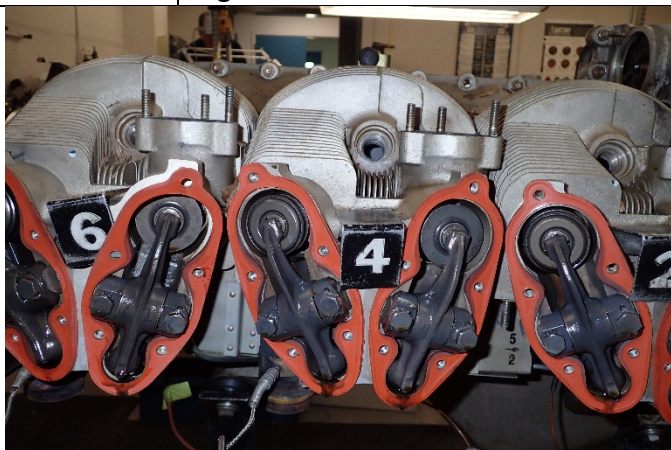
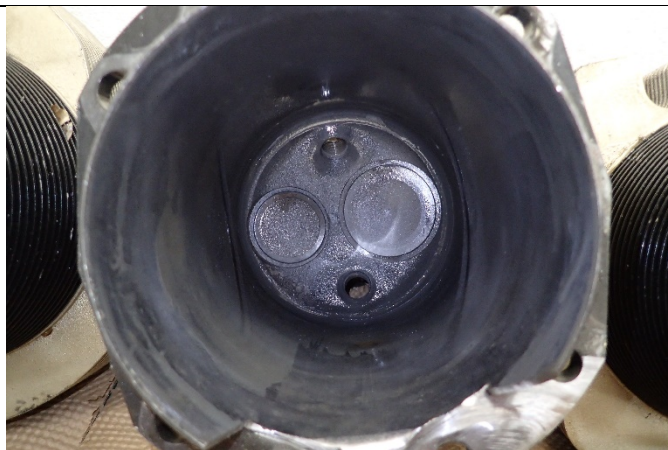
The cylinder remained attached to the engine and displayed mechanical damage to the cylinder skirt. The cylinder was removed and visually inspected. The cylinder bore and valve heads displayed normal operating and combustion signatures. The overhead components (valves, springs, and rocker arms) displayed normal operating and lubrication signatures.

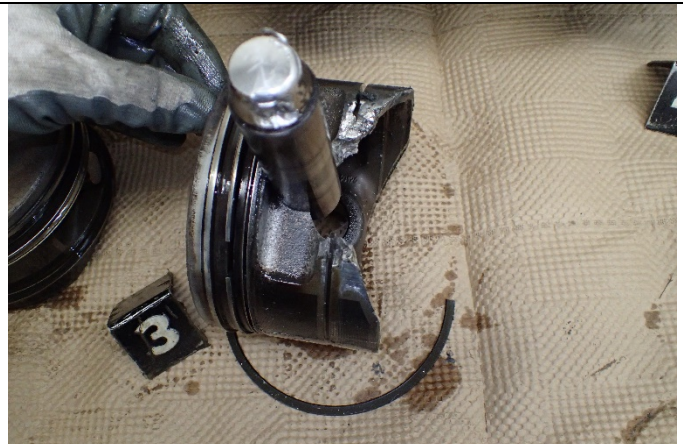
## #3 PISTON, RINGS AND PIN

The piston remained attached to its connecting rod and displayed a significant amount of mechanical damage to the rear of the piston as well as the piston skirt. The rear piston ring was broken; however, the remaining piston rings remained installed in their grooves, were undamaged, and were capable of normal movement. There were no anomalies noted with the piston.

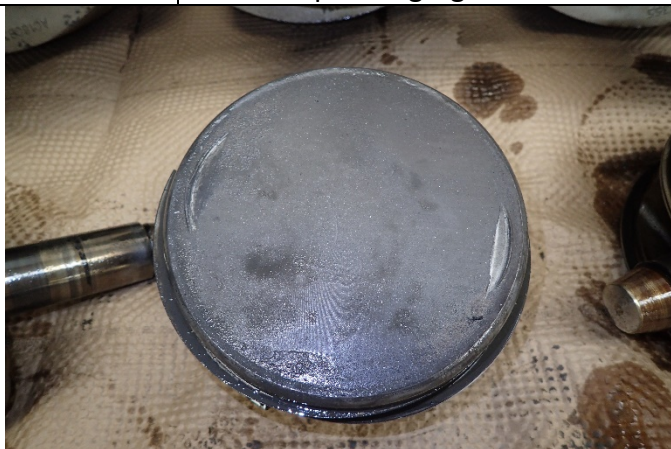
The piston remained attached to its connecting rod; however, the connecting rod had separated from the crankshaft. The piston displayed a significant amount of mechanical damage to the rear of the piston as well as the piston skirt. There were two semi-circular indentations on the piston face consistent with valve strikes. The rear piston ring displayed mechanical damage; the remaining piston rings were undamaged and displayed normal operating signatures.

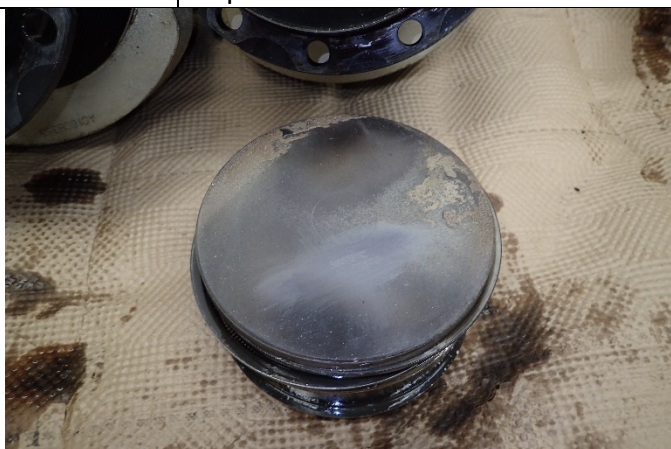
## #6 PISTON, RINGS AND PIN

The piston remained attached to its connecting rod and displayed mechanical damage to the rear of the piston as well as the piston skirt. The rear piston ring was broken; however, the remaining piston rings remained installed in their grooves, were undamaged, and were capable of normal movement. There were no anomalies noted with the piston.

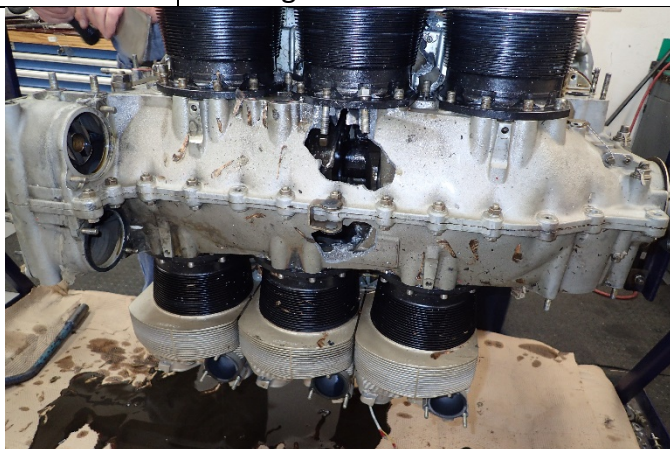
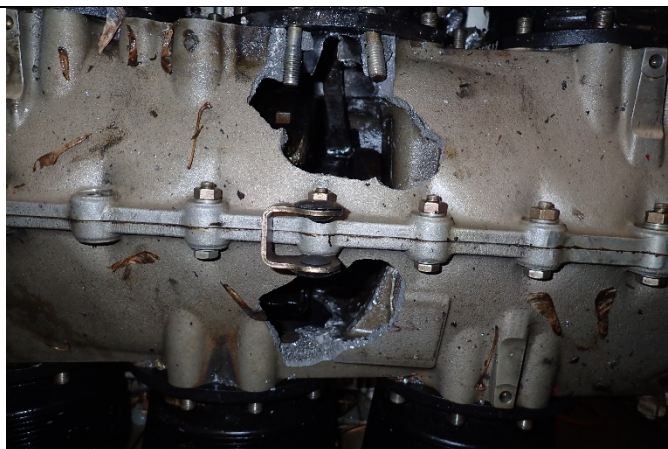
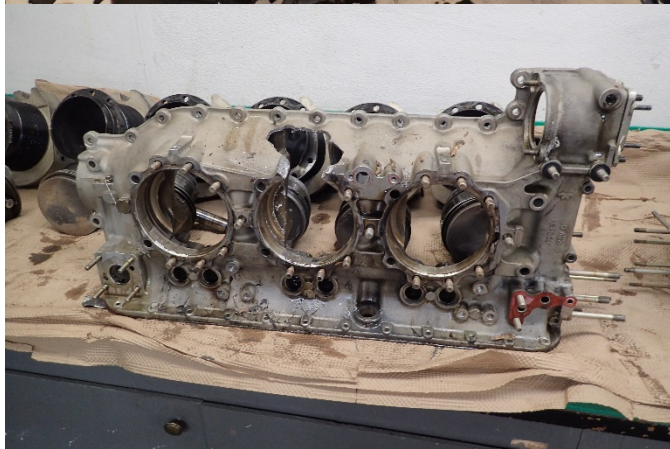
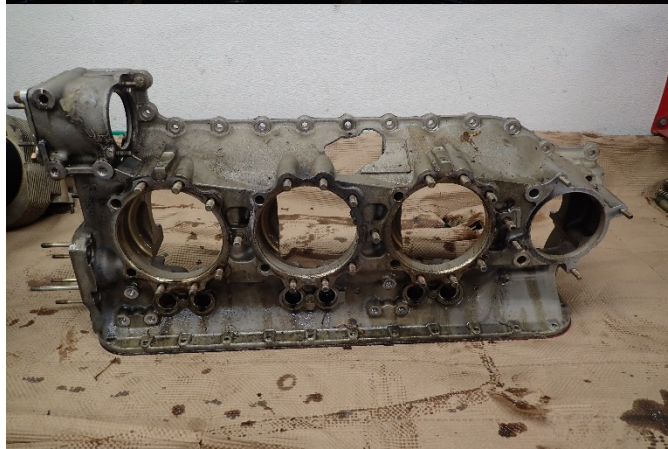
The crankcase had two holes in the top of the crankcase; one hole was adjacent to the #4 cylinder, the other hole was located near the data plate installation point. The inside of both of the crankcase halves displayed mechanical damage with the most damage concentrated near the two holes. There were no signs of fretting on the bearing supports or signs of bearing shift. The oil galley were checked for blockages; there were no blockages found.

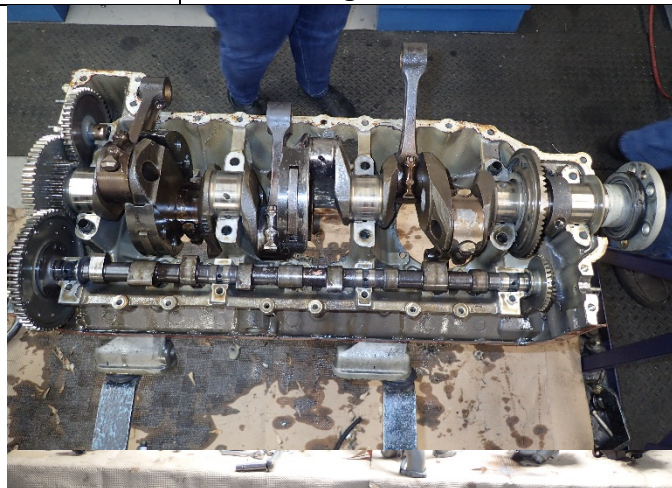
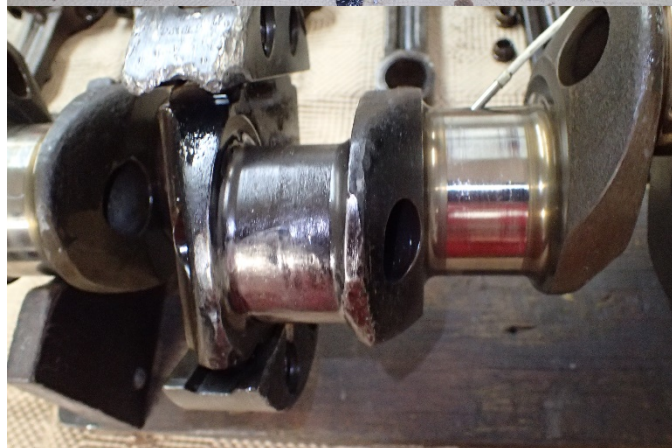
The crankshaft remained intact and displayed varying amounts of thermal damage to the connecting rod journals with the #4 connecting rod journal displaying the most thermal damage; the #4 connecting rod journal also displayed mechanical damage. The oil galleries were inspected using a light and all the galleries were found to be clear of obstructions. The crankshaft gear remained secured and there was no damage noted to the gear teeth.

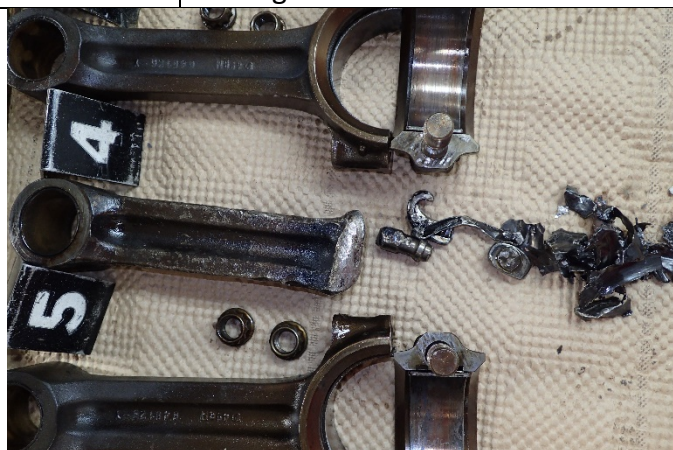
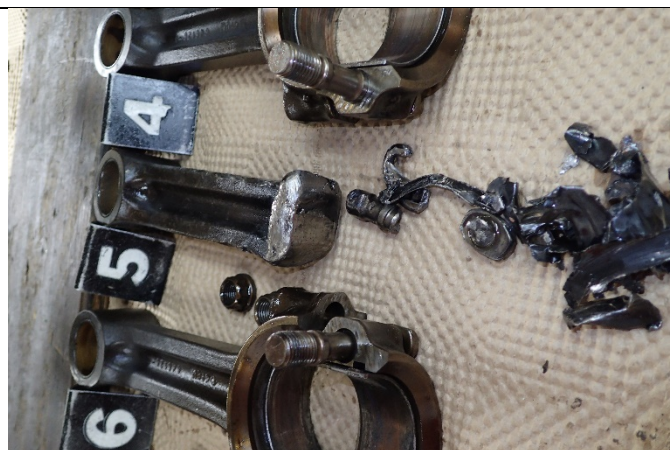
The #4 connecting rod had separated from the crankshaft and displayed thermal damage signatures to the rod. All of the connecting rod bearings displayed wiping of the bearing surface consistent with lubrication distress; the #4 bearings were severely damaged consistent with a lack of lubrication.

The connecting rod had separated from its connecting rod journal and displayed thermal discoloration and mechanical damage. Portions of the connecting rod bolts and cap were found separate from the connecting rod and displayed mechanical damage and thermal discoloration.

Portions of the bearings were located in the oil sump and displayed a significant amount of damage consistent with lubrication distress.

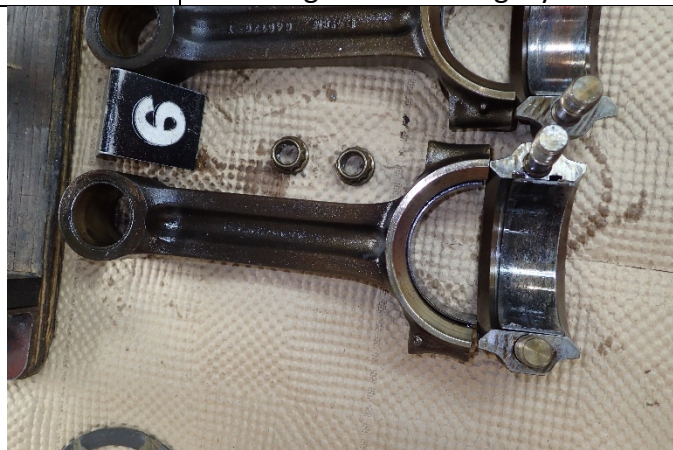
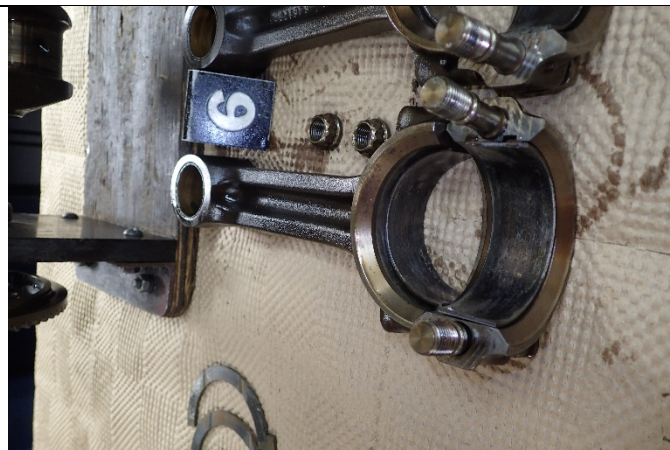
## #6 CONNECTING ROD

The bearings remained within the bearing supports. The bearing displayed wiping and smearing of the bearing layers which is consistent with lubrication distress.

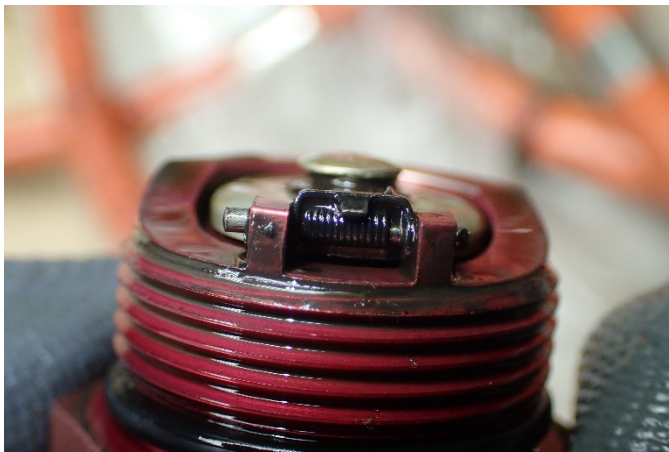
Both of the check valves remained attached to their installation points and were undamaged. The check valves were removed and disassembled. The check valve for the turbocharger scavenge oil was found to have a broken spring causing the valve to not close automatically; however, the valve was able to move freely. The inlet check valve was disassembled and was capable of normal operation.

Scavenge oil check valve not closing automatically

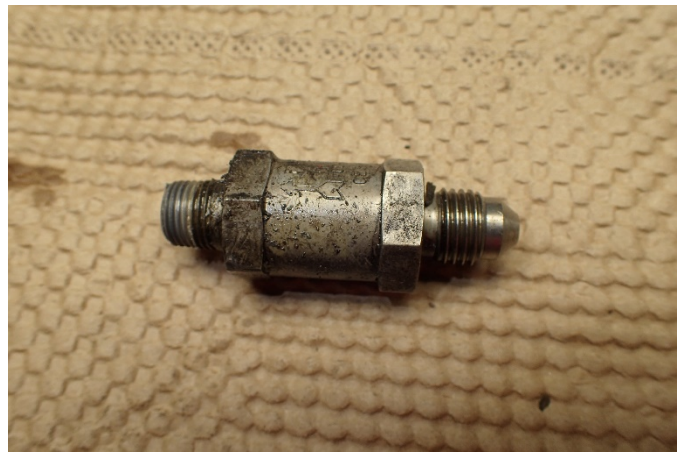
Broken oil scavenge check valve spring
