# NATIONAL TRANSPORTATION SAFETY BOARD

## MATERIALS LABORATORY FACTUAL REPORT

Report No. 17-094

Place : Harvard, Illinois  
Date : November 8, 2017  
Vehicle : Cessna 170  
NTSB No. : CEN18LA044  
Investigator : Jennifer Rodi

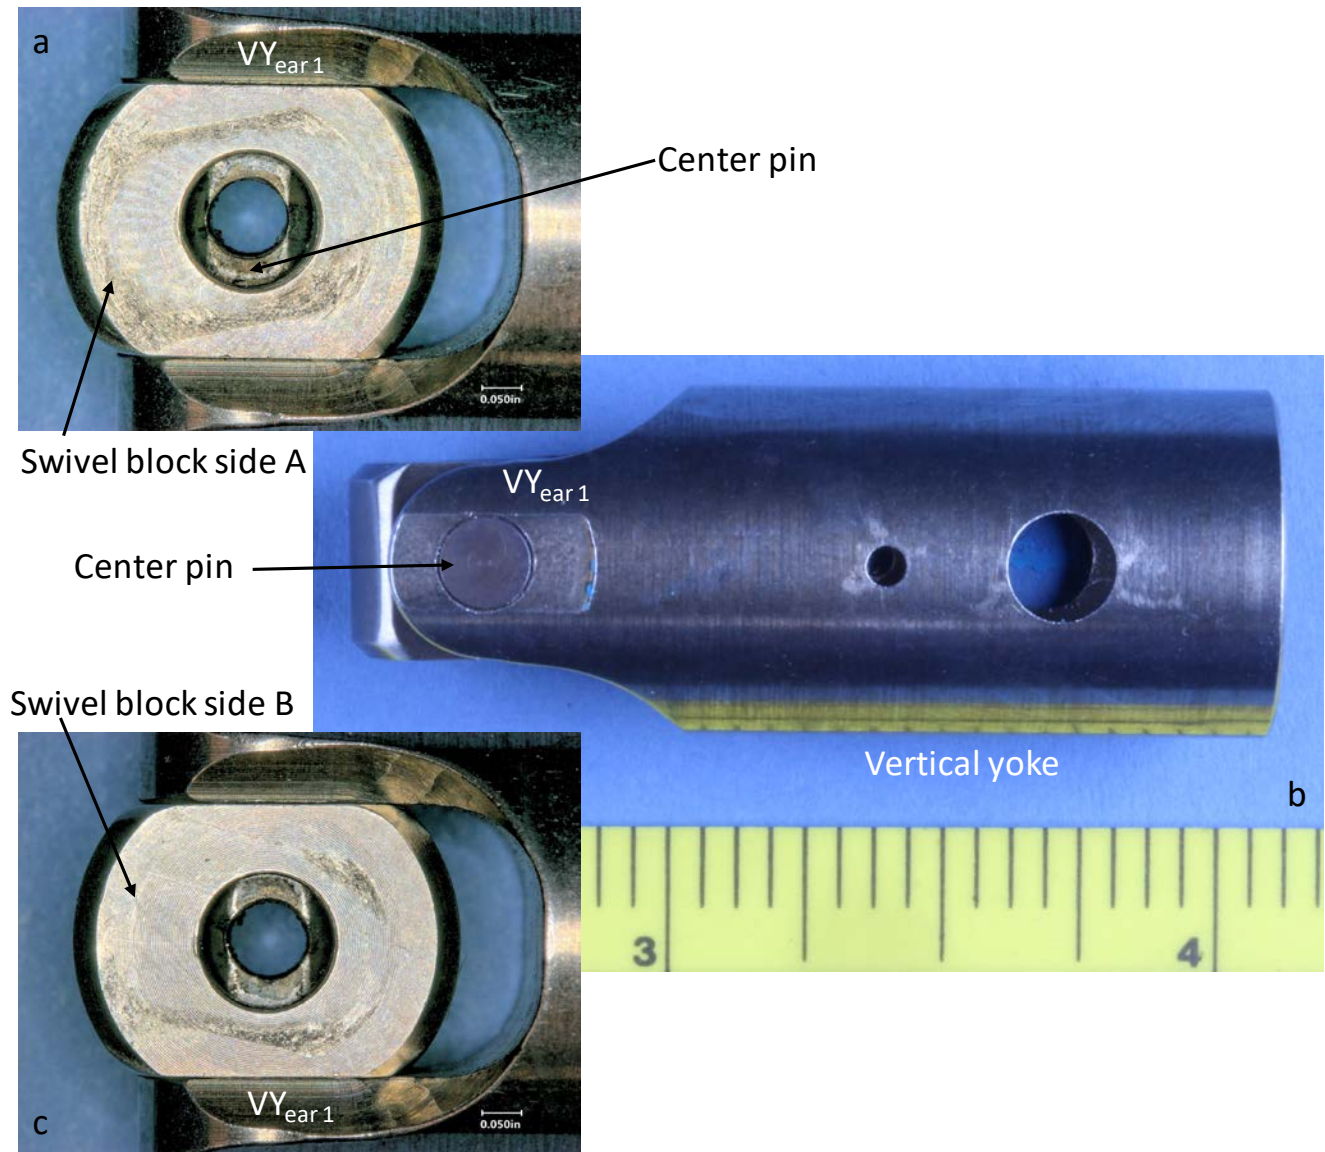
Figure 3 is an image the vertical yoke portion of the incident universal, with the swivel block and the center pin installed. The key features are labelled in the image. As received, the swivel block could be rotated about the center pin. Hand-applied torque of close-fitting gage pin installed in the cross-drilled hole in the center pin revealed that the center pin could not be rotated about its main axis. Closer views of the wear scars on the flat sides of the swivel block that were in contact with the faying surfaces of the HY<sub>ear 1</sub> and HY<sub>ear 2</sub> ears on the horizontal yoke are shown in Figures 4 and 5. The wear scars, when viewed under a 50X stereo-zoom microscope, exhibited fine excrescence<sup>1</sup> features associated with incipient galling and material loss and transfer associated with adhesive wear. The scars were primarily oriented +/- 11° from the long axis of the universal. Closer views of the flat features on the center pin are shown in Figure 6. The flats on the center

Figure 3 Views of the surfaces of the swivel block that contact the horizontal yoke ears. Closer views of the swivel block contact surfaces are shown in Figures 4 and 5.

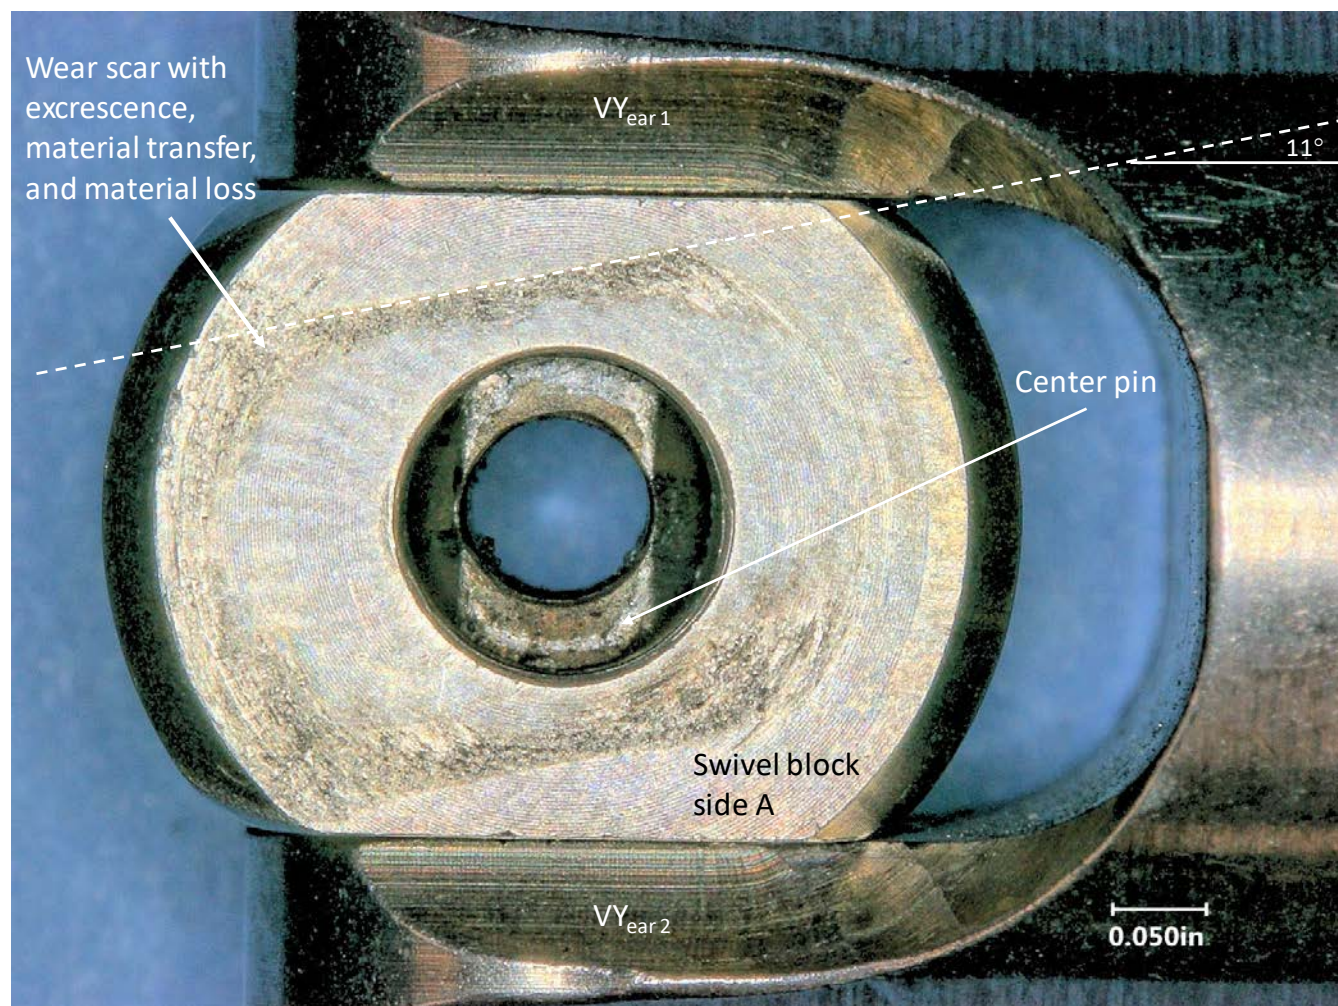
Figure 4 Closer view of the swivel block surface that contacts ear HY<sub>ear1</sub>.

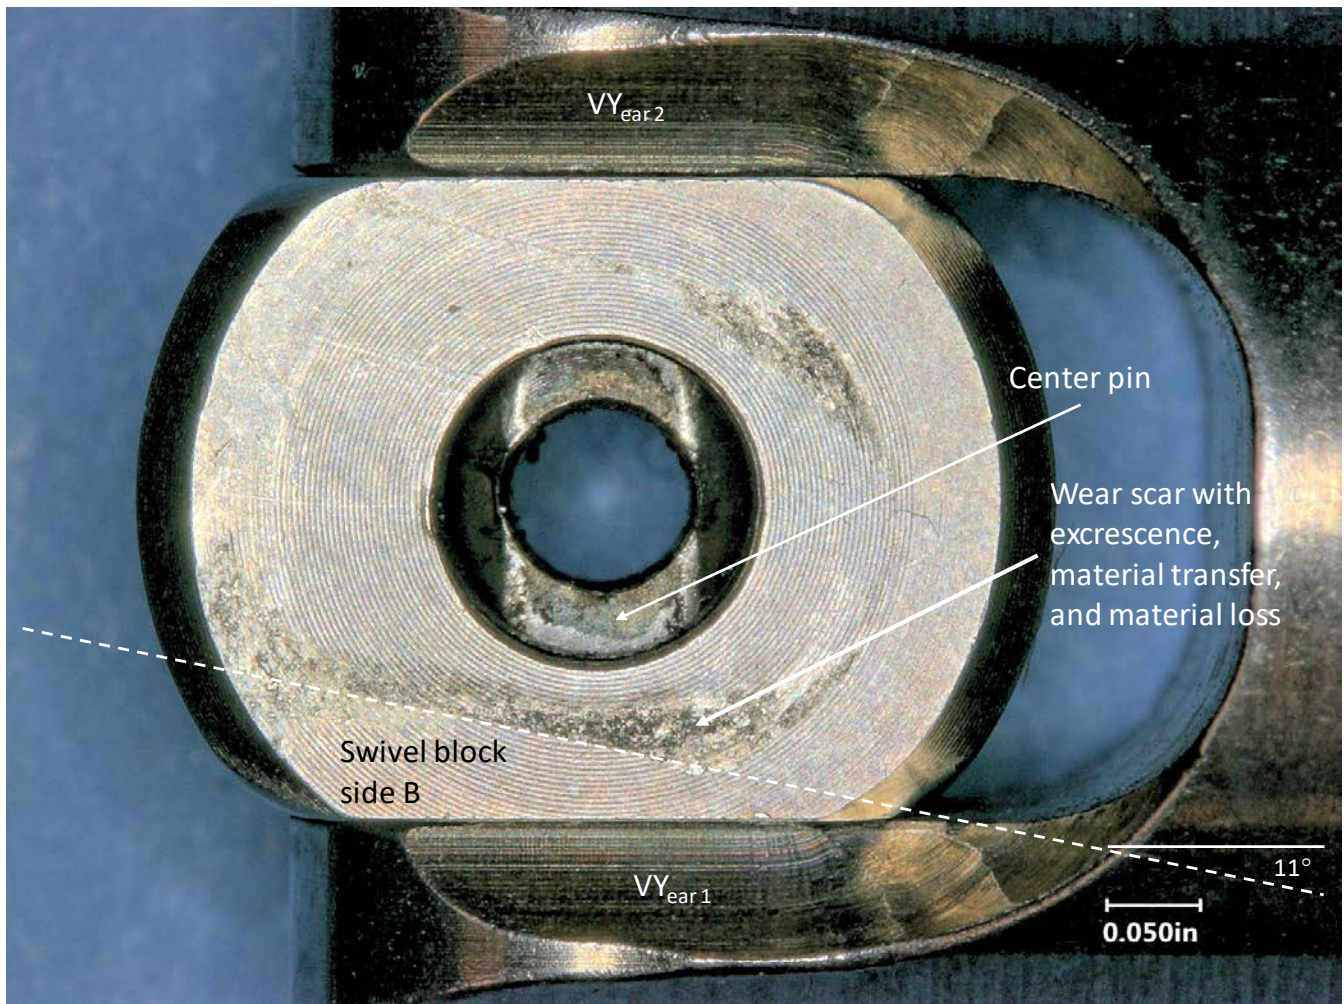
Figure 5 Closer view of the swivel block surface that contacts ear HY<sub>ear 2</sub>.

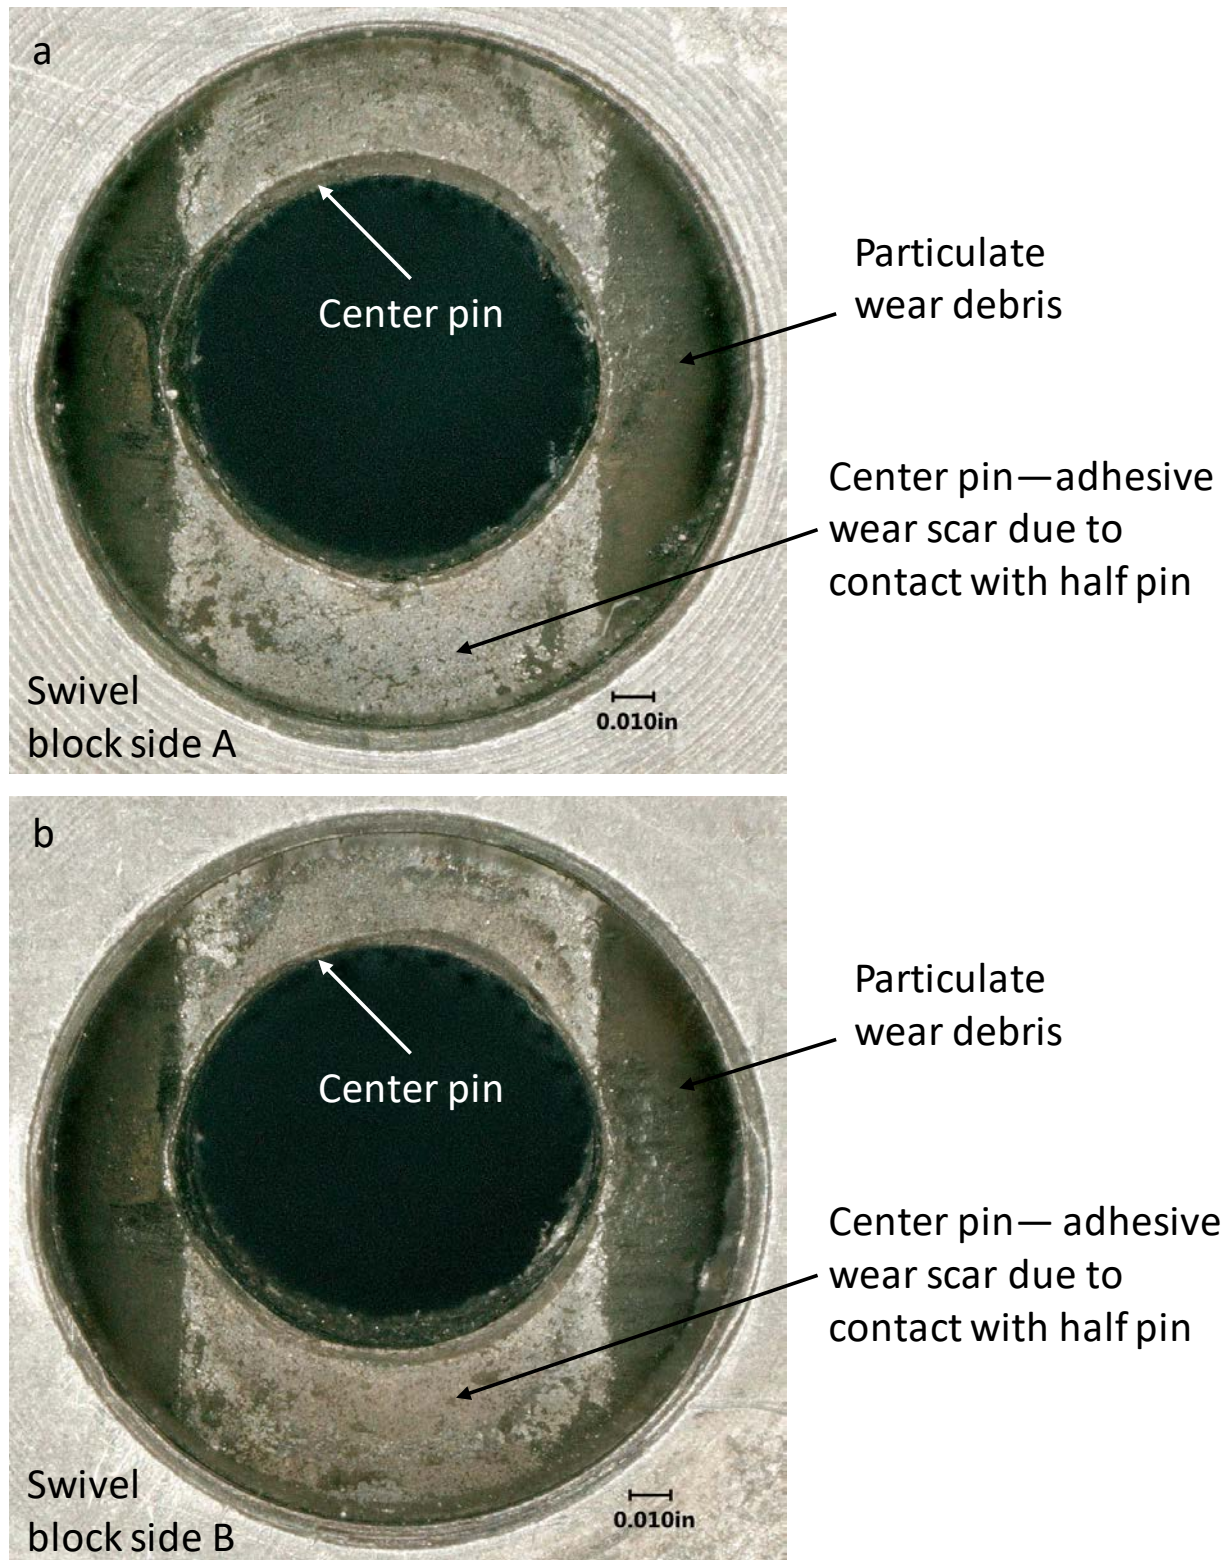
pin exhibited adhesive wear scars and the exposed round surfaces of the center pin exhibited particulate wear debris consistent with adhesive wear.

Figure 6 Closer views of the flat features on the center pin. The flats on the center pin exhibited adhesive wear scars and the exposed round surfaces of the center pin exhibited particulate wear debris.

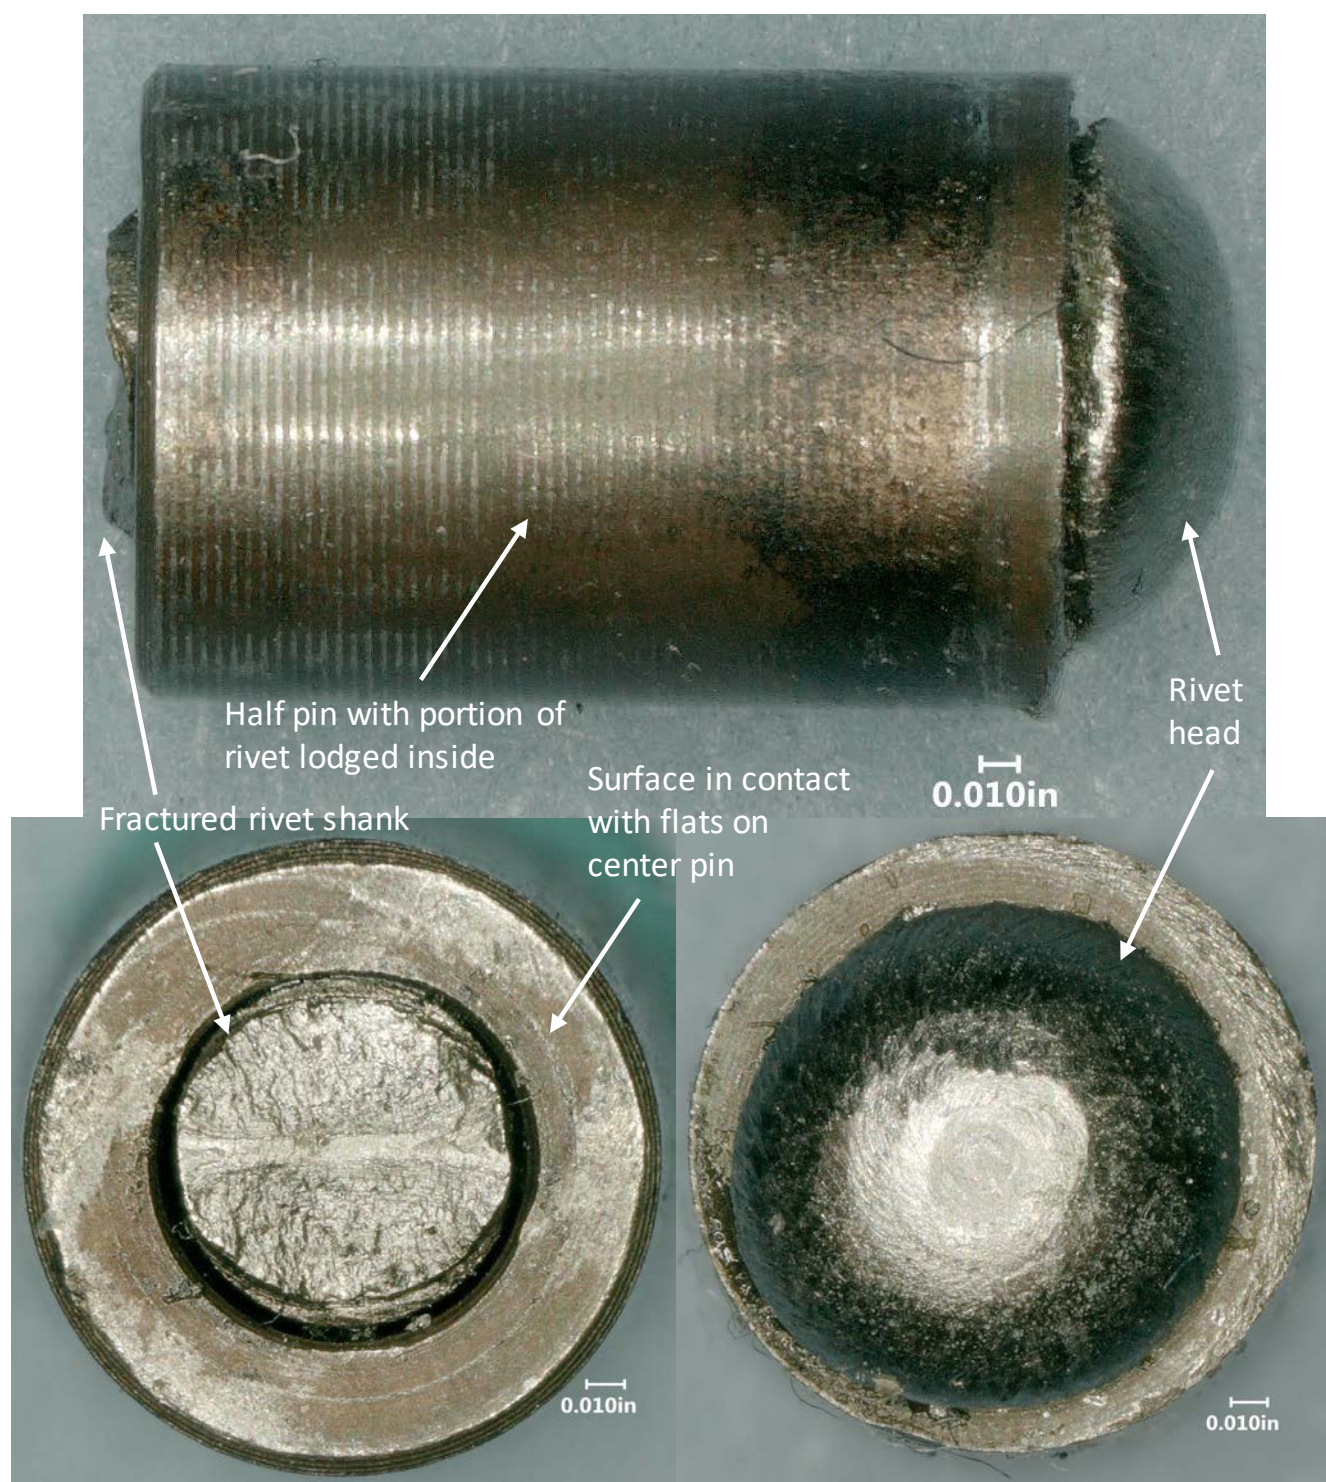
Overall views of the half pins are shown in Figures 7 and 8. The half pin in Figure 7 has a portion of the rivet. The rivet piece exhibited a transverse fracture through the thickness. The outside diameter surfaces of the half pins exhibit material loss and wear debris deposits. The ends of the half pins that contact the center pin flats exhibit a modicum of adhesive wear. Top-down views of the fracture surface in the rivet shank is shown in Figures 9-13. As identified in the annotated image in Figure 11, the rivet shank fractured due to fatigue crack propagation from two crack advancing cracks, initiating approximately 180° from each other, consistent with reversed bending fatigue. A small region at the neutral axis fractured in overstress. As indicated in Figure 11, there are regions of mechanical damage associated with the origin regions of the two fatigue cracks, consistent with reversed bending of the rivet shank within the assembly.

Figure 7 Three views of a half pin, recovered with a fractured portion of rivet.

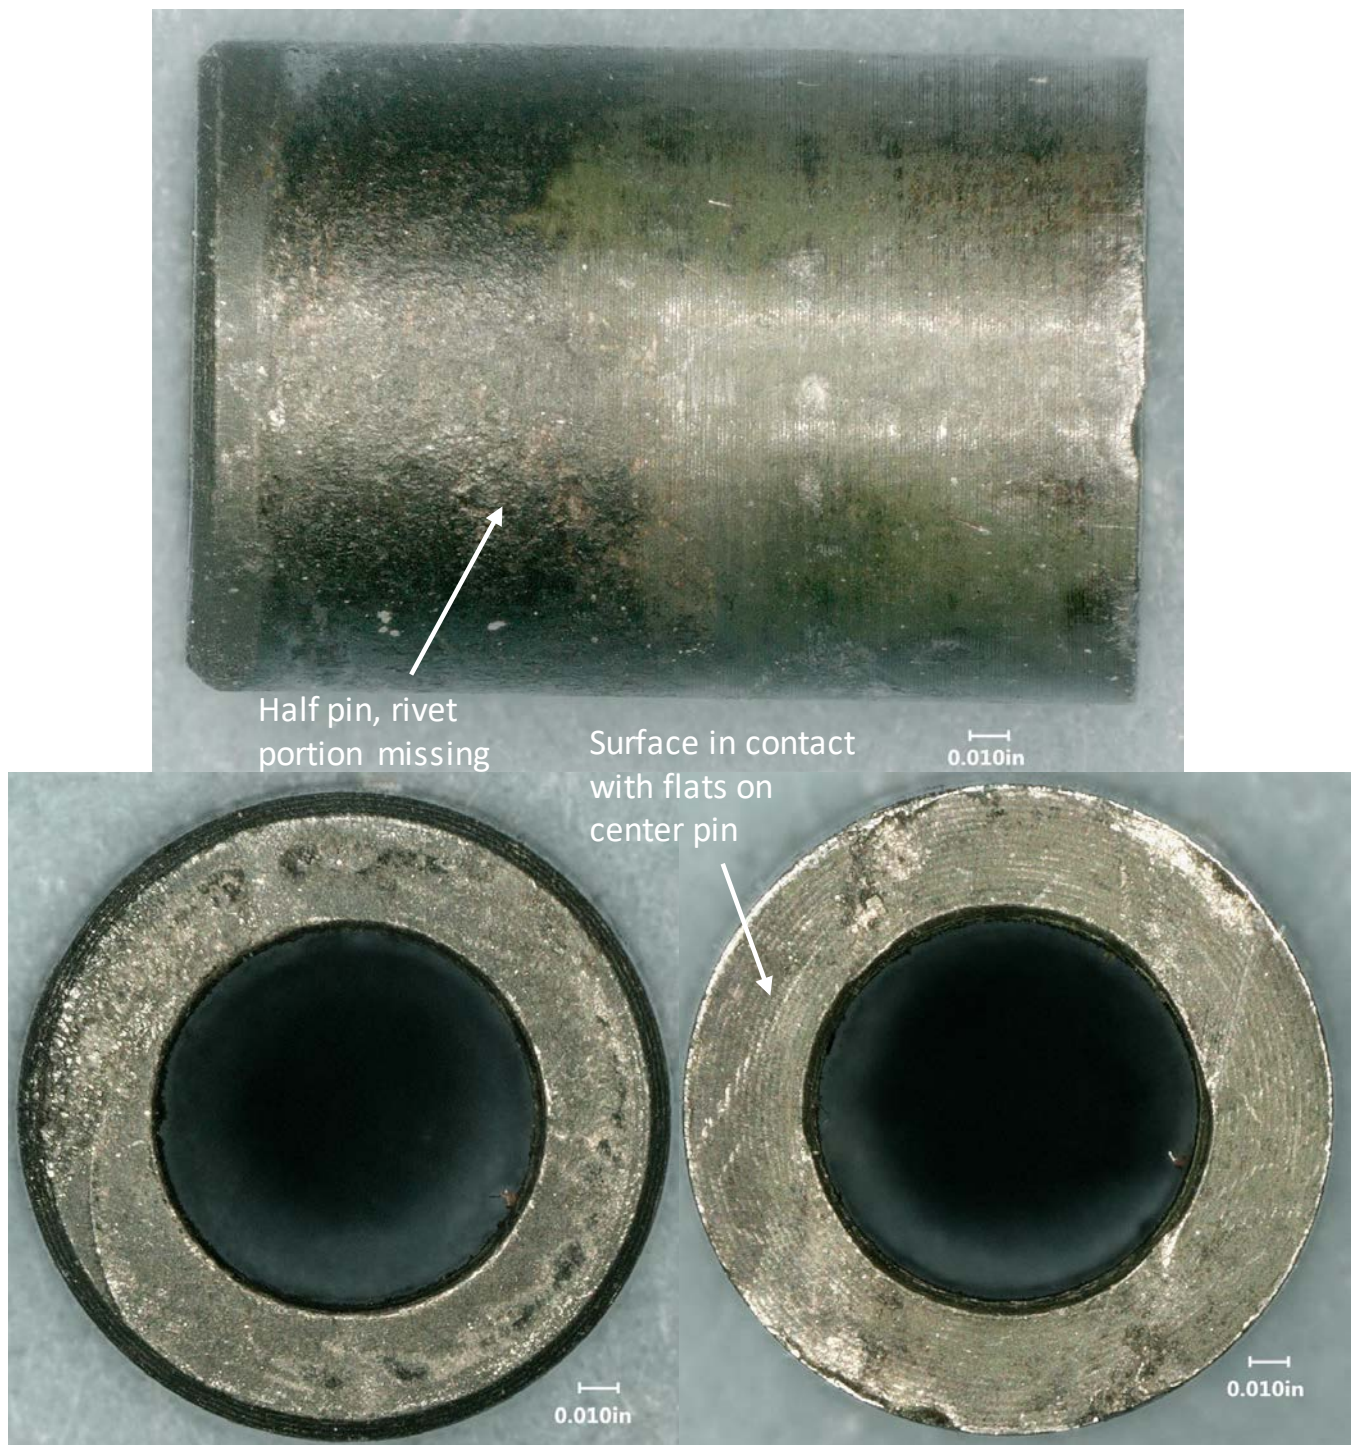
Figure 8 Three views of a half pin.

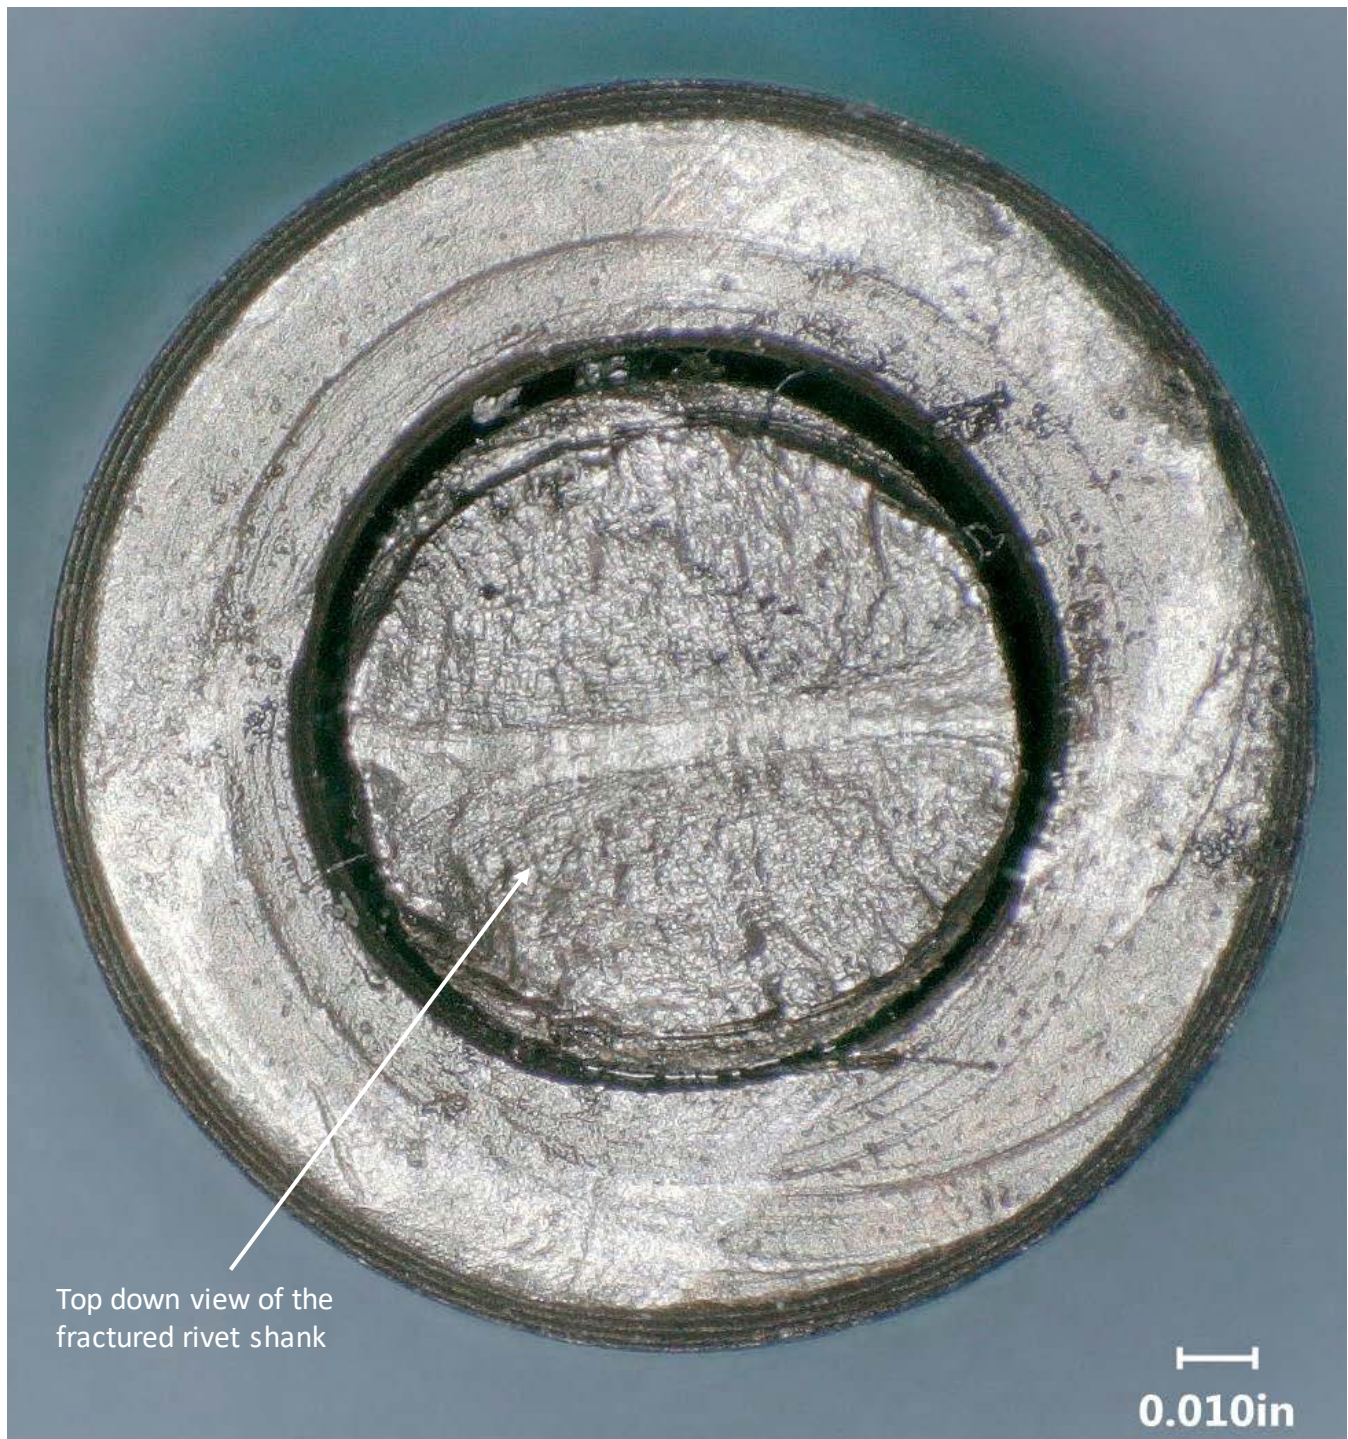
Figure 9 Digital microscope fractograph of the rivet shank fracture surface.

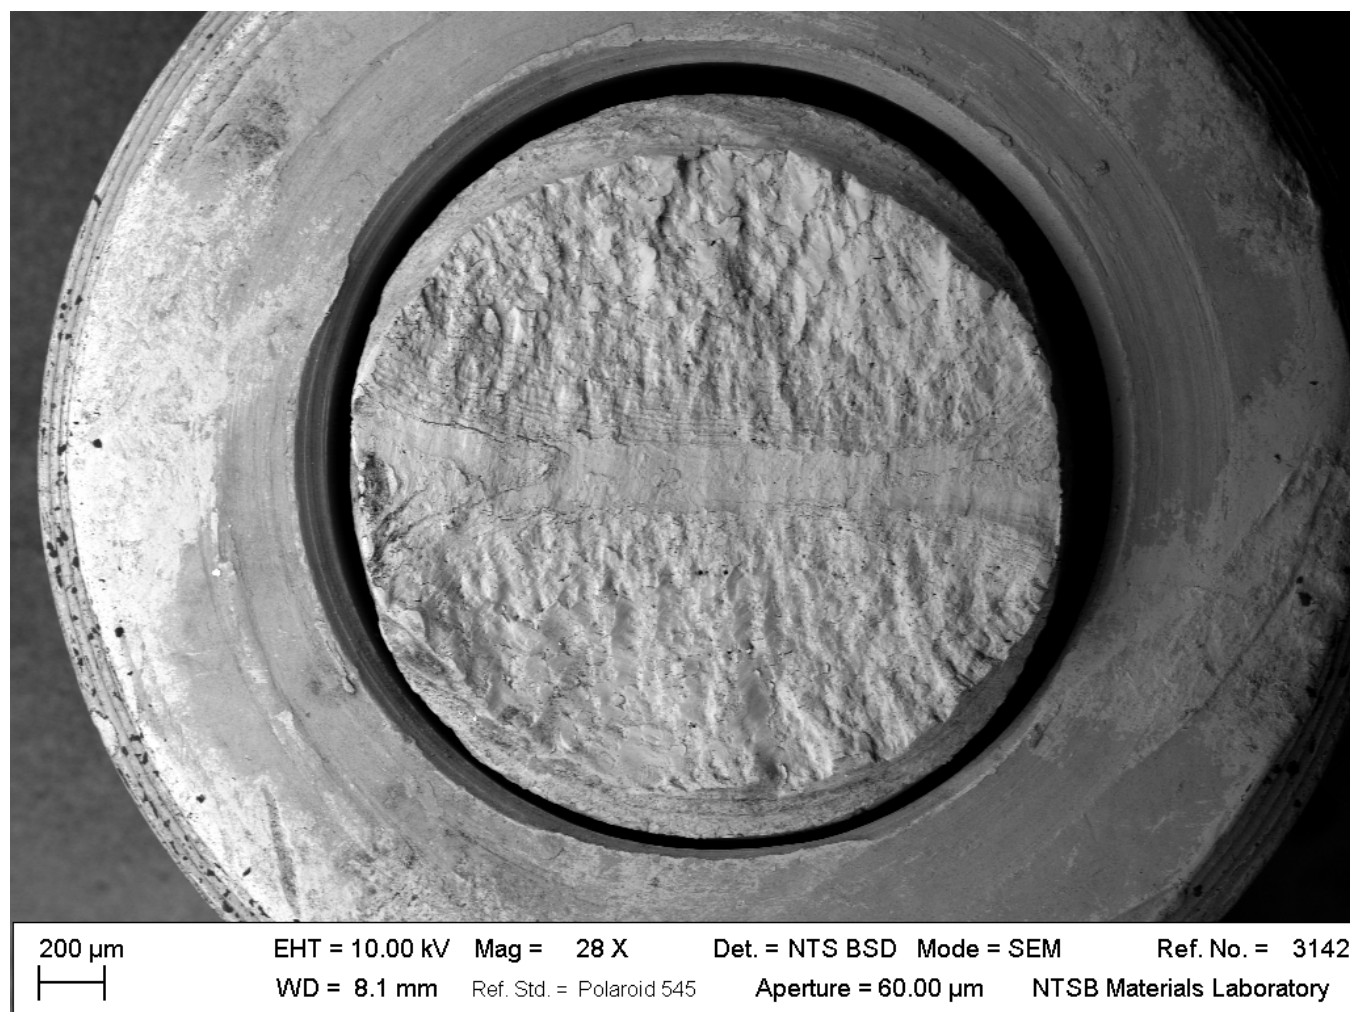
Figure 10 Backscatter scanning electron fractograph of the rivet shank fracture surface.

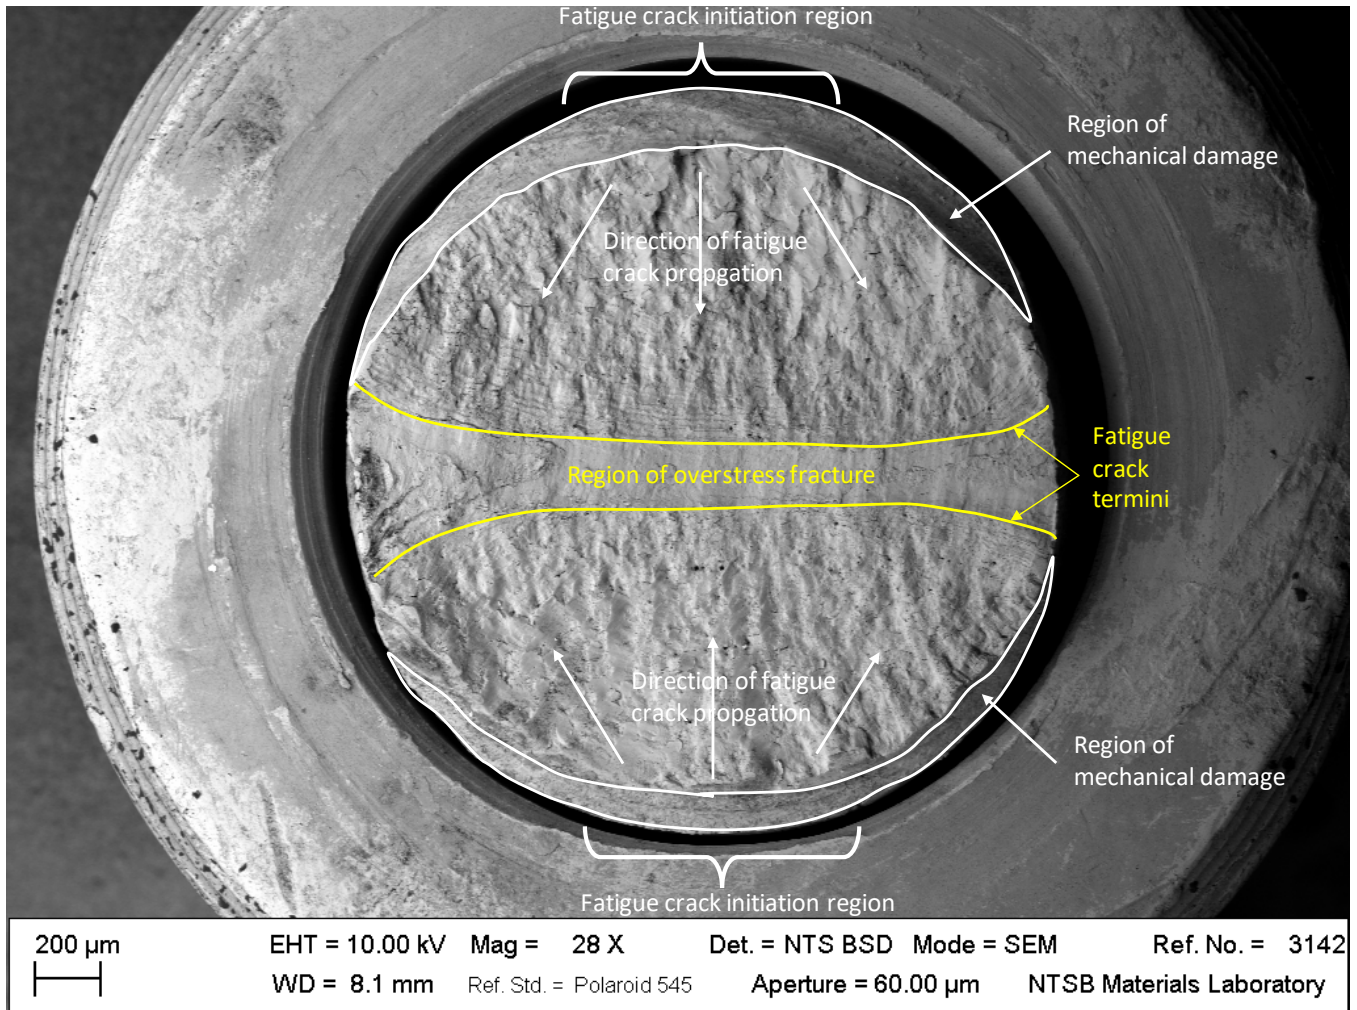
Figure 11 Backscatter scanning electron fractograph of the rivet shank fracture surface, annotated to identify key fracture surface features.

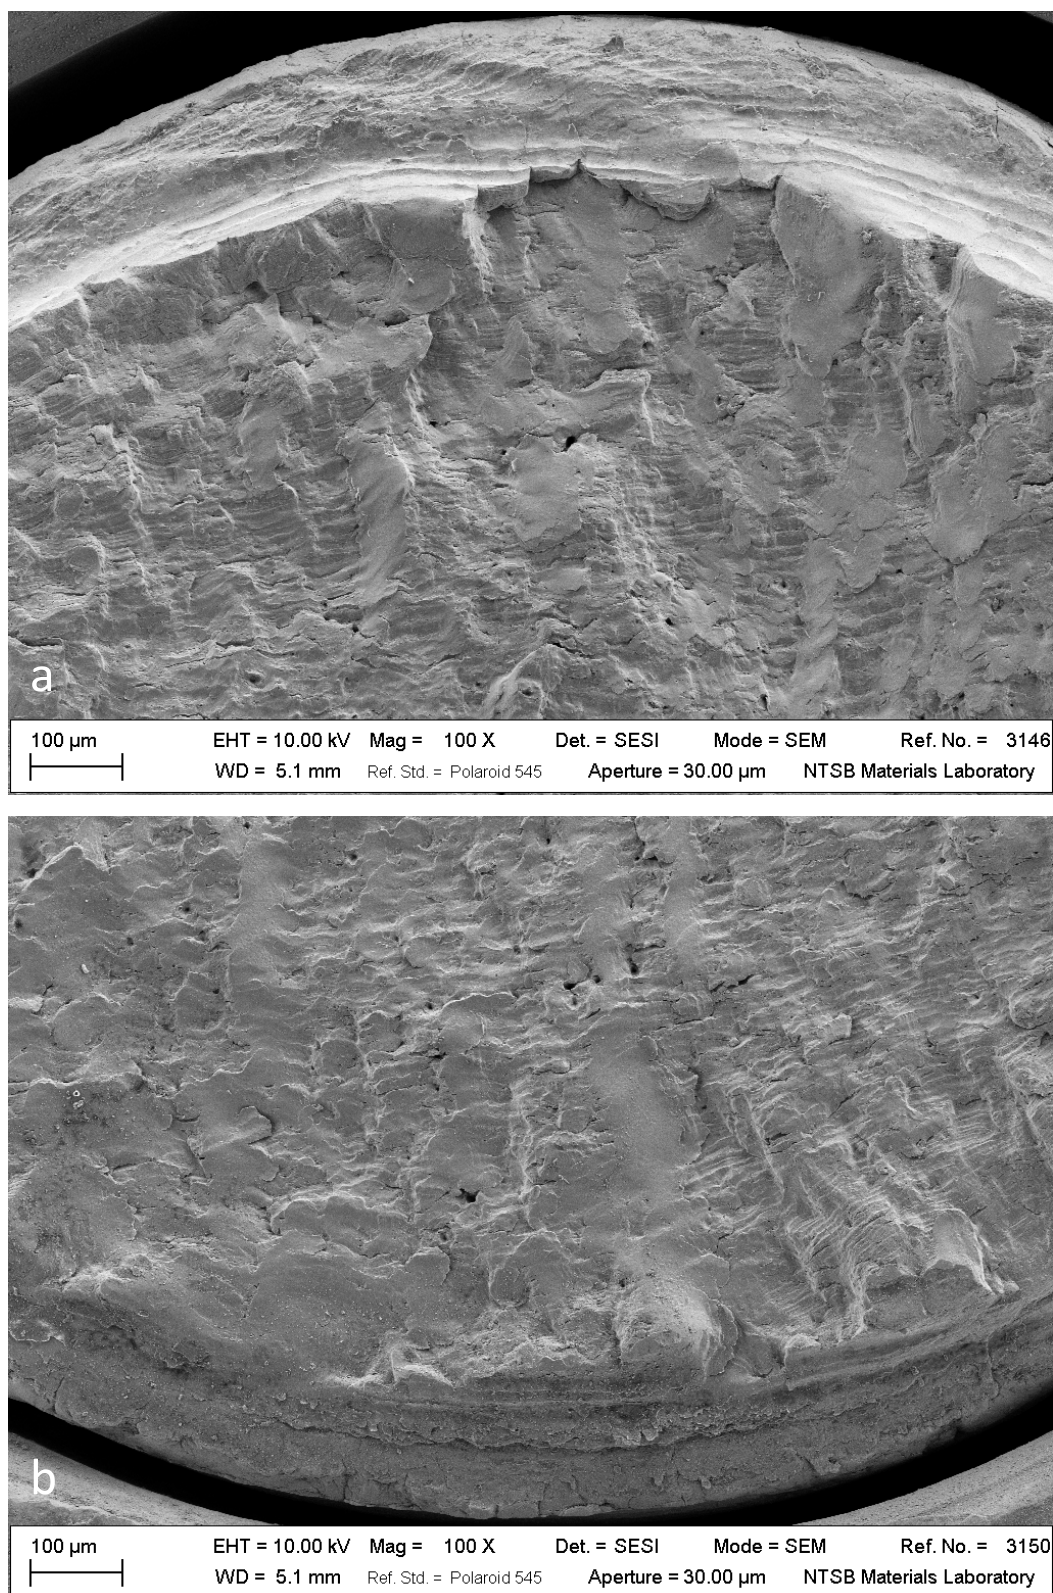
Figure 12 Secondary electron scanning electron fractographs of the two initiation regions identified in Figure 11.

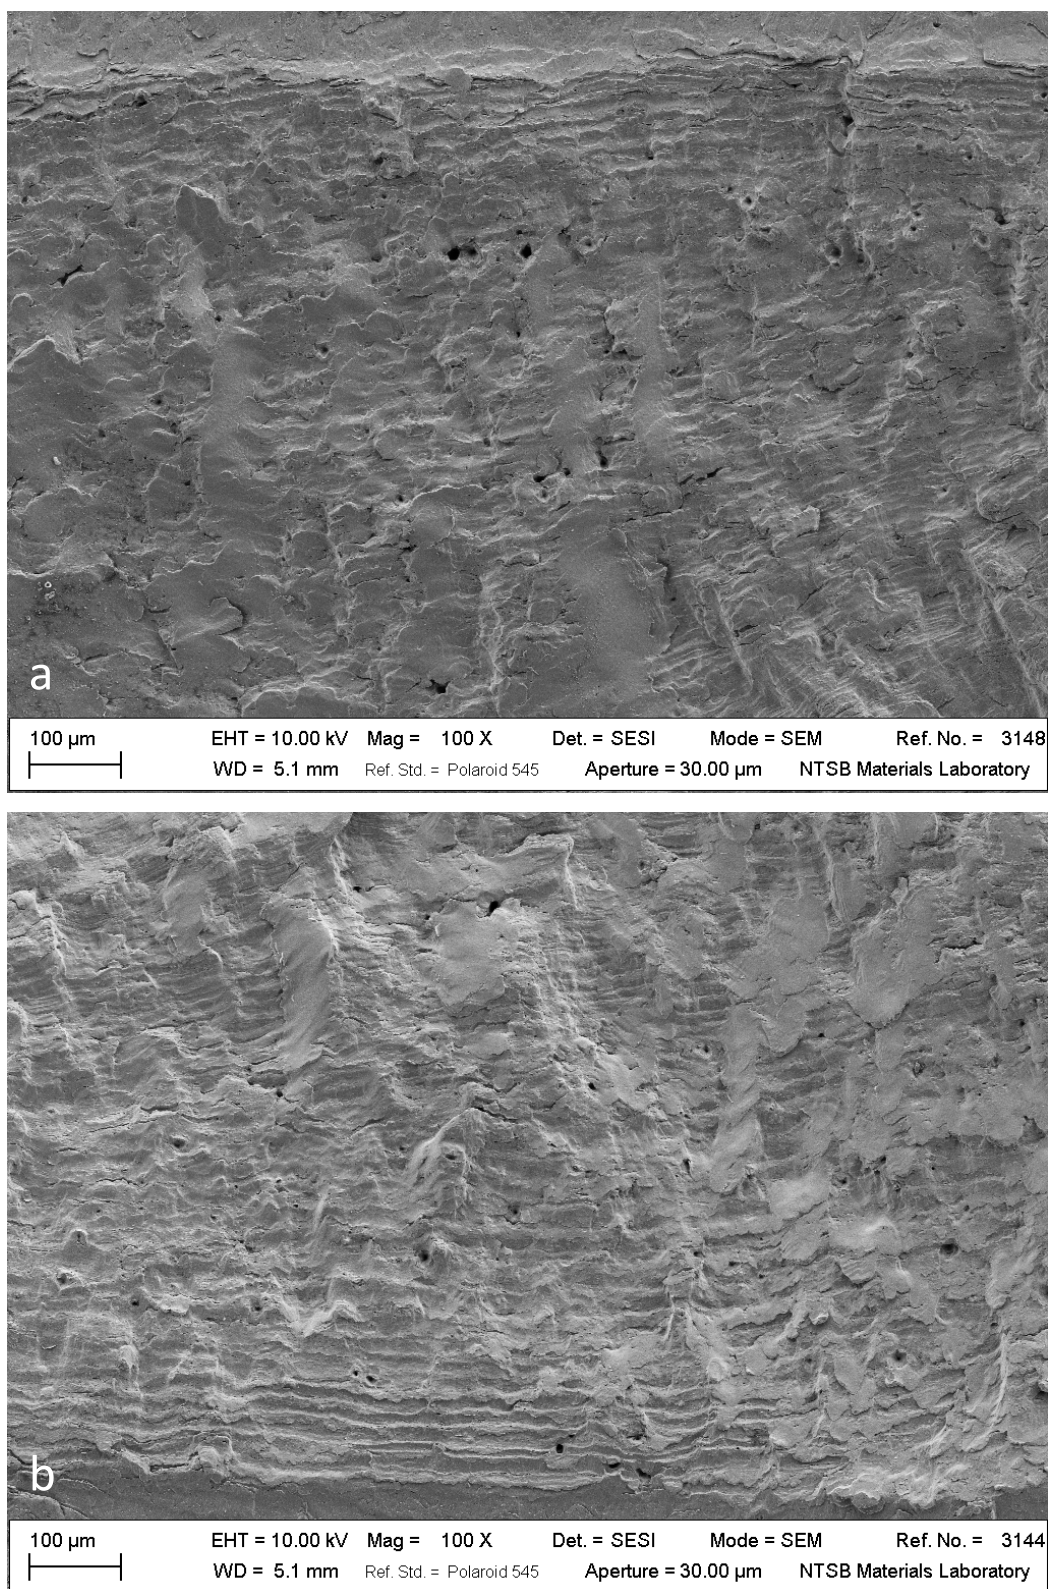
Figure 13 Closer secondary electron scanning electron fractographs of the two initiation regions identified in Figure 11.

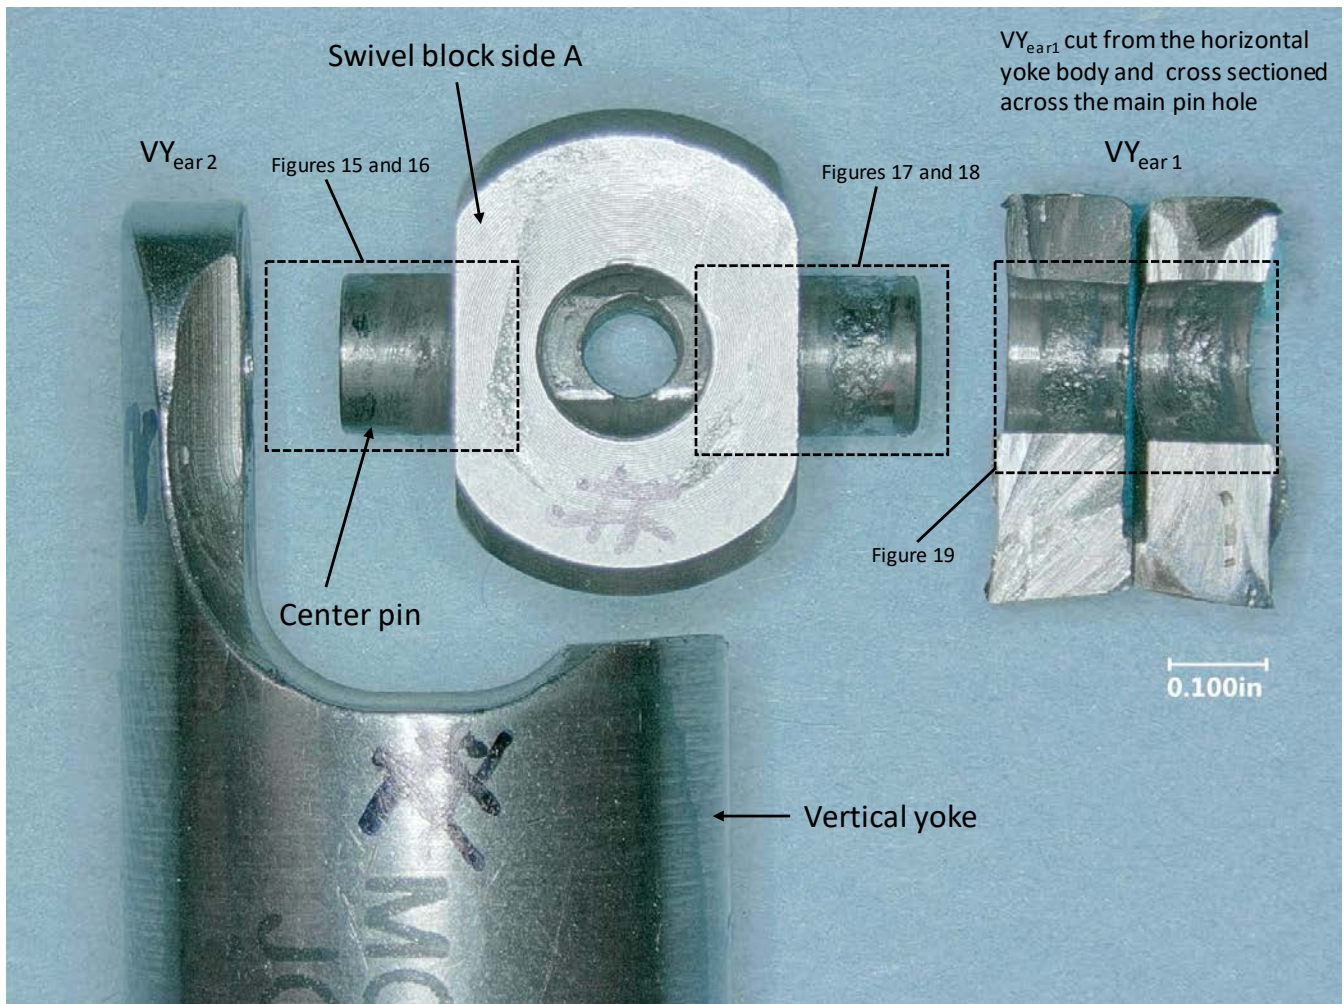
Ear VY<sub>ear 1</sub> was cut from the horizontal yoke as indicated in Figure 14. After cutting, the swivel block, center pin, and ear VY<sub>ear 1</sub> could be removed from the horizontal yoke subassembly as the center pin could be directly slid from ear VY<sub>ear 2</sub>. The center pin portion that mated with VY<sub>ear 2</sub> exhibited wear debris and material loss consistent with adhesive wear (see Figures 15 and 16). The hole in VY<sub>ear 2</sub> exhibited similar adhesive wear scars and wear debris deposits.

Figure 14 View of the swivel block and center pin sub-assembly as-removed from the vertical yoke assembly. Ear VY<sub>ear1</sub> was transversely sectioned from the vertical yoke then cut longitudinally to reveal the surfaces of the cross-drilled hole and the center pin.

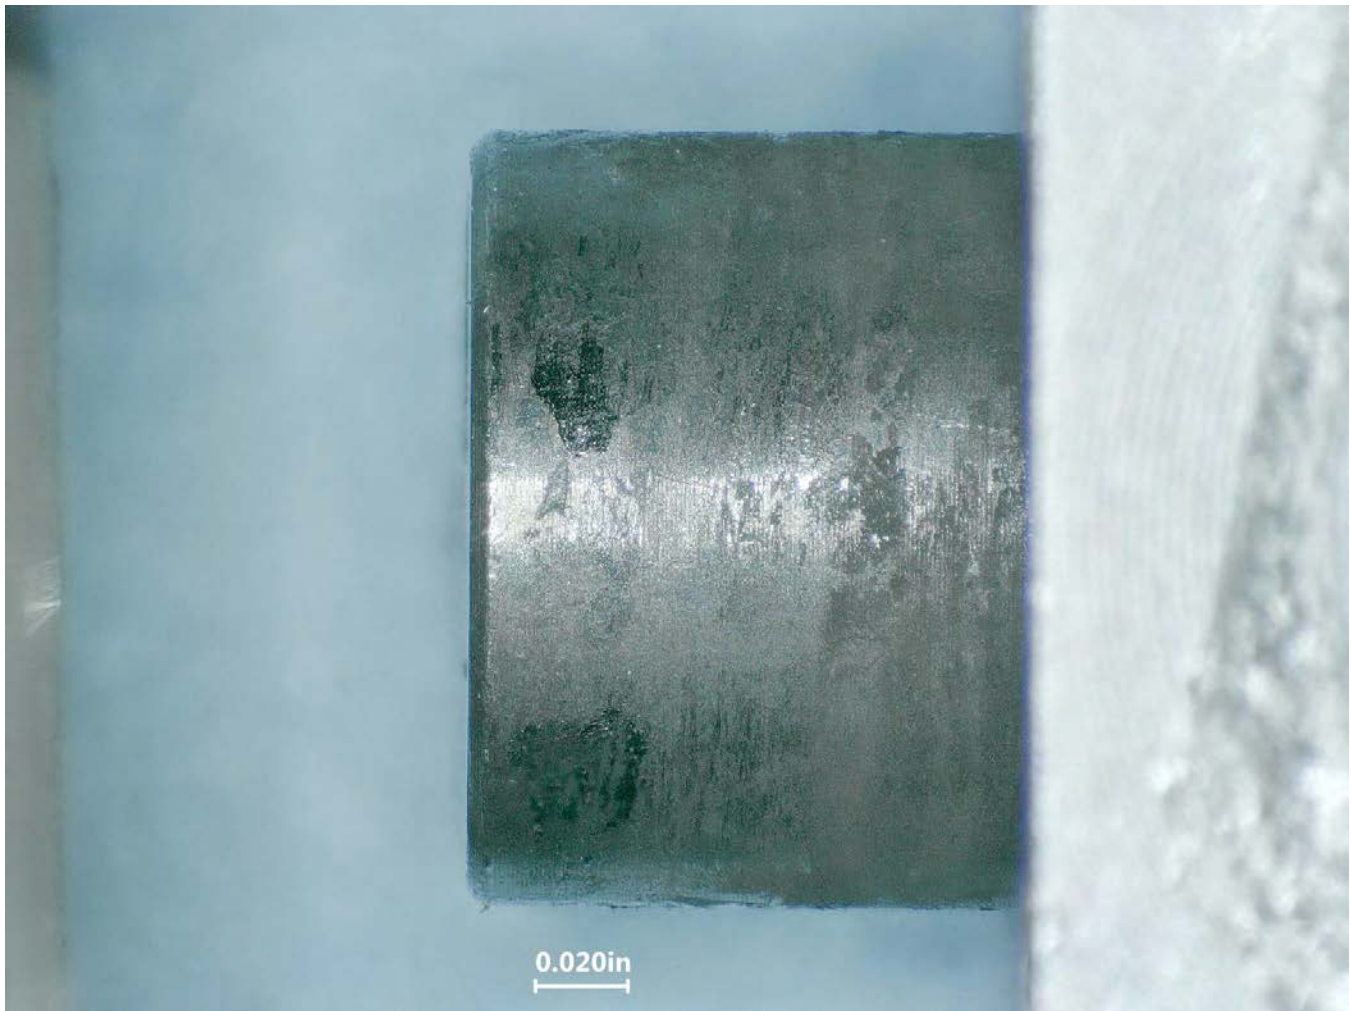
Figure 15 Digital microscope image of the center pin portion that is inserted into the cross-drilled hole in ear VY<sub>ear2</sub> (see Figure 14).
