# NATIONAL TRANSPORTATION SAFETY BOARD

## MATERIALS LABORATORY FACTUAL REPORT

Report No. 17-094

Place : Harvard, Illinois  
Date : November 8, 2017  
Vehicle : Cessna 170  
NTSB No. : CEN18LA044  
Investigator : Jennifer Rodi

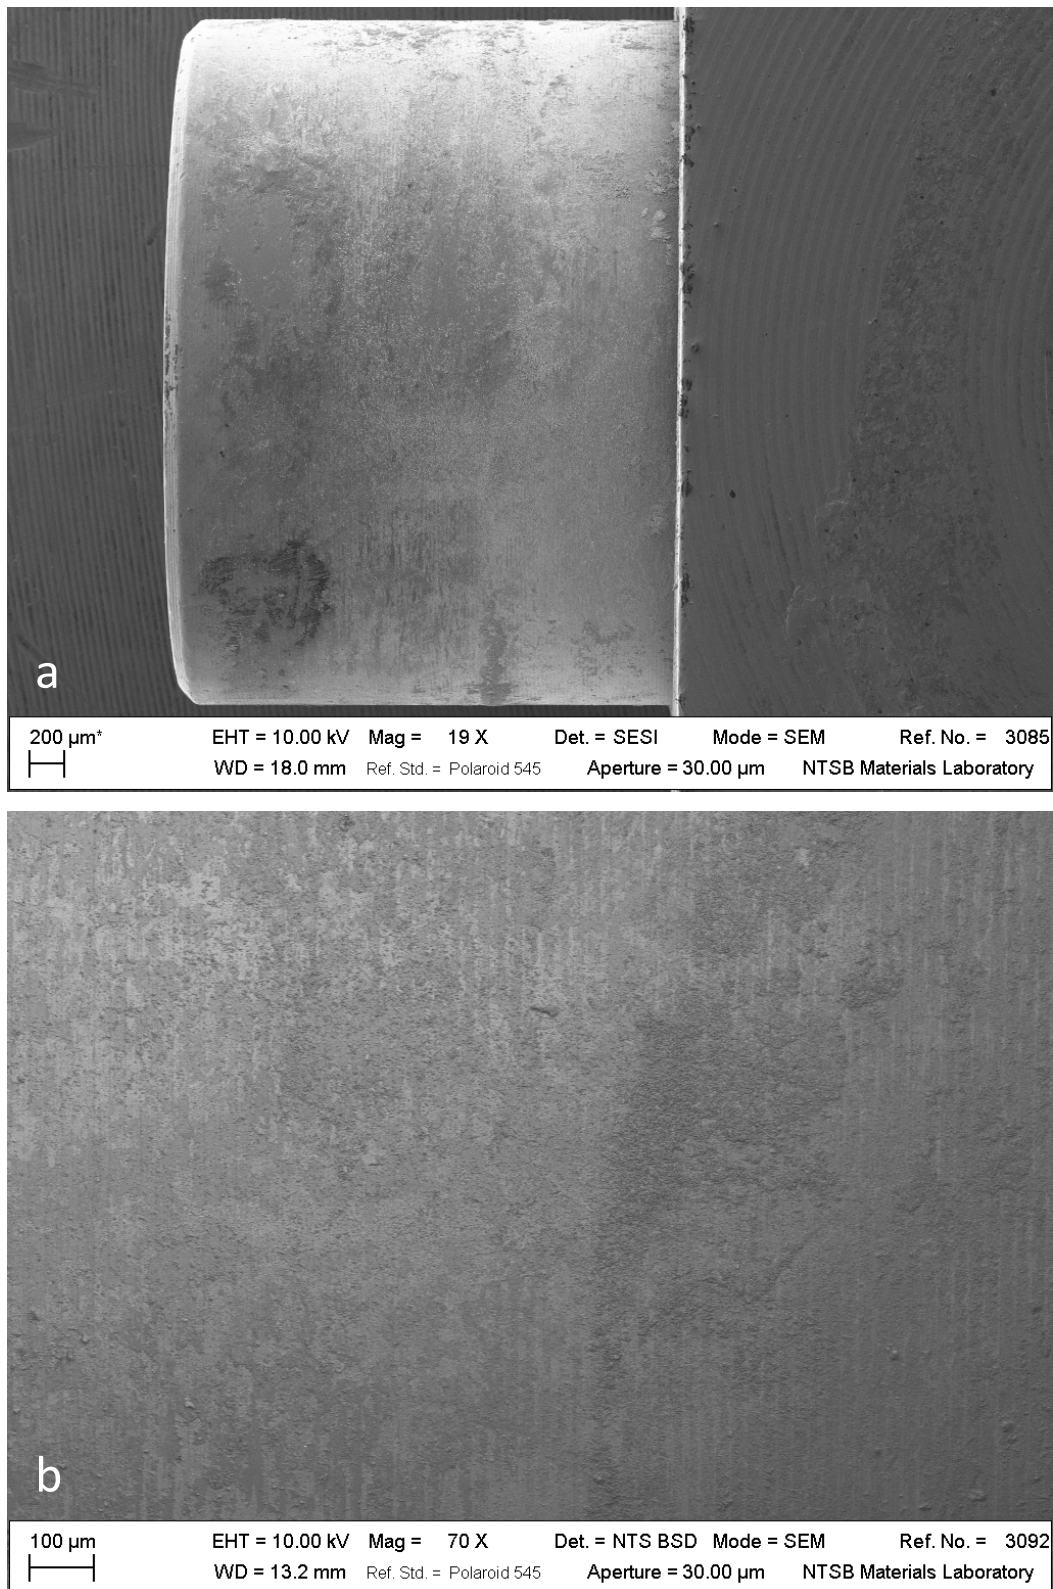
Ear VY<sub>ear 1</sub> was cut from the horizontal yoke as indicated in Figure 14. After cutting, the swivel block, center pin, and ear VY<sub>ear 1</sub> could be removed from the horizontal yoke subassembly as the center pin could be directly slid from ear VY<sub>ear 2</sub>. The center pin portion that mated with VY<sub>ear 2</sub> exhibited wear debris and material loss consistent with adhesive wear (see Figures 15 and 16). The hole in VY<sub>ear 2</sub> exhibited similar adhesive wear scars and wear debris deposits.

Figure 16 Secondary electron (view a) and backscattered electron (view b) scanning electron microscope images of the center pin portion that is inserted into the cross-drilled hole in ear VY<sub>ear2</sub> (see Figure 14).

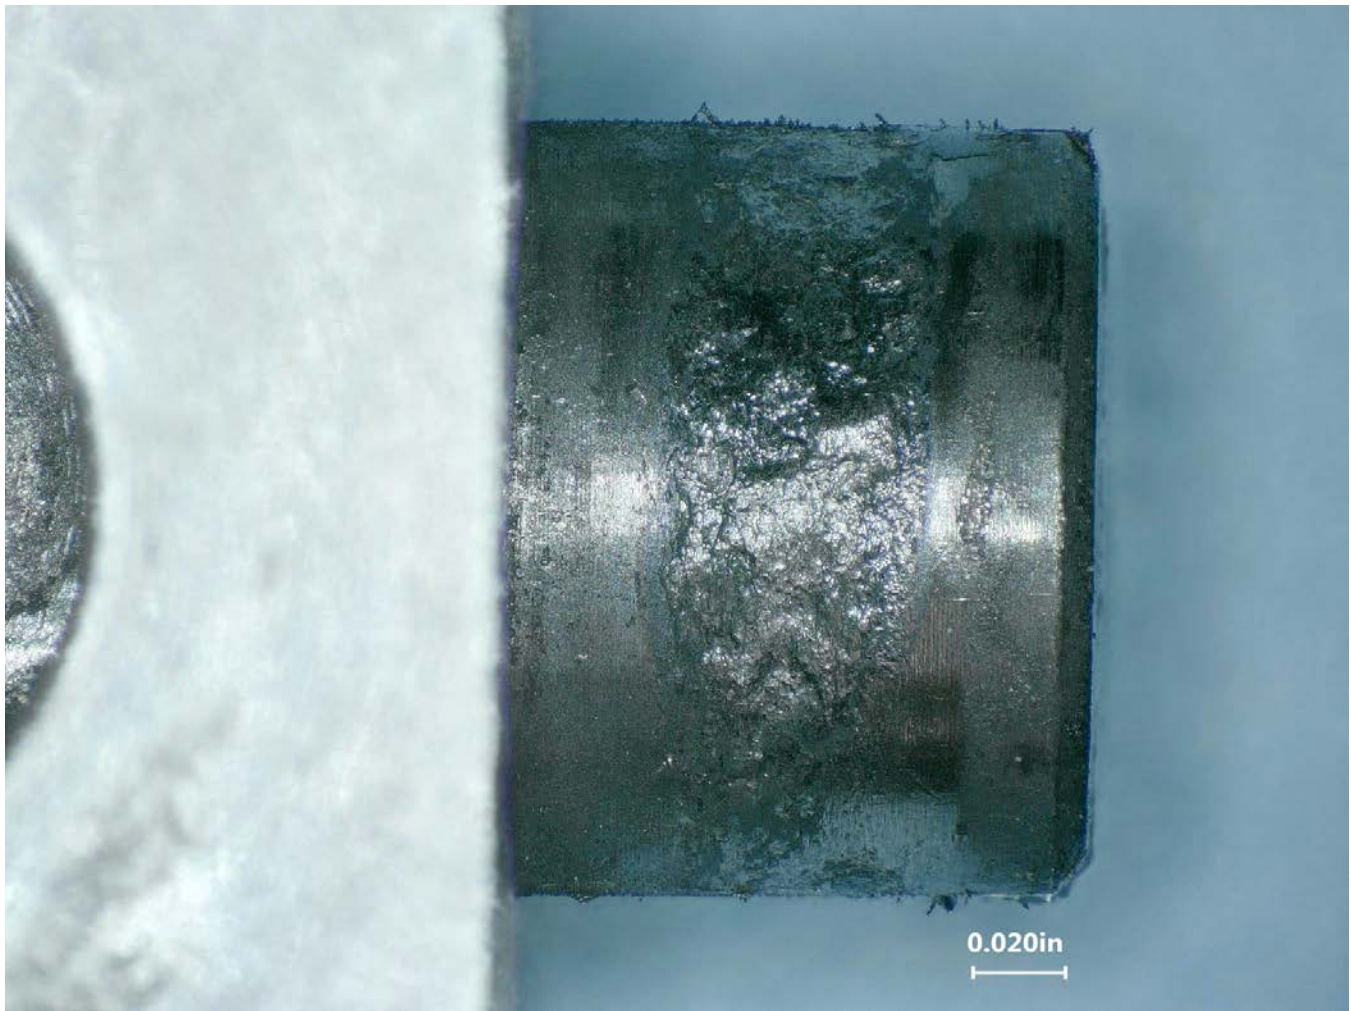
Ear VY<sub>ear 1</sub> would not spin freely about the center pin with any amount of hand force. To reveal the surface condition of the center pin in the ear VY<sub>ear 1</sub> hole, the ear and center pin were longitudinally cross-sectioned to allow the two halves of the VY<sub>ear 1</sub> ear to be removed (see Figures 17 and 18). The center pin portion that mated with VY<sub>ear 1</sub> exhibited wear debris, material loss and excrescence features consistent with adhesive and galling wear. The hole in VY<sub>ear 1</sub> exhibited similar adhesive and galling wear scars and wear debris deposits (see Figure 19).

Figure 17 Digital microscope image of the center pin portion that is inserted into the cross-drilled hole in ear VY<sub>ear1</sub> (see Figure 14).

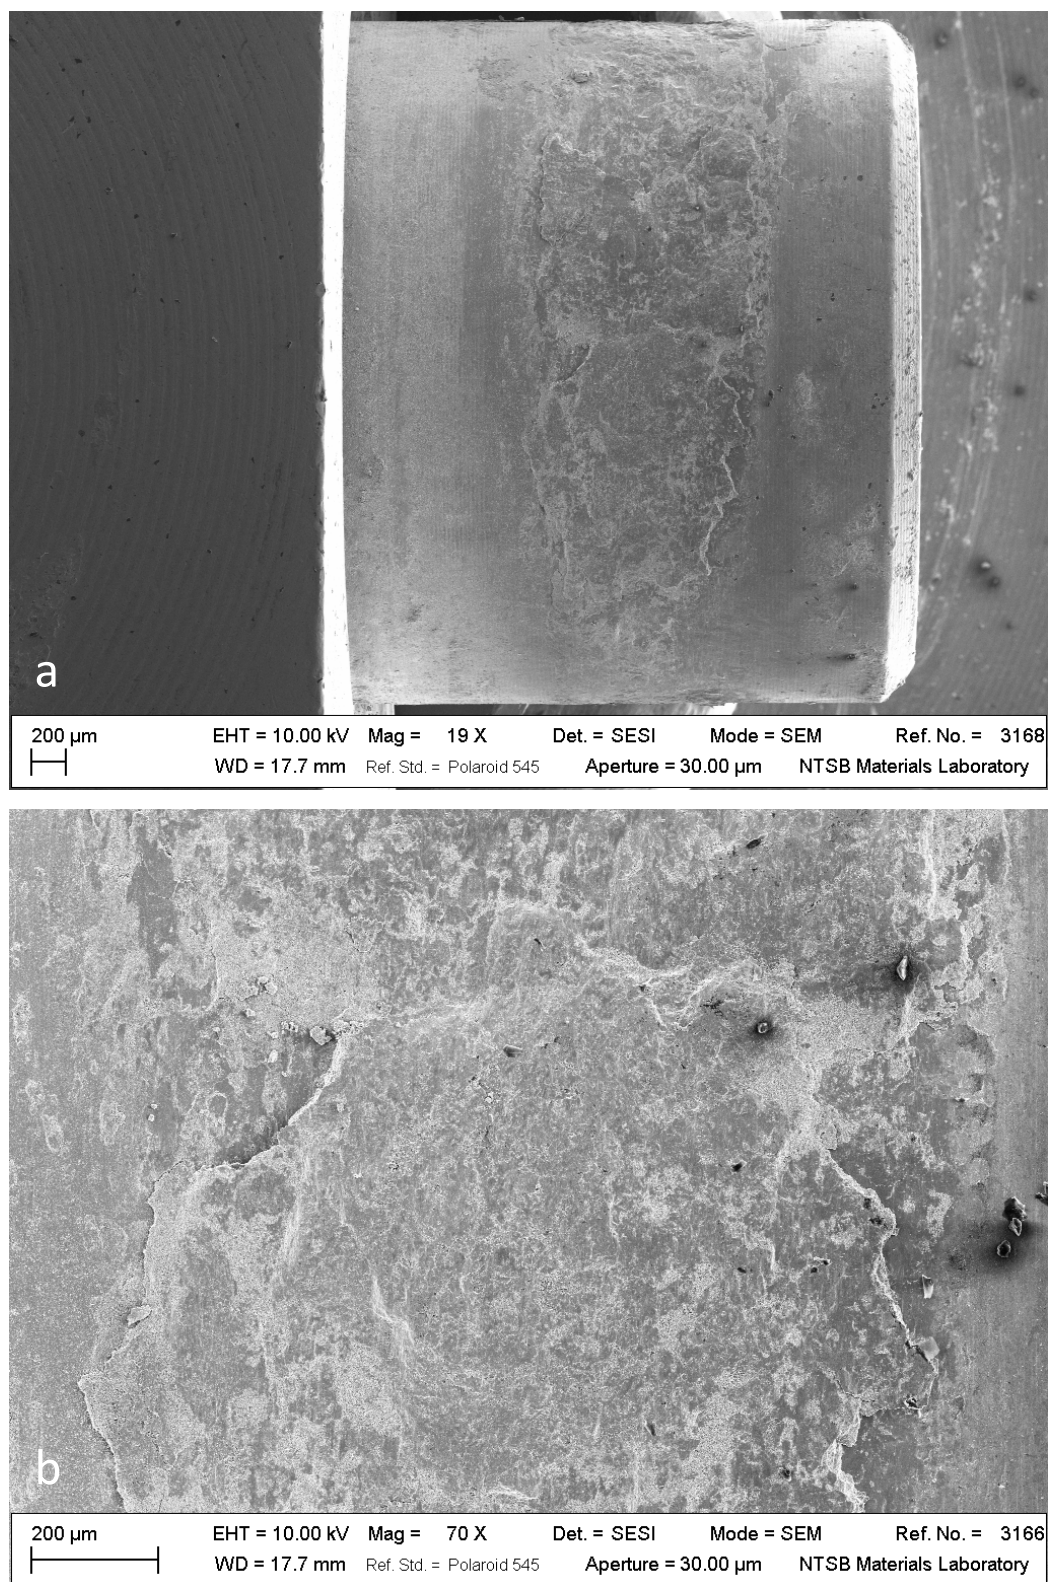
Figure 18 Secondary electron scanning electron microscope images of the center pin portion that is inserted into the cross-drilled hole in ear VY<sub>ear1</sub> (see figure 14).

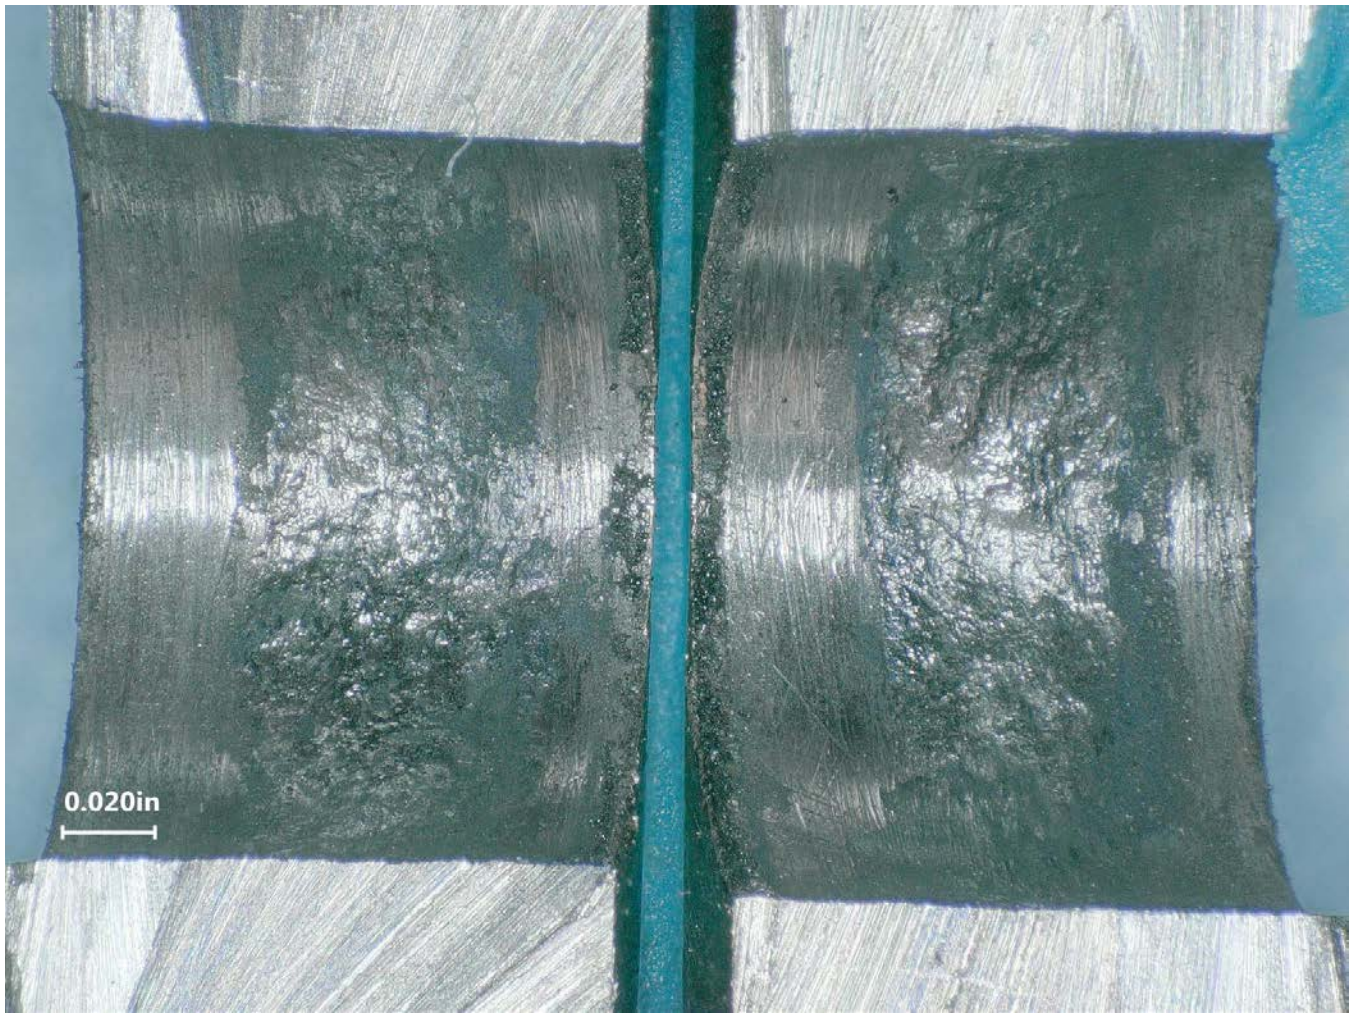
Figure 19 Digital microscope image of surfaces of the cross-drilled hole in ear VY<sub>ear1</sub> (see Figure 14).
