**Accident / Incident Report**

**Report No.: 17-183**

[REDACTED]  
Beech C90, N500KR  
Rockford, Illinois  
December 4<sup>th</sup> 2017  
PT6A-21  
Left-hand S/N 24390  
Right-hand S/N 24387

**Date of Issue:** May 25, 2018

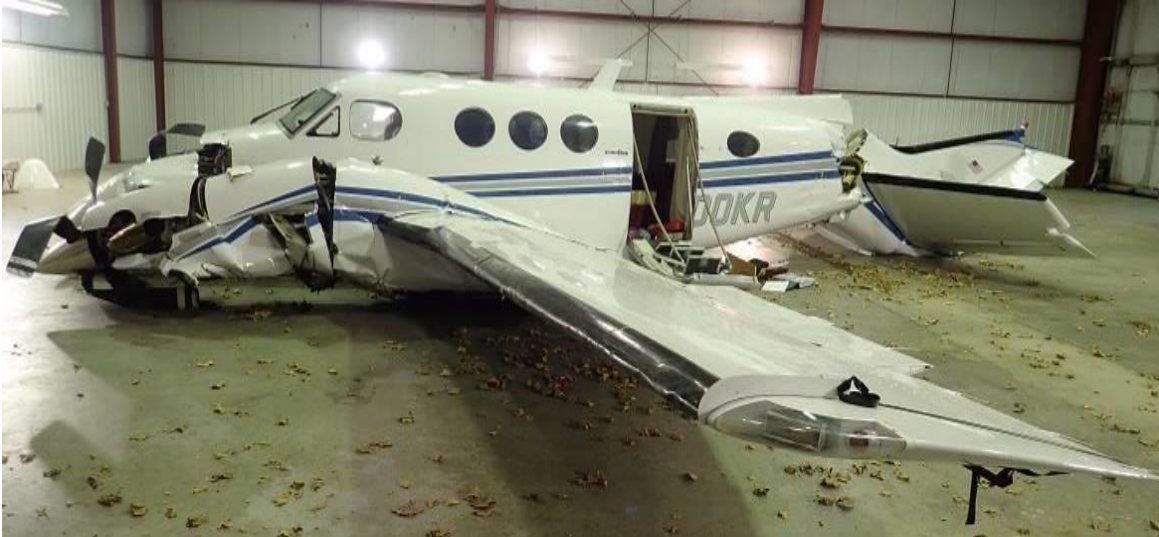
Photo No. 1

- 3.1 External Condition:** The propeller blades displayed varying degrees of bending and the aircraft cowling was bent and distorted at numerous locations (Ref. Photos No. 1 & 2). The engine was attached to the aircraft mounts (Ref. Photo No. 3). The engine data plate shows the engine serial number is PC-E 24390 (Ref. Photo No. 4).

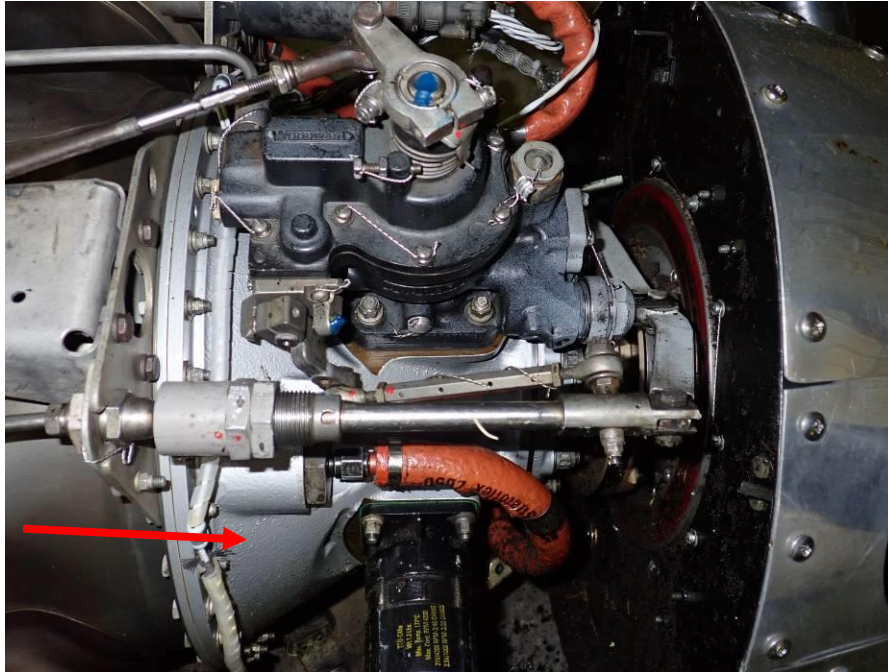
Photo No. 5

**Reduction Gearbox:** The gearbox was in place and no visible external damage was evident (Ref. Photo No. 5, red arrow).

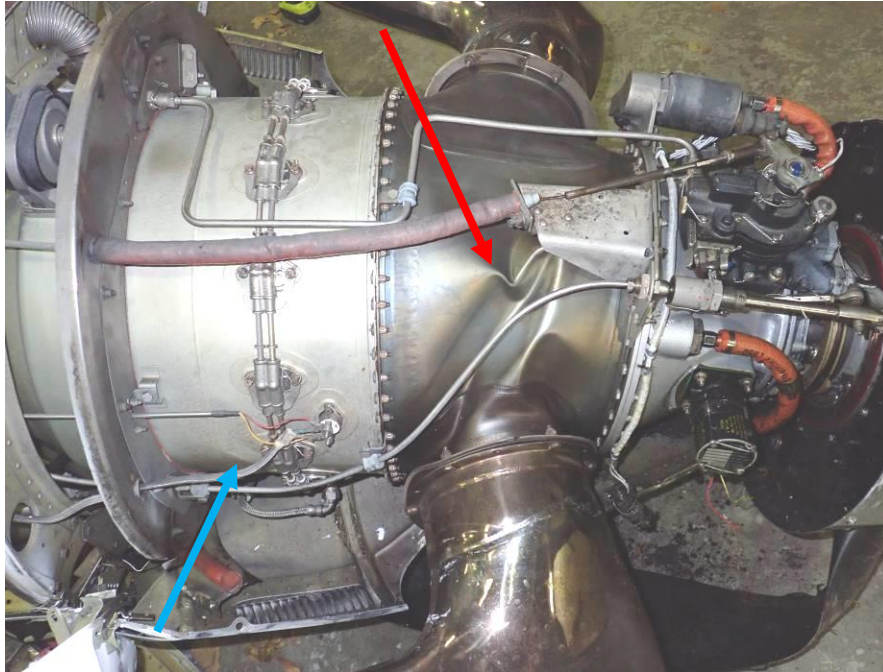
Photo No. 6

The left and right hand engines both sustained compressional damage to their exhaust ducts and the gas generator cases were bent during impact.

**Exhaust Duct:** The right hand side of the duct was compressed (Ref. Photo No. 6, red arrow).

**Gas Generator Case:** The case was bent adjacent to the right hand igniter plug (Ref. Photo No. 6, blue arrow). The visible portion of the rear section of the case was unremarkable (Ref. Photo No. 7, blue arrow).

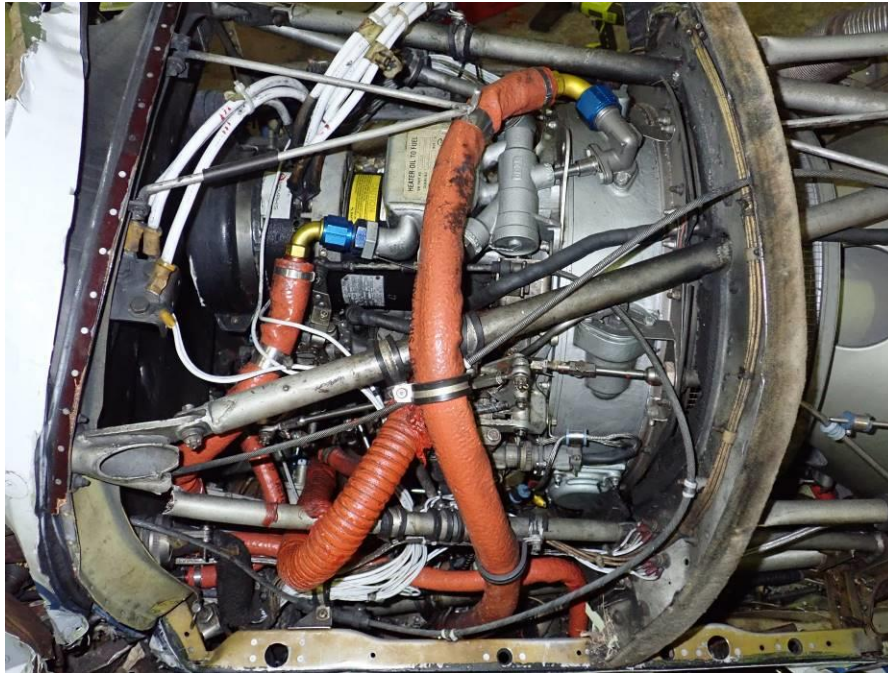
Photo No. 8

**Accessory Gearbox:** The gearbox and inlet case were in place and no visible external damage was evident (Ref. Photo No. 8).

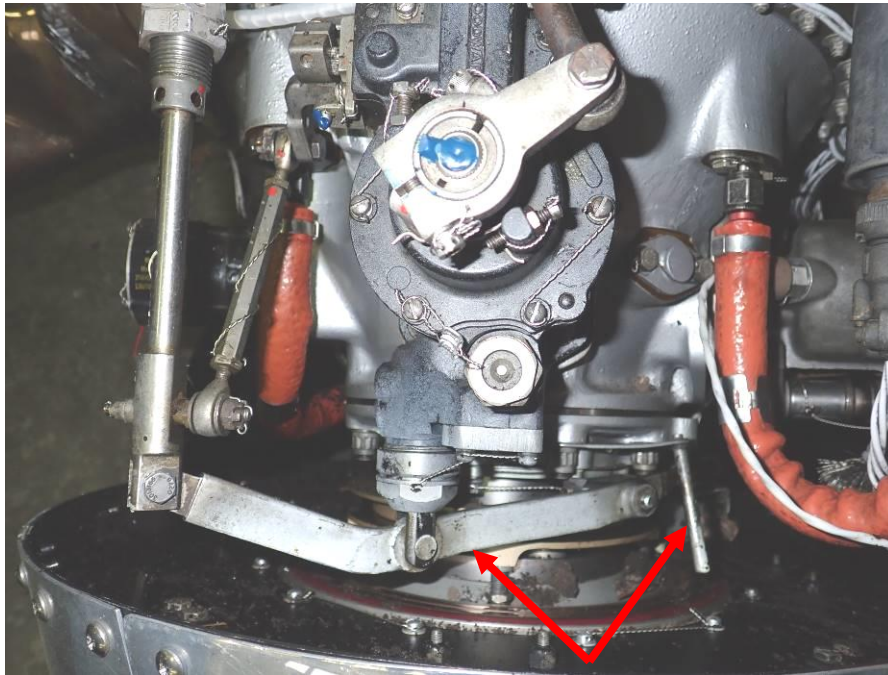
Photo No. 9

**3.1.2 Power Control and Reversing Linkage:** The propeller reversing lever and guide pin were bent (Ref. Photo No. 9, red arrows). The front linkage was in place (Ref. Photo No. 10, red arrow). The rear linkage was in place (Ref. Photo No. 11, red arrows). The end of the fuel control connection rod was bent (Ref. Photo No. 12, red arrow).

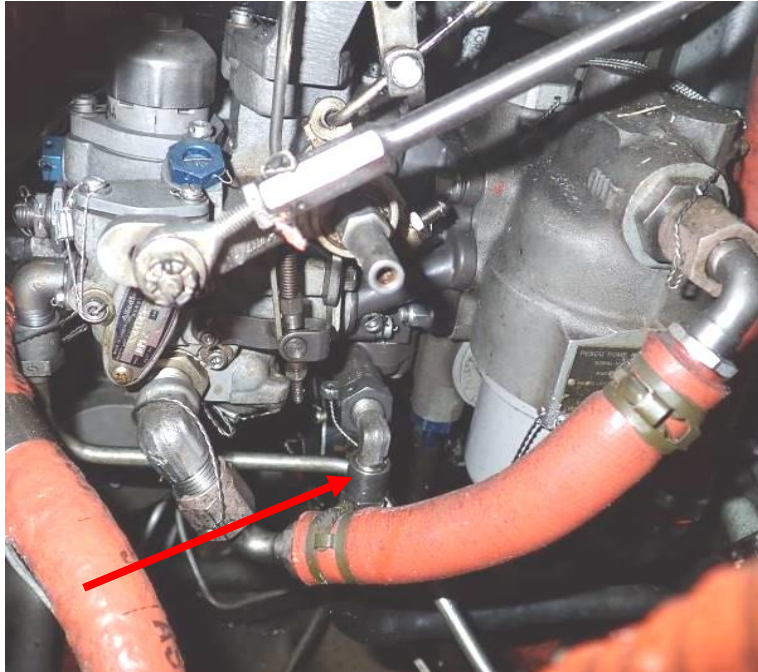
Photo No. 13

**Compressor Discharge Air (P3):** The line was in place and the fitting connections were secure (Ref. Photo No. 13, red arrow).

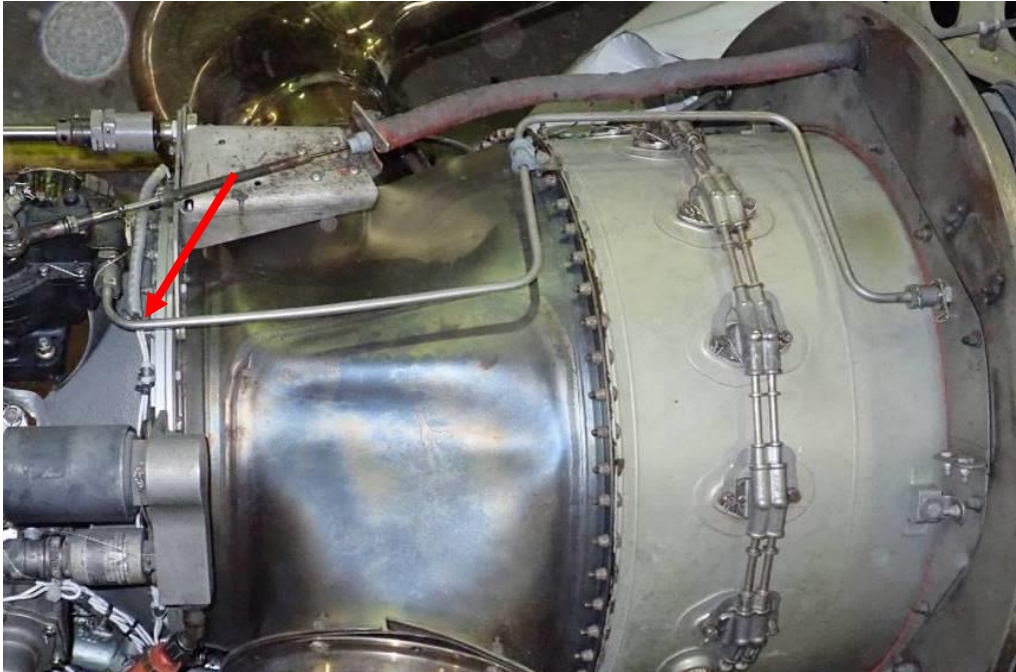
Photo No. 14

**Power Turbine Control (Py):** The line was in place and the fitting connections were secure (Ref. Photos No. 14 & 15, red arrows).

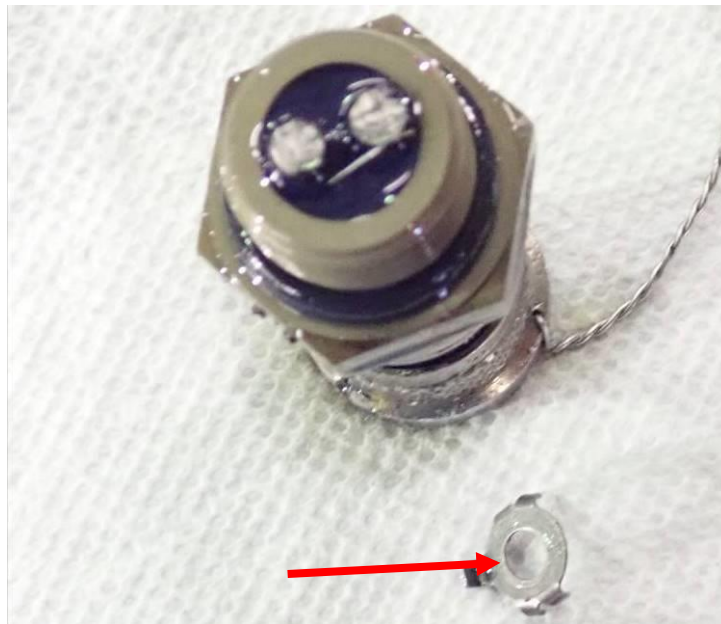
Photo No. 16

**Reduction Gearbox Chip Detector:** The chip detector was removed and a lock washer fell out of the gearbox port (Ref. Photo No. 16, red arrow). Some magnetic debris was adhered to the magnetic poles (Ref. Photo No. 17).

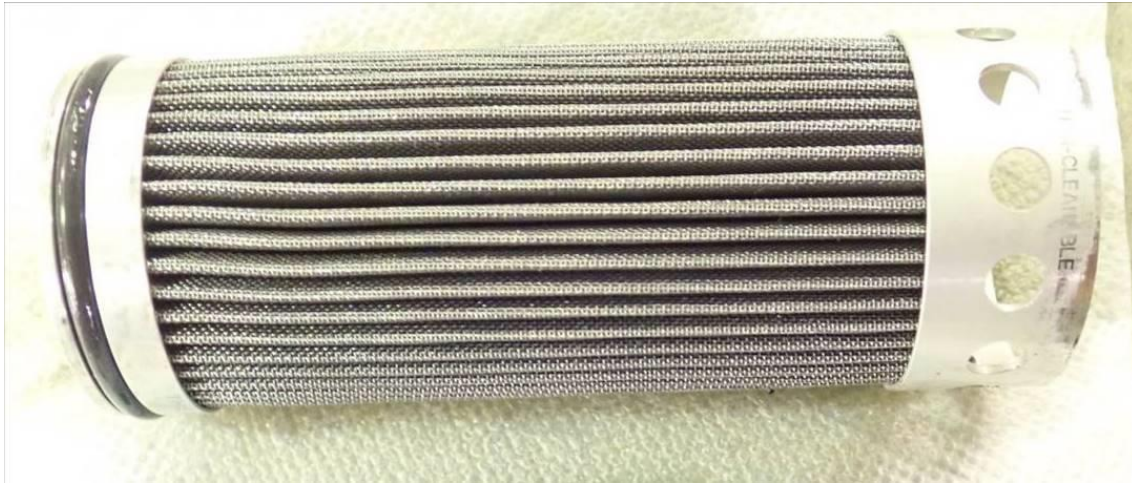
Photo No. 18

**Oil Filter:** No visible debris was evident in the oil filter (Ref. Photo No. 18).

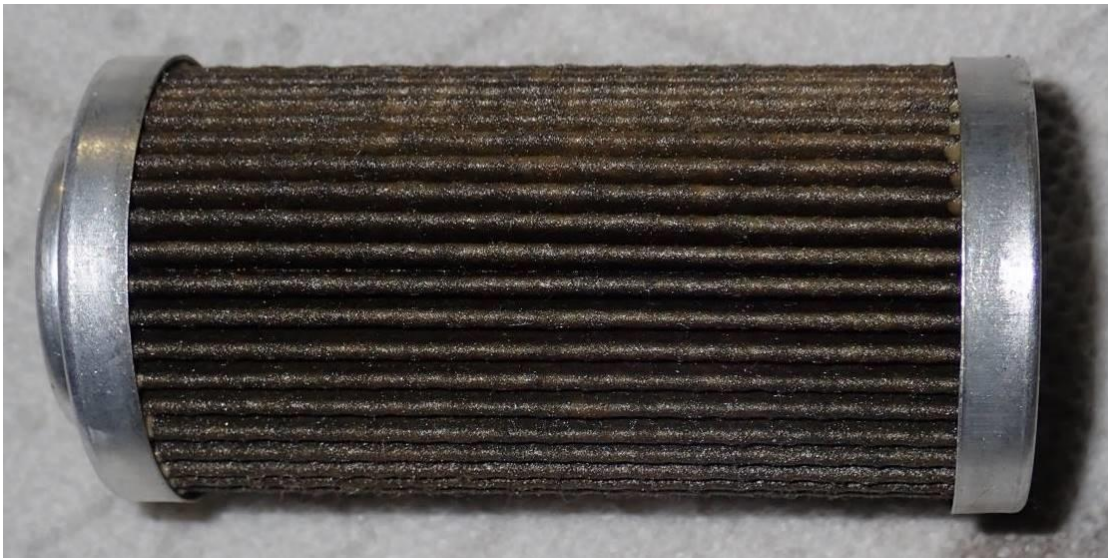
Photo No. 19

**Fuel Filter:** The filter was discoloured, most likely from sediment in the fuel (Ref. Photo No. 19). The residual fuel in the filter bowl was clean but the interior of the bowl was stained (Ref. Photo No. 20).

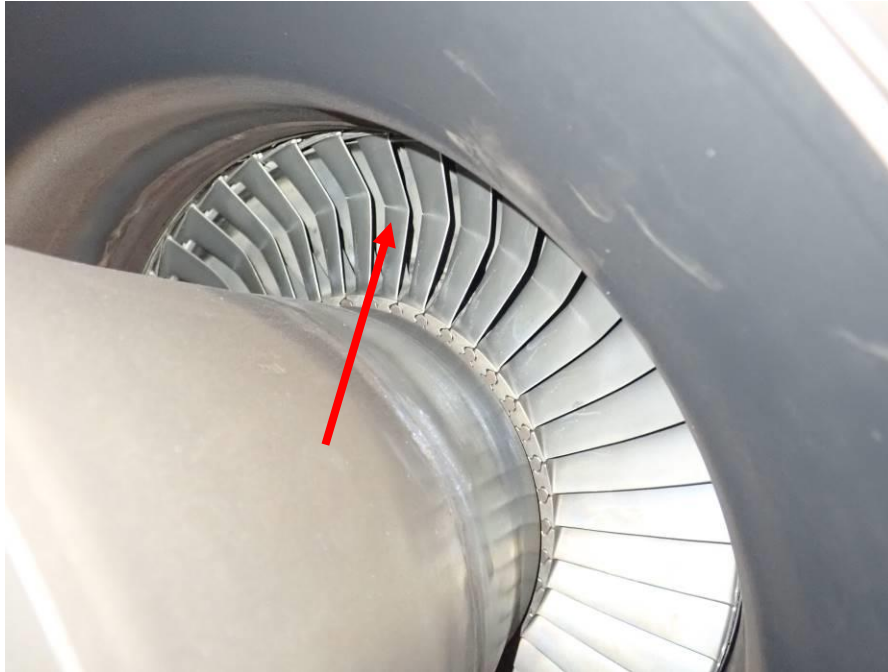
Photo No. 21

**Power Turbine:** The left hand exhaust stack was removed and the power turbine was viewed through the exhaust port. Several of the turbine blades were partially fractured (Ref. Photo No. 21, red arrow).

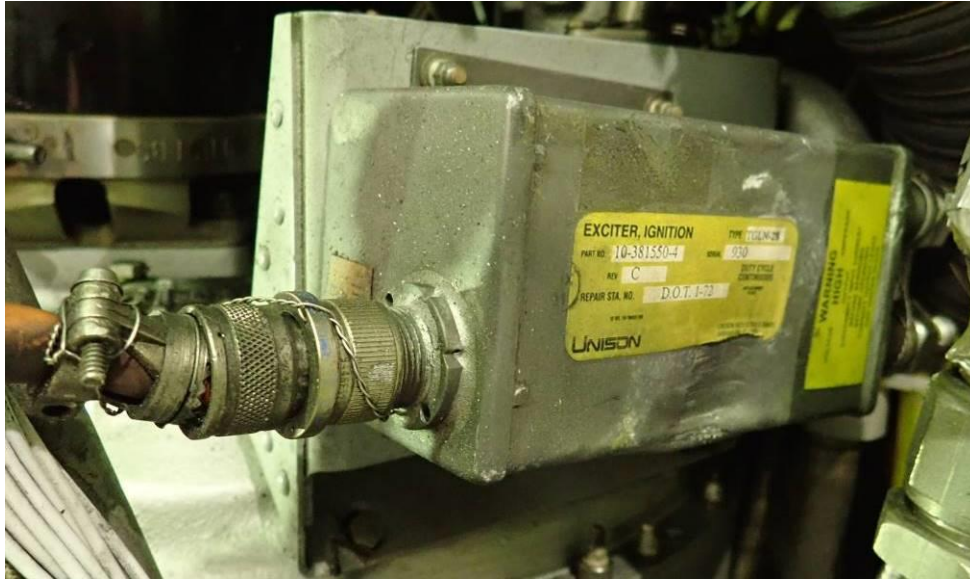
Photo No. 22

**Exciter Box:** The box was attached to its respective mount on the aircraft. The exterior of the box exhibited impact damage (Ref. Photo No. 22).

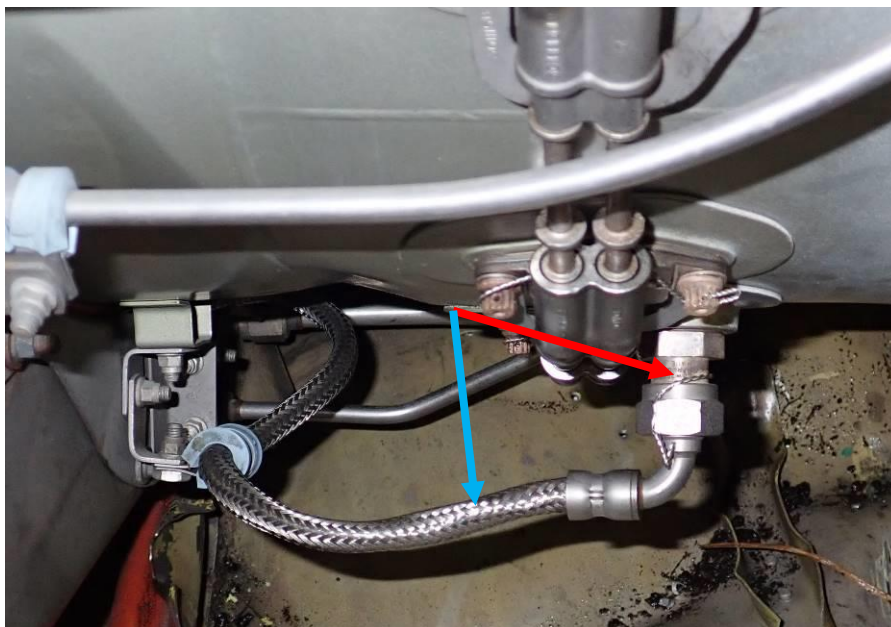
Photo No. 23

**Ignition Leads:** The leads were in place and did not display any visible distress (Ref. Photo No. 23, blue arrow).

**Ignition Plugs:** The plugs were in place and secure (Ref. Photo No. 23, red arrow).

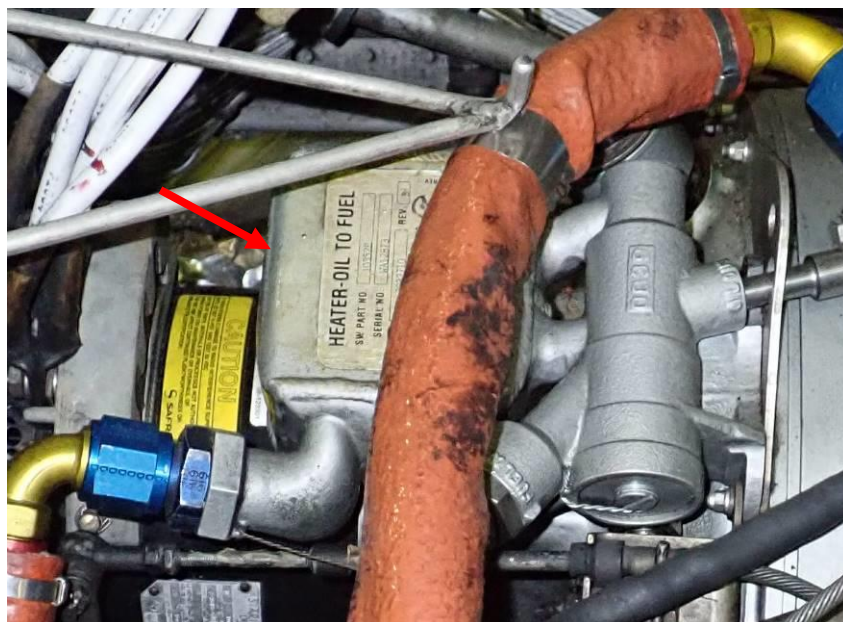
Photo No. 24

**Fuel Heater:** The heater was in place on the accessory gearbox (Ref. Photo No. 24, red arrow).

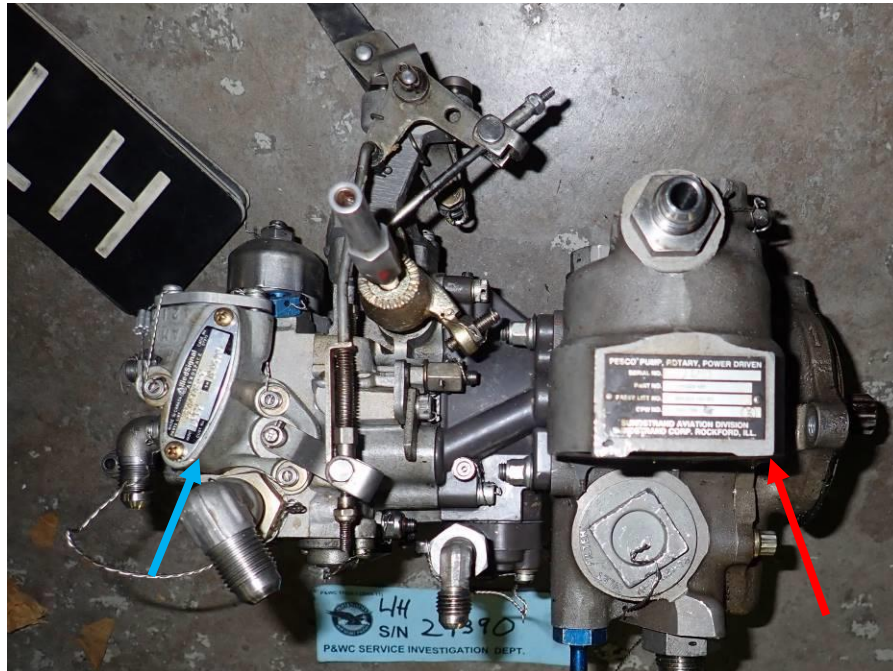
Photo No. 25

**Fuel Pump:** The pump was in place on its respective accessory gearbox mounting pad. The pump was removed (Ref. Photo No. 25, red arrow) from the gearbox and it was separated from the fuel control. The pump was capable of manual rotation. The inlet filter was removed, no contamination was noted, but the strainer portion was stained (Ref. Photo No. 26). The pump was disassembled (Ref. Photo No. 27).

**Fuel Control Unit:** The control was secured to the mounting pad on the fuel pump (Ref. Photo No. 25, blue arrow). The control was removed from the pump (Ref. Photo No. 34). The fuel control to fuel pump coupling was found unremarkable (Ref. Photo No. 34, red arrow). The control rotated freely with manual input on the drive shaft.

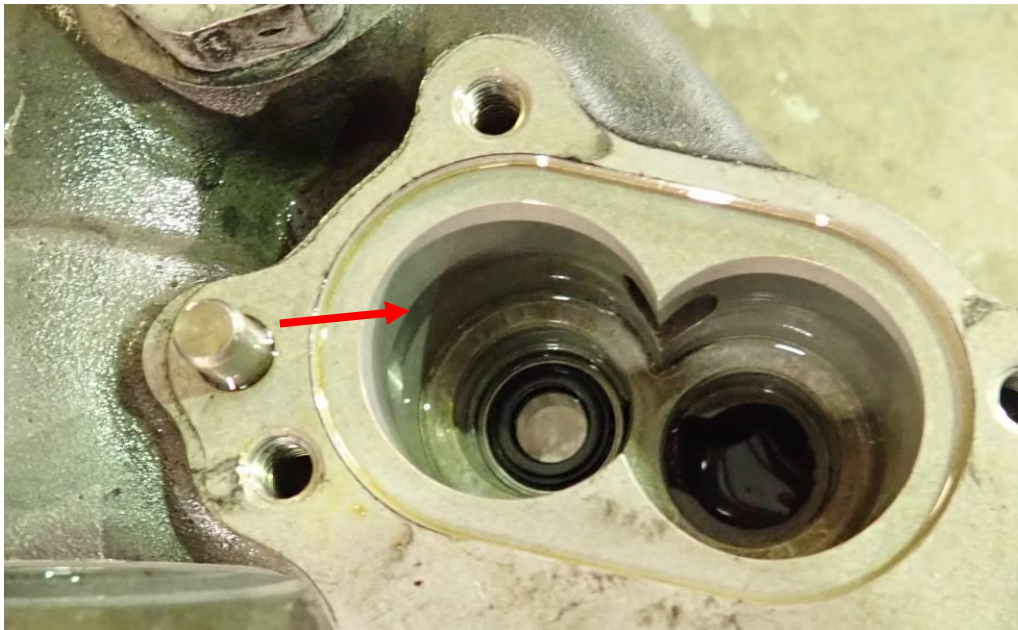
Photo No. 28

The left hand engine's fuel pump displayed cavitation pits on the front and rear plain bearings, the discoloration on the bearings, polishing of the housing and the scoring on the shafts indicates that the pump was operated without an adequate supply of fuel.

The fuel pump housing exhibited some polished regions from contact with the gears (Ref. Photo No. 28, red arrow). The teeth on both gears exhibited frosted regions on their contact surfaces (Ref. Photos No. 29 & 30). Light scoring was evident on the shaft bearing land surfaces of the gears (Ref. Photo No. 29).

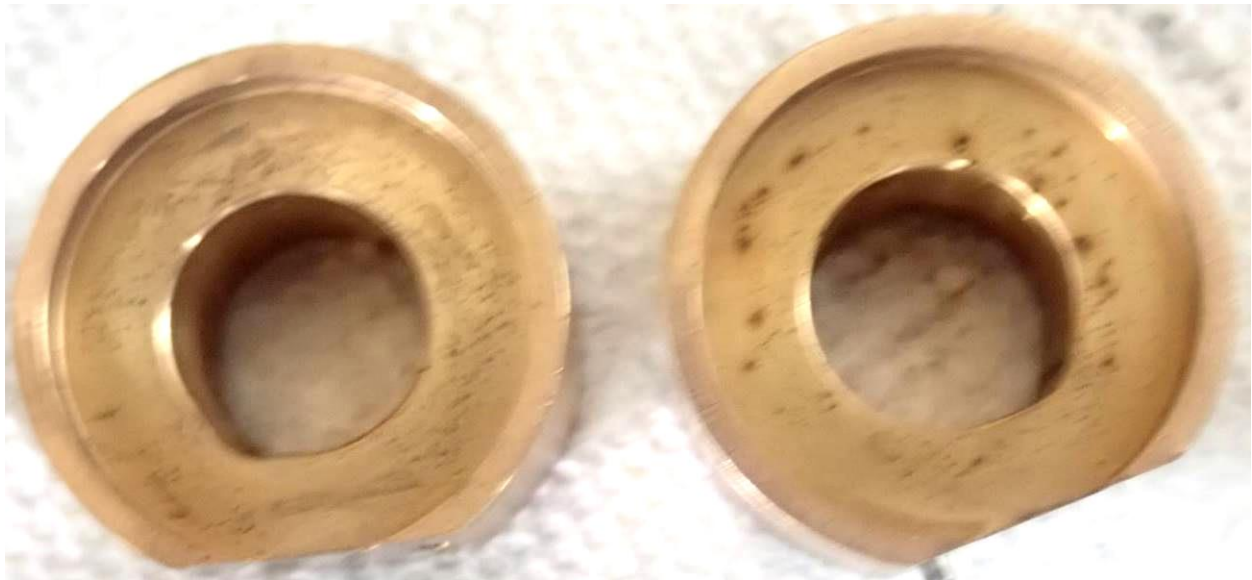
The fuel pumps from both engines exhibited evidence of cavitation from a lack of lubrication on the plain bearings. This damage is consistent with the pumps operating without an adequate fuel supply.

The front bearings exhibited multiple cavitation pits on their front face, which does not have contact with the gears (Ref. Photo No. 31). The bearings exhibited multiple cavitation pits on the gear contact faces and in the plain bearing bores (Ref. Photos No. 32 & 33). Some localized discoloration was observed adjacent to some of the pits. The pump surfaces are lubricated by the fuel passing through the pump. The bearing cavitation pits indicates that pump was operated without an adequate fuel supply.

Photo No. 31, Front bearings

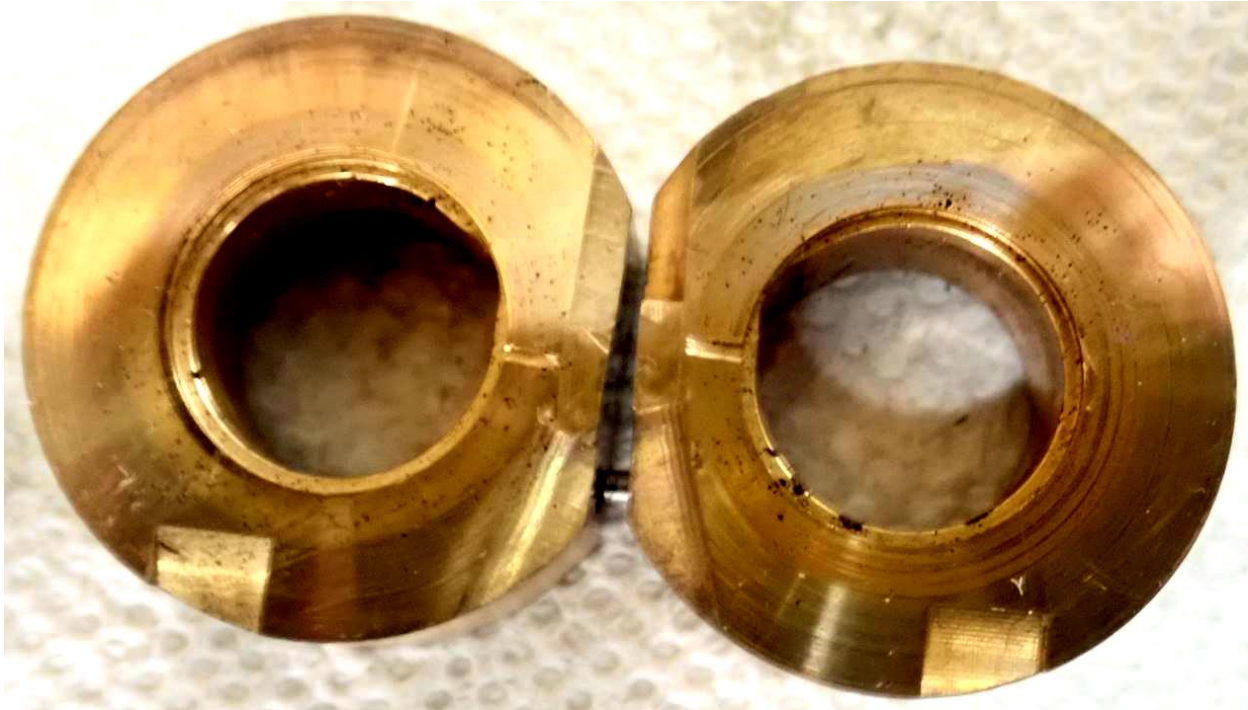
Photo No. 32, Front bearings

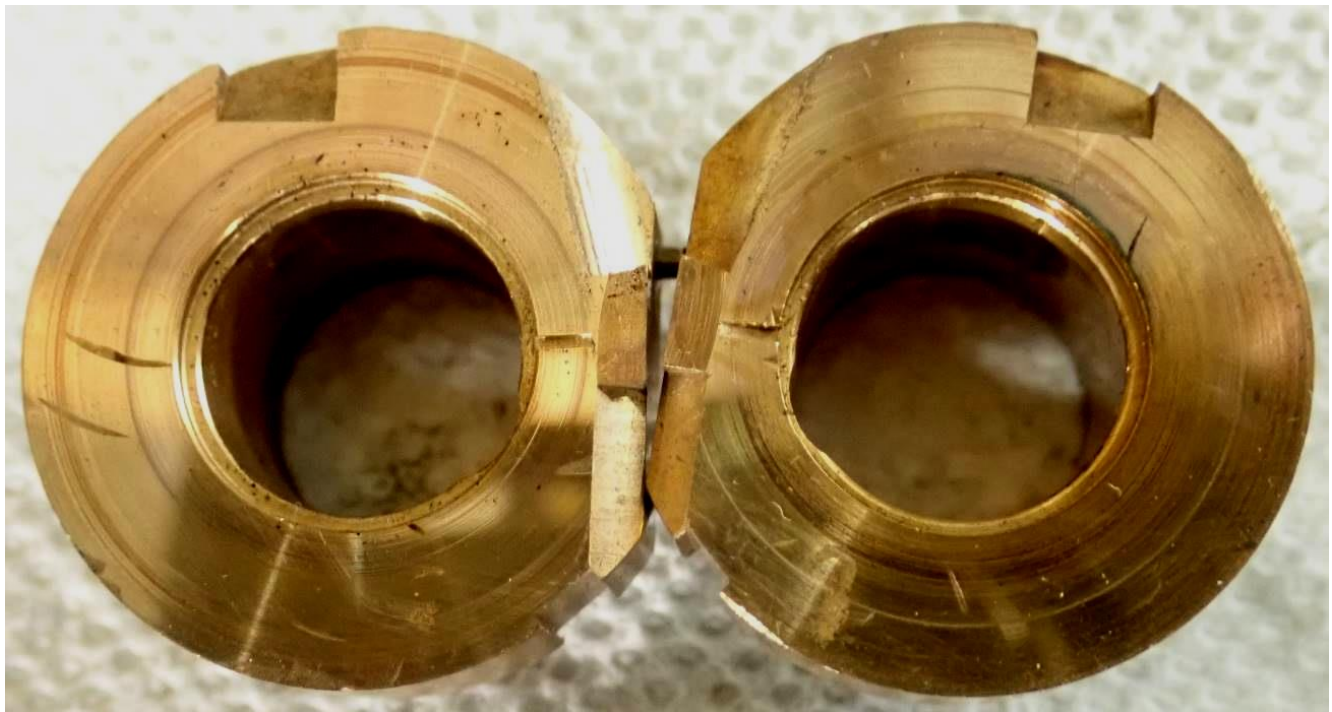
Photo No. 33, Rear bearings

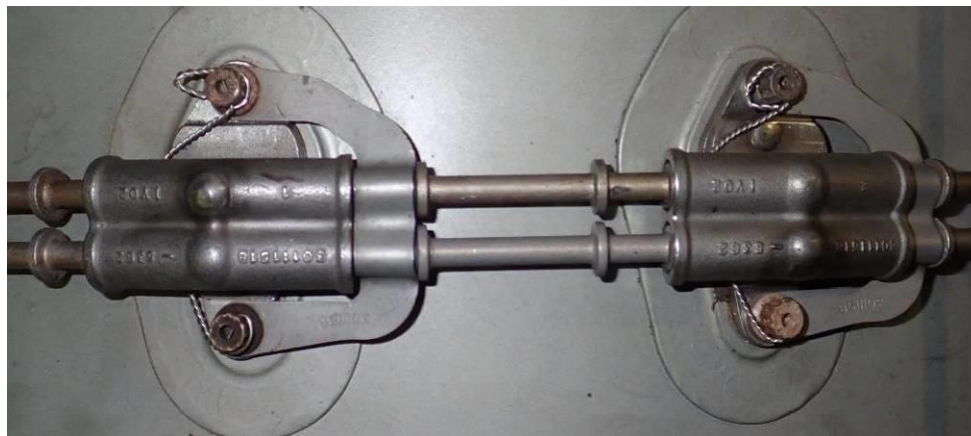
Photo No. 35

**Fuel Nozzles:** The nozzles were in place and were visually unremarkable (Ref. Photo No. 35).

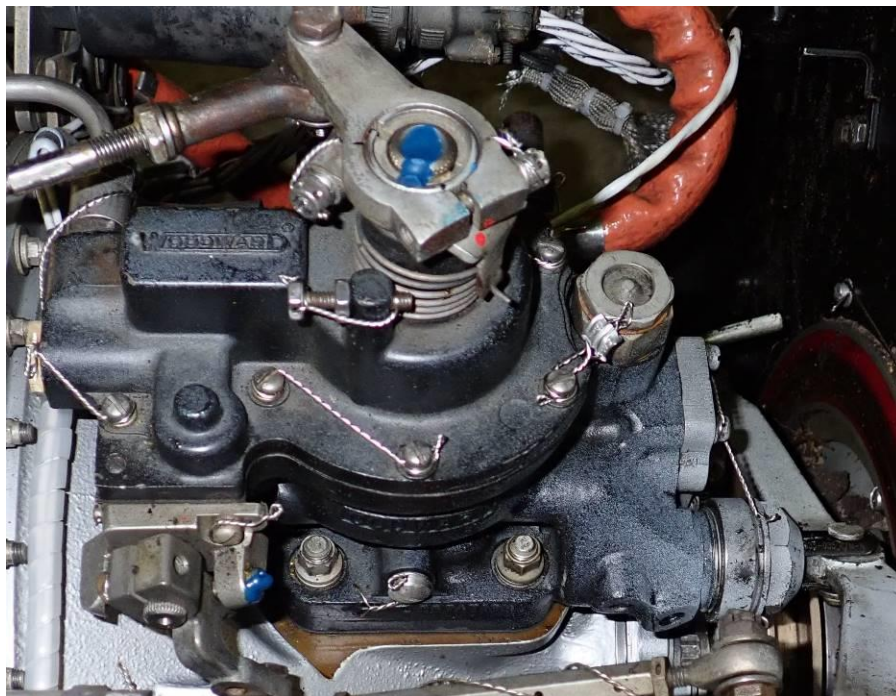
Photo No. 36

**Propeller Governor:** The governor was in place and was visually unremarkable (Ref. Photo No. 36).

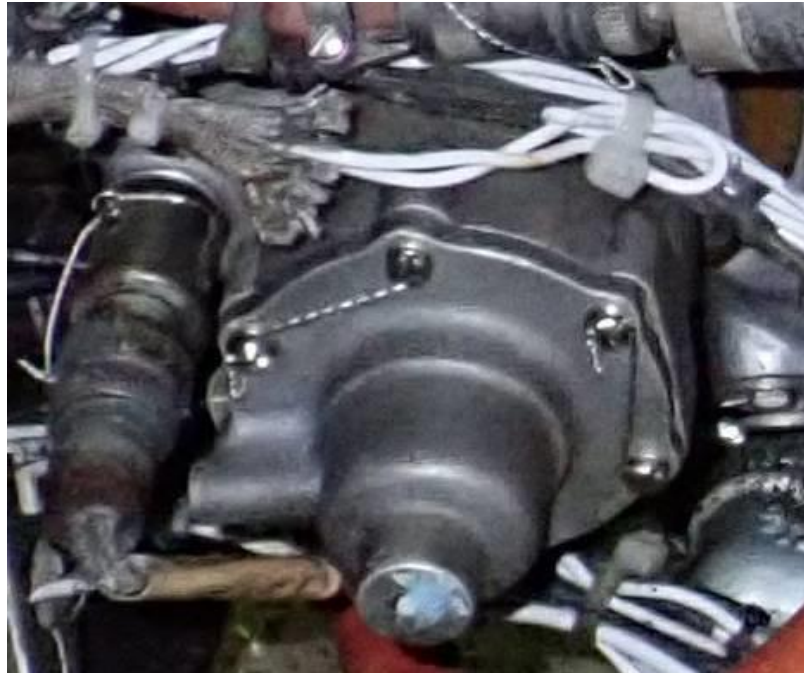
Photo No. 37

**Overspeed Governor:** The governor was in place and was visually unremarkable (Ref. Photo No. 37).

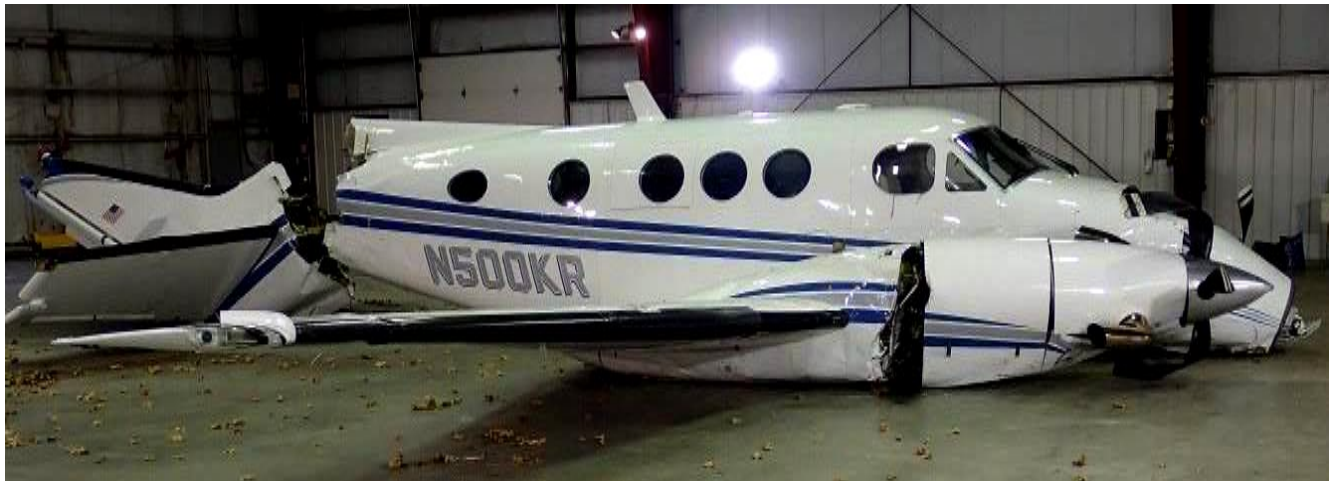
Photo No. 38

- 5.1 **External Condition:** The propeller blades displayed varying degrees of bending and the aircraft cowling was bent and distorted at numerous locations (Ref. Photos No. 38 & 39). The engine was attached to the aircraft mounts (Ref. Photo No. 40). The engine data plate shows the engine serial number is PC-E 24387 (Ref. Photo No. 41).

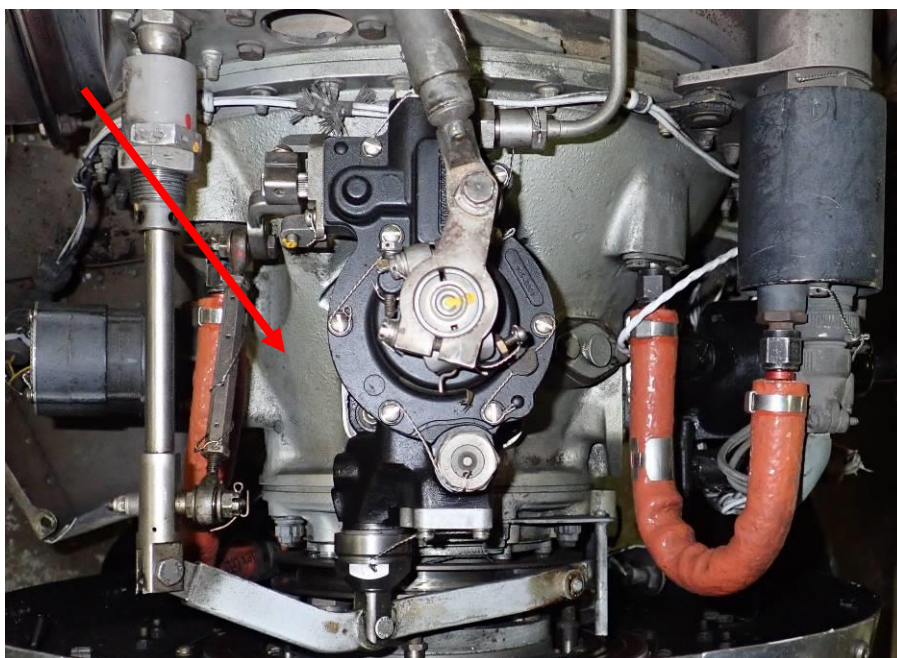
Photo No. 42

**Reduction Gearbox:** The gearbox was in place and no visible external damage was evident (Ref. Photo No. 42, red arrow).

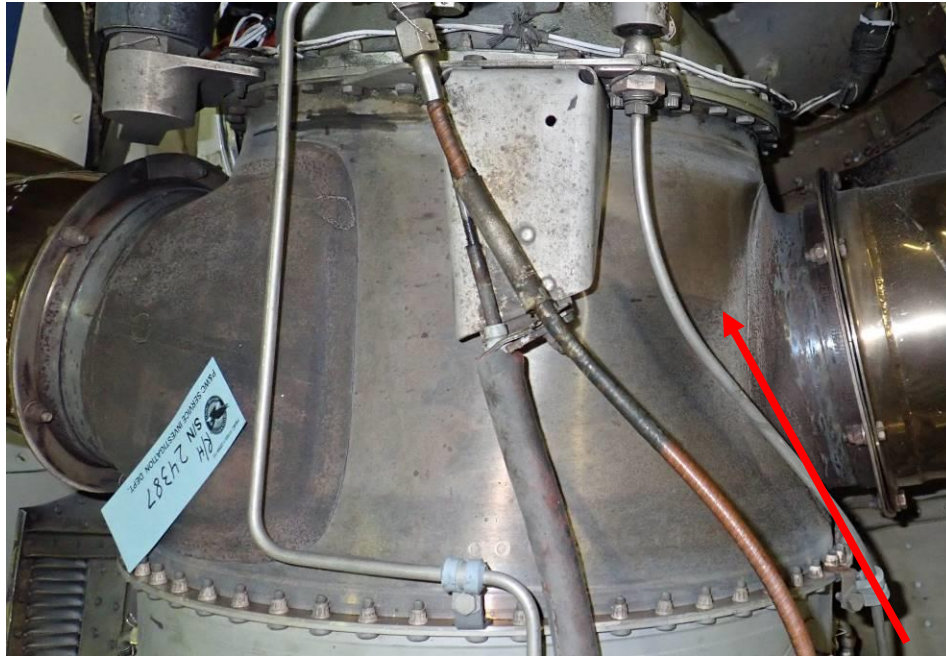
Photo No. 43

**Exhaust Duct:** The duct was compressed on the right hand side (Ref. Photo No. 43, red arrow).

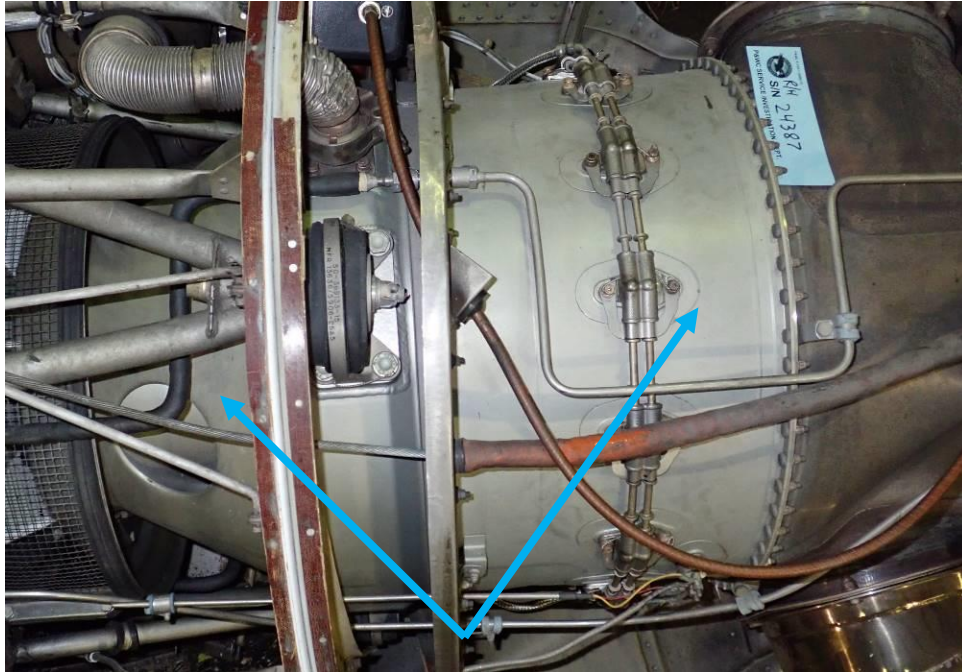
Photo No. 44

**Gas Generator Case:** The upper section of the front of the case and the visible portion of the rear section of the case were unremarkable (Ref. Photo No. 44, blue arrows). The bottom section of the case was bent adjacent to the center fire seal (Ref. Photo No. 45, blue arrow).

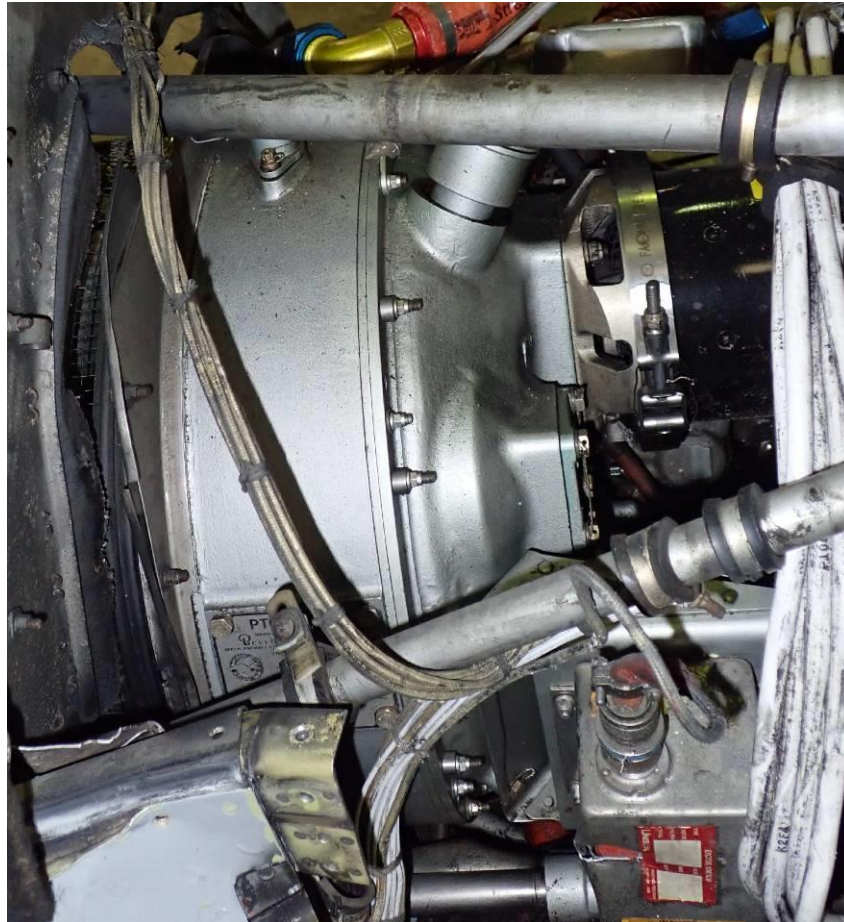
Photo No. 46

**Accessory Gearbox:** The gearbox and inlet case were in place and no visible external damage was evident (Ref. Photo No. 46).

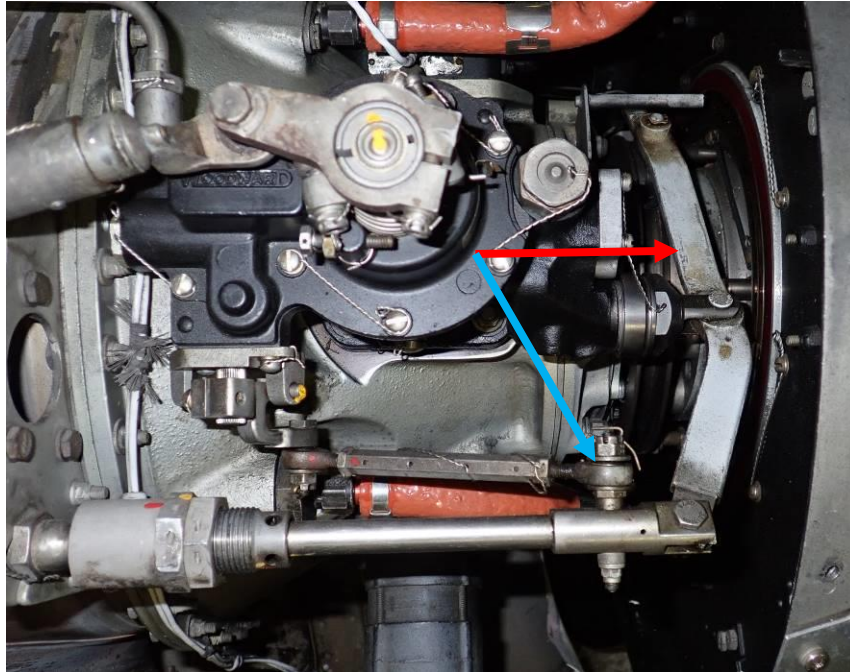
Photo No. 47

**5.1.2 Power Control and Reversing Linkage:** The propeller reversing lever was in place (Ref. Photo No. 47, red arrow). The front linkage was in place (Ref. Photo No. 47, blue arrow). The rear linkage was in place (Ref. Photo No. 48, red arrow). The end of the fuel control connection rod was bent (Ref. Photo No. 49, yellow arrow).

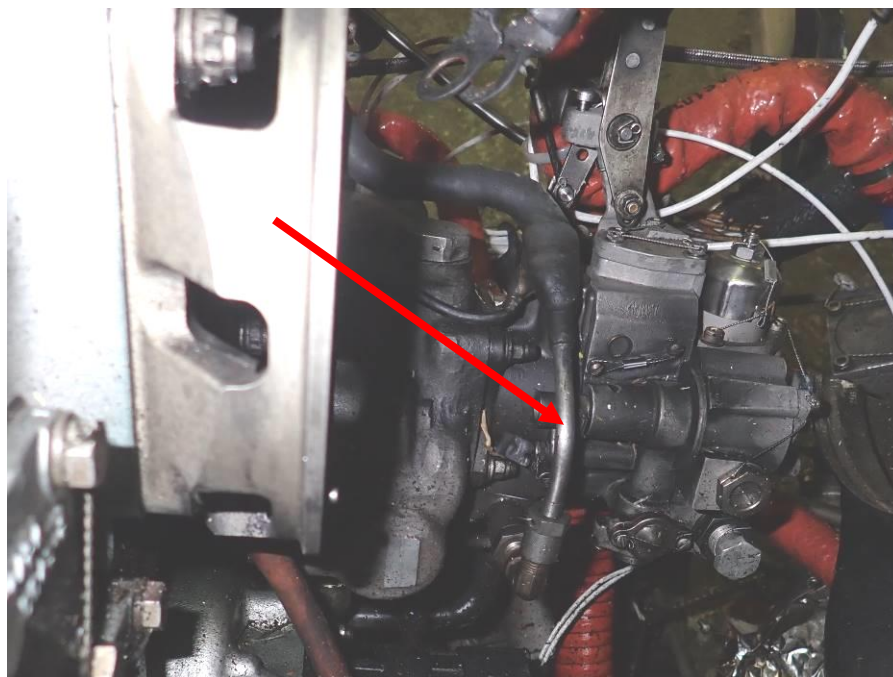
Photo No. 50

**Power Turbine Control (Py):** The line was in place and the fitting connections were secure (Ref. Photo No. 50, red arrow). The line was bent adjacent to the rear fire seal (Ref. Photo No. 51, red arrow).

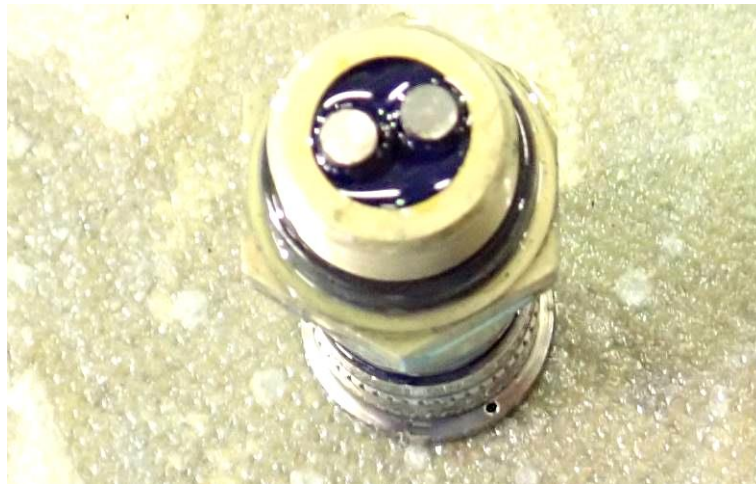
Photo No. 52

**Reduction Gearbox Chip Detector:** The chip detector poles were clean (Ref. Photo No. 52).

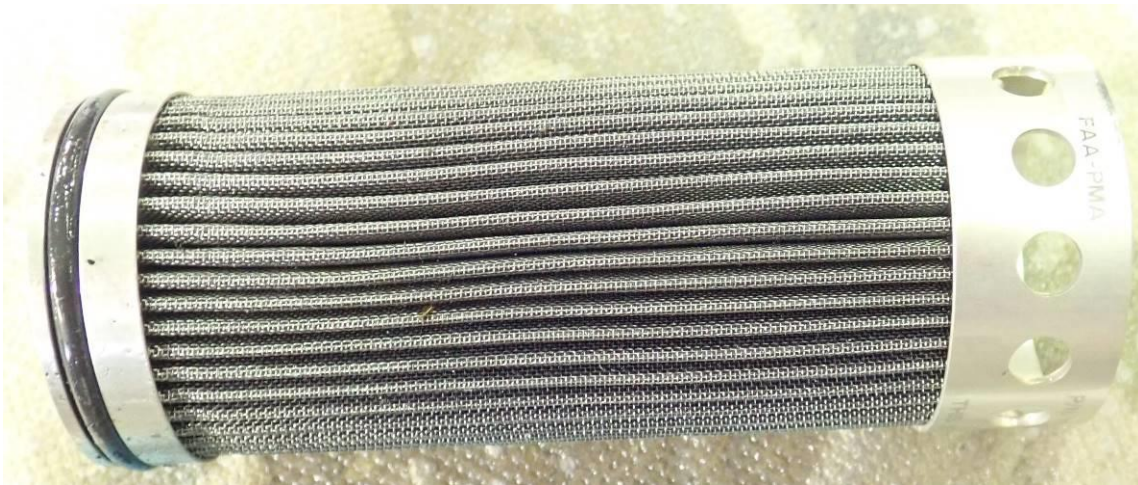
Photo No. 53

**Oil Filter:** No visible debris was evident in the oil filter (Ref. Photo No. 53).

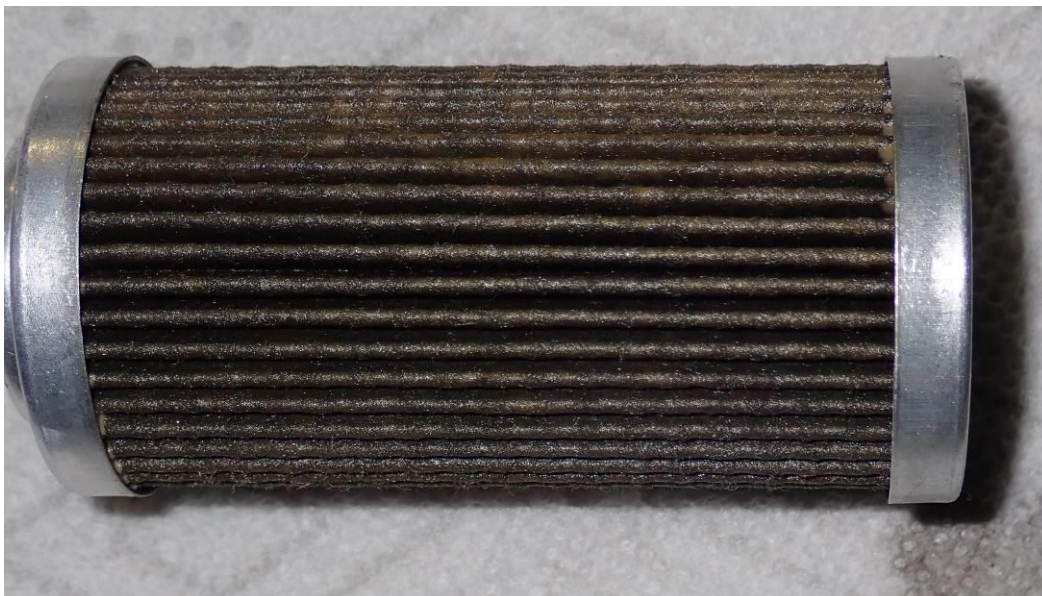
Photo No. 54

**Fuel Filter:** The filter was discoloured, most likely from sediment in the fuel (Ref. Photo No. 54). The residual fuel in the filter bowl was clean but the interior of the bowl was stained (Ref. Photo No. 55).

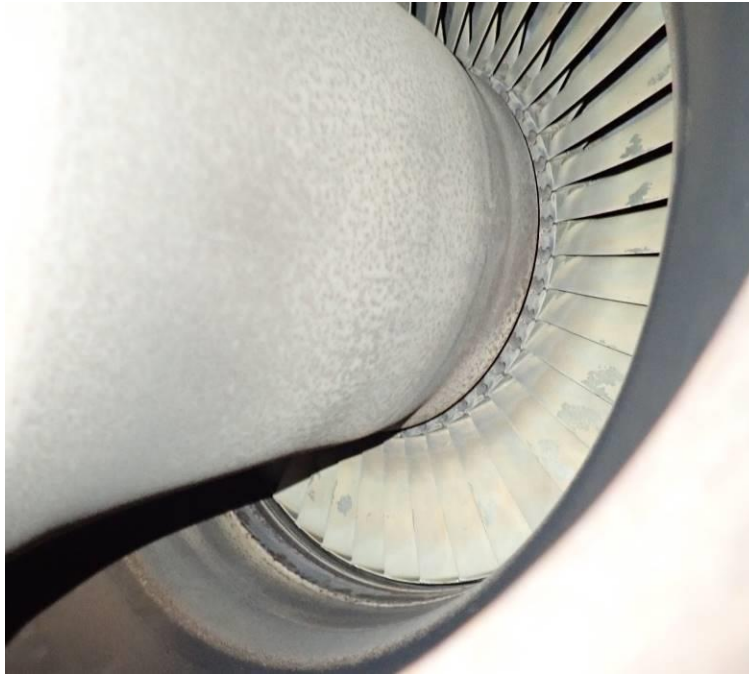
Photo No. 56

**Power Turbine:** The left hand exhaust stack was removed and the power turbine was viewed through the exhaust port. The turbine blades were in place (Ref. Photo No. 56).

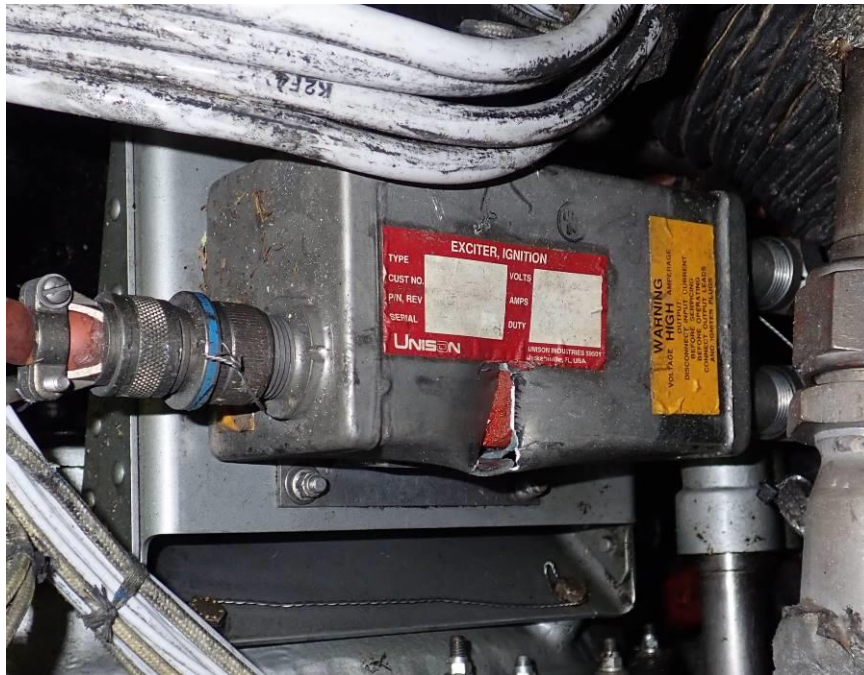
Photo No. 57

**Exciter Box:** The box was attached to its respective mount on the aircraft. The exterior of the box breached from impact damage (Ref. Photo No. 57).
