**Accident / Incident Report**

**Report No.: 17-183**

[REDACTED]  
Beech C90, N500KR  
Rockford, Illinois  
December 4<sup>th</sup> 2017  
PT6A-21  
Left-hand S/N 24390  
Right-hand S/N 24387

**Date of Issue:** May 25, 2018

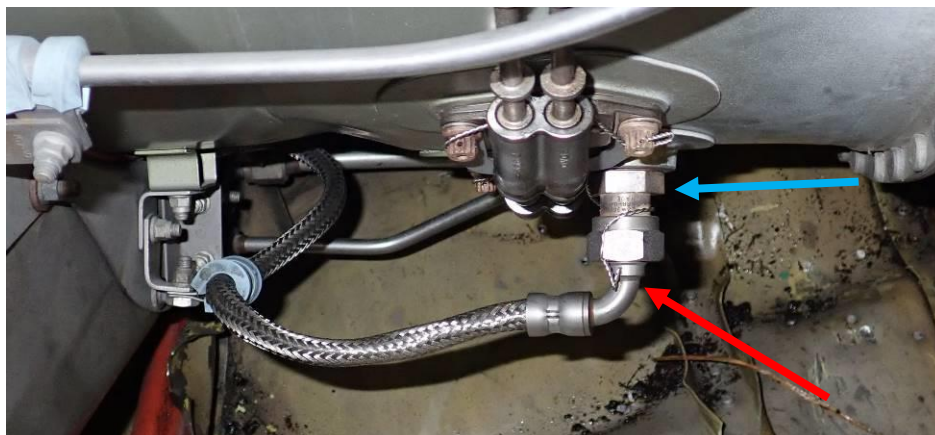
Photo No. 58

**Ignition Leads:** The leads were in place and secured (Ref. Photo No. 58, red arrow).

**Ignition Plugs:** The leads were in place and secured (Ref. Photo No. 58, blue arrow).

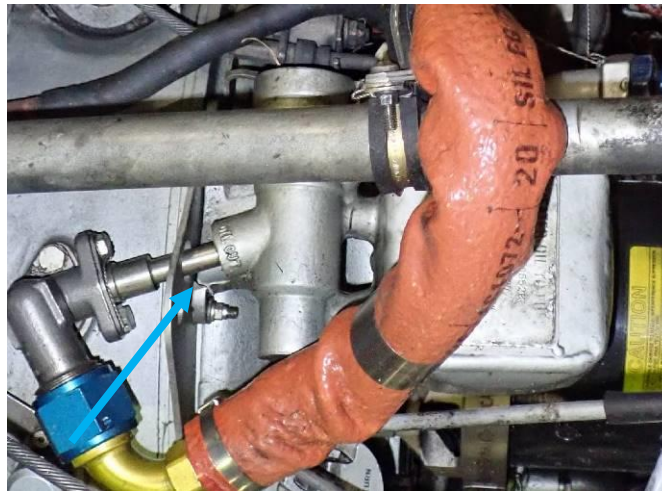
Photo No. 59

**Fuel Heater:** The heater was in place and one mount was fractured (Ref. Photo No. 59, blue arrow).

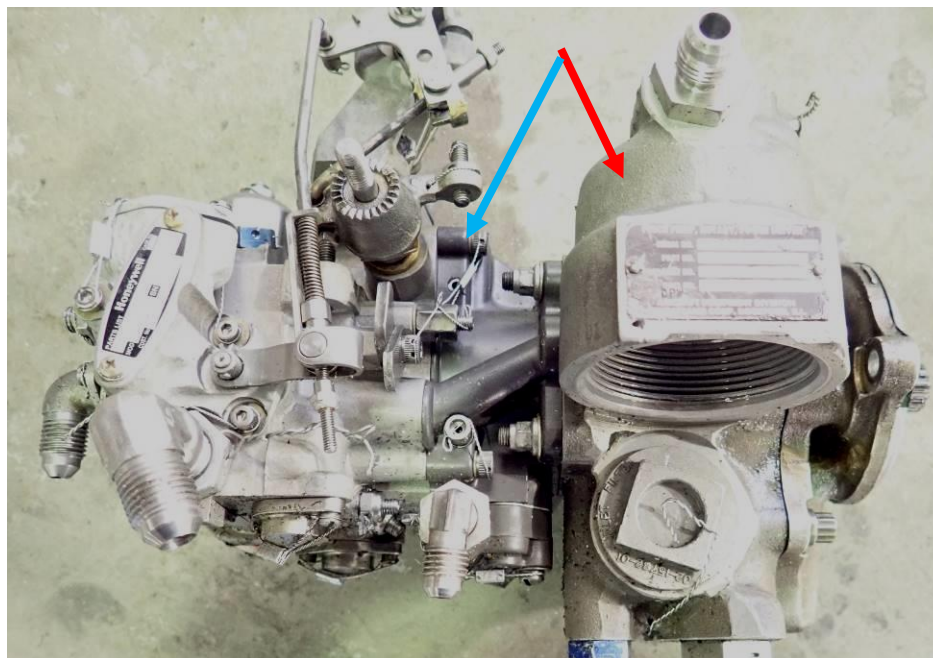
Photo No. 60

**Fuel Pump:** The pump was in place on its respective accessory gearbox mounting pad. The pump was removed (Ref. Photo No. 60, red arrow) from the gearbox and it was separated from the fuel control. The pump was capable of manual rotation. The inlet filter was removed, no contamination was noted, but the strainer portion was stained (Ref. Photo No. 61). The pump was disassembled (Ref. Photo No. 62).

**Fuel Control Unit:** The control was secured to the mounting pad on the fuel pump (Ref. Photo No. 60, blue arrow). The control was removed from the pump (Ref. Photo No. 68). The fuel control to fuel pump coupling was found unremarkable (Ref. Photo No. 68, red arrow). The control rotated freely with manual input on the drive shaft.

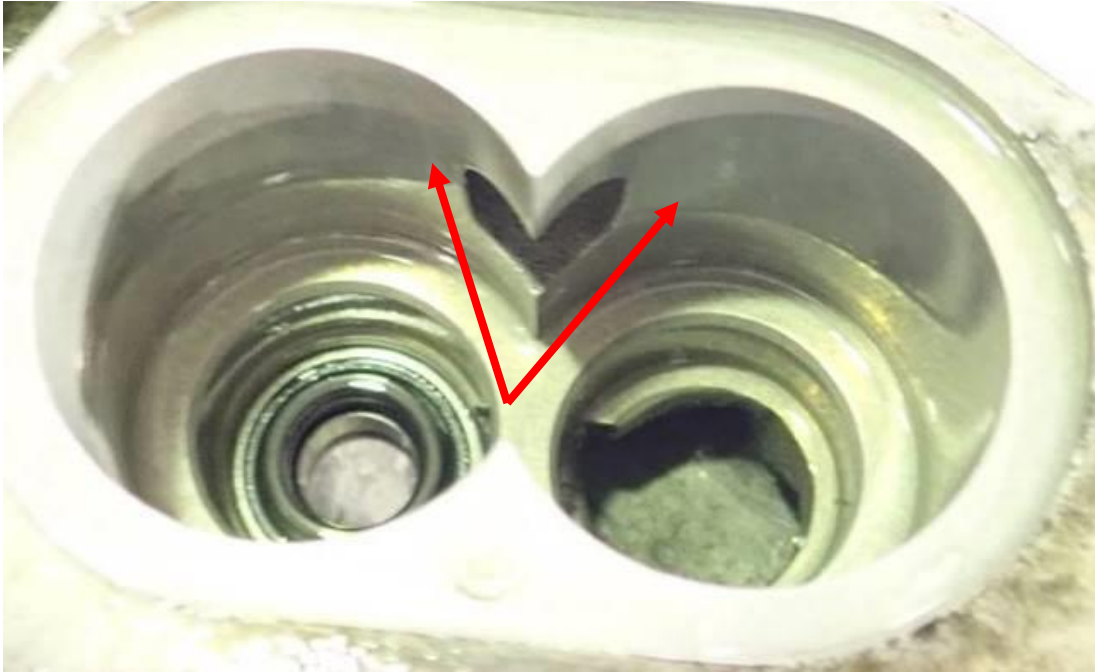
Photo No. 63

The right hand engine's fuel pump displayed cavitation pits on the front plain bearing, several pits on one of the rear bearings, polishing of the pump housing, and the scoring on the shafts indicates that the pump was operated without an adequate supply of fuel.

The fuel pump housing exhibited some polished regions from contact with the gears (Ref. Photo No. 63, red arrows). The teeth on both gears exhibited frosted regions on their contact surfaces (Ref. Photos No. 64 & 66). Light scoring was evident on the shaft bearing land surfaces of the gears (Ref. Photos No. 64 & 65).

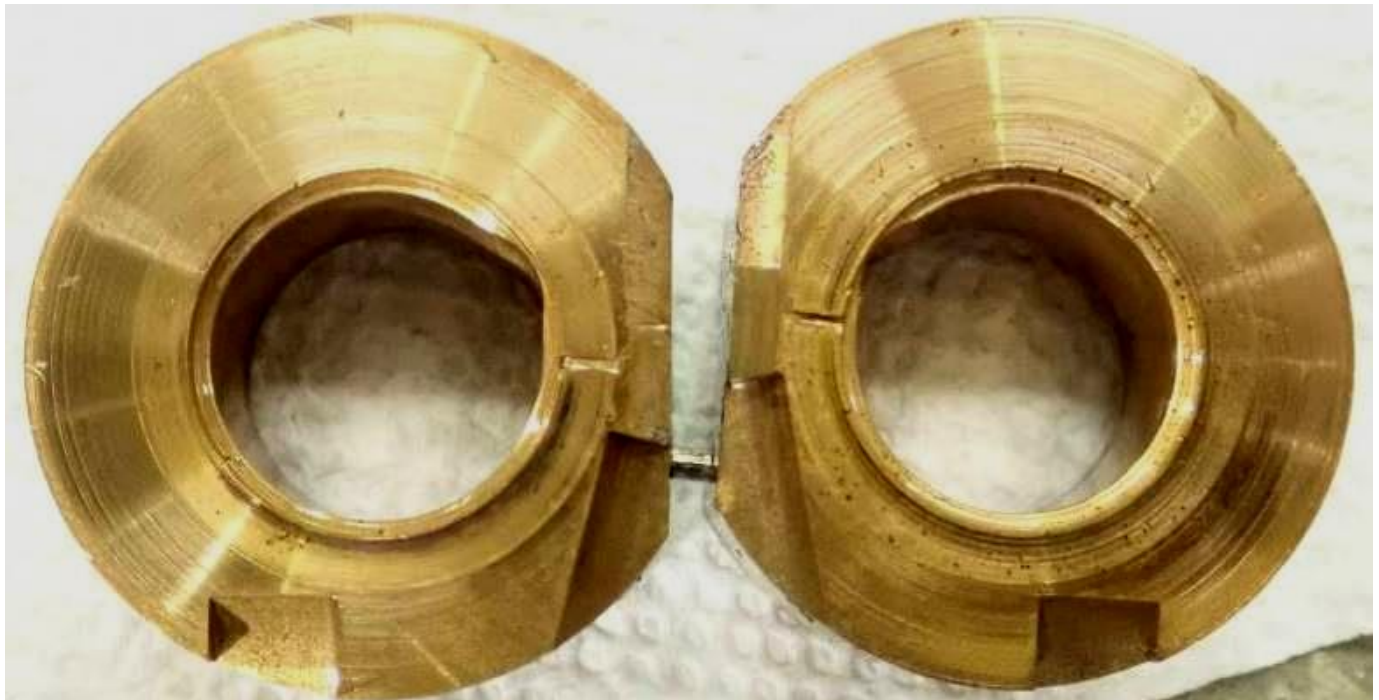
The fuel pumps from both engines exhibited evidence of cavitation from a lack of lubrication on the plain bearings. This damage is consistent with the pumps operating without an adequate fuel supply.

The front bearings exhibited multiple cavitation pits on the gear contact faces and in the bearing bores (Ref. Photo No. 66). The rear bearing exhibited some pits on the gear contact face (Ref. Photo No. 67). The pump surfaces are lubricated by the fuel passing through the pump. The bearing cavitation pits indicates that pump was operated without an adequate fuel supply.

Photo No. 66, Front bearings

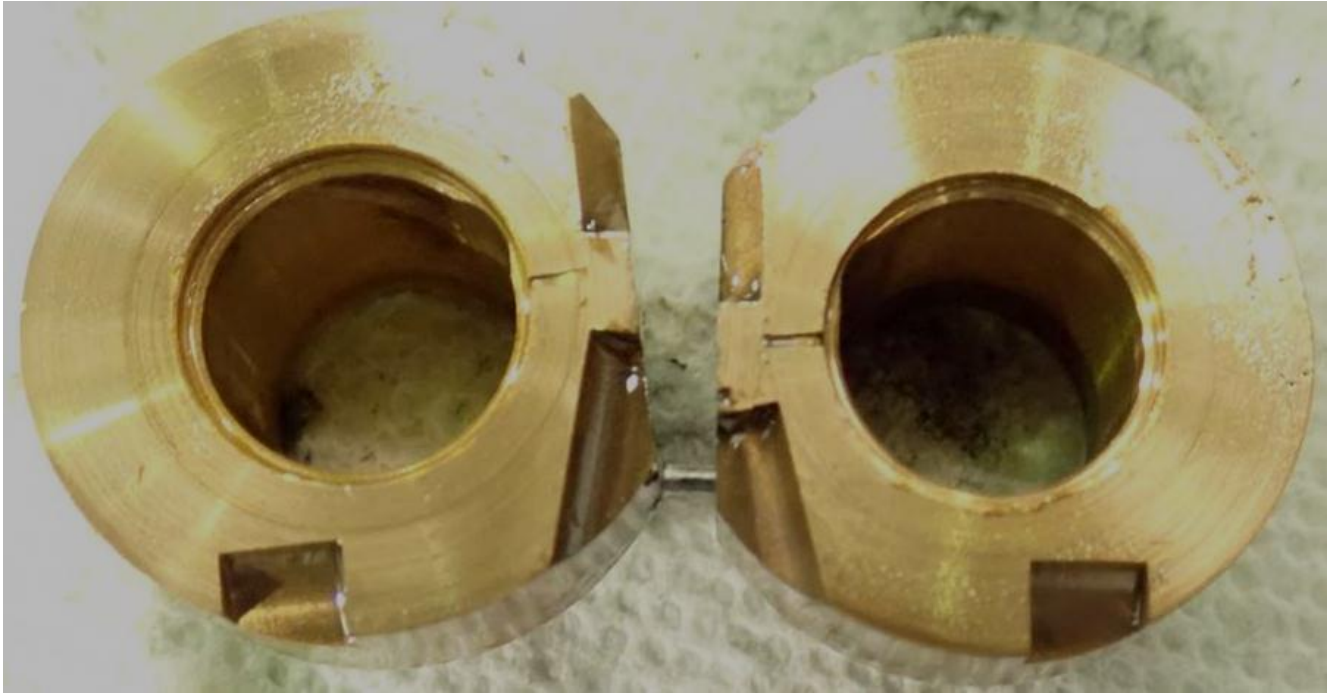
Photo No. 67, Rear bearings

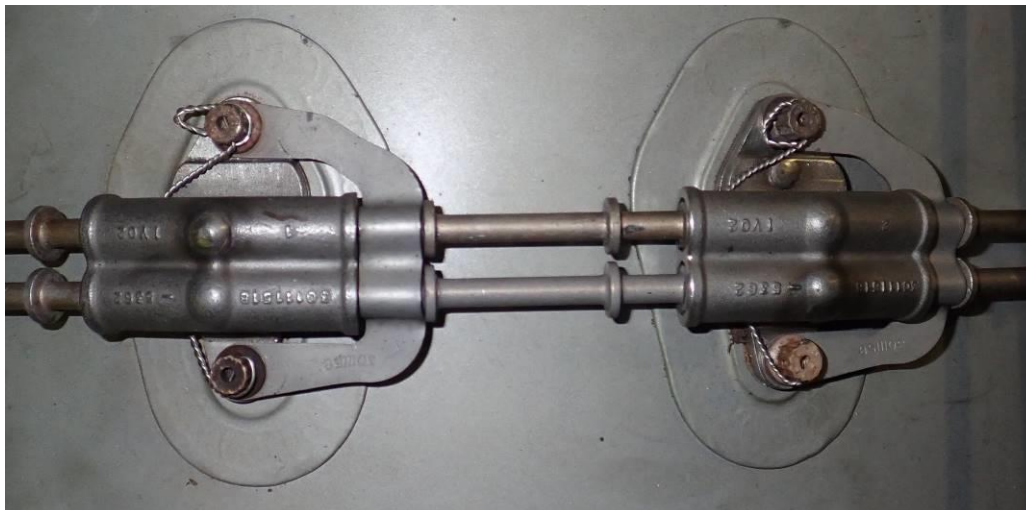
Photo No. 69

**Fuel Nozzles:** The nozzles were in place and were visually unremarkable (Ref. Photo No. 69).

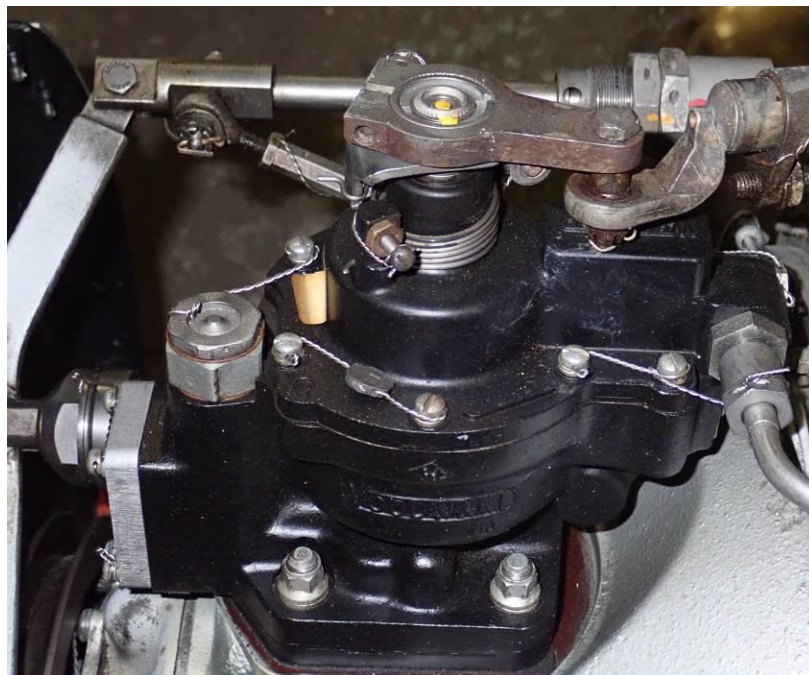
Photo No. 70

**Propeller Governor:** The governor was in place and was visually unremarkable (Ref. Photo No. 70).

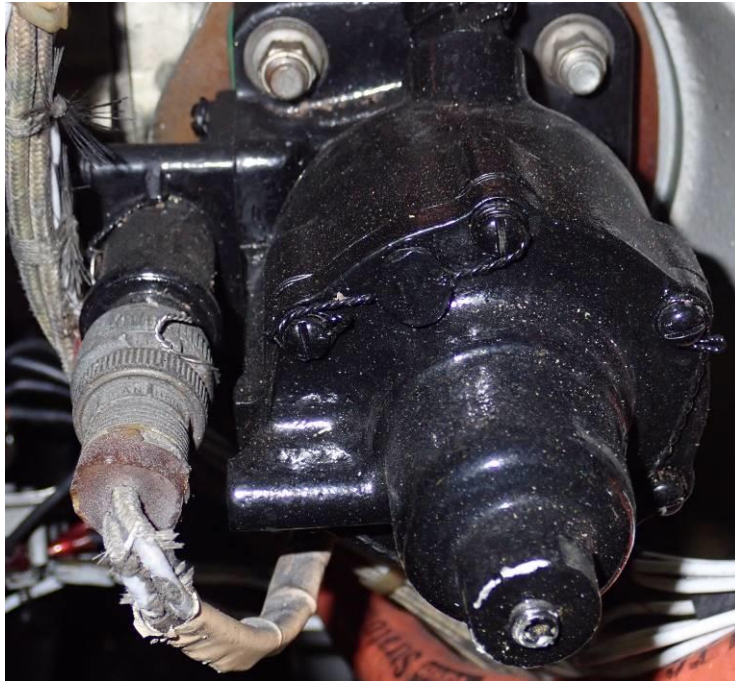
Photo No. 71

**Overspeed Governor:** The governor was in place and was visually unremarkable (Ref. Photo No. 71).
